1. Project Name: Agat SBH
2. Date of Inspection: January 28, 2004
3. Inspection Personnel:

AGAT SMALL BOAT HARBOR, GUAM

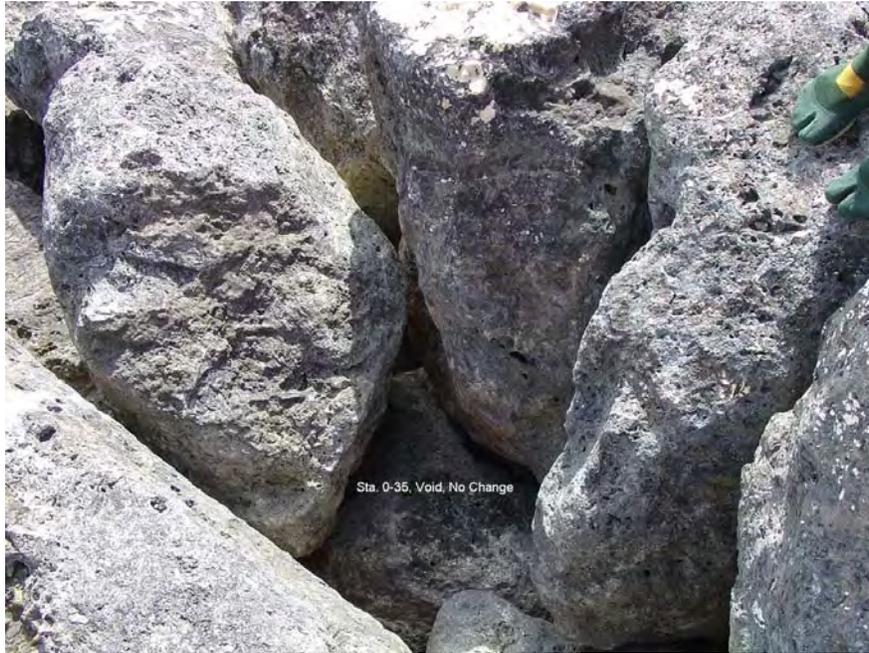
a. Sta. 0-35, Crest/Sideslope, Void, the missing armor stones appear to be resting on the OS of the structure. No Change (NC) this year.

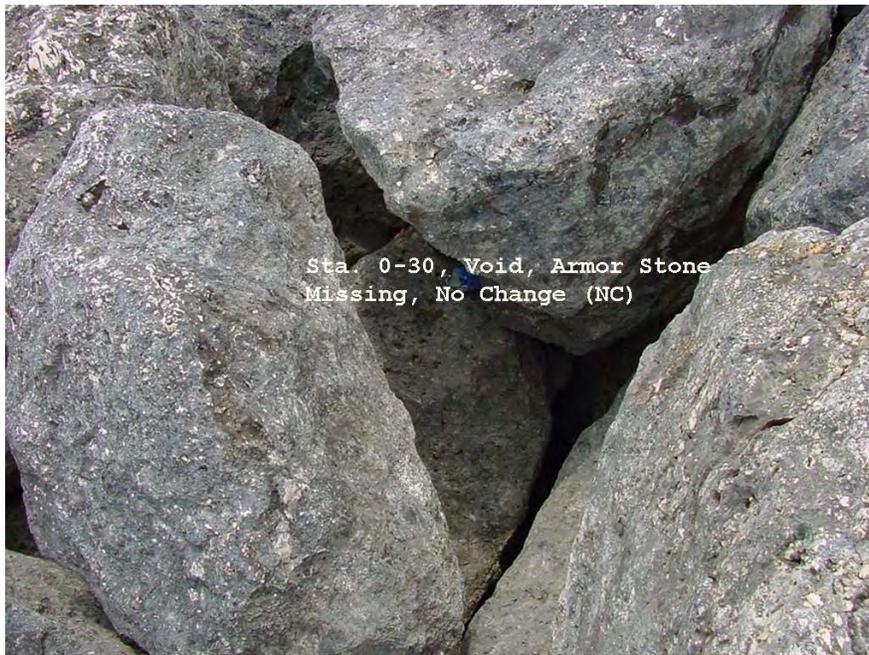
b. Sta. 0-30, Crest/Sideslope, Void, the missing armor stones appear to be resting on the OS of the structure. (FY03 photo, NC)

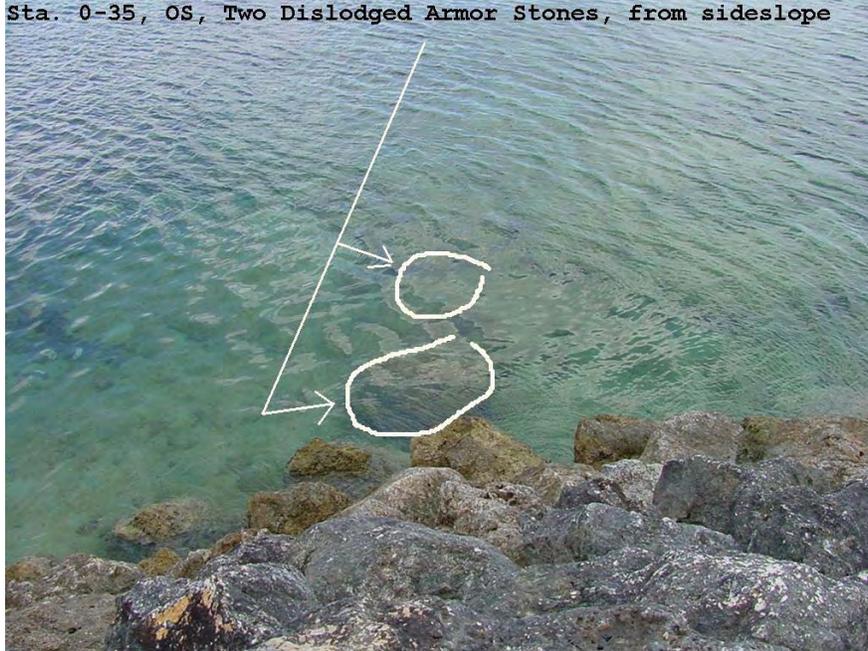
c. Sta. 0-35, 2 ea. armor stones (AS) are resting adjacent the structure. These AS may be from the above identified voids. NC this year (FY03 photo).

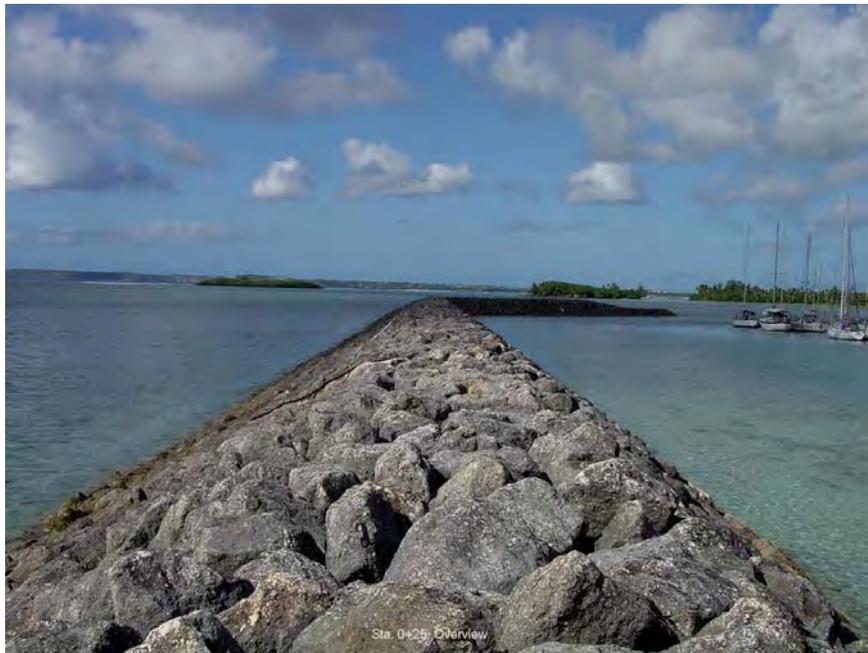
d. Sta. 0+25, Overview (reference photo).

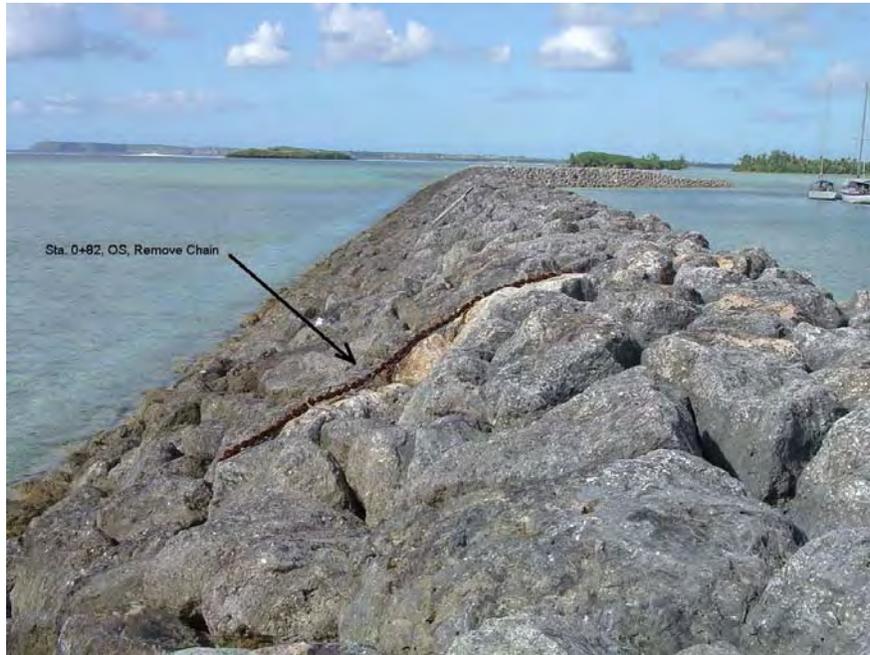
e. Sta. 0+82, OS, Remove chain.

Vegetation removal from the structures should be accomplished before conditions worsen. The chains that are installed by persons unknown, on the main breakwater needs to be removed. These are used for temporary mooring during storms and have not been designed into the project. The issue was discussed in a meeting with Mr. Simion DeLosSantos and Deputy Director, Mr. Paul M. Shintaku of Guam Port Authority. The Corps' concerns were re-iterated regarding the encroachment into the access channel and turning basin and its associated potential hazards. Mr. Shintaku requested that we send another letter stating our concerns and mentioned that this would help to facilitate the removal process. Mr. Meyers will follow-up with Mr. DeLosSatos regarding this issue.

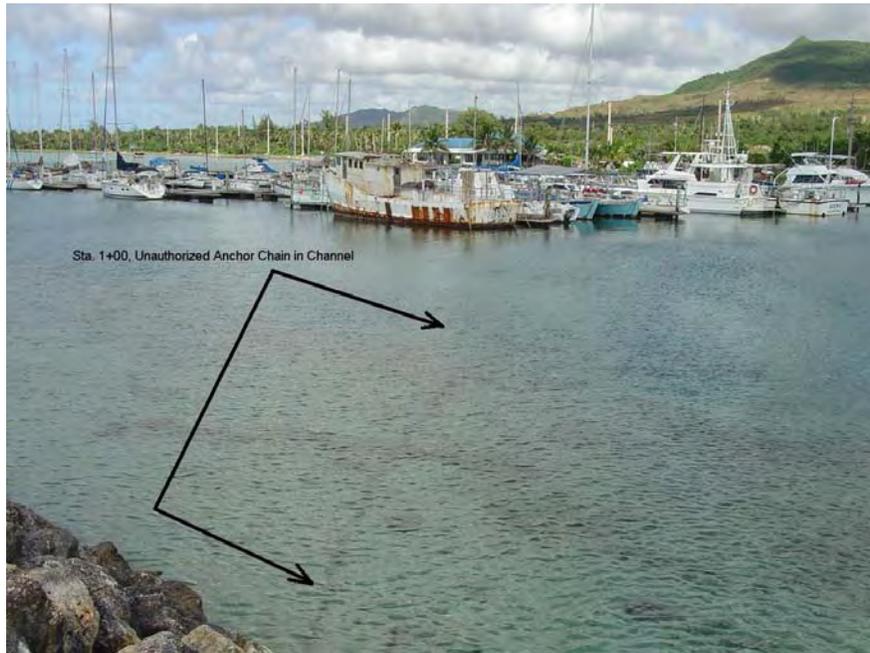
f. Sta. 1+00, HS, Un-authorized Anchor chain crossing channel.

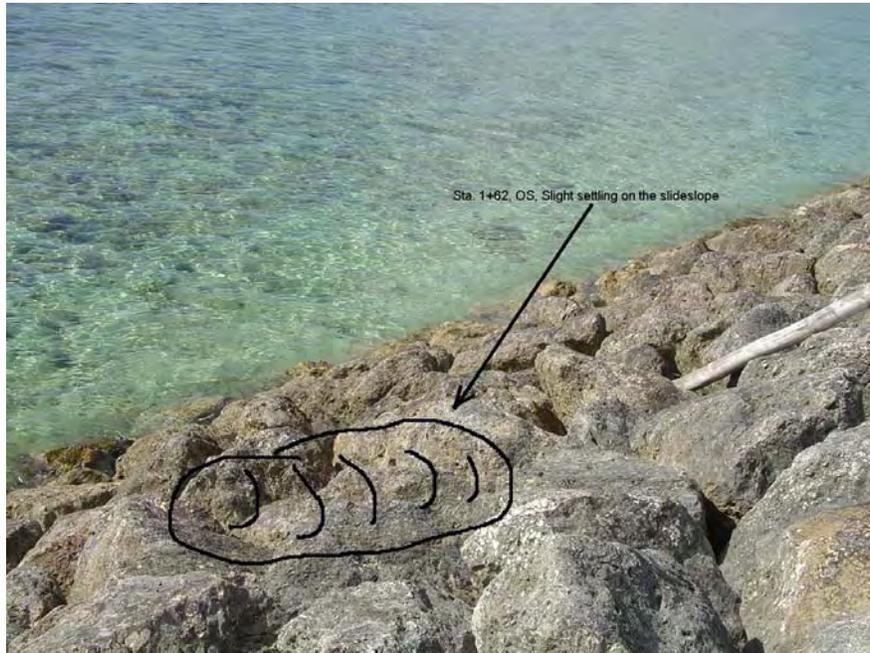
g. Sta. 1+62, OS, Monitor slight settling on the sideslope.

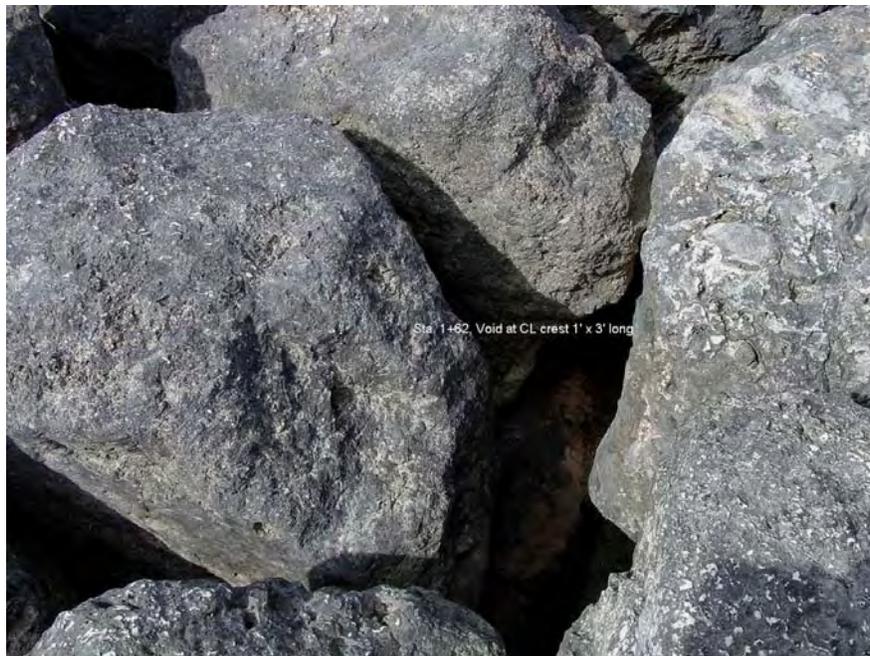
h. Sta. 1+62, CL, 1' x 3' void at crest (new this year).

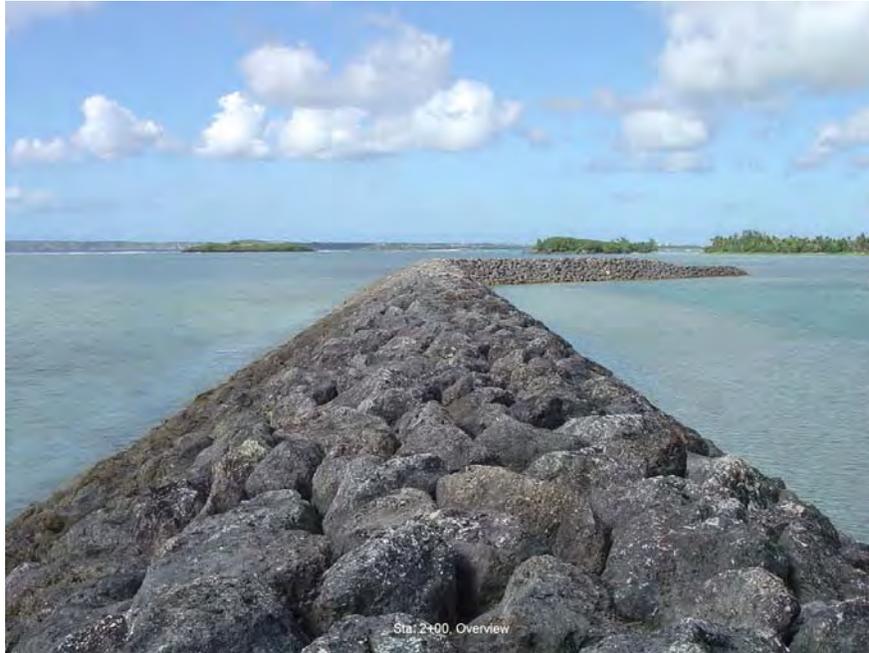
i. Sta. 2+00, Overview (reference photo).

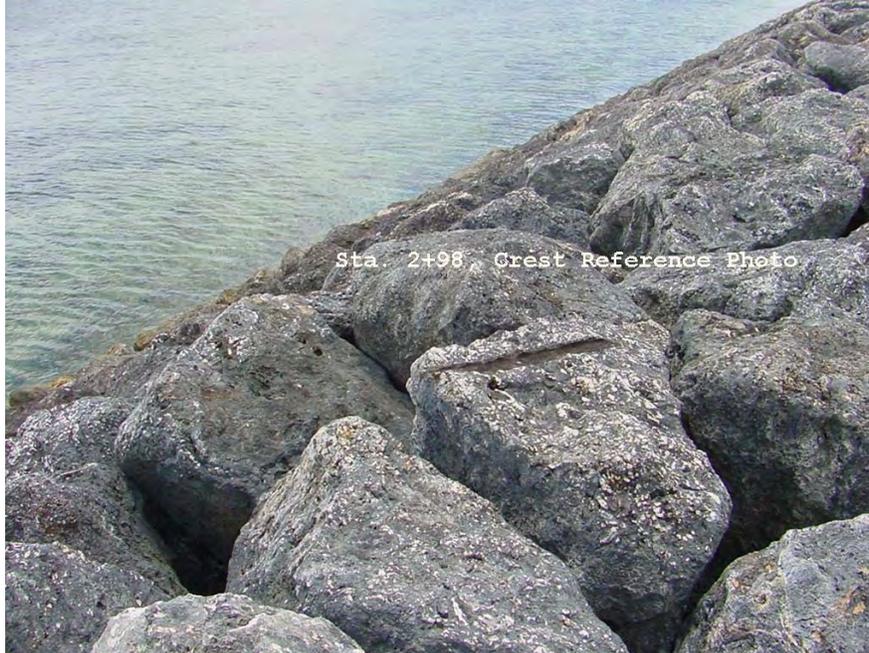
j. Sta. 2+98, Overview (FY03 photo).

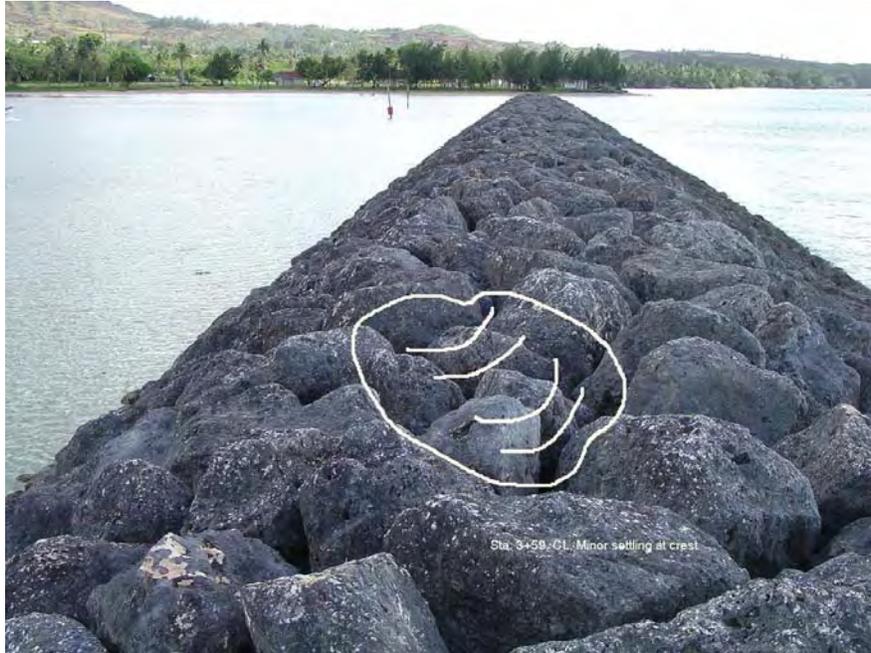
k. Sta. 3+59, CL, Monitor minor settling.

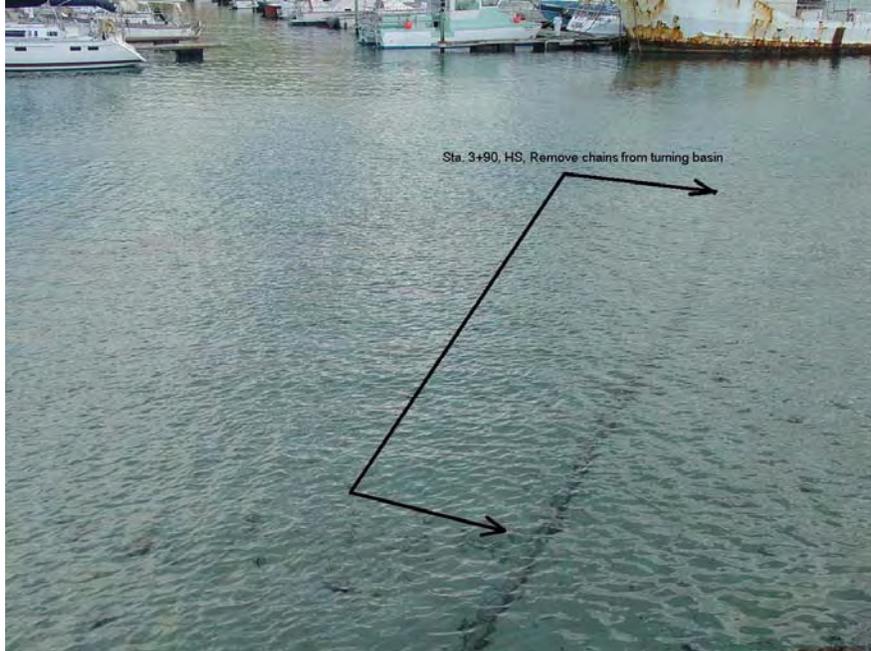
l. Sta. 3+90, HS, Remove chains.

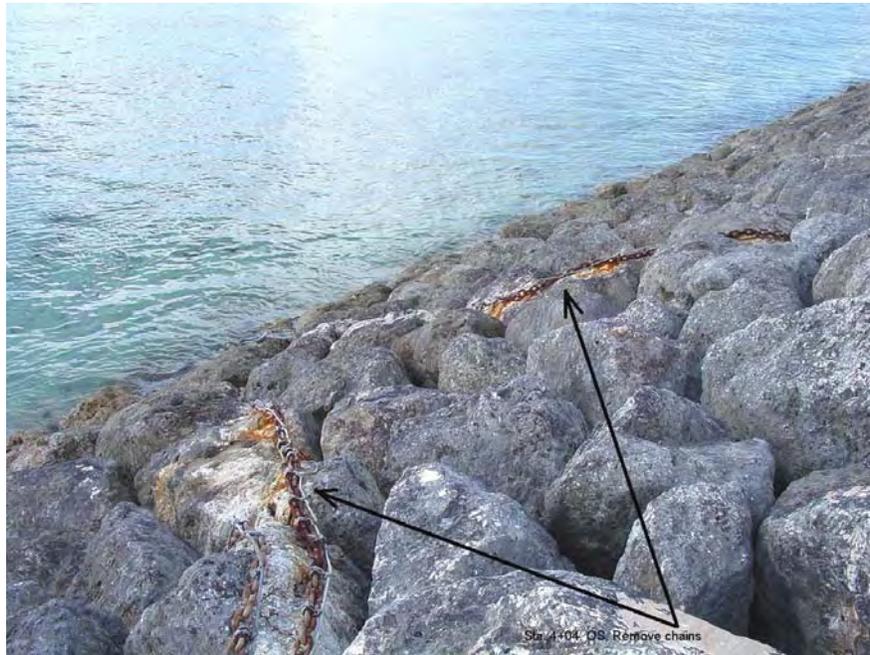
m. Sta. 4+04, OS, Remove chains.

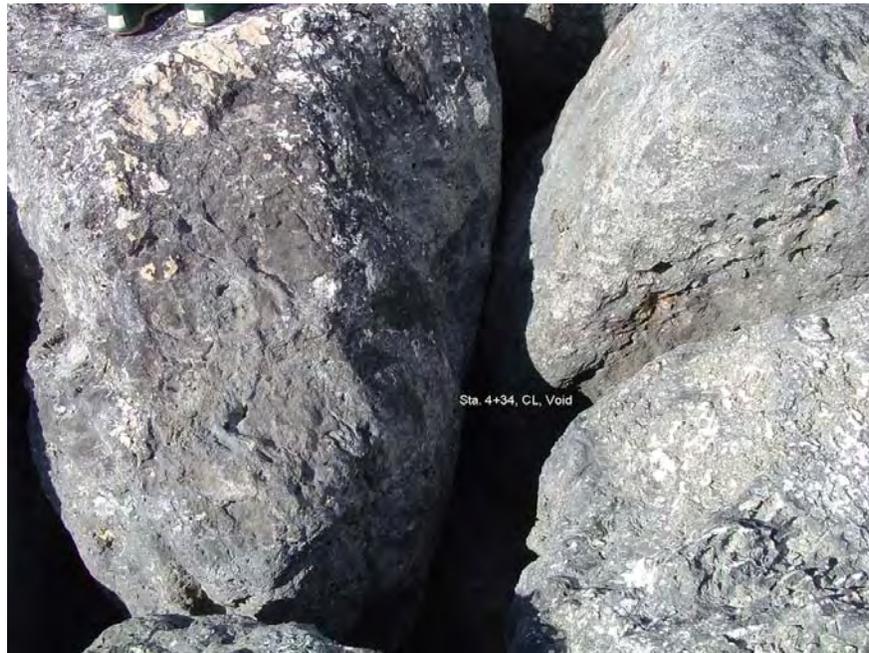
n. Sta. 4+34, CL, Void (new this year).

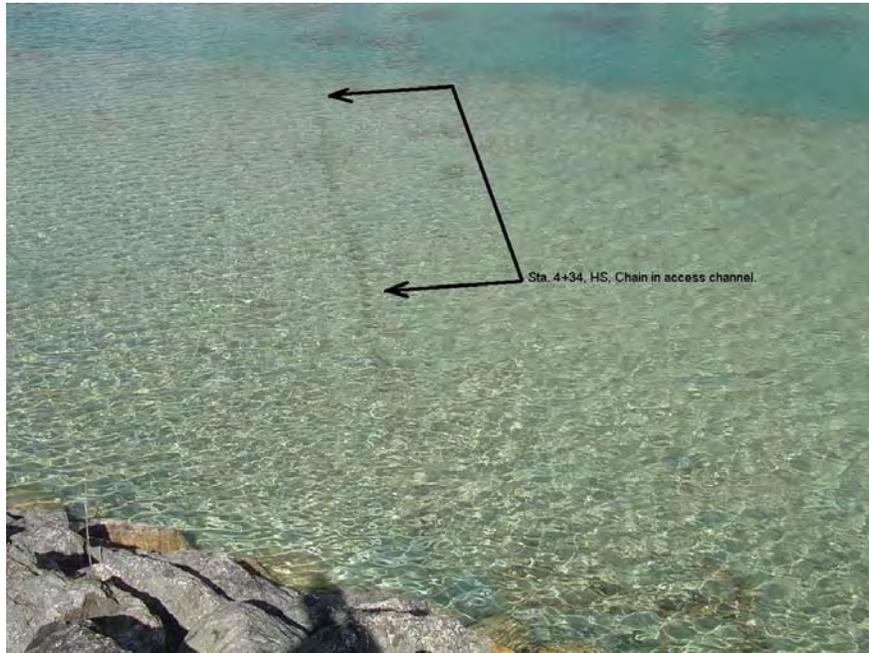
o. Sta. 4+34, HS, Remove chain in access channel (new this year).

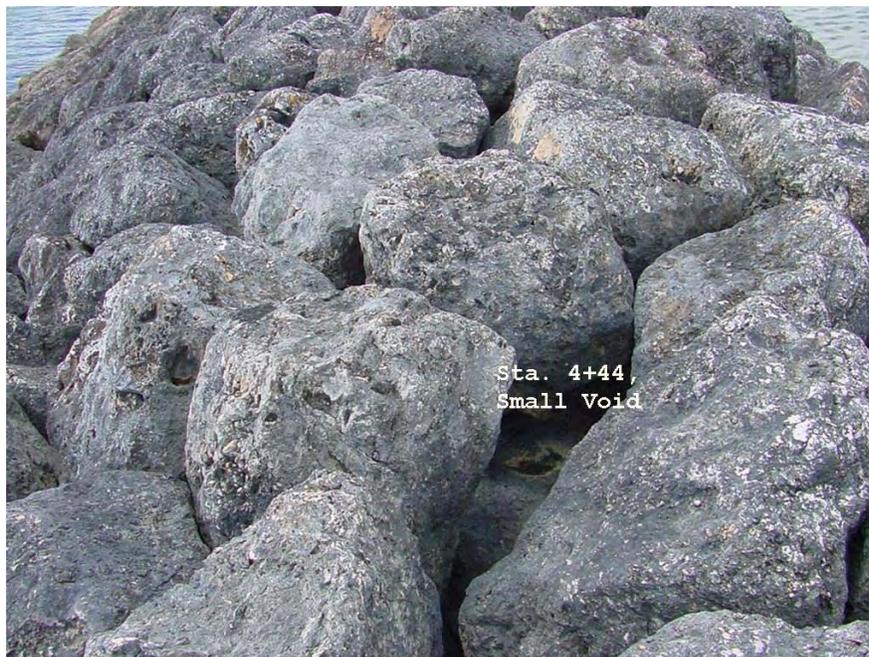
p. Sta. 4+44, CL, Monitor small void, no obvious settling. (FY03 photo, NC).

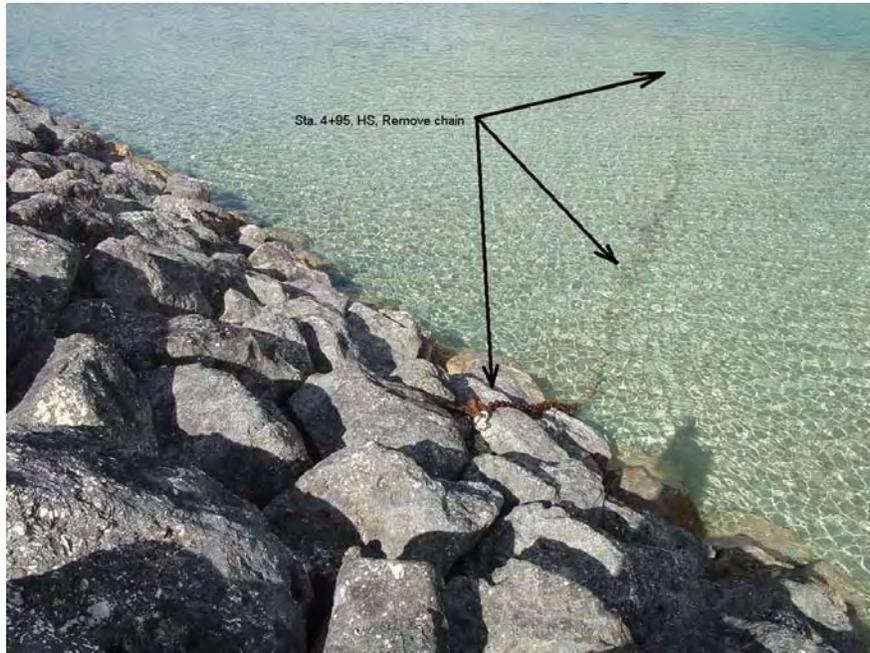
q. Sta. 4+95, HS, Remove chains, slight settling at crest.

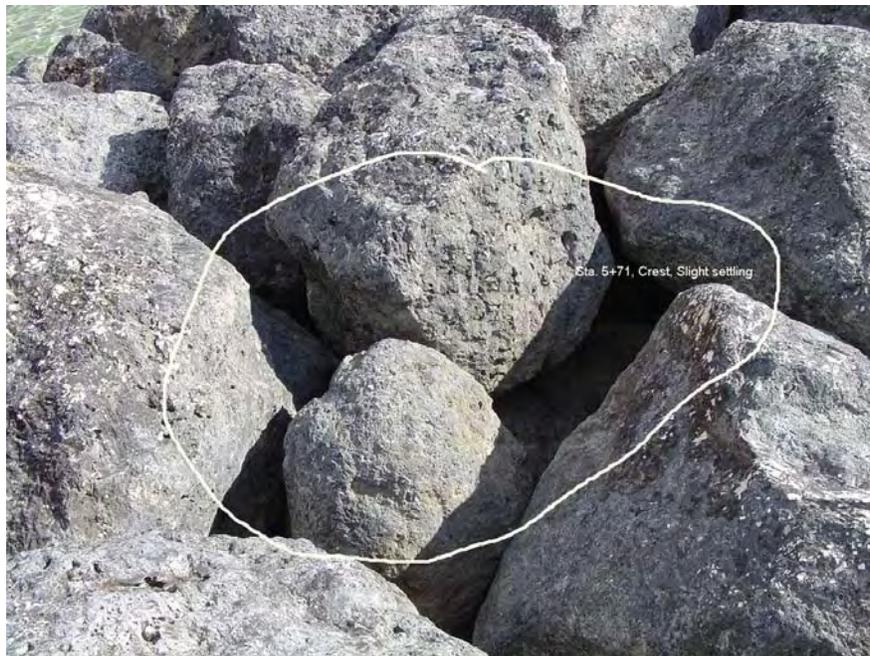
r. Sta. 5+71, CL, Monitor slight settling.

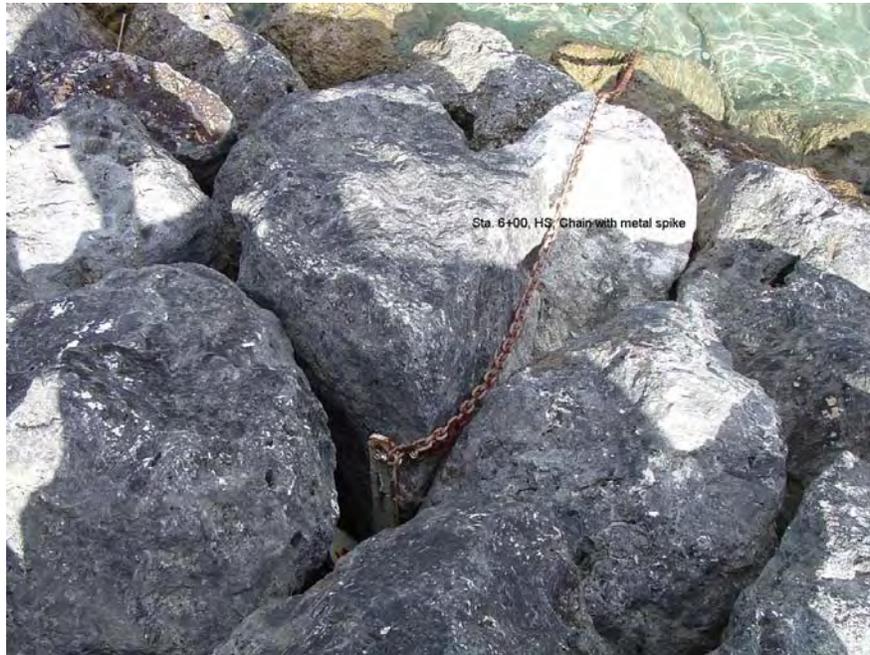
s. Sta. 6+00, HS, Chain w/metal spike.

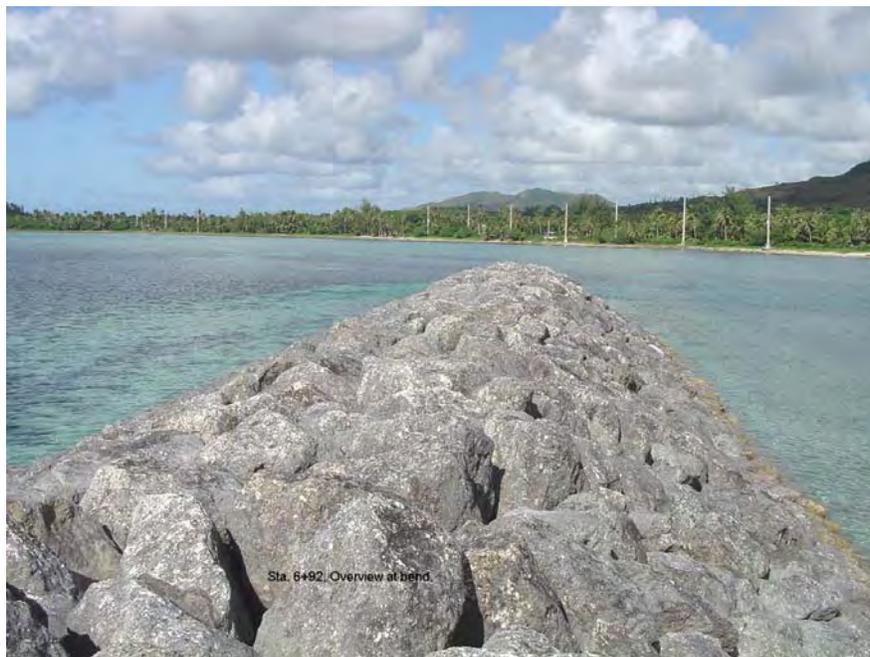
t. Sta. 6+92, Overview (reference photo).

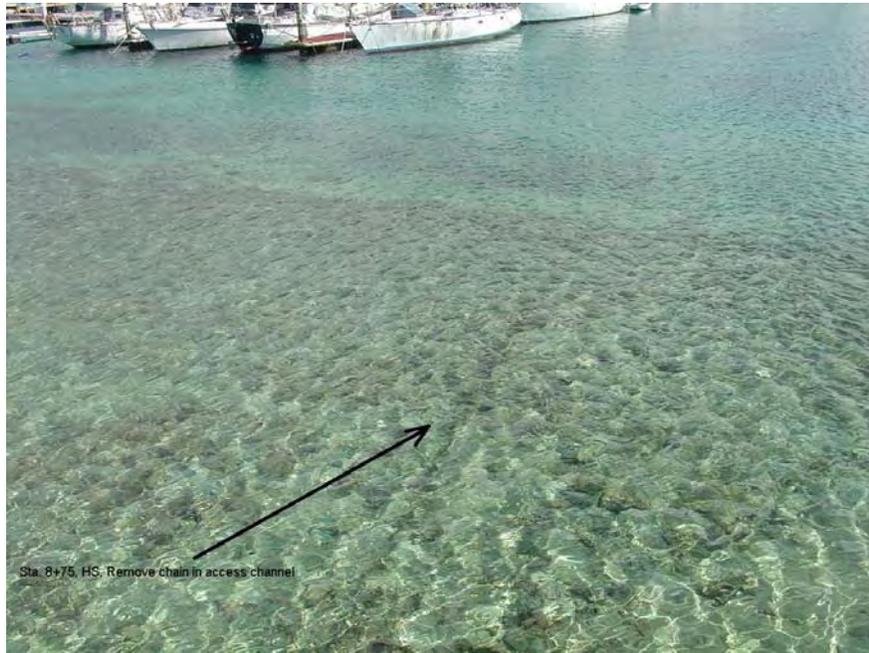
u. Sta. 8+75, HS, Remove chain in access channel.

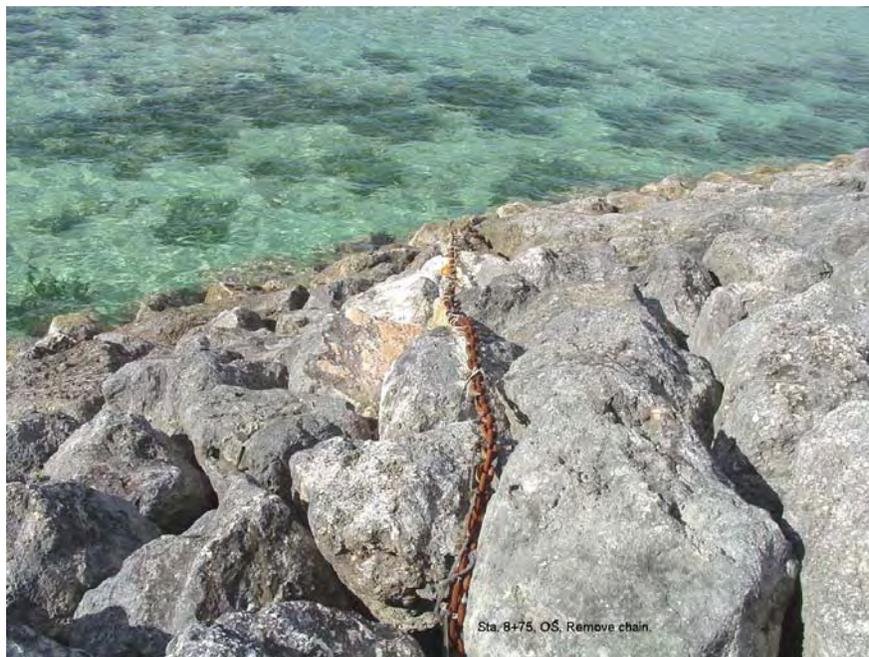
v. Sta. 8+75, OS, Remove chain.

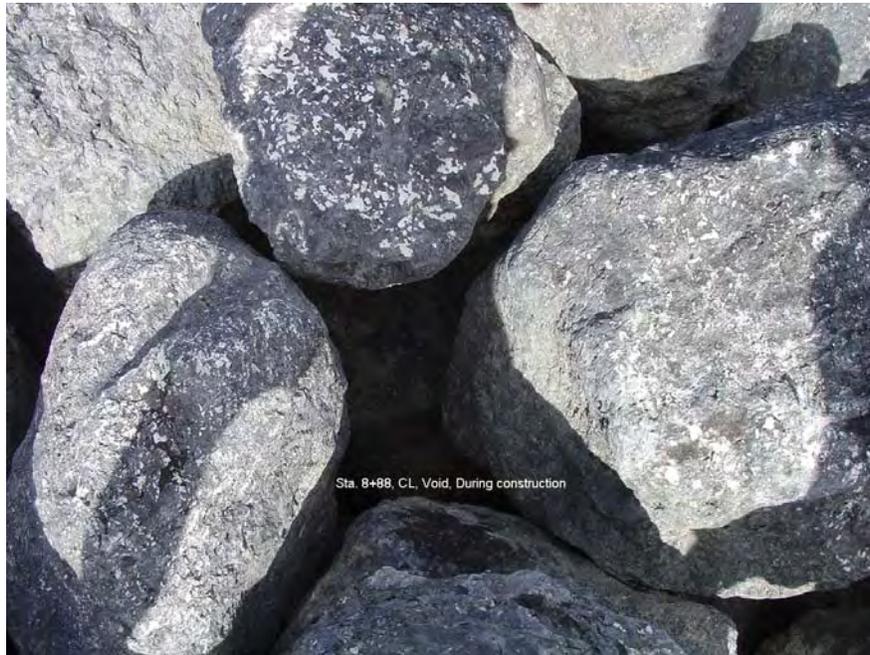
w. Sta. 8+88, CL, Monitor void area, no change this year.

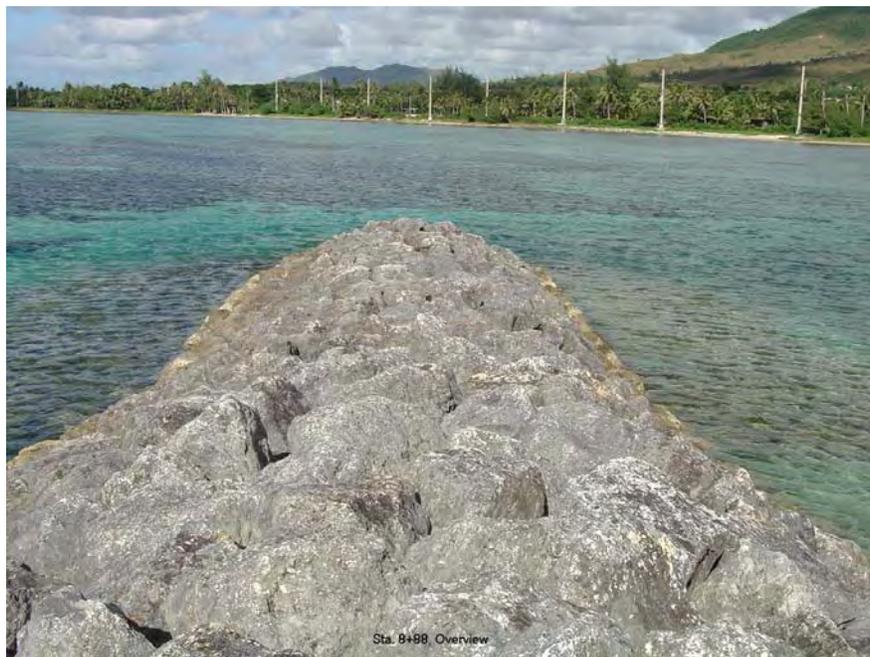
x. Sta. 8+88, Overview.

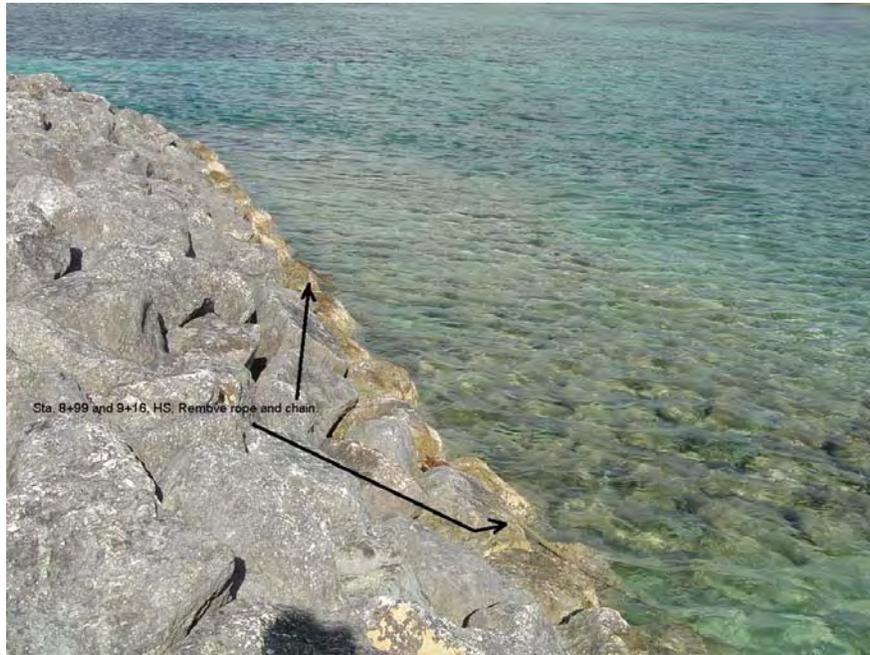
y. Sta. 8+99, HS, and 9+16, Rope and chain.

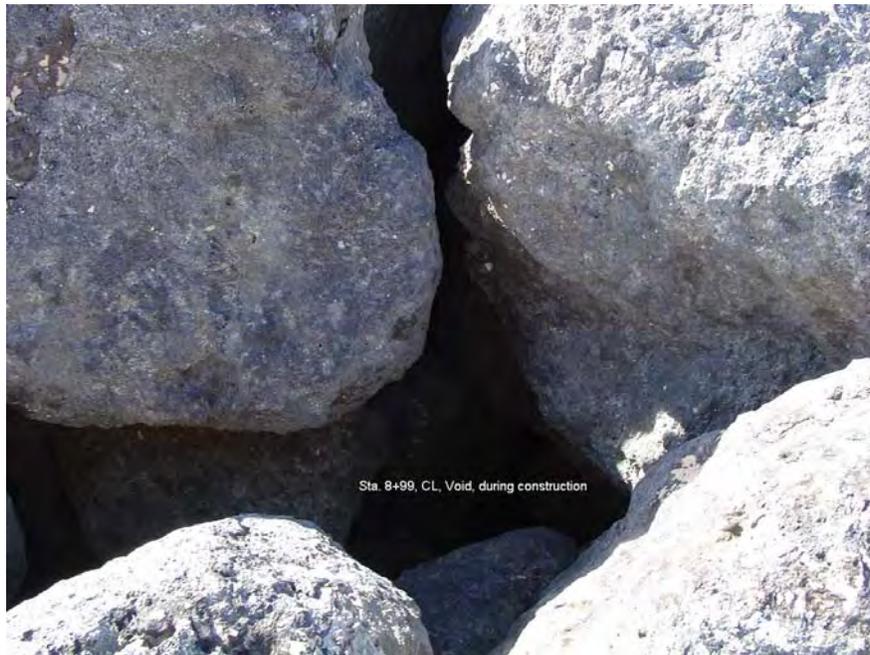
z. Sta. 8+99, CL, Monitor void area. No Change this year.

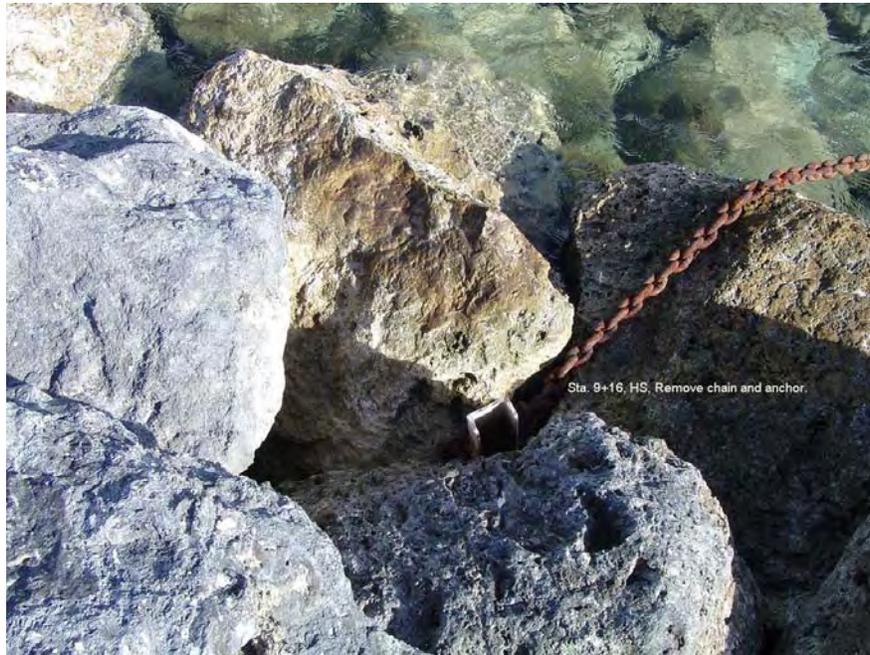
aa. Sta. 9+16, HS, Remove chain and anchor.

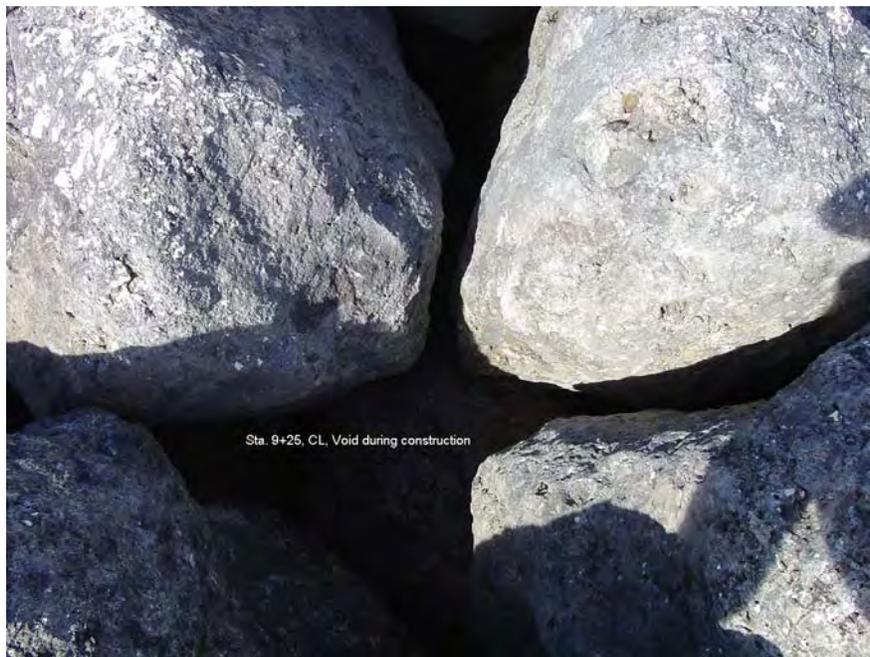
bb. Sta. 9+25, CL, Monitor void area. No Change this year.

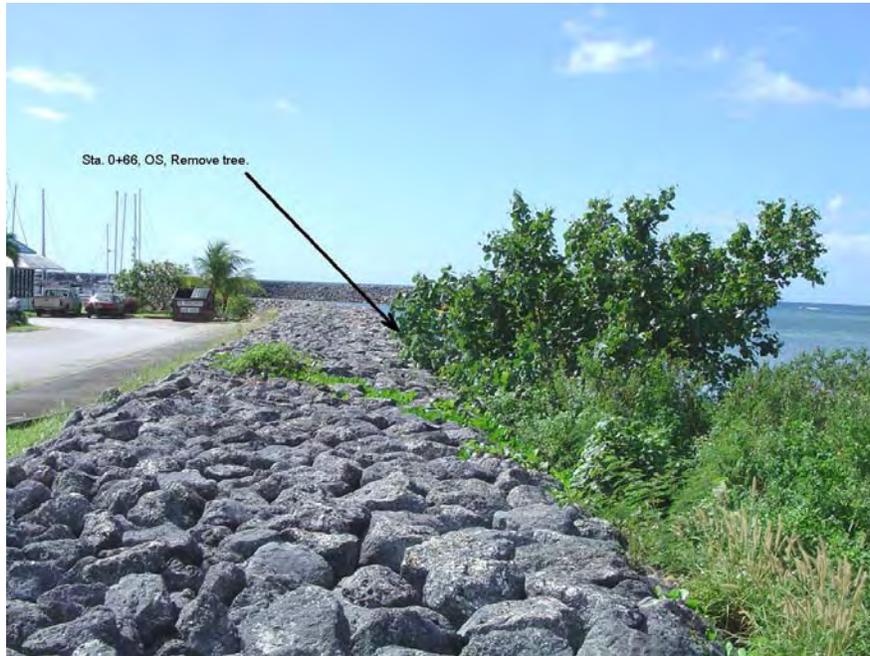
- b. Sta. 0+66, OS, Tree is larger, still existing vegetation on crest.

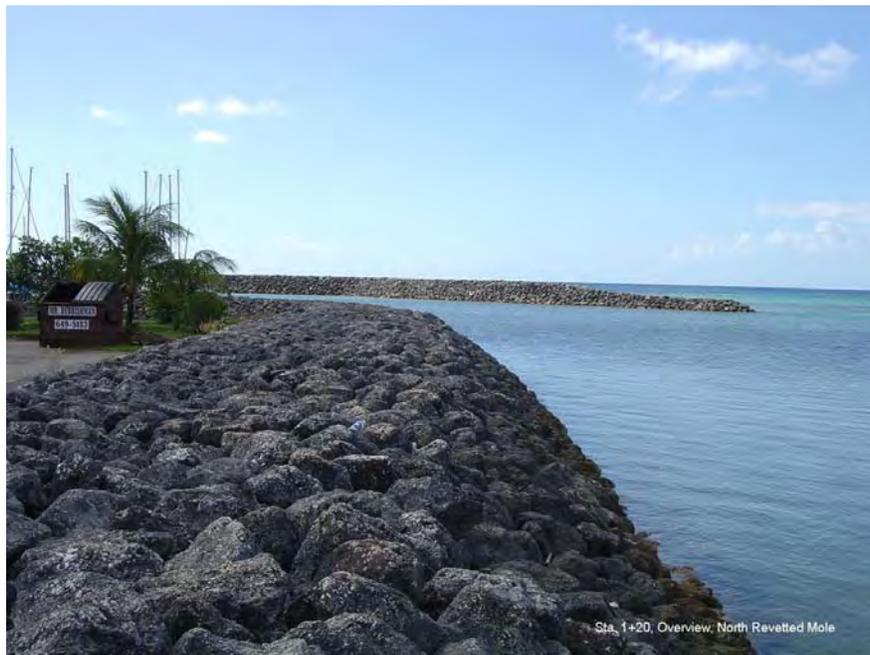
- c. Sta. 1+20, Overview (reference photo).

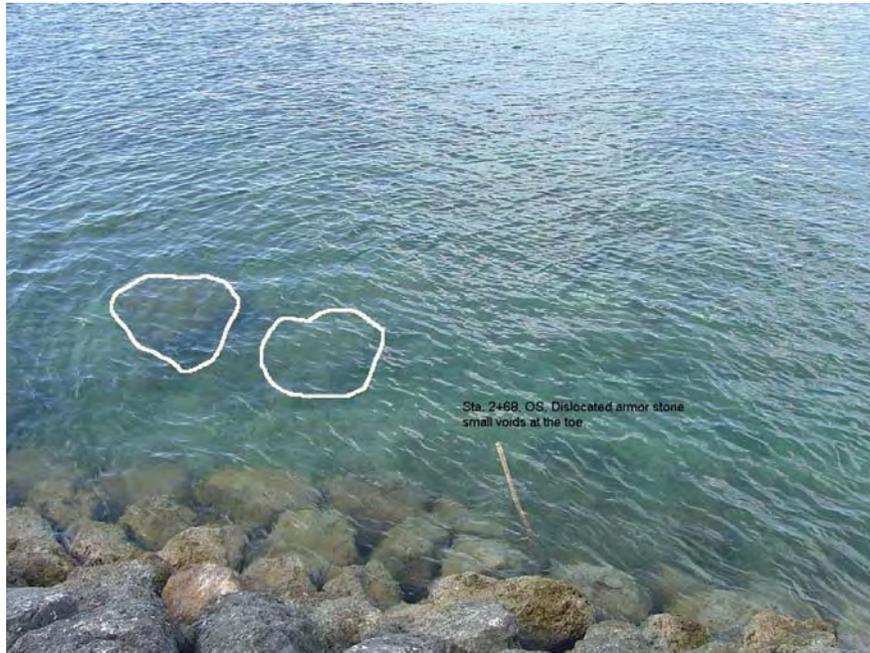
d. Sta. 2+68, OS, Monitor the toe of the structure and dislocated armor stones at this area. This area at the intersection of the berthing area dredge cut and the reef flat has "scoured" a small channel. No Change this year.

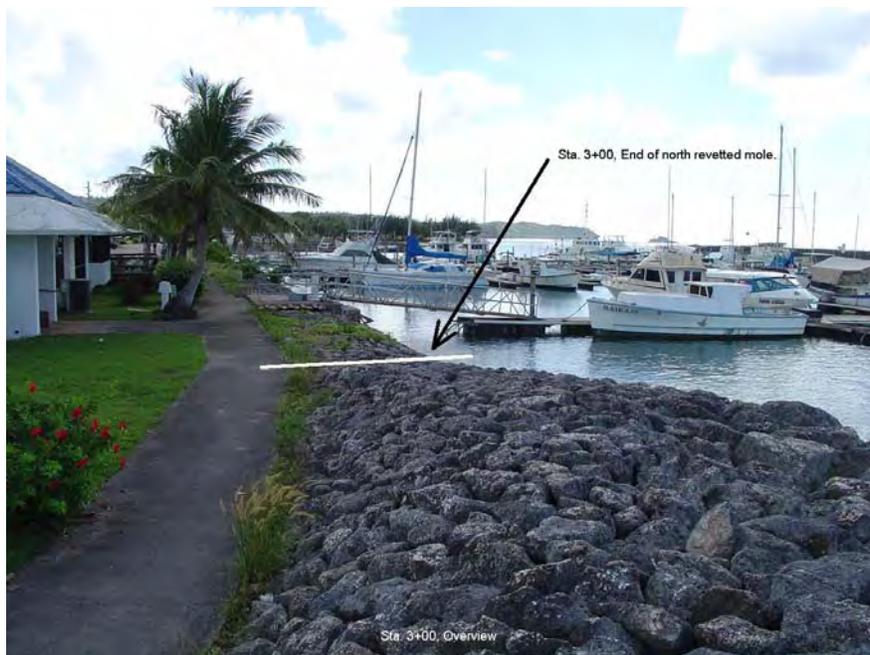
e. Sta. 3+00, Overview (reference photo).

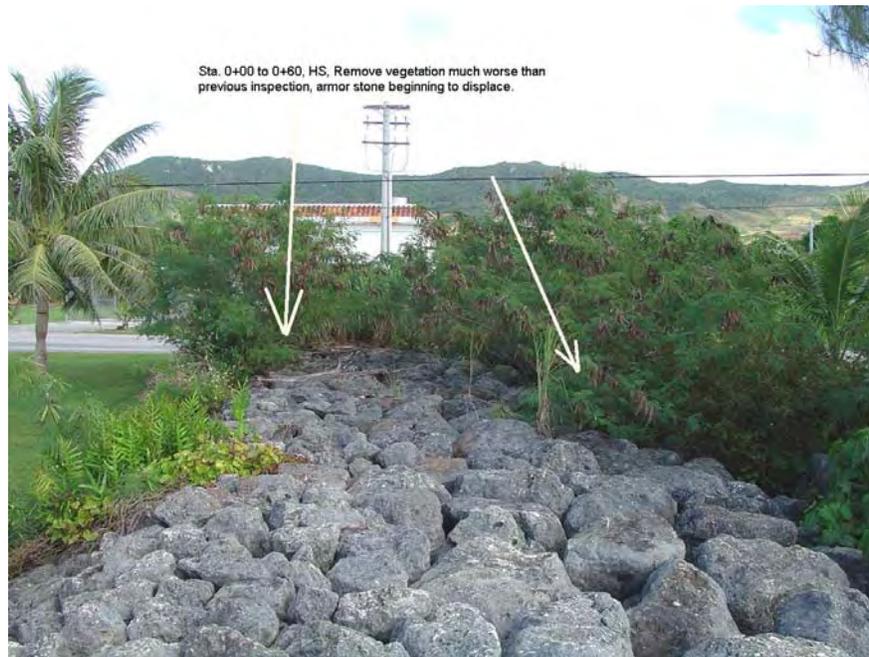
a. Sta. 0+00 to Sta. 0+60, HS, Remove vegetation worse than last year.

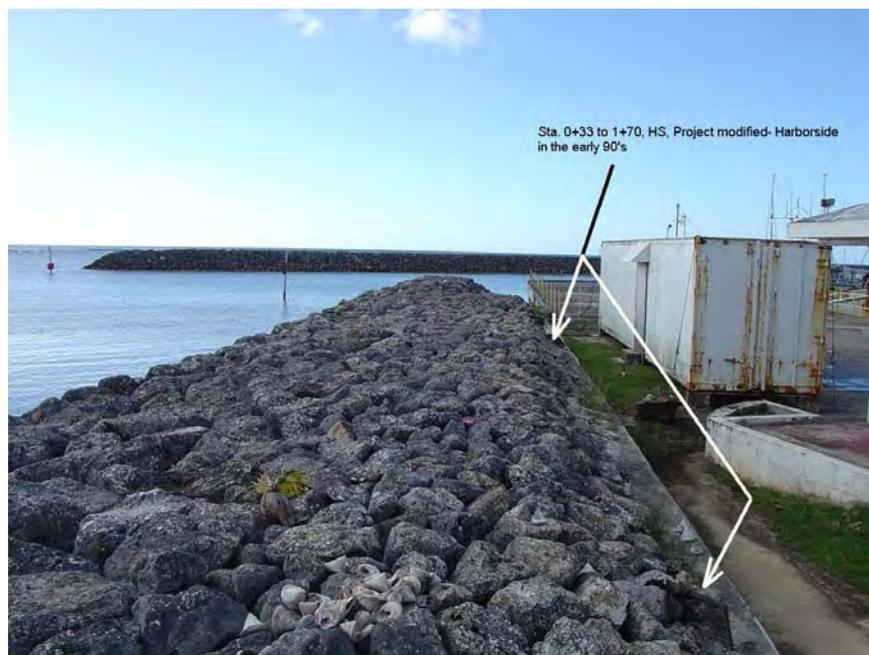
b. Sta. 0+33 to Sta. 1+70, HS, Structure modified.

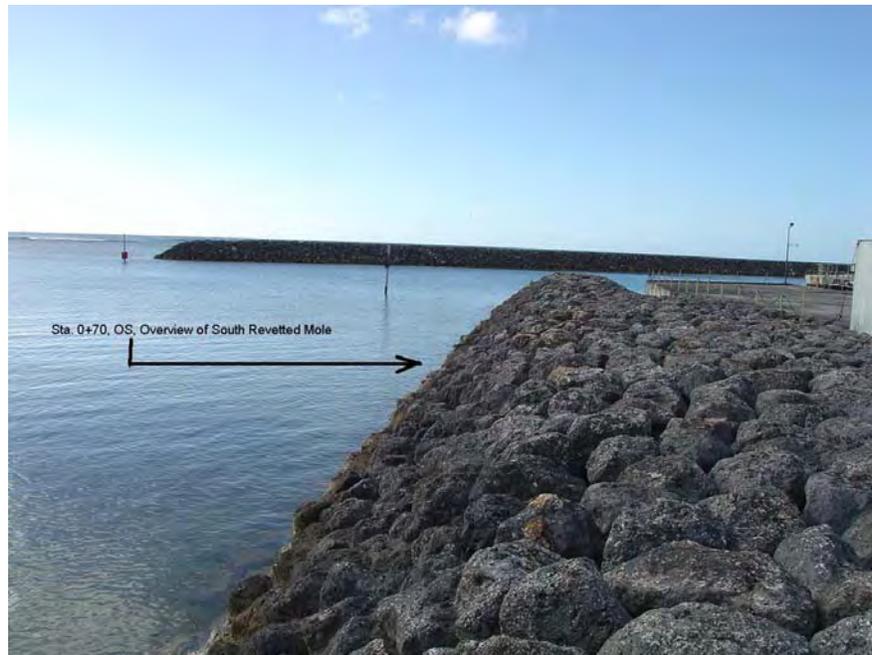
c. Sta. 0+70, OS, Overview (reference photo).

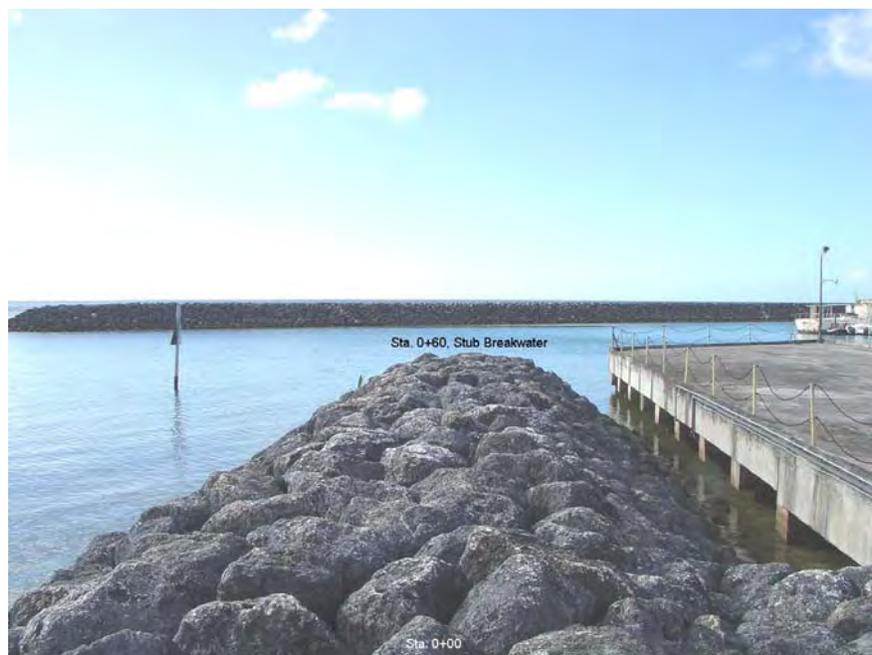
a. Sta. 0+00, Overview (reference photo).

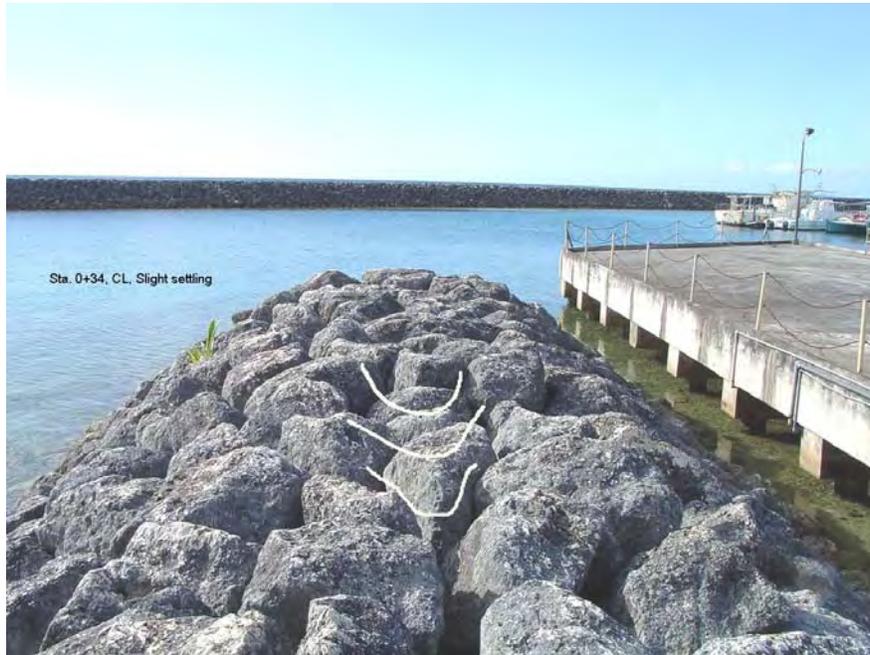
b. Sta. 0+34, CL, Monitor slight settling.

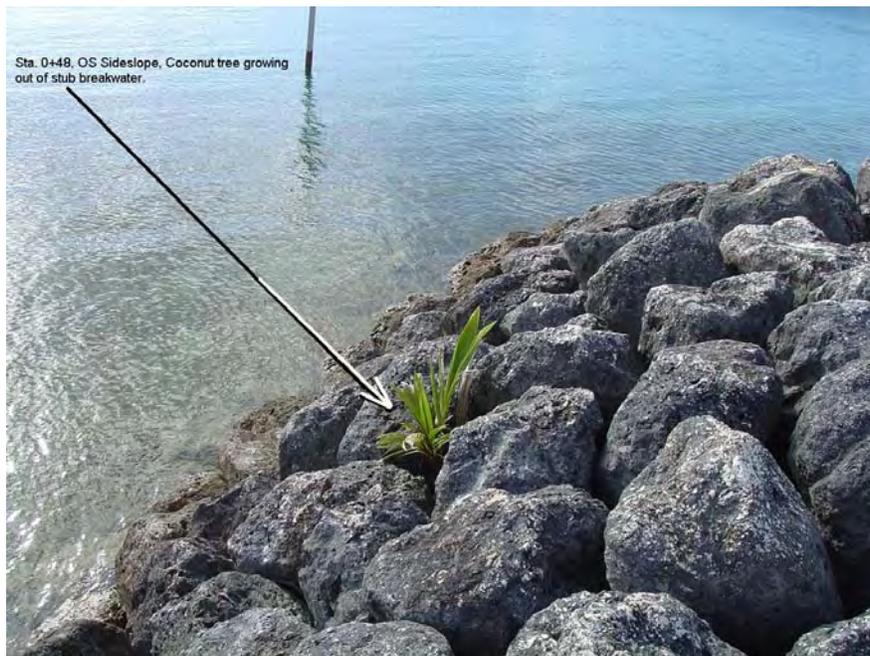
c. Sta. 0+48, OS, Coconut tree growing out of stub breakwater (new this year).

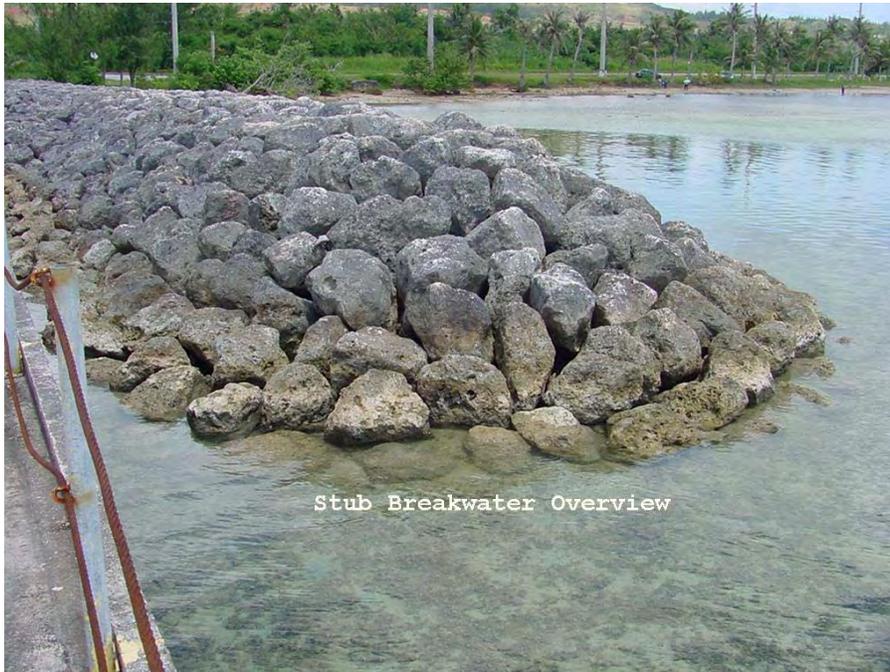
d. Sta. 0+60, Head, Overview (reference FY03 photo).
