**CONTINUING ELIGIBILITY INSPECTION (CEI) REPORT FOR
FLOOD CONTROL WORKS (FEDERAL)**

Honolulu Engineer District
CEPOH-EC-T

1. Project Name: Asan River Flood Control Project
2. Date of Inspection: March 24, 2004
3. Inspection Personnel:

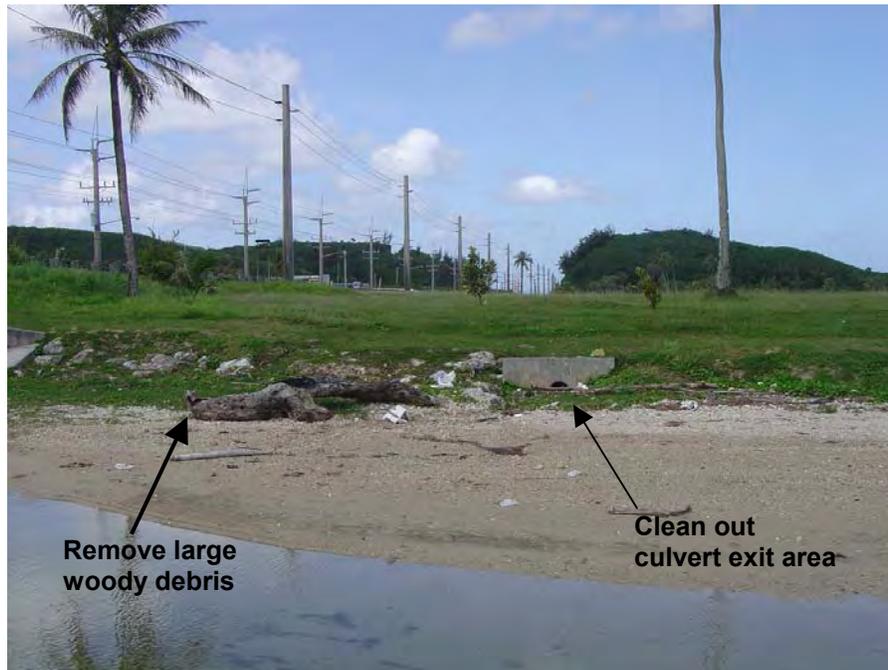
a. Sta. 6+00, Remove large woody debris from channel and clean out culvert exit pathway

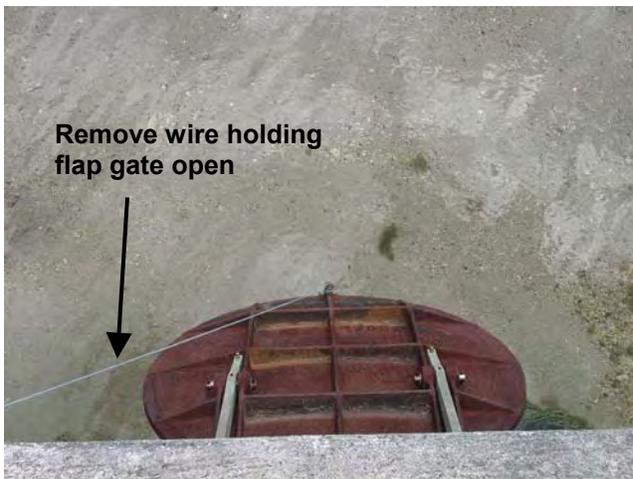
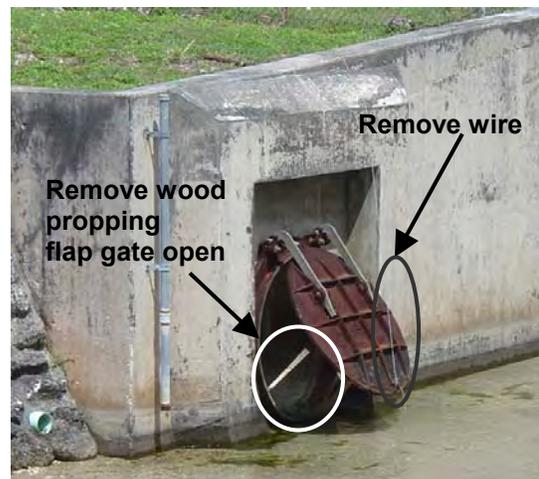
b. Sta. 7+50 (approx), Remove wire holding flap gate open (left) and remove wood propping flap gate open (right), grease hinges on flap gate, left bank u/s from Marine Drive

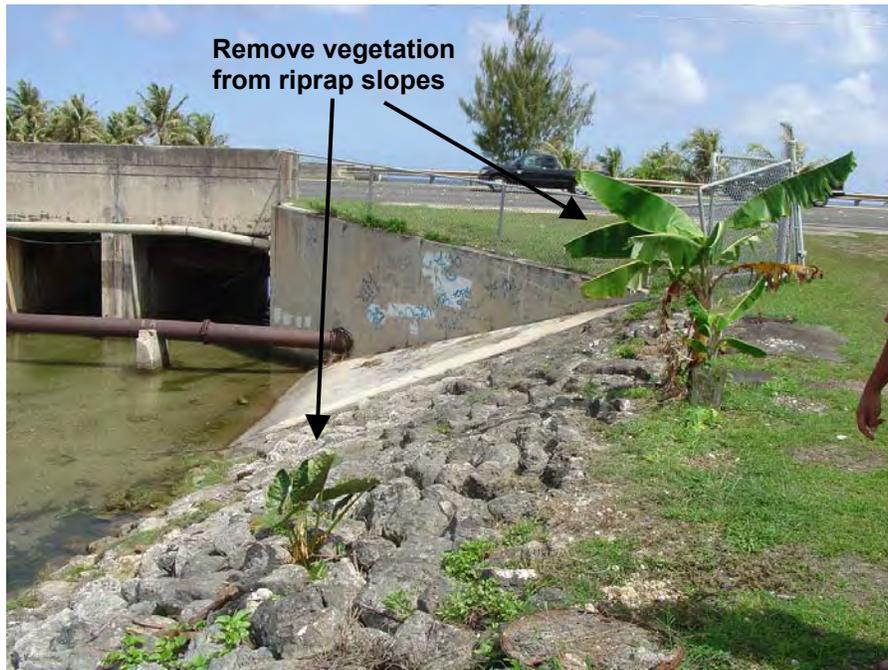
c. Sta. 8+00 (approx), Remove vegetation from riprap slope protection, right bank looking downstream toward Marine Drive

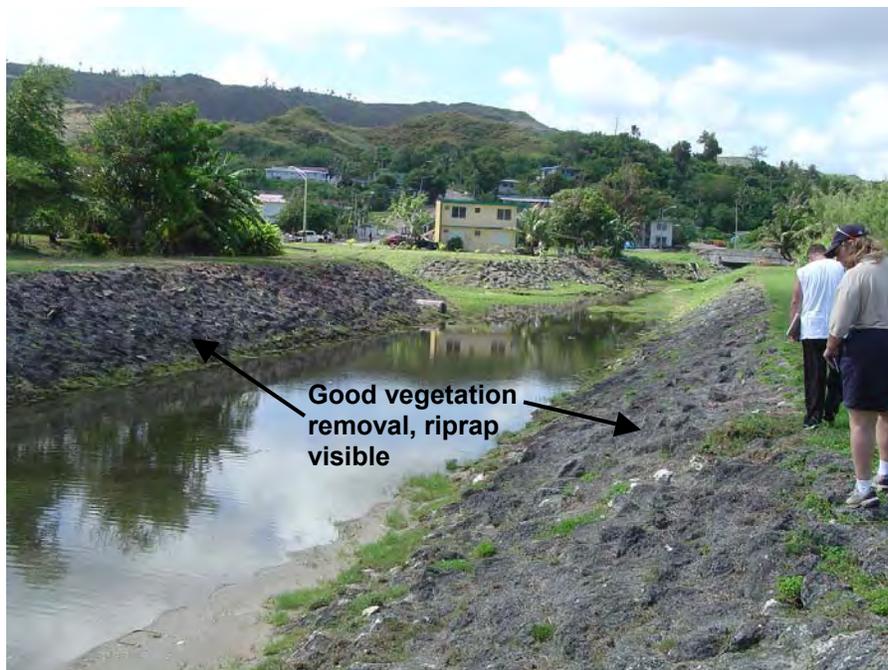
d. Sta. 8+50, Project looks good in this reach, nice vegetation removal, can see riprap, continue herbicide control on banks, looking upstream from Marine Drive

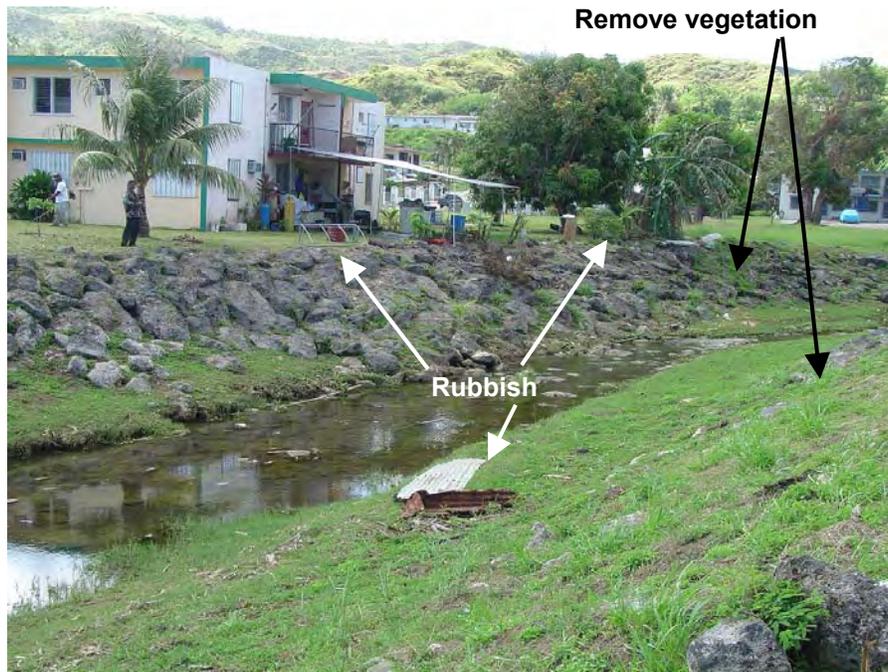
e. Sta. 11+00 (approx), RB & LB clean up rubbish in channel, herbicide channel to control vegetation on riprap, looking upstream

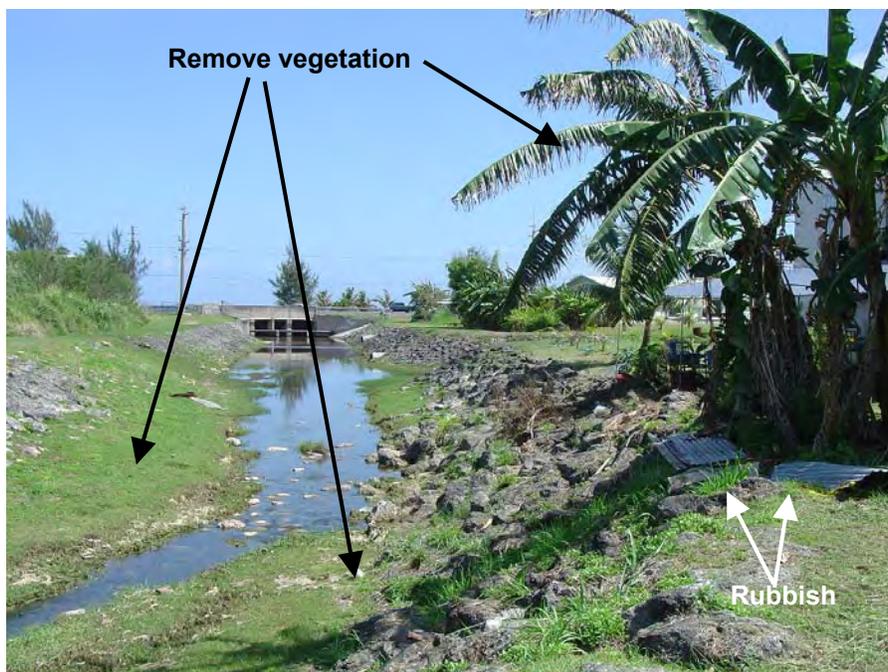
f. Sta. 13+50, RB remove rubbish and remove trees and vegetation in the maintenance ROW, looking downstream

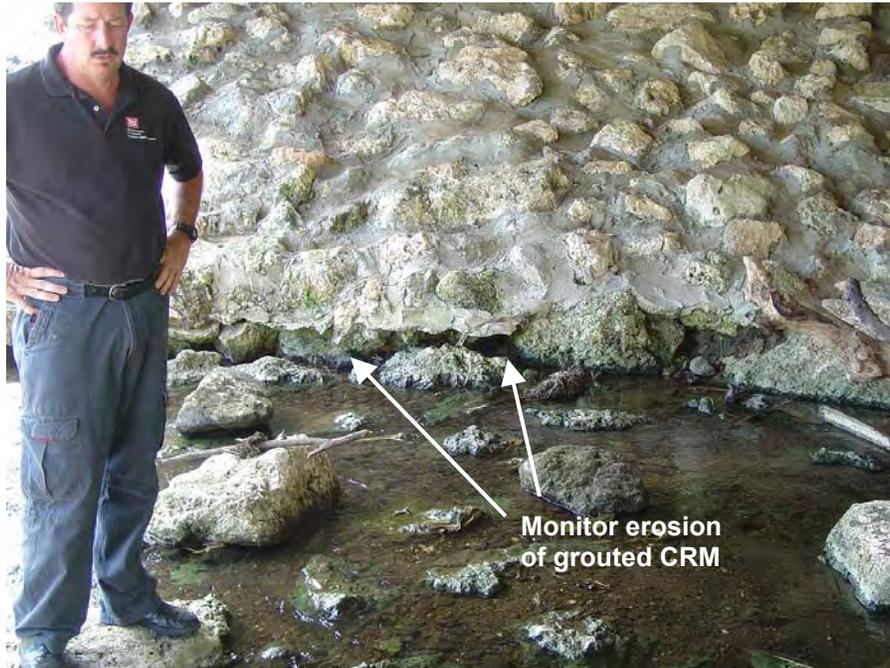
g. Sta. 14+00 (approx), Continue to monitor erosion of grouted CRM toe under bridge

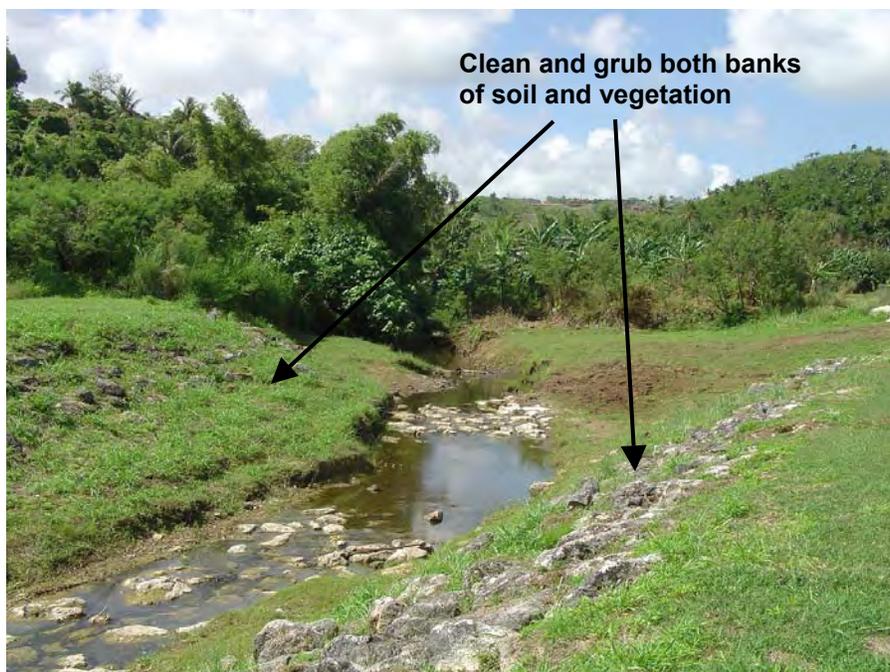
h. Sta. 13+30 to 15+75 (approx), Clean and grub RB & LB of all soil and vegetation on riprap channel lining, need to be able to see the riprap, looking upstream

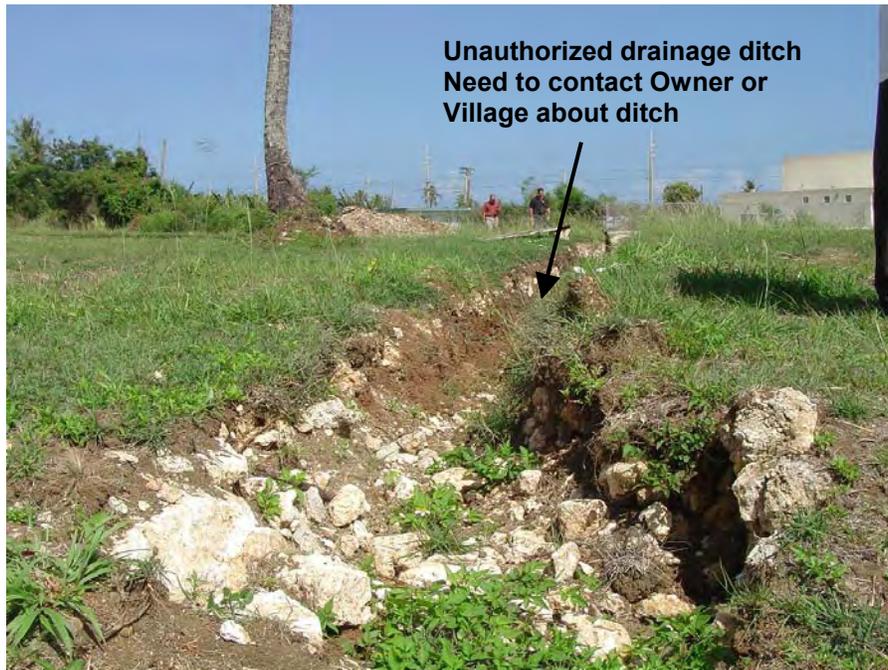
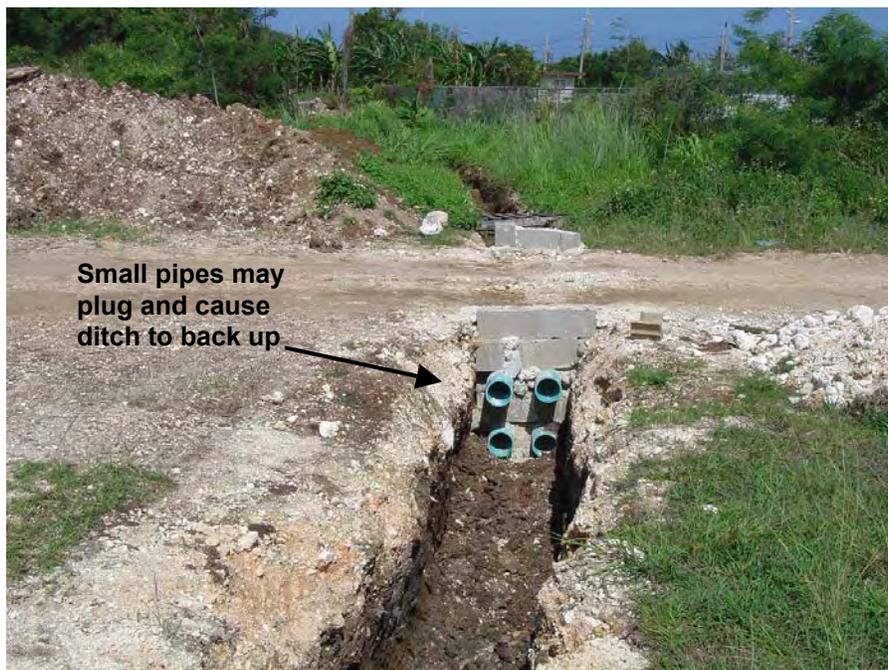
- i. Sta. 14+75 (approx), Unplanned and unauthorized drainage channel entering Project, need to contact owner or Village to get a correct design for this ditch. Outlet (top picture) should be oriented at an angle downstream in the direction of flow, located on the LB of Project. Multiple piping is good idea, but small pipes may clog causing backup of ditch drainage.

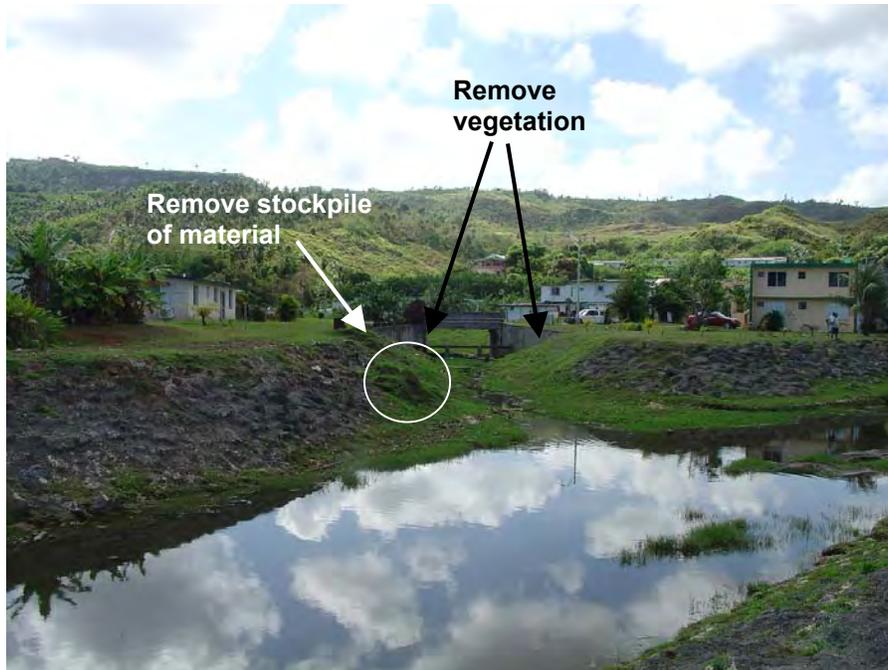
j. Sta. 0+50C (C=Calacag River), Remove stock pile of material from invert cleanout, clean banks of soil so riprap is visible and herbicide banks

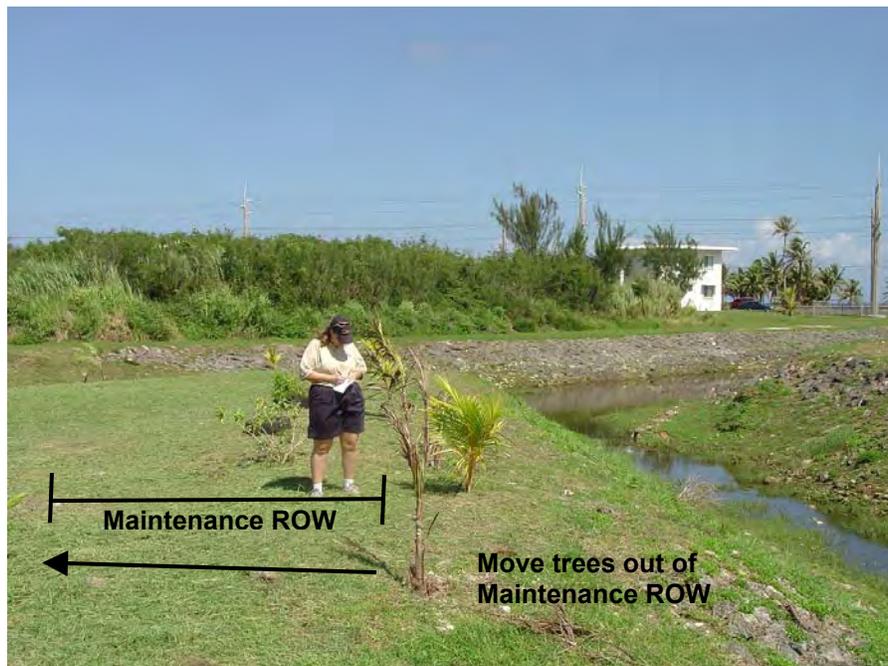
k. Sta. 1+00C to 2+00C (approx), Remove (or move back) trees to preserve maintenance ROW

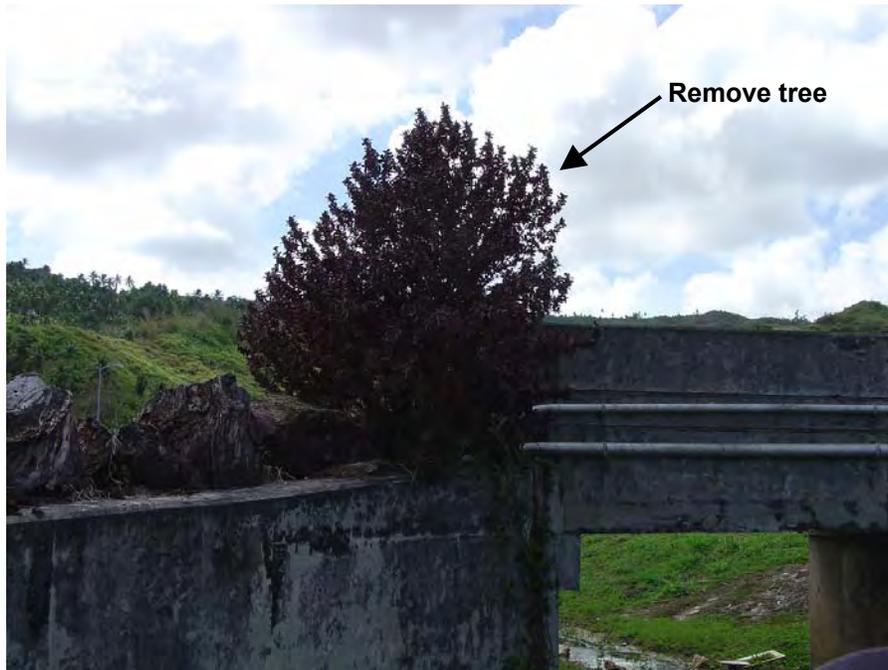
l. Sta. 2+15C, Remove tree at RB d/s bridge abutment

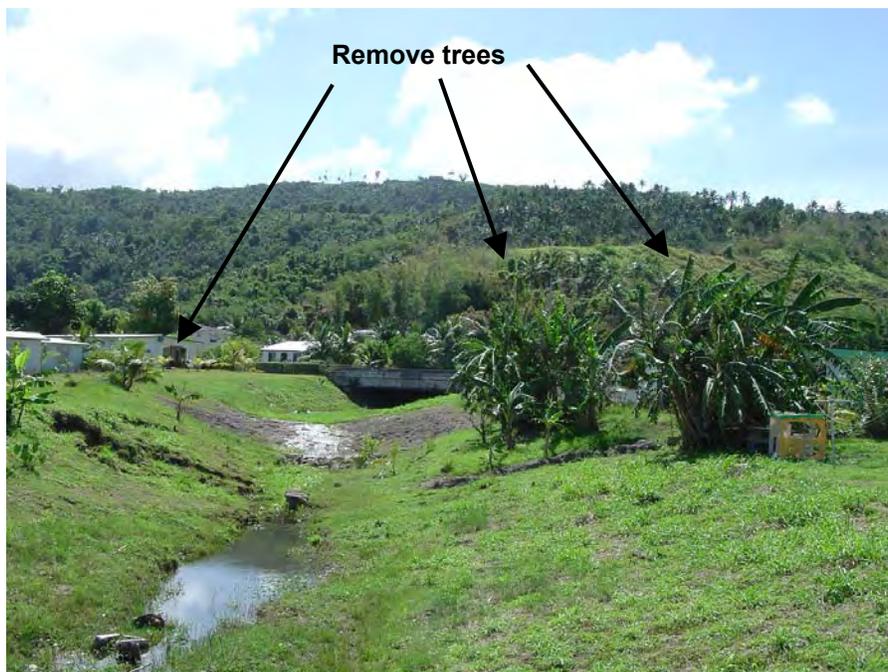
m. Sta. 2+75C, Remove trees in channel RB & LB and on LB maintenance ROW, looking u/s from lower bridge

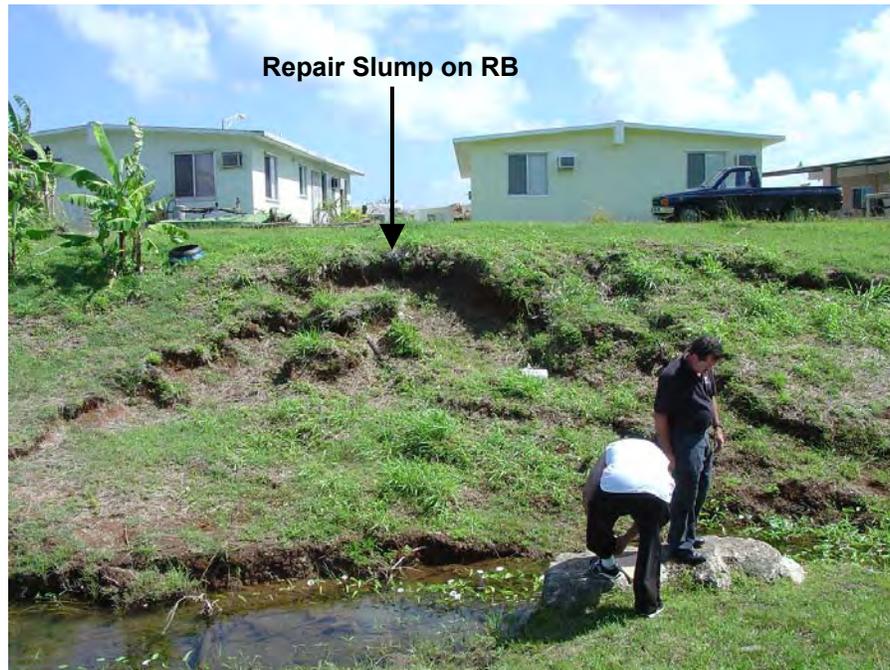
- n. Sta. 3+80C (approx), Slumping on RB, Repair slumping by either rebuilding slope with proper compaction or by adding rock. Attention needs to be taken to maintain channel capacity and invert and remove material stockpiles.

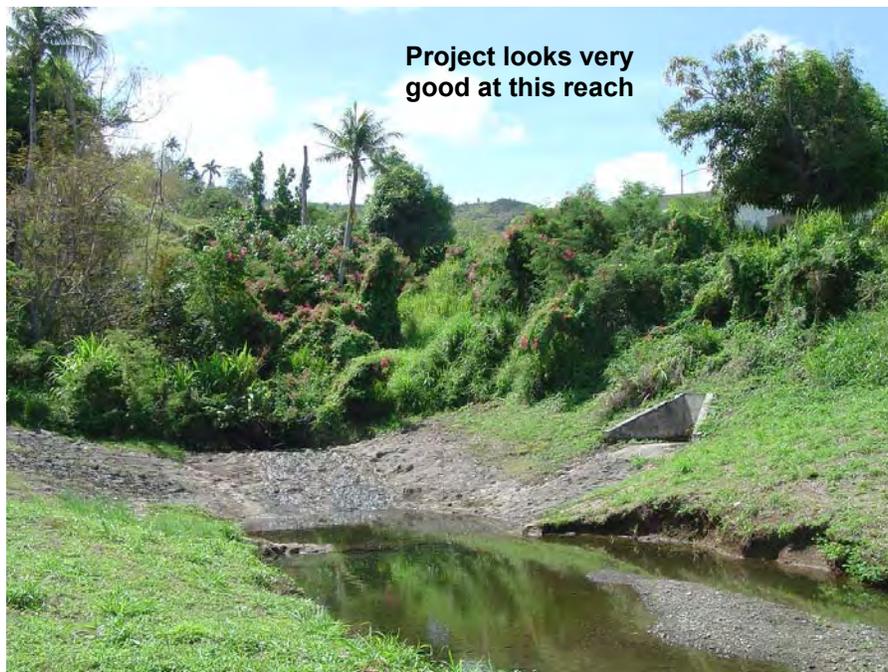
- o. Sta. 7+50C (approx), Project looks good at u/s reach of Calacag River
