**O & M INSPECTION REPORT  
FOR NAVIGATION AND SHORE PROTECTION PROJECTS**

1. Project Name: Aunu'u SBH
2. Date of Inspection: April 12, 2002
3. Inspection Personnel:

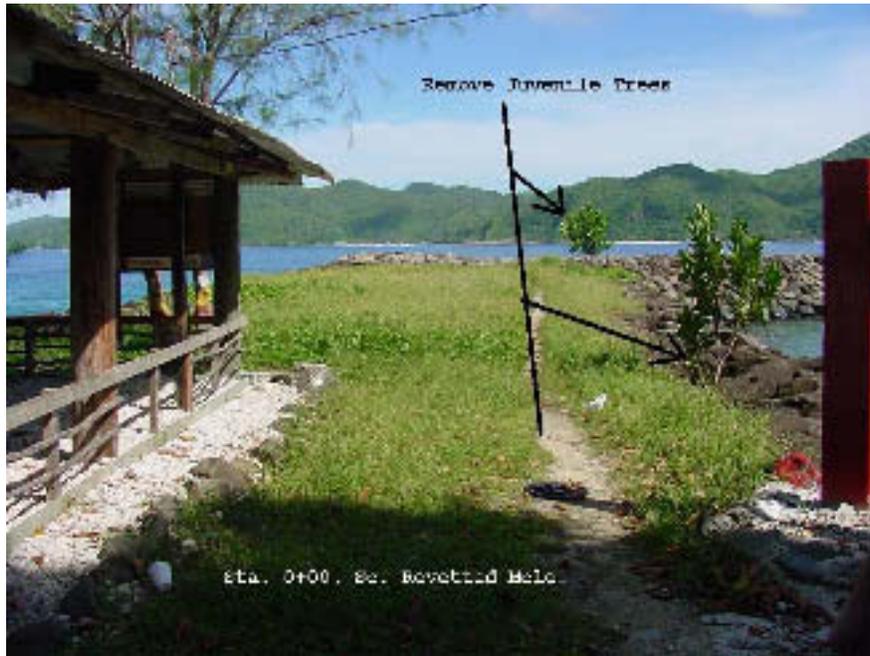
a. Sta. 0+00, HS, Remove Trees from Armor stones.

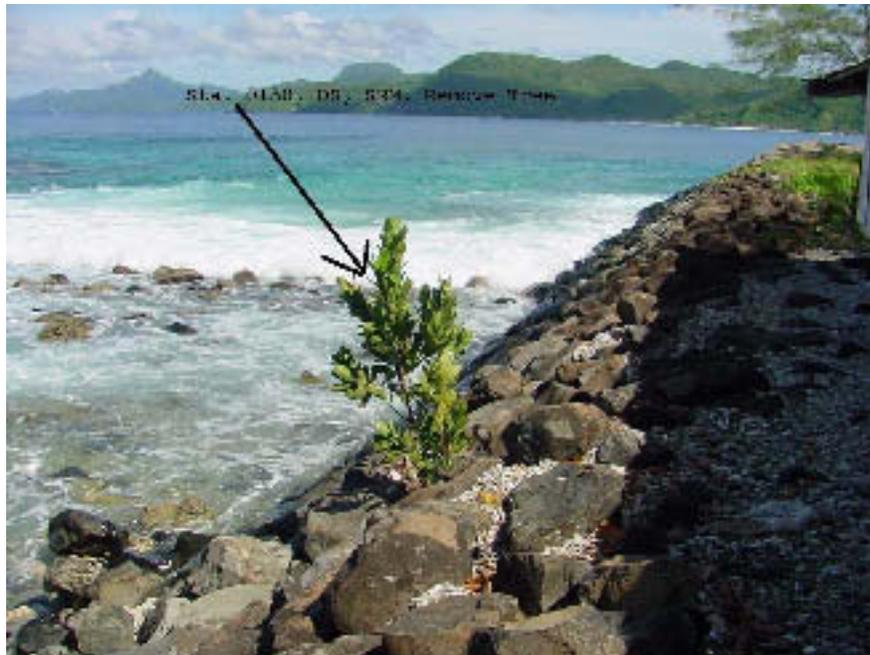
b. Sta. 0+30, OS, Remove tree from sideslope.

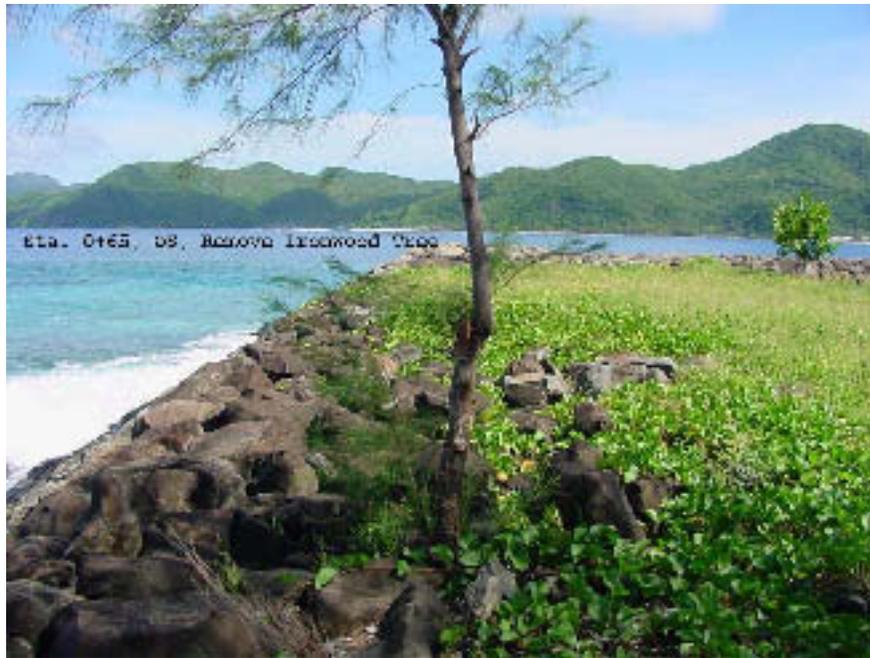
c. Sta. 0+65, OS/Crest, Remove tree from revetment.

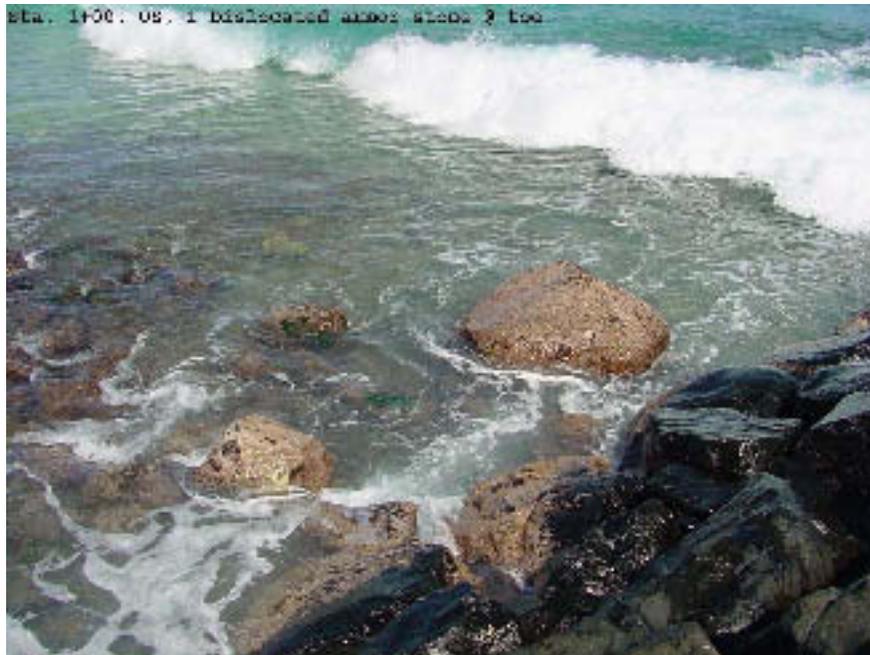
d. Sta. 1+00, OS, Monitor lea. Dislodged armor stone at the toe.

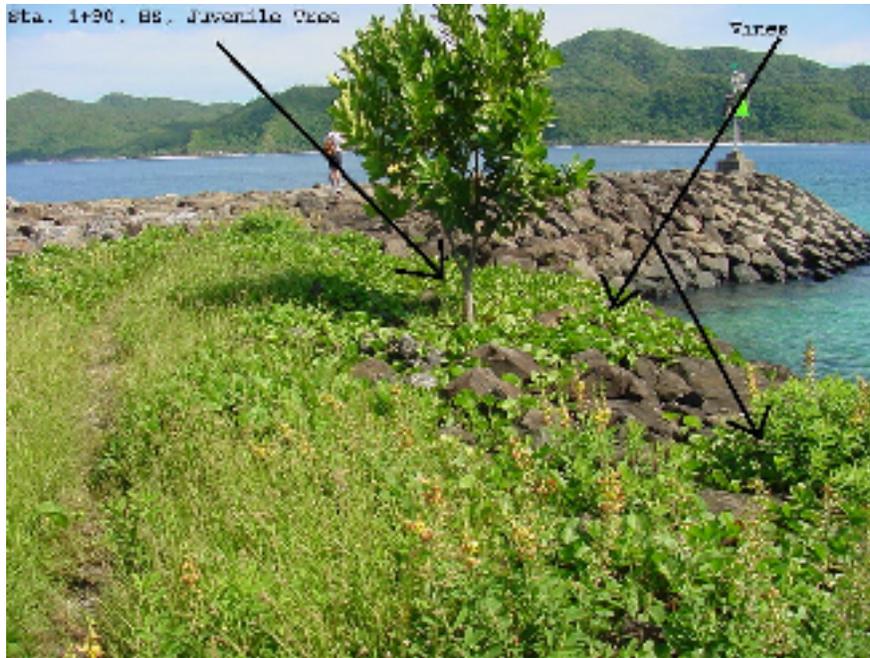
e. Sta. 1+90, HS, Remove trees and vines from revetment.

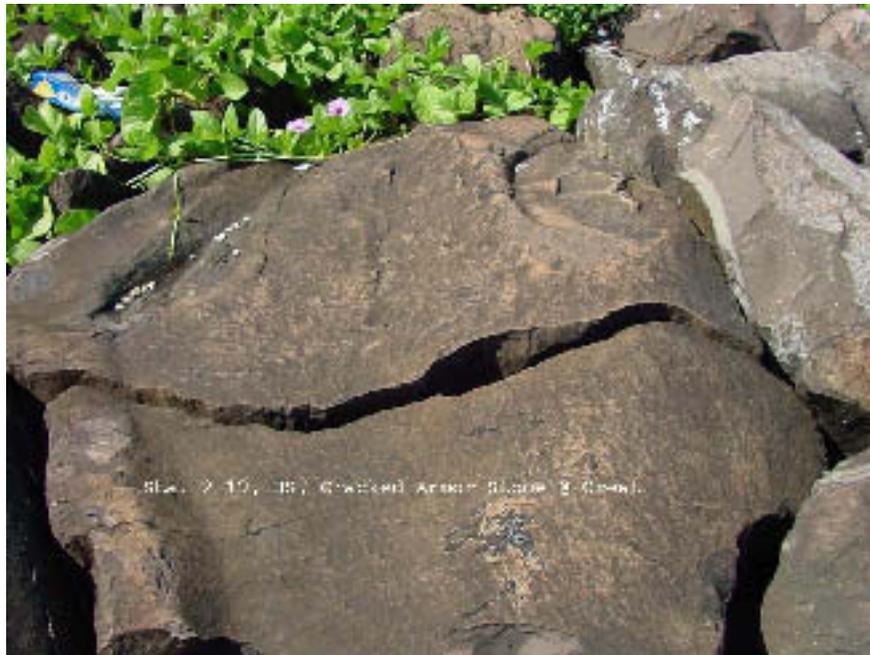
f. Sta. 2+19, HS, Cracked armor stone.

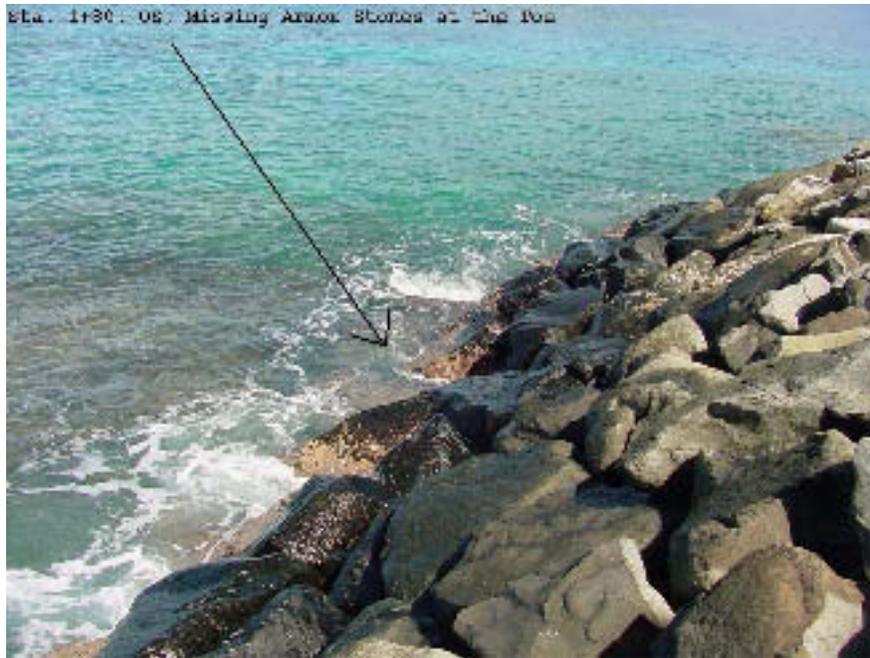
g. Sta. 1+80, OS, Monitor armor toe stones.

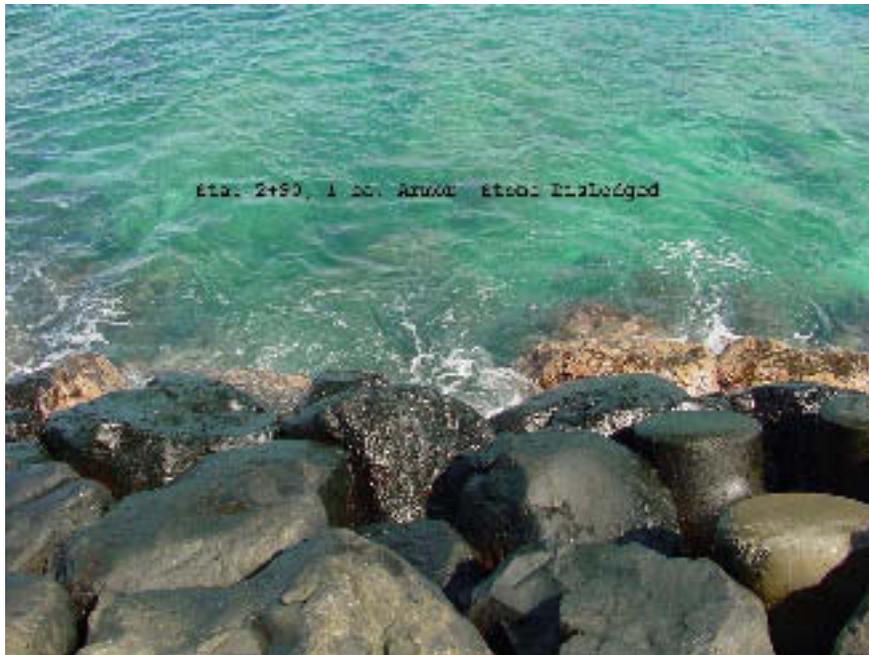
j. Sta. 2+90, OS, Monitor 1 ea. Dislocated armor stone at the toe.

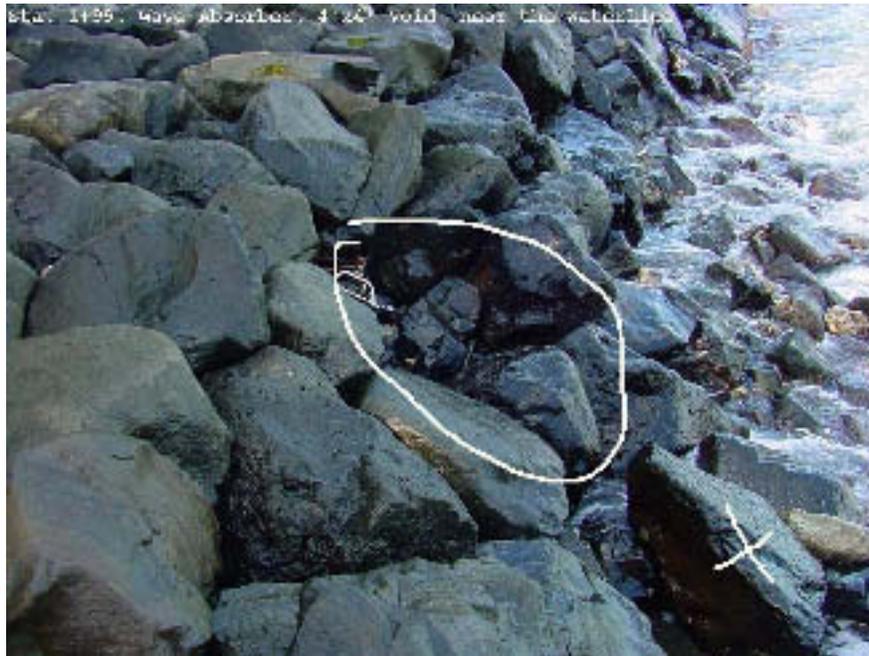
- a. Sta. 1+99, Monitor changes @ 4'x4' void on the sideslope, UL exposed and one armor stone resting downside of void.

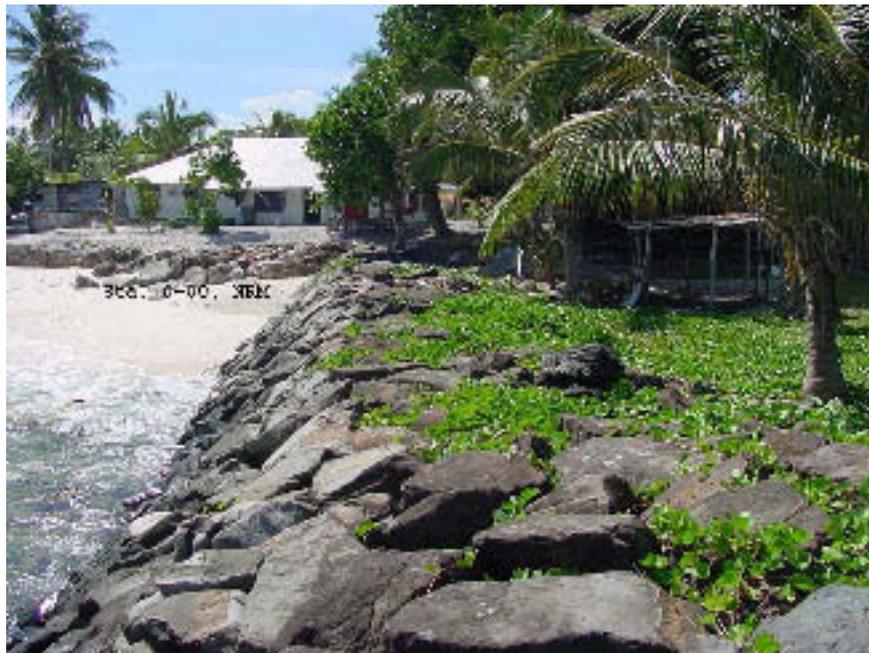
- a. Sta. 0+00, OS, Remove vines from structure.

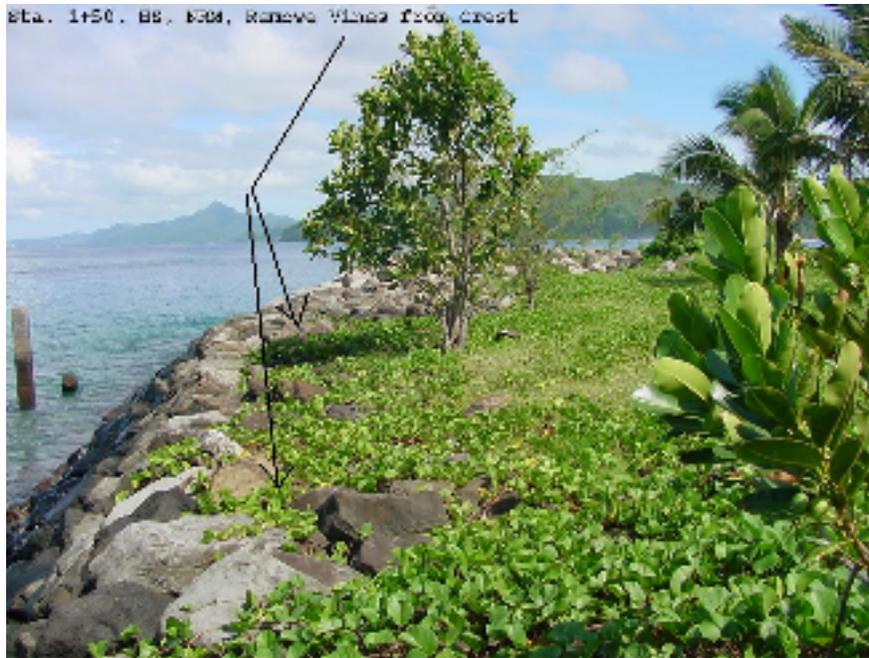
d. Sta. 1+50, Crest, remove trees on crest.

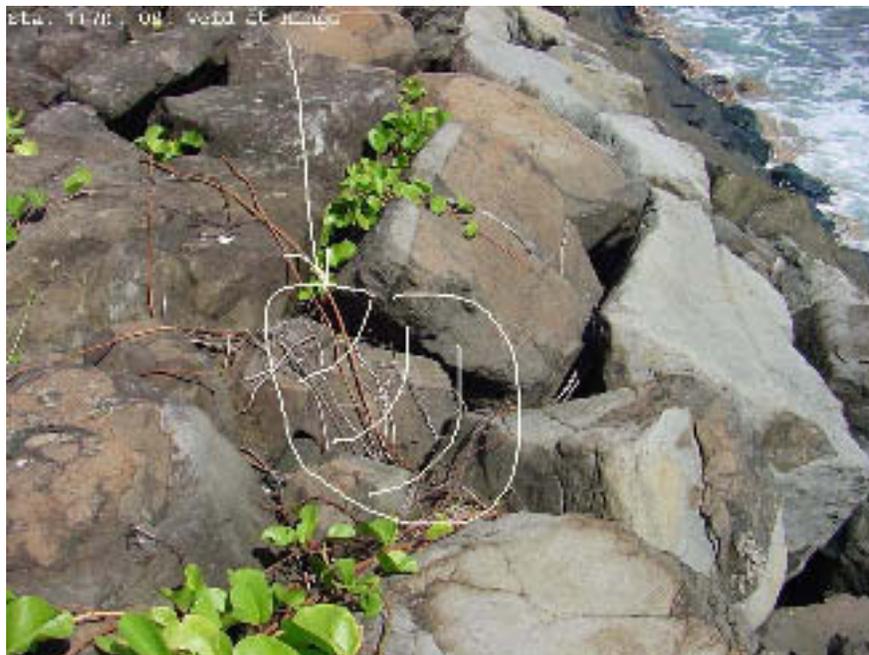
e. Sta. 1+70, OS, Monitor void and dislodged toe armor stones.

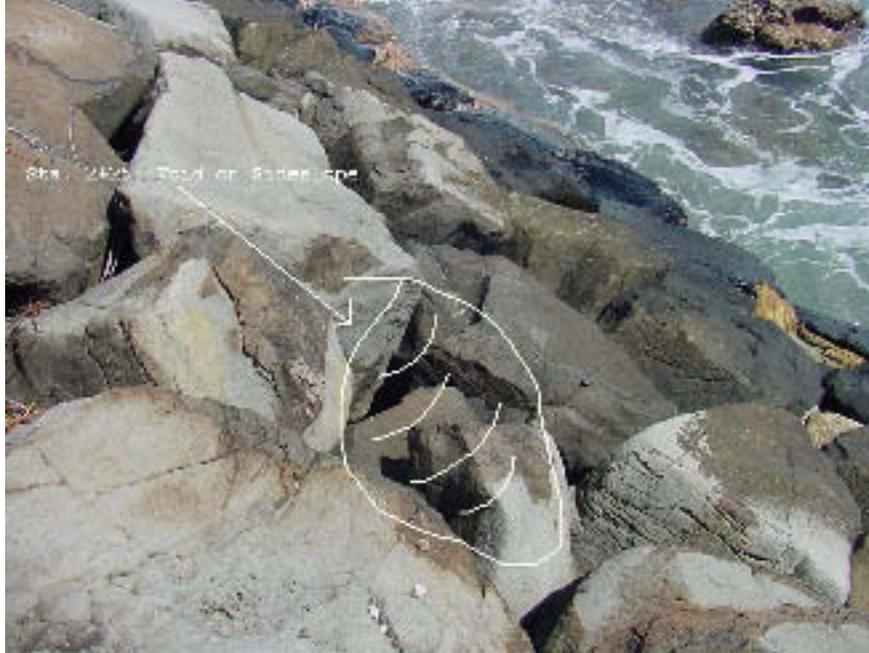
f. Sta. 2+25, OS, Monitor void and dislodged toe armor stone.
