O & M INSPECTION REPORT
FOR NAVIGATION AND SHORE PROTECTION PROJECTS

1. PROJECT NAME: HALEIWA SMALL BOAT HARBOR

2. DATE OF INSPECTION: 28 August 2002

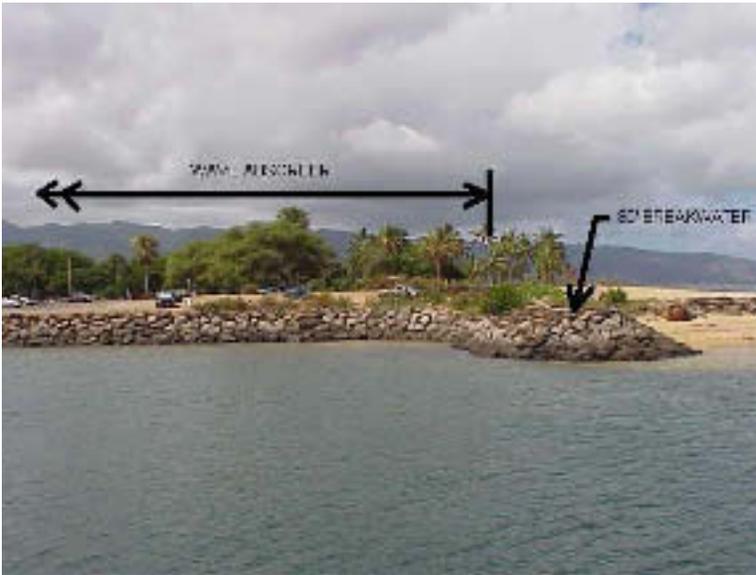
a. Overview of 80' breakwater and start of wave absorber.

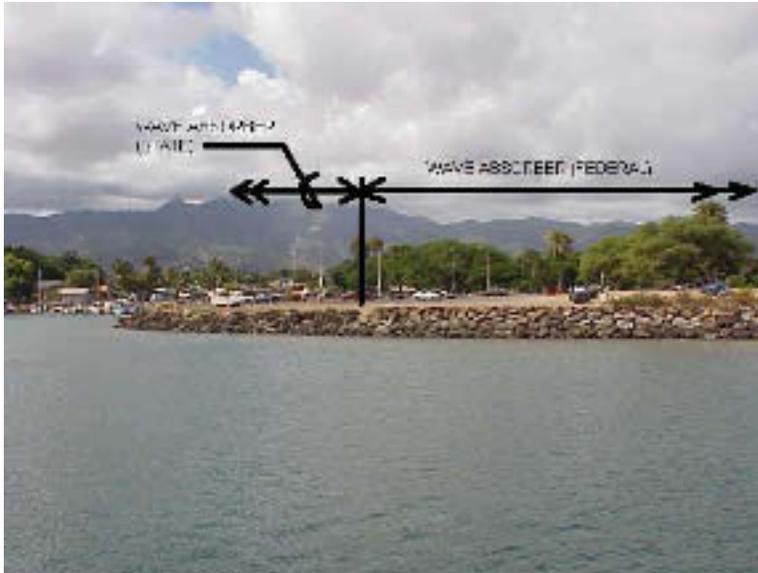
b. Overview of Federal wave absorber transitioning to State owned wave absorber.

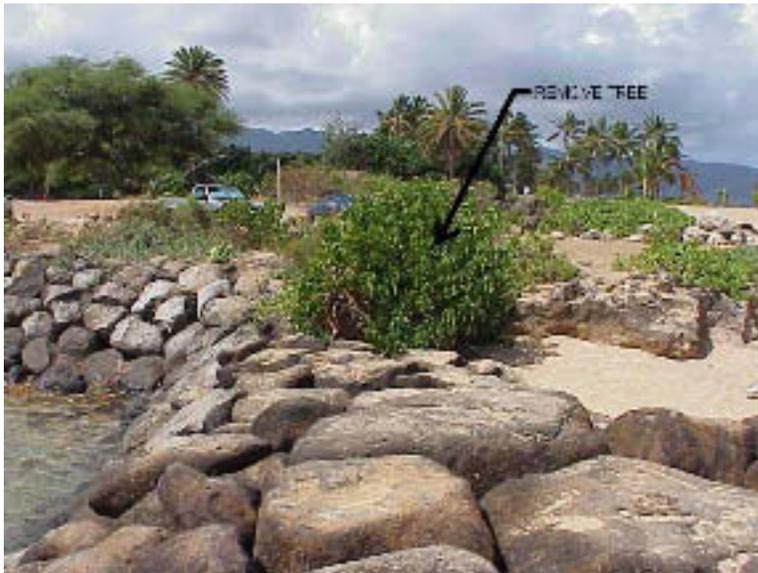
c. Remove tree from start of breakwater and start of wave absorber (WA). Also monitor toe armor stones at head, Sta 0+80.

5. CONCLUSION: The revetted mole, breakwater, and wave absorber is in operational condition. Action should be taken to fill the void at crest in the Wave Absorber at Sta. 1+20. Removal of vegetation along 80' breakwater and 140' wave absorber is suggested. Continue to monitor depressions along wave absorber and erosion at revetted mole sta. 12+00 (nearby concrete navigational monument).

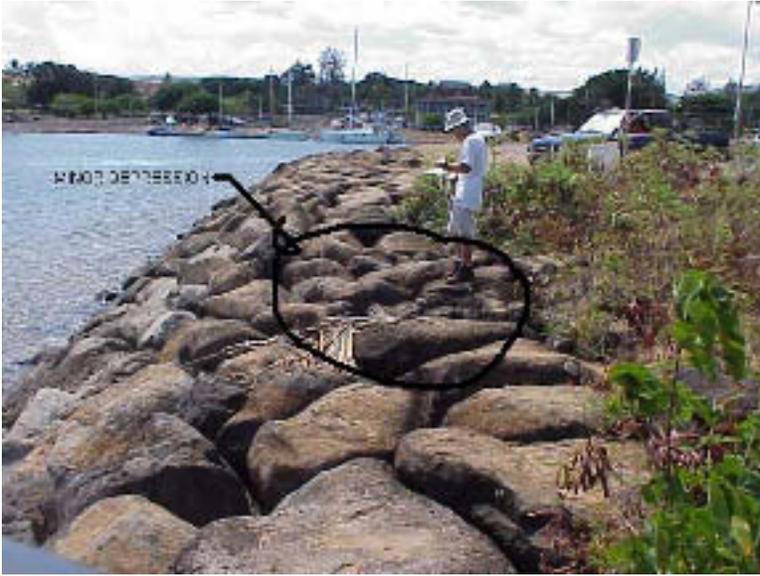
d. WA, Sta. 0+20 - 0+30, continue to monitor minor depression at crest of structure. Sta. 0+00 - 0+35, Remove vegetation.

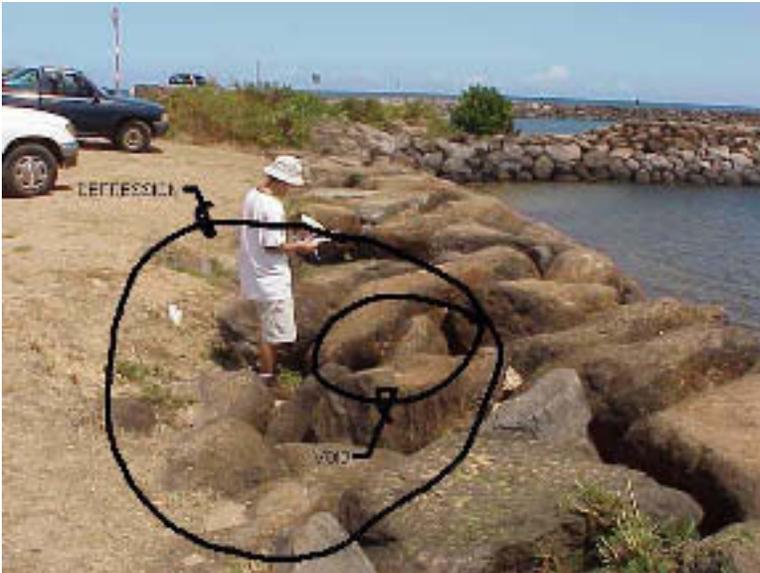
e. WA, Sta. 1+20, void at crest (Action Required). Sta. 1+00 to 1+30, continue to monitor depression at crest.

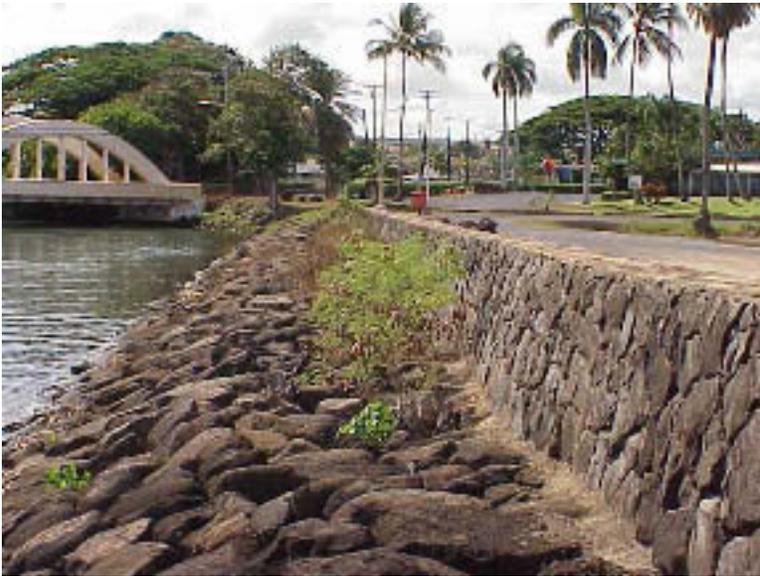
c. Sta. 4+00 - 5+00, remove vegetation from crest.

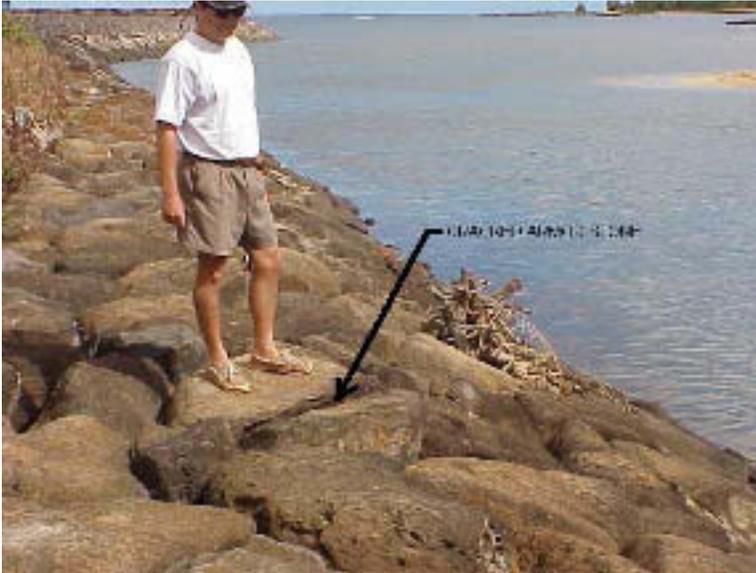
d. Sta. 4+00, OS, 1 ea. cracked armor stone at crest.

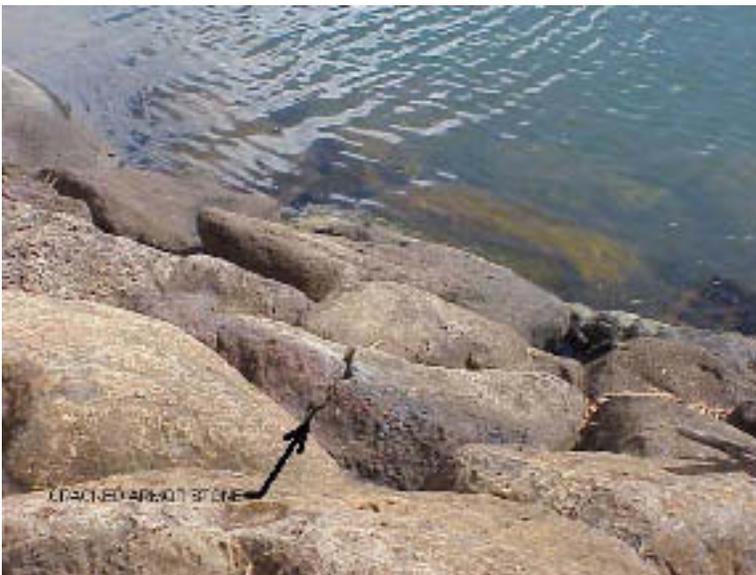
e. Sta. 4+12, OS, 1ea. cracked armor stone on sideslope.

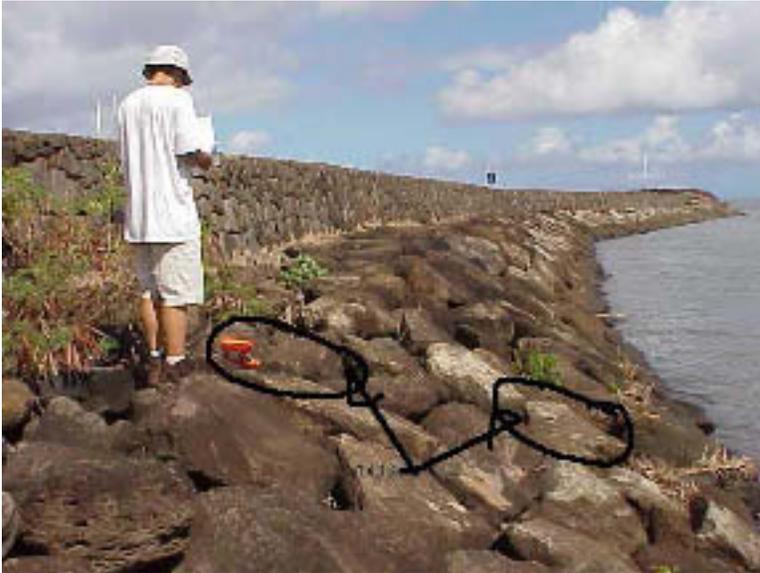
f. Sta. 4+85, OS, 1 void at crest and 1 void on sideslope. Poor contact between armor stones.

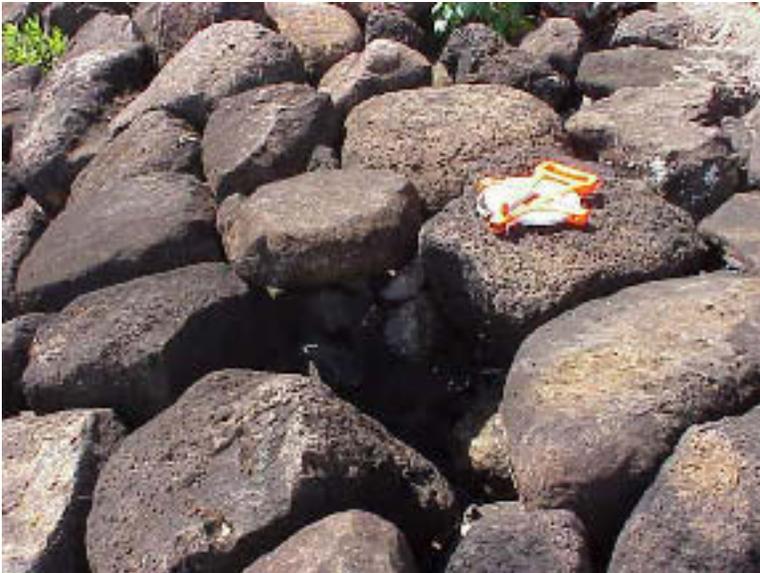
g. Sta. 5+35, void at crest. Under layer is exposed.

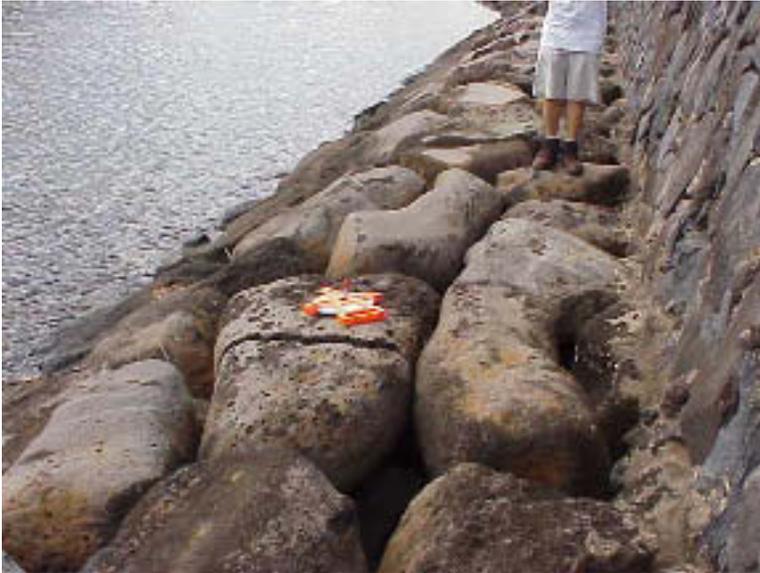
h. Sta. 7+50, OS, 1 ea. Big cracked armor stone at crest.

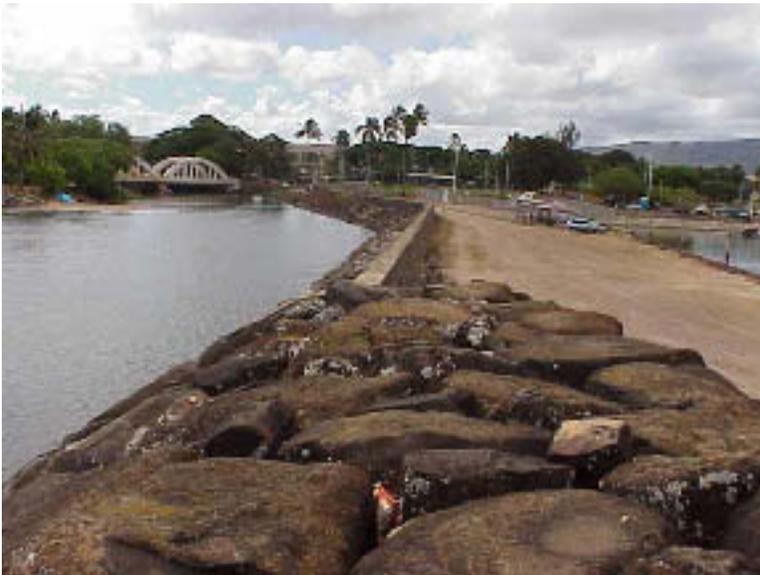
i. Sta. 8+90 to start - overview.

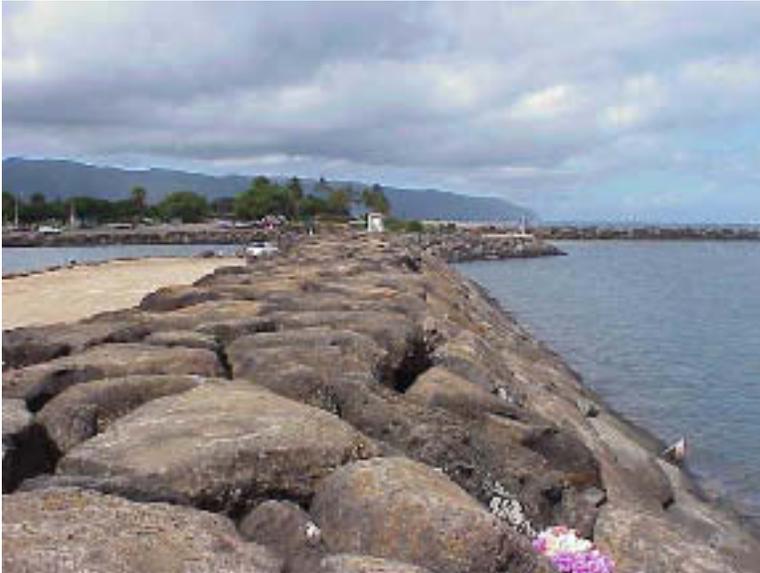
j. Sta. 8+90 to end - overview

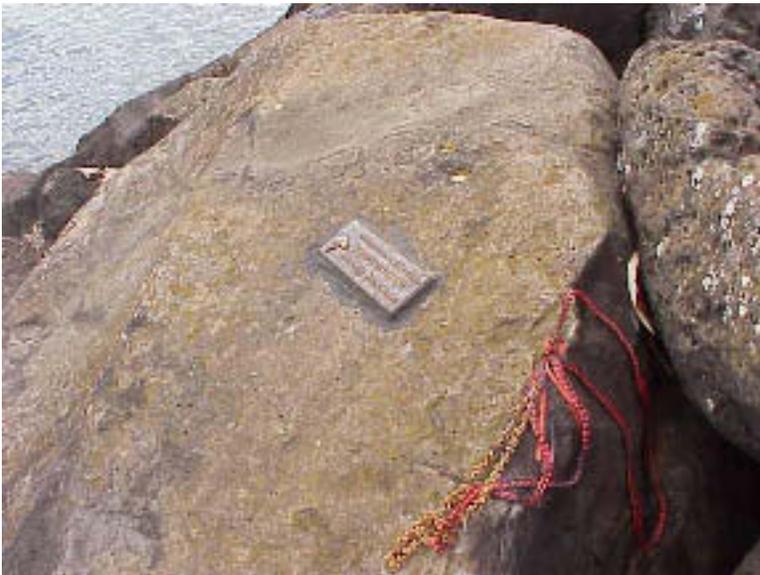
k. Sta. 8+90, OS, memorialized armor stone with plaque.

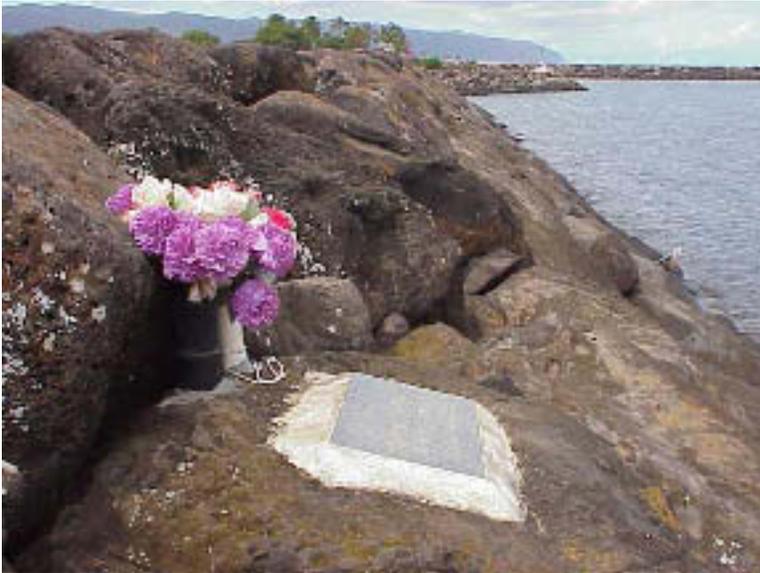
l. Sta 9+00, OS, another memorialized armor stone with plaque and flowers.

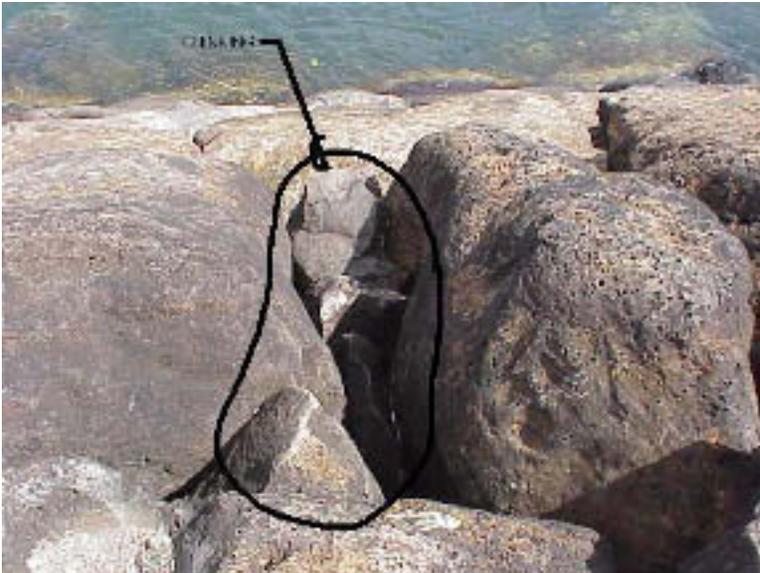
m. Sta. 11+00, OS, chinking along hinge.

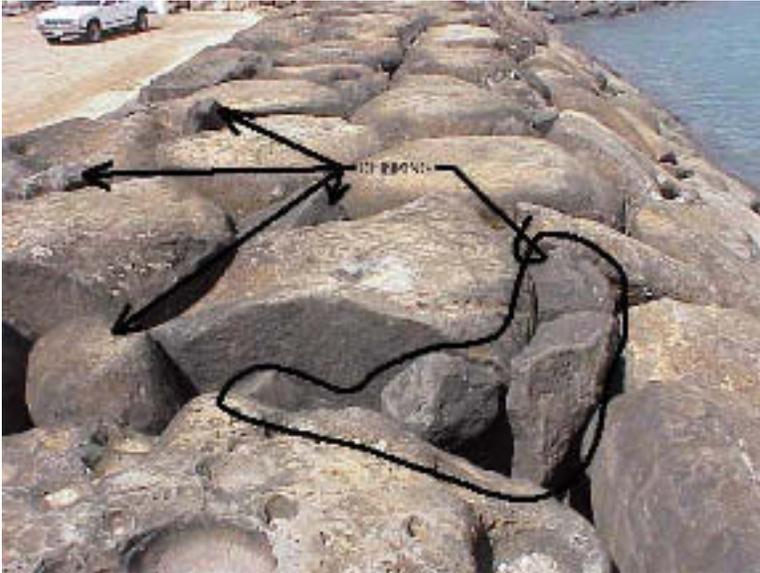
n. Sta. 11+00, chinking along crest.

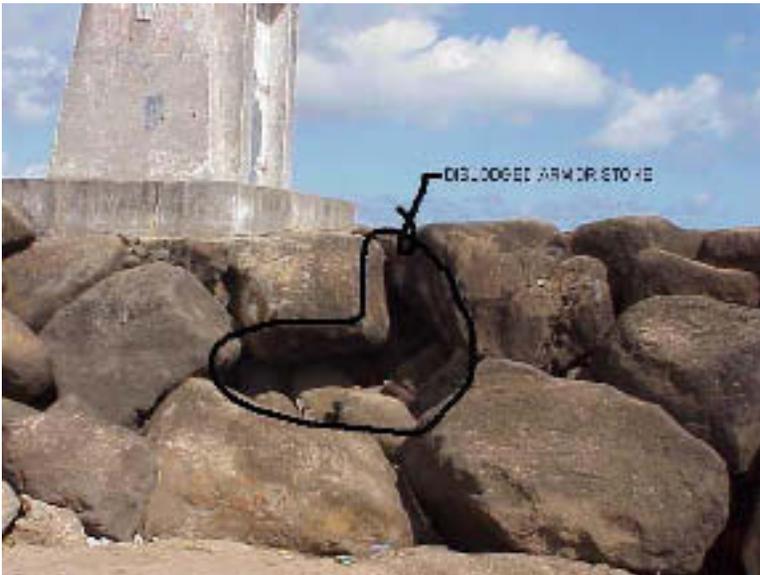
o. Sta. 11+97, HS, dislodged armor stone on sideslope. No movement noted.

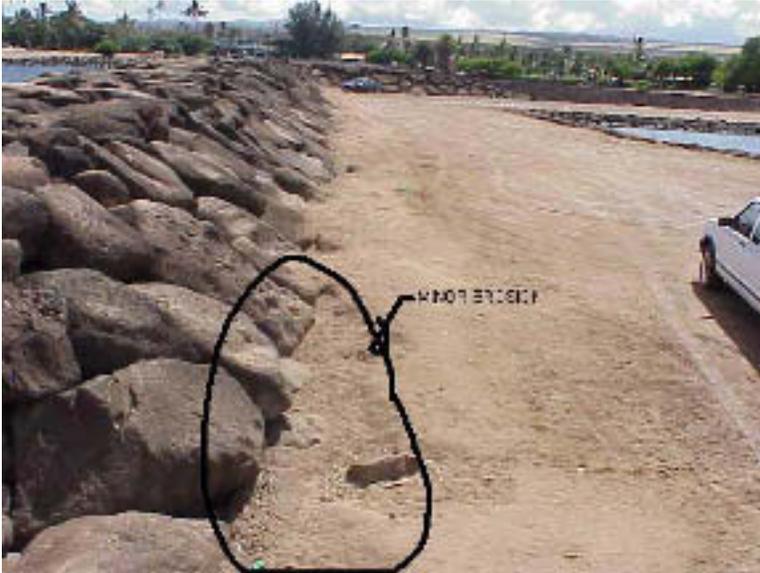
p. Sta. 12+00, HS, monitor minor erosion at toe.

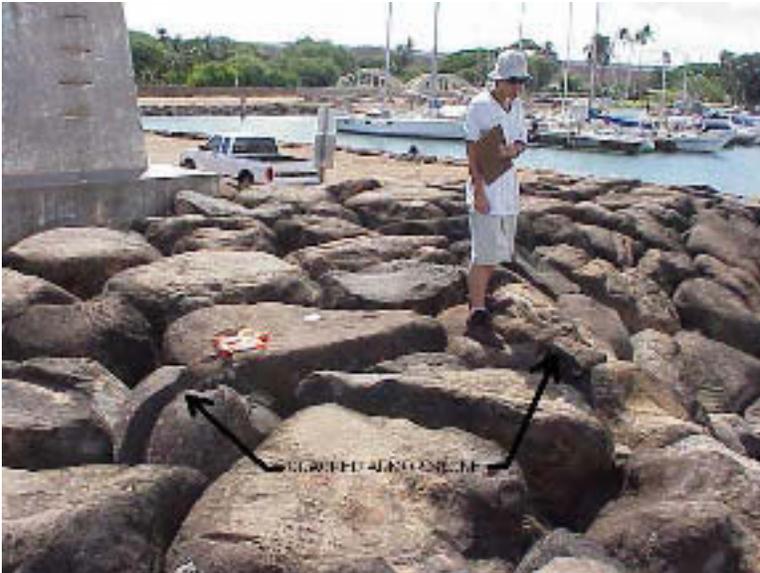
q. Sta. 12+20, 2 ea. cracked armor stones at crest.
