CONTINUING ELIGIBILITY INSPECTION (CEI) REPORT
FOR FLOOD CONTROL PROJECTS

1. Project Name: Hanapepe Stream FCP

2. Date of Inspection: December 4, 2001

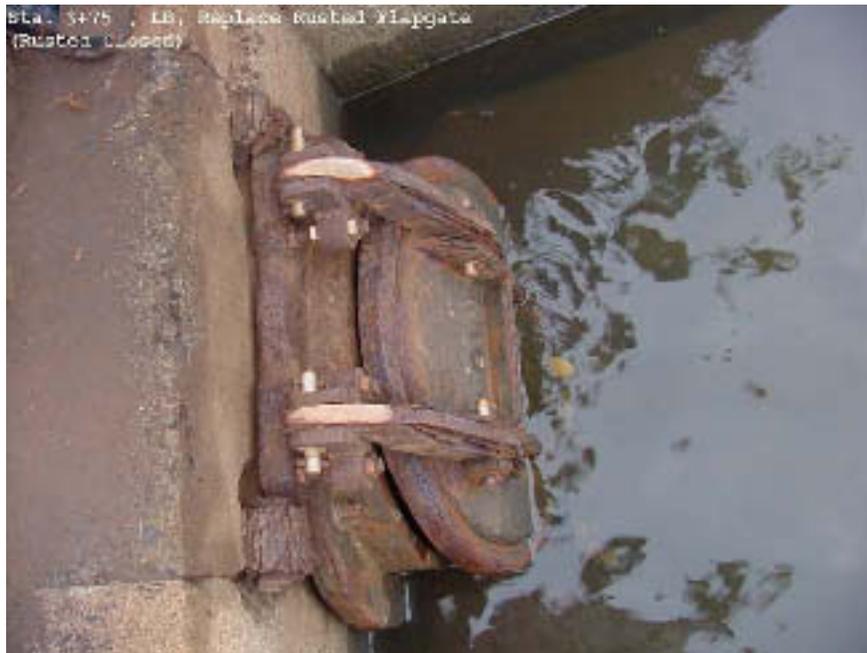
a. Sta. 3+75, LB, Replace inoperable flapgate (®).

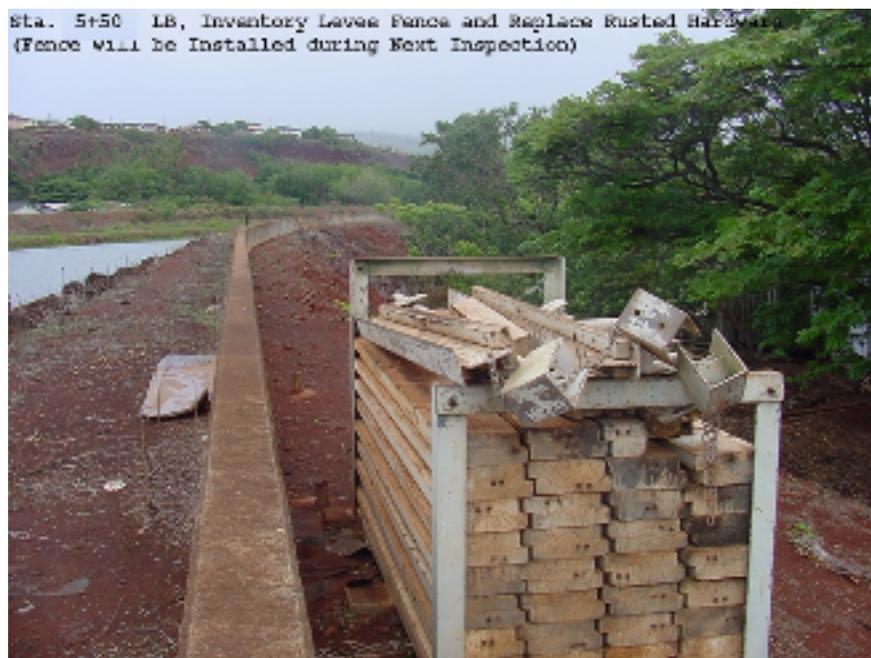
c. Sta. 5+50, LB, Inventory levee fence and replace rusted hardware (®).

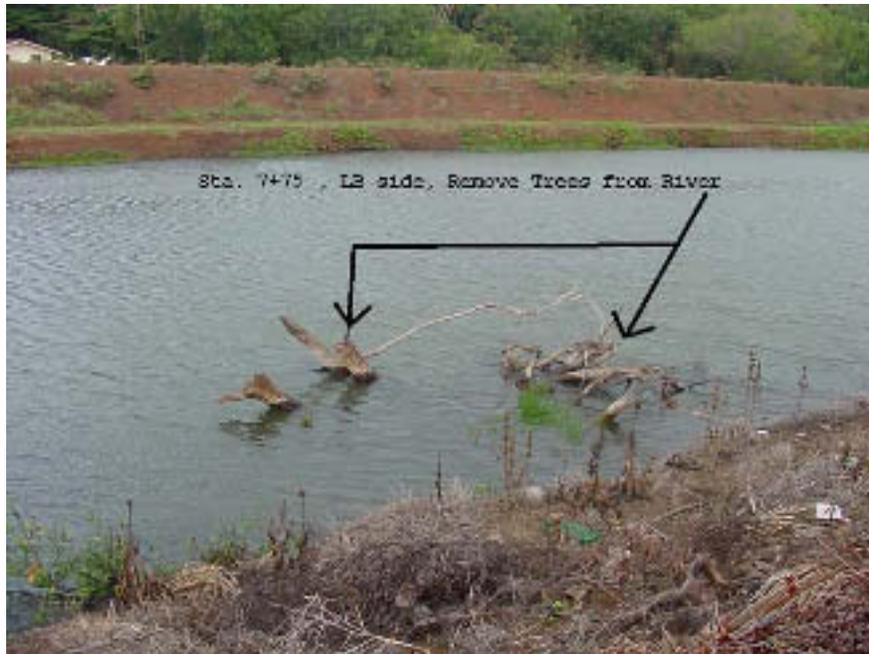
d. Sta. 7+75, LB side of river, remove vegetation & trees from river.

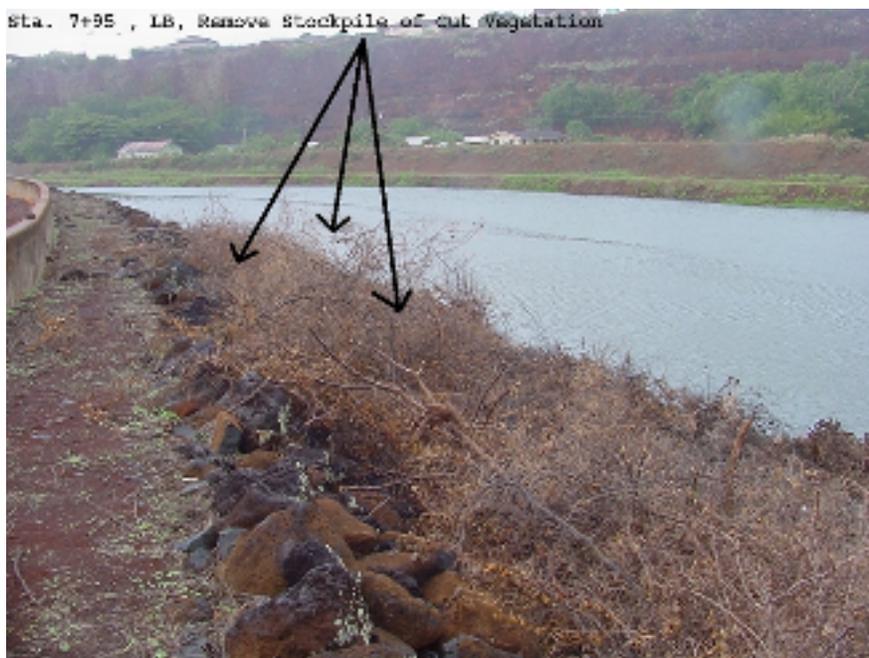
e. Sta. 7+95, LB, remove stockpile of cut vegetation from levee sideslope.

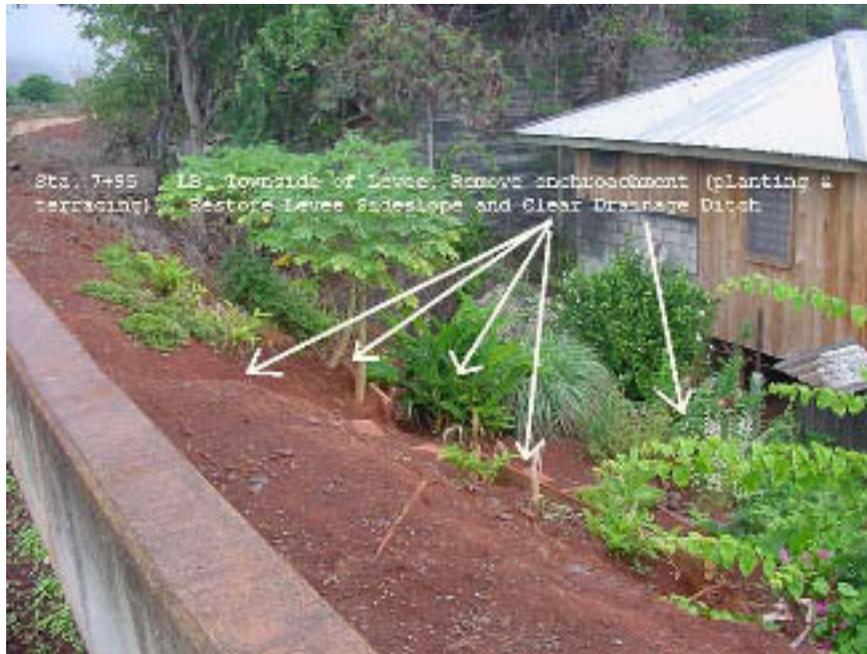
f. Sta. 7+95, LB, Remove encroachments, restore drainage ditch and restore terraced levee sideslope (®).
