**CONTINUING ELIGIBILITY INSPECTION (CEI) REPORT**  
**FOR FLOOD CONTROL WORKS**  
Honolulu Engineer District  
CEPOH-EC-T

1. Project Name: KK Dam Flood Control Project
2. Date of Inspection: December 10, 2003
3. Inspection Personnel:

4. Ratings for FY04  
Project Rating: "S, **Satisfactory**"  
Project Condition Code: "A, **Acceptable**"  
Project Status: "**Active**"

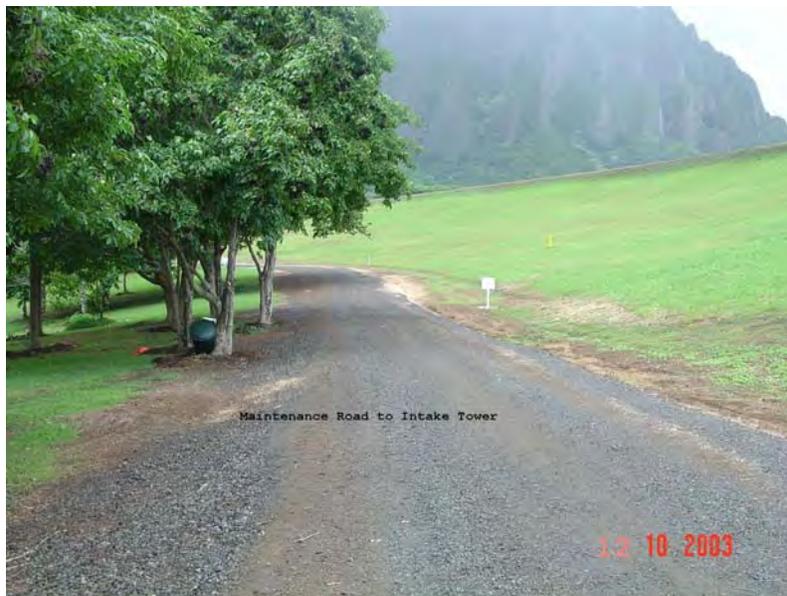
- a. The maintenance access road to intake structure is in good condition.

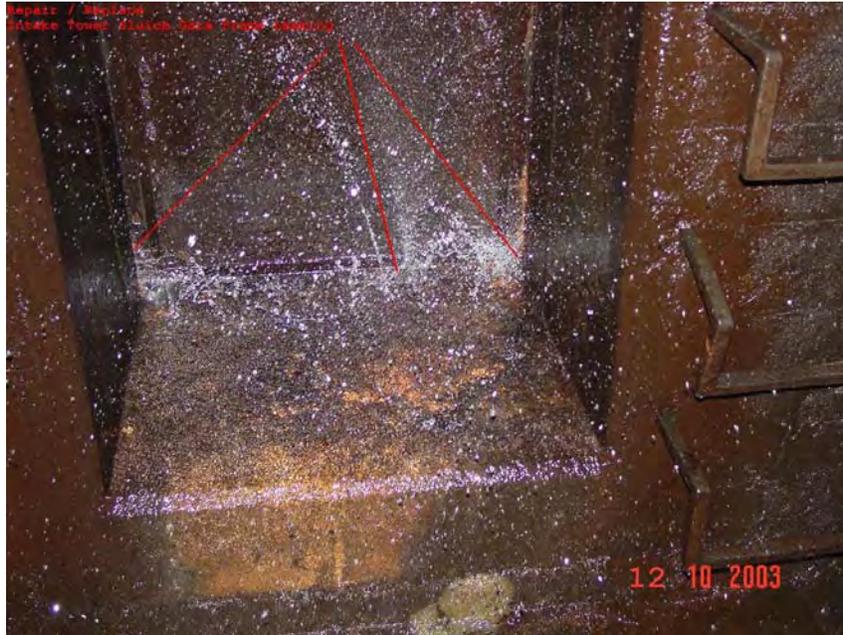
b. Verify leaking from intake tower sluice gate frame and repair if required.

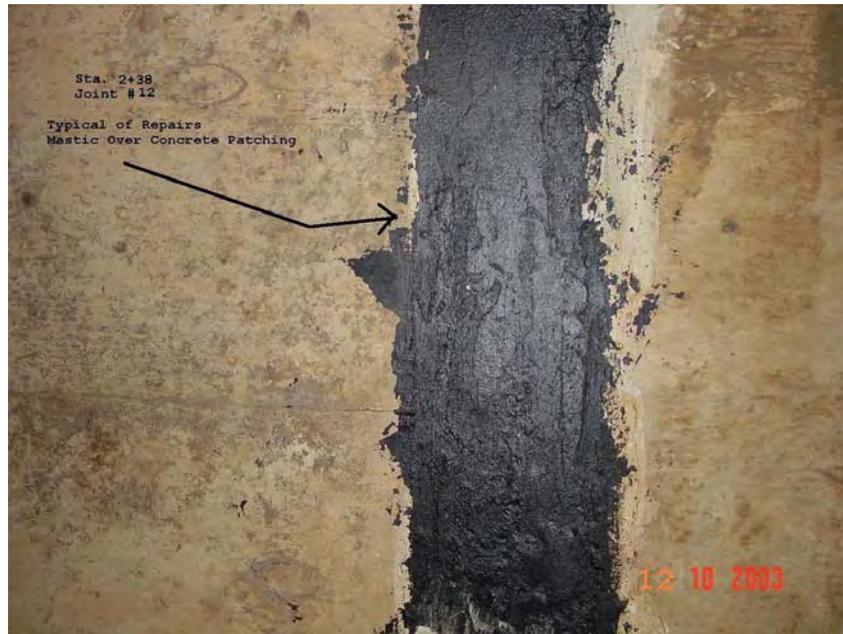
c. Sta. 2+38, (joint # 12) typical mastic over concrete patch.

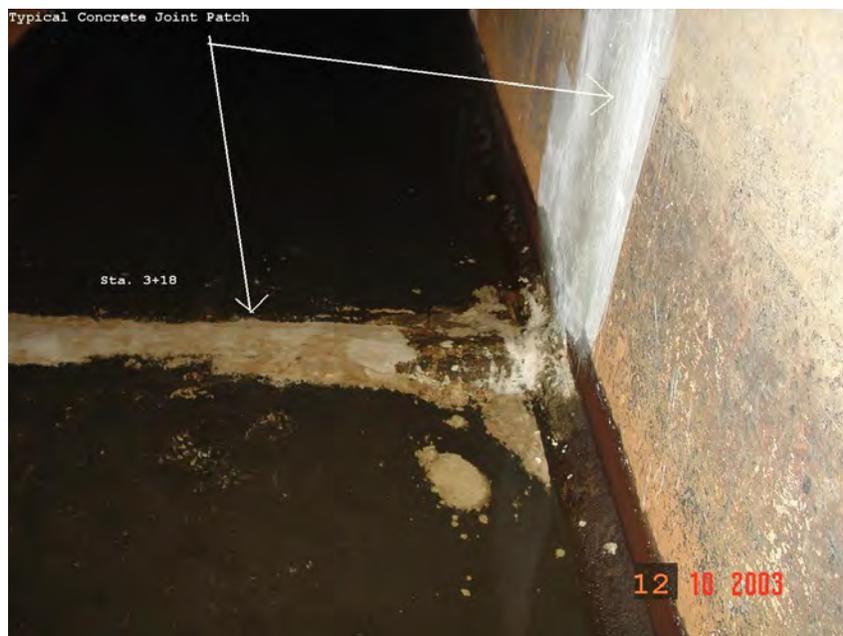
- d. Typical concrete joint patch.

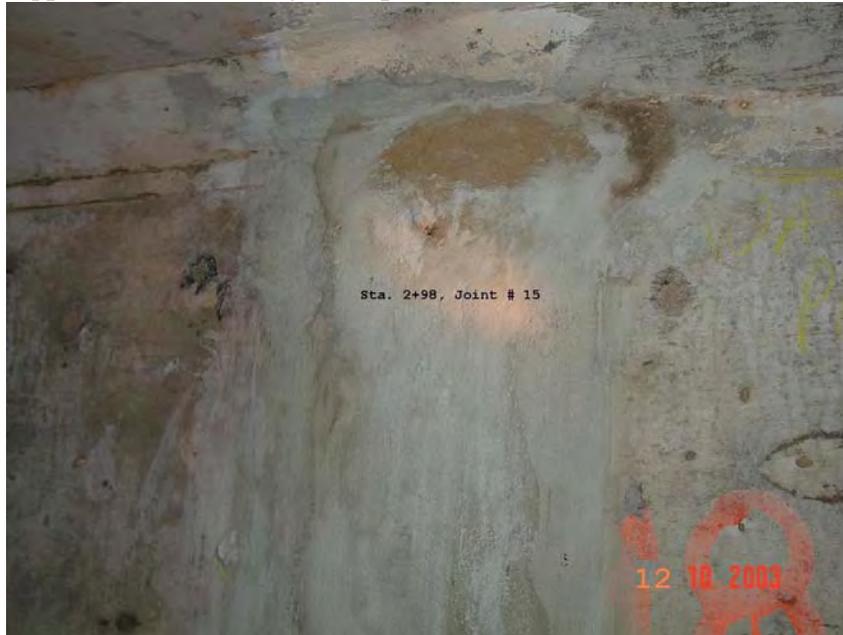
- e. Sta. 2+98, Joint # 15.

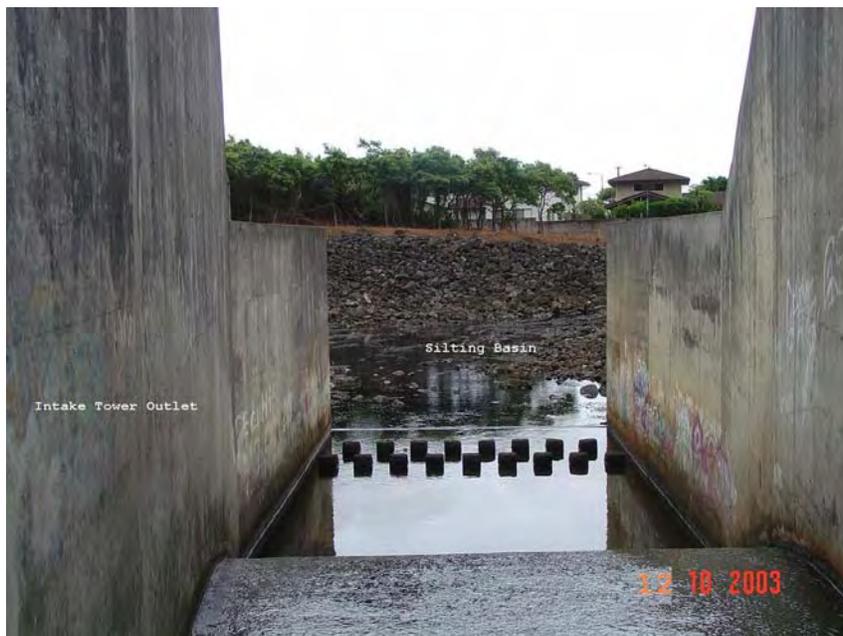
- f. Overview of intake tower outlet and silting basin.

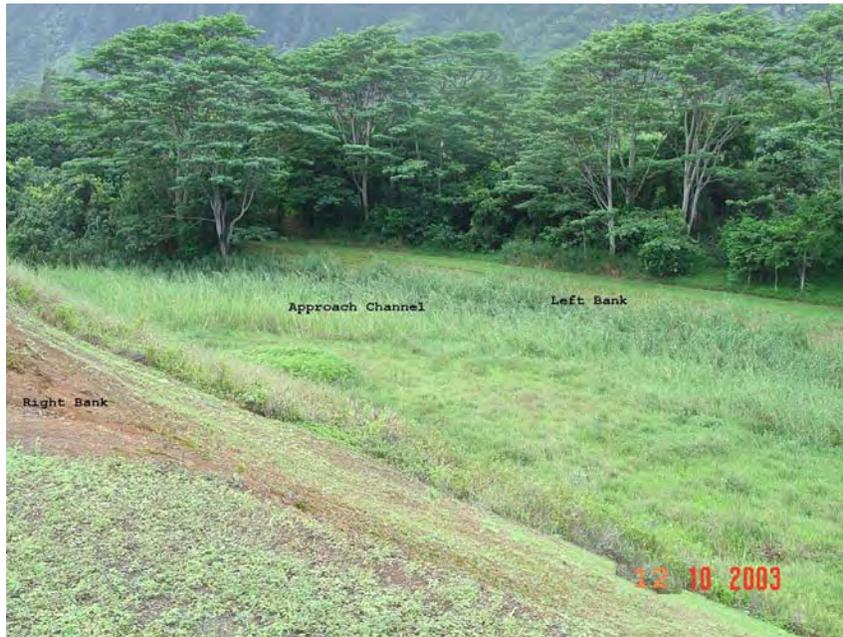
g. Overview of Approach Channel, no deficiencies noted.

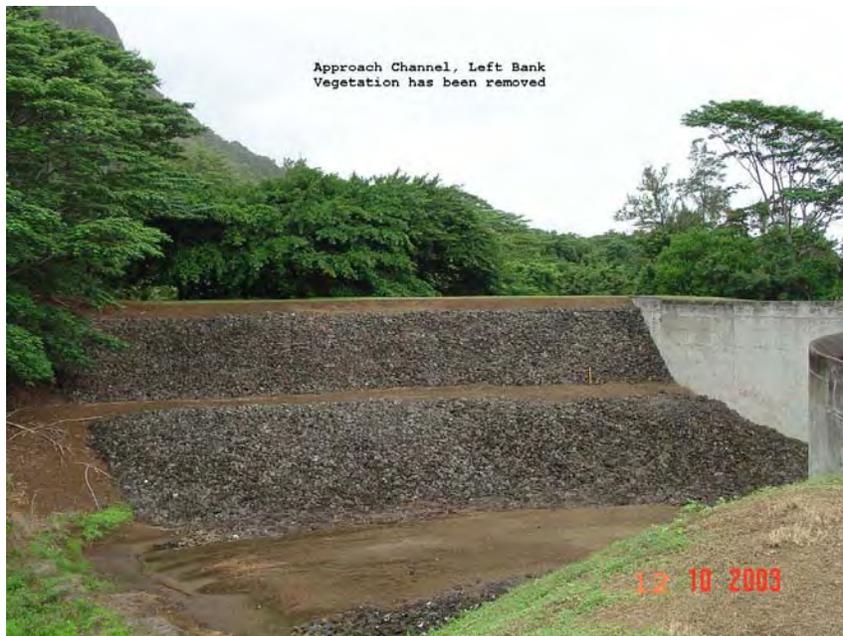
h. Approach Channel transition to spillway, vegetation has been removed from riprap.

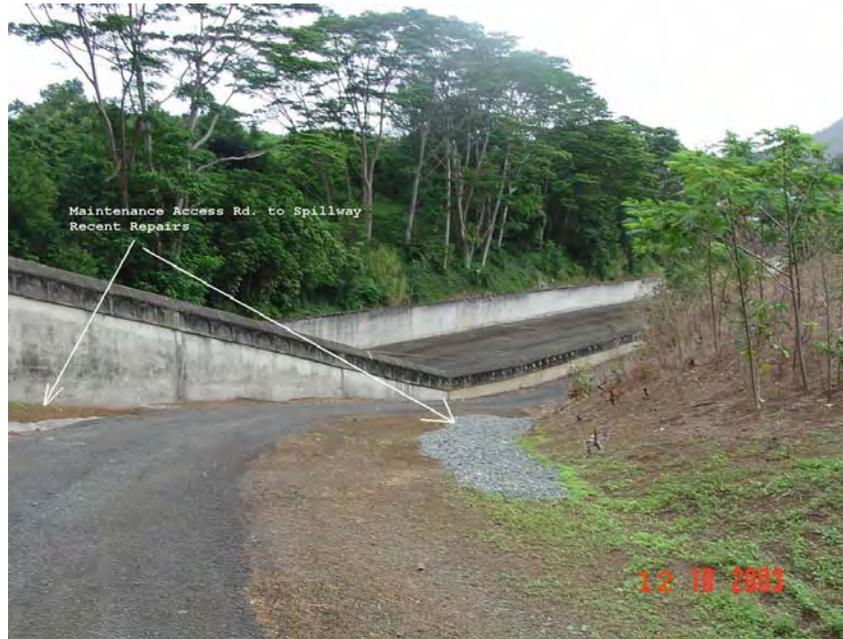
i. Overview of maintenance access road "B" to spillway; recent repairs made.

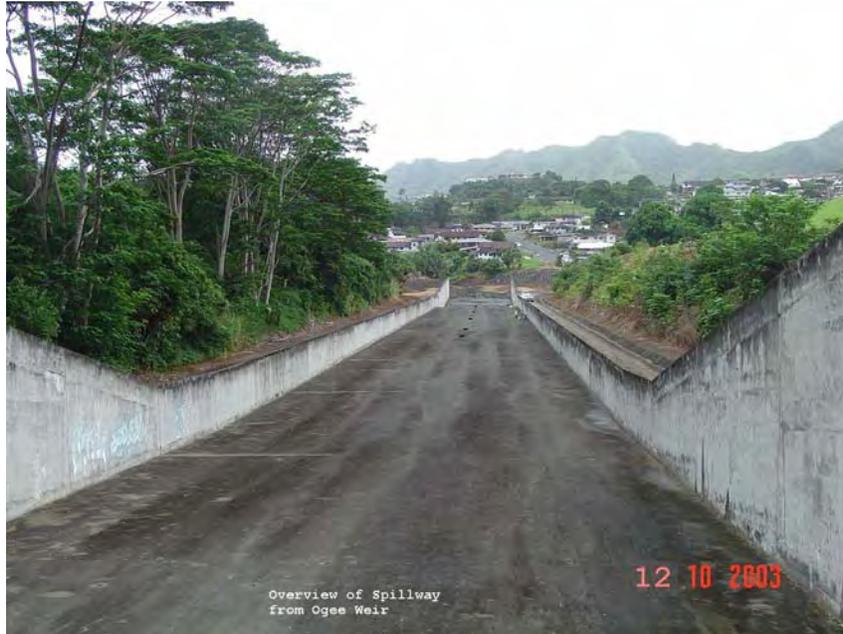
j. Overview of spillway from Ogee weir.

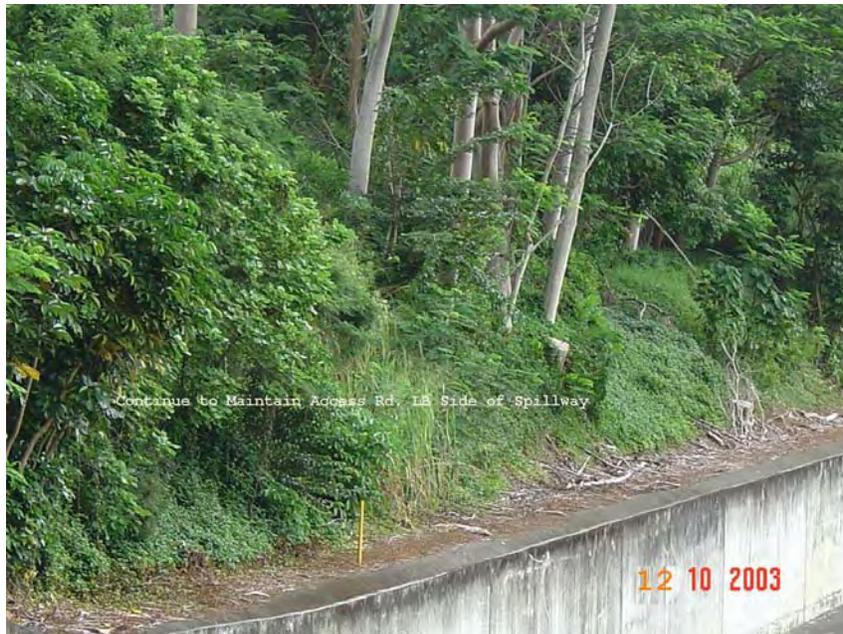
k. Continue to maintain access road on left bank (LB) side of spillway.

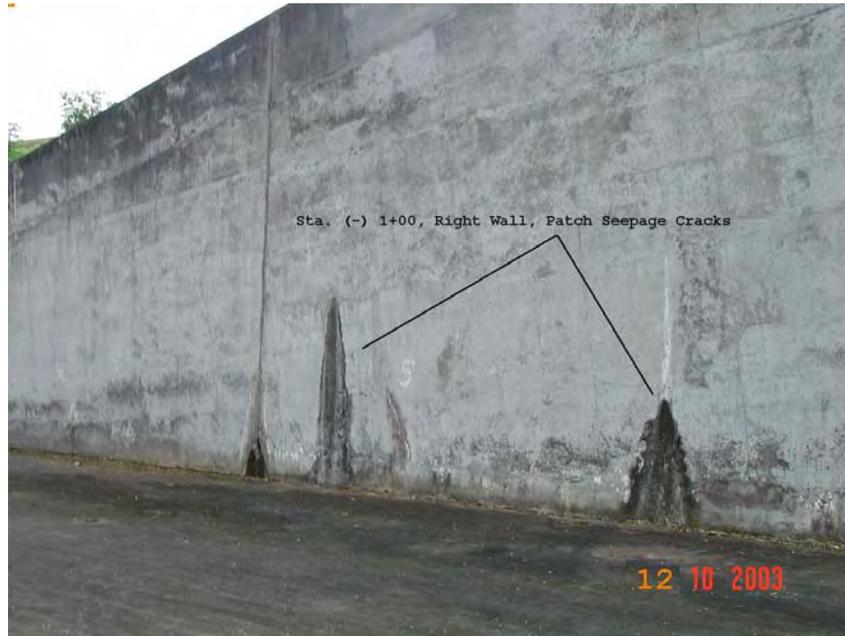
1. Sta. (-) 1+00, right bank (RB) wall, patch seepage cracks.

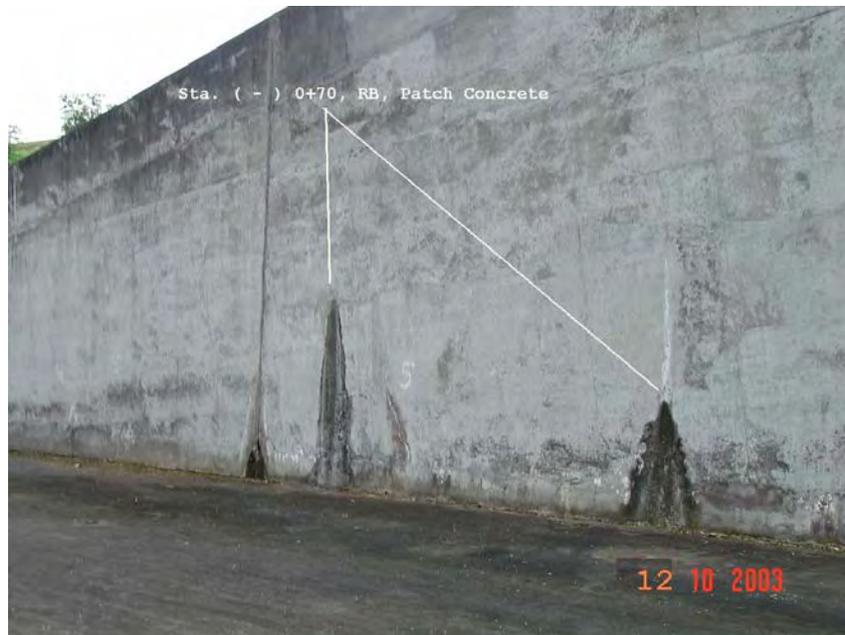
- m. Sta. (-) 0+70, (RB) wall, patch seepage cracks.

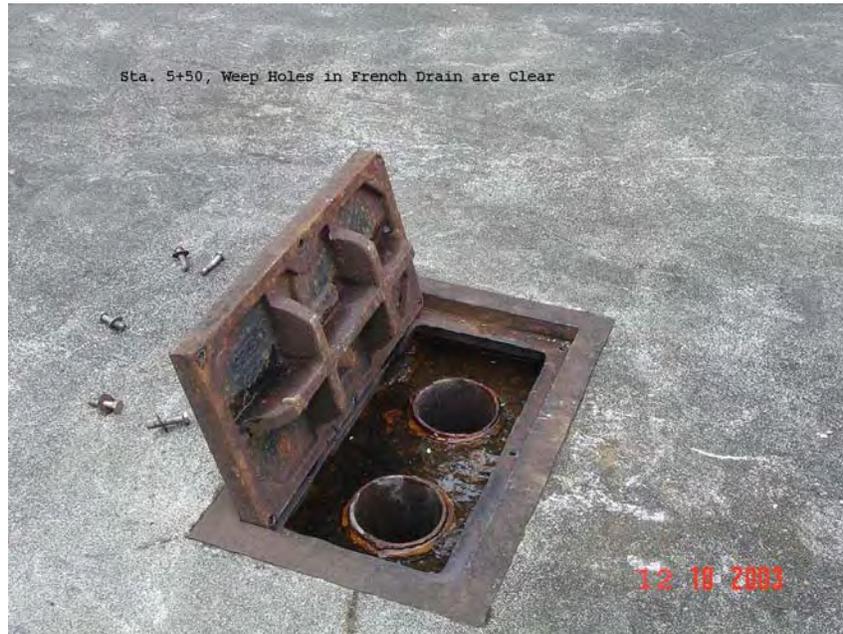
- n. Sta. 5+50, weep holes at drain are clear.

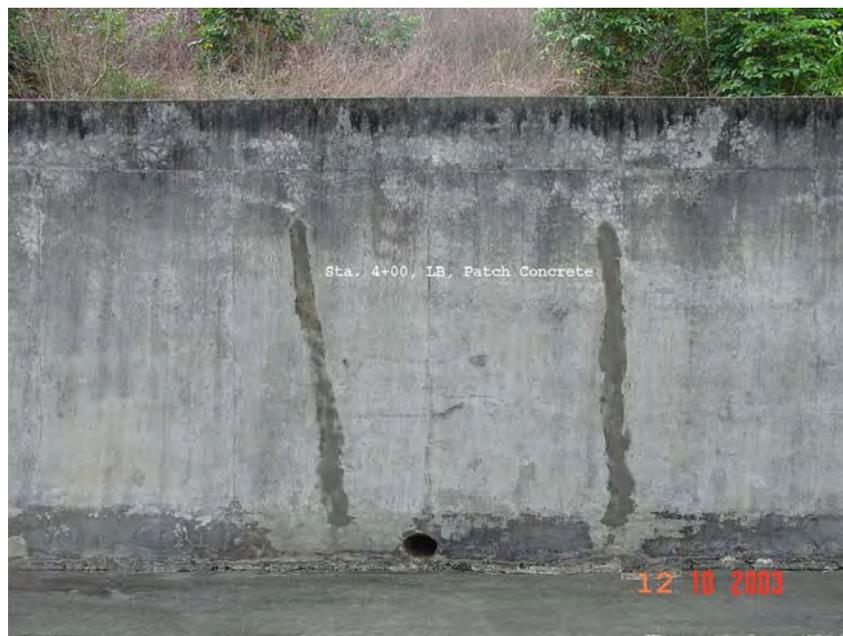
- o. Sta. 4+00, (RB) wall, patch seepage cracks.

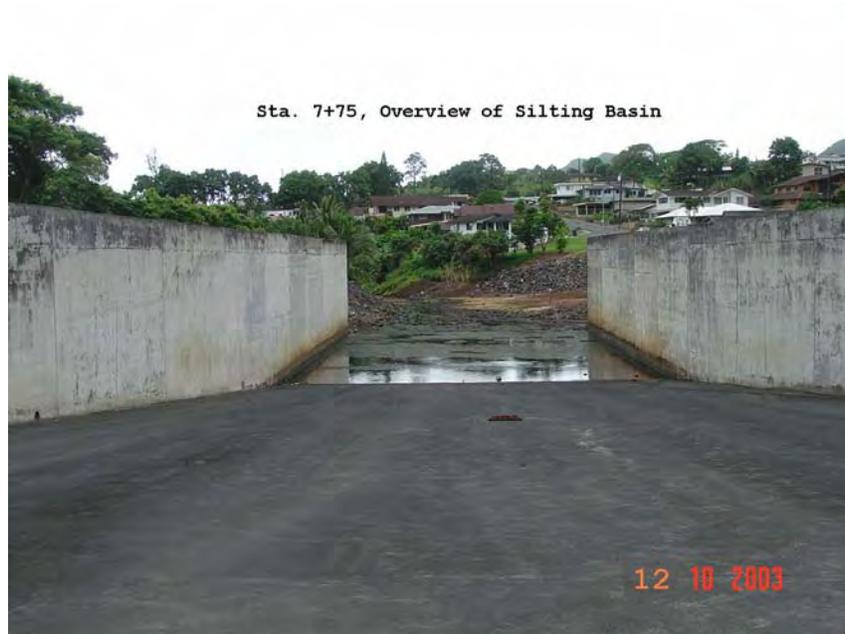
p. Sta. 7+75, Overview of silting basin, no action required.

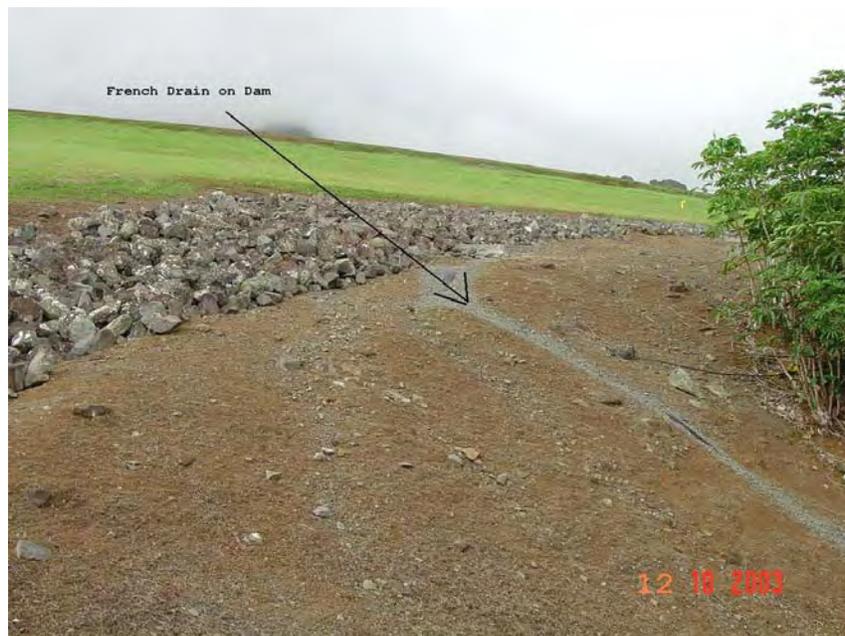
- q. Monitor Eroded areas approximately 25 - 35 LF adjacent the toe drain, downstream face of the dam between Sta. 10+00 and Sta. 11+50, which was been repaired.

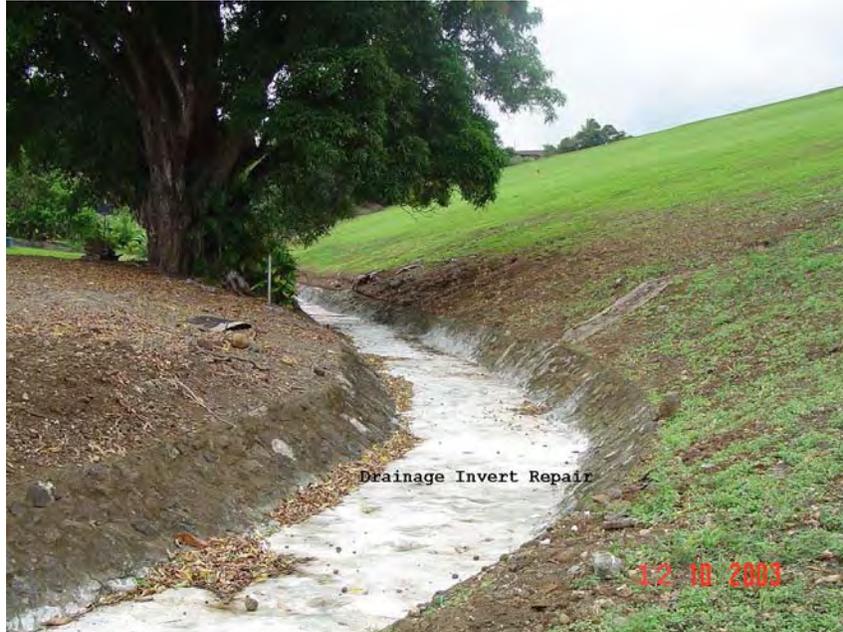
- r. Drainage invert repaired, no action required.

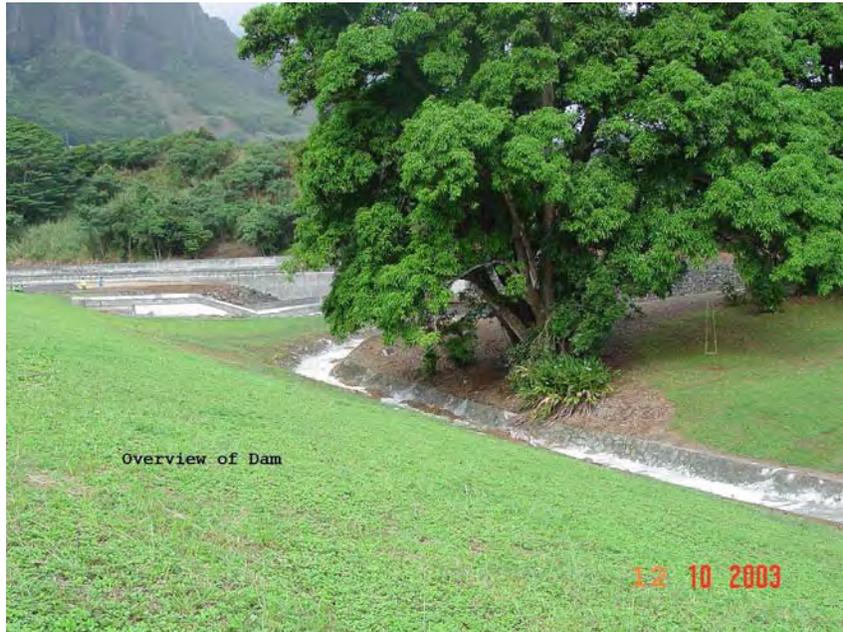
- s. Overview of dam, continue to maintain grass.

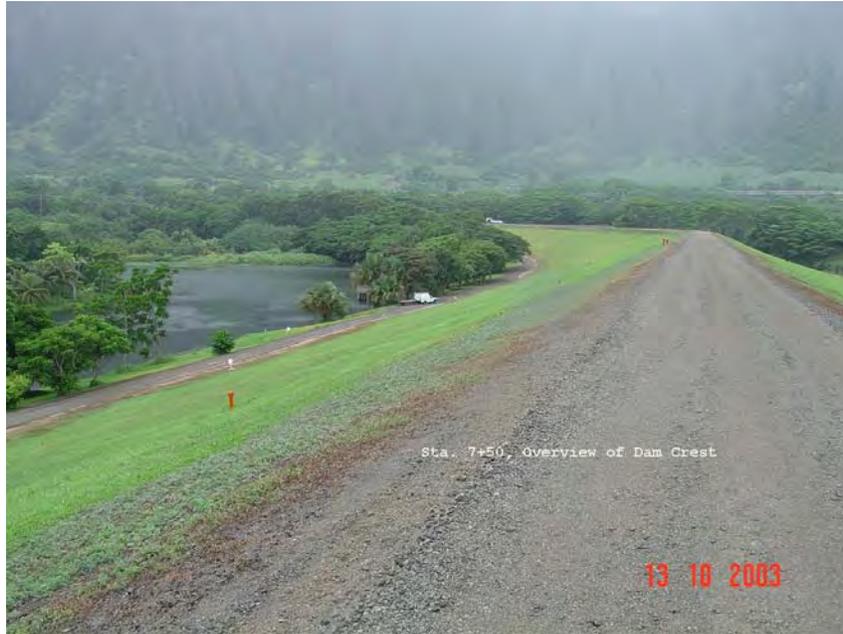
t. Sta. 7+50, Crest of Dam, new layer of base course, potholes have been repaired.

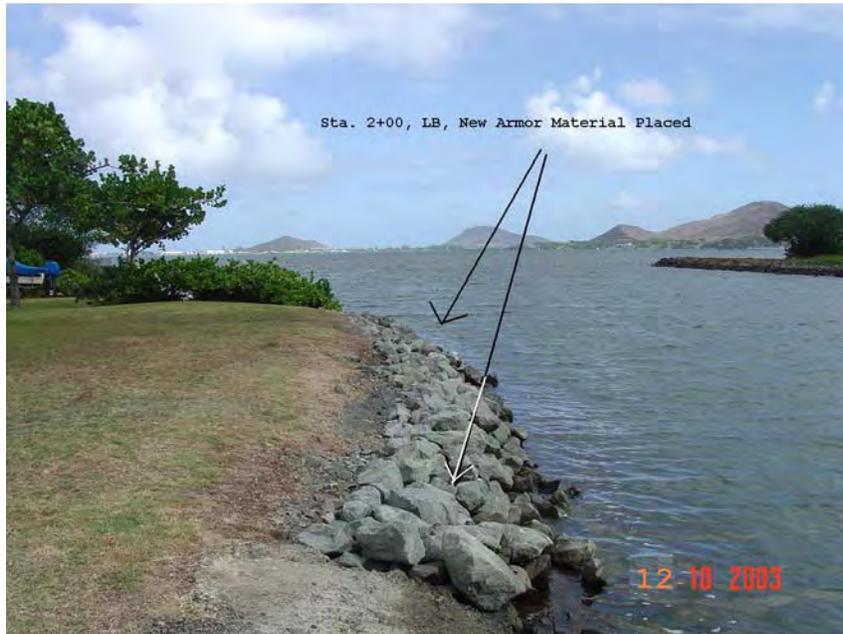
- u. Sta. 2+00, LB, new armor layer placed.

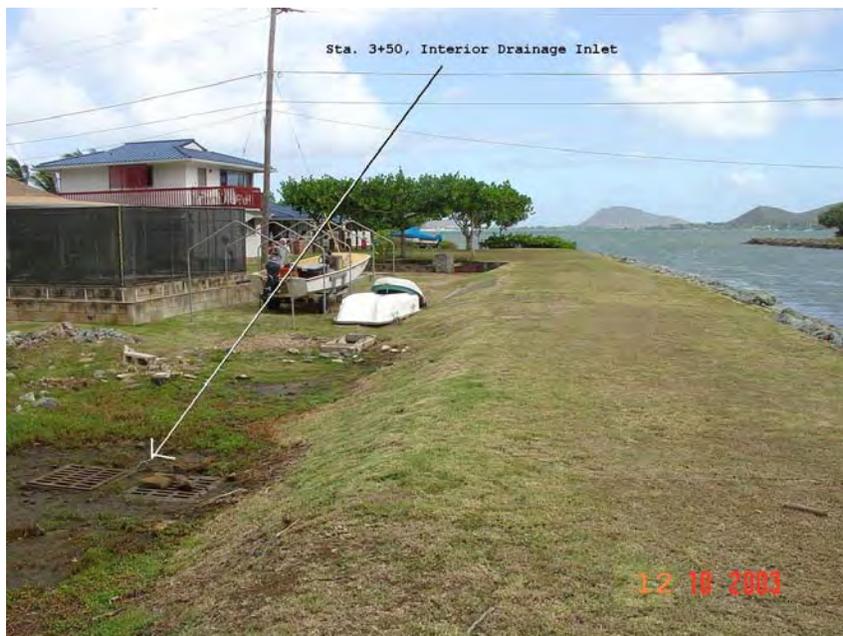
- v. Sta. 3+50, interior drainage intake open.

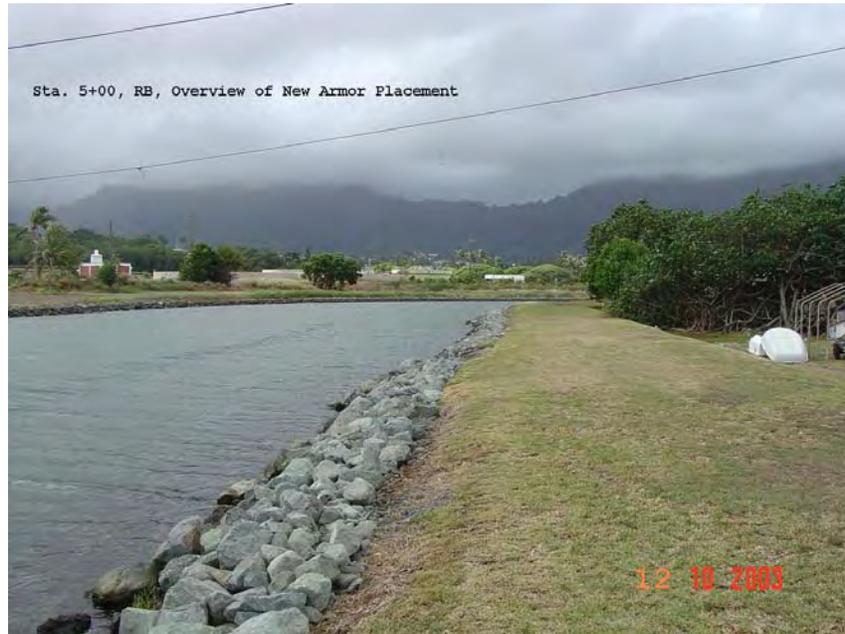
- w. Sta. 5+00, LB, Overview of new armor placement.

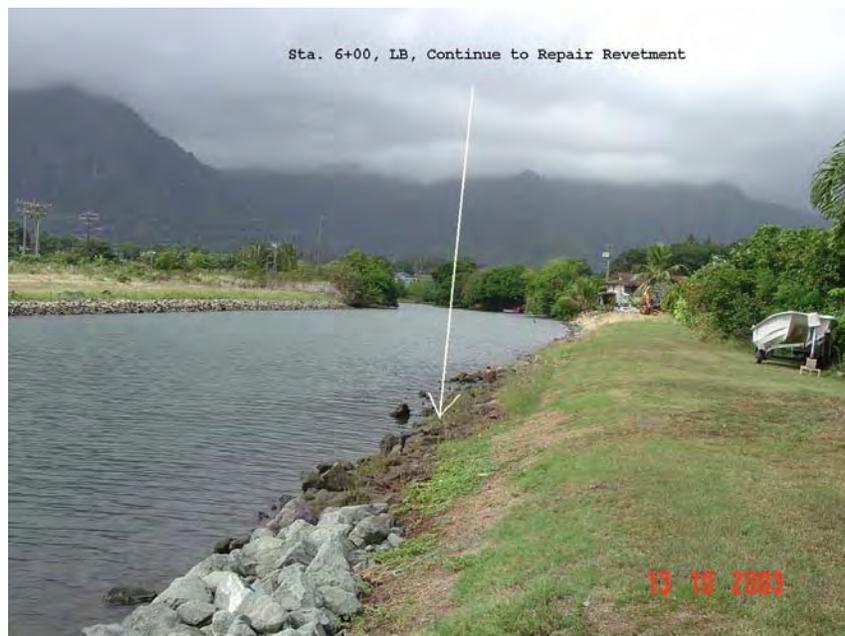
- x. Sta. 6+00, RB, continue to replace armor stone as required.

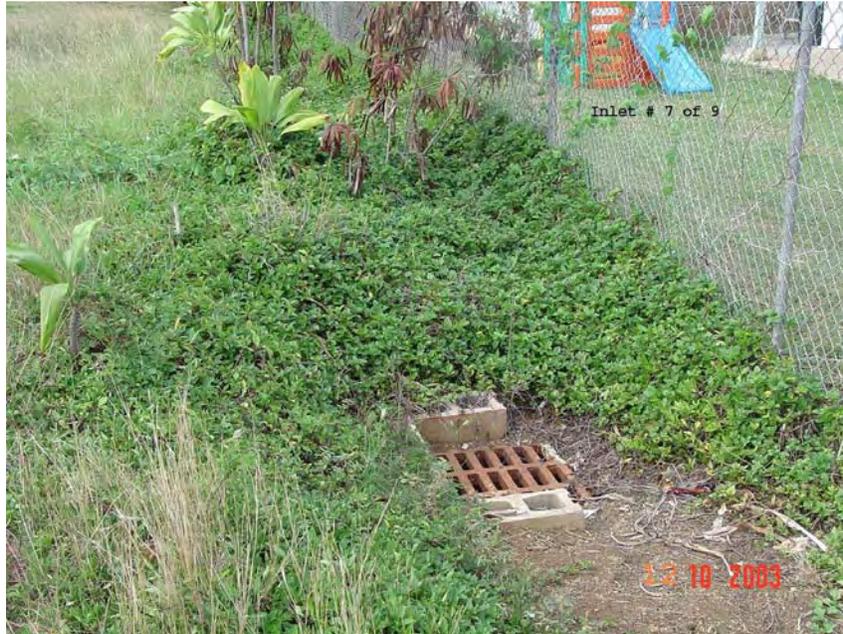
y. Typical interior drainage # 7 of 9 each.

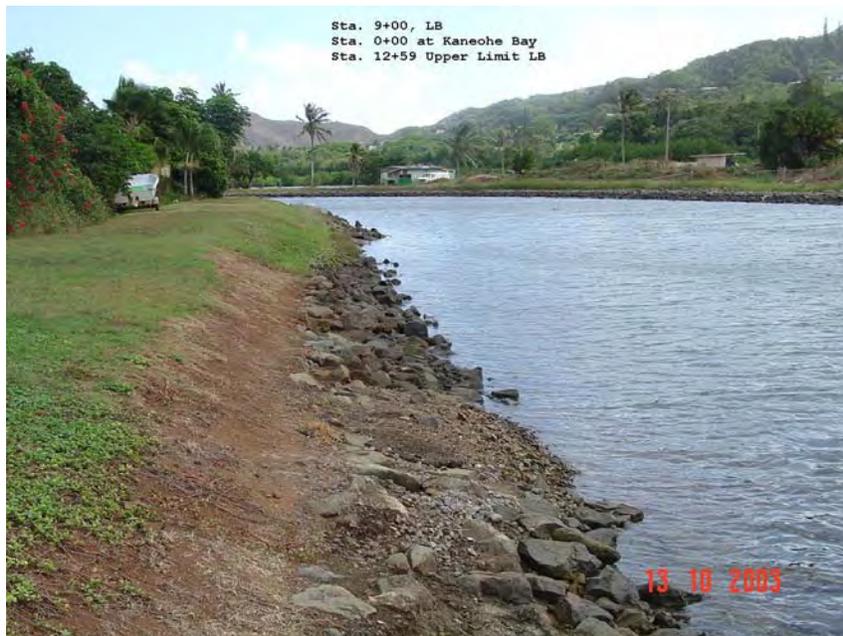
z. Sta. 9+00, LB, add armor layer to levee sideslope.

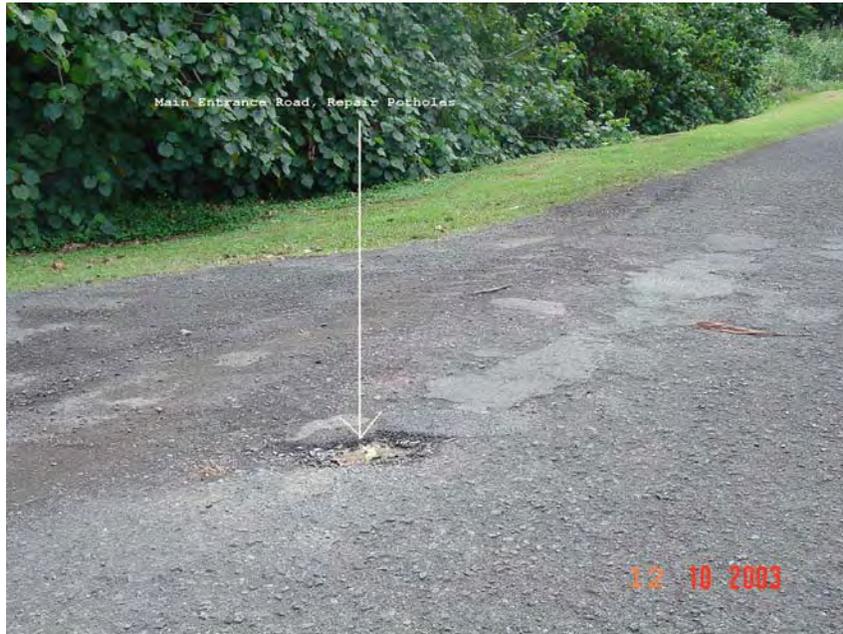
aa. Main Road, Repair pothole at main entrance.

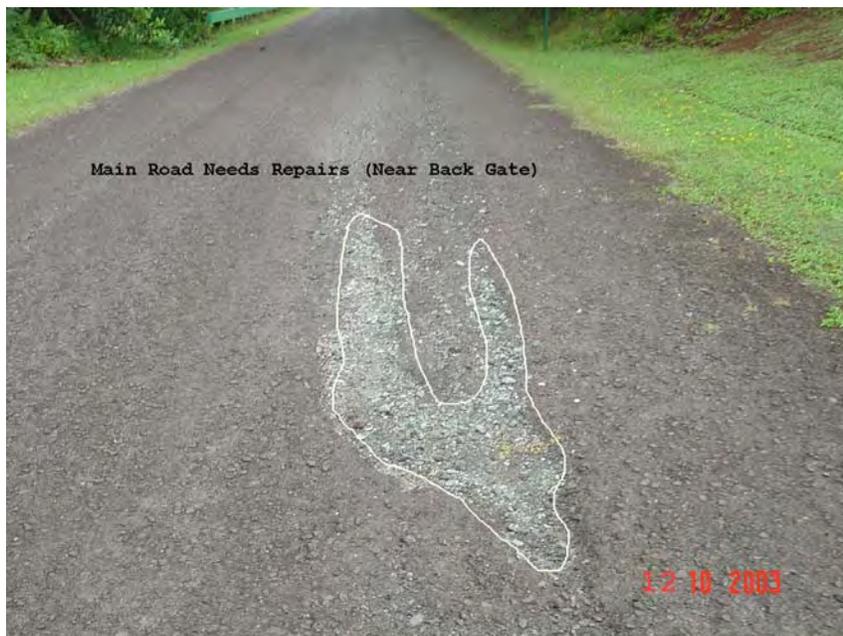
bb. Repair pothole near back gate.

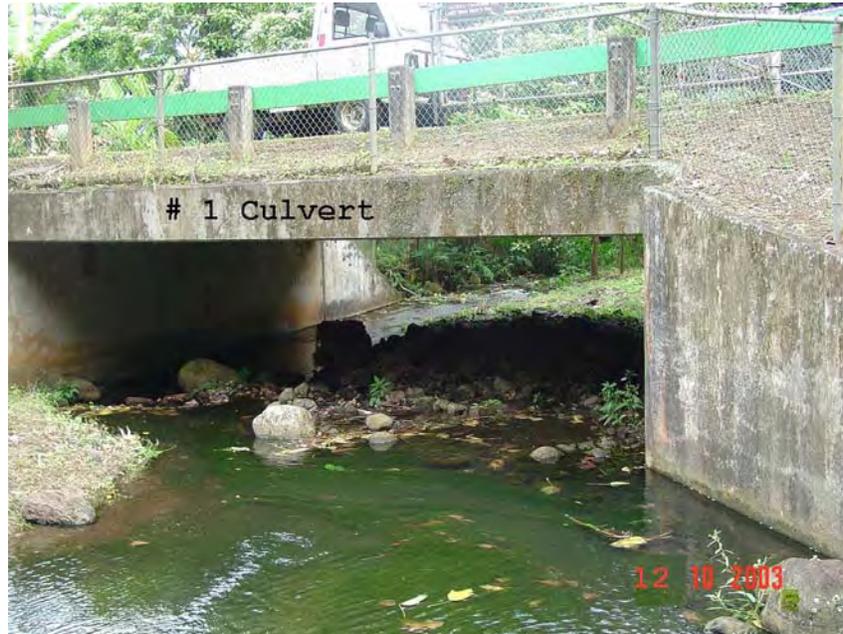
cc. Culvert # 1 (nearest to main entrance) continue to maintain.

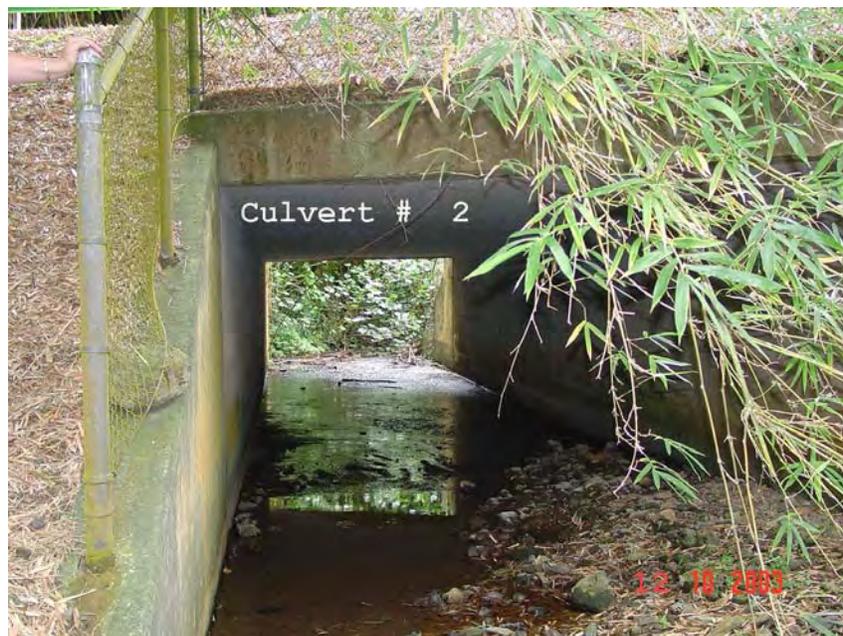
dd. Culvert # 2, continue to maintain.

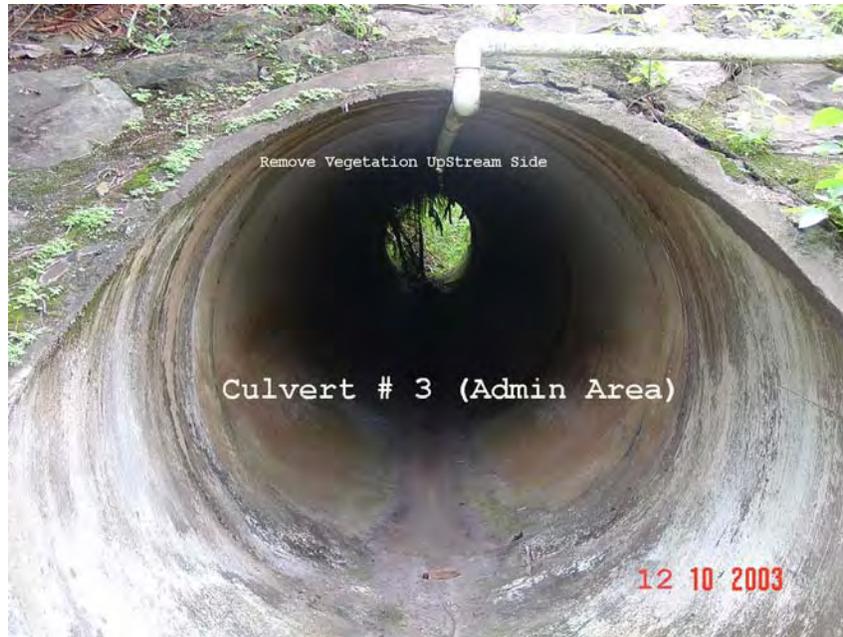
ee. Culvert # 3 (adj admin area) continue to maintain.

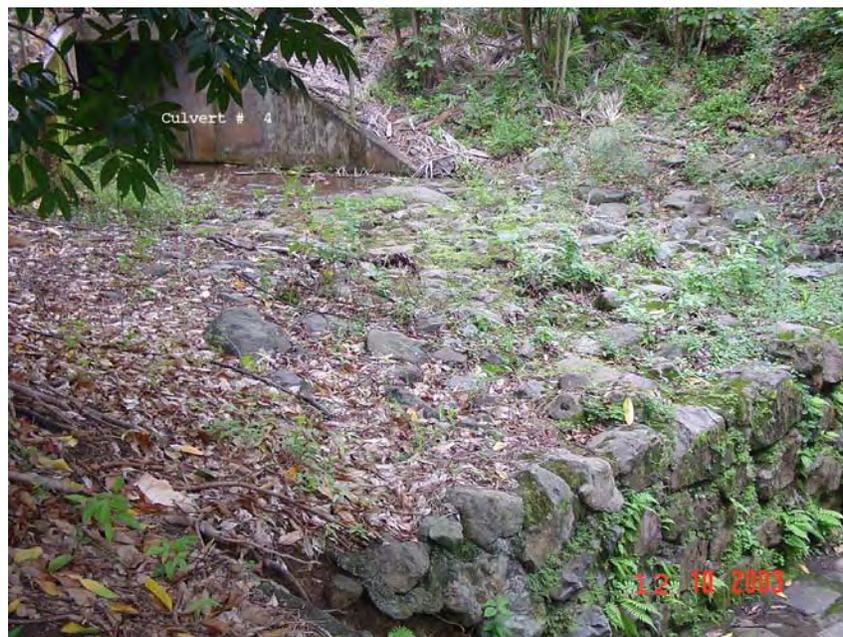
ff. Culvert # 4, continue to maintain.

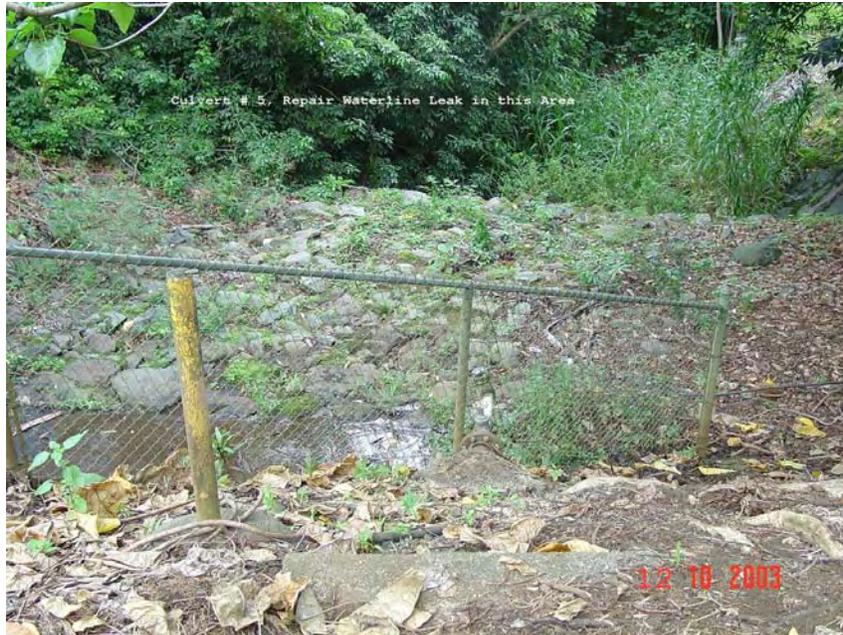
gg. Culvert # 5, continue to maintain.

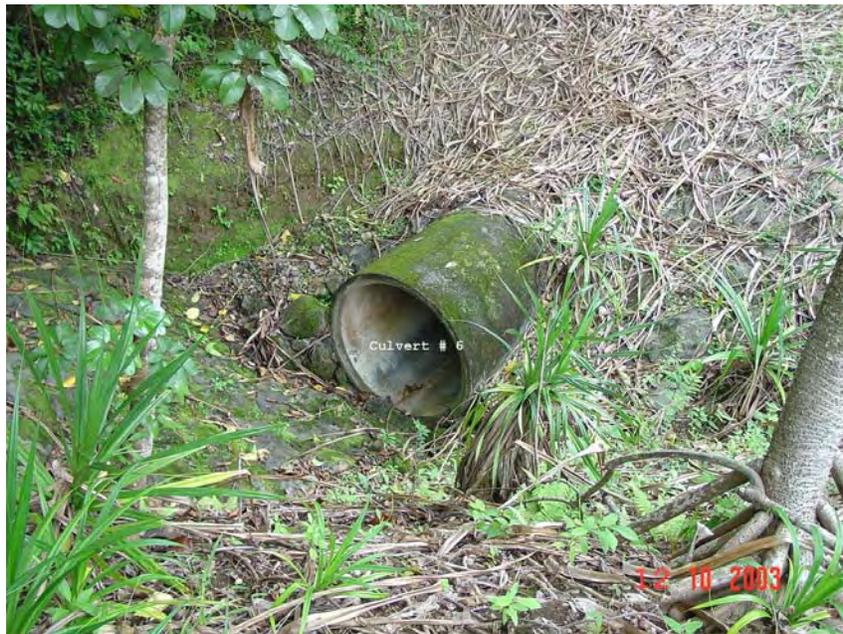
hh. Culvert # 6, continue to maintain.

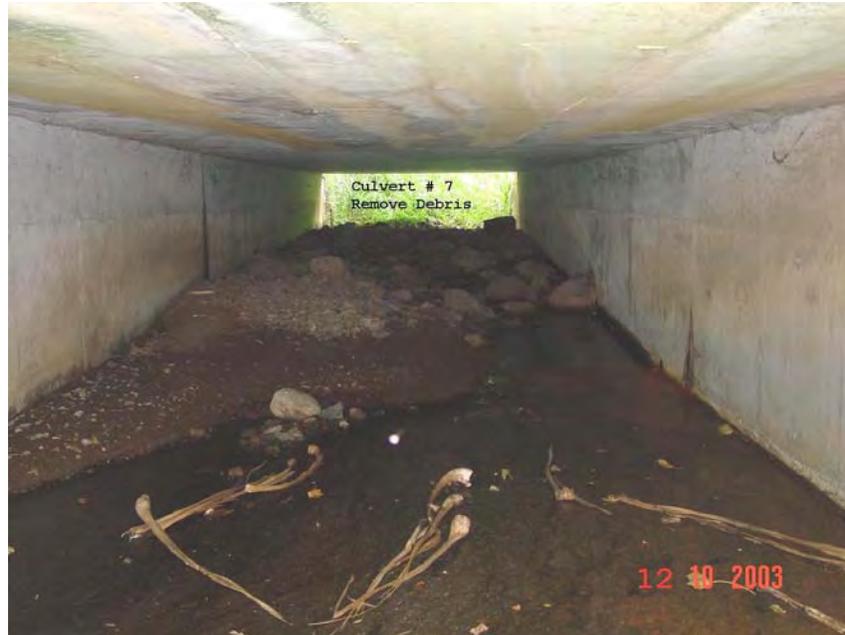
ii. Culvert # 7, remove debris buildup.

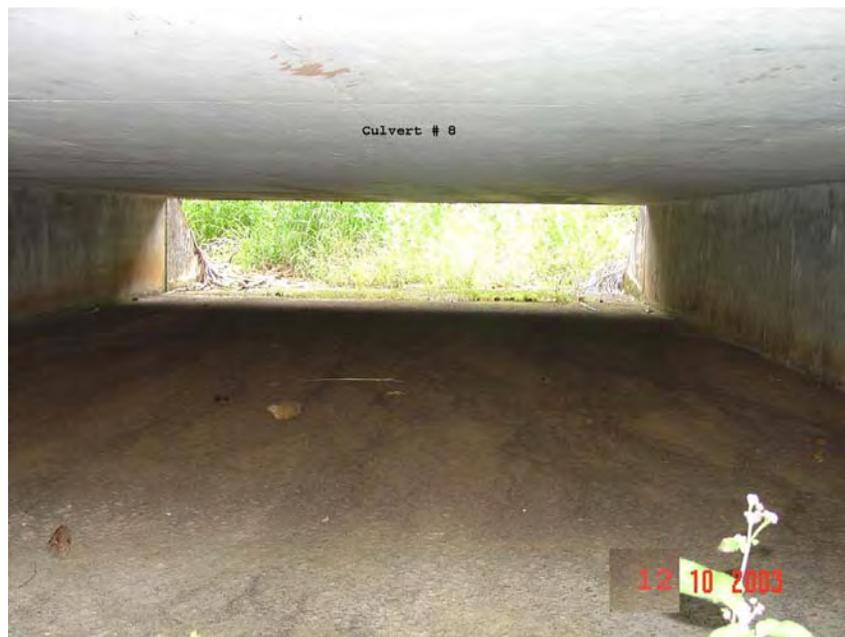
jj. Culvert # 8, continue to maintain.

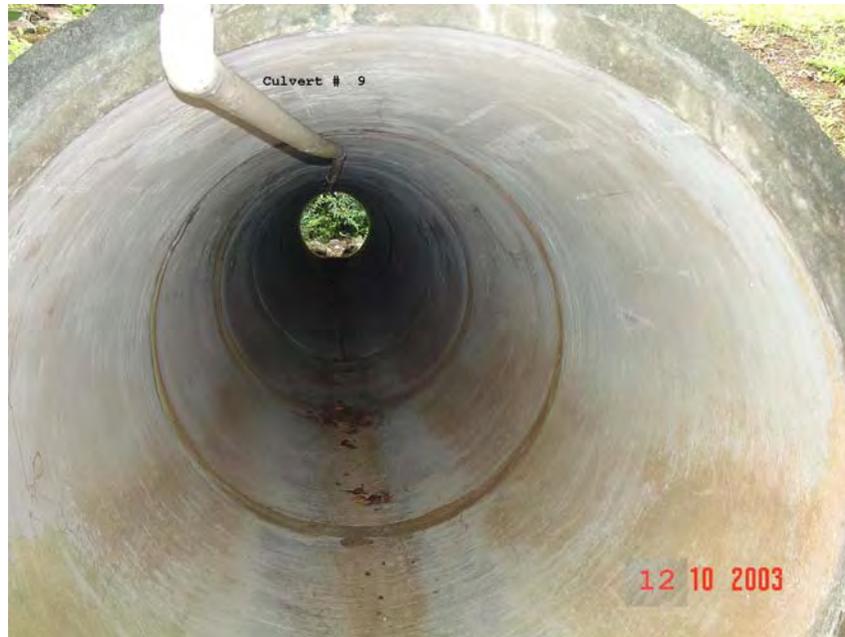
kk. Culvert # 9, continue to maintain.

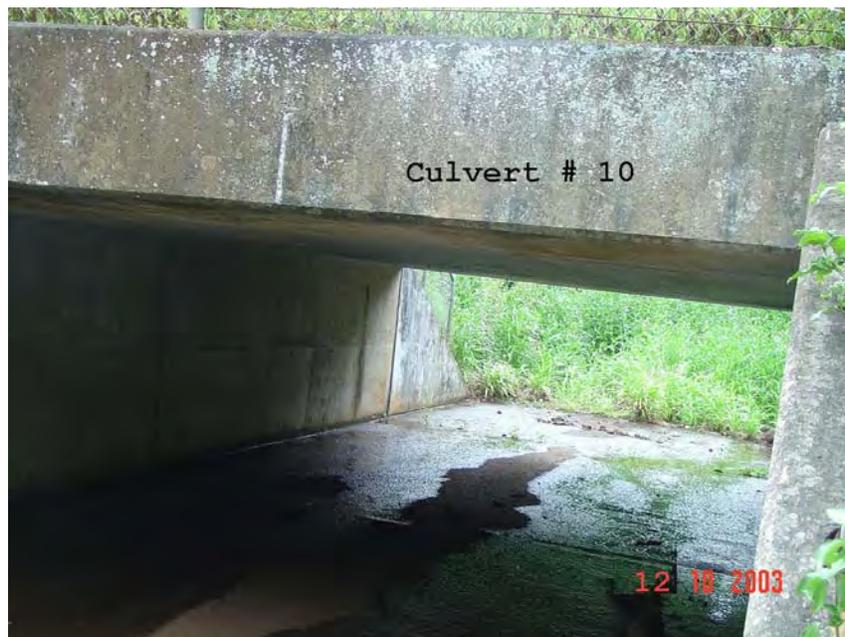
ll. Culvert # 10, continue to maintain.

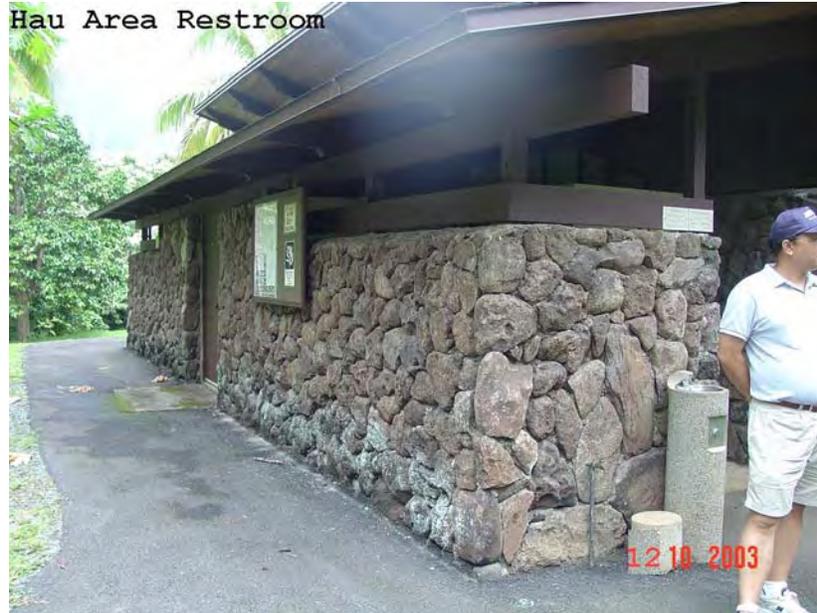
mm. Hau Area Restroom, good condition, good maintenance, no action required.

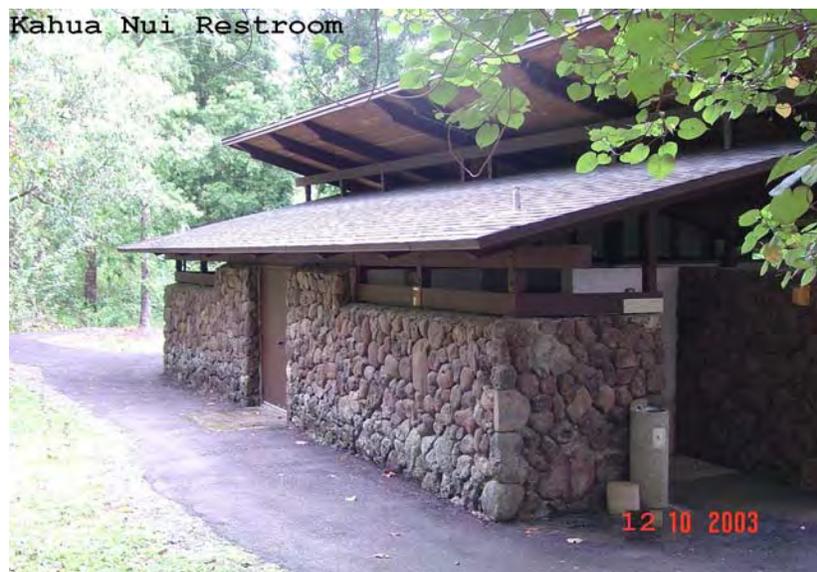
nn. Kahua Nui Area Restroom, good condition, good maintenance, no action required.

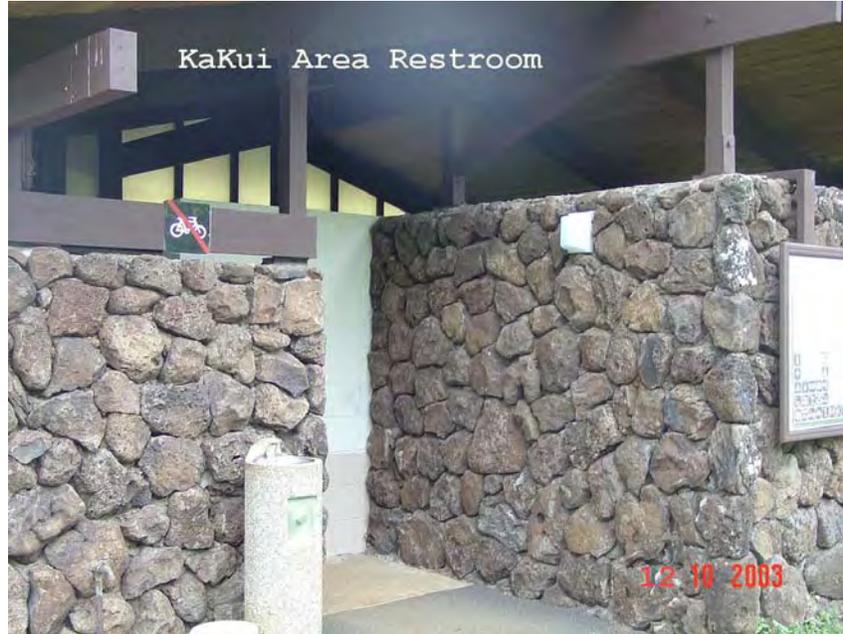
oo. Kakui Area Restroom, good condition, good maintenance, no action required.

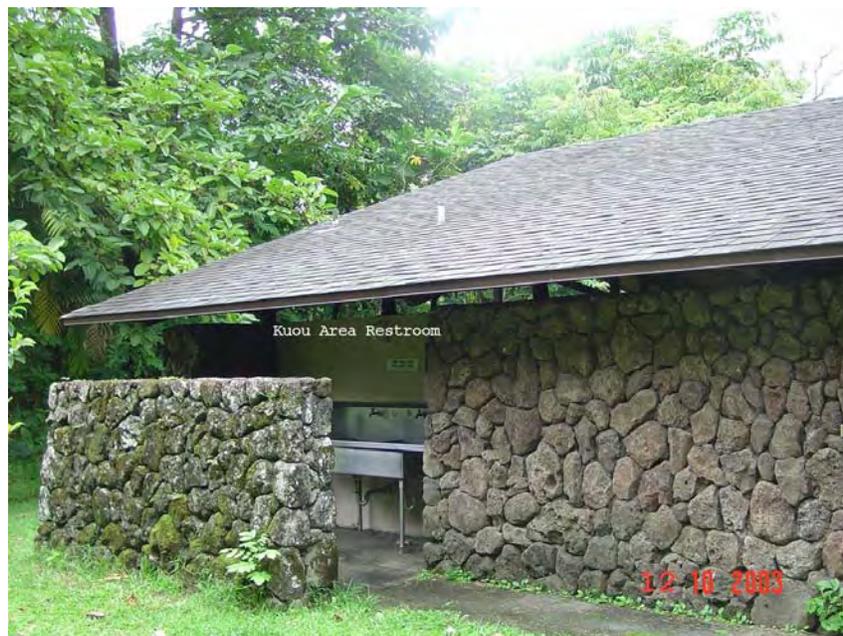
pp. Kahua Kuou Area Restroom, good condition, good maintenance, no action required.
