**CONTINUING ELIGIBILITY INSPECTION (CEI) REPORT**  
**FOR FLOOD CONTROL WORKS**  
Honolulu Engineer District  
CEPOH-EC-T

1. Project Name: KK Dam Flood Control Project
2. Date of Inspection: December 10, 2003
3. Inspection Personnel:

4. Ratings for FY04  
Project Rating: "S, **Satisfactory**"  
Project Condition Code: "A, **Acceptable**"  
Project Status: "**Active**"

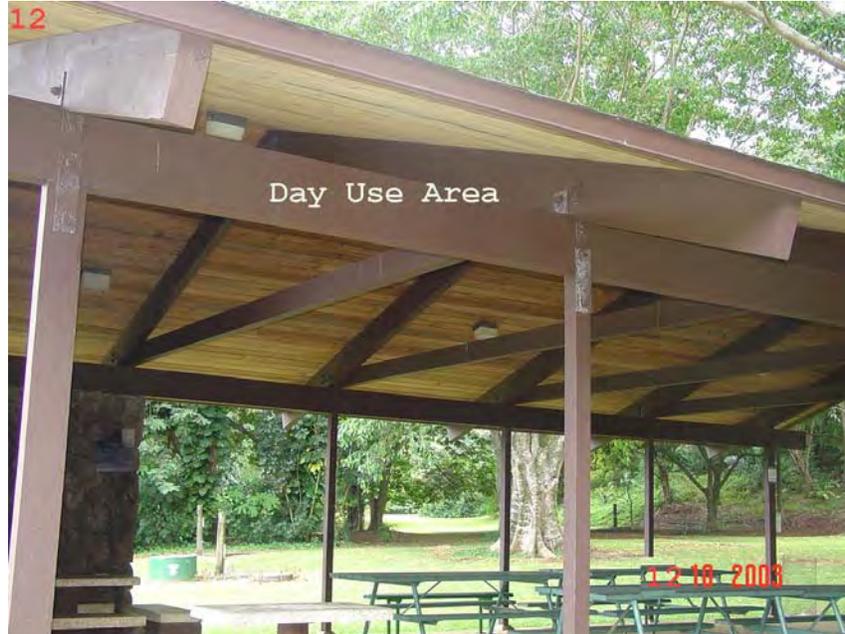
qq. Day Use Area, good condition, good maintenance, no action required.

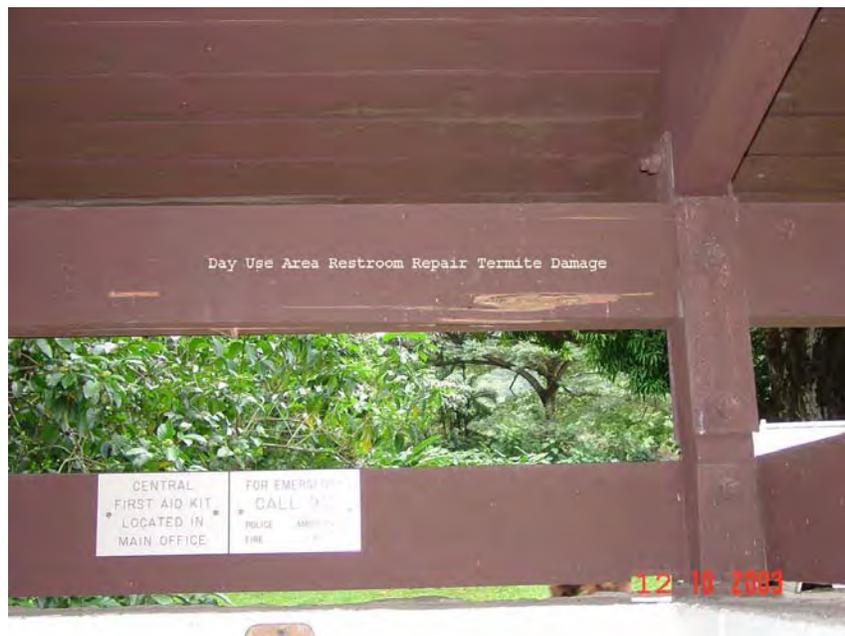
rr. Perform structural repairs to "Day Use" restroom. Roof structure, brace & support beams and rafters has been damaged by termites.

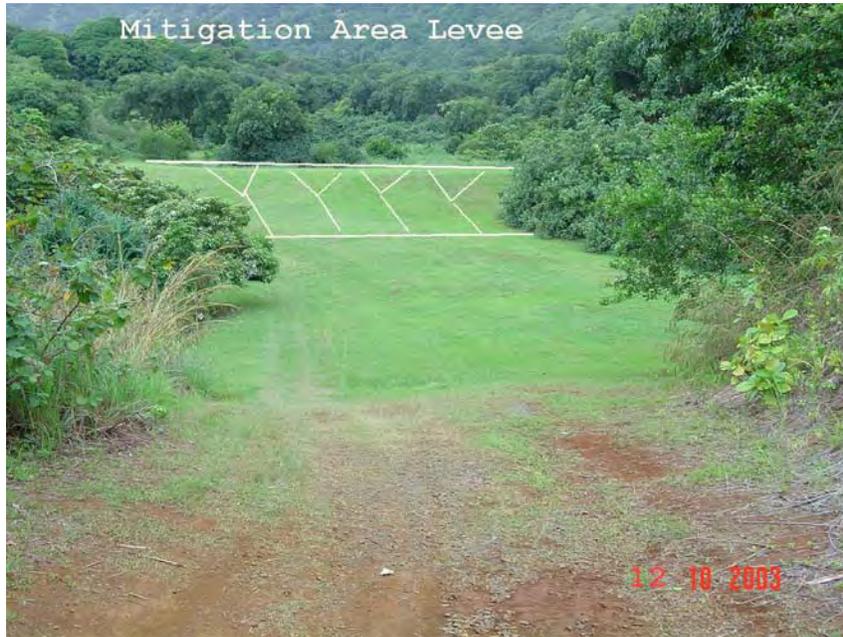
ss. Mitigation Area Levee, in good condition continue to maintain.

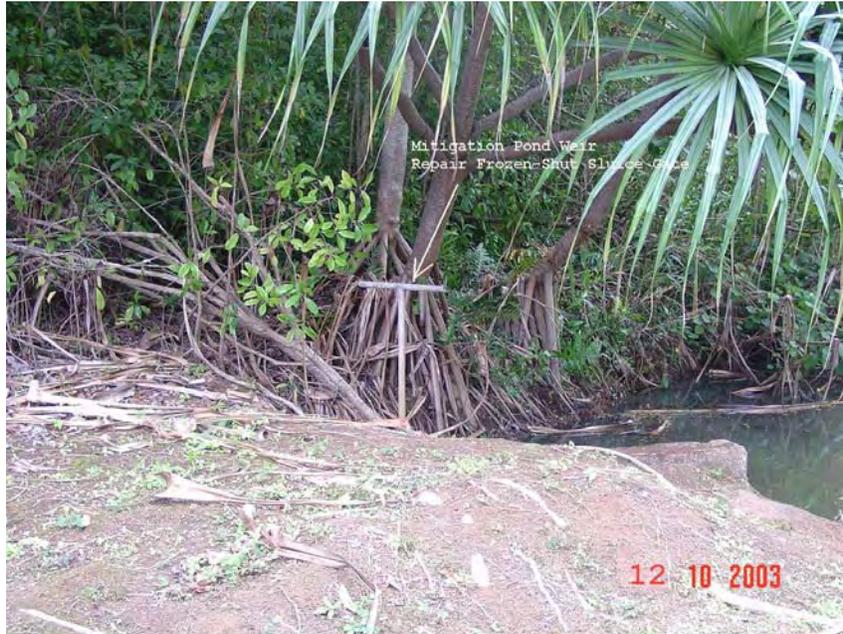
tt. Mitigation Area Spillway Weir, maintenance required to free stuck control gate.

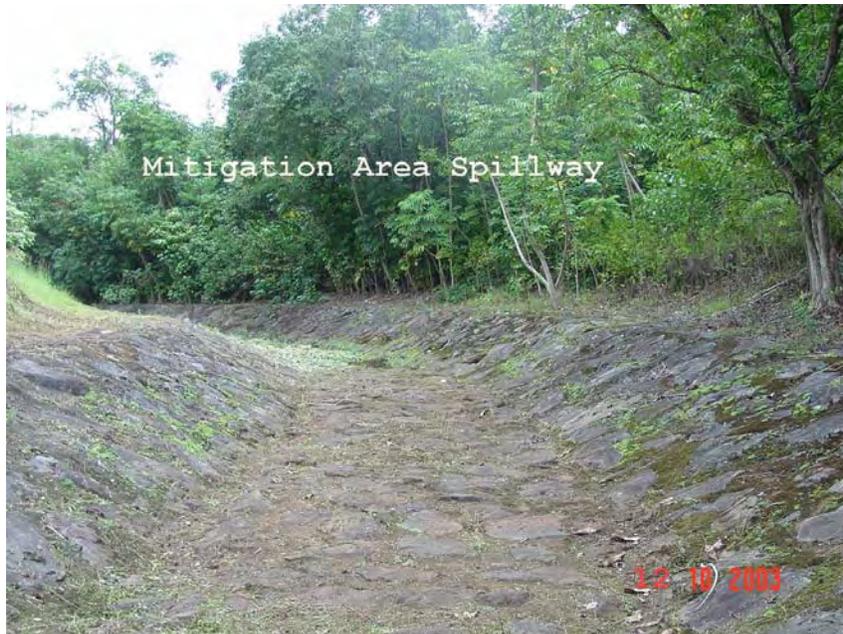
uu. Mitigation Area Spillway, in good condition continue to maintain.
