1. Project Name: Kahului Wastewater SPP

2. Date of Inspection: June 15, 2004

CONTINUING ELIGIBILITY INSPECTION (CEI) REPORT  
FOR HURRICANE & SHORE PROTECTION PROJECTS  
Honolulu Engineer District  
CEPOH-EC-T

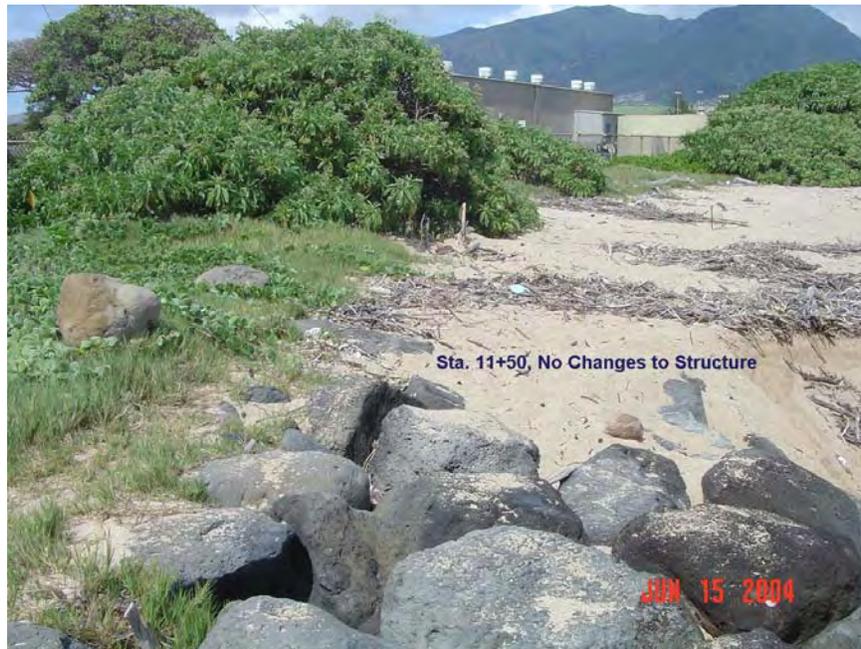
- a. Sta. 11+50, Beginning of project, west-end, photo for reference.

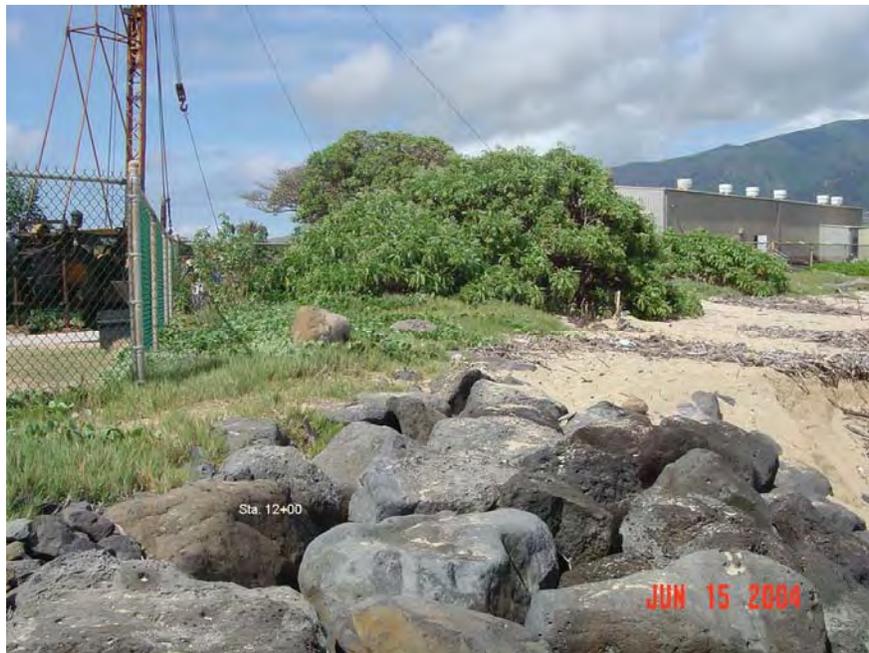
- b. Sta. 12+00, Remove the vegetation from the crest of the structure, as needed.

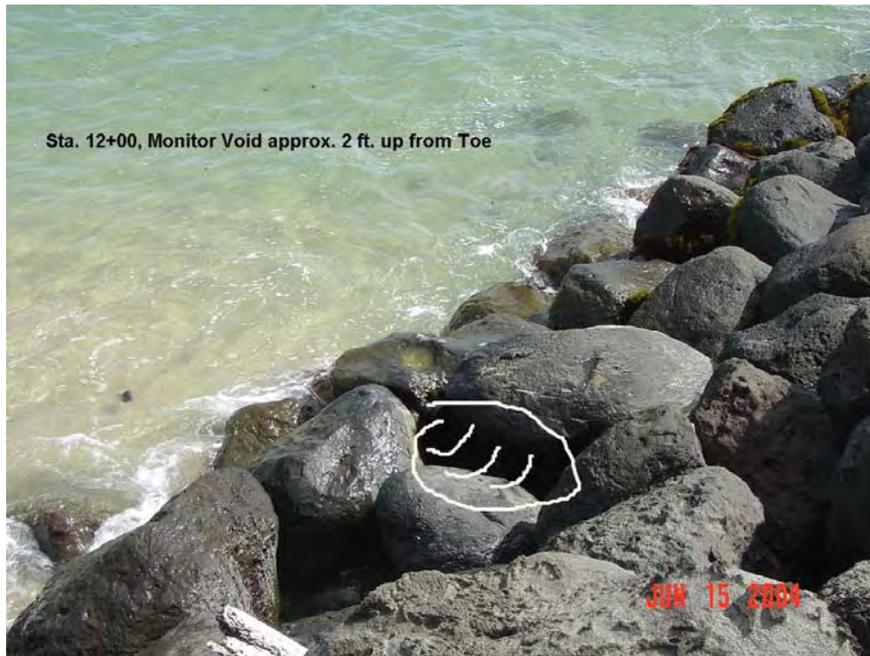
- c. Sta. 12+00, Monitor void 2 ft. up sideslope from toe.

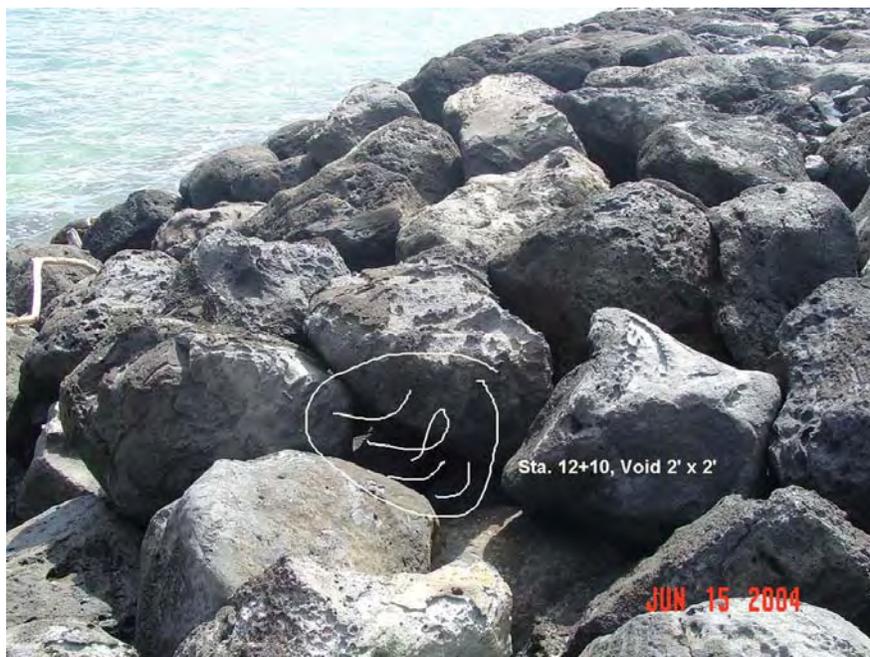
- d. Sta. 12+10, Monitor void on the sideslope. No change.

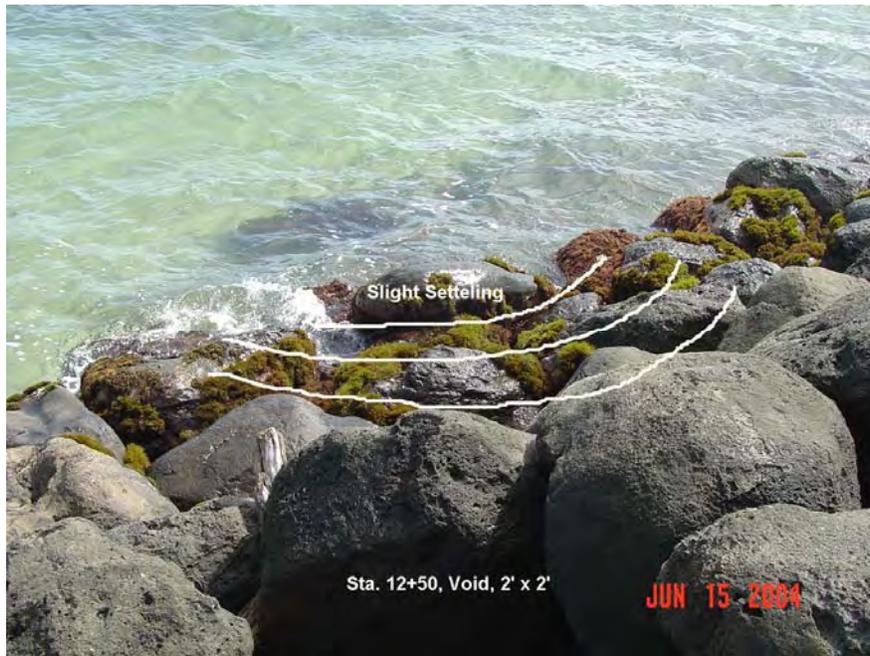
- e. Sta. 12+50, Monitor void and bridging armor stone on the sideslope. No change this year.

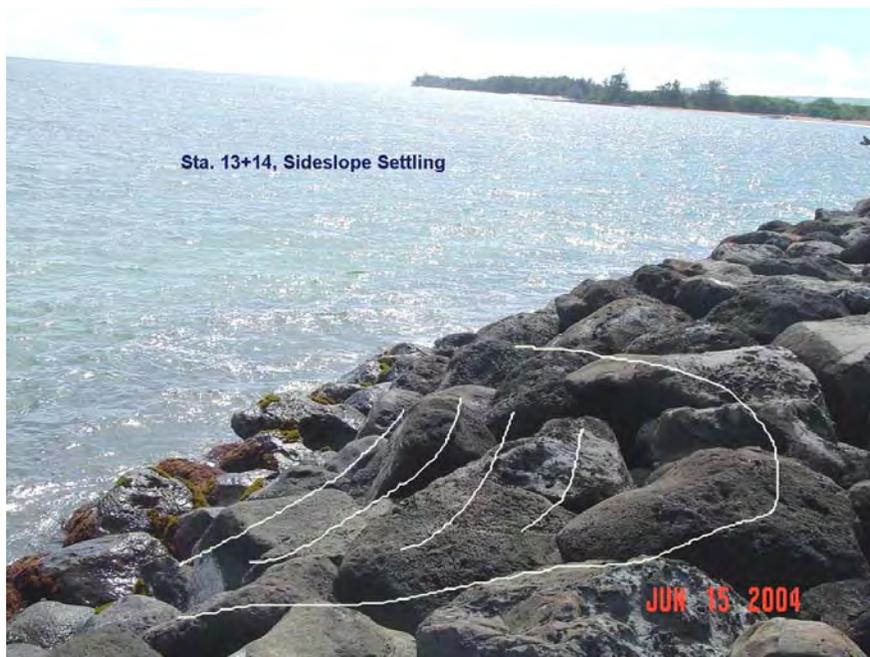
- f. Sta. 13+14, Monitor settling at the crest. No change this year.

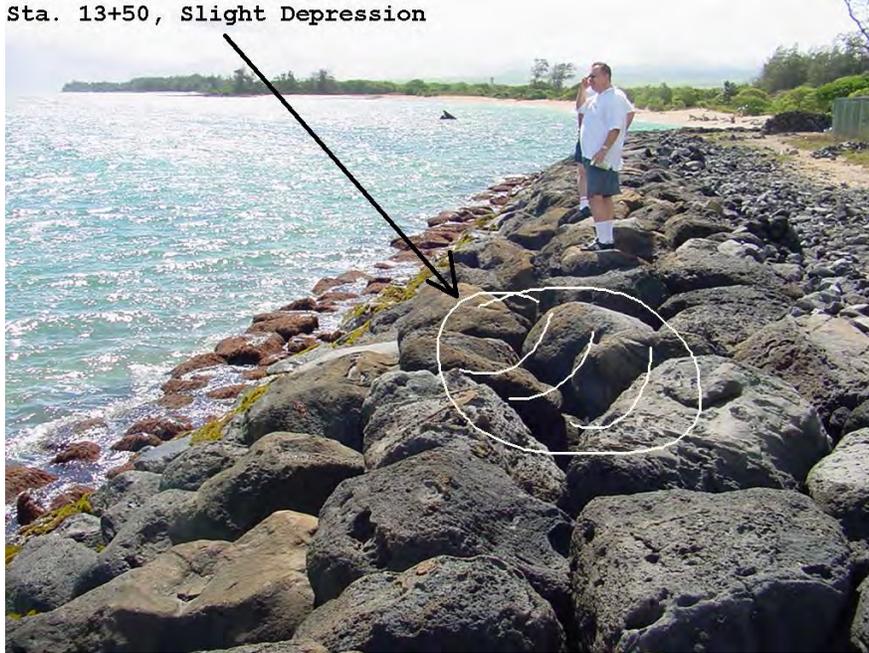
Sta. 13+50, Slight Depression

- g. Sta. 13+50, Monitor slight depression at the hinge.

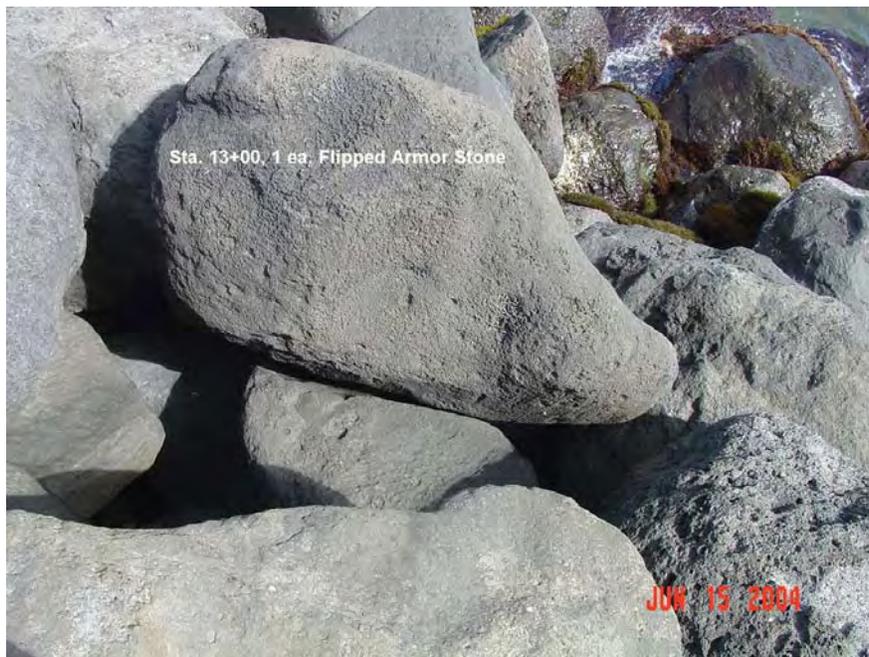
- h. Sta. 13+00, 1 ea. Flipped armor stone, new this inspection.

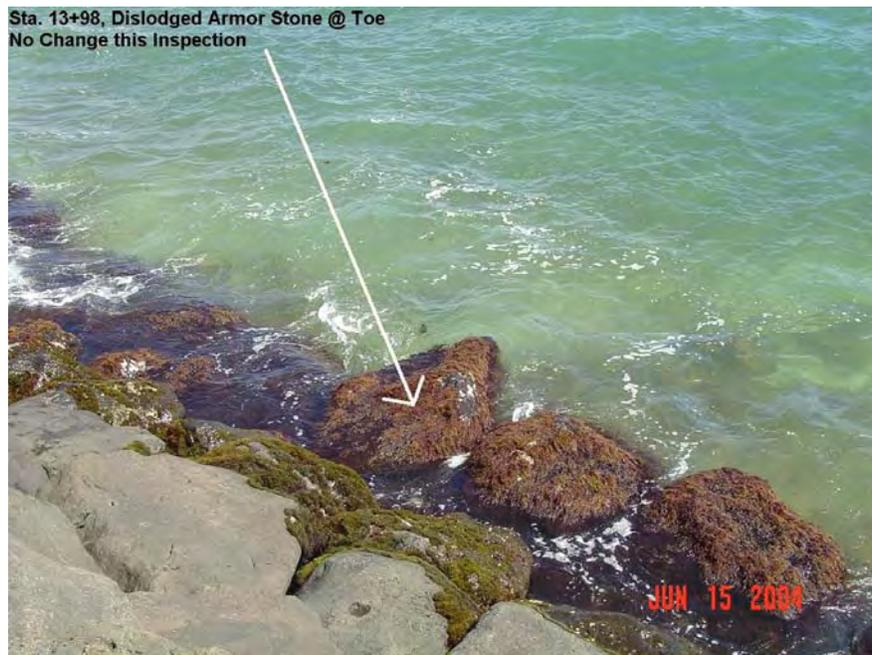
- i. Sta. 13+98, Monitor Dislodged armor stone at the toe.

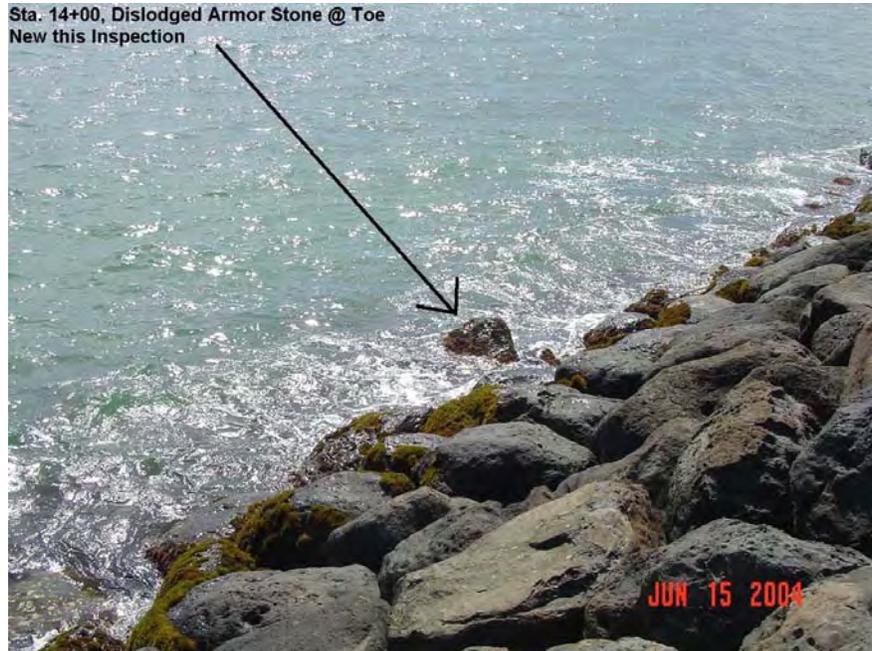
- j. Sta. 14+00, 1 ea. Dislodged armor stone resting adj. toe, new this inspection.  
k. Sta. 14+03, Monitor slight depression at the hinge. Slight Change this year.

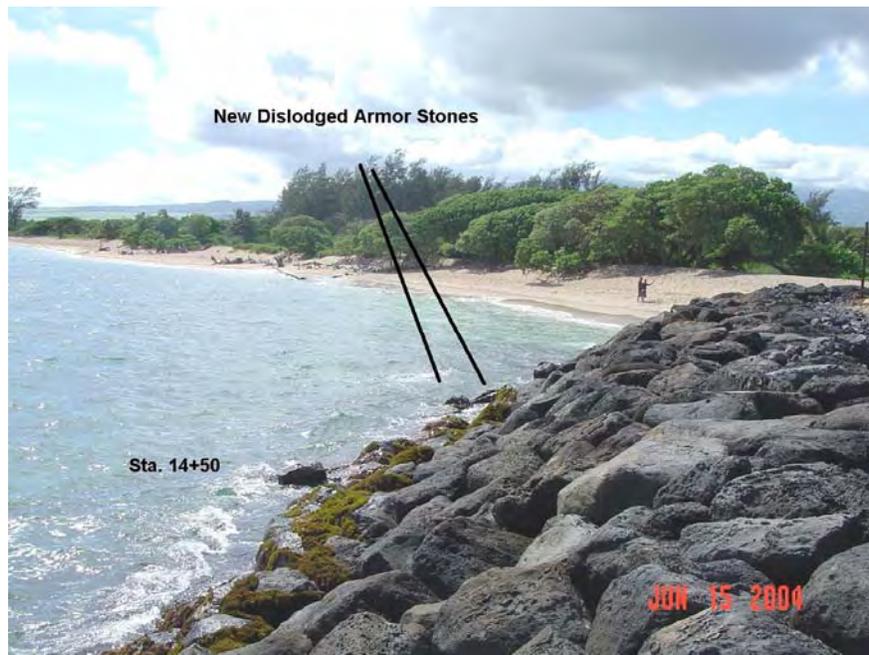
- l. Sta. 14+50, 1 ea armor stone resting at toe, no obvious voids. 2 ea. Armor stones resting adj. toe are New this year.

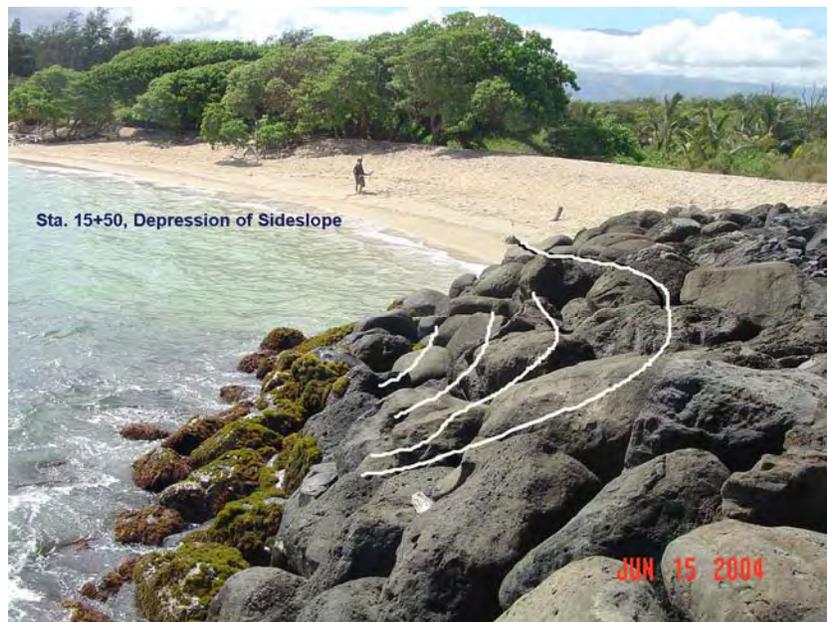
- m. Sta. 15+50 to Sta. 15+86, The void and depression have combined. Monitor sideslope settling and armor stone movement. Approximately 5 armor stones in the water. Monitor closely (post storms).

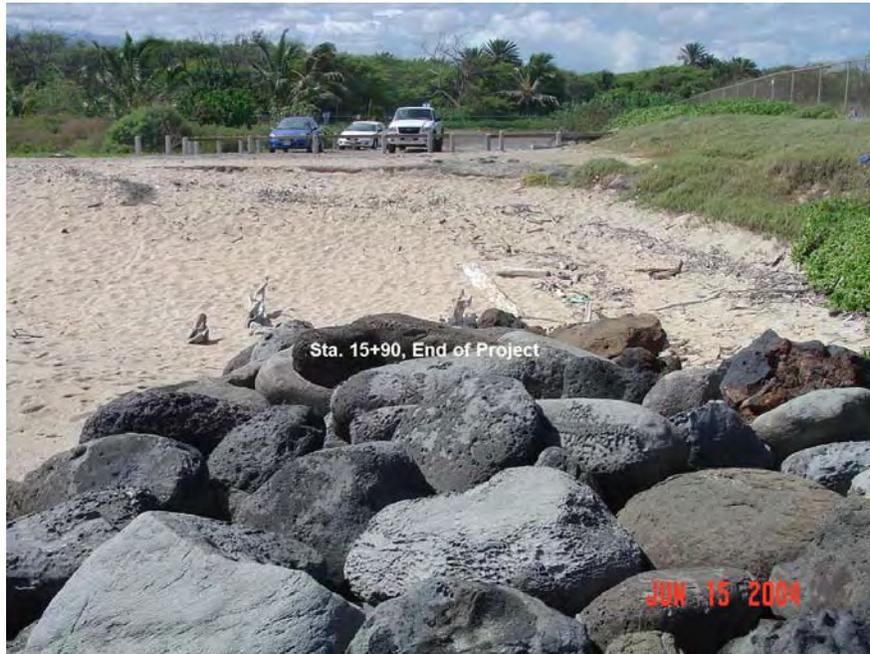
- n. Sta. 15+90, Overview, photo for reference. Additional erosion of sand from behind the structure. Monitor closely (post storm).

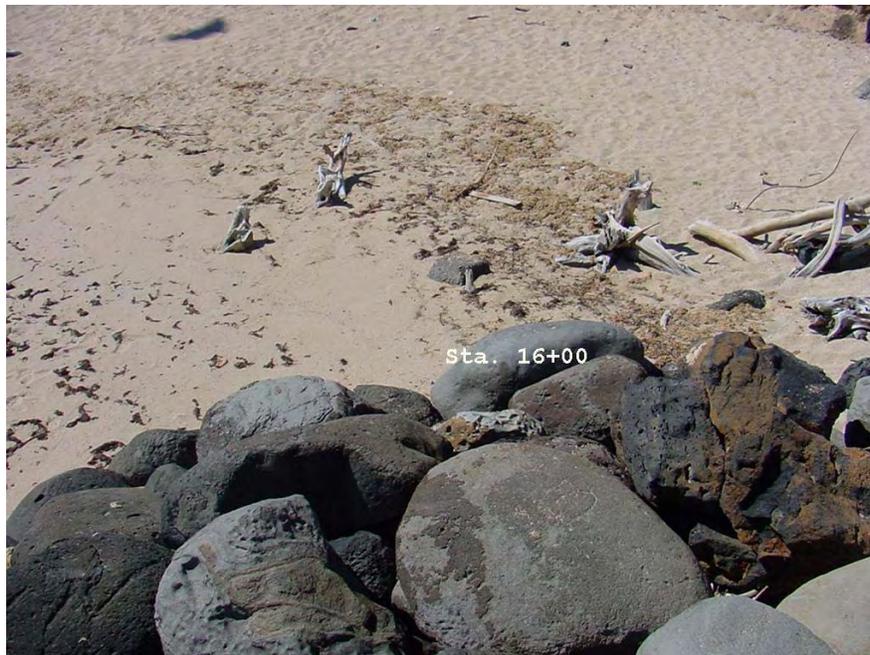
- o. Sta. 16+00, Monitor erosion at tie-back, photo for reference from FY 2003.
