1. Project Name: Kawaihae Small Boat Harbor

2. Date of Inspection: May 21, 2003

West Breakwater 1,260LF:

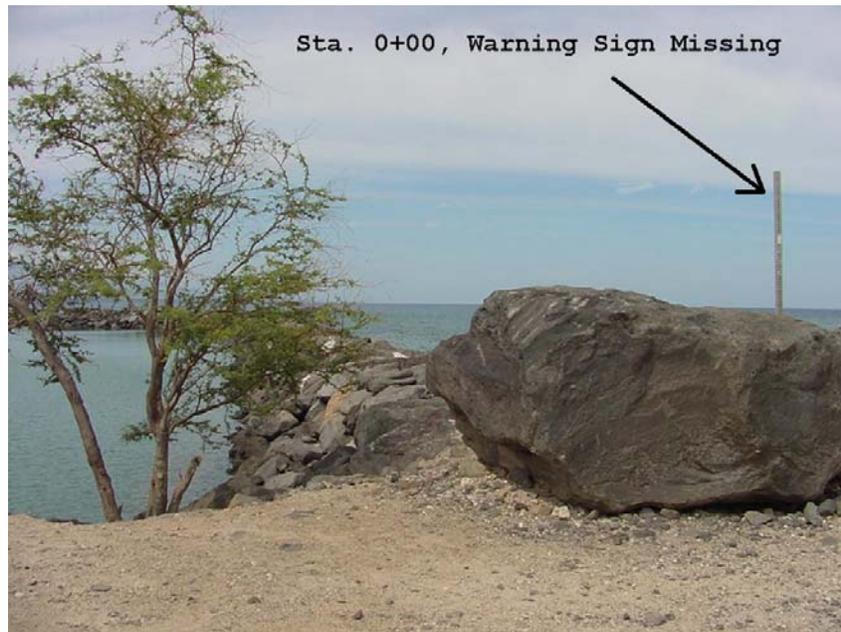
a. Breakwater warning sign missing.

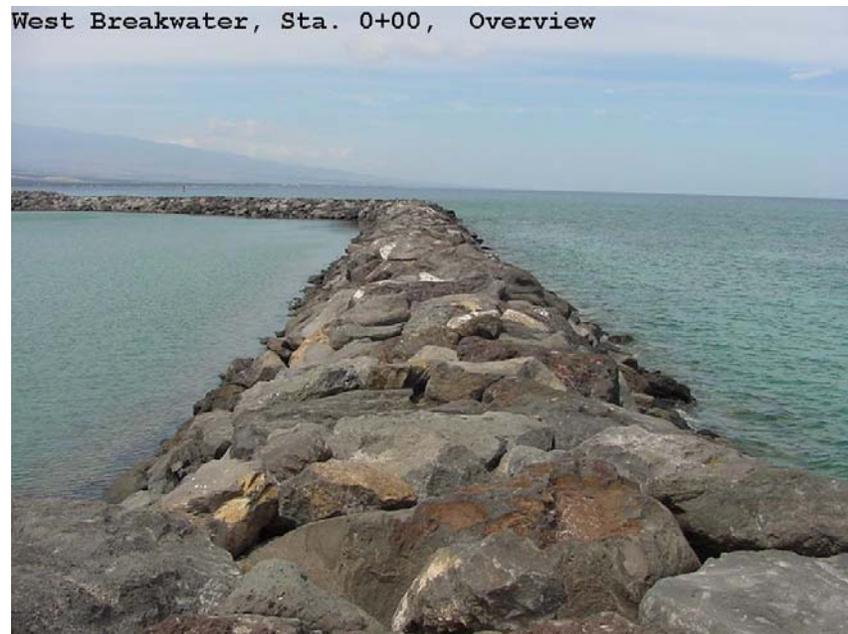
b. Sta. 0+00, Overview photo for reference.

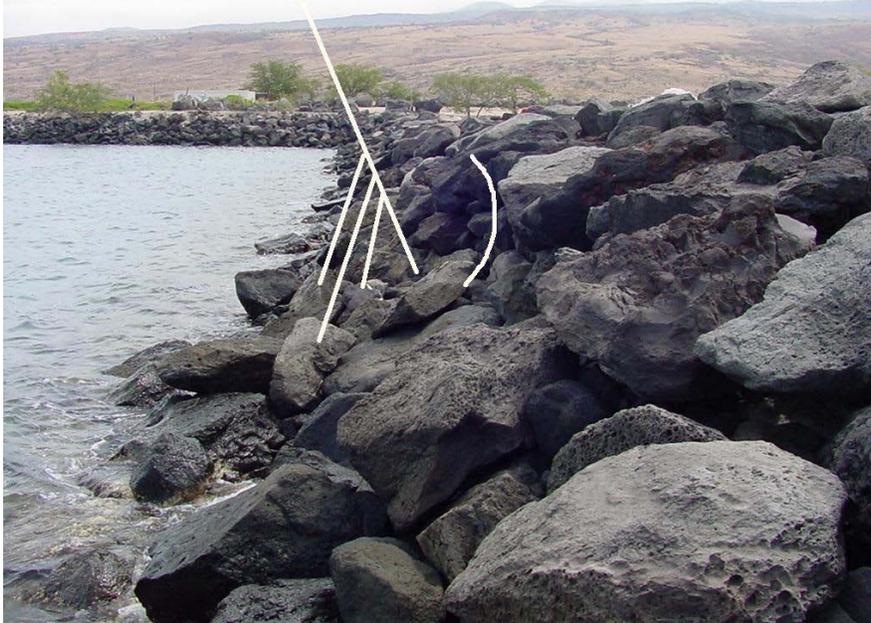
Sta. 2+50, OS, Dislodged Armor Stones on Sideslope

c. Sta. 2+50, OS, Dislodged armor stones on sideslope.

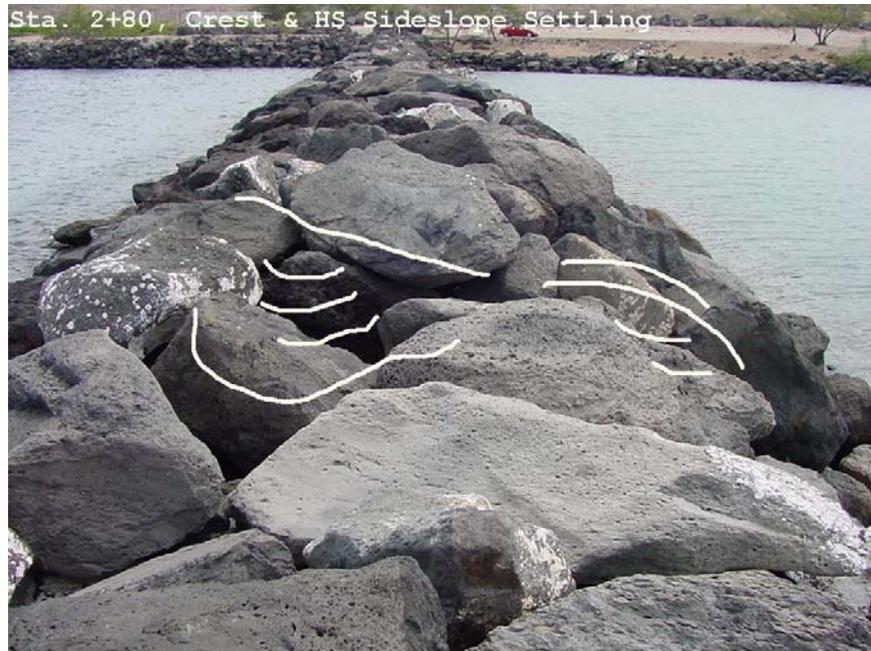
d. Sta. 2+80, OS & HS - Crest, Settling of armor stones approx. 4' deep. Monitor this area.

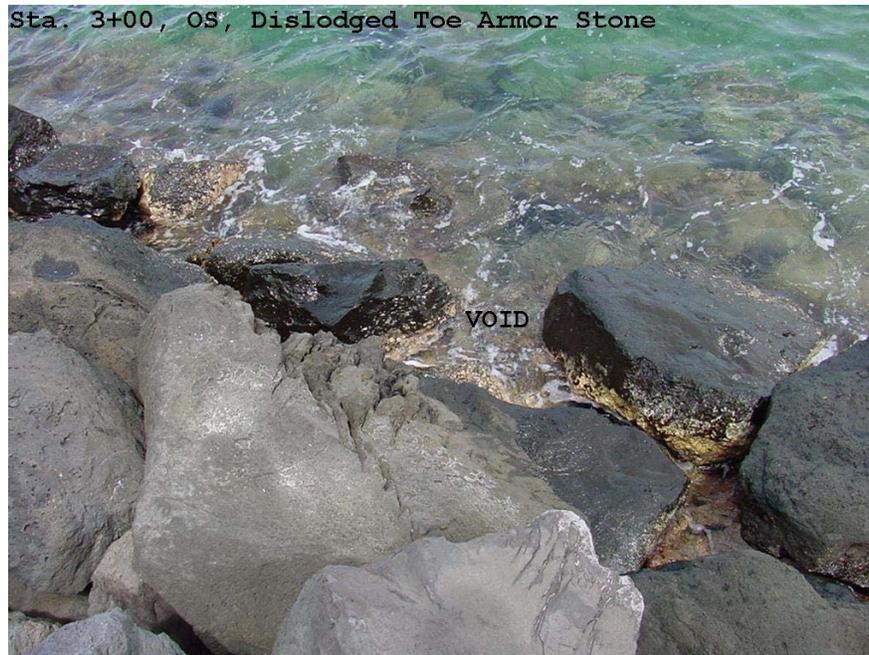
e. Sta. 3+00, OS, Displaced armor stone & exposed underlayer at waterline.

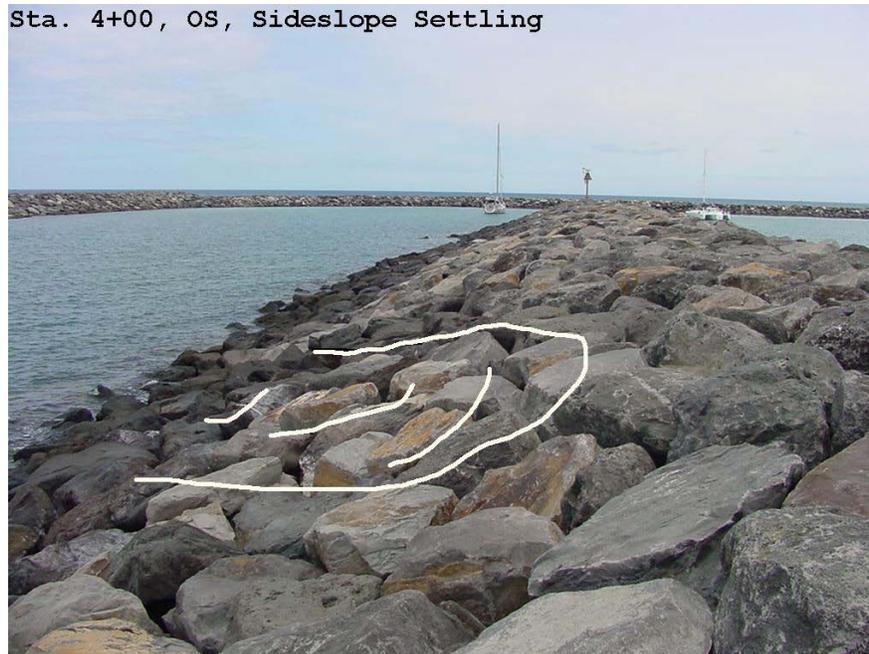
g. Sta. 4+00, OS, Sideslope settling.

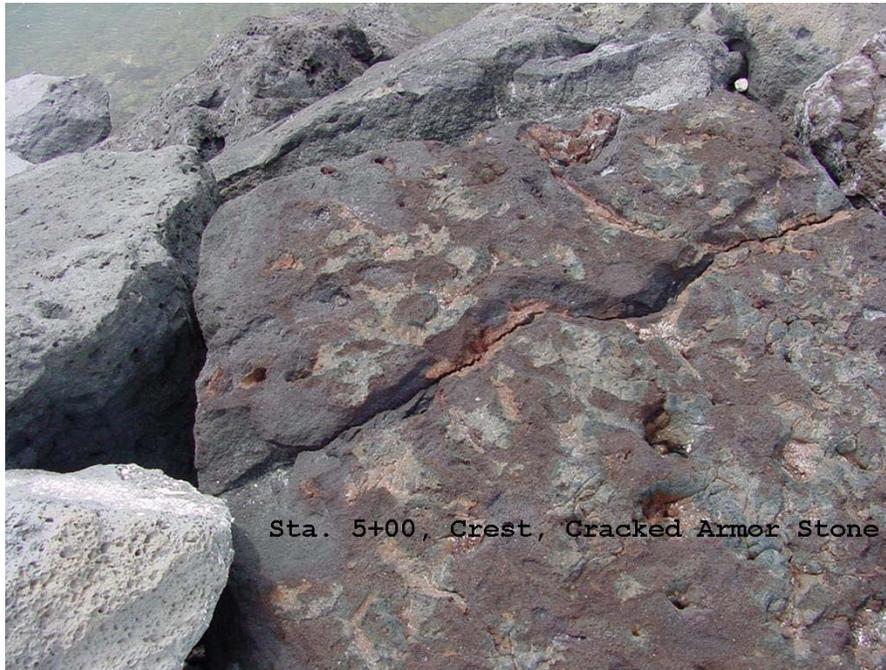
h. Sta. 5+00, Crest, cracked armor stone.

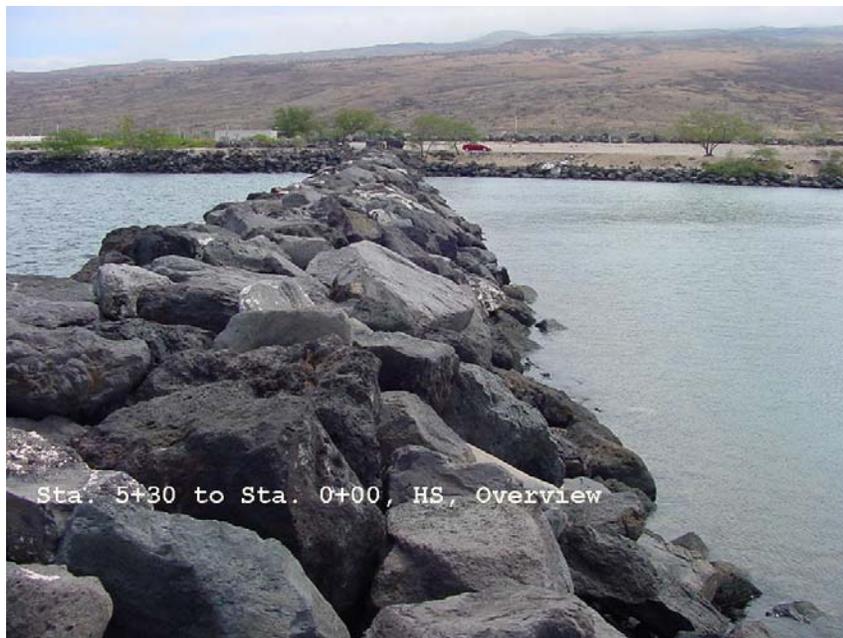
i. Sta. 5+30, HS, Photo for reference.

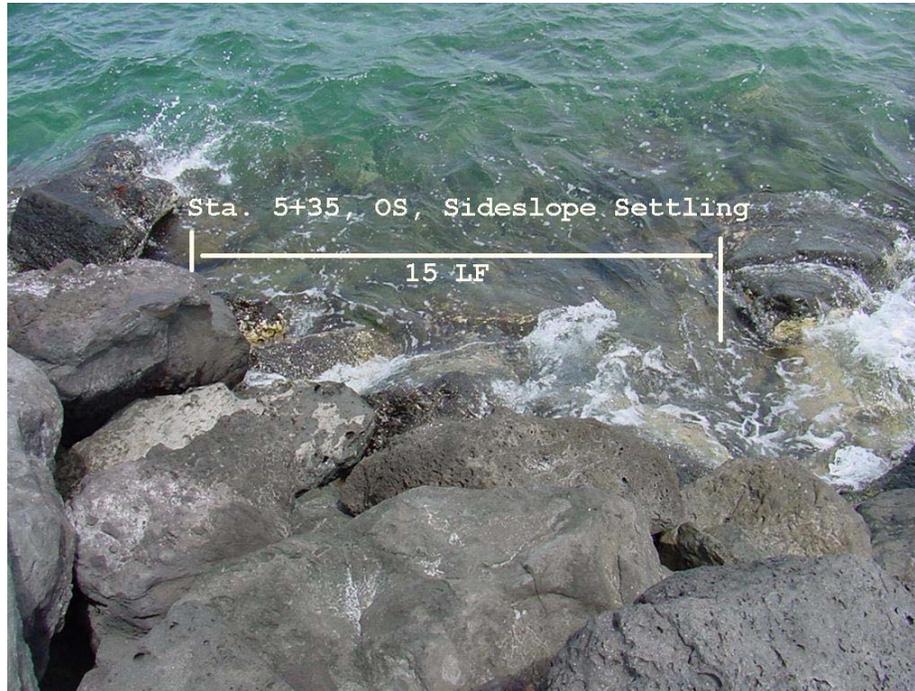
j. Sta. 5+35, OS, Possible sideslope sliding, dislocated armor stones, void.

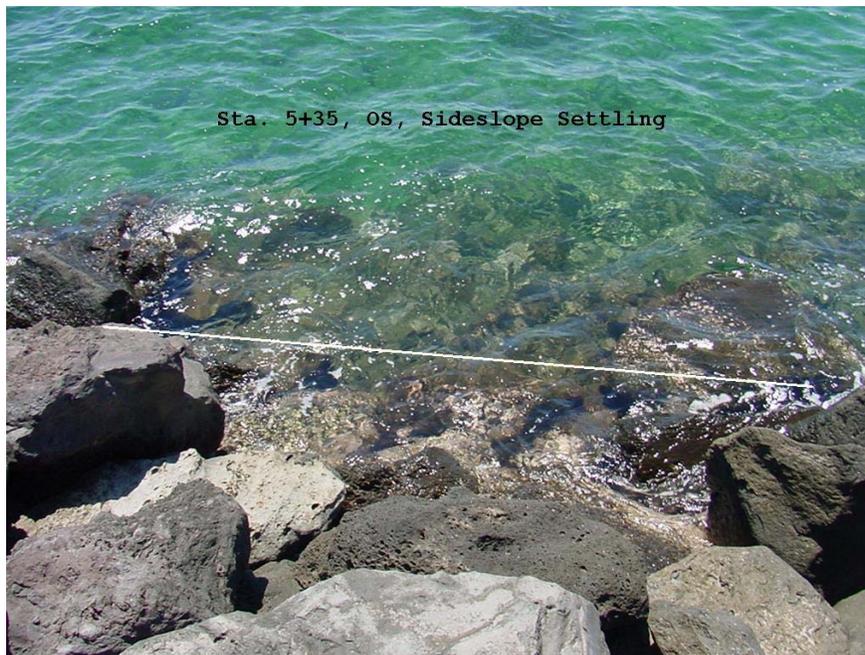
k. Sta. 5+35, OS, Sideslope settling, armor stones missing.

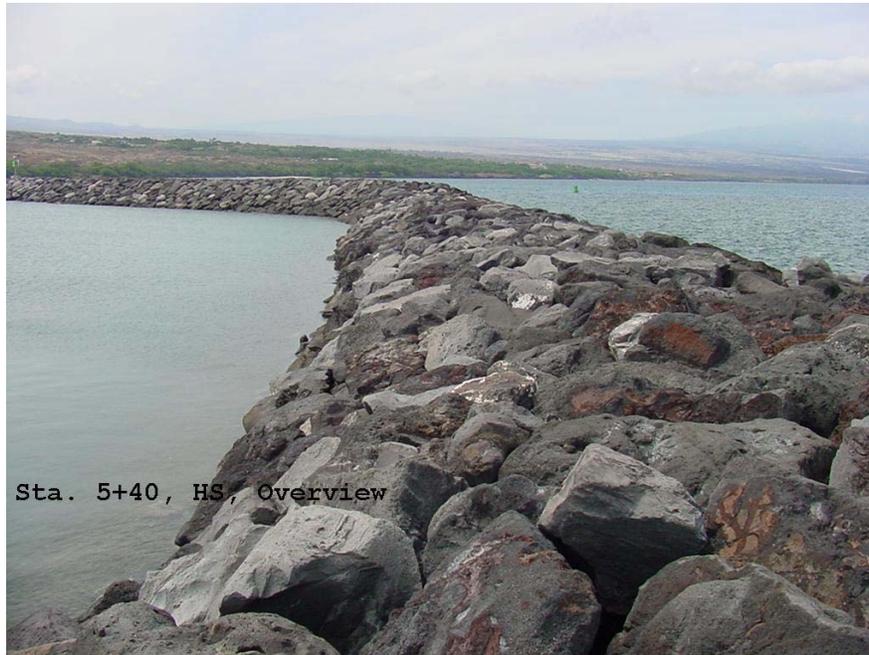
1. Sta. 5+40, Overview photo for reference.

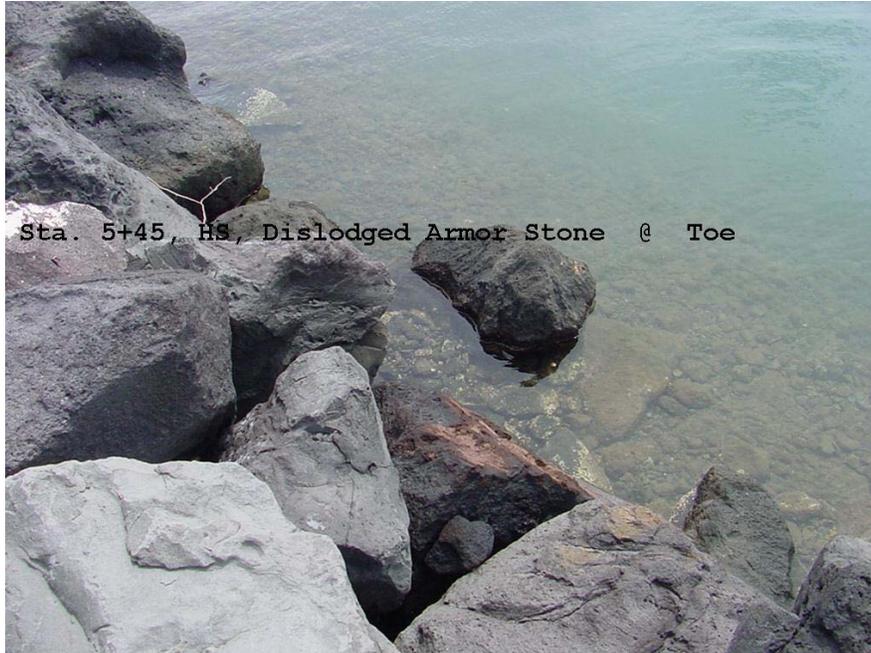
- m. Sta. 5+45, HS, 1 ea. dislocated armor stone at toe.

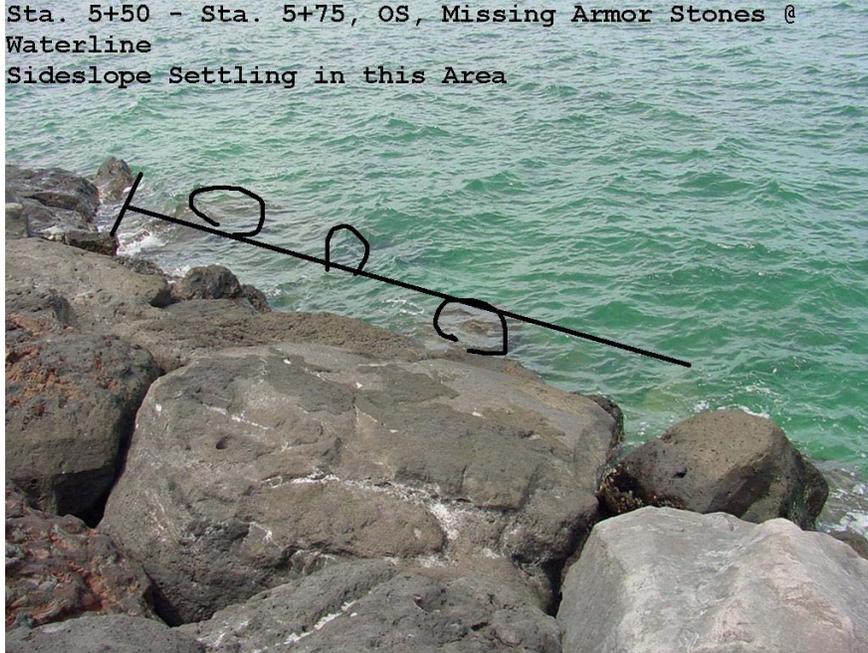
Sta. 5+50 - Sta. 5+75, OS, Missing Armor Stones @
Waterline
Sideslope Settling in this Area

o. Sta. 5+50 - Sta. 5+75, OS, Possible sideslope failure, toe stones missing, void, approx. 20LF.

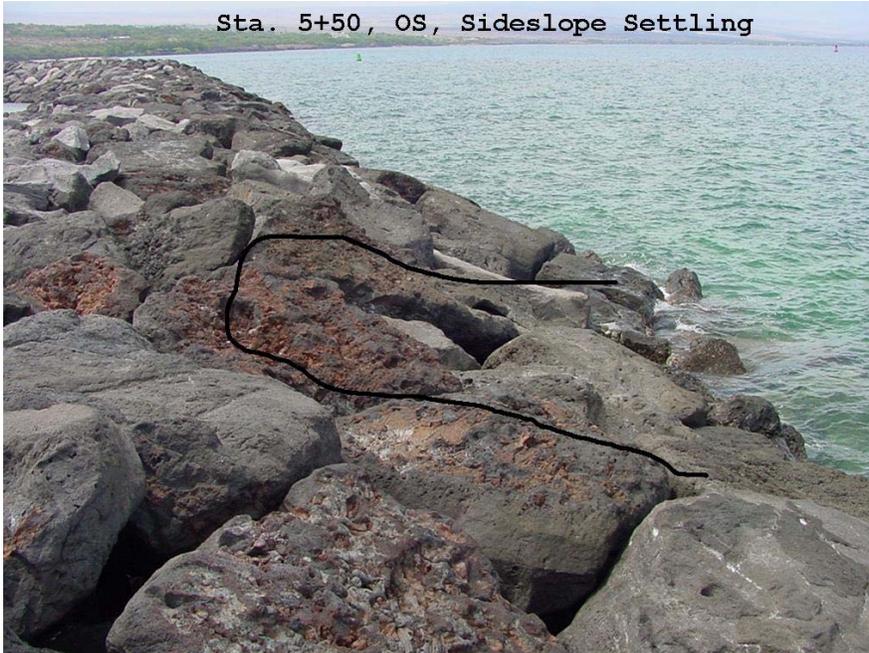
Sta. 5+50, OS, Sideslope Settling

p. Sta. 5+50 - Sta. 5+75, OS, Possible sideslope failure, toe stones missing, void, approx. 20LF.

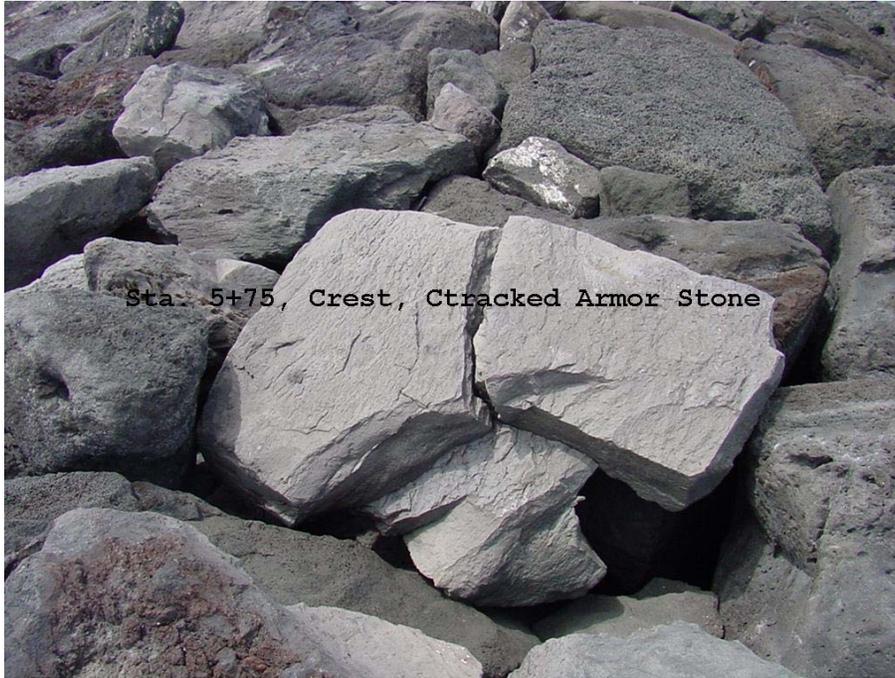
- q. Sta. 5+75, Cracked armor stone at centerline of crest.

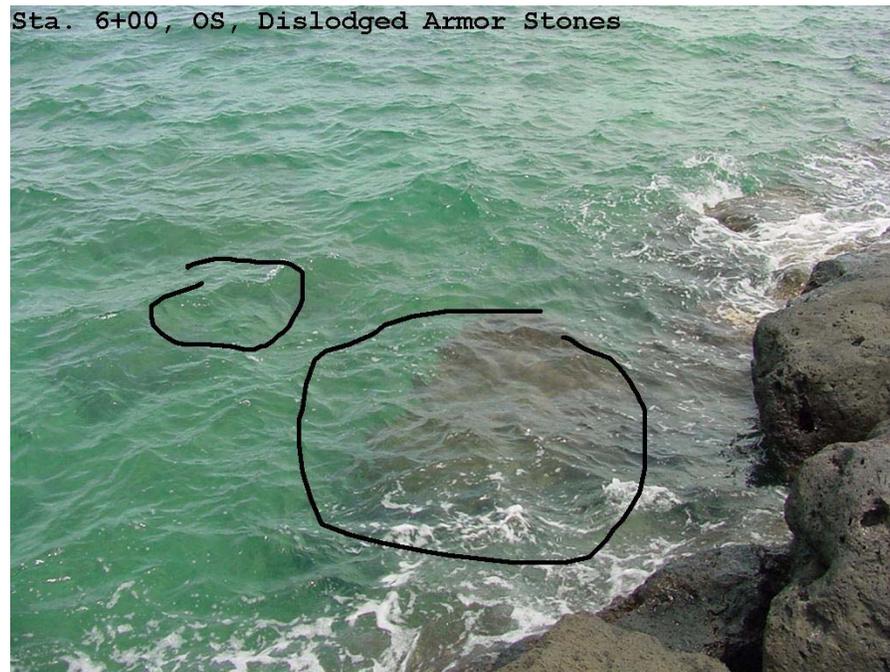
- r. Sta. 6+00, OS, Dislodged armor stone @ toe, cavity/void.

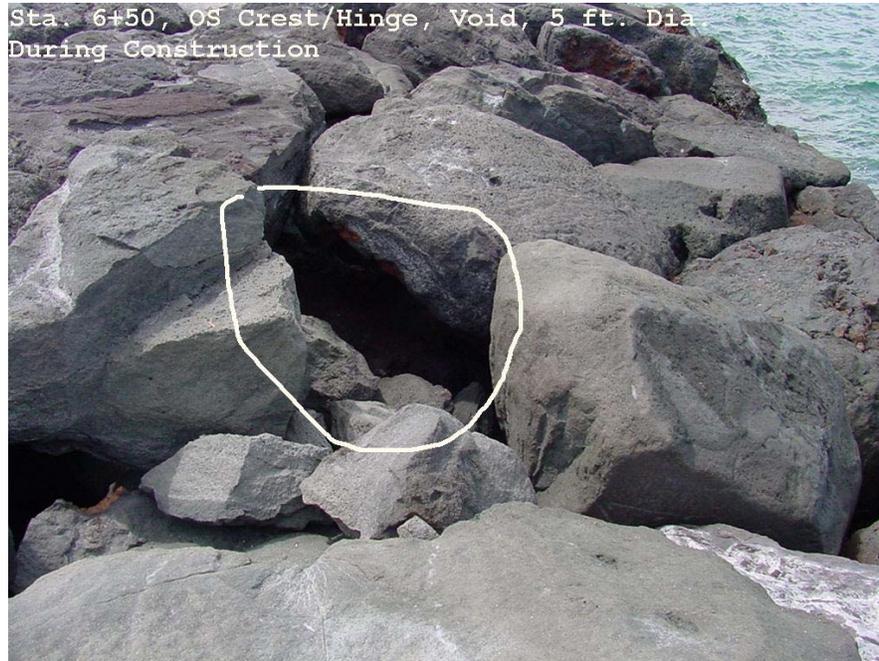
- s. Sta. 6+50, OS, Cavity, five foot dia., sideslope steeping.
- t. Sta. 7+10, OS, Bridging of armor stone, large cavity.
- u. Sta. 7+50, OS, 1ea. 12T armor stone dislodged.
- v. Sta. 7+52, 7+90, and 8+00 OS, one 12T armor stone perched on a 100# stone.
- w. Sta. 8+04, Toe stones have a vertical face, ocean side.

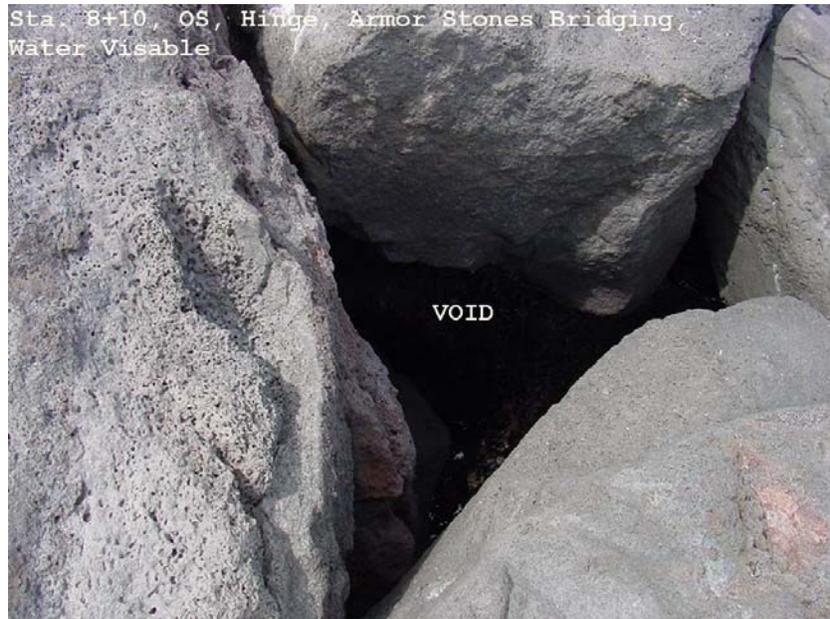
- x. Sta. 8+10, OS of crest, large void.

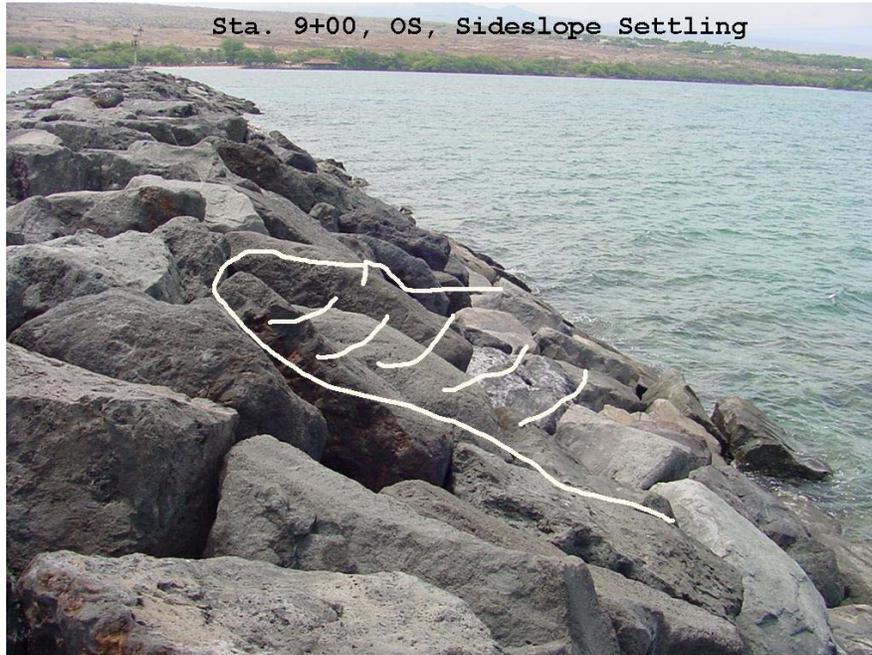
- z. Sta. 9+00, OS, Settling of sideslope.

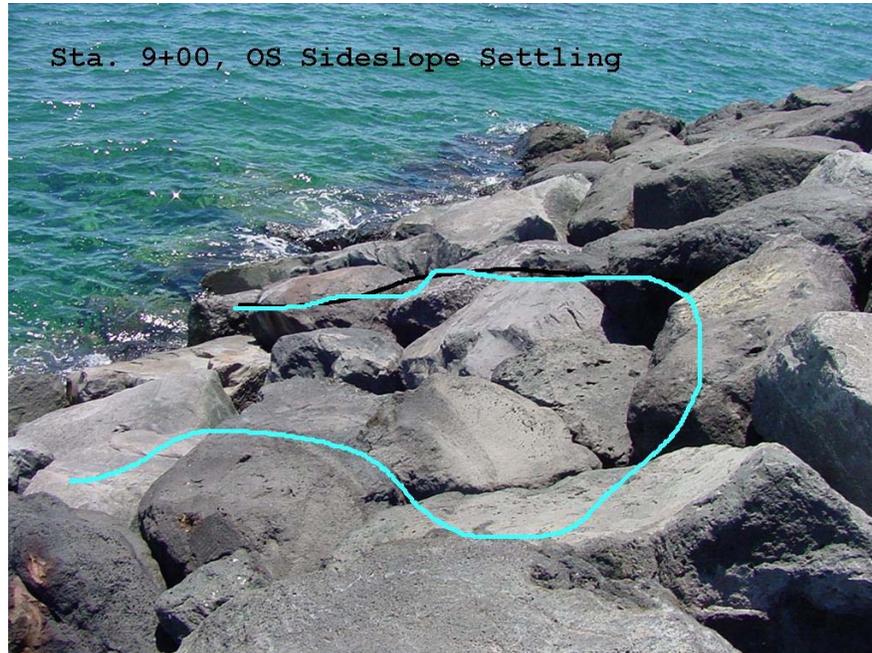
- aa. Sta. 9+00, OS, Settling of sideslope. (FY 2002 Photo)

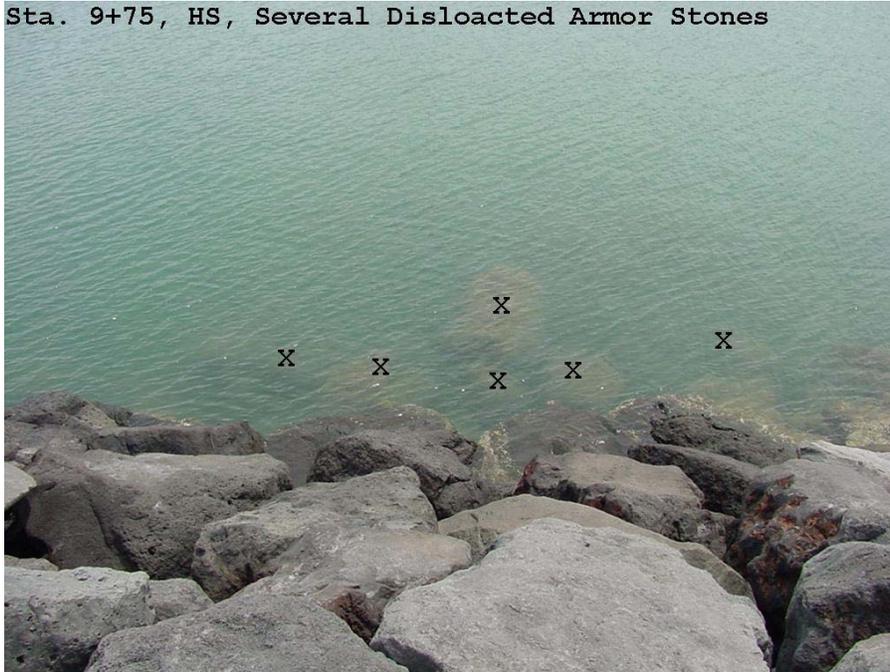
Sta. 9+75, HS, Several Dislocated Armor Stones

bb. Sta. 9+45, HS, Several dislocated armor stones.

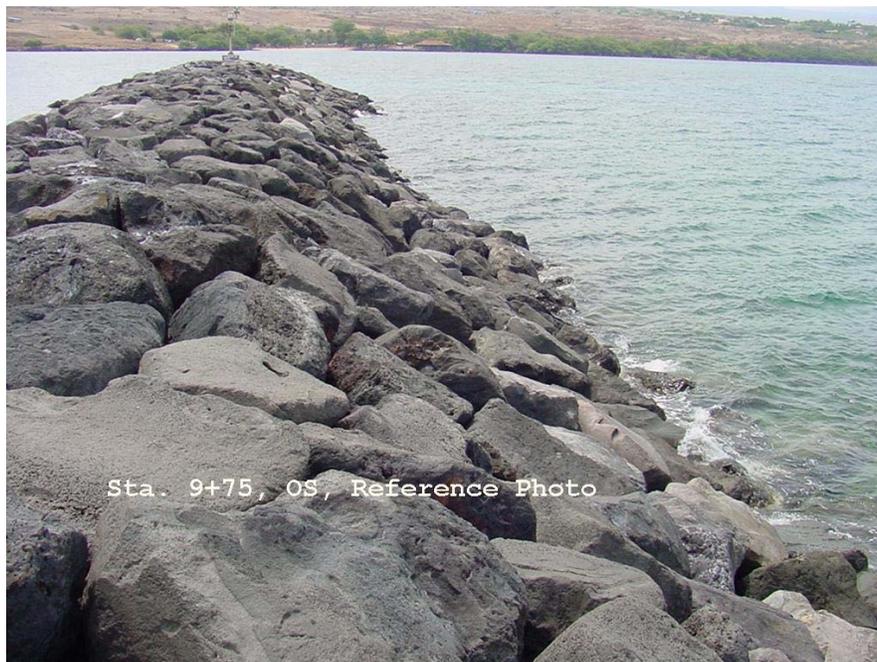
cc. Sta. 9+75, OS, Overview photo for reference.

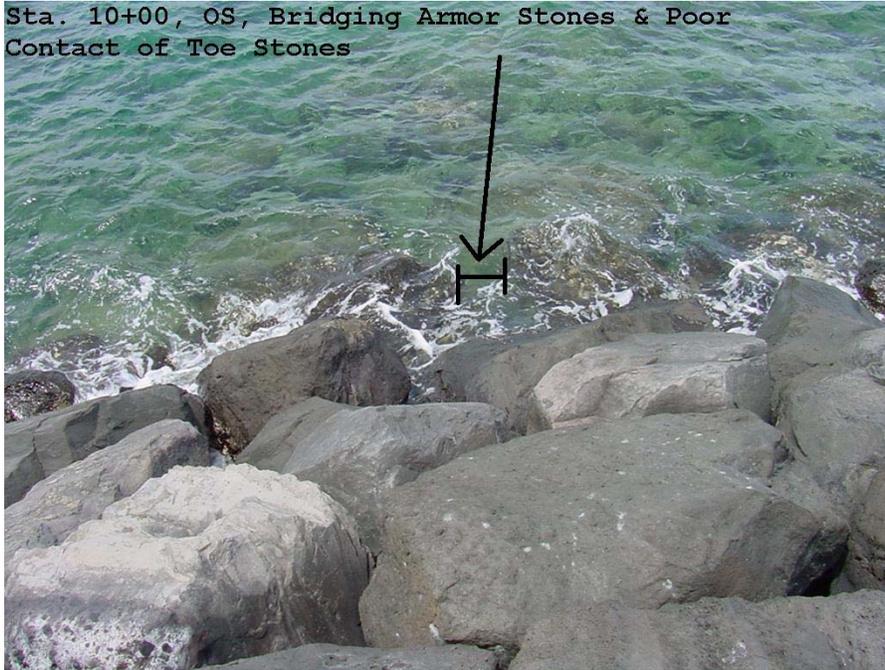
Sta. 10+00, OS, Bridging Armor Stones & Poor Contact of Toe Stones

- dd. Sta. 10+20, HS, 1ea. armor stone with cavity under the top layer.
- ee. Sta. 10+00, OS, Bridging, armor stone @ toe w/o contact.
- ff. Sta. 11+00, Crest, Cracked armor stone.
- gg. Sta. 11+00, HS, Chinker 2/3 up the sideslope, no bottom contact.
- hh. Sta. 11+20, HS, 3ea. chinkers, one 12T-15T armor stone bridging.
- ii. Sta. 11+50, OS, 2ea. armor stones at waterline dislodged.
- jj. Sta. 12+15, OS, Armor stone larger than specified in the contract specs, 15T-18T.
- kk. Sta. 12+20, OS, 1ea. armor stone bridging.

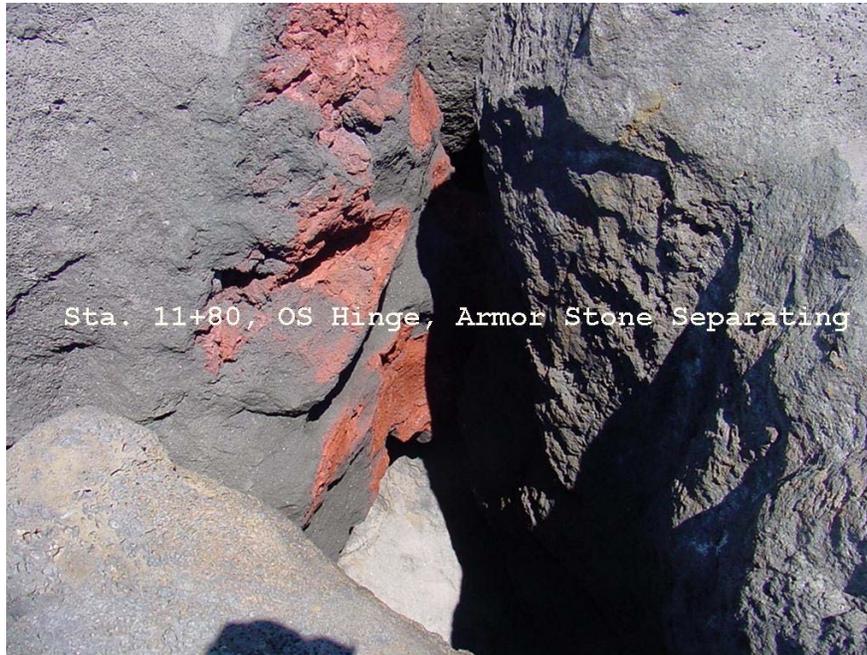
11. Sta. 11+80, OS hinge of crest, Armor stone separating (FY 2002 Photo).

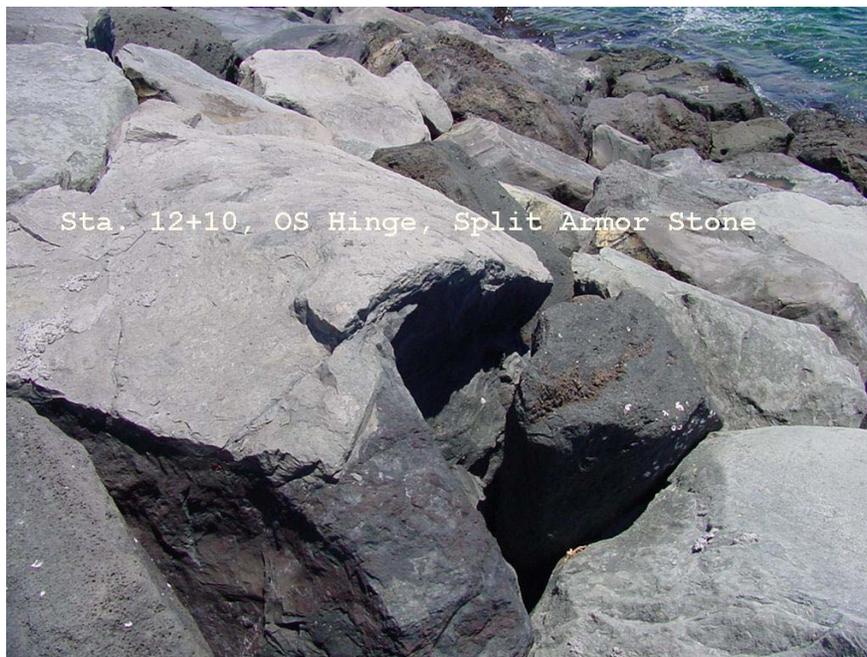
- mm. Sta. 12+10, OS Hinge, Split armor stone (FY 2002 Photo).

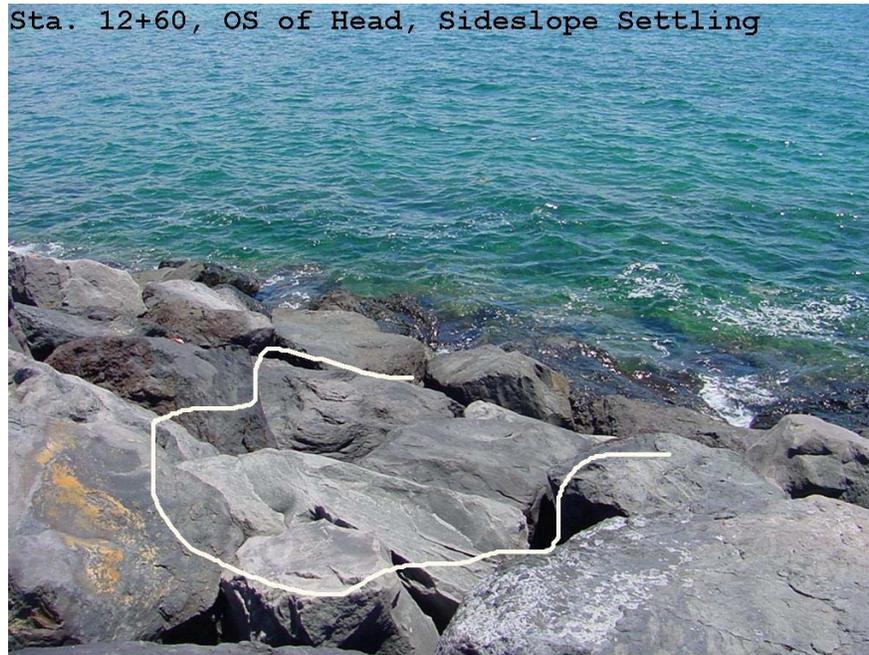
nn. Sta. 12+60, OS Head, Sideslope settling (FY 2002 Photo).

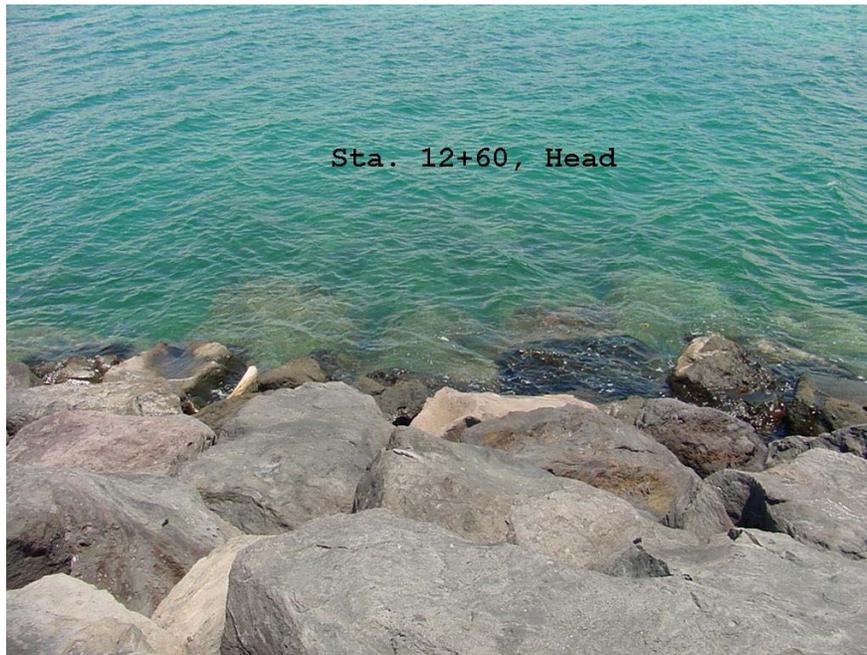
oo. Sta. 12+60, Head, 0 deg., Possible 8' void at the head's waterline (FY 2002 Photo).

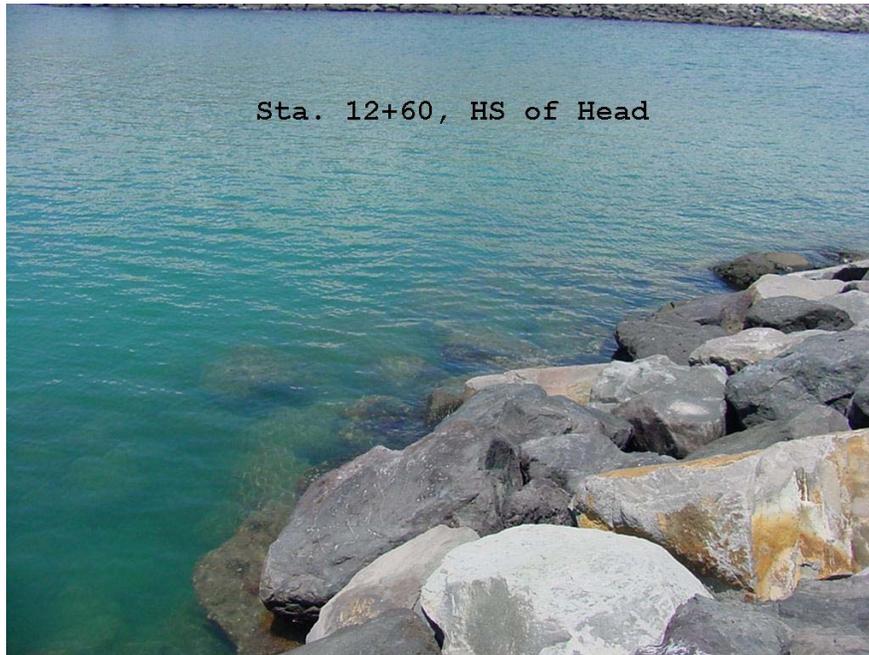
pp. Sta. 12+60, Head, 45 deg., HS, lea. armor stone bridging (FY 2002 Photo).

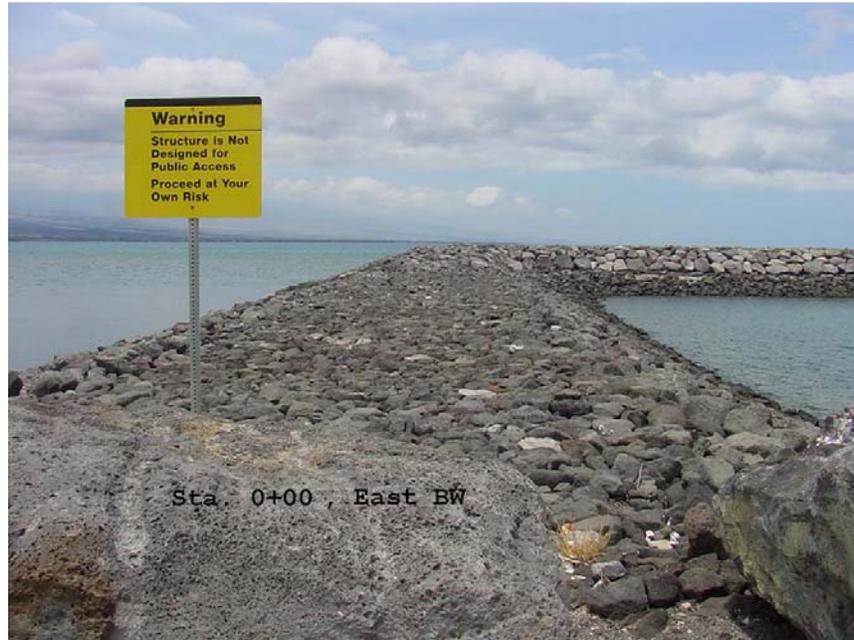
a. Sta. 0+50 to 2+00, harbor and ocean side. Numerous voids in the armor layer, which expose the underlayer. Underlayer and armor stones are undersized. Most undersized stones appear to be located within the splash zone of both the HS and OS.

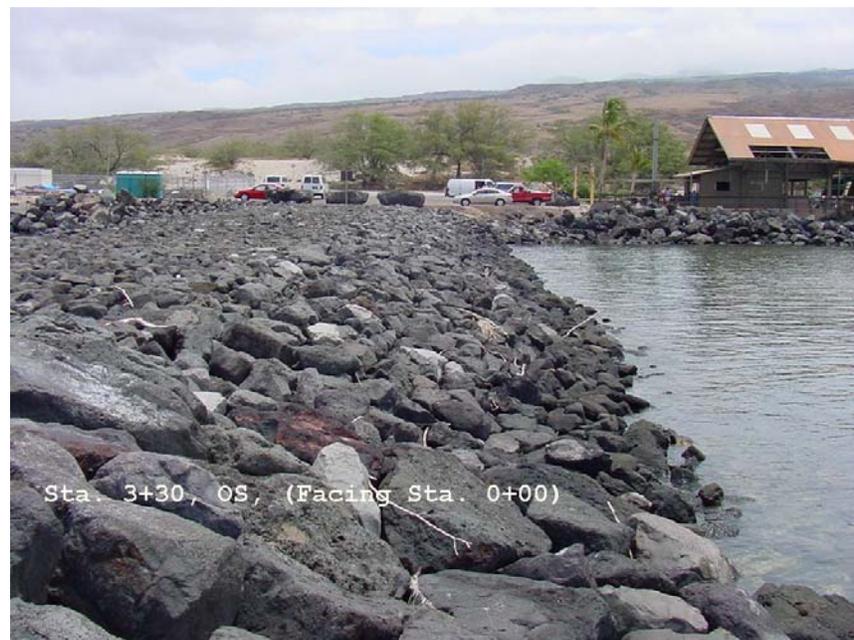
c. Sta. 2+80 to 4+00, OS, Monitor minor settling on sideslope.

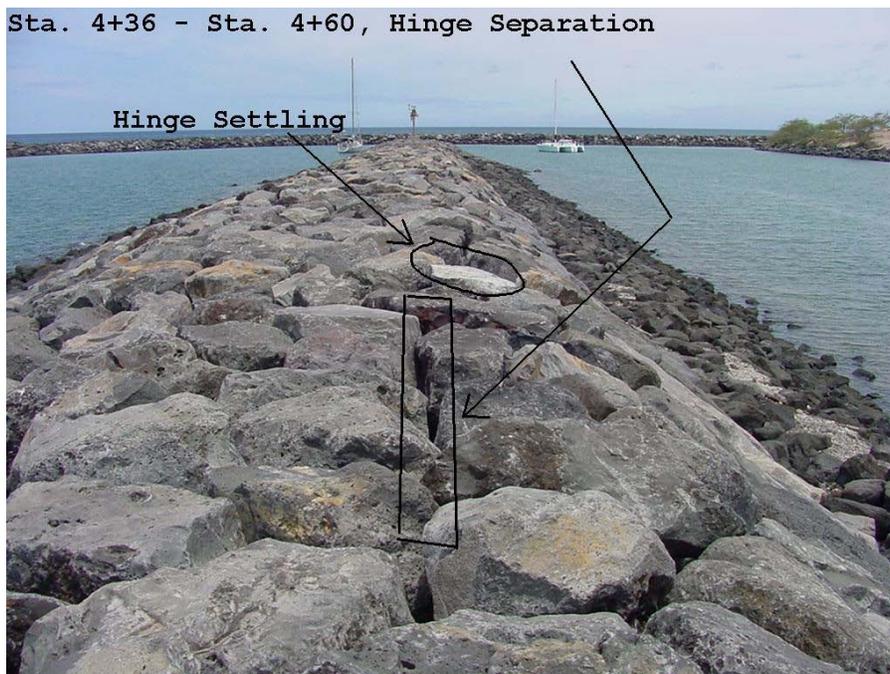
e. Sta. 4+36, OS, Minor settling, area approximately 30' x 40', sideslope.

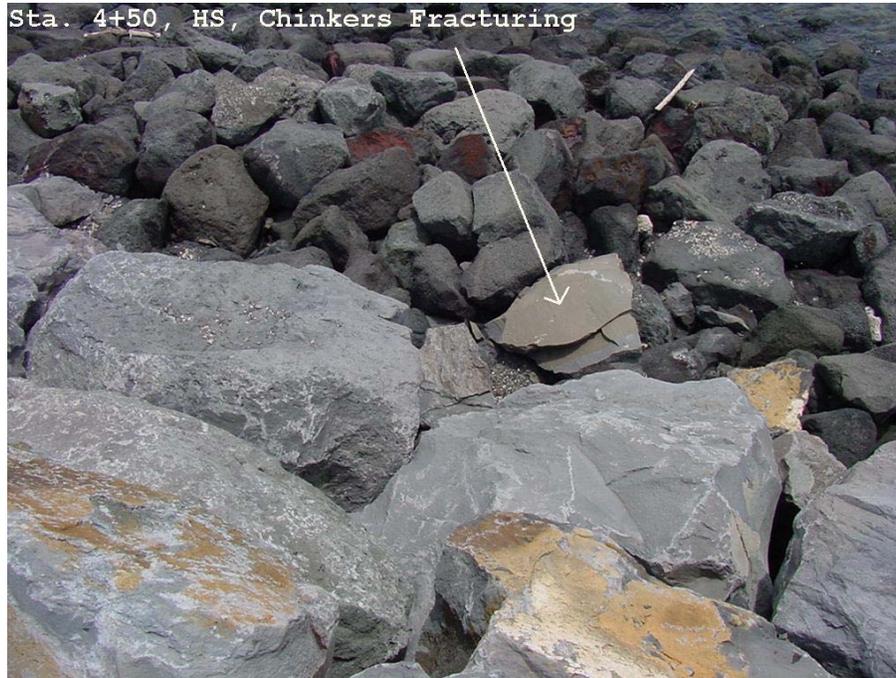
f. Sta. 4+50, HS, Chinkers have begun to break due to weight of armor stone.

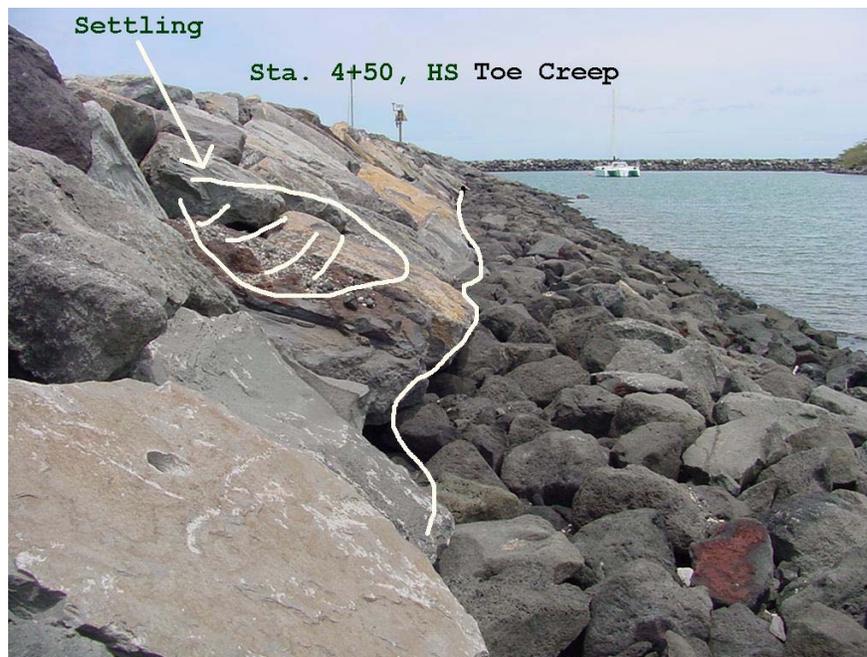
g. Sta. 4+50, HS, Chinkers have begun to break due to weight of armor stone, sideslope beginning to separate @ the hinge and creep @ the toe.

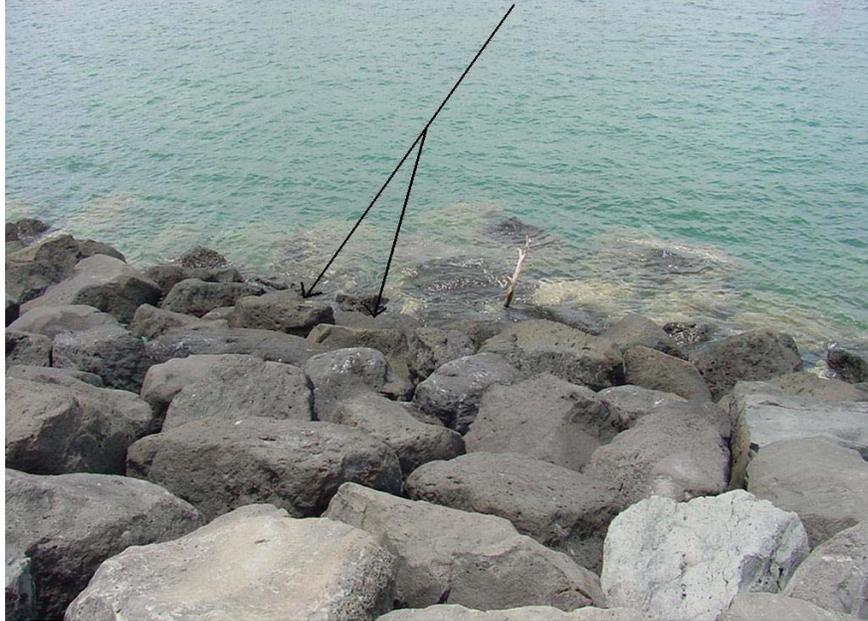
h. Sta. 6+00, OS, 2 ea. armor stones are displaced @ the toe.

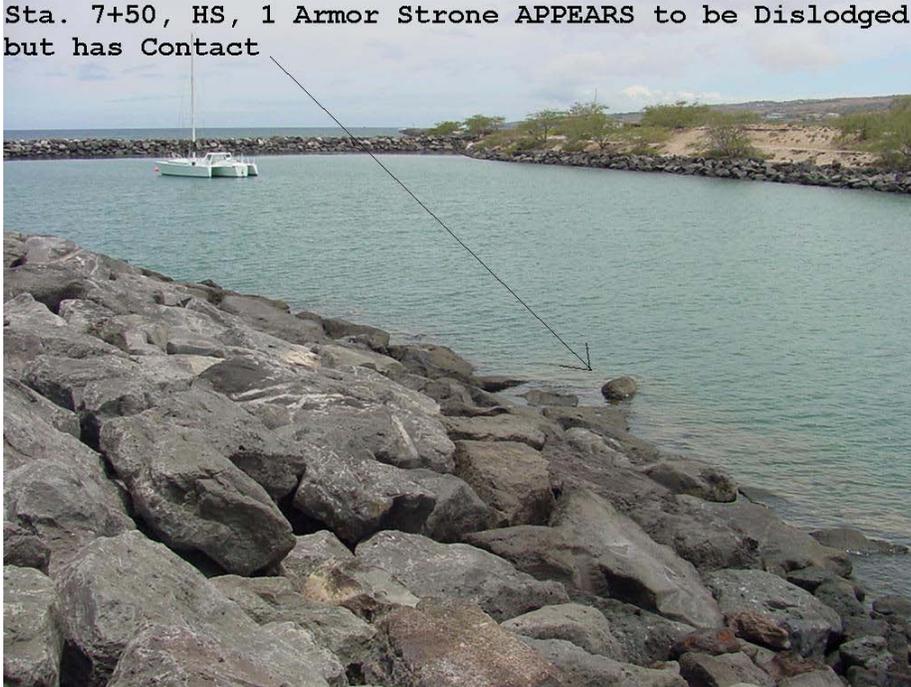
Sta. 7+50, HS, 1 Armor Stone APPEARS to be Dislodged but has Contact

j. Sta. 7+50, HS, 1 armor stone appears to be dislodged but has contact.

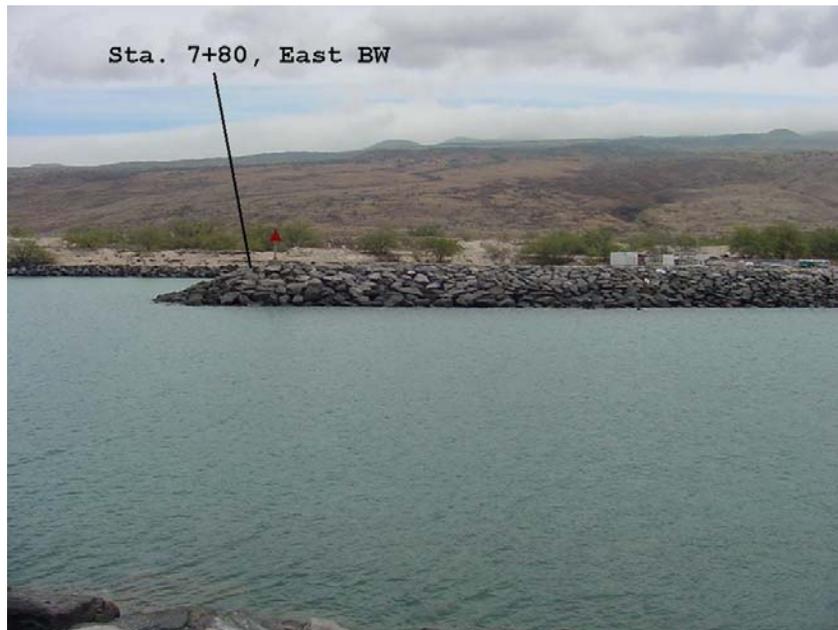
m. Sta. 7+80, HS of head, 1 ea. armor stone dislodged at the toe small void.
