**O & M INSPECTION REPORT  
FOR NAVIGATION AND SHORE PROTECTION PROJECTS**

1. Project Name: Lepua Shore Protection Project

2. Date of Inspection: February 13, 2001

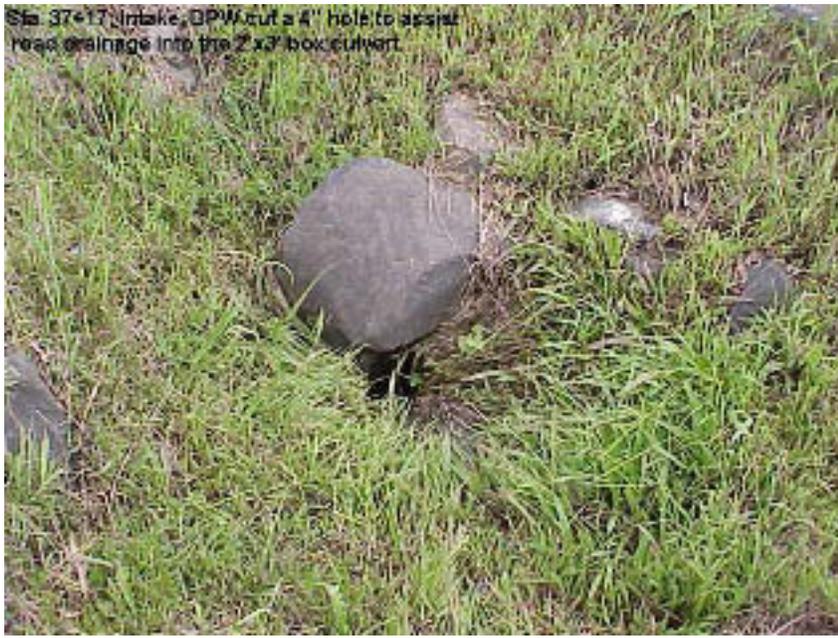
n. Sta. 37+17, Breach in SPP.

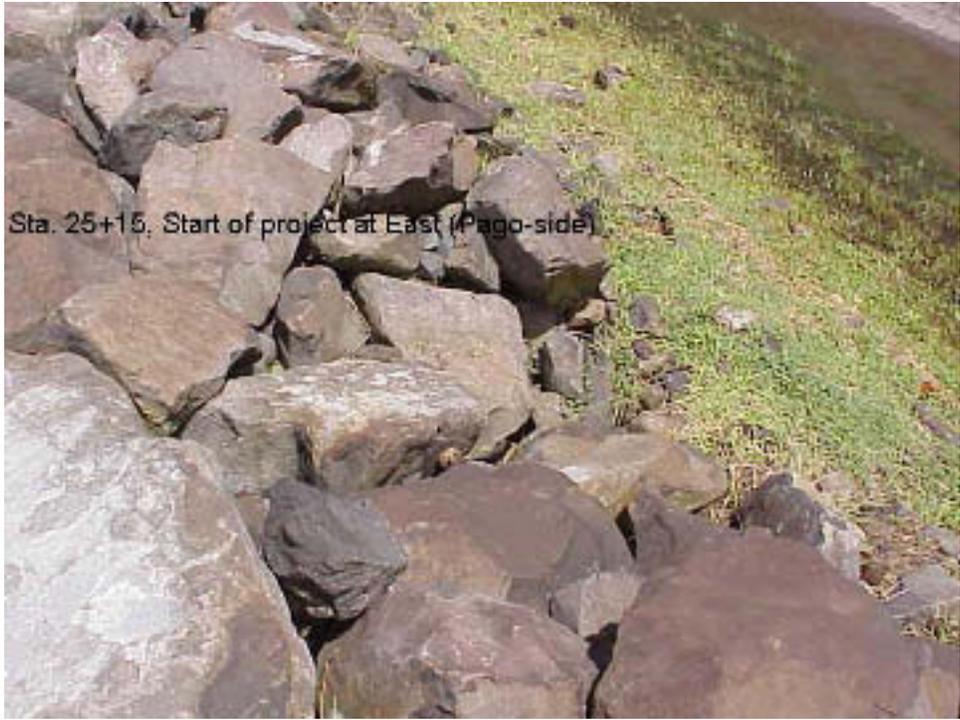
Sta. 25+15, Start of project at East (Pago-side)

Start of SPP

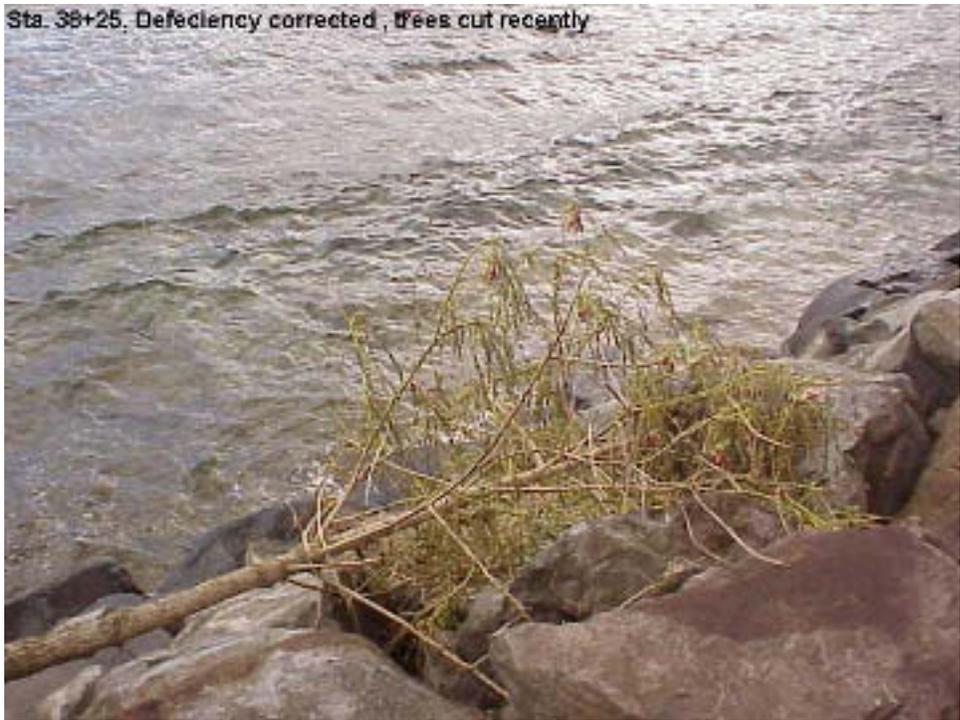
Sta. 38+25, Defeciency corrected , trees cut recently

Recently cut trees

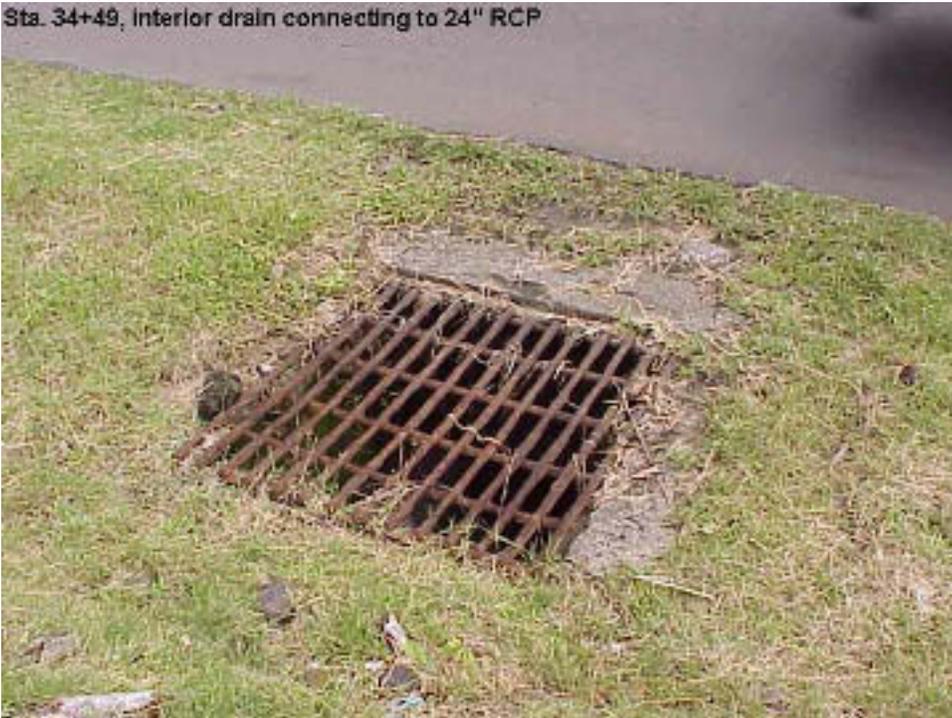
Sta. 34+49, interior drain connecting to 24" RCP

Typical grating over interior drainline

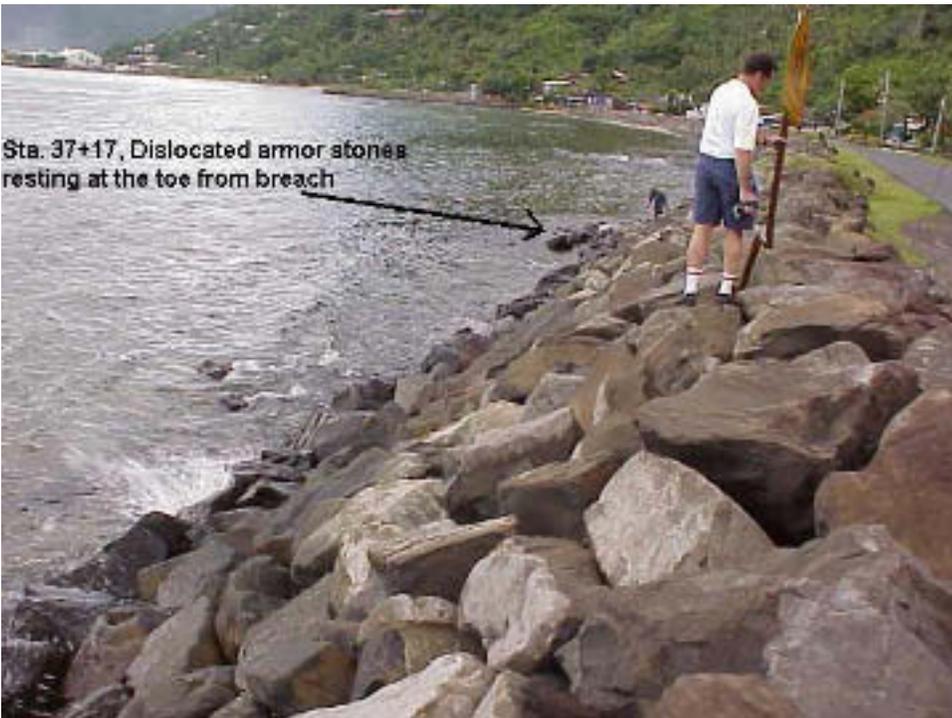
Sta. 37+17, Dislocated armor stones resting at the toe from breach

Dislodged armor stones from breach

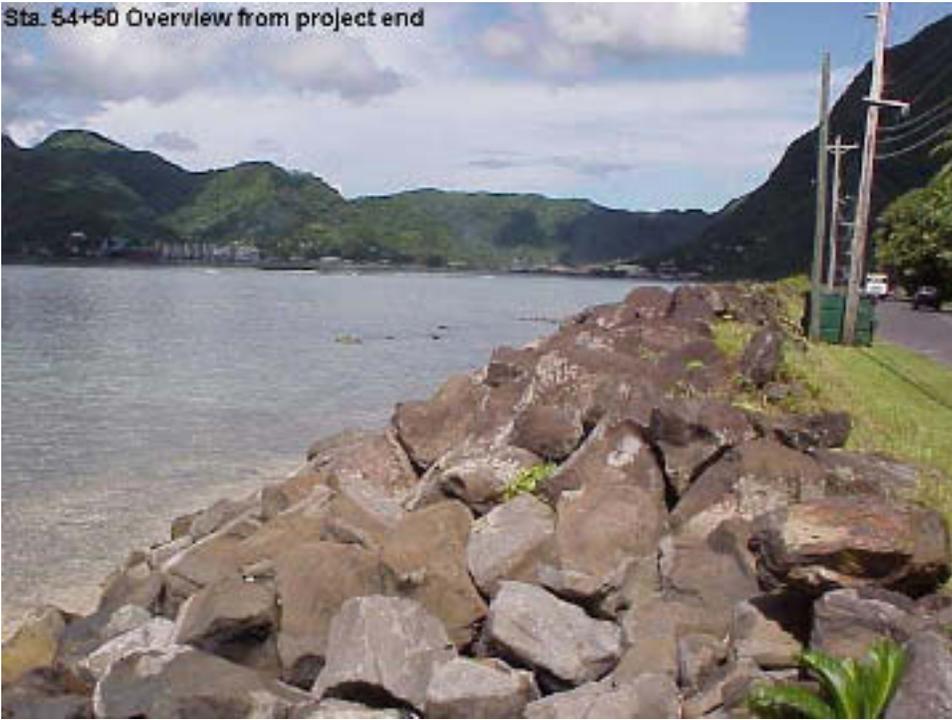
Sta. 54+50 Overview from project end

End of SPP
