O&M INSPECTION REPORT FOR NAVIGATION PROJECTS

MANELE SMALL BOAT HARBOR

Honolulu Engineer District

1. Project Name: Manele SBH
2. Date of Inspection: October 17, 2003
3. Inspection Personnel:

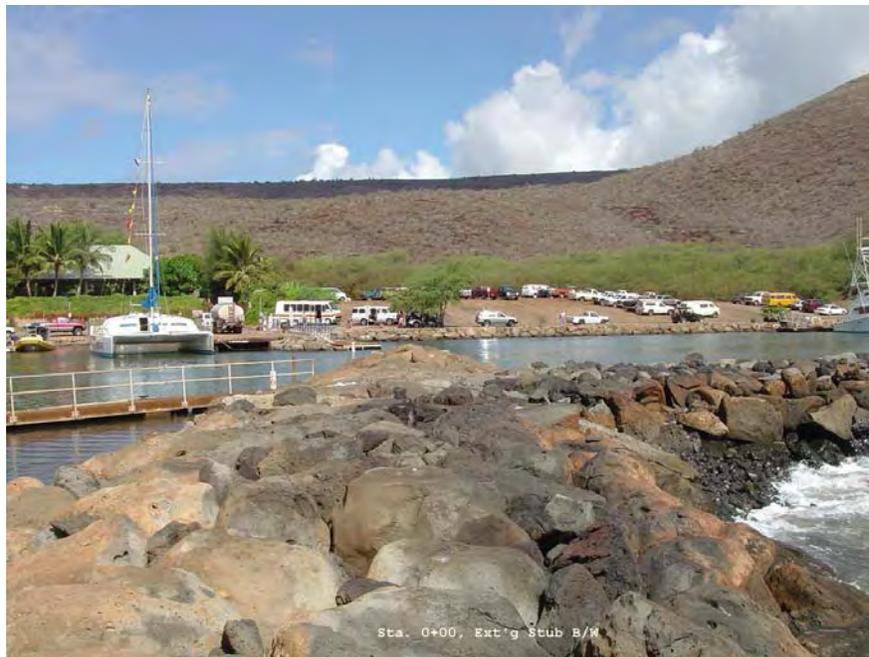
- a. Overview at start of the existing Stub Breakwater from trunk to root. Ocean side is to the right, and harbor side is to the left.

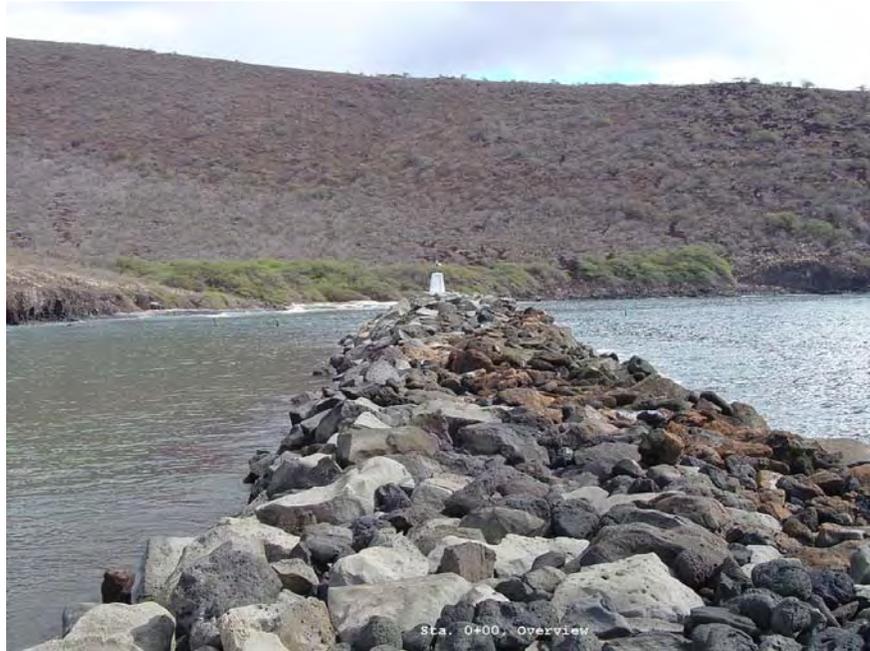
b. Overview at end of project from trunk to head. Ocean side is to the right, and harbor side is to the left.

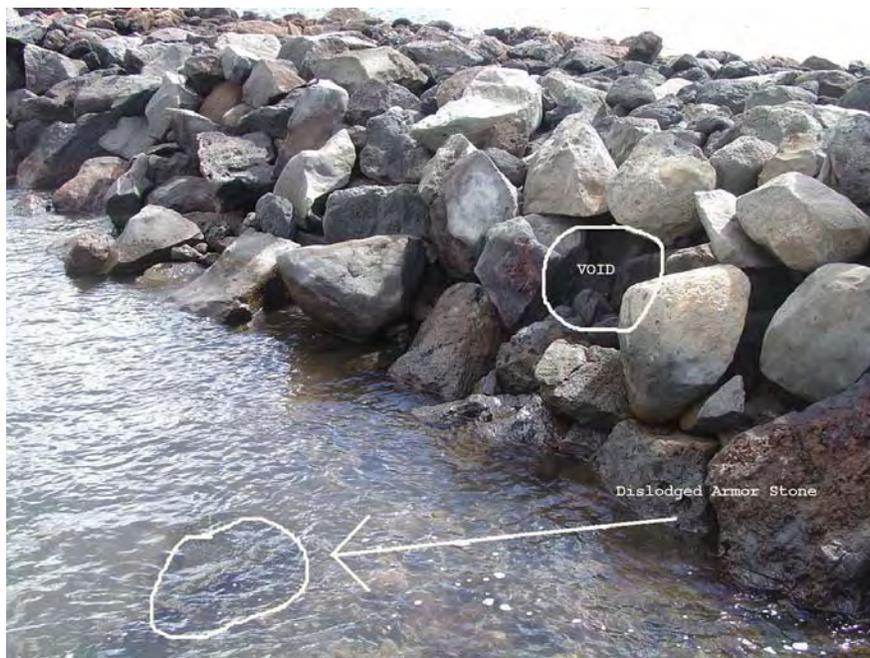
c. Sta. 1+09, HS, dislodged armor stone 3' from toe. Void is half way up side slope.

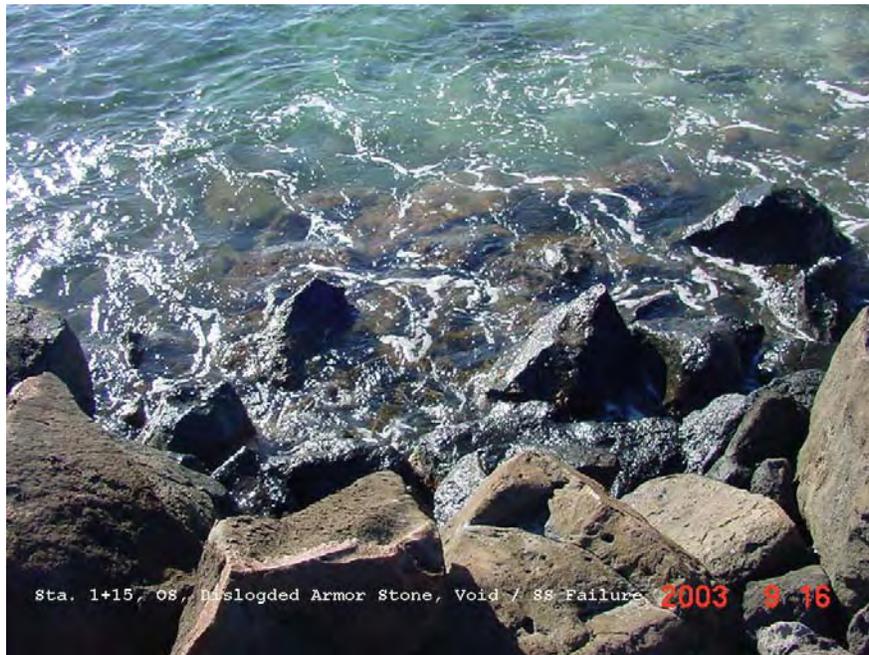
d. Sta. 1+15, OS, dislodged armor stone w/ voids, lower sideslope failure. No change 2003 Photo.

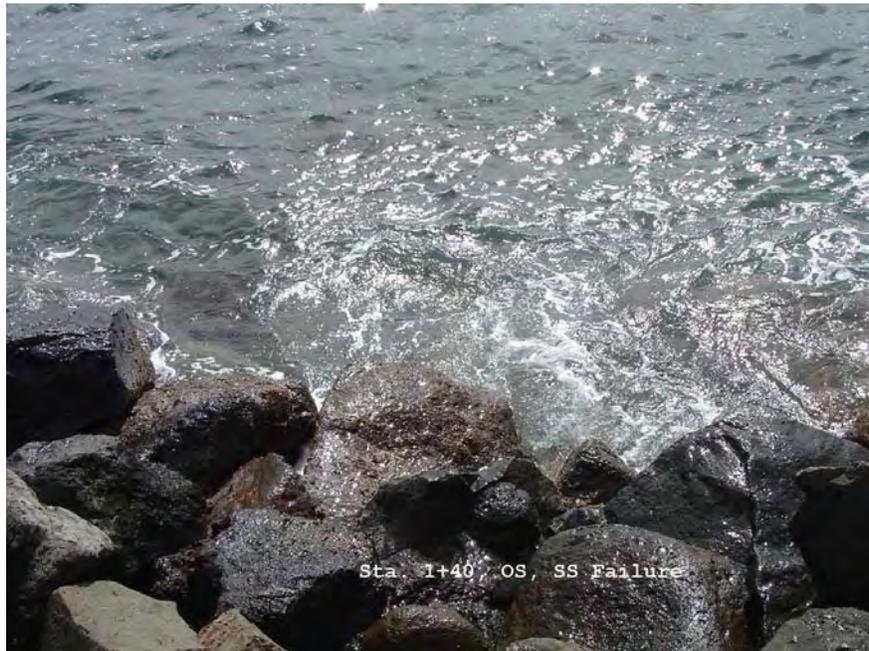
e. Sta. 1+40, OS, sideslope failure. 8 LF hinge to toe under layer exposed.

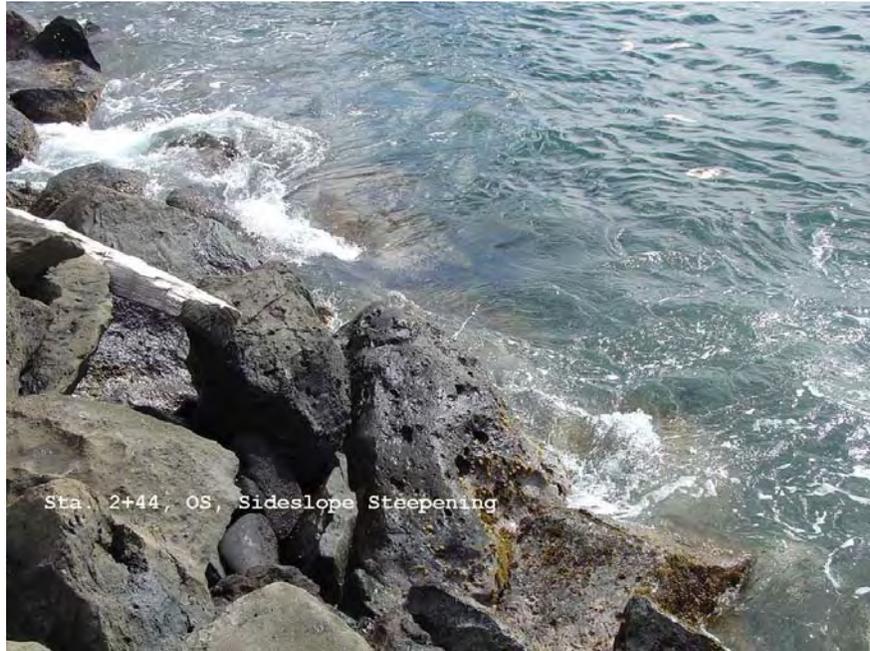
h. Sta. 2+44, OS, side slope steepening. Void under side slope. Under layer not exposed. (Adjacent white cross)

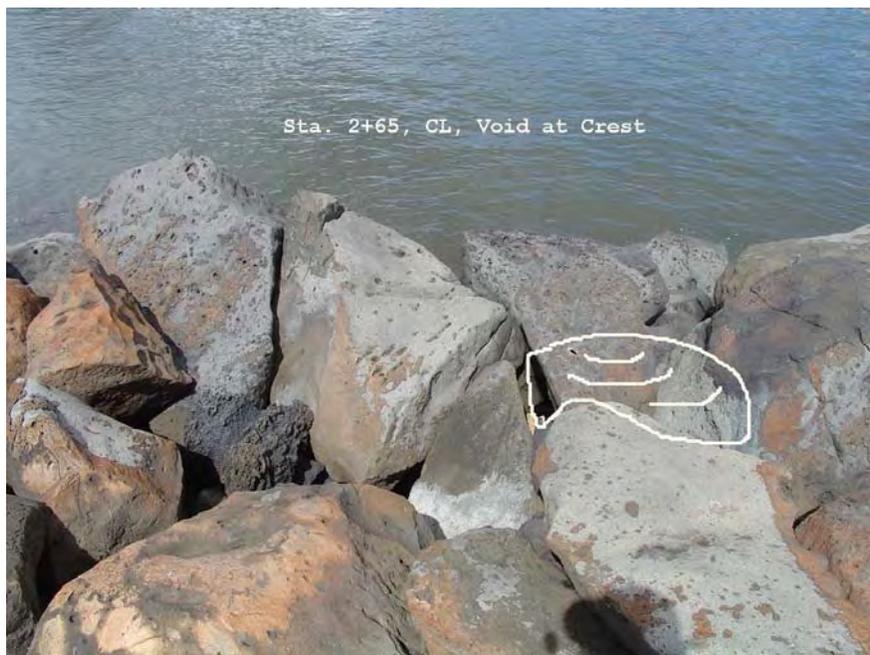
i. Sta. 2+65, Crest, void.

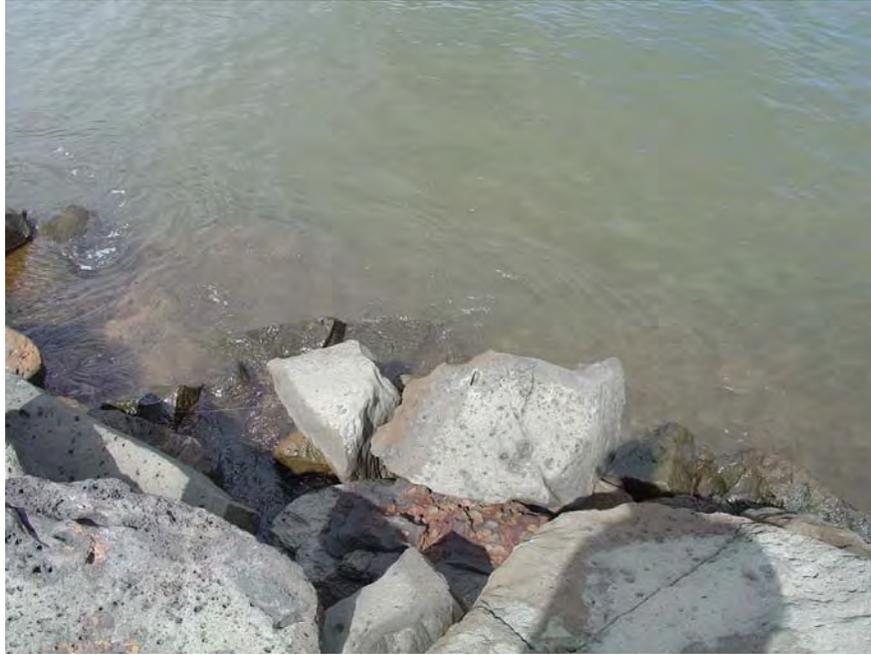
j. Sta. 2+65, HS, dislocated armor stones from sideslope, new this inspection.

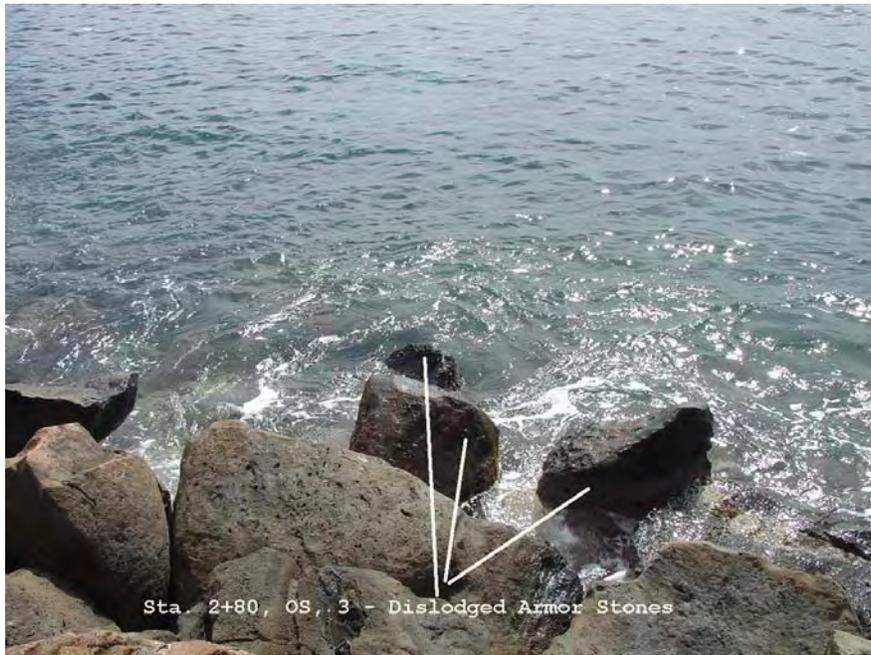
k. Sta. 2+80, OS, Dislodged armor stones at water line.

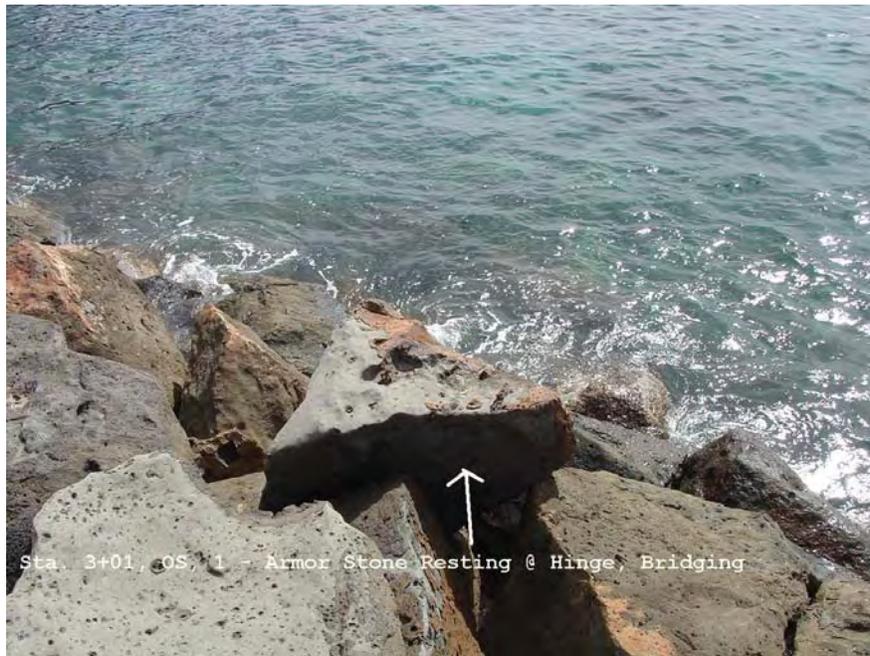
1. Sta. 3+01, OS, 1 armor stone resting at hinge, bridging.

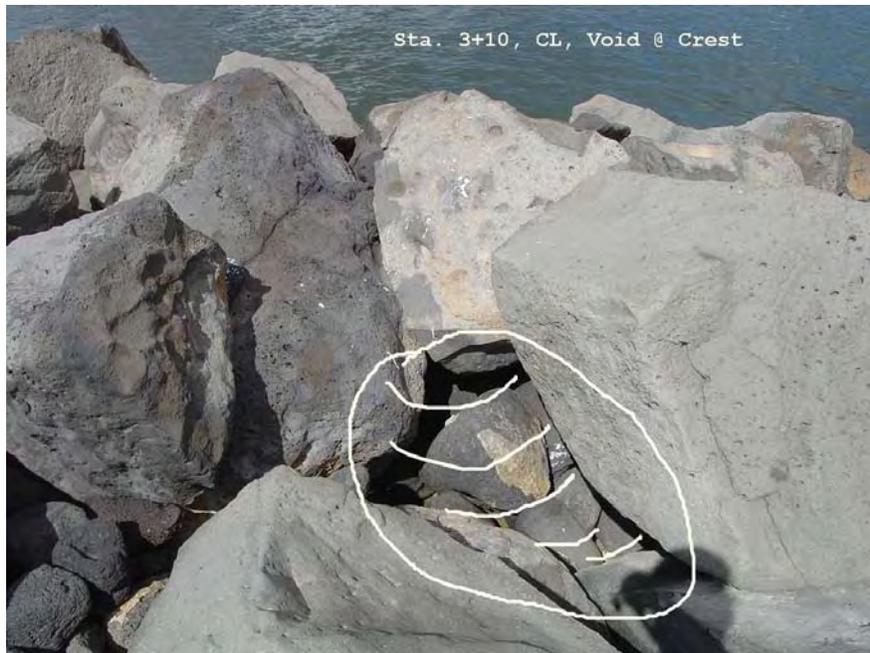
- m. Sta. 3+10, Void centerline of crest, new this inspection, adjacent white cross.

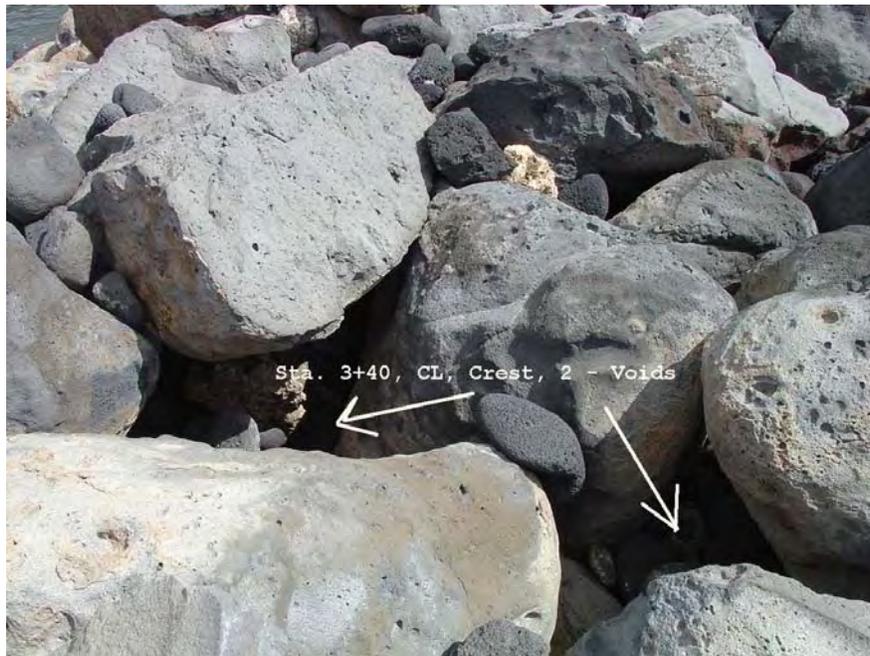
- n. Sta. 3+40, 2 large voids at center line of crest.

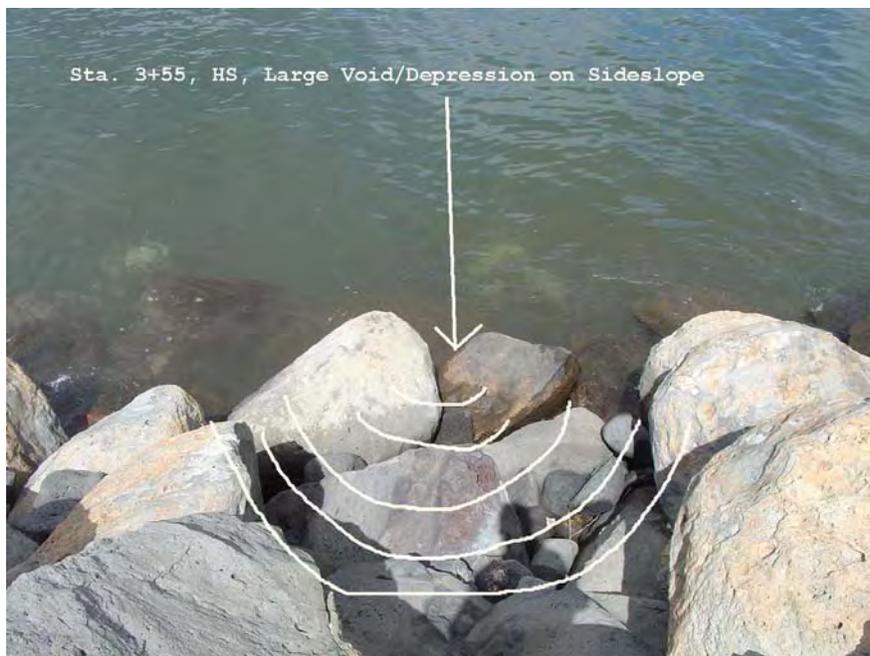
- o. Sta. 3+55, HS, Large void/depression on sideslope.
- p. Sta. 3+74, OS, 3 dislodged armor stones at toe. 1 flipped armor stone at hinge.

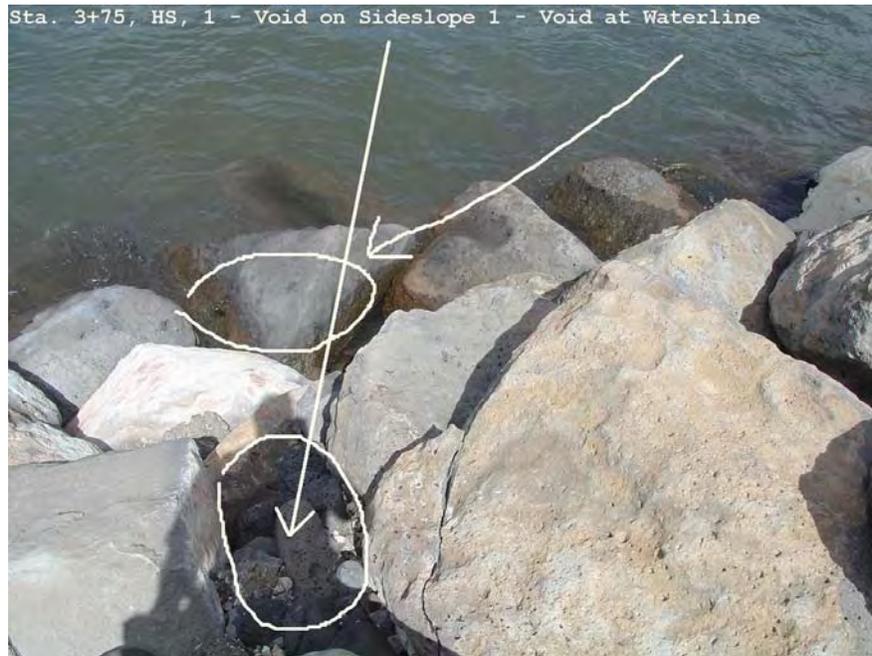
- r. Sta. 3+75, HS, 2 - voids on sideslope.
- s. Sta. 4+01, OS, 1 fracture armor stone at hinge.

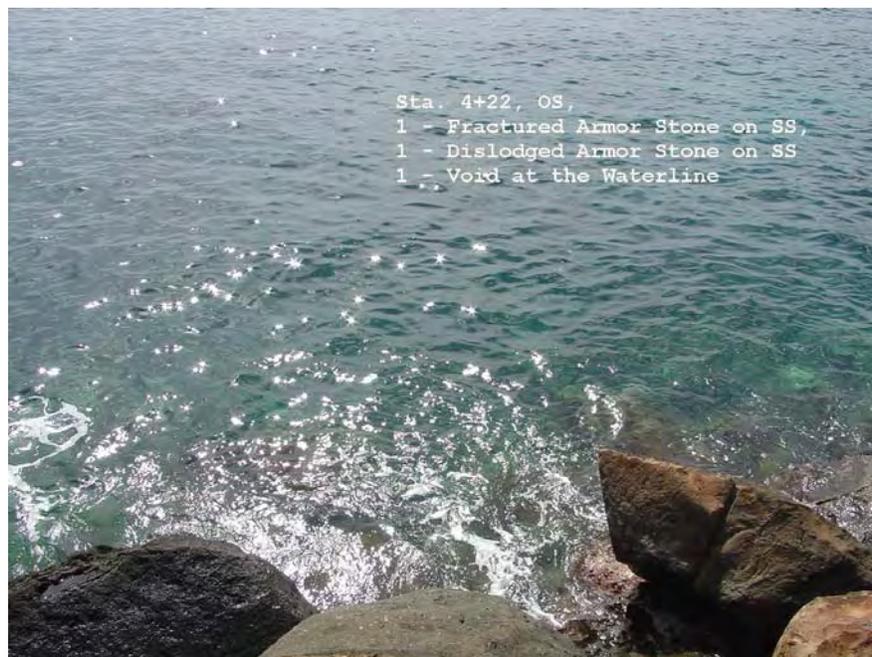
- t. Sta. 4+22, OS, 1 armor stone dislodged resting on side slope, 1 fractured armor stone, void at waterline.

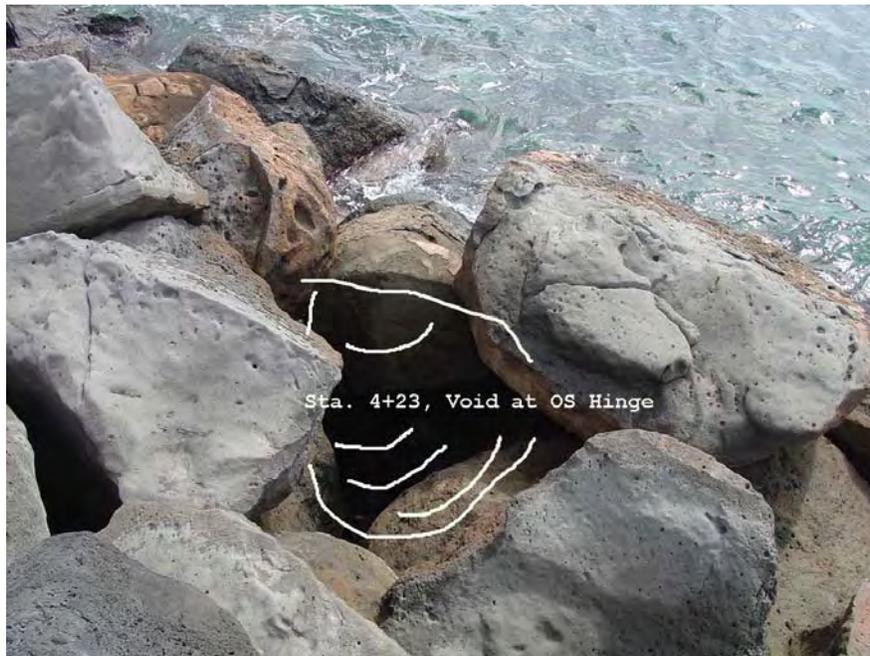
u. Sta. 4+23, OS, hinge, void.

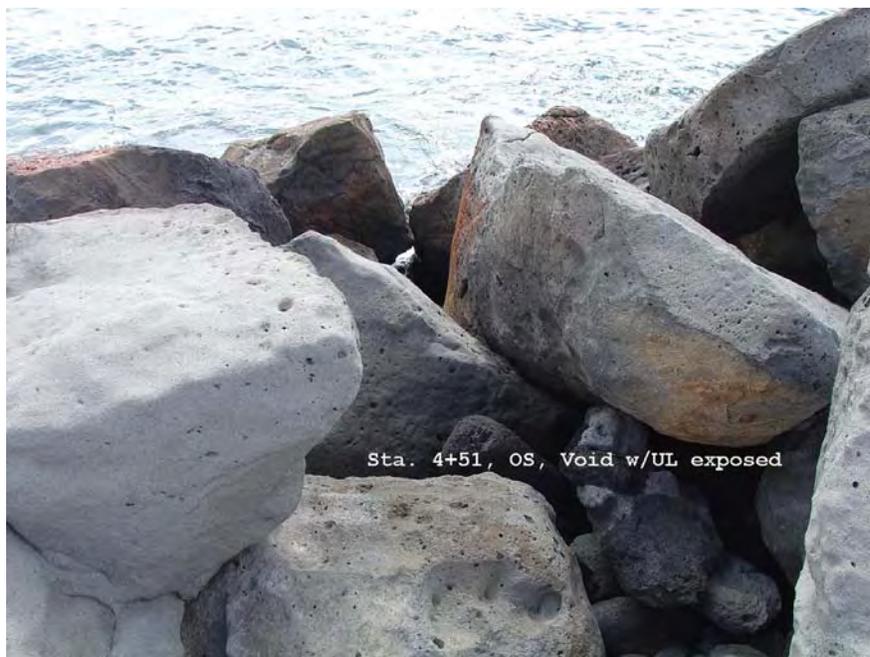
v. Sta. 4+51, OS, large void with exposed under layer. Dislocated armor stone is resting on side slope, which is also steepening.

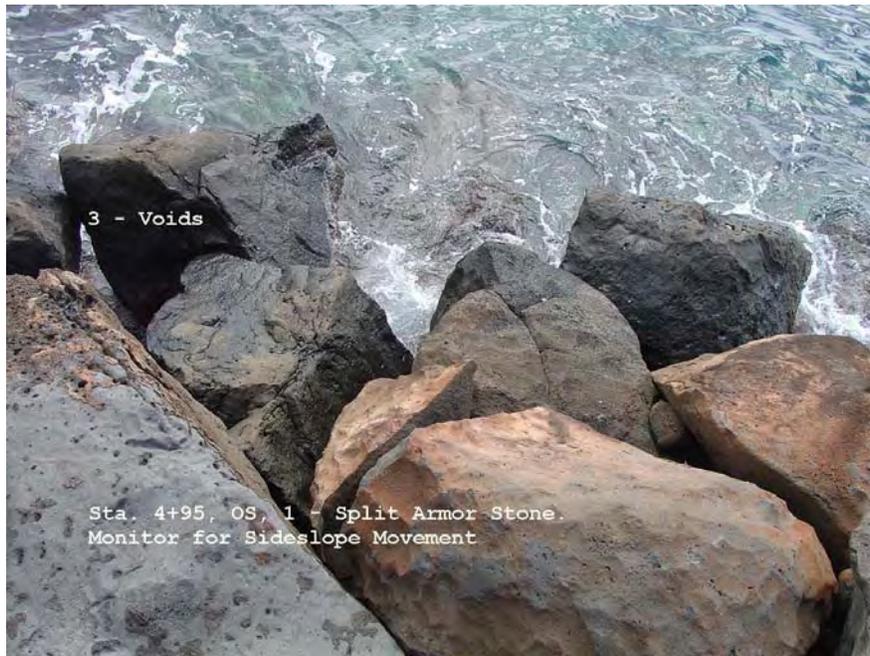
- w. Sta. 4+95, OS, sideslope movement, 1 - split armor stone.

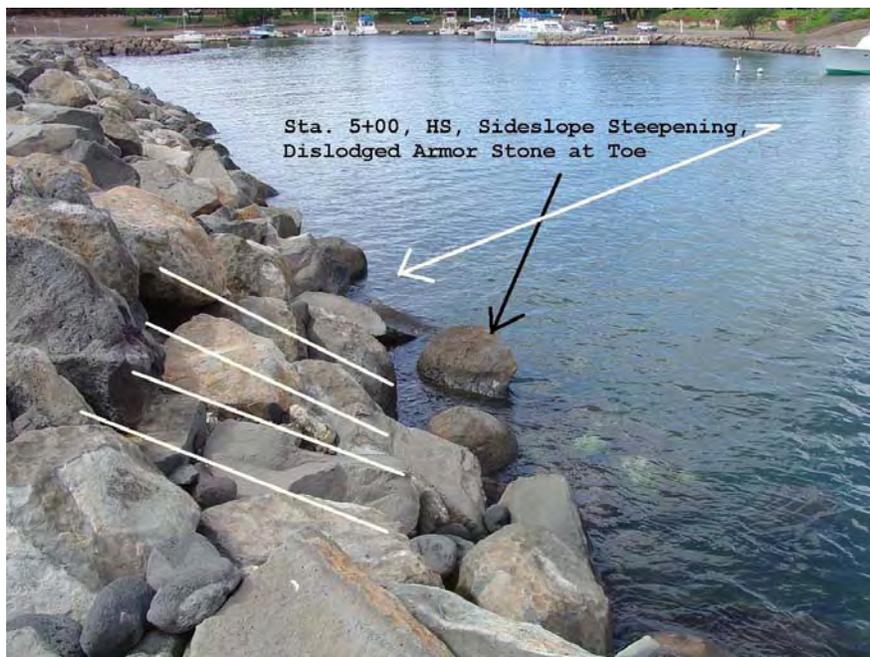
- x. Sta. 5+00, HS, 1 armor stone at toe w/o contact, (possibly from void on the sideslope at Sta. 4+85, new this inspection).

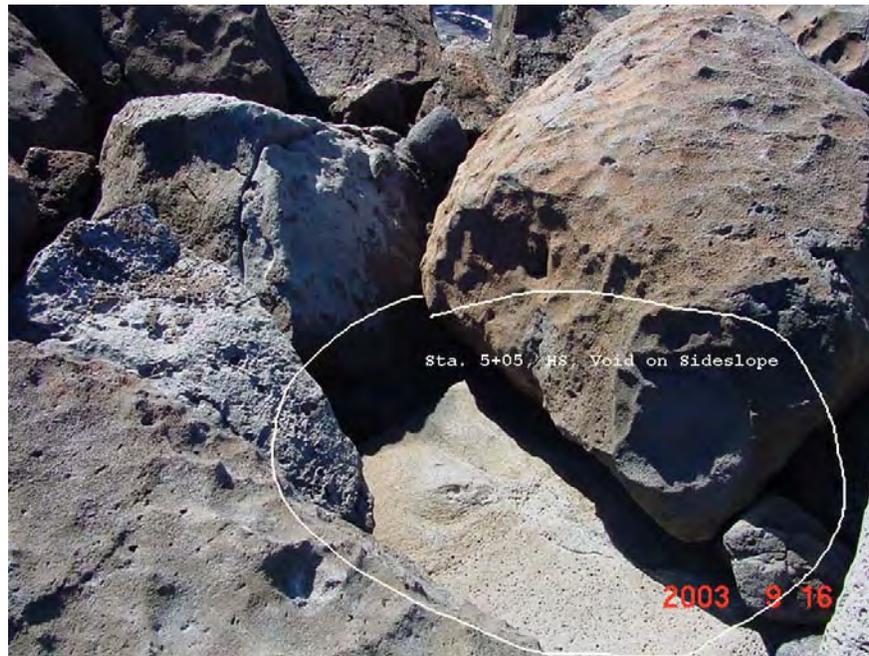
y. Sta. 5+05, HS, Void on sideslope, 2003 photo.

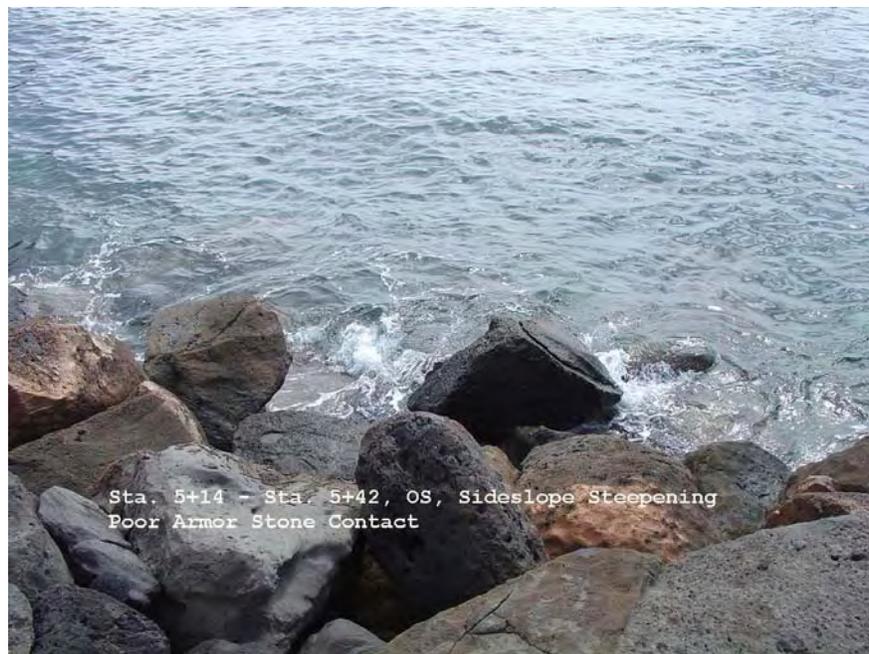
z. Sta. 5+14 to Sta. 5+42, OS, side slope steepening. Dislodged armor stone at toe with poor contact.

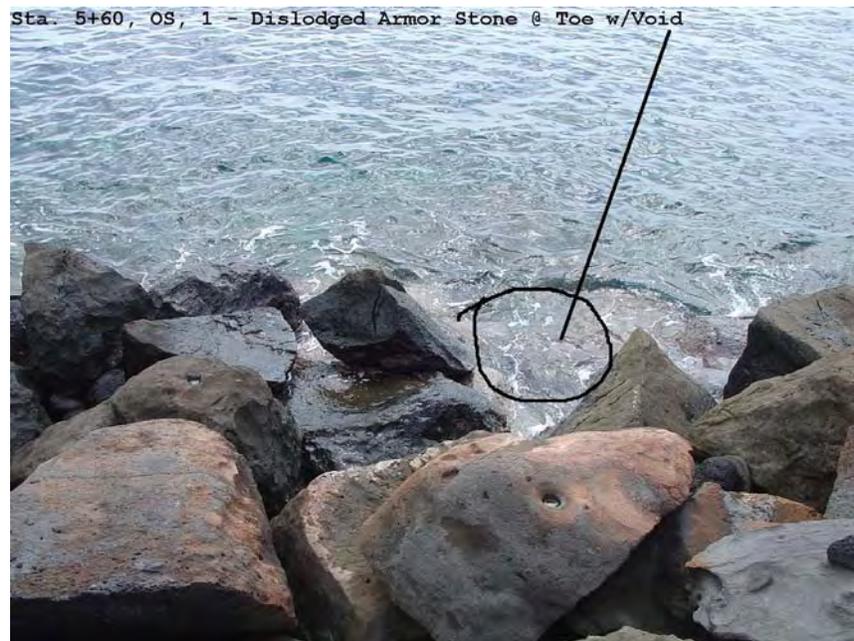
aa. Sta. 5+60, OS, 1 - dislodged armor stone w/void.

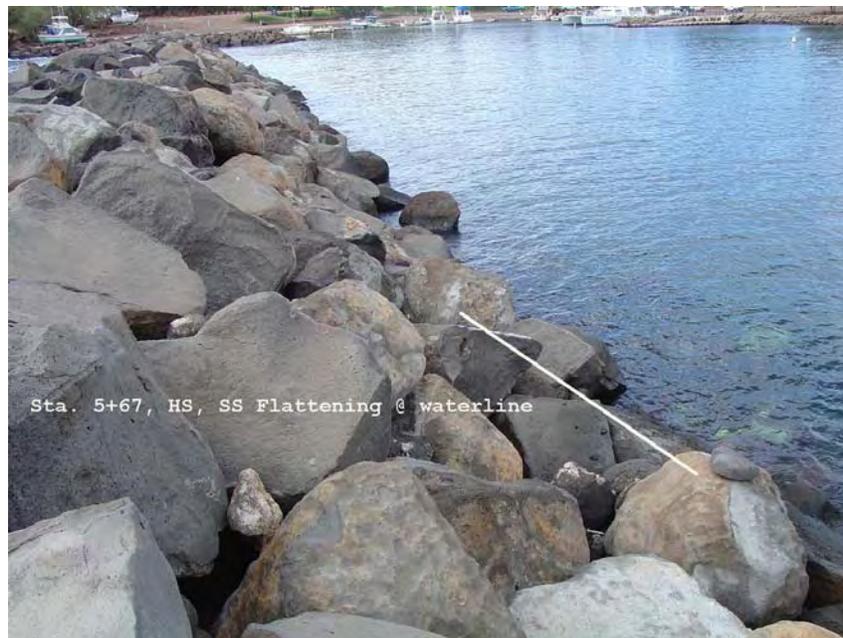
bb. Sta. 5+67, HS, structure flattening and steepening at water line.

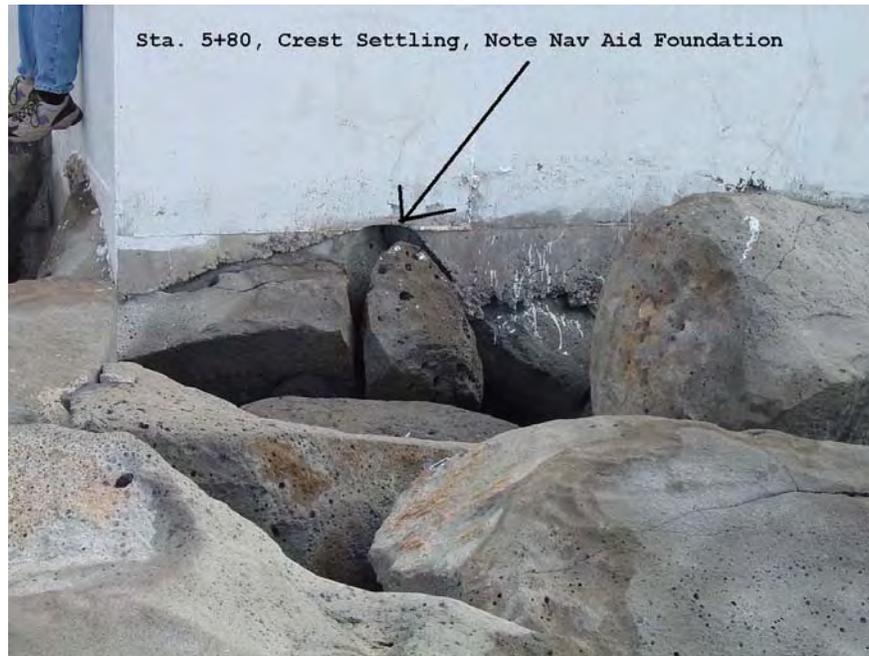
cc. Sta 5+80, crest settling, note NavAid foundation.

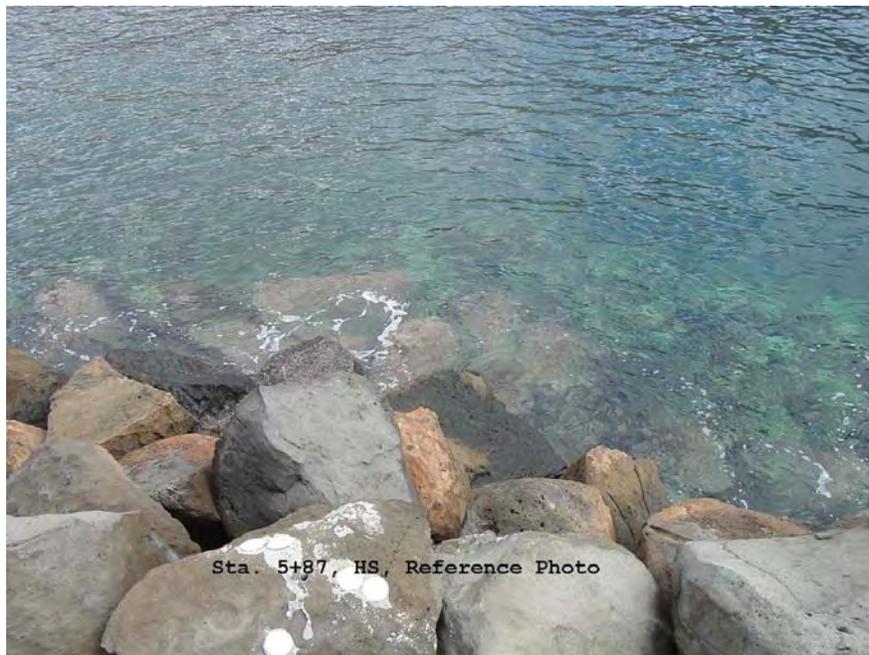
dd. Sta. 5+87, picture taken from 22 degrees HS to 22degrees OS at the head of the structure. There is a possibility of a missing layer of armor stones at water line.

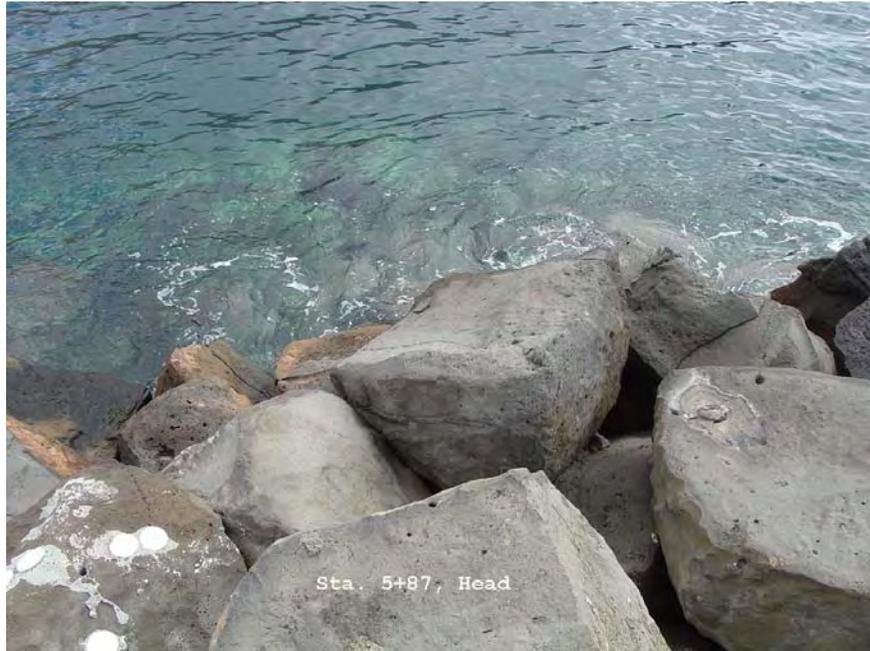
ee. Sta. 5+87, picture taken from top of monument at 20 degrees HS to centerline of head at 0 degrees. There is a possibility of a missing layer of armor stones at water line.

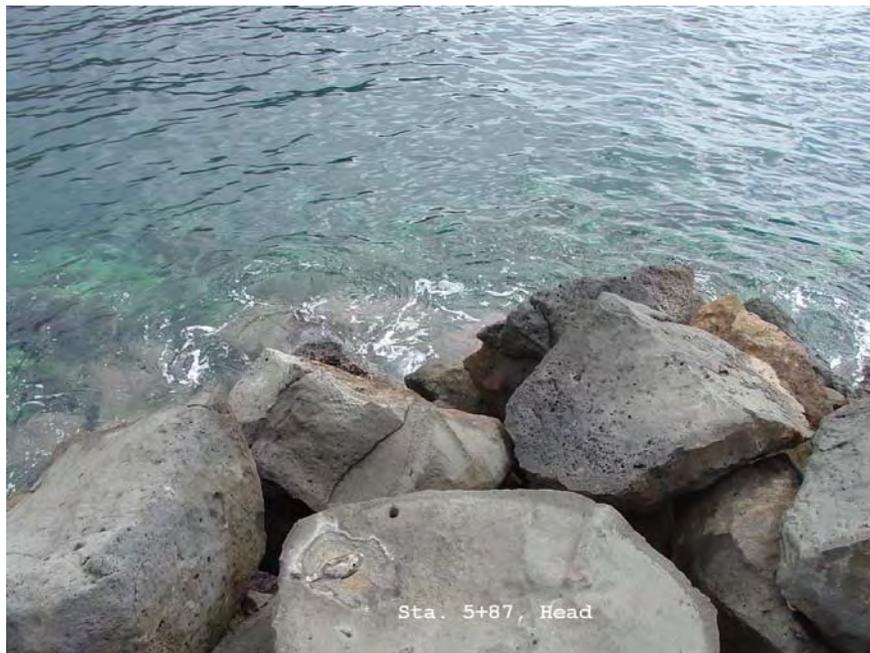
ff. Sta. 5+87, picture taken from top of monument at center line of head at 0 degrees to 22 degrees OS. There is a possibility of a missing layer of armor stones at water line.

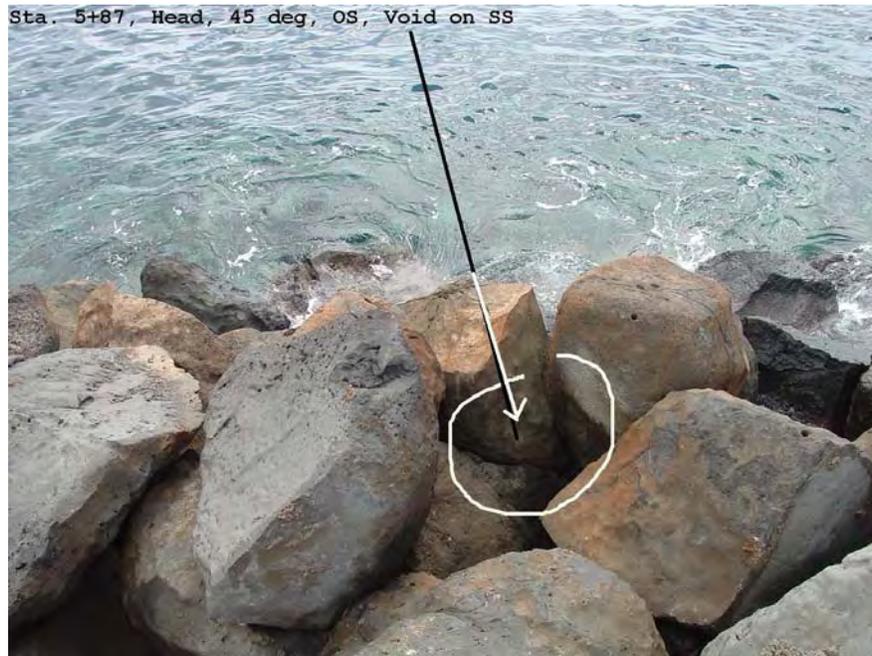
gg. Sta. 5+87, Head, OS, Void, 90 deg.

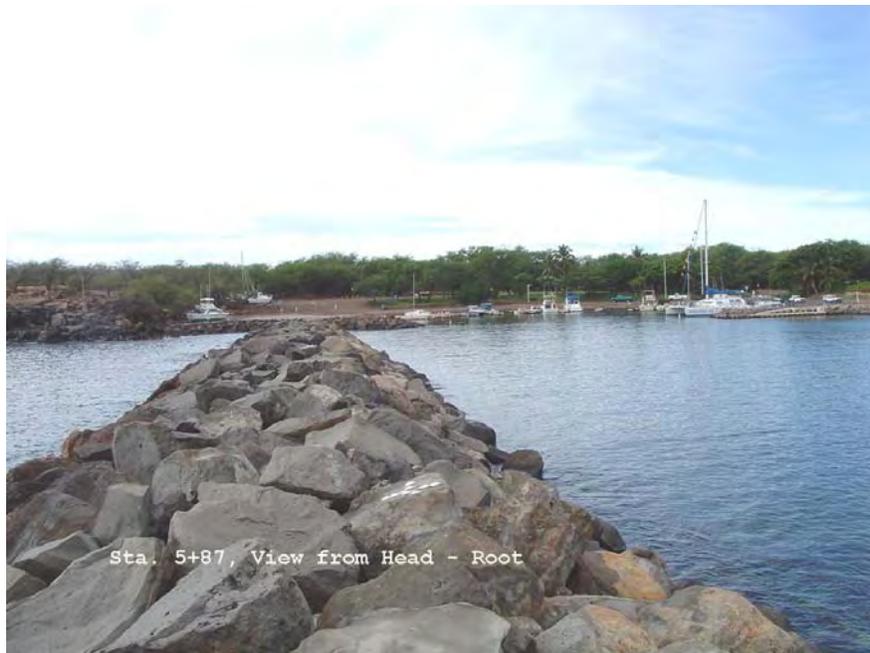
hh. Reference Photo, Head to Root OS.

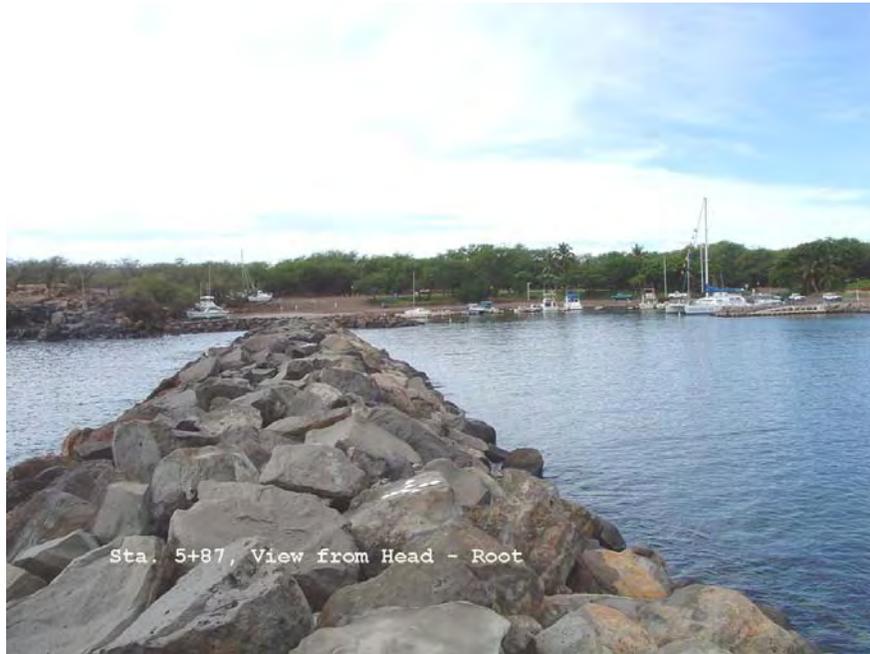
ii. Reference Photo, Head to Root HS.
