POST STORM INSPECTION REPORT - Tropical Cyclone Heta

OFU SBH

Honolulu Engineer District

1. Project Name: Ofu SBH
2. Date of Inspection: January 12, 2004
3. Inspection Personnel:

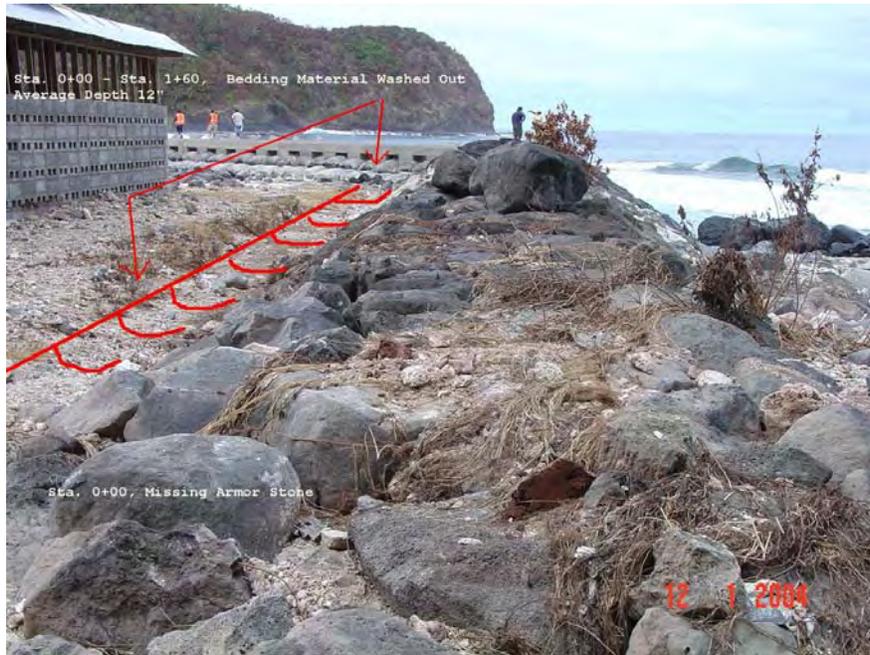
a. Sta. 0+00 to 1+60, one ea. armor stones are missing. Restore the washed out fill material on the harborside adjacent the toe of the structure. Re-set the perched armor stones from the crest to the Sta. 0+00 area.

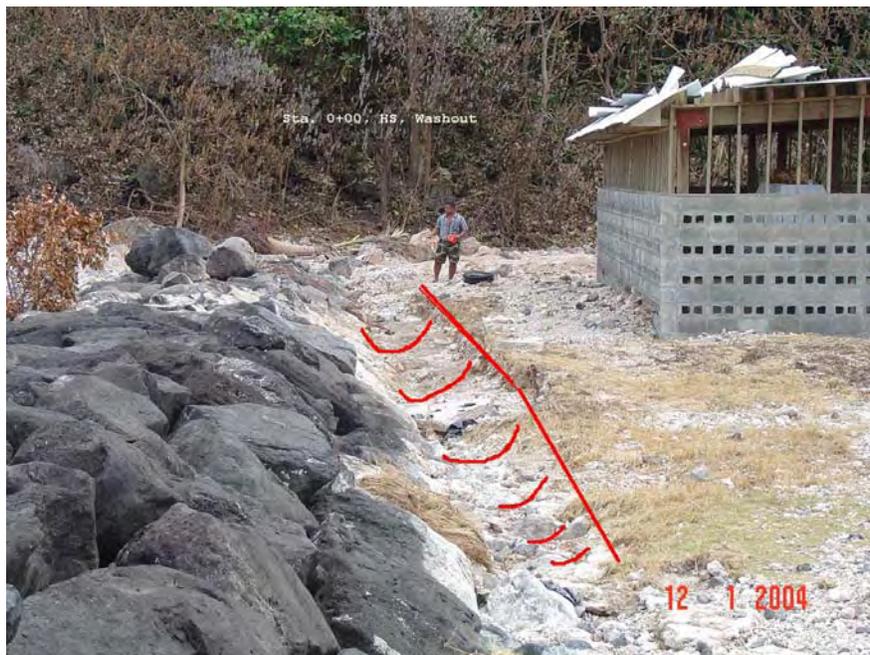
b. Same as Above.

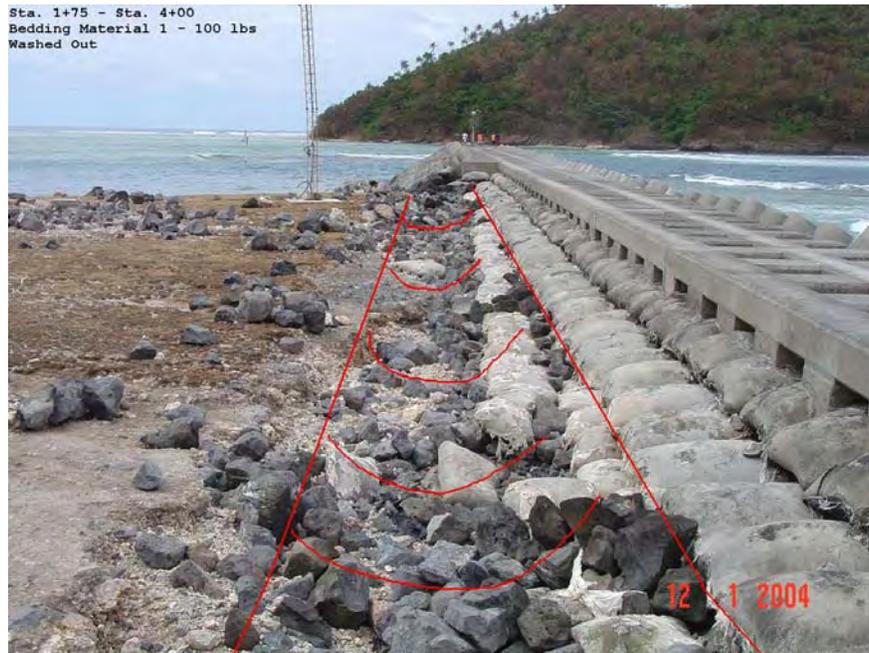
c. Sta. 1+75 to Sta. 4+00, HS, Bedding material has been washed out from the concrete pillows under the ribcap. Washed out area is averaged to 12 feet wide x 4 feet deep.

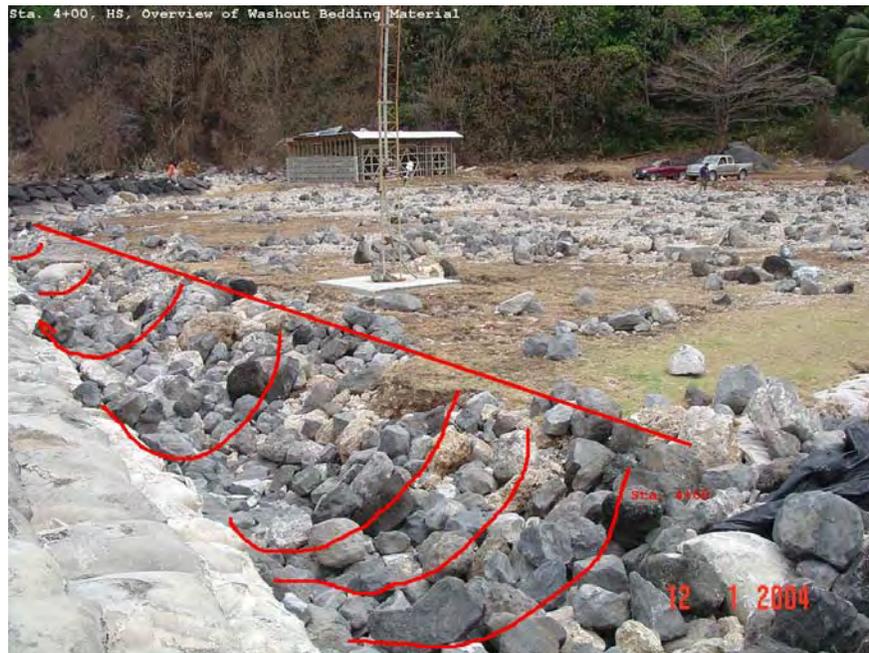
d. Same as Above - photo facing from Sta. 4+00

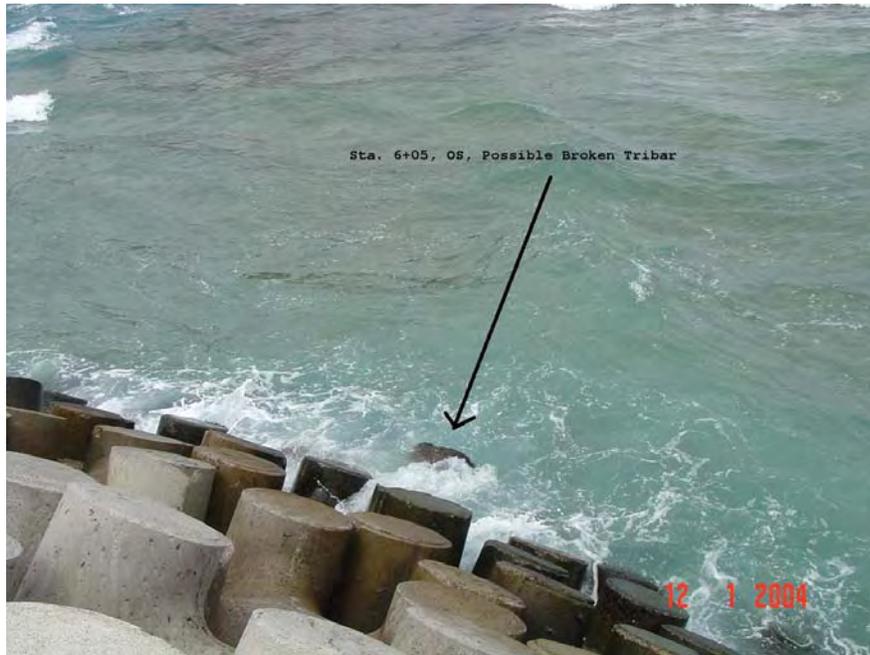
e. Sta. 6+05, OS, possible dislodged or broken tribar.

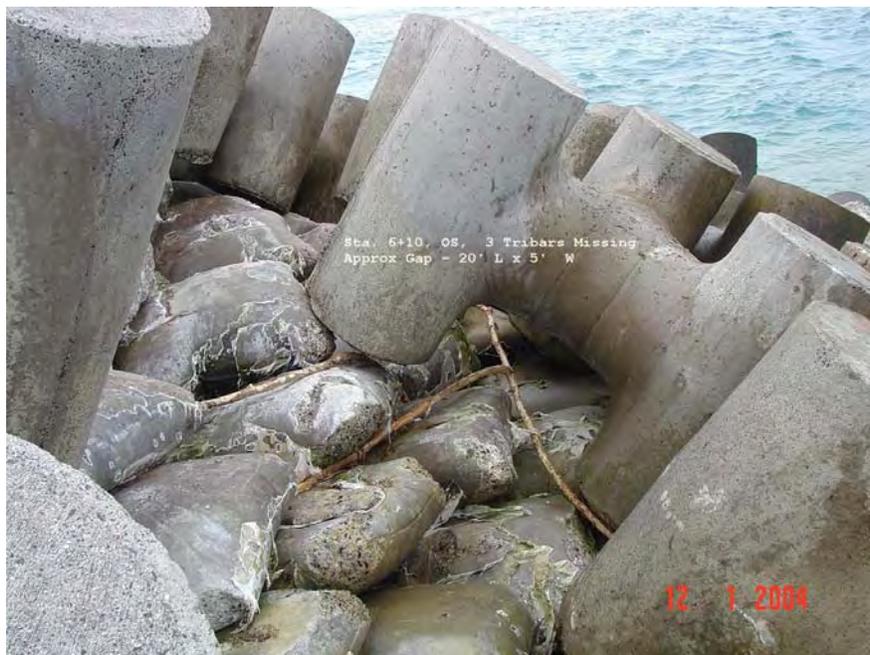
f. Sta. 6+10, OS Head, Approximately 3 ea. tribars have been washed out adjacent the ribcap.

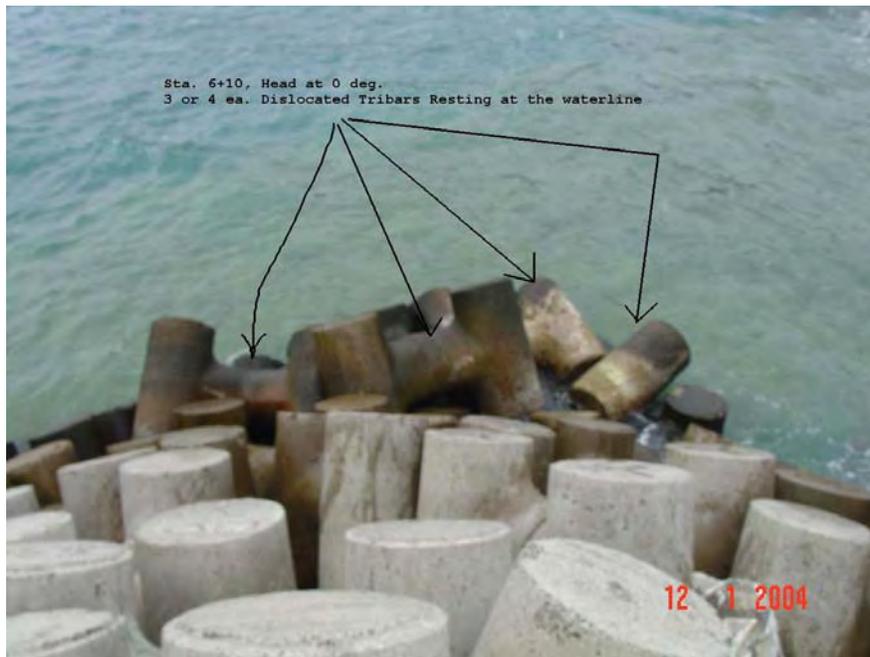
g. Sta. 6+10, 0 deg. Head, approximately 3 or 4 tribars resting at adjacent the toe of the structure.

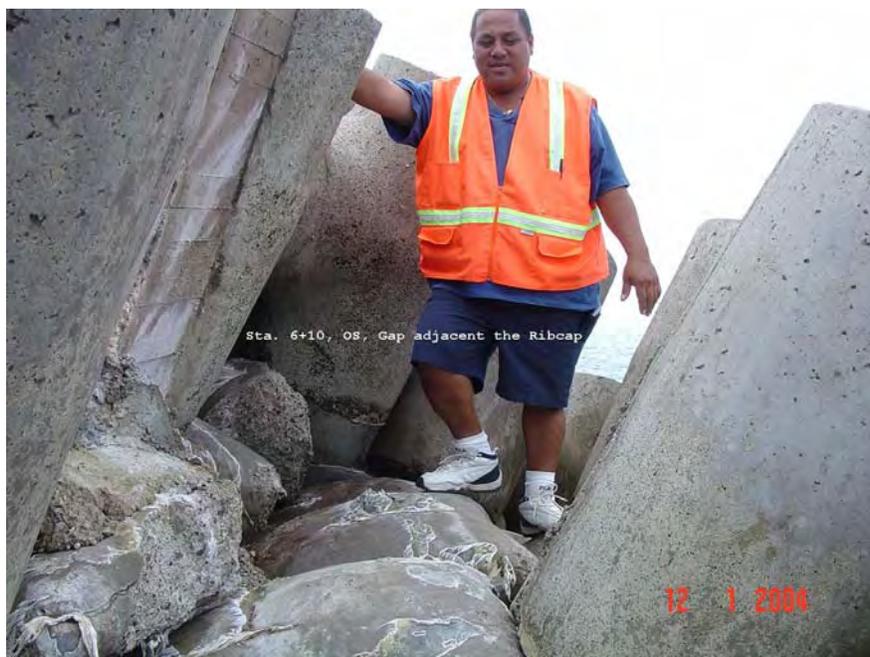
h. Sta. 6+10, OS, Gap from missing tribars.

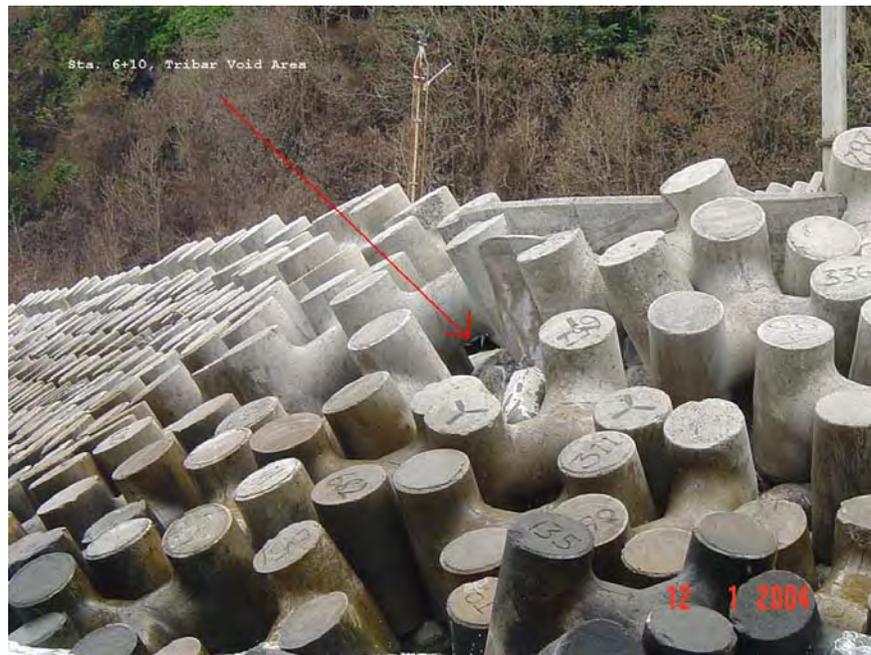
i. Sta. 6+10, OS, View from the water.

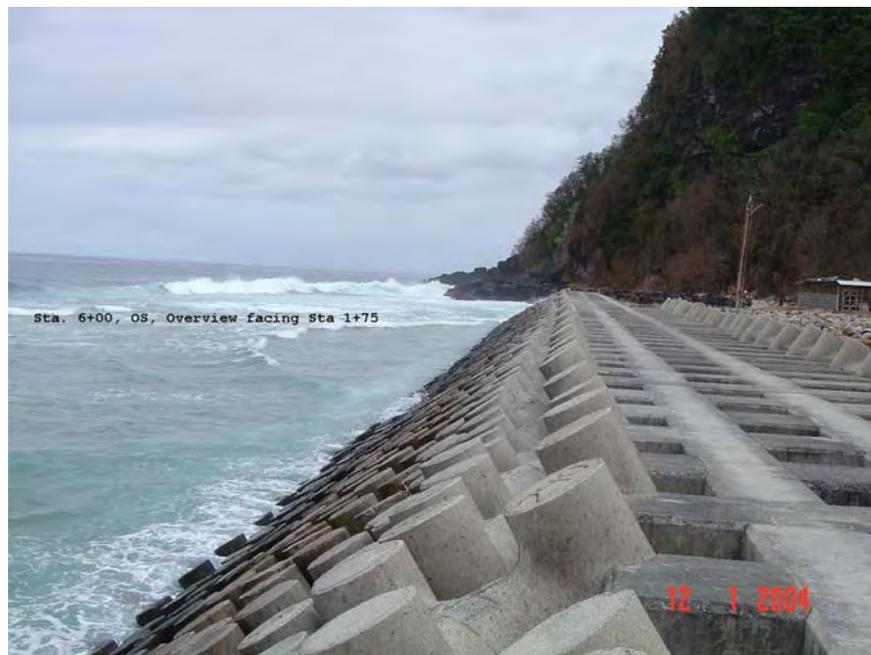
j. Sta. 6+10, OS, Typical Overview (Photo for Reference).

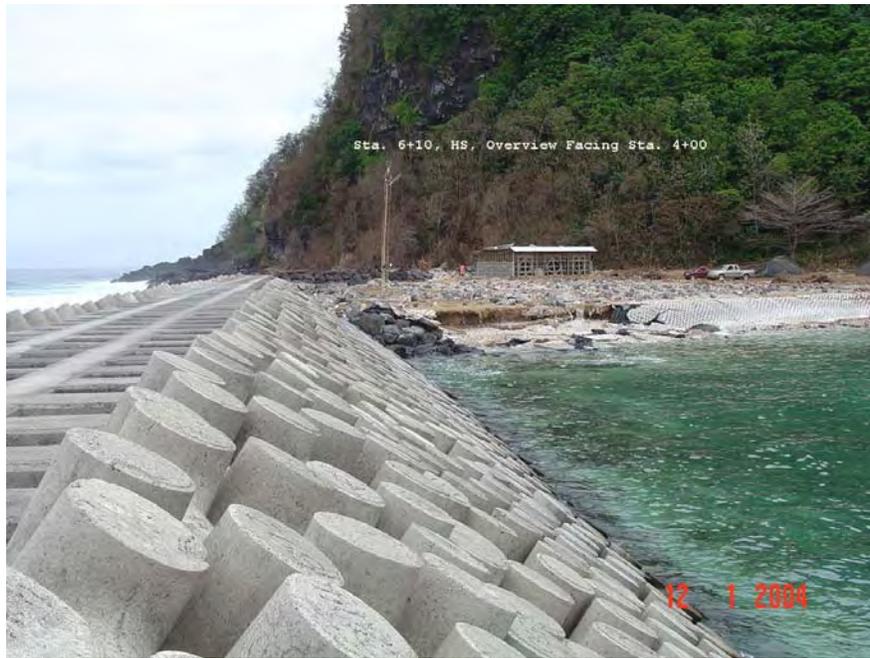
k. Sta. Sta. 6+10, HS, Typical Overview (Photo for Reference).

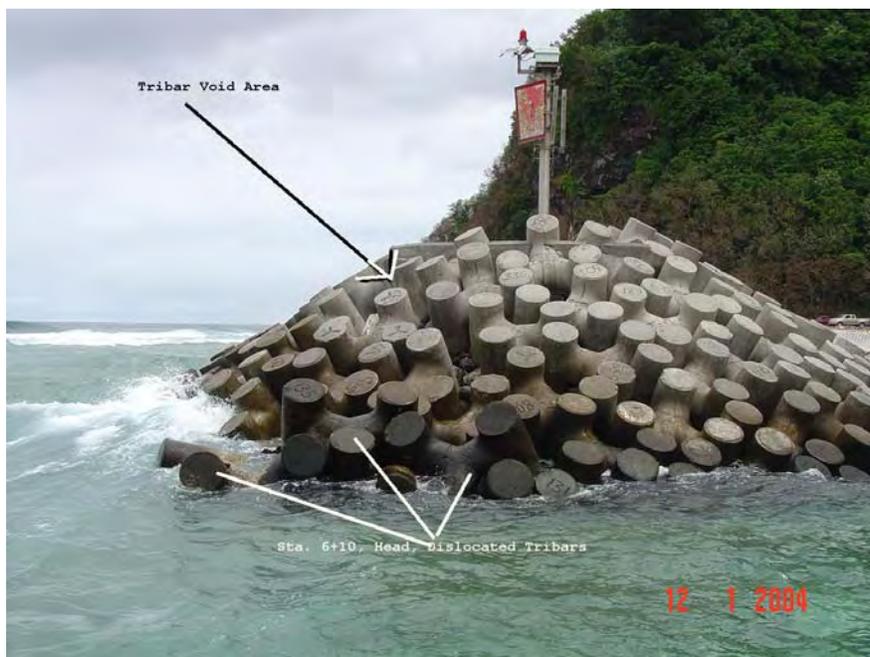
l. Sta. 6+10, Head damage.

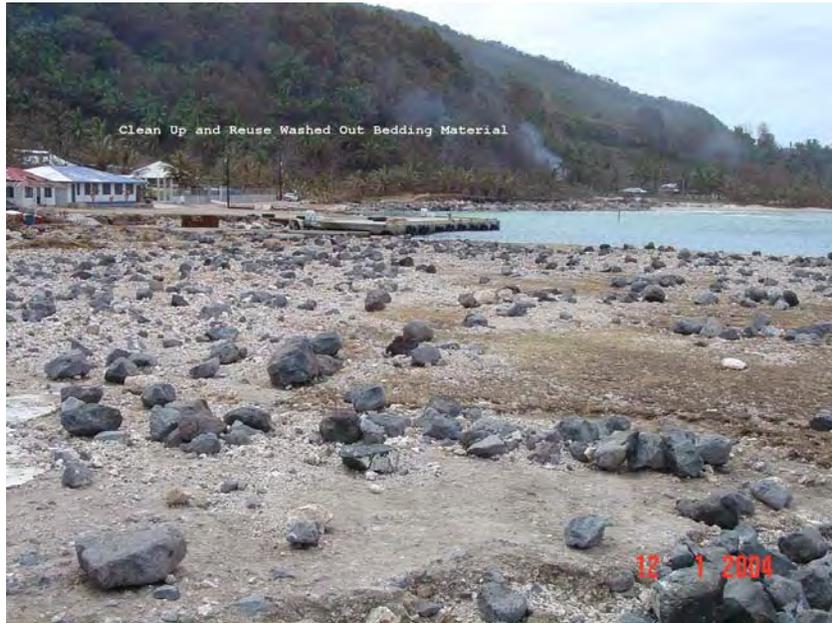
m. Sta. 1+75 - Sta. 4+00, HS, bedding material.
