## O & M INSPECTION REPORT FOR NAVIGATION AND SHORE PROTECTION PROJECTS

1. Project Name: Port Allen Deep Draft Harbor
2. Date of Inspection: 06 September 2002
3. Inspection Personnel:

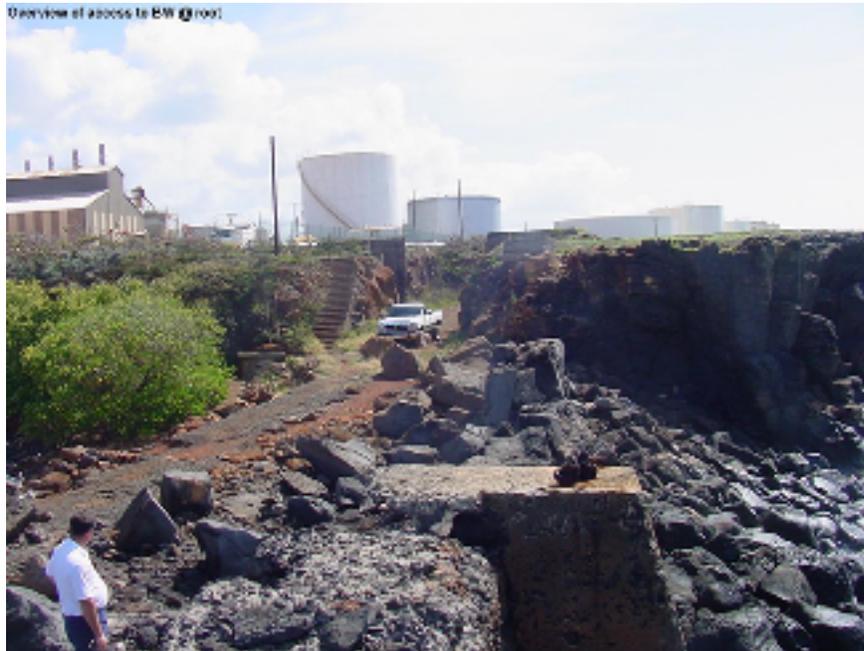
- a. \*Access to breakwater.

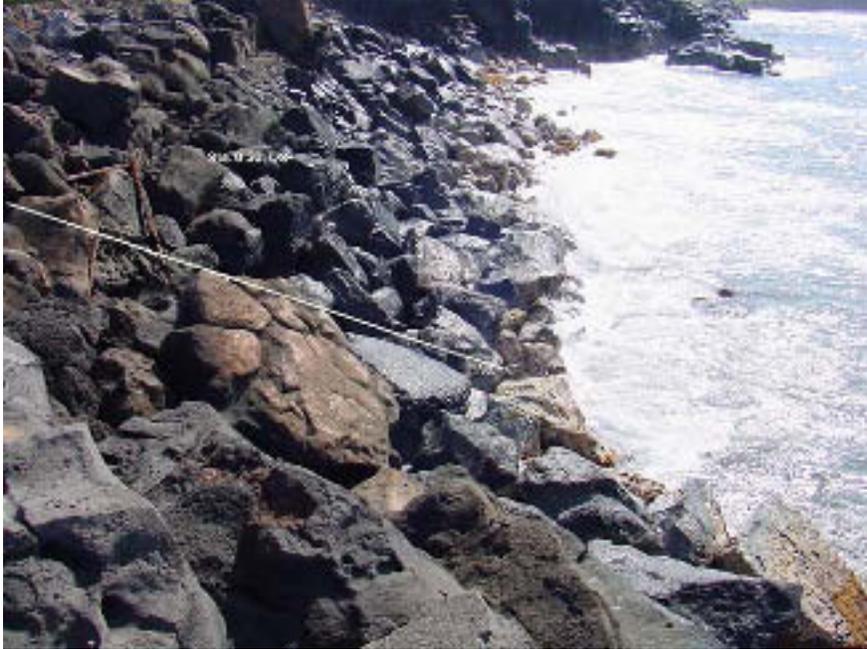
d. \*Sta. 0-30, OS, sideslope is OK.

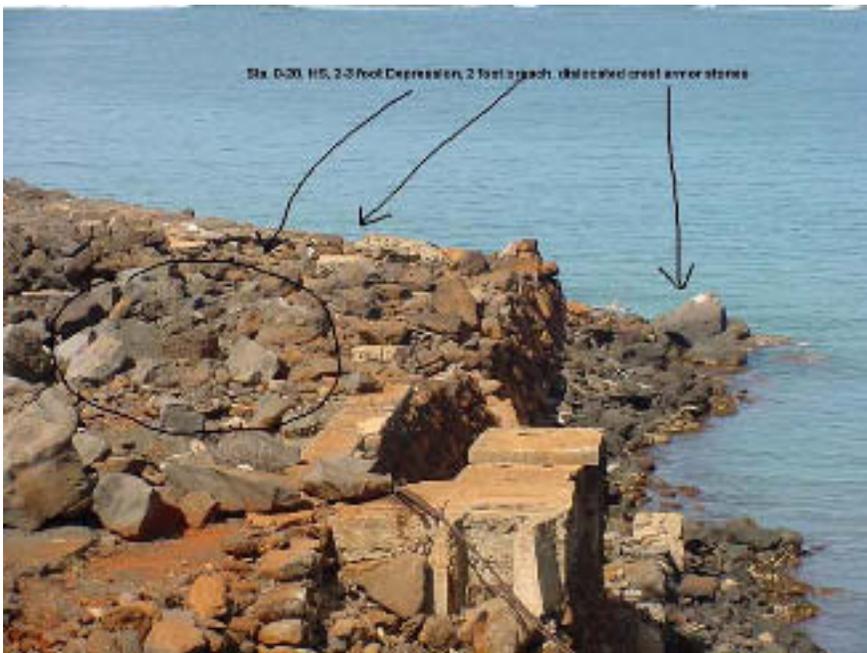
e. \*Sta. 0-20, HS, 2-3 foot depression, 2 foot breach, and dislocated crest armor stones.

Funds have been budgeted for FY04 to prepare plans and specs for the repair of the root section of the breakwater, between Sta. 0-20 and Sta. 3+00. Funds have been budgeted for FY05 for a construction contract to repair this root section.

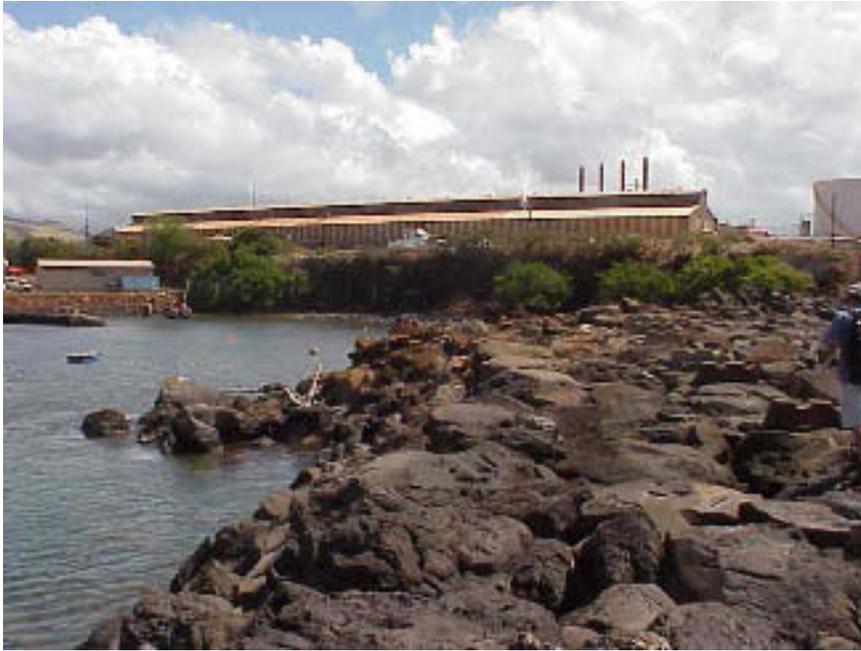
f. Sta. 0-20, picture taken 2002. See last years comment paragraph "g".

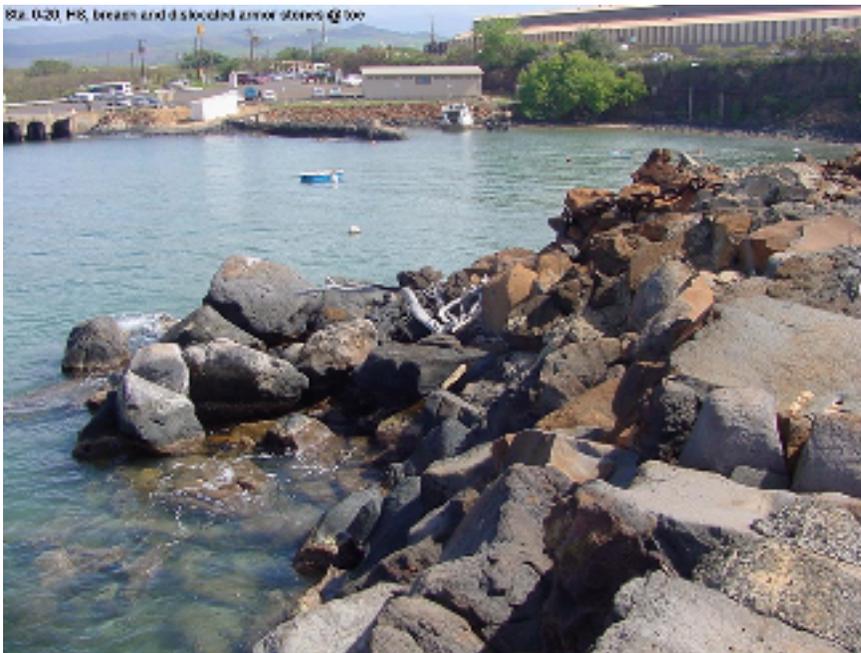
g. \*Sta. 0-20, Crest/HS, It appears the breakwater overtopped washing-out an area approx. 30 sqft. HS of centerline, and breached a 2' - 3' opening, armor stones and underlayer are resting adjacent the toe on the HS .

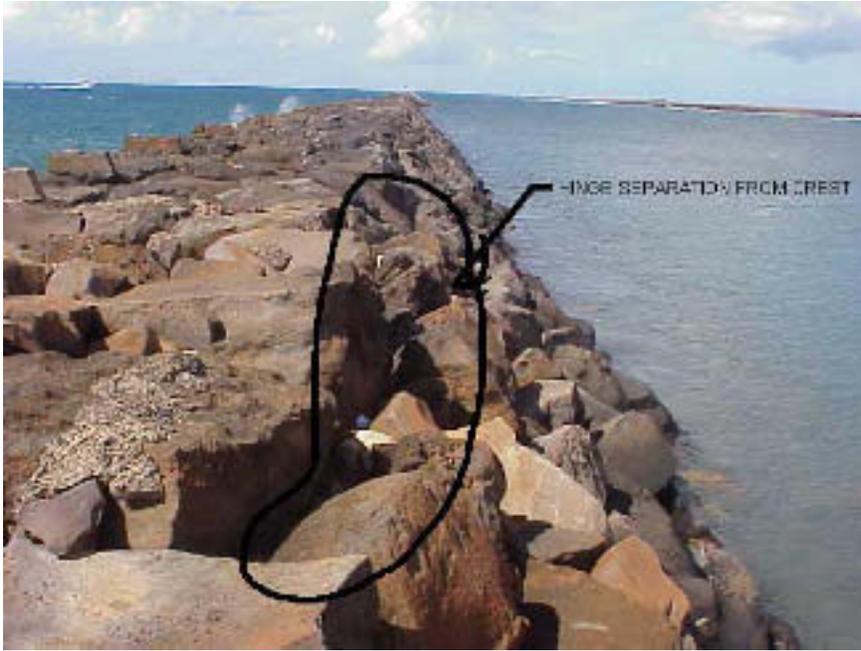
i. Sta. 0+75 to Sta. 1+00, HS, sideslope steepening, 1' separation at the hinge. No change - same as last year.

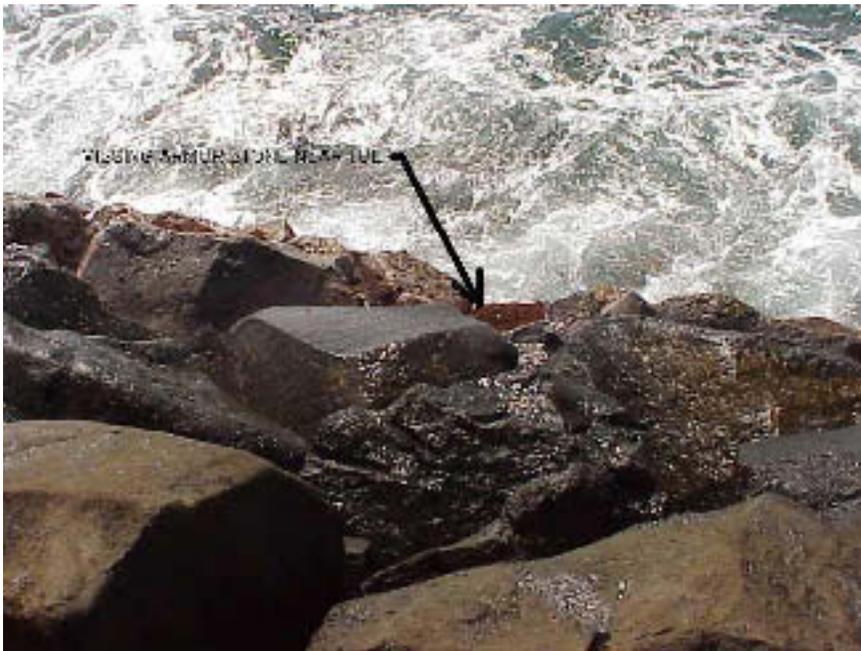
j. Sta. 1+20, OS: 1 ea. armor stone dislodged, no other damage noted. No change - same as last year.

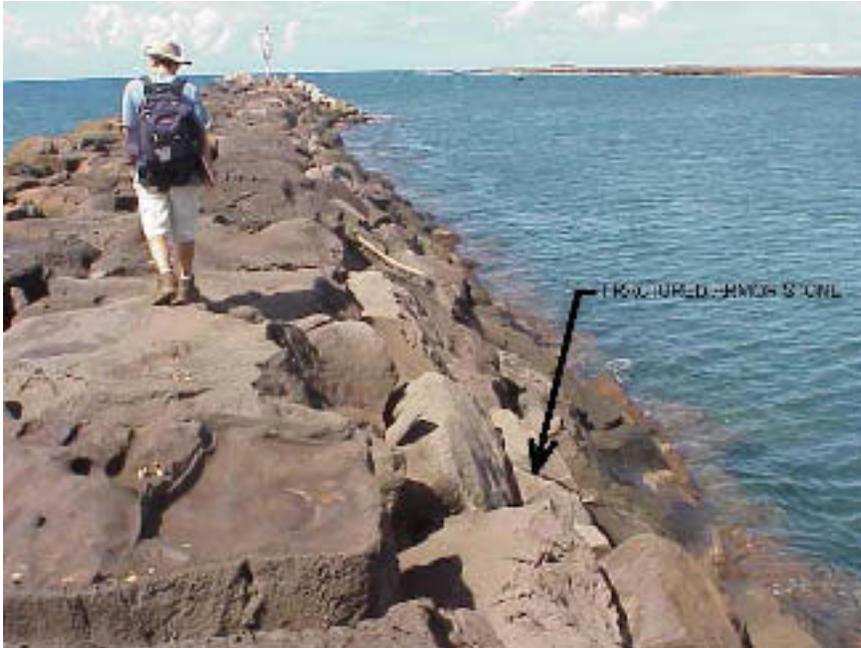
k. Sta. 2+30, HS,: fractured armor stone on sideslope.

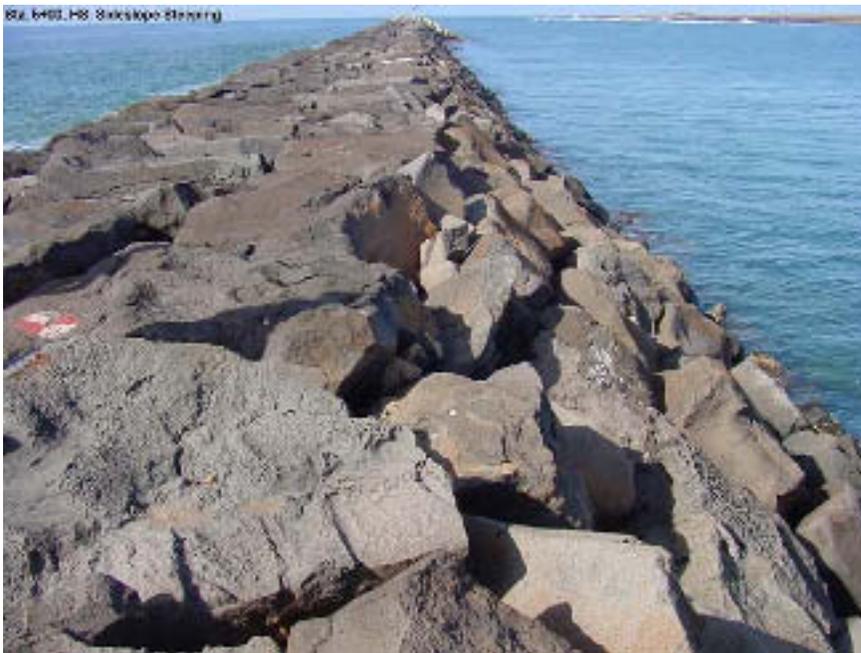
l. \*Sta. 5+00, HS, Sideslope steepening, minor separation at the crest/sideslope hinge.

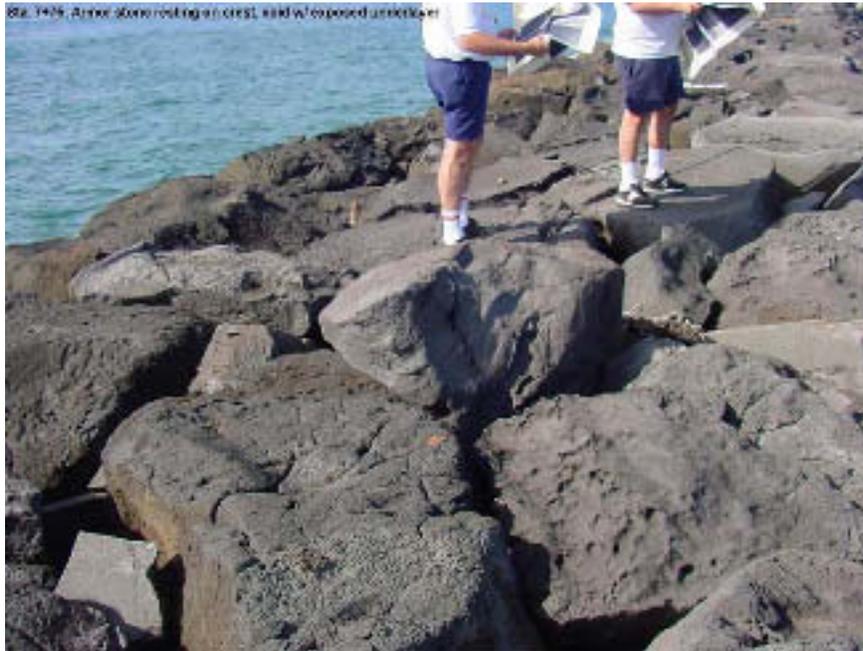
p. \*Sta. 7+75, Armor stone resting on crest, small adj. void.

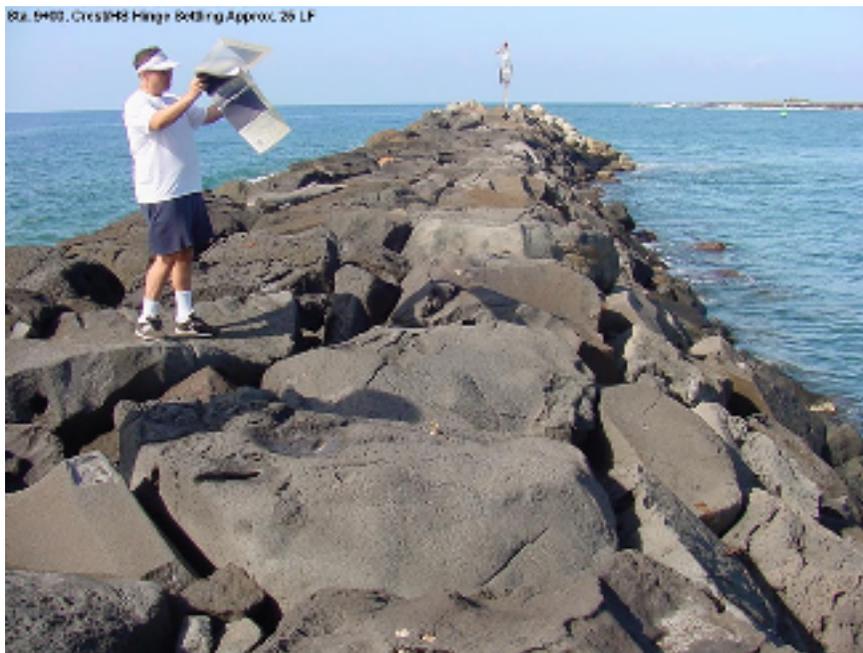
q. \*Sta. 9+00, Crest, 25LF settling of armor stone, minor separation at crest/sideslope hinge.

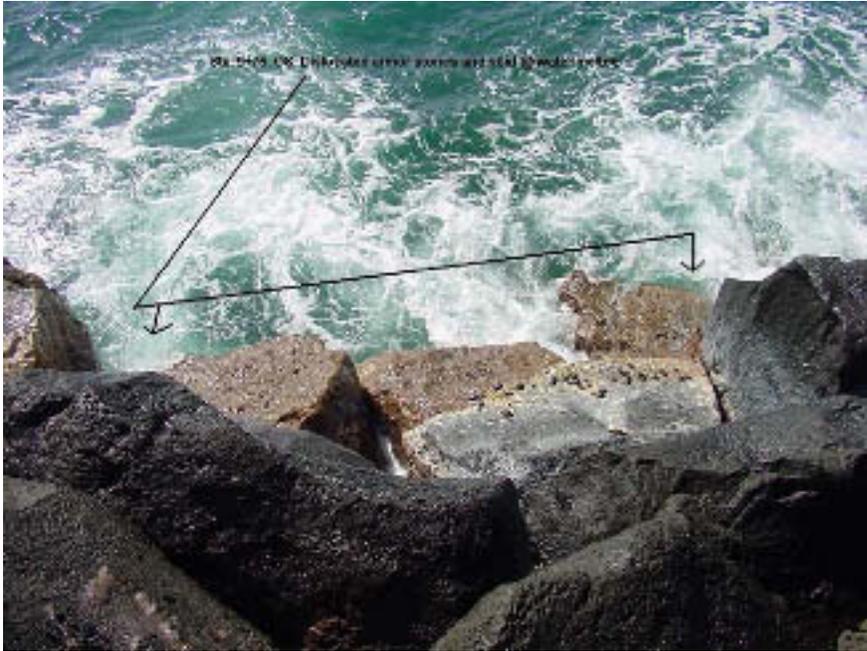
r. \*Sta. 9+78, OS, Voids at waterline approx. 5' x 5'.

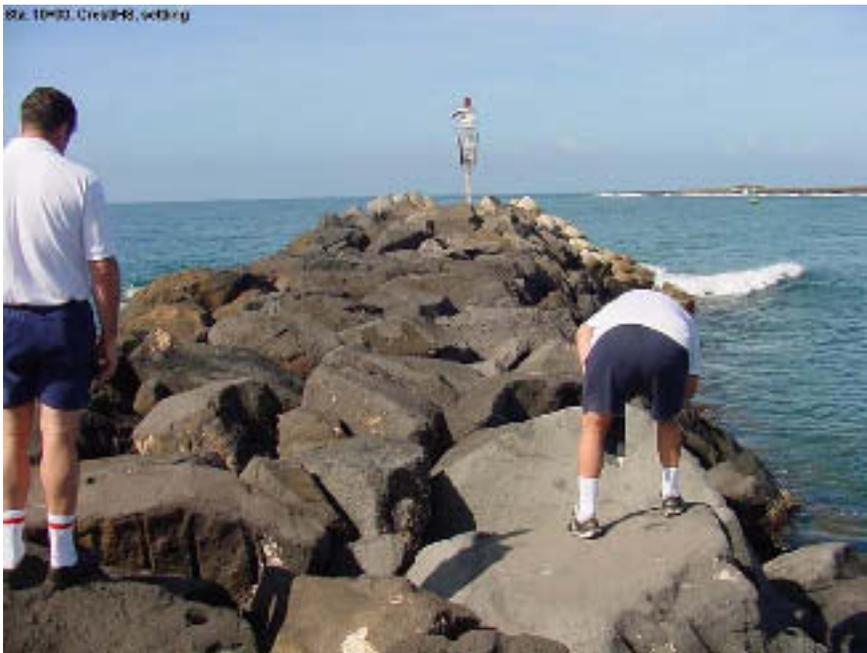
s. \*Sta. 10+00, Crest 25LF settling of armor stone.

u. \*Sta. 10+00, OS, Dislocated armor stones @ waterline/toe, voids and sideslope settling.

Continue to monitor root section and Sta. 10+00 depression/sideslope movement.

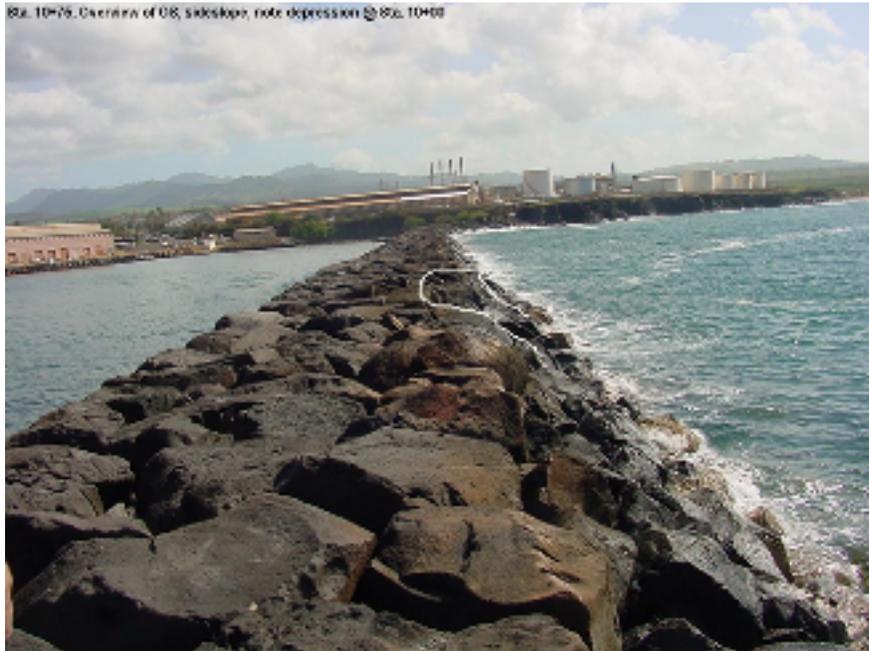
v. \*Sta. 10+00, OS, Overview.

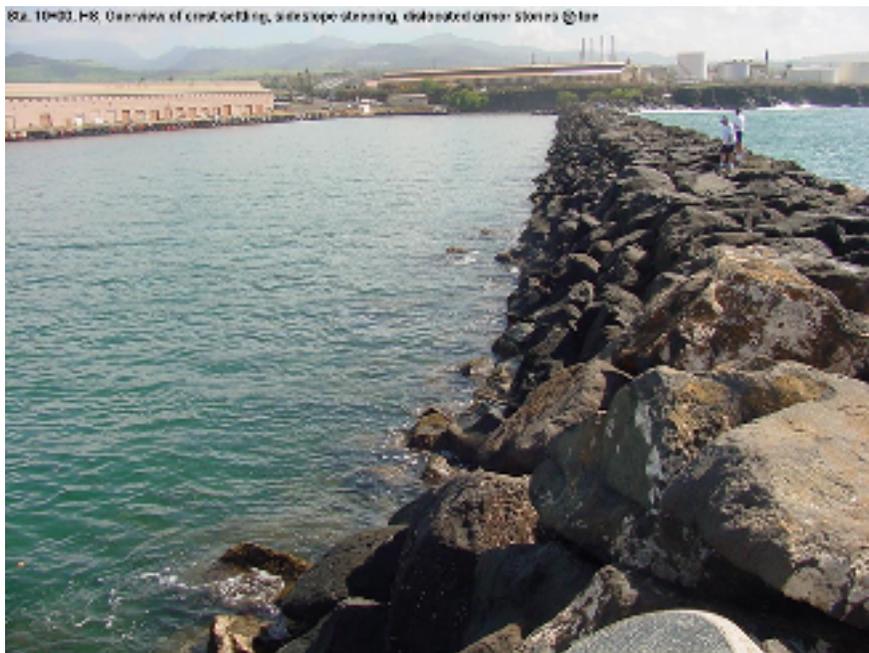
W. \*Sta. 10+00, HS, Overview

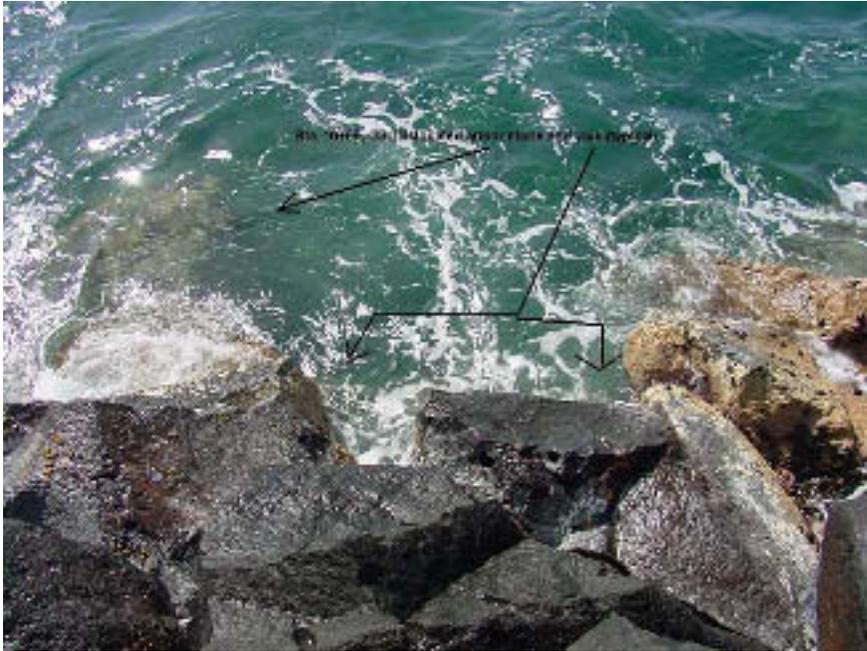
Y. \*Sta. 10+69 (area), OS, Dislocated armor stones @ waterline/toe, voids.
