CONTINUING ELIGIBILITY INSPECTION (CEI) REPORT
FOR HURRICANE & SHORE PROTECTION PROJECTS
Honolulu Engineer District
CEPOH-EC-T

1. Project Name: Vatia Shore Protection Project
2. Date of Inspection: April 13, 2004
3. Inspection Personnel:

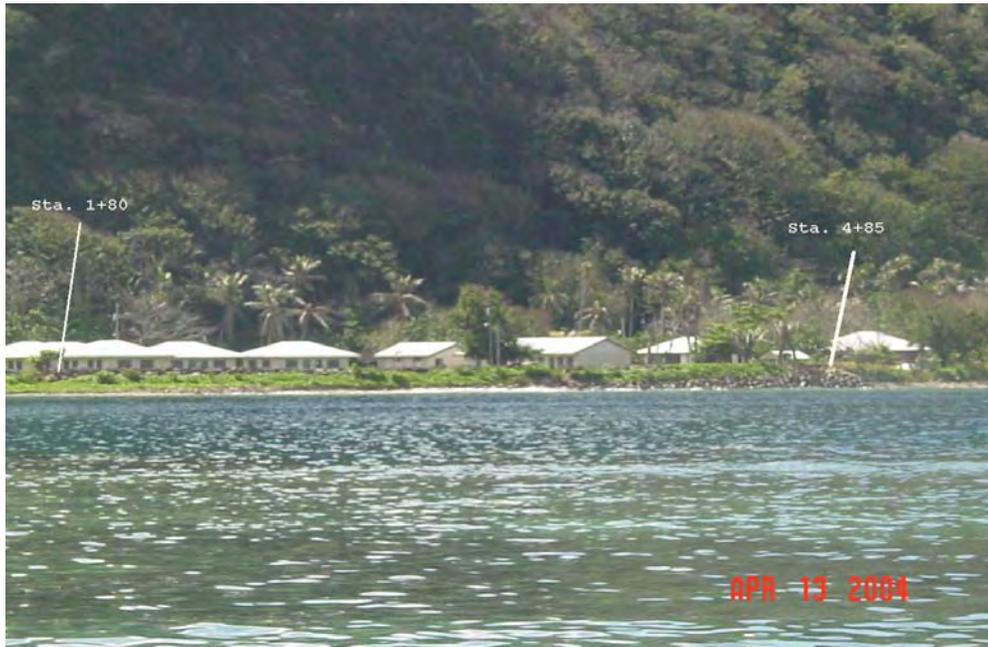
Overview of Vatia SPP

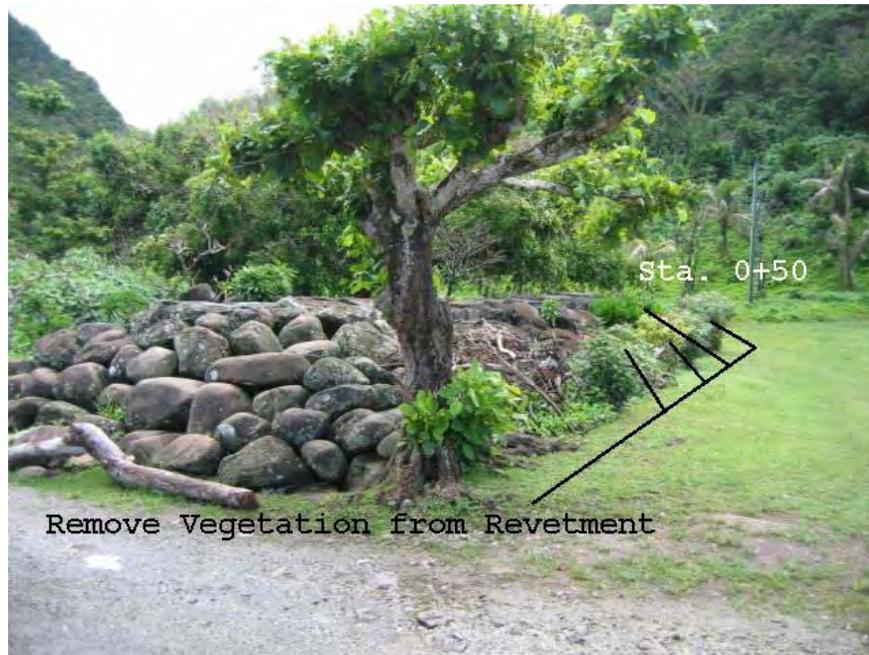
- a. Sta. 0+50 Interior tieback, remove vegetation growing among interior toe stones.

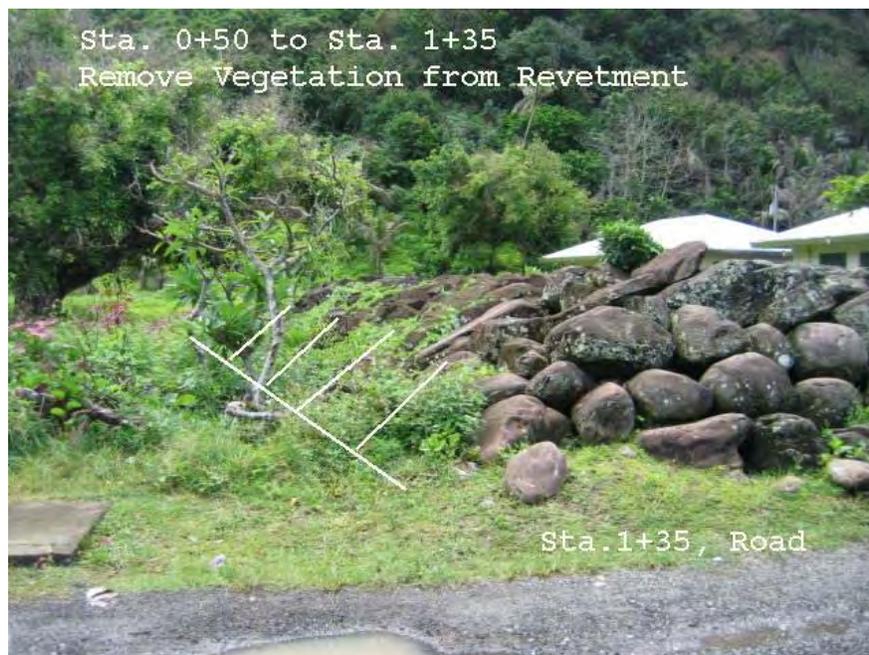
- b. Sta. 0+50 - 1+35, Remove vegetation that covers structure.
- c. Sta. 2+10 a 15', The coral road through the revetment is OK.

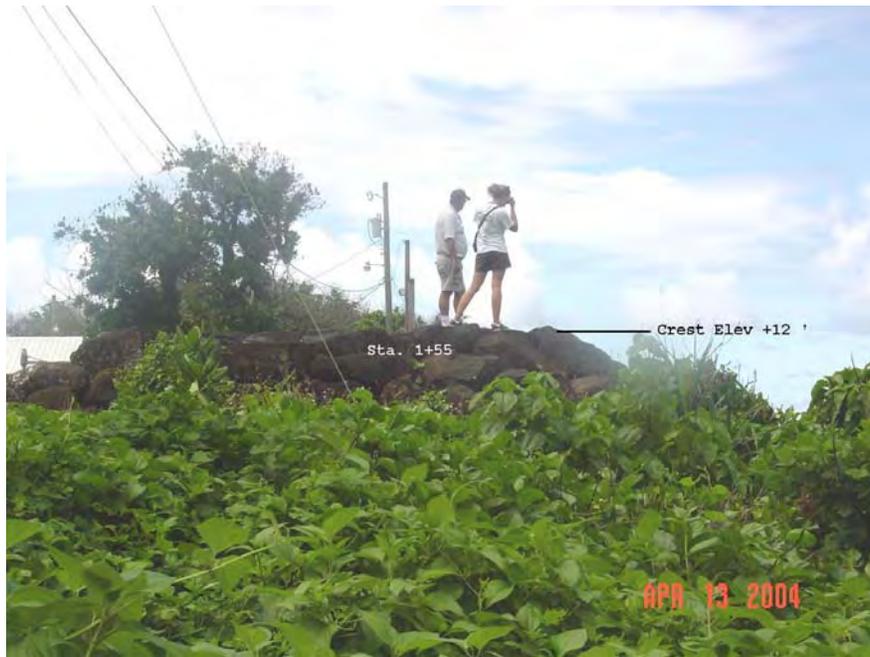
d. Sta. 1+55, Structure not visible from +10' to toe of revetment.

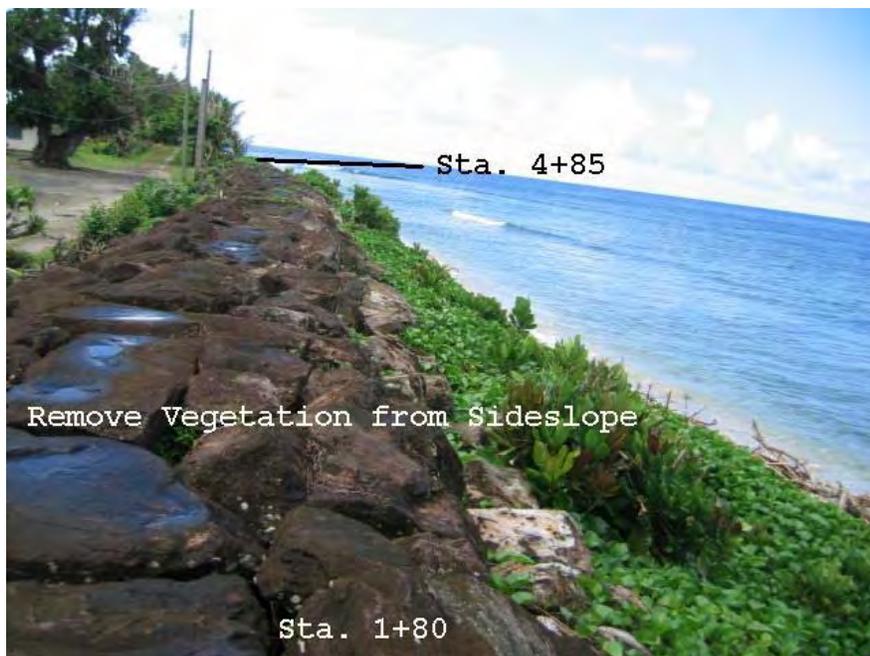
e. Sta. 1+80 - Sta. 4+85, Structure not visible from +10' to toe of revetment at numerous locations.

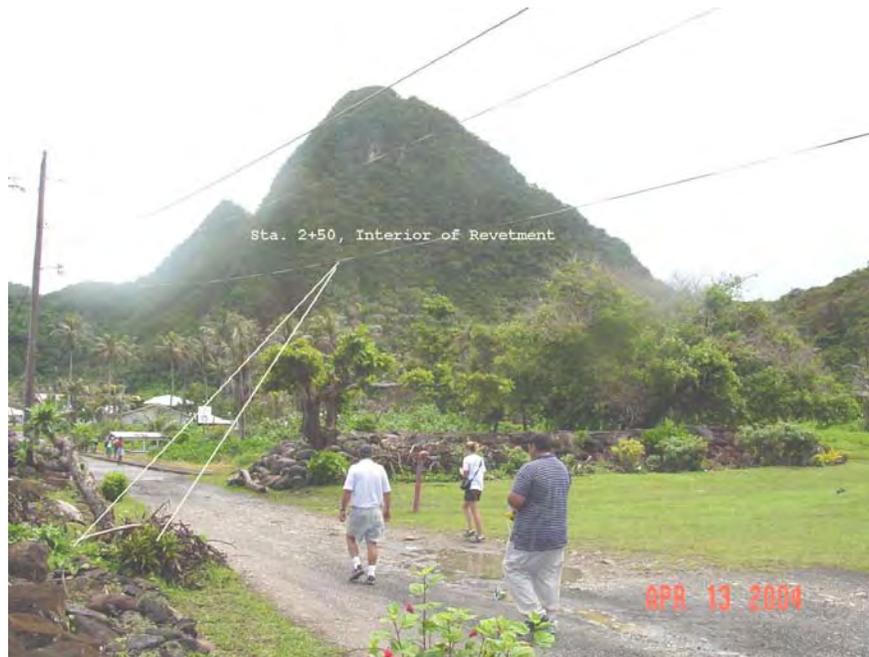
f. Sta. 2+50, interior-side, remove debris and vegetation.

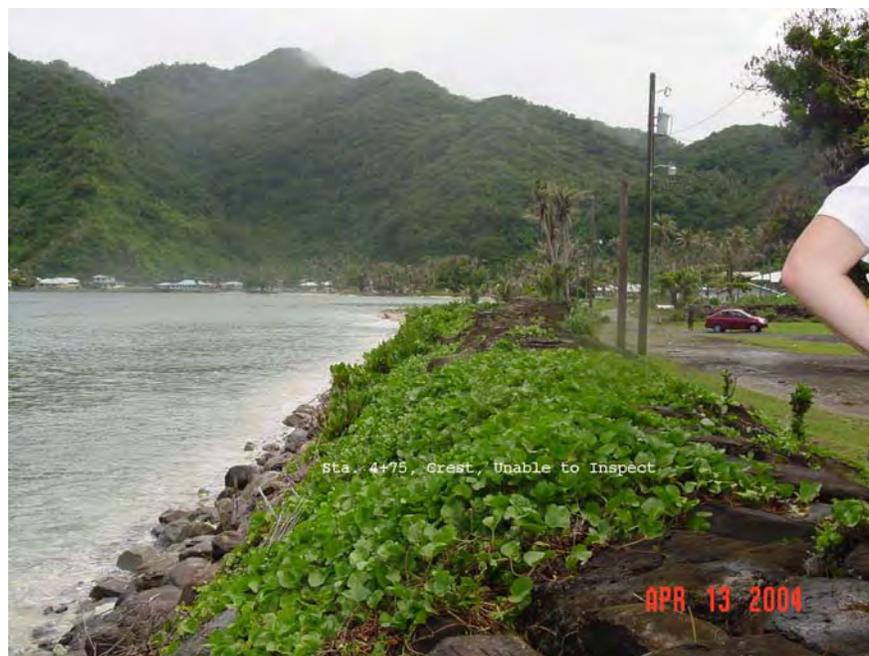
g. Sta. 4+75, Unable to inspect crest due to vegetation.

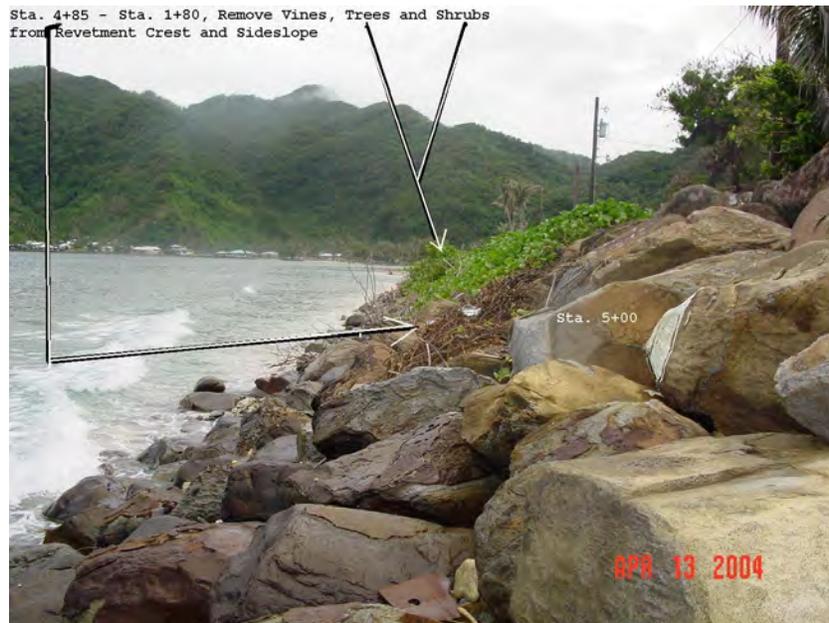
- h. Sta. 5+00, Visible for approx. 20'.
(The entire structure should be like this)

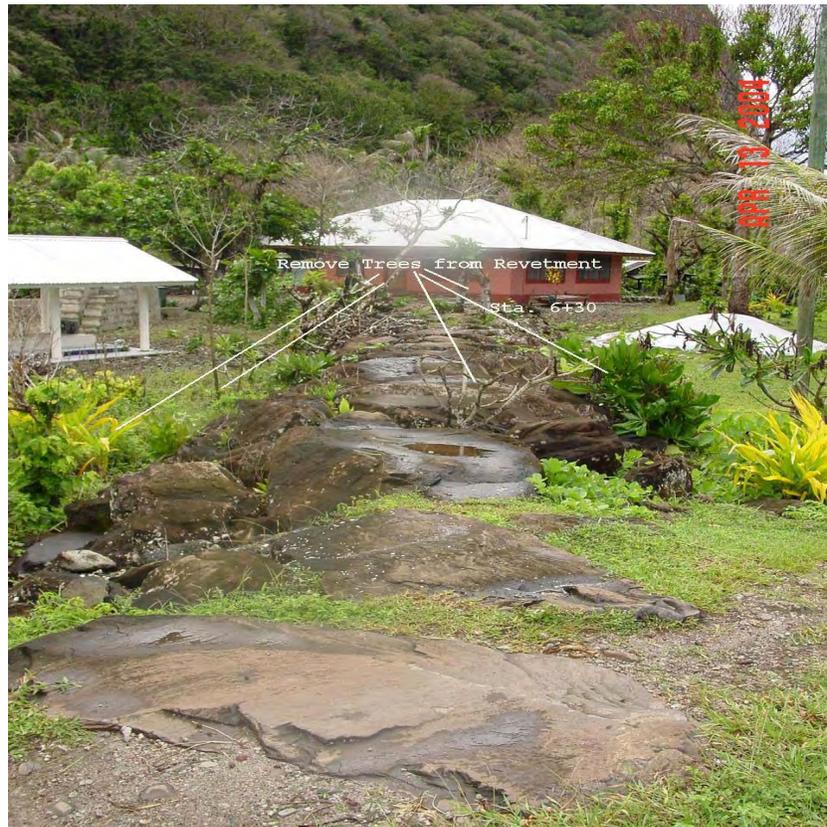
- i. Sta. 5+00 - Sta. 6+30, Remove vegetation.
