**OPERATIONS AND MAINTENANCE REPORT**  
**FOR NAVIGATION PROJECTS**  
**Honolulu Engineer District**  
**CEPOH-EC-T**

1. Project Name: KALAUPAPA HARBOR

2. Date of Inspection: October 16, 2003

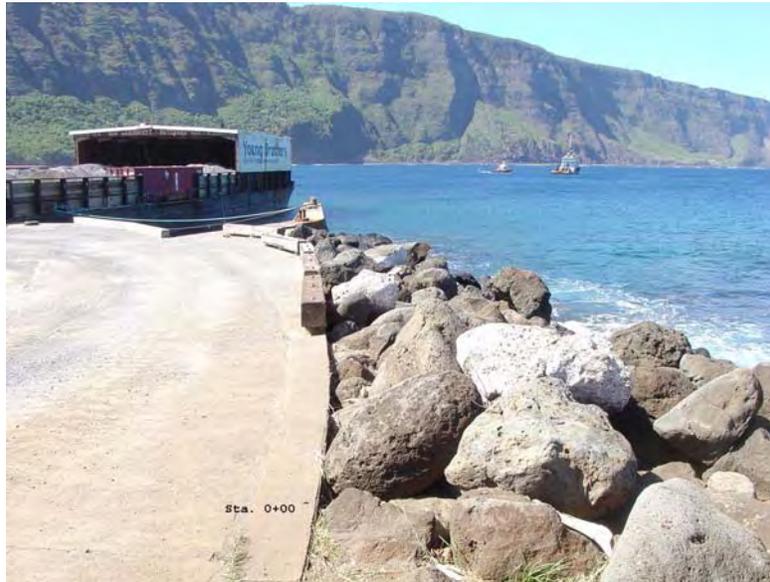
a. Sta. 0+00, Oceanside (OS), overview.

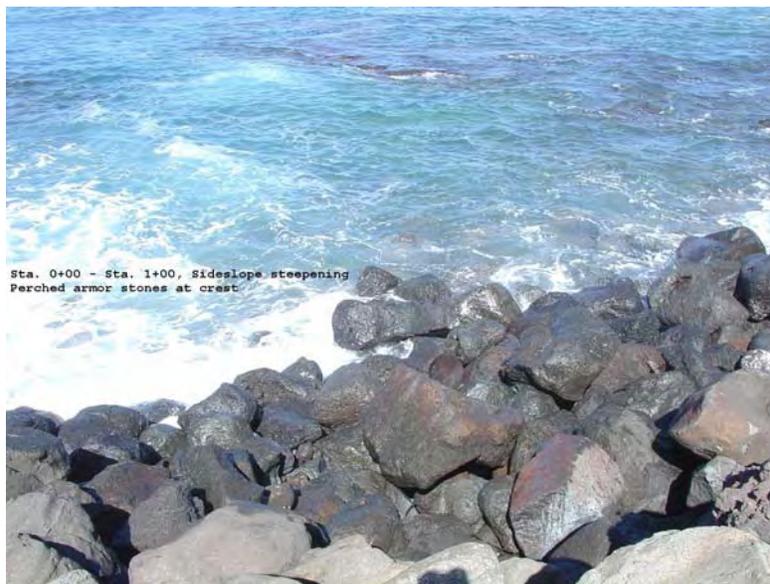
b. Sta. 0+00 to Sta. 1+00, several perched and placed armor stones resting on the top of the sideslope.

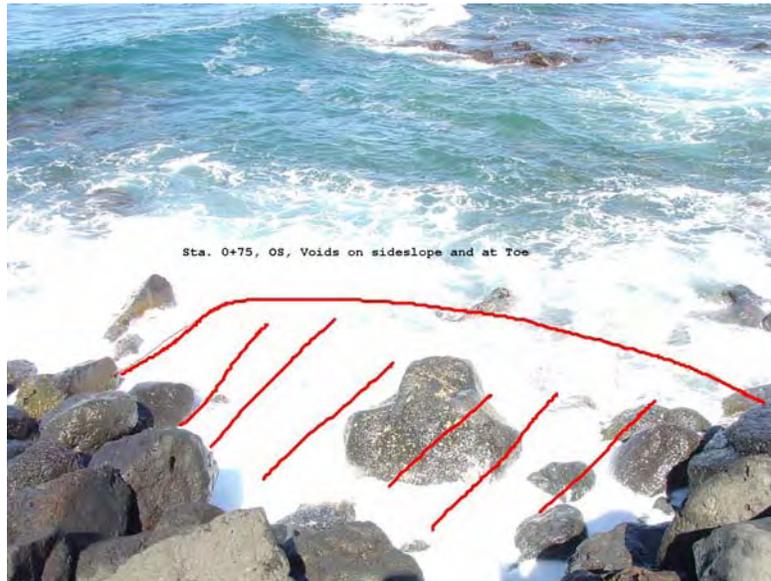
c. Sta. 0+75, sideslope failure, oceanside (OS), 20' l x 10' W x 6' D, underlayer & some core material exposed, one large armor stone perched.

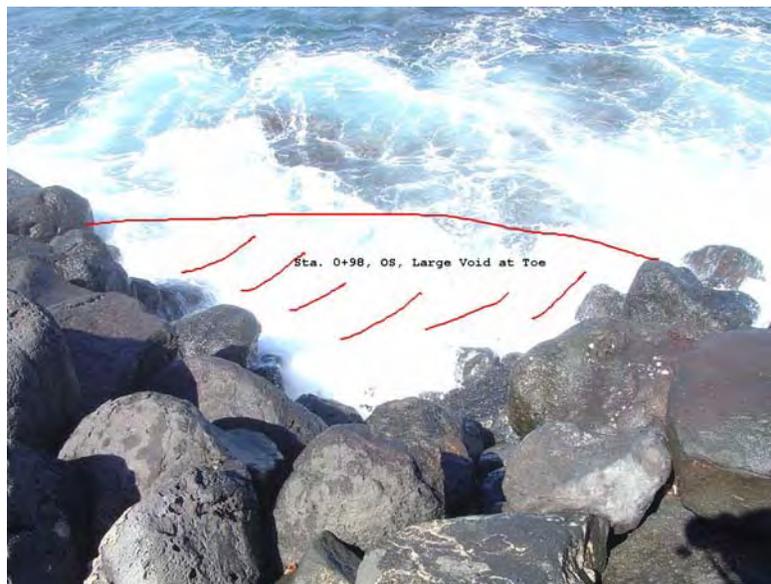
d. Sta. 0+98, OS, missing armor stones and sideslope steepening.

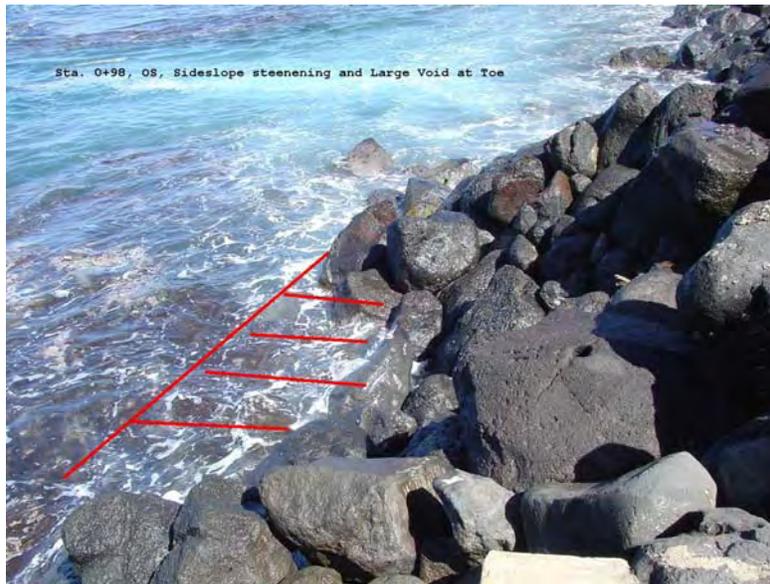
e. Same as above, Sta. 0+98, OS, missing armor stones and sideslope steepening, photo taken from top of sideslope to toe.

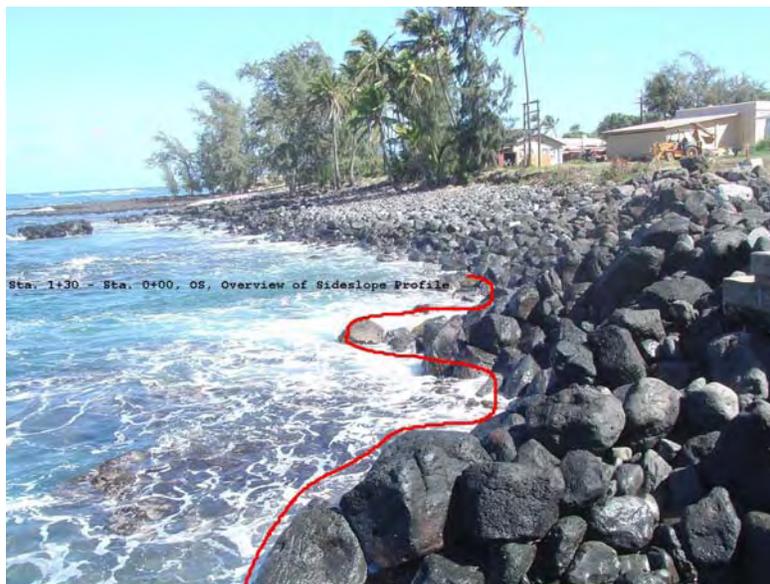
f. Sta. 1+30 to Sta. 0+00, OS, sideslope overview.

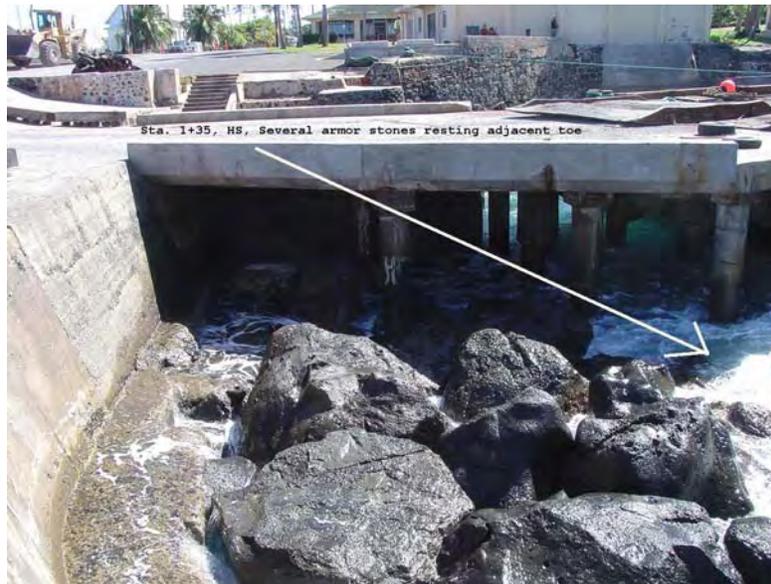
g. Sta. 1+35, Harborside (HS), several armor stones resting adjacent the toe. (Possibly from Sta. 1+98, HS head area).

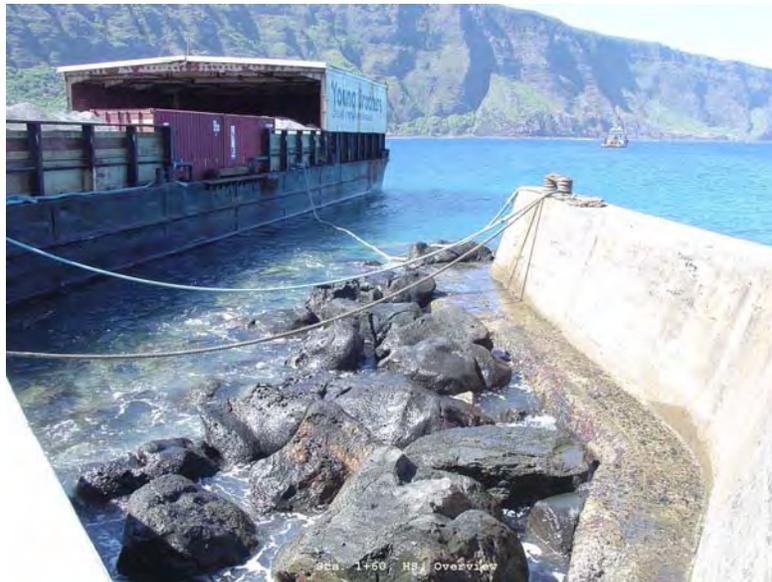
h. Sta. 1+60, HS, overview of armor stones.

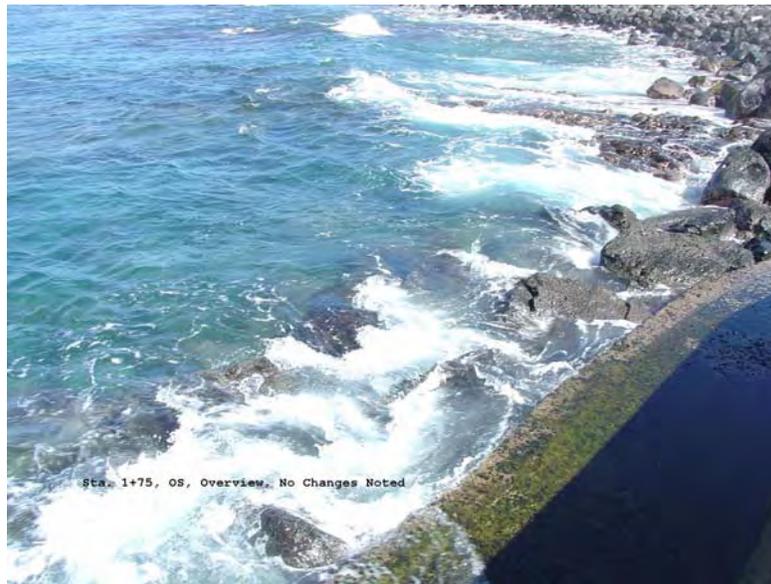
i. Sta. 1+75, OS, overview of armor stones.

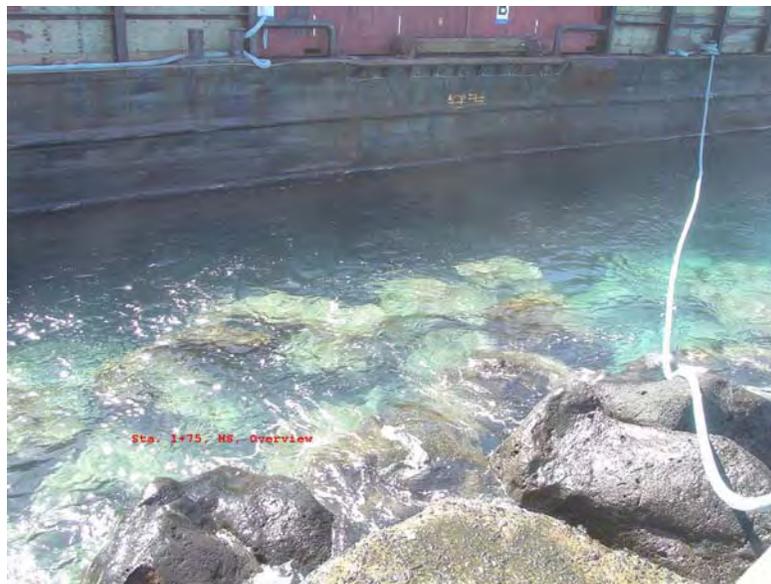
j. Sta. 1+75, HS, Perched armor stone.

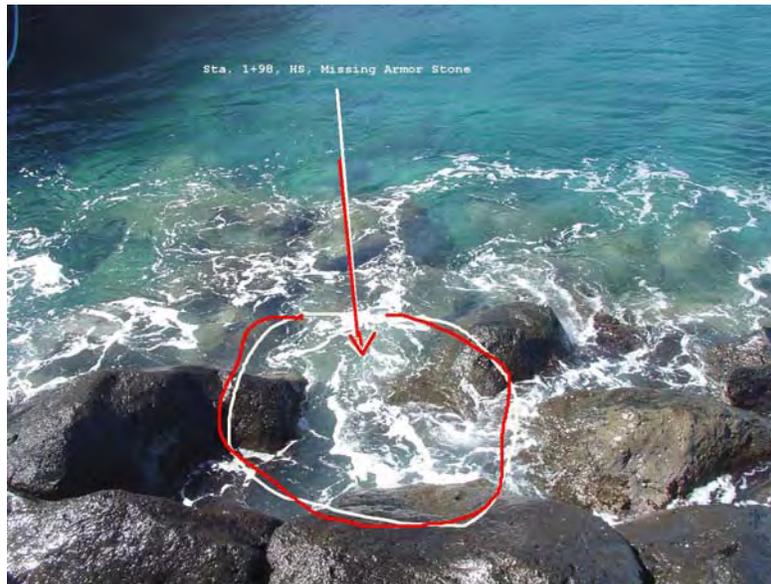
k. Sta. 1+98, HS, missing armor stones from top layer.

The overall rating of the project is **FAIR**. There are indications of armor stone movement at the breakwater's root, trunk areas on the oceanside of the structure and additional armor stone displacement observed at the harborside head area.

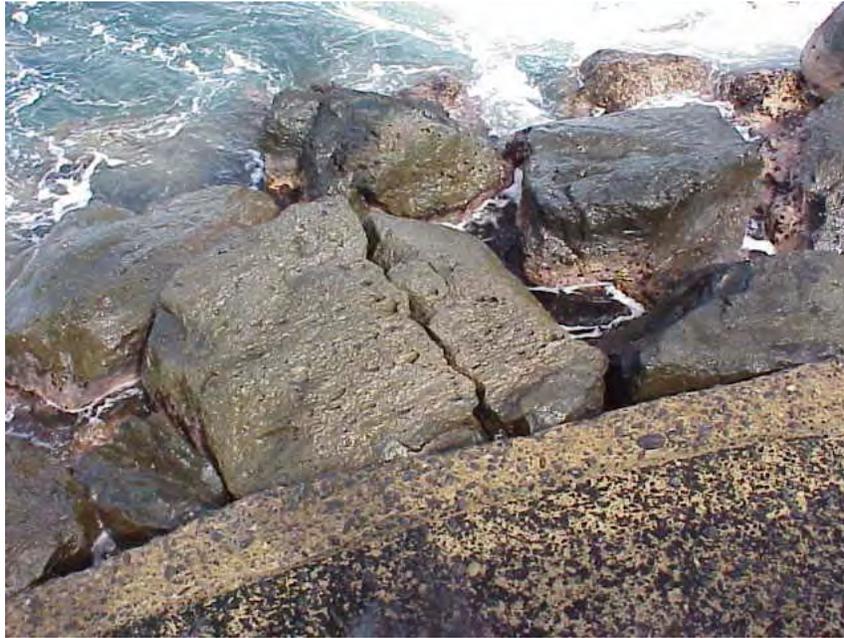
2000 Photo - Sta. 1+56, OS, 1 cracked in-place armor stone.

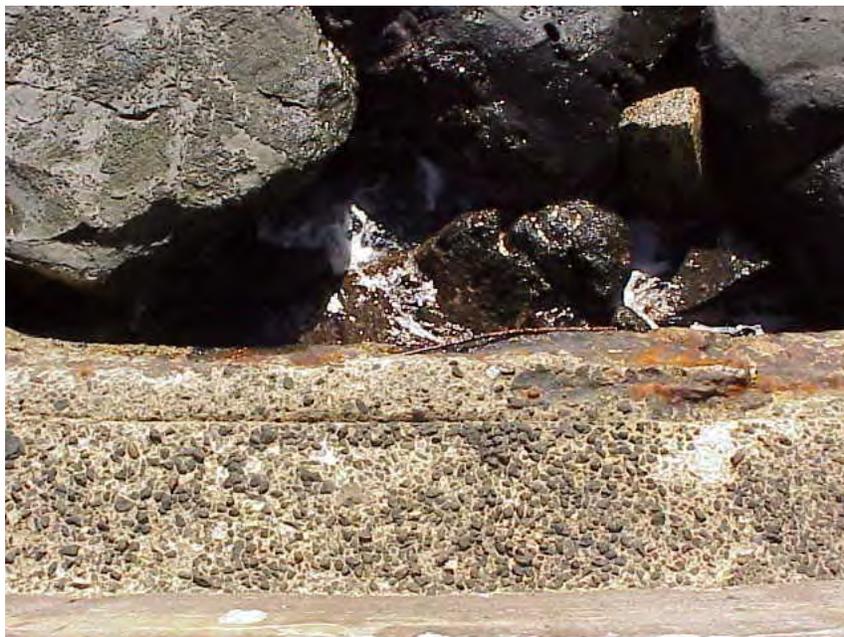
2000 Photo - Sta. 1+70, HS, concrete spalling and rust noted at footing of breakwall.

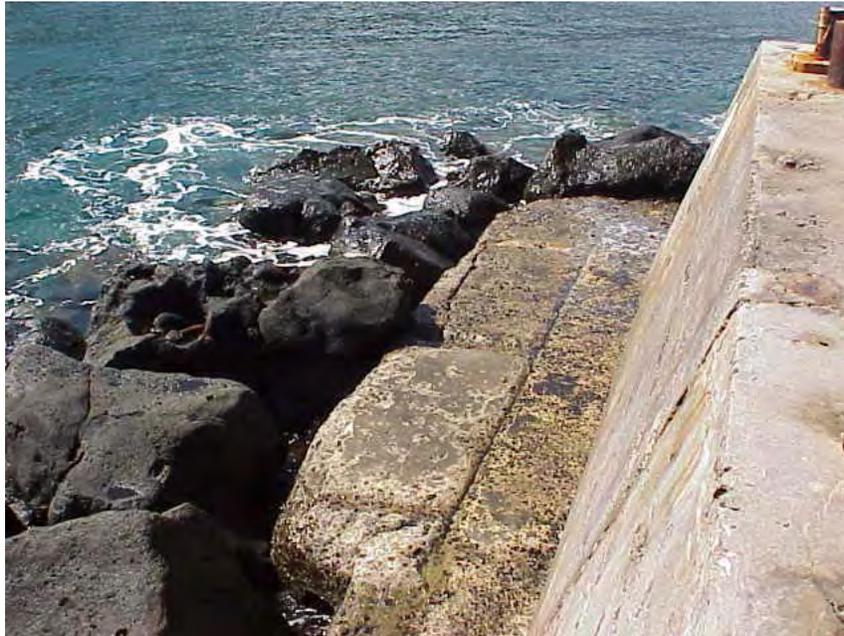
2000 Photo - Sta. 1+90, HS, concrete spalling and rust noted at footing of breakwall.

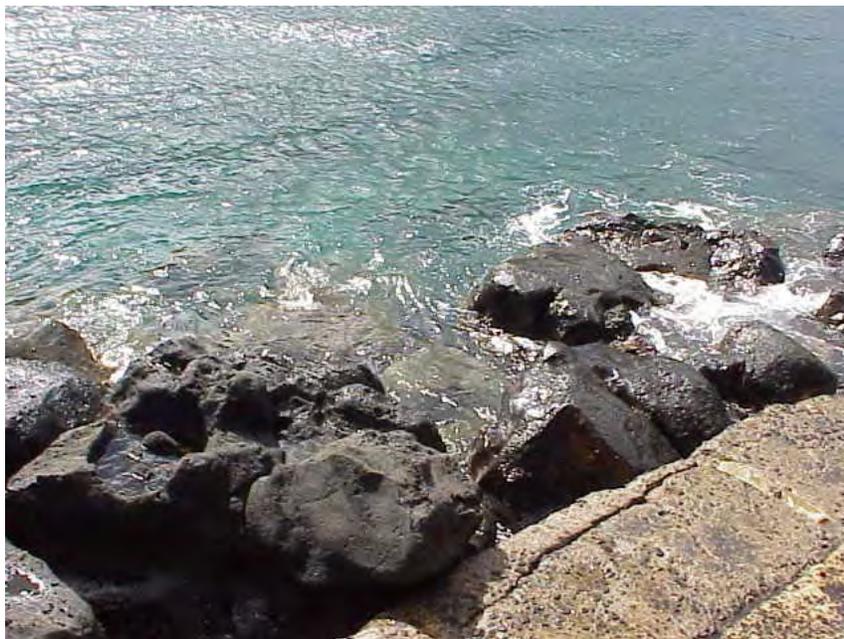
2000 Photo - Sta. 1+95, HS, 1 armor stone dislodged, void, at the crest on the hinge.
