**O & M INSPECTION REPORT
FOR NAVIGATION AND SHORE PROTECTION PROJECTS**

1. Project Name: Aunu'u SBH
2. Date of Inspection: March 11, 2005
3. Inspection Personnel:

AUNUU SMALL BOAT HARBOR, AMERICAN SAMOA

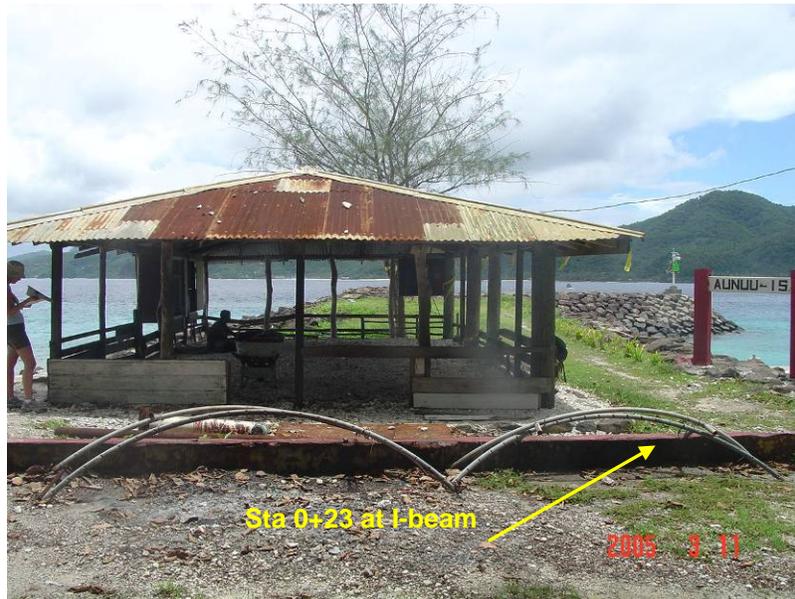
a. Sta. 0+23, Overview, Notice encroachments - Fale and sign. Station 0+23 is measured at the I-beam.

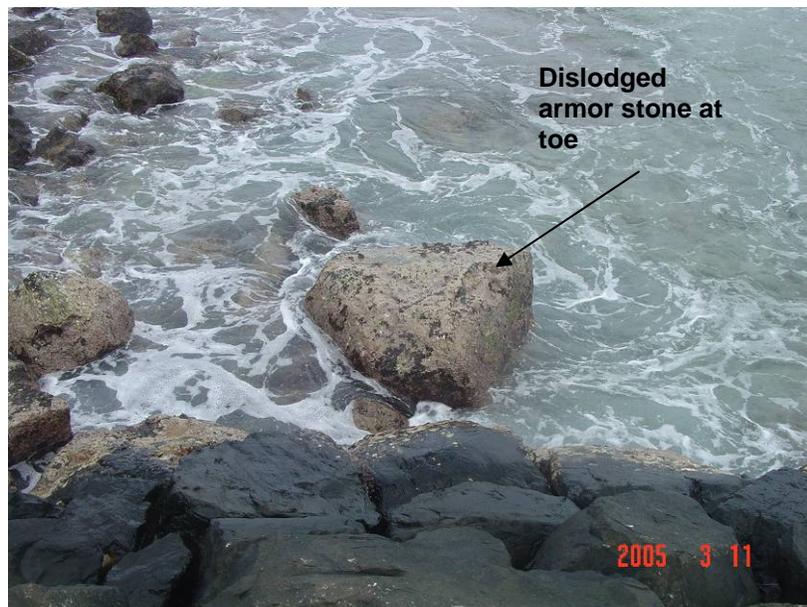
b. Sta. 1+00, OS, Monitor lea. Dislodged armor stone at the toe, no obvious void.

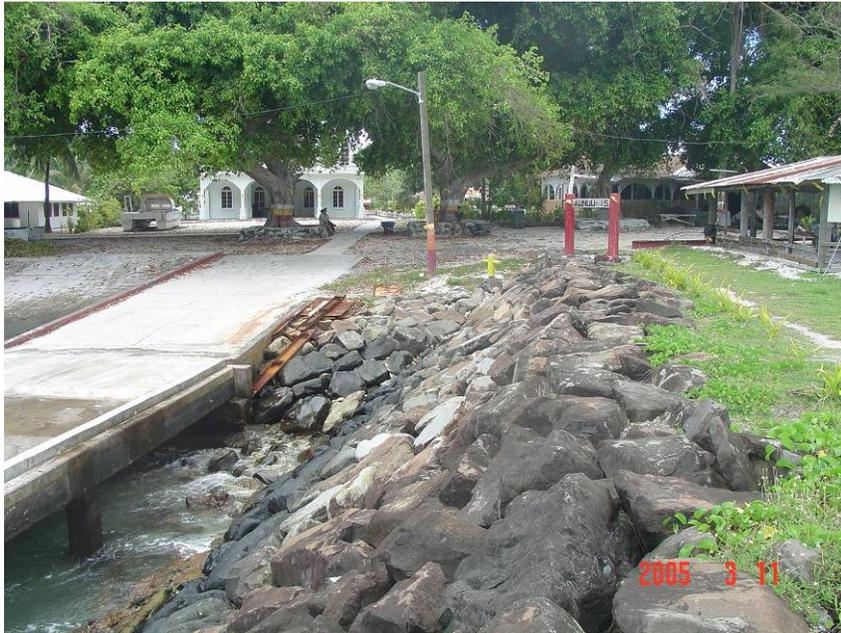
c. Sta. 1+00, HS, Overview of harborside root, no damage noted.

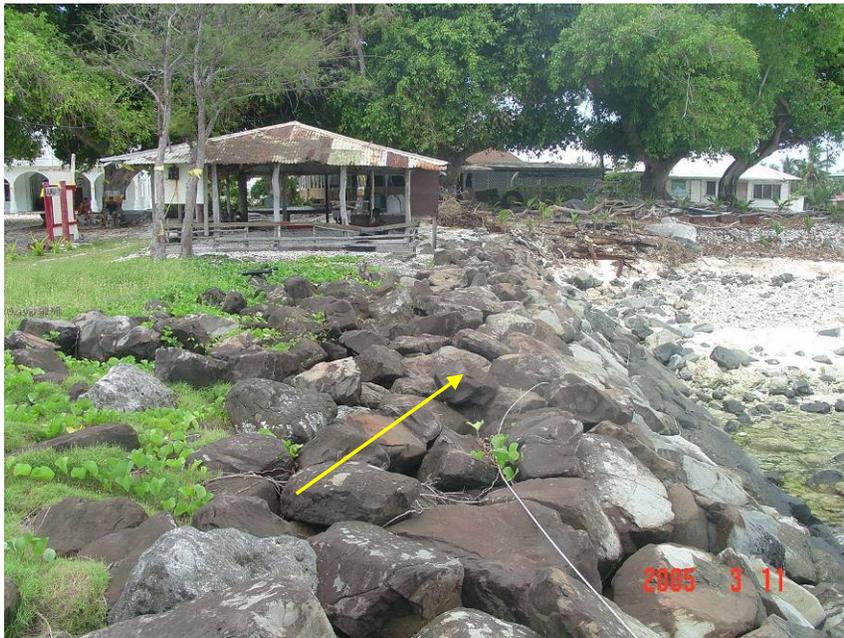
d. Sta. 1+23, OS, 1 ea. Irregular small stone on crest.

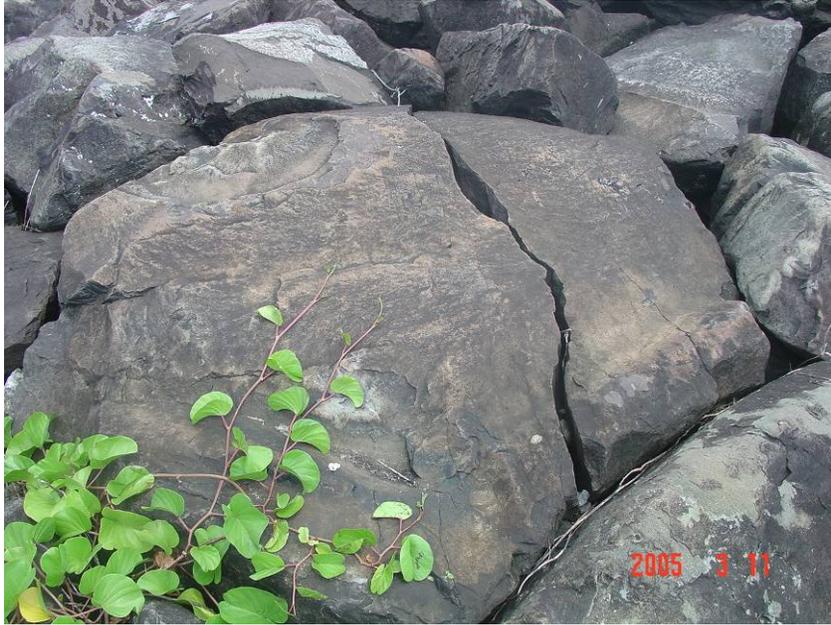
e. Sta. 1+82, HS, Cracked armor stone at crest.

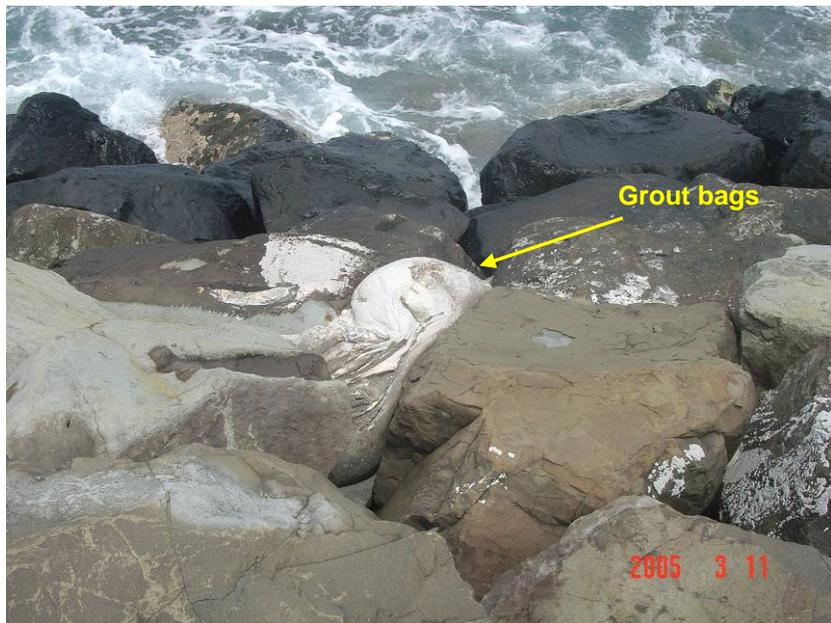
f. Sta 1+82, OS, 2 grout bags on oceanside slope.

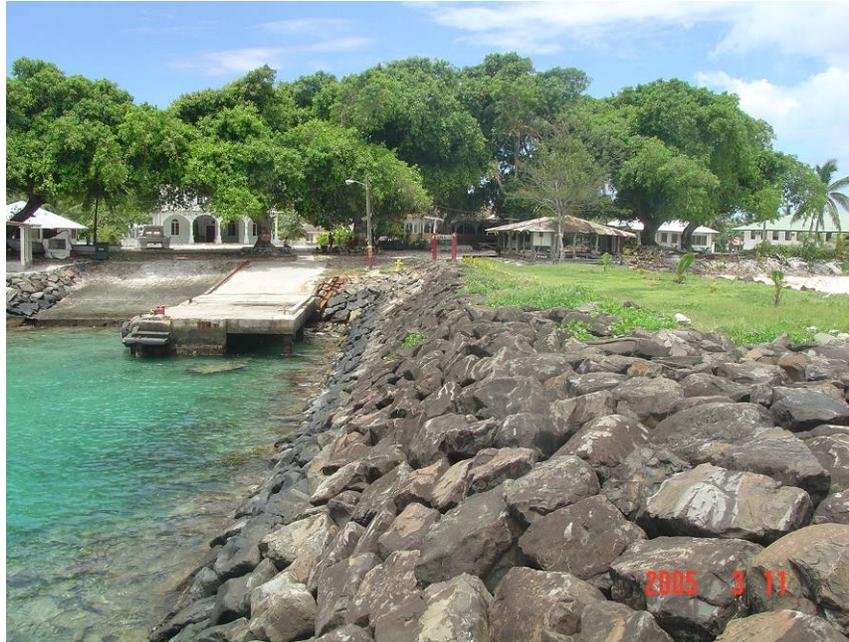
g. Overview of harborside of revetted mole from Sta 2+00.

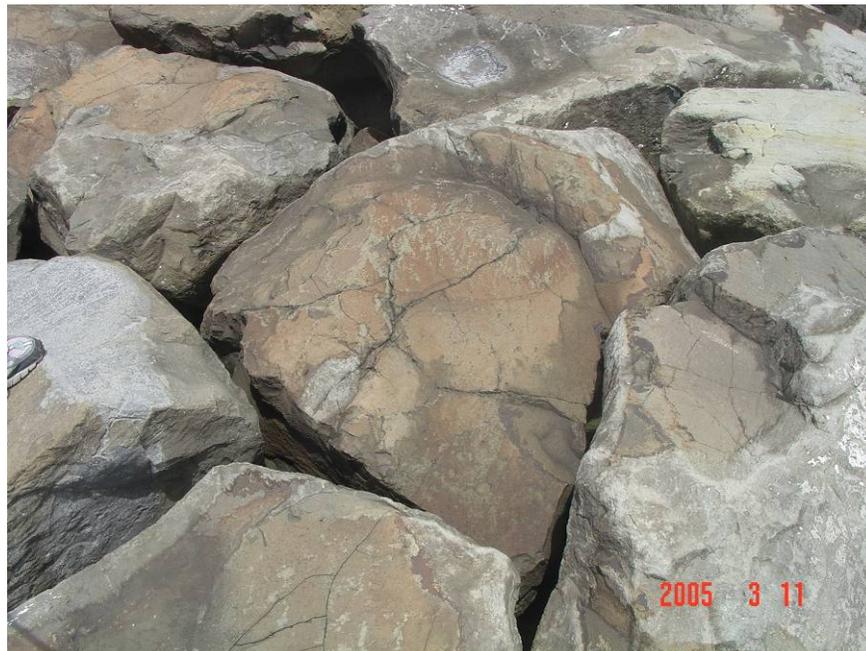
h. Photo of stone used as turning point between revetted mole and breakwater, approx. Sta. 2+12 of mole and Sta. 0+00 of breakwater.

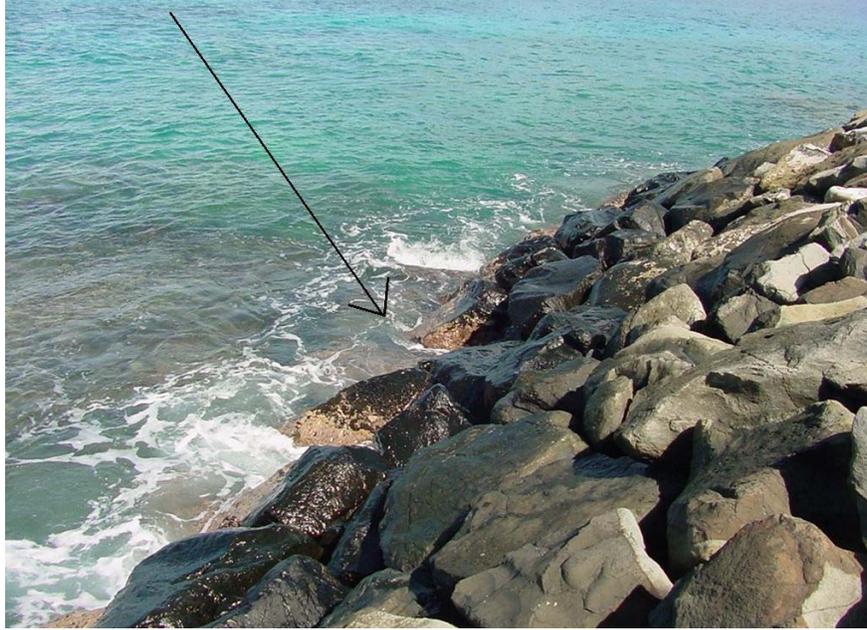
i. Sta. 0+10, OS, At high tide appears to be a void, but view at low tide shows no void, armor stones at toe are intact (2002 PHOTO).

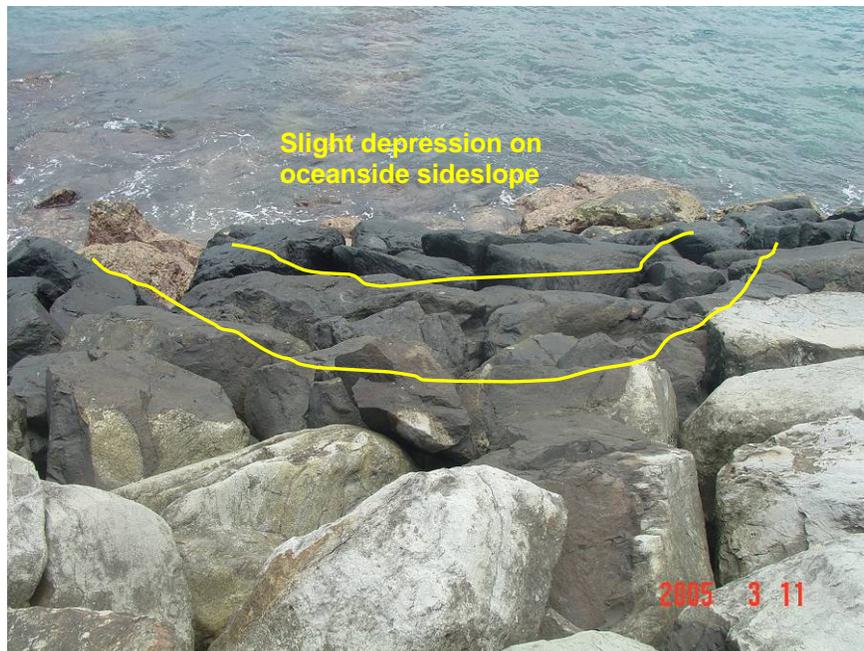
j. Sta. 0+22, OS Sideslope, Monitor slight depression 15' long x 10' wide.

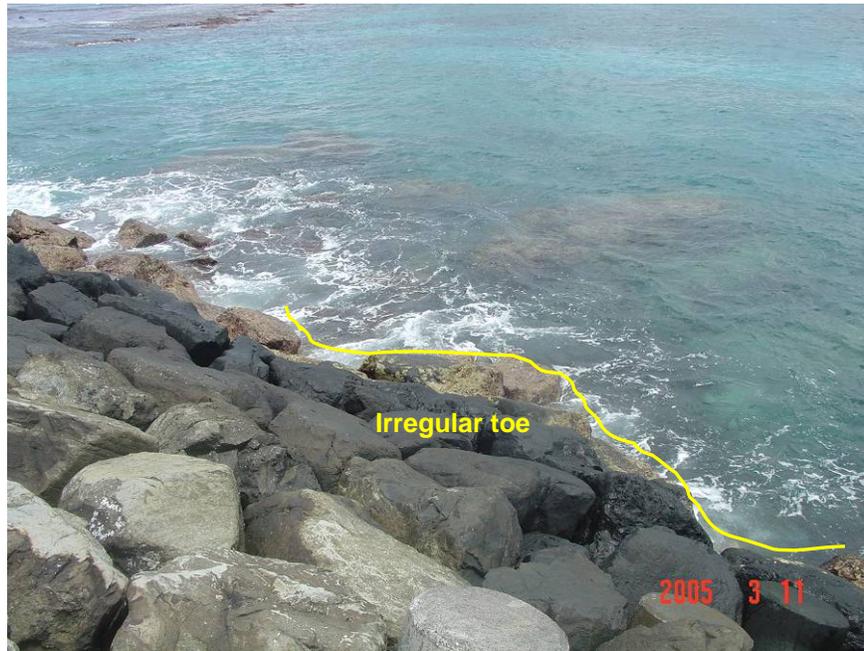
k. Sta. 0+20 to 0+48, OS, Monitor irregular toe including dislodged stones. Beginning of tribars at Sta. 0+48.

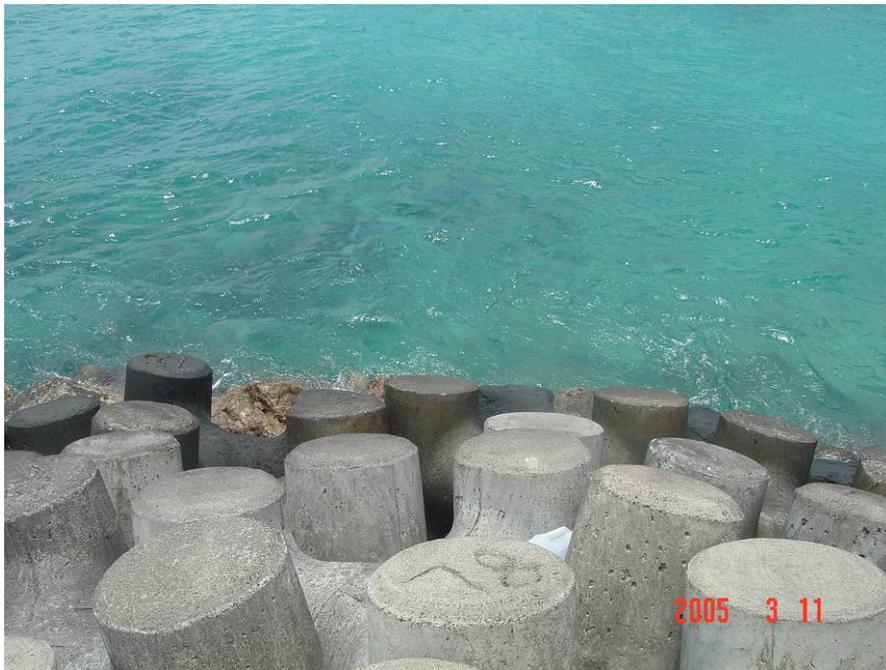
l. Sta. 0+90, Head of breakwater is in good condition, no deficiencies noted.

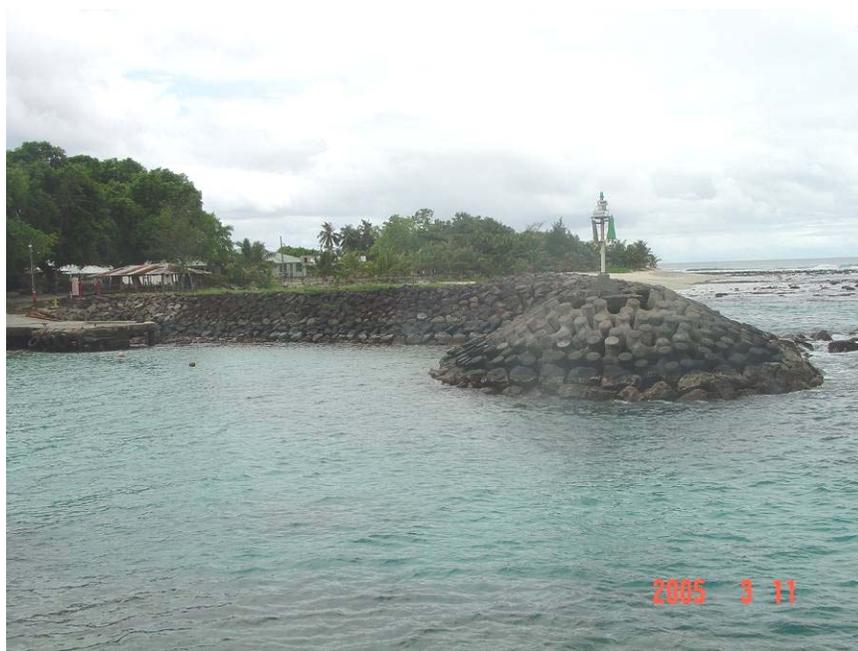
m. View of revetted mole and breakwater.

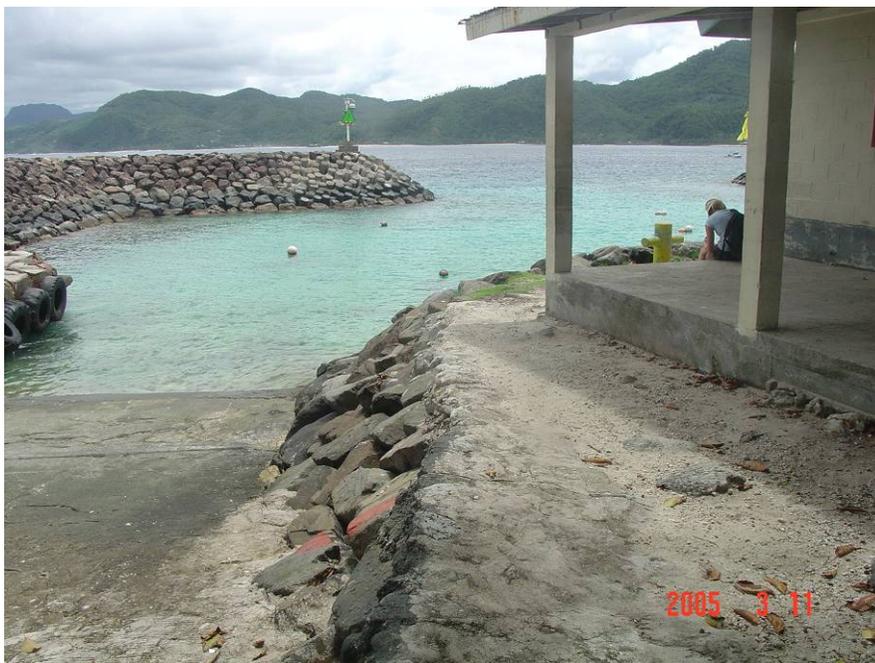
a. Sta. 0+00 to 0+50 of wave absorber adjacent to boat ramp, with interior of south revetted mole and breakwater in the background.

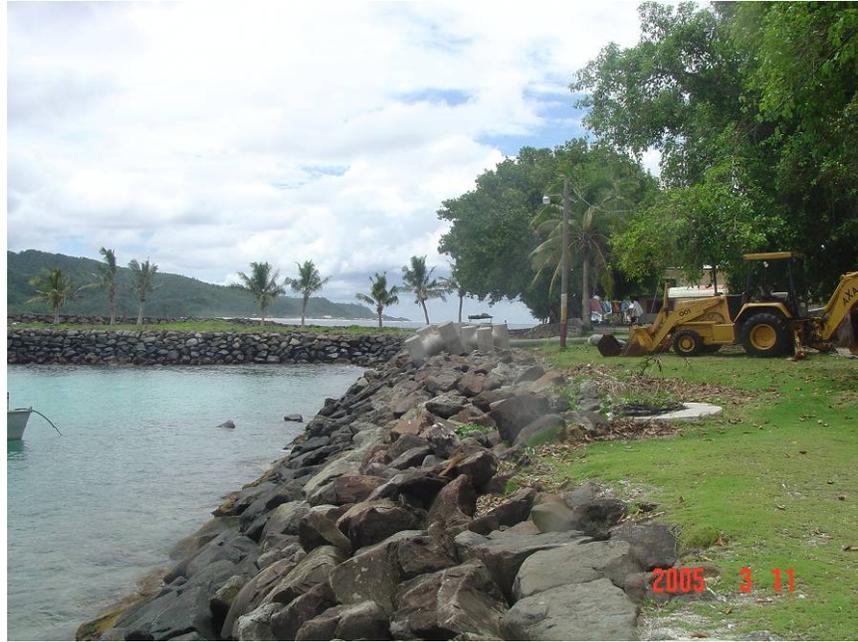
b. Sta. 0+50 to 2+00, crest is erratic with displaced armor stones and poor contact of armor stones.

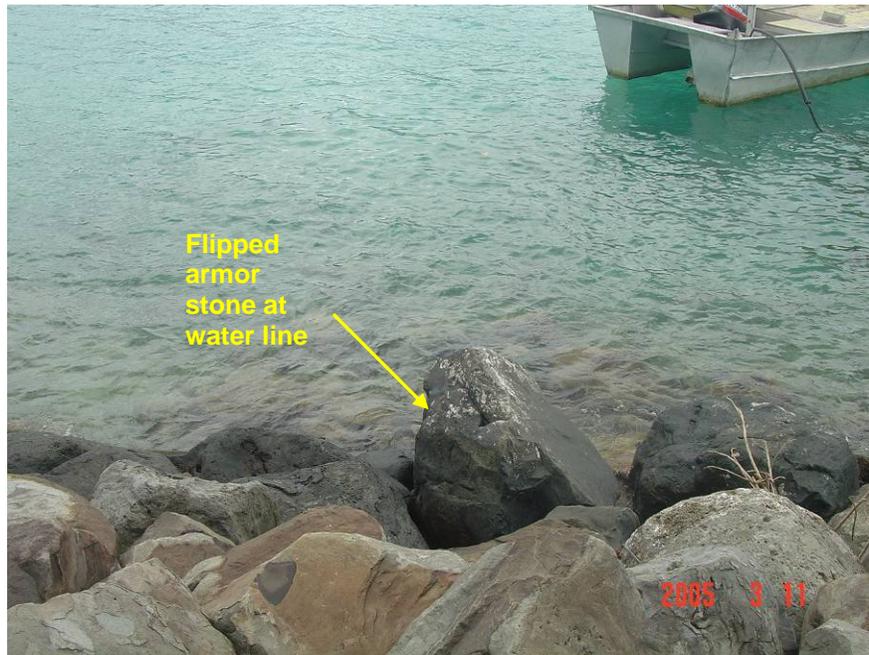
c. Sta. 0+77, Monitor sideslope depression, flipped armor stone at water line.

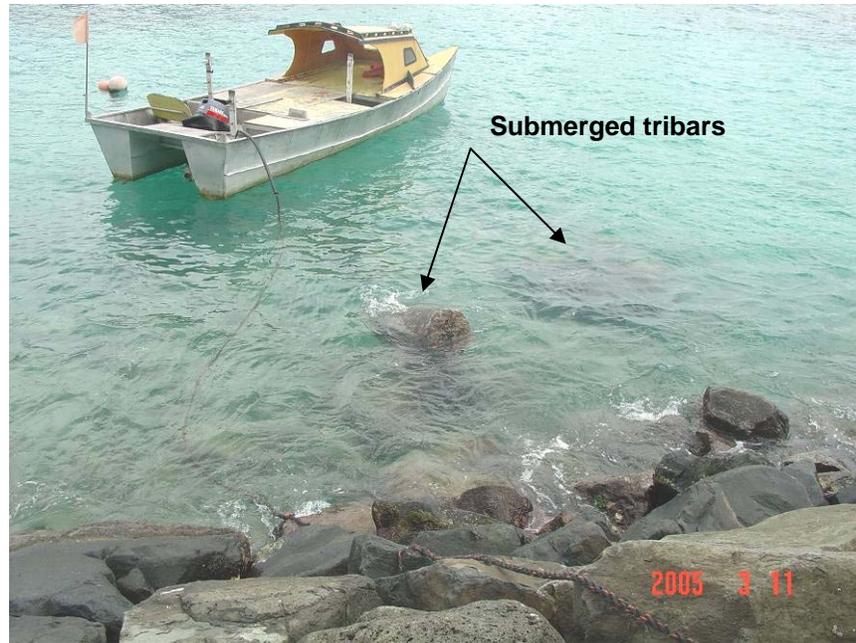
d. Sta. 1+02, 2 tribars underwater, first noted this inspection, monitor the location of tribars in future inspections.

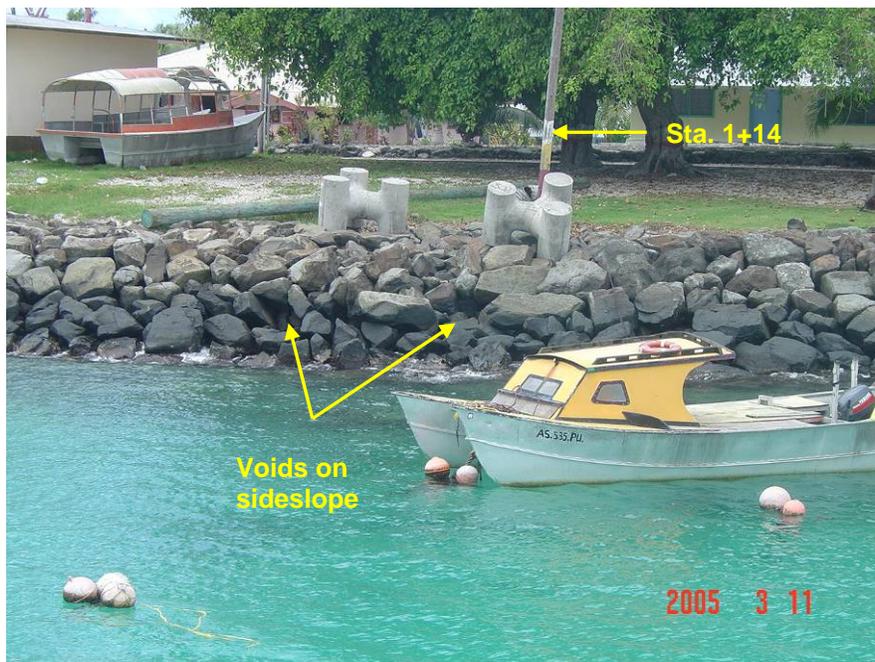
e. Sta. 1+14, Telephone pole at Sta. 1+14 for reference, and voids on sideslope at 1+12 and 1+15, between first 2 tribars resting on structure crest used as moorings.

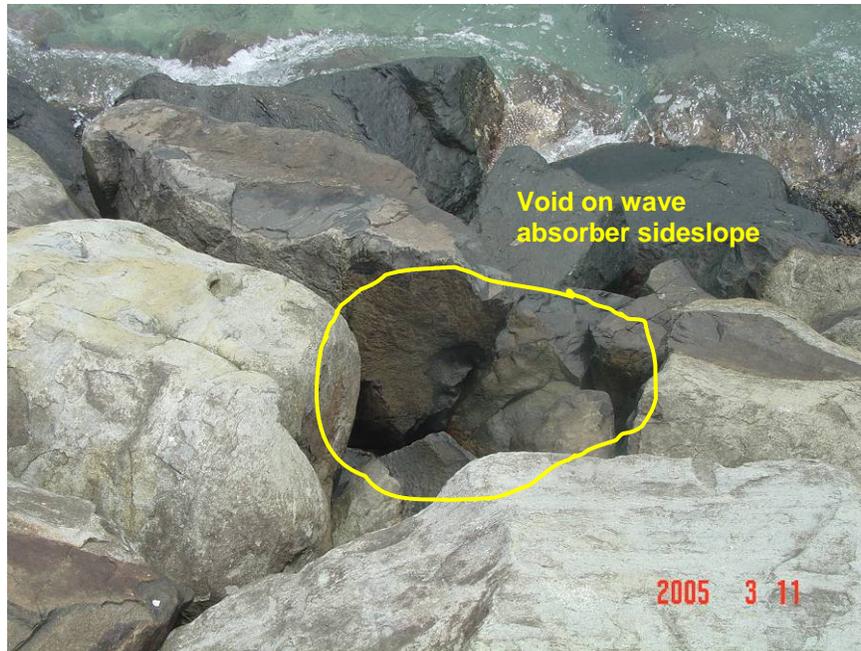
f. Sta. 1+49, Void on sideslope with underlayer exposed, no dislodged stones visible.

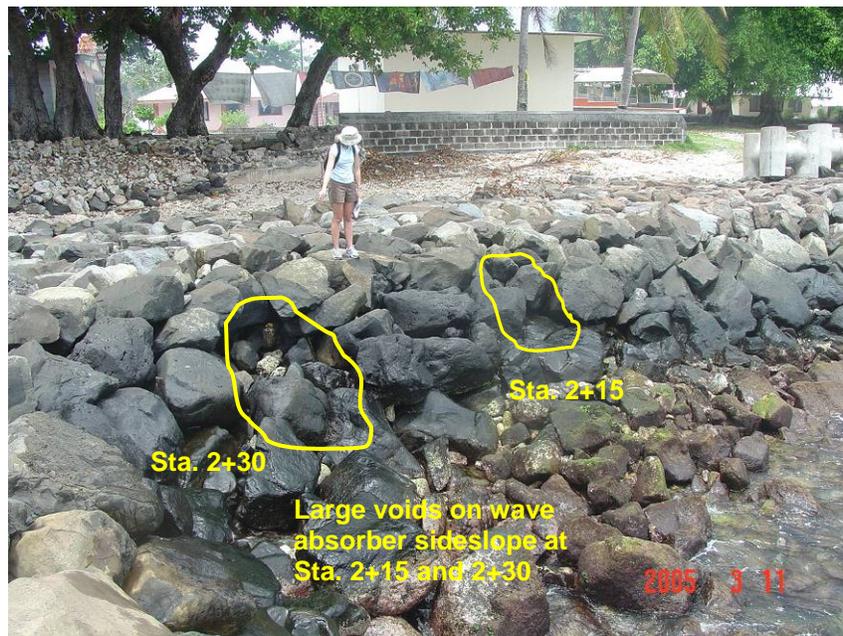
g. Sta. 2+15 to 2+30, Monitor changes @ 10' diameter x 5' deep void, and 4'x4' void on the sideslope, UL exposed.

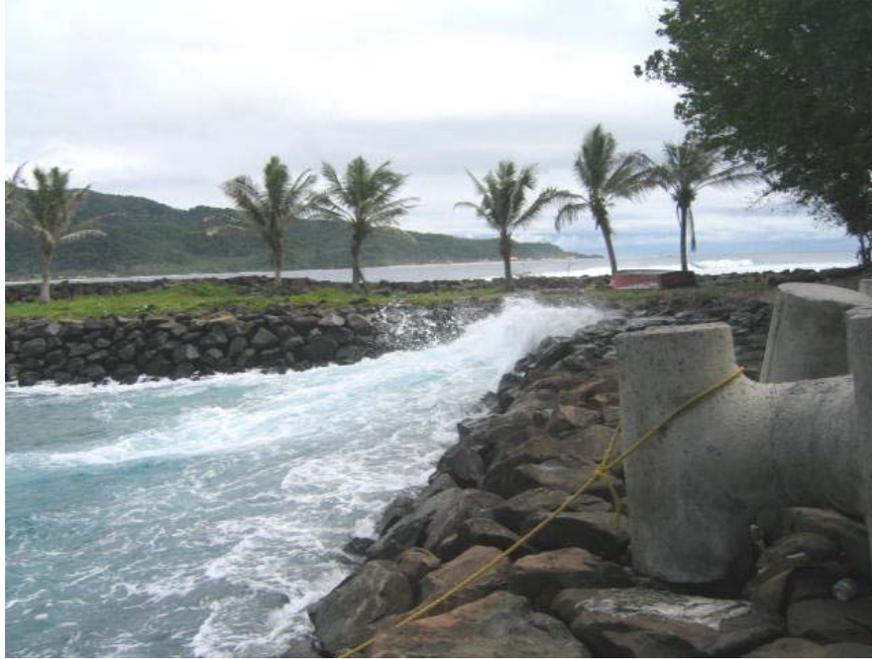
h. Harbor surge and overtopping at joint between wave absorber and North Revetted Mole (2004 Photo).

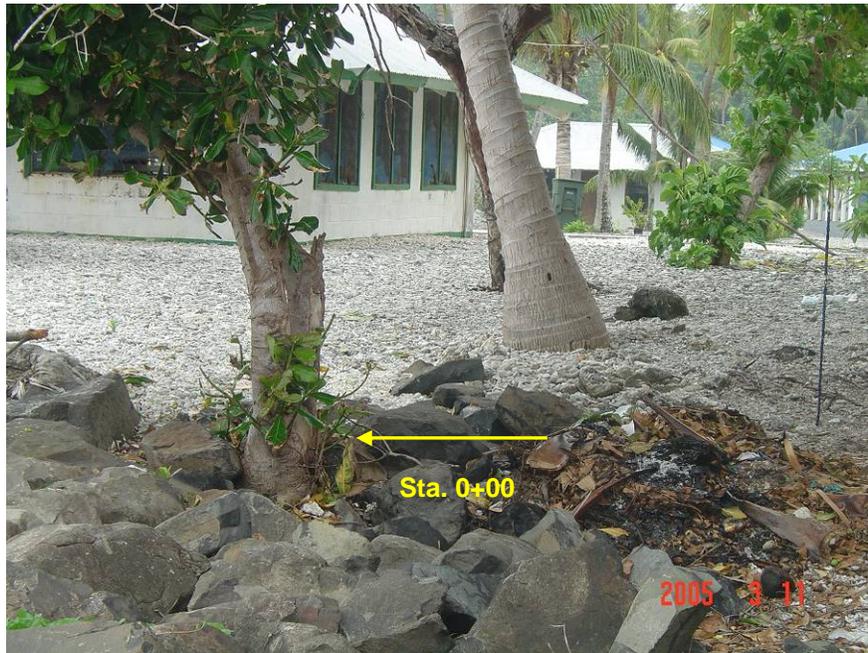
a. Sta. 0+00, OS, Coconut tree marks beginning of North Revetted Mole.

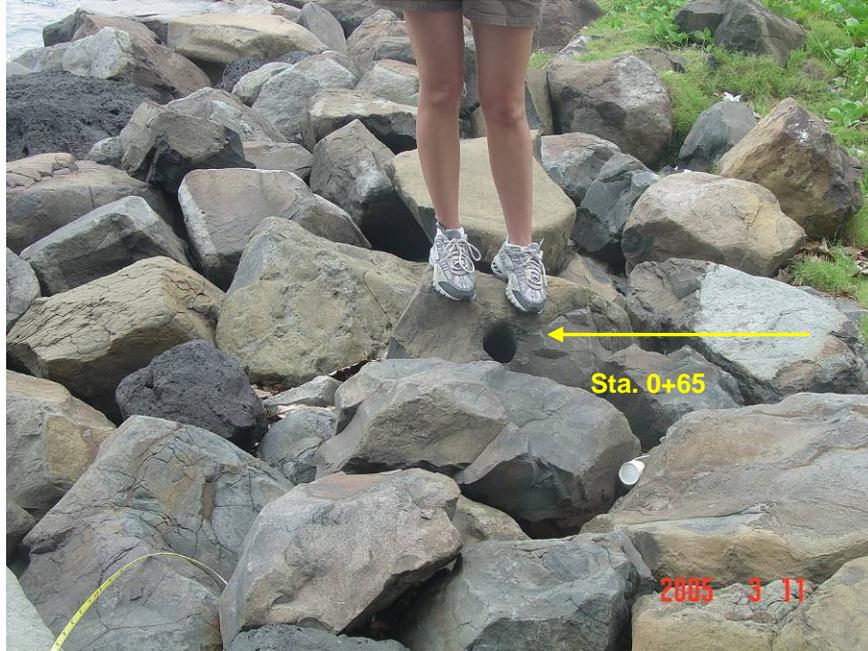
b. Sta. 0+65, HS, Reference rock with hole for stationing.

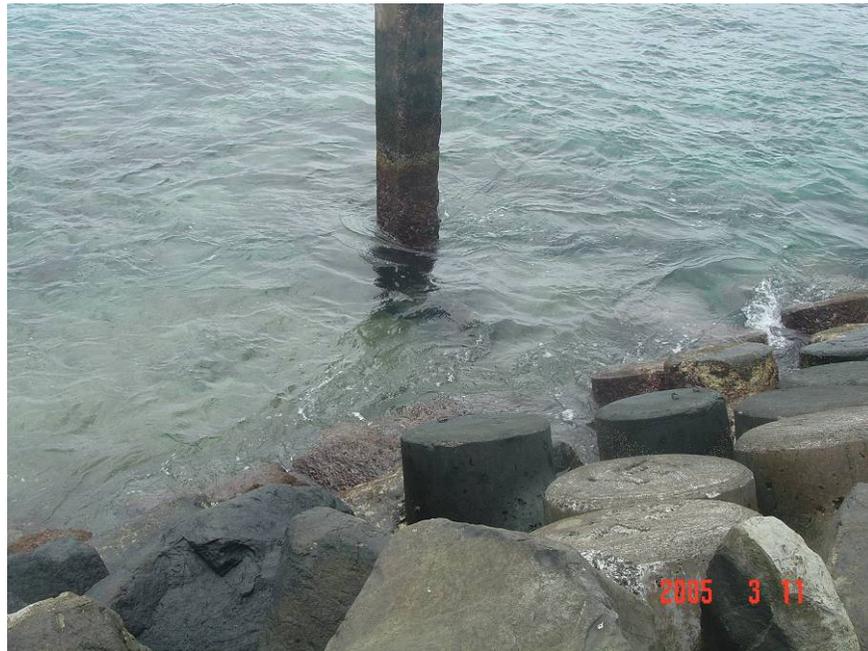
c. Sta. 1+65, HS, Tribar begins on harborside, noted for stationing reference.

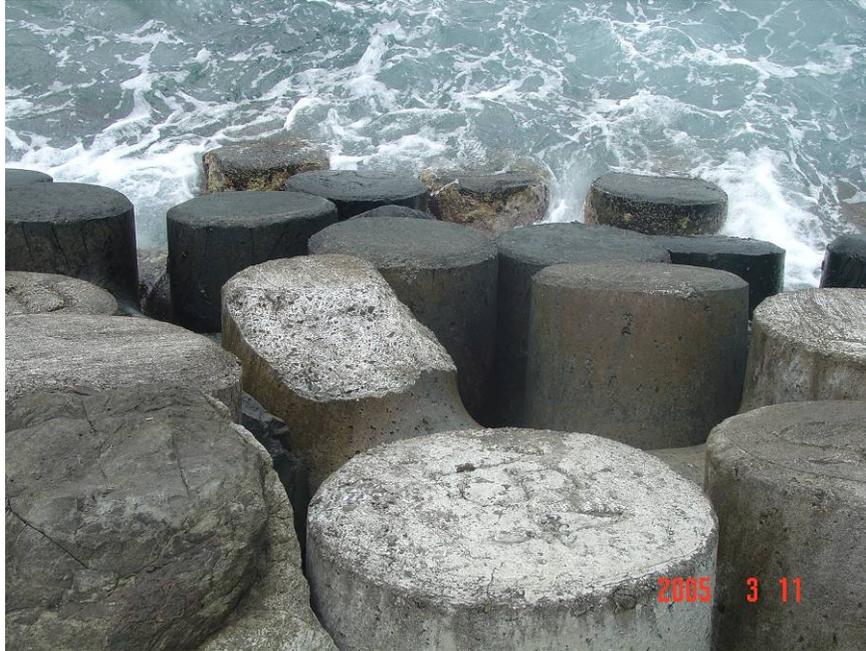
d. Sta. 1+83, HS, Chipped tribar #184.

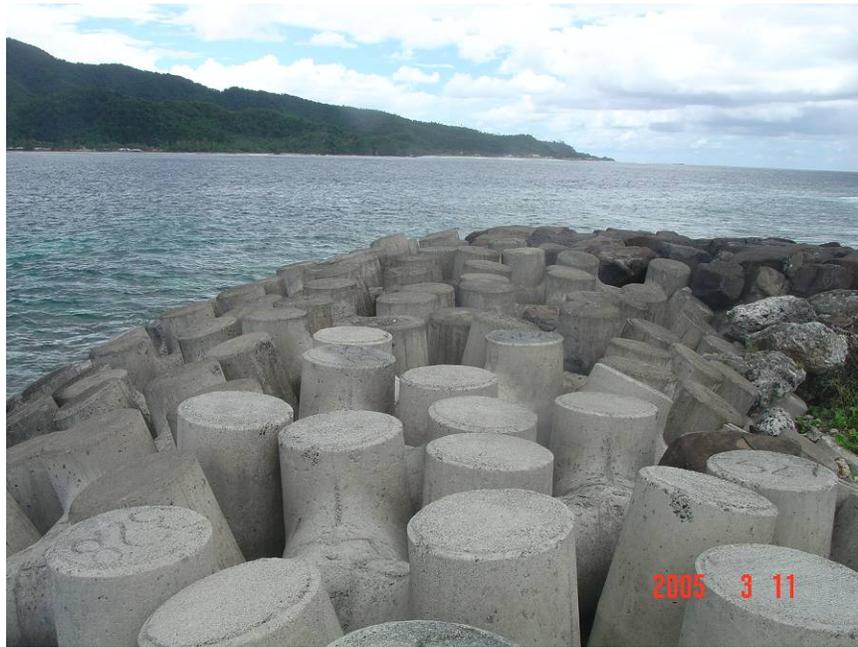
e. Sta. 2+25, Tribar #39 is at centerline of head. Head is in good condition with no damages noted.

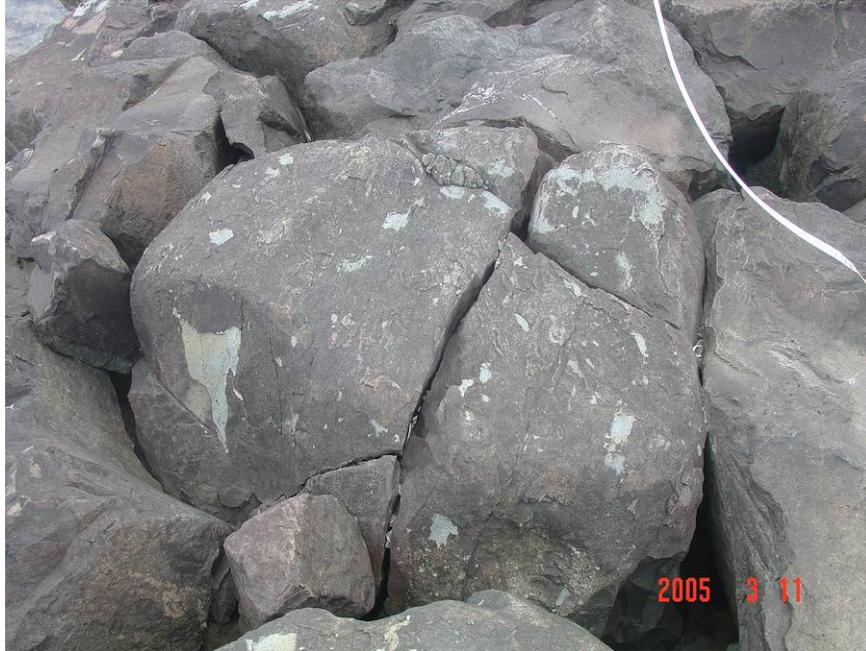
f. Sta. 1+74, OS, Cracked armor stone on crest.

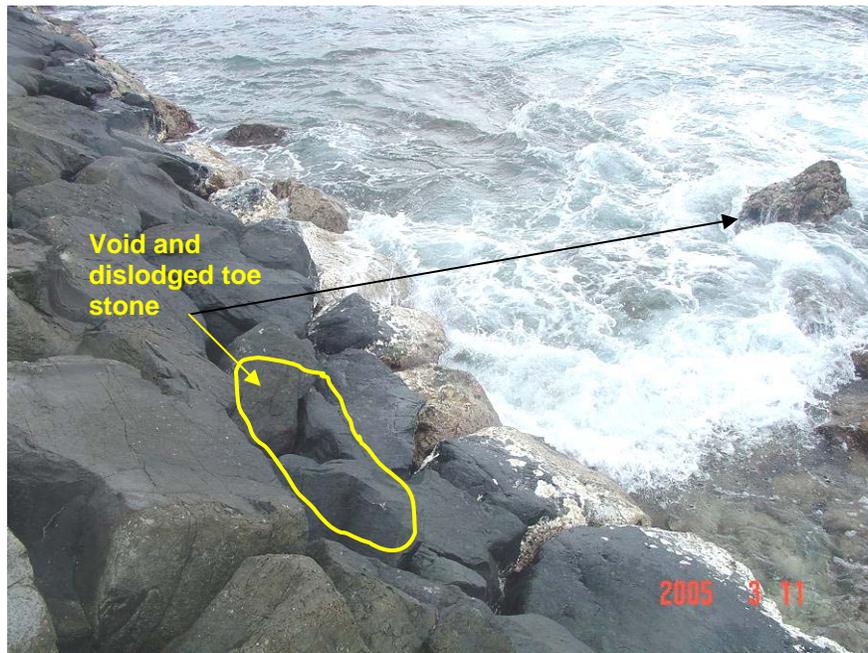
g. Sta. 1+54, OS, Monitor void and dislodged toe stone.

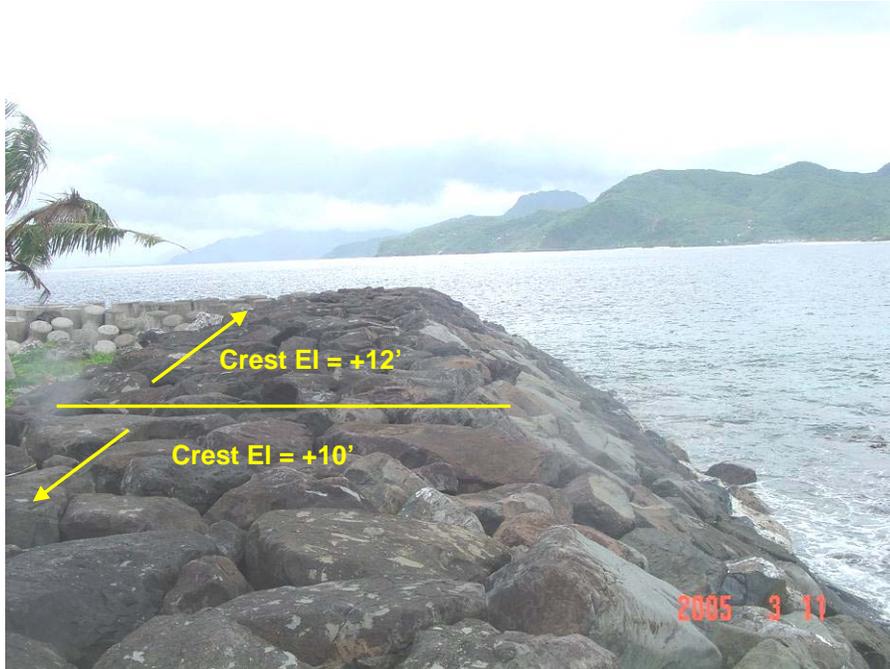
h. Sta. 1+03, OS, Elevation transitions from 10' to 12'.

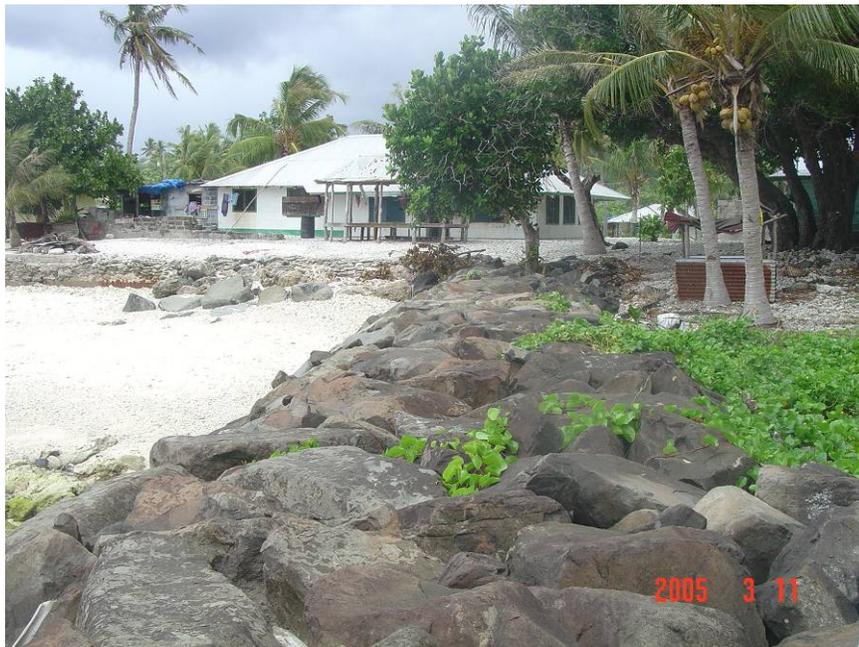
i. Sta. 1+03, Overview of OS of mole looking landward.

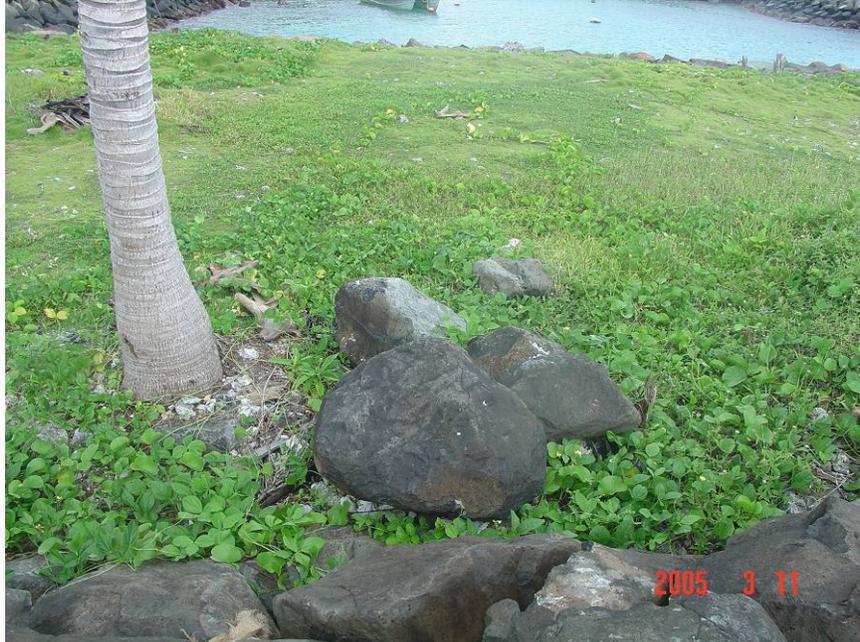
j. OS, 3 ea. Armor stones resting landward of oceanside crest on mole. (No station measured).

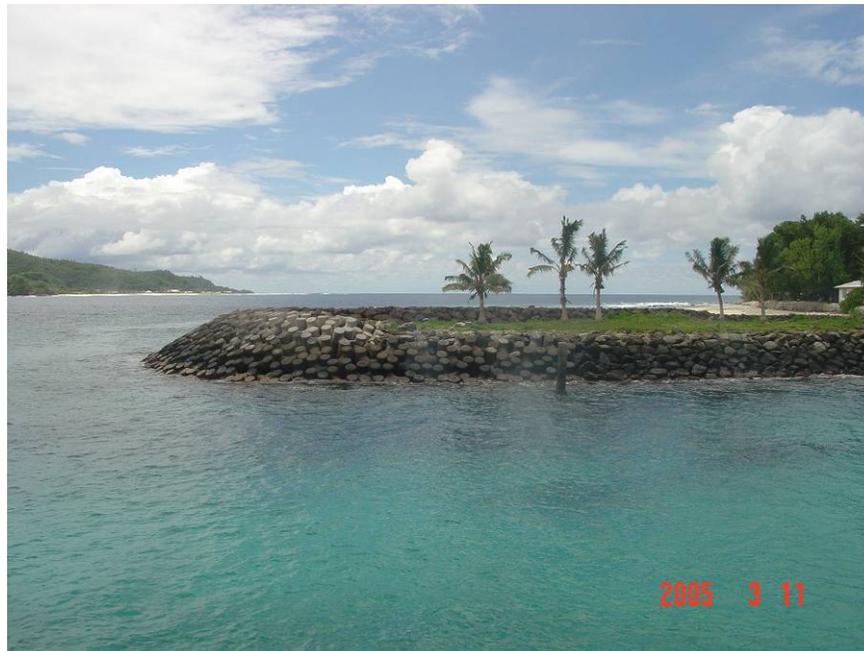
k. View of head of North Revetted Mole.
