**CONTINUING ELIGIBILITY INSPECTION (CEI) REPORT**  
**FOR HURRICANE & SHORE PROTECTION PROJECTS**  
Honolulu Engineer District  
CEPOH-EC-T

1. Project Name: Aoa Shore Protection Project

2. Date of Inspection: March 14, 2005

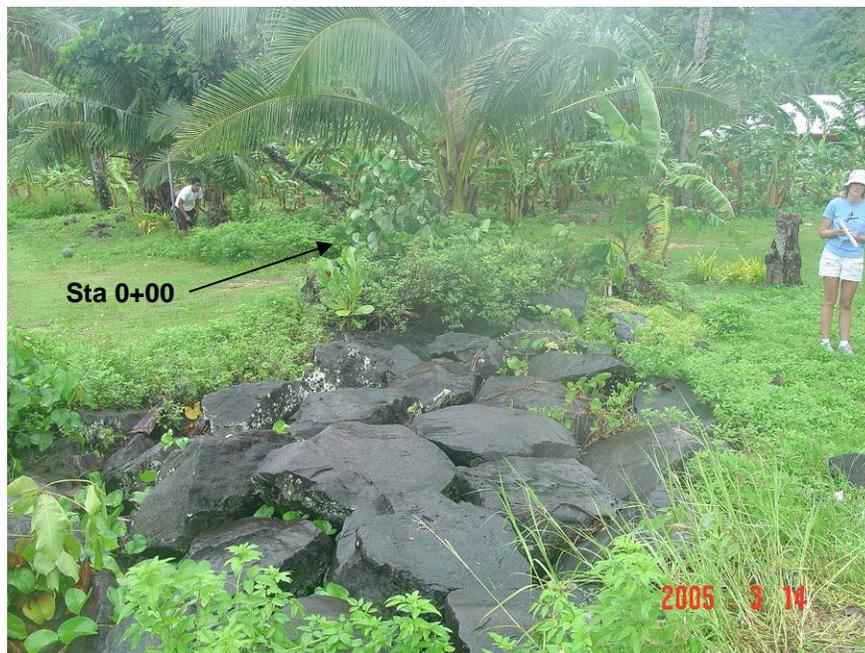
a. Sta. 0+00, End of west tieback, in need of vegetation removal. Increased vegetation since 2004, trees have been removed, but stumps remain, remove.

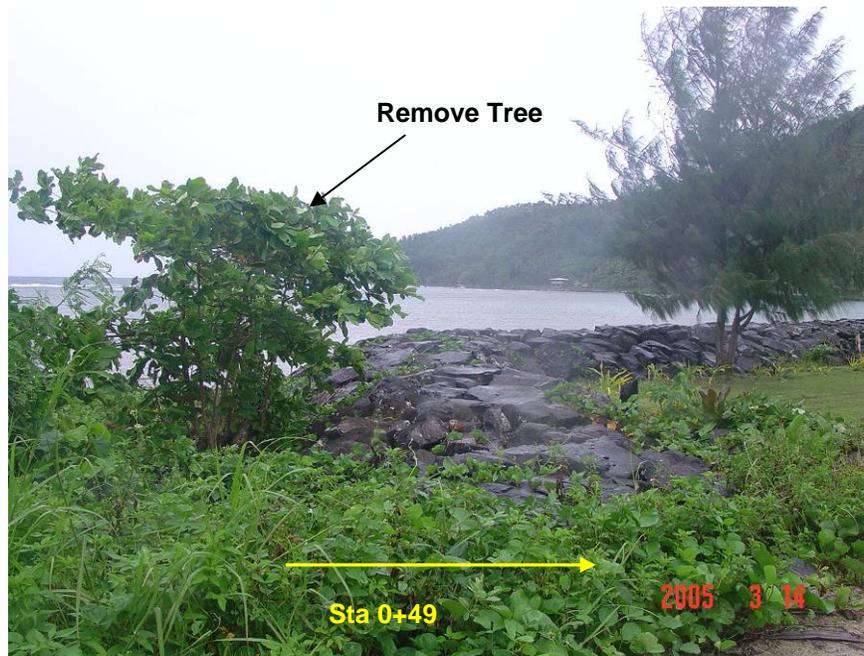
b. Sta 0+49, Vegetation continues to grow in this area. Trees at interior of revetment have been cut, but trees on exterior of revetment have grown larger. Remove trees and vegetation.

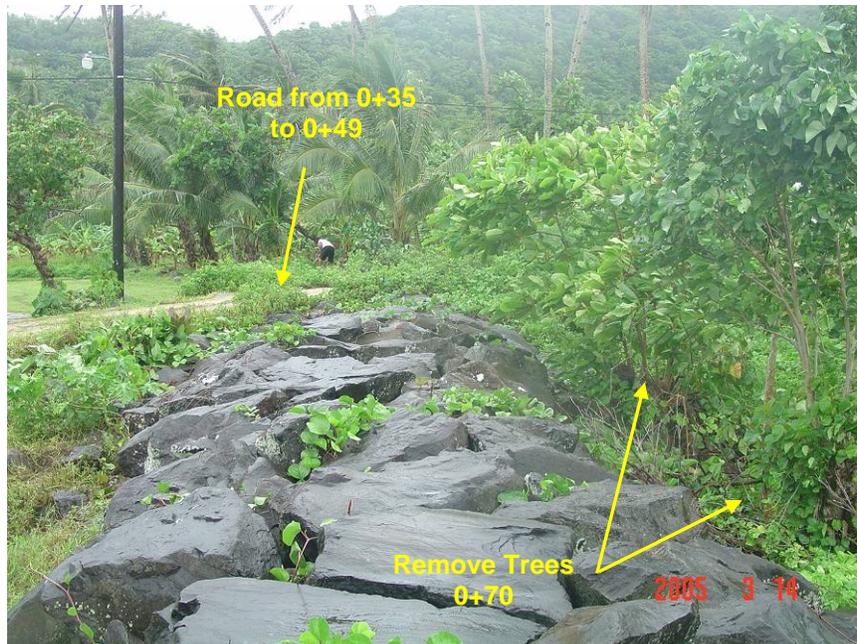
c. Road built over the revetment from 0+35 to 0+49 by DPW. Remove tree at 0+70 exterior sideslope toe.

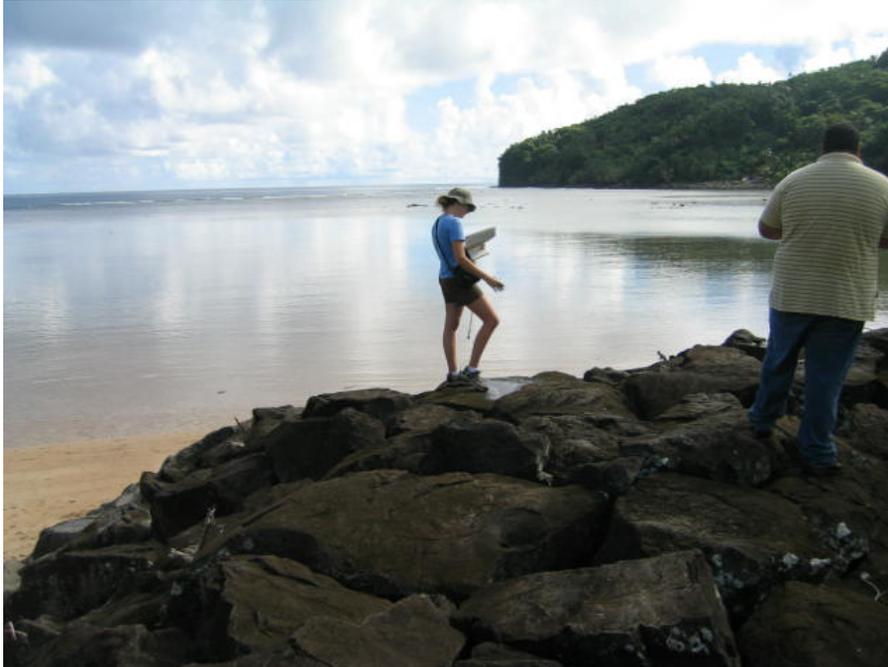
d. Sta. 1+16, Structure alignment changes perpendicular to shoreline.  
(2004 PHOTO)

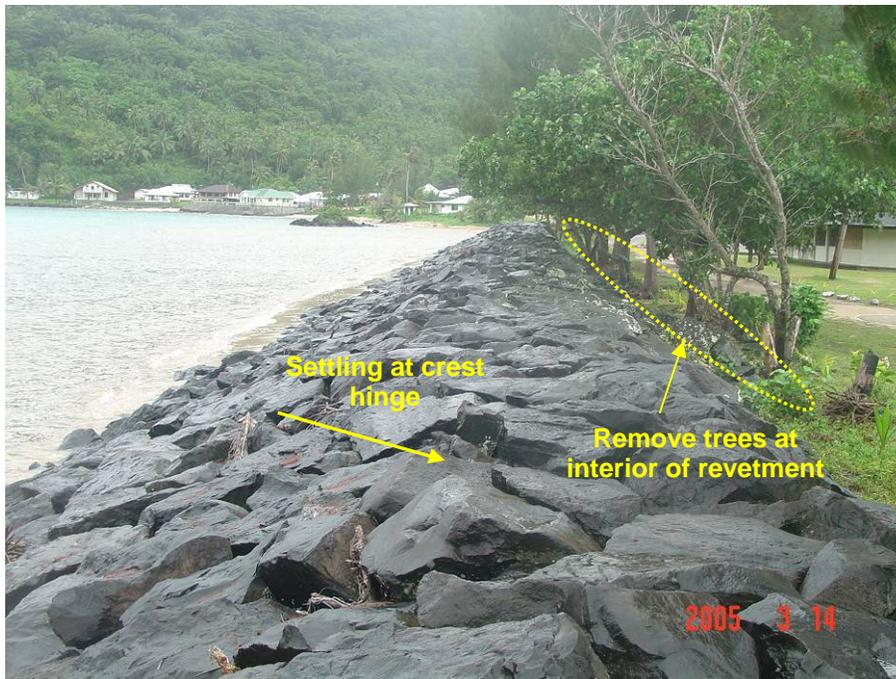
e. Sta. 1+34, Begin area of settling and undermining. Settling at crest hinge, monitor. Remove all trees at interior of revetment within 5 feet of the structure.

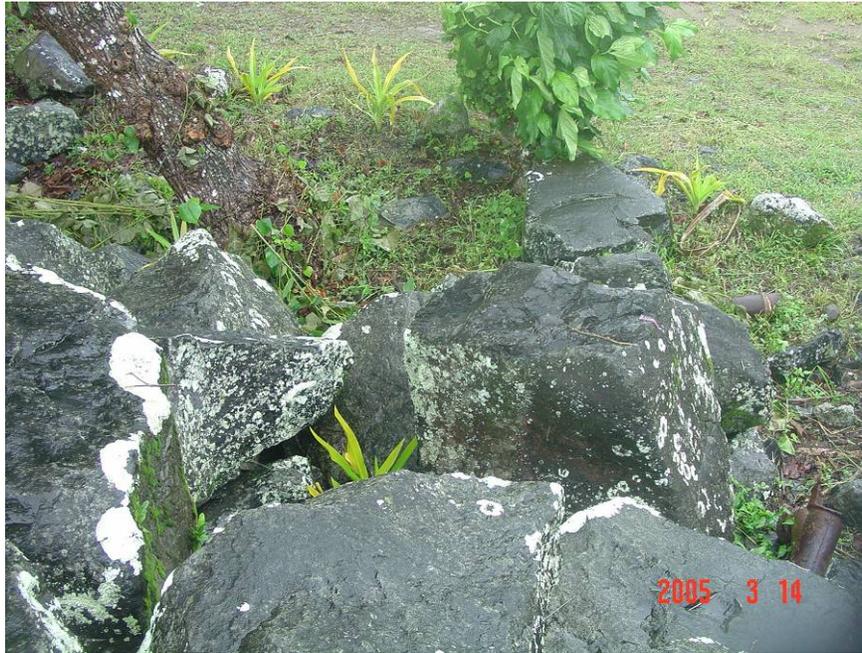
f. Sta. 1+87, 3 ea. dislodged armor stones at the interior slope and voids. Reset stones to fill voids. Remove trees within 5 feet from toe of structure.

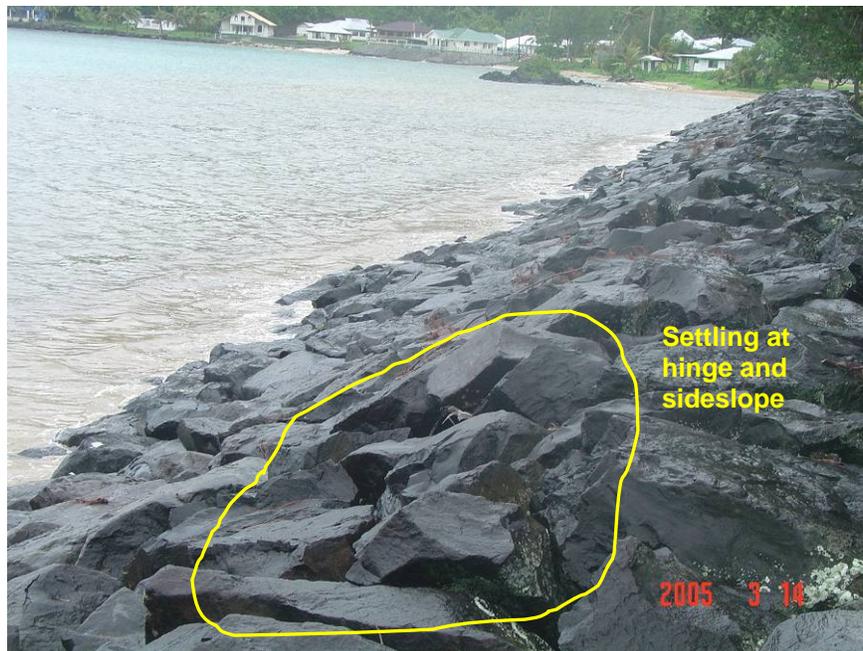
g. Sta 2+05, Settling at crest hinge and on exterior side slope, monitor.

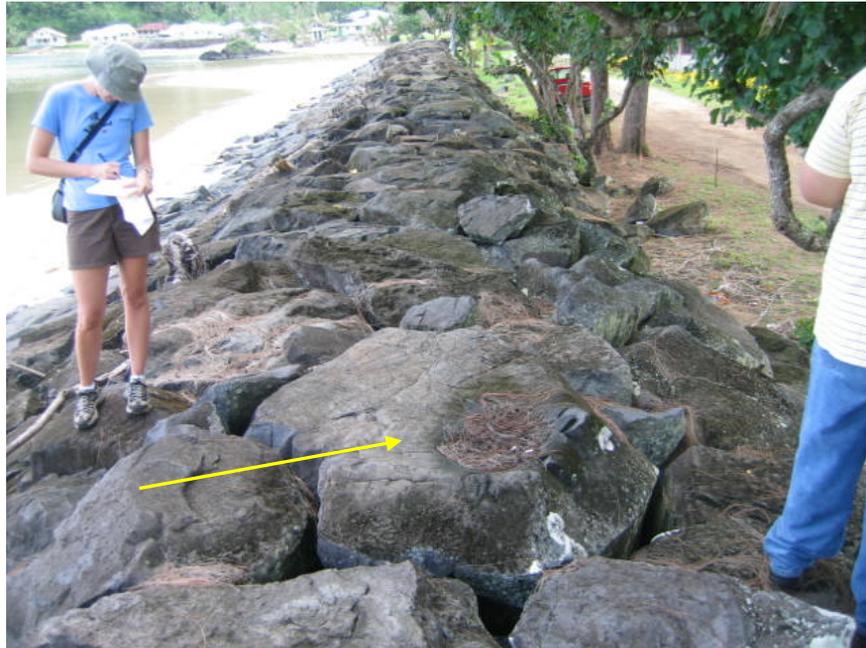
h. Sta. 2+47, Reference armor stone on centerline approx. 5 ft in length. Adjacent to restrooms. (2004 PHOTO)

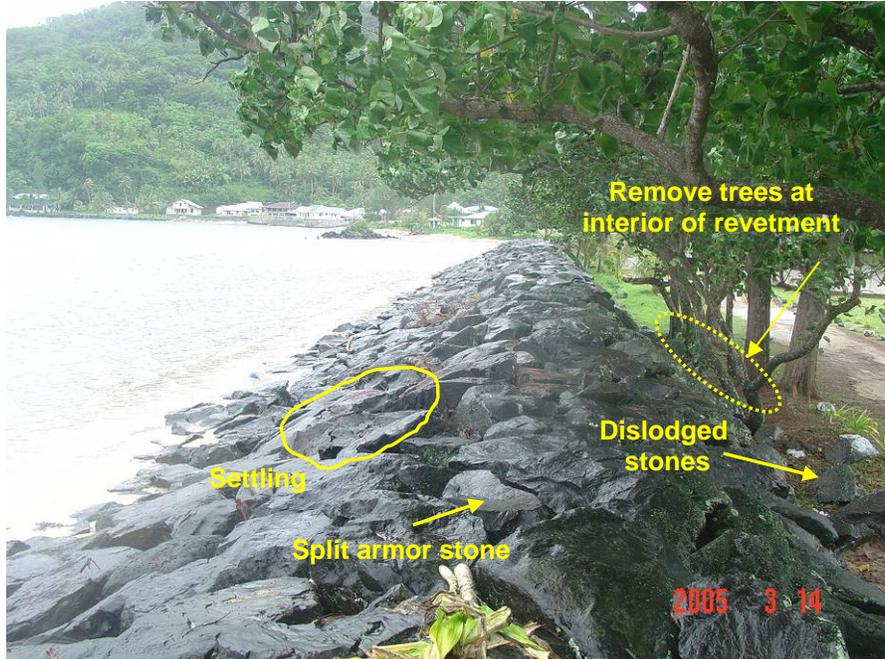
i. Sta. 2+82, Split armor stone on crest, reset dislodged stones on interior slope, and 10 ft area of settling on exterior slope. Remove trees at interior of revetment.

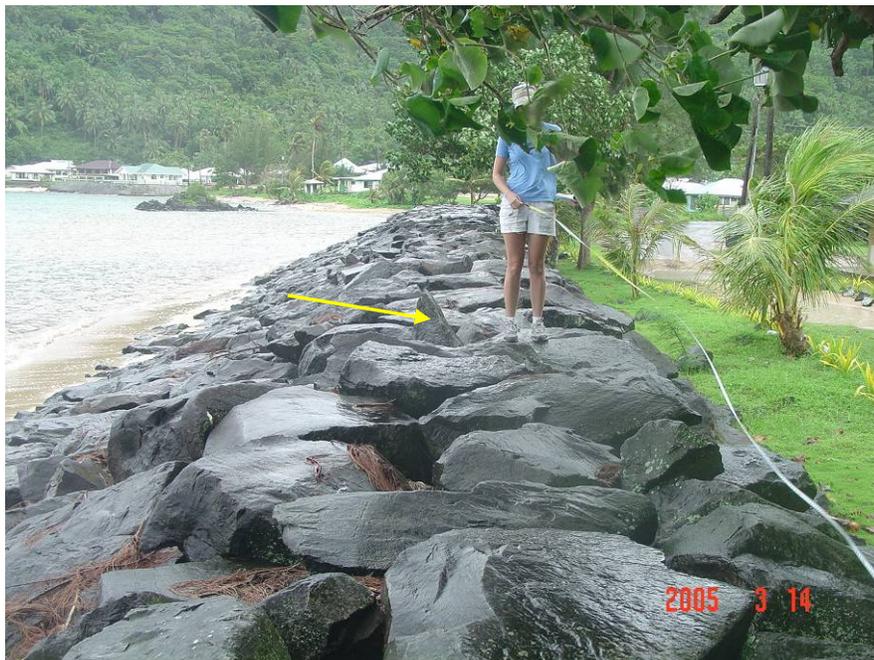
l. Sta. 3+50, Monitor slight depression through crest and down the sideslope.

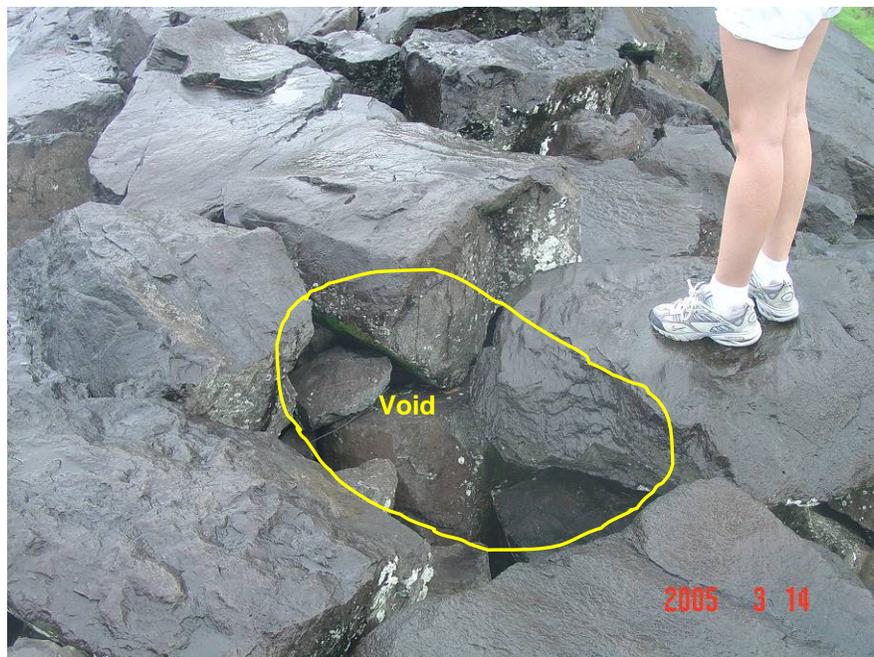
m. Sta 3+55, Reset flipped armor stone on crest.

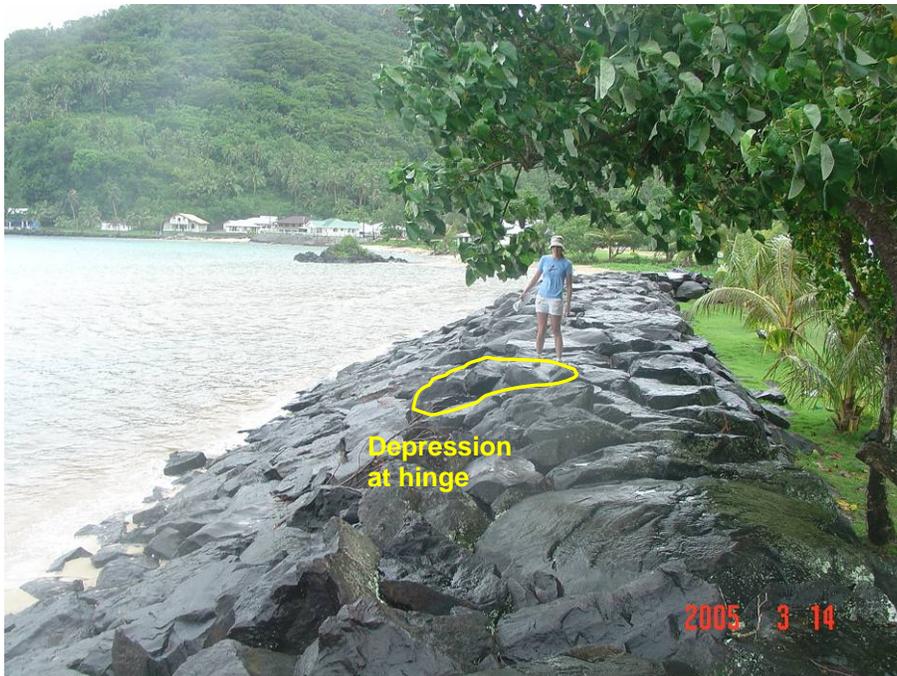
o. Sta. 4+20, Monitor 4 ft wide depression on exterior sideslope hinge.

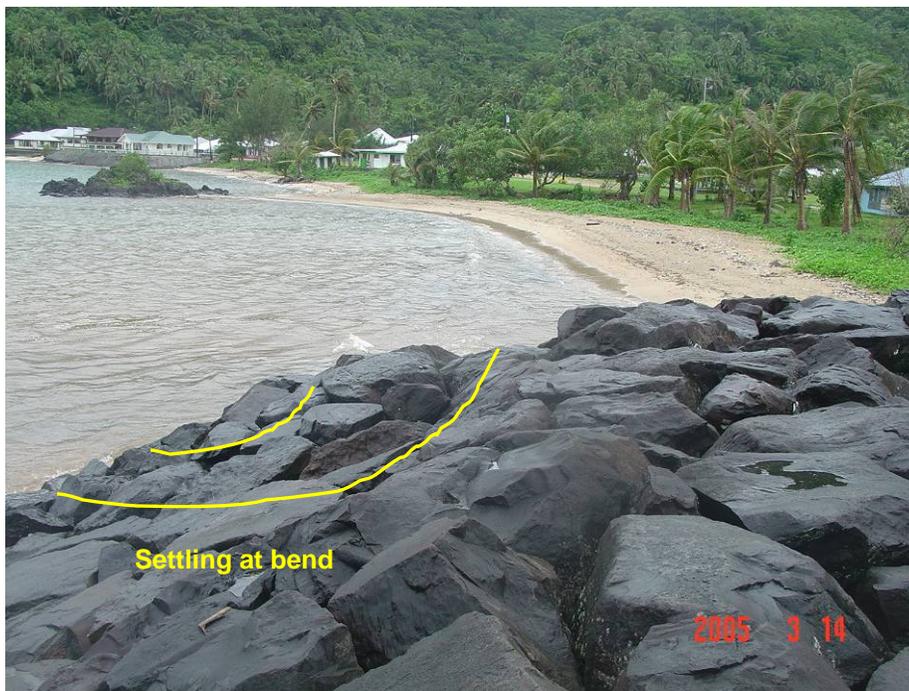
s. Sta 5+20, Monitor depression at interior crest hinge. New this inspection.

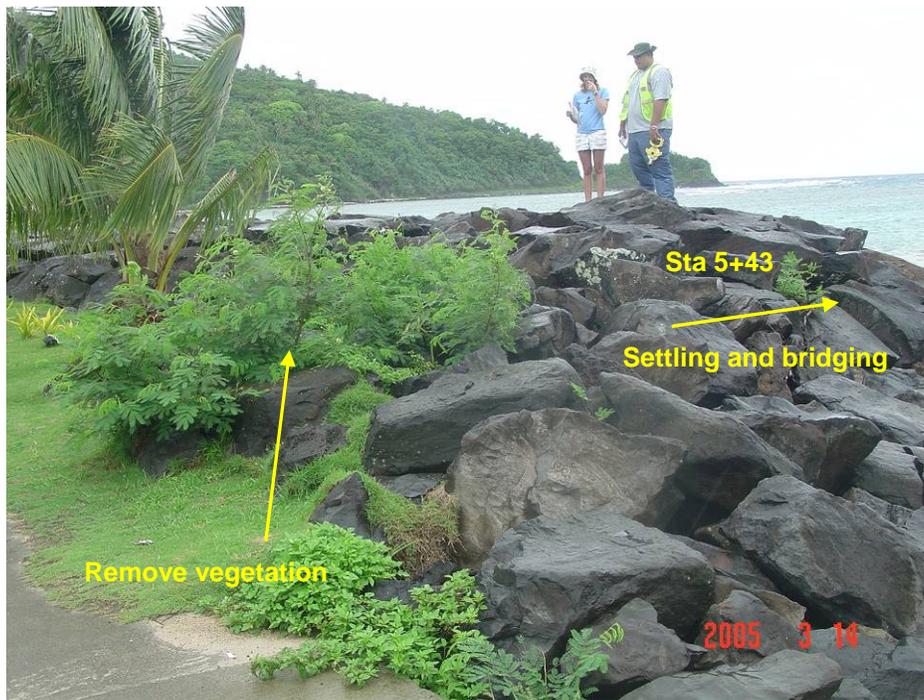
t. Sta. 5+43 to 5+59, Monitor settling of exterior sideslope at bend in structure.

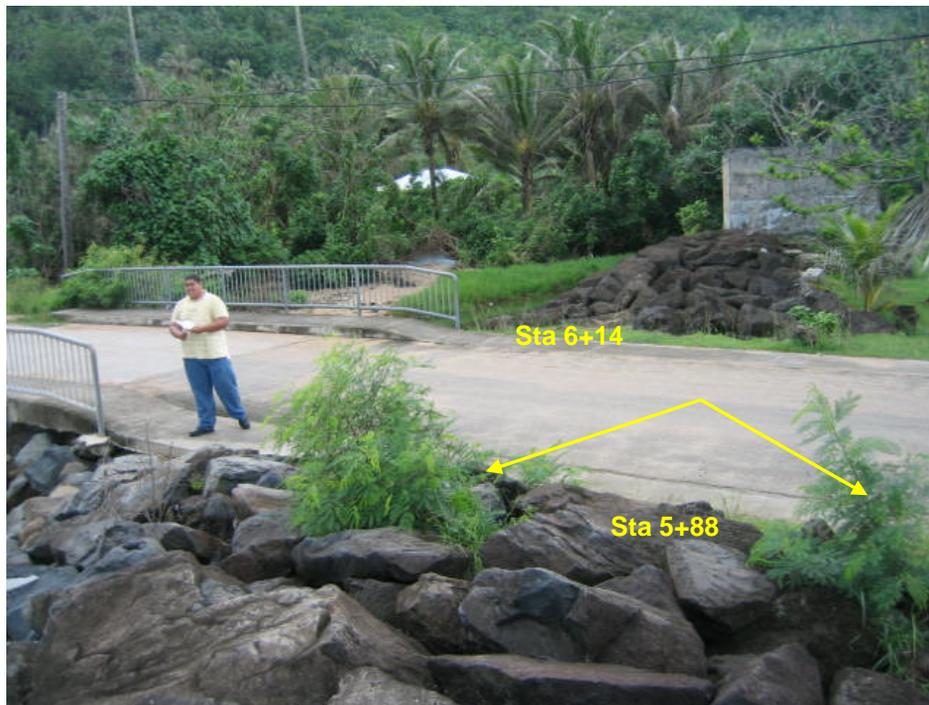
u. Sta. 5+43, Start of bend toward road. Oversized stones and poor gradation. 15 ft area of settling. Remove woody vegetation adjacent to road (Sta 5+88).
