**O & M INSPECTION REPORT
FOR NAVIGATION AND SHORE PROTECTION PROJECTS**

1. Project Name: Auasi SBH
2. Date of Inspection: March 9, 2005
3. Inspection Personnel:

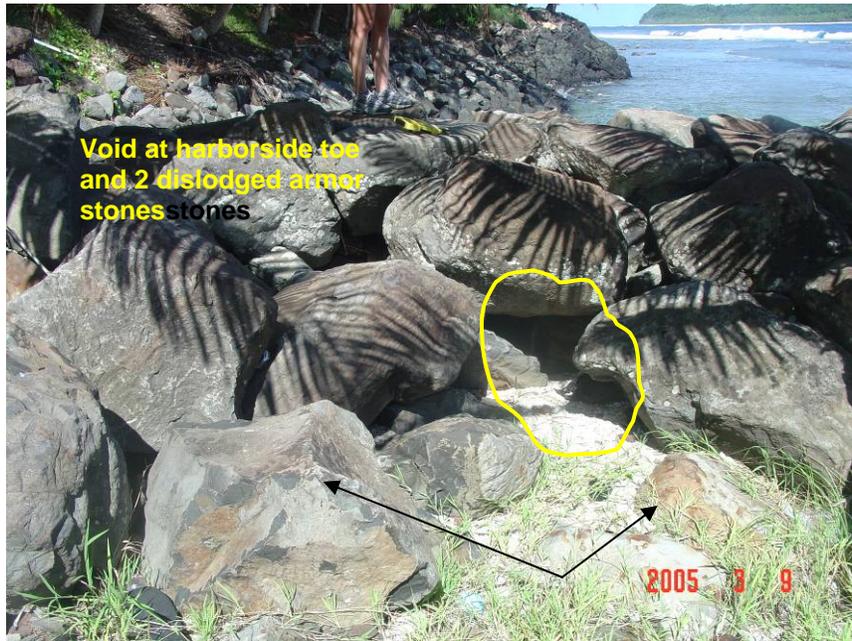
a. Sta. 0+22, HS, Void and 2 dislodged armor stones resting near toe.

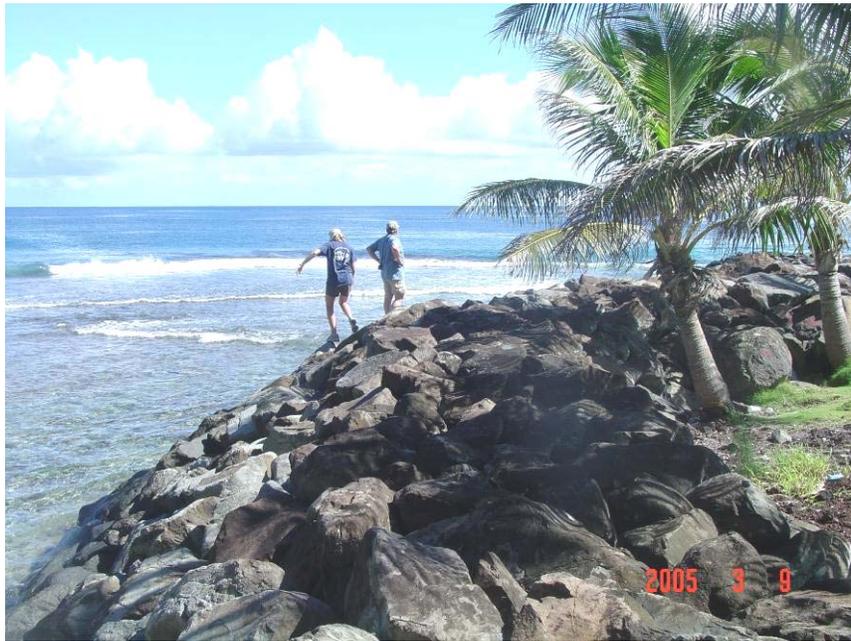
b. Sta. 0+25 to 0+77, Overview of Revetment Reach 1, no damage noted along this reach.

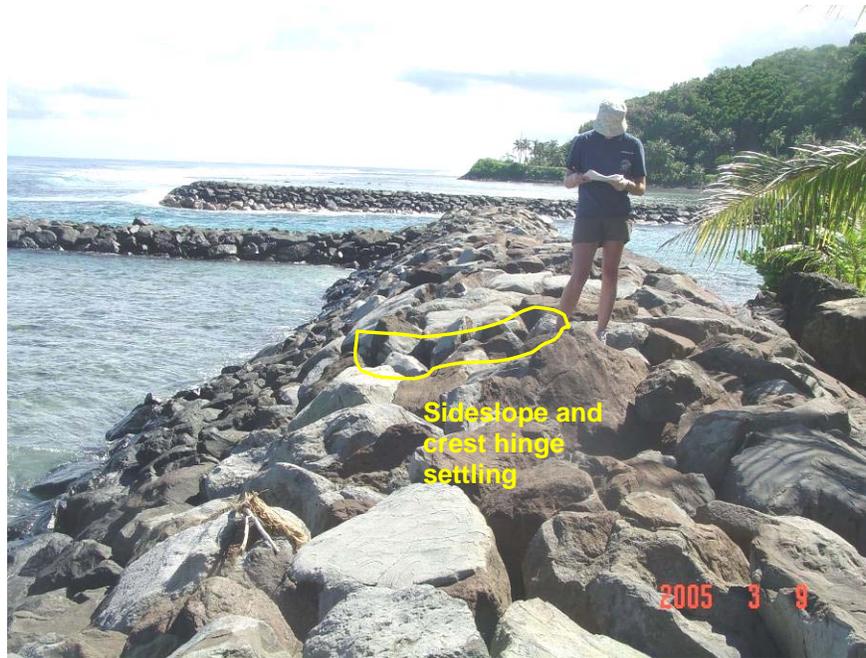
c. Sta. 1+04, OS, settling of sideslope and crest hinge, approx. 5ft in diameter.

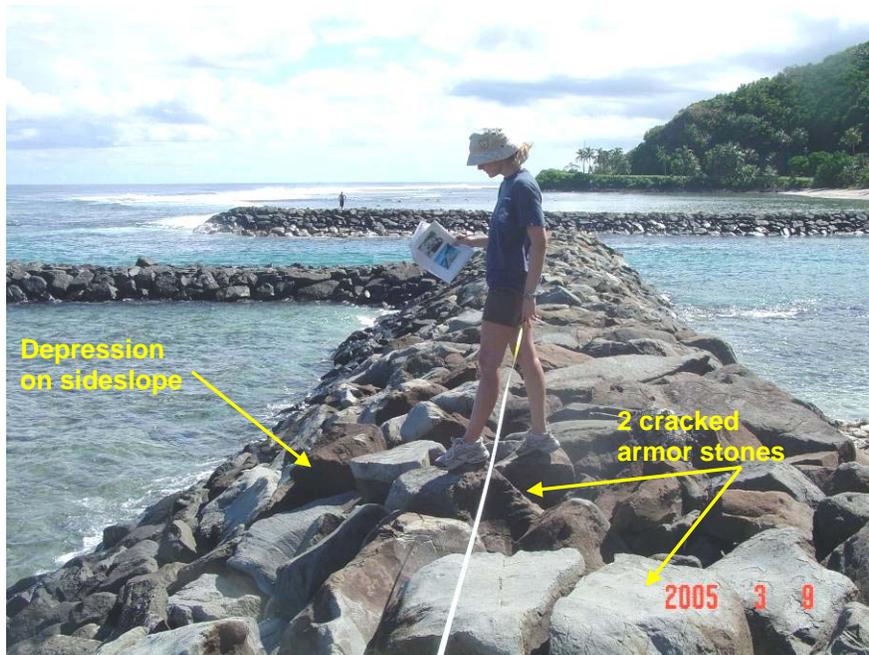
d. Sta. 1+29, OS, Depression on sideslope and 2 cracked armor stones on crest.

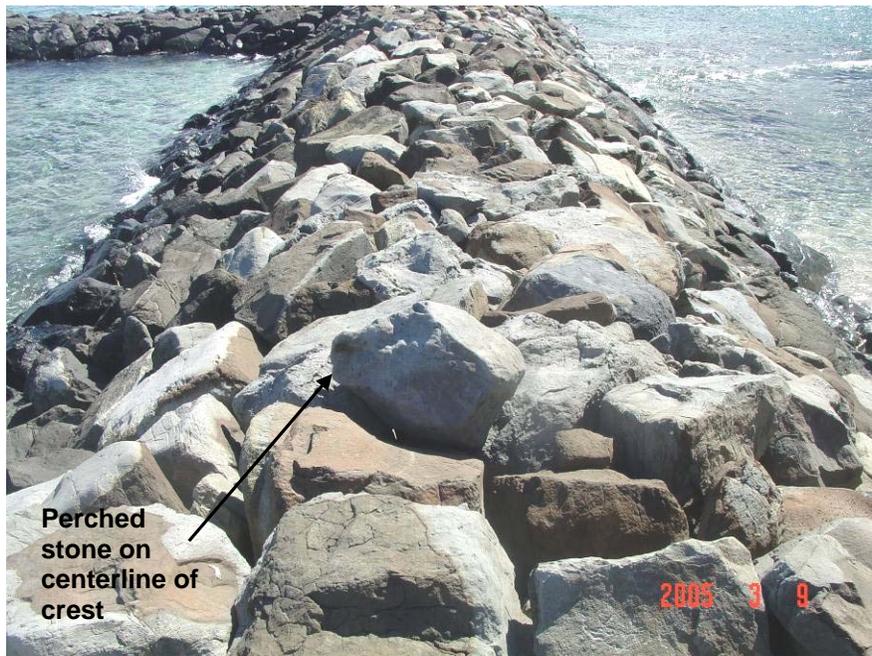
f. Sta. 1+65, End of revetment and crest elevation change, single perched stone on centerline.

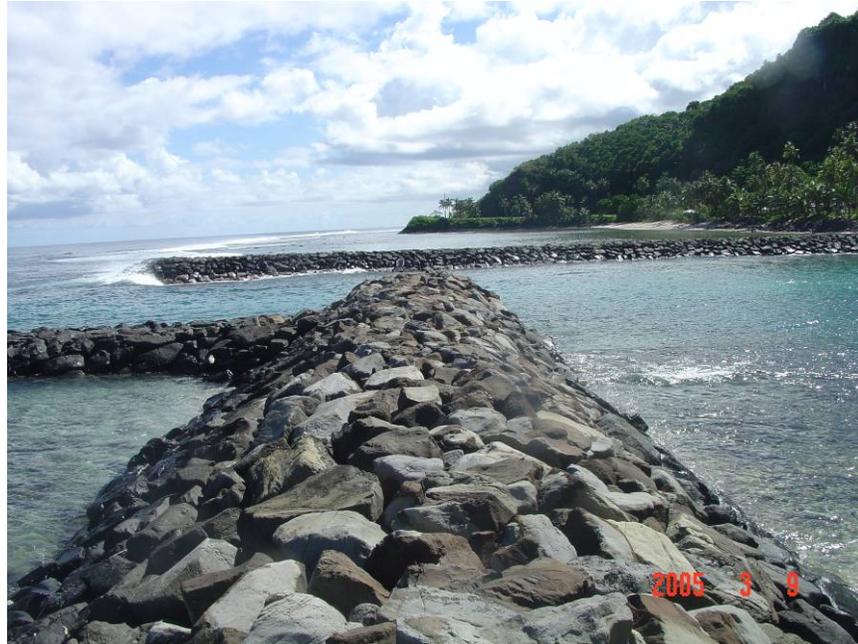
g. Sta 1+91 to 2+87, Overview of breakwater and joint with west jetty.

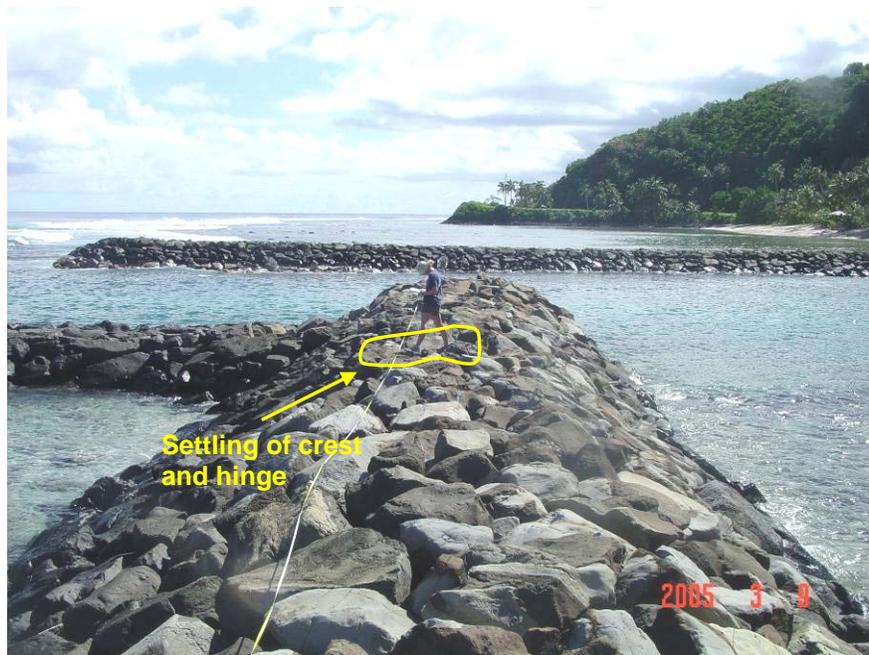
h. Sta 2+52, Minor settling of crest and hinge.

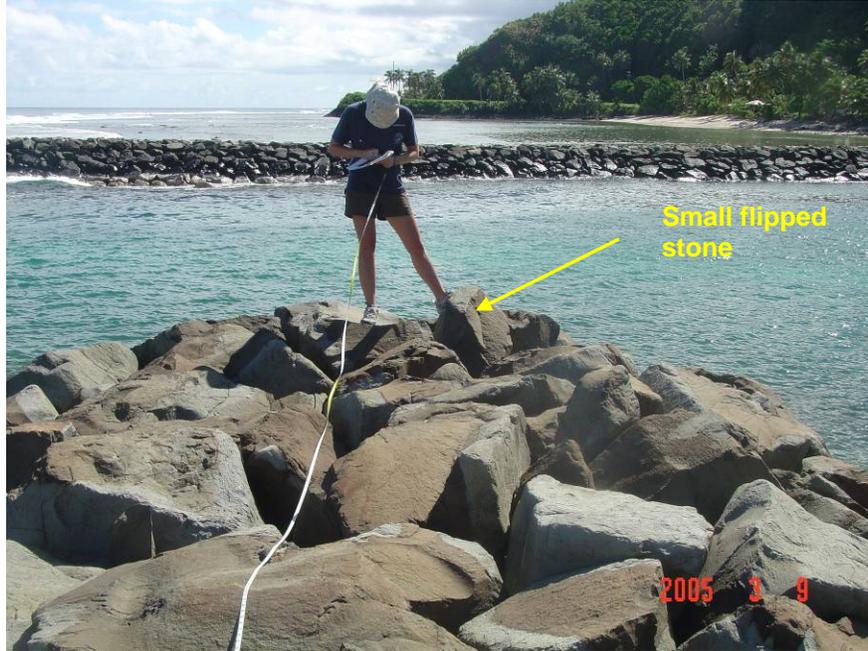
i. Sta 2+87, Small flipped stone near end of breakwater.

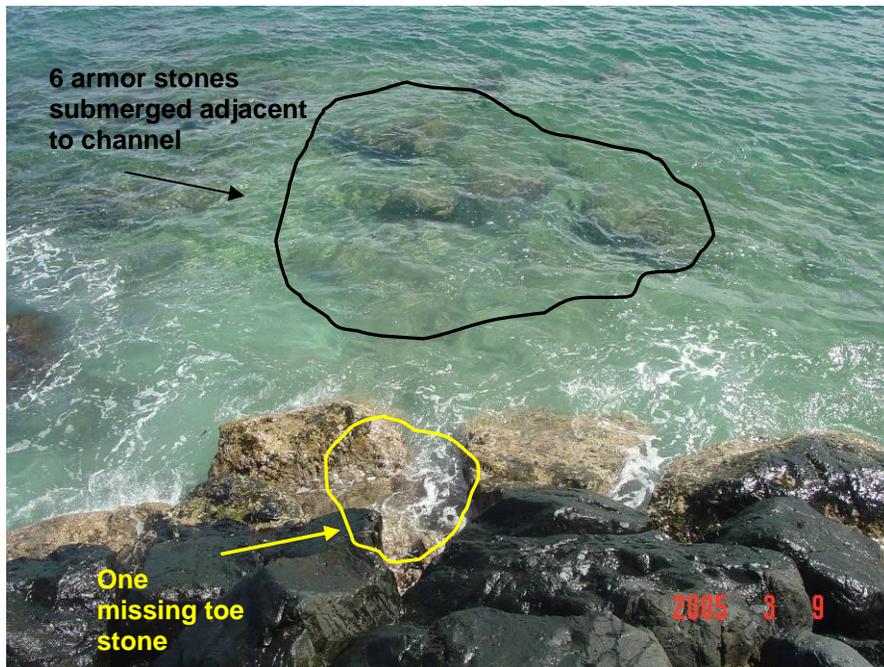
j. Sta 2+87, End of breakwater, one missing toe stone, 6 armor stones adjacent to channel.

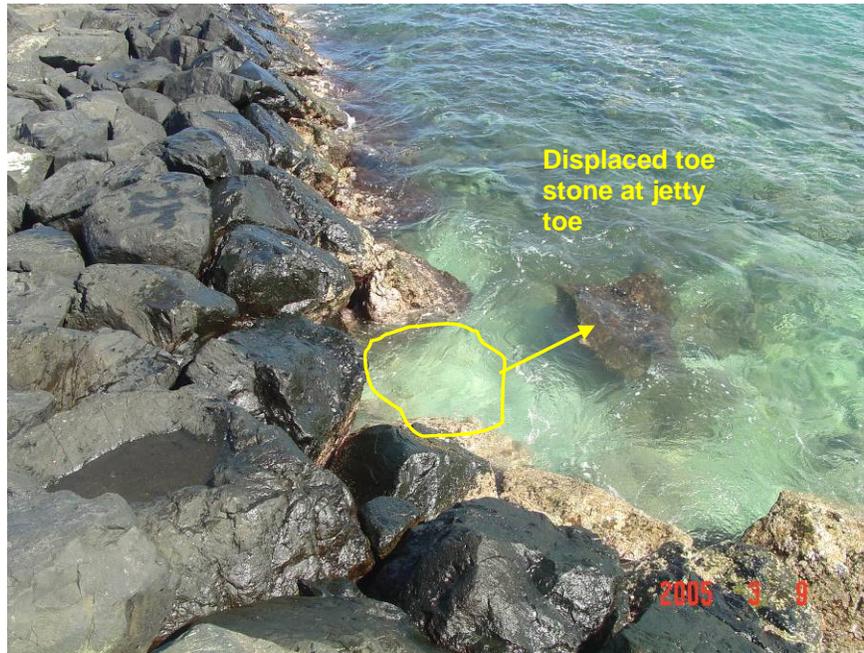
k. Sta. 0+00, HS, toe stone displaced at breakwater/jetty joint. Note that jetty station 0+00 is located at first stone of lowered elevation.

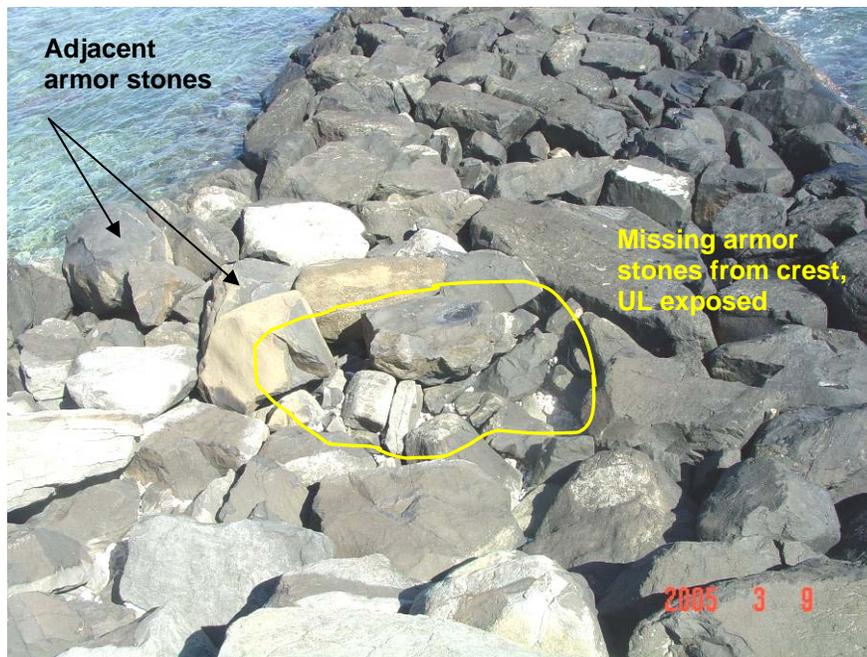
l. Sta. 0+05, Crest missing armor stone with underlayer exposed, same as in previous inspections. 2 armor stones adjacent may have been dislodged from this area.

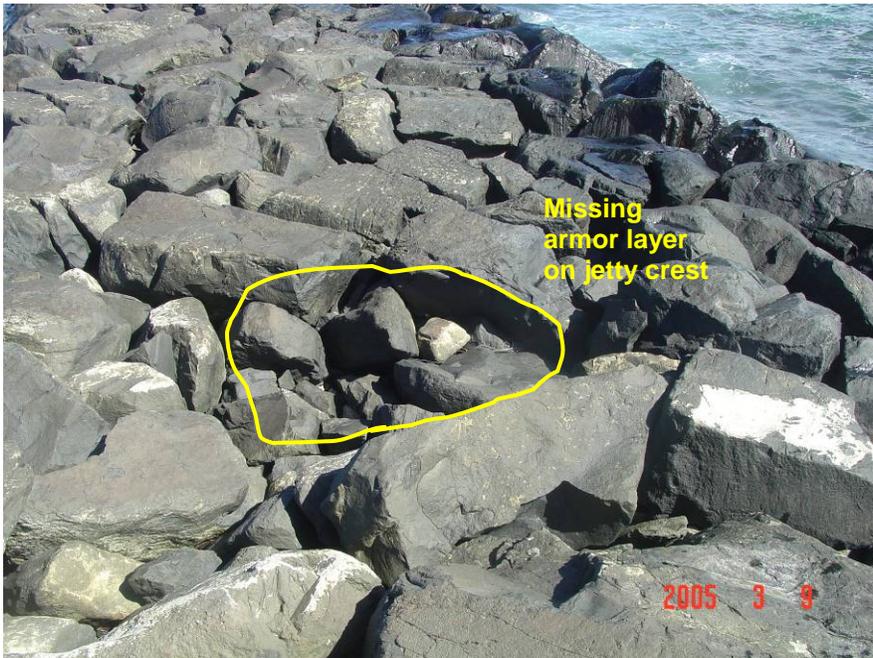
m. Sta. 0+17, Crest missing armor stone with underlayer exposed.

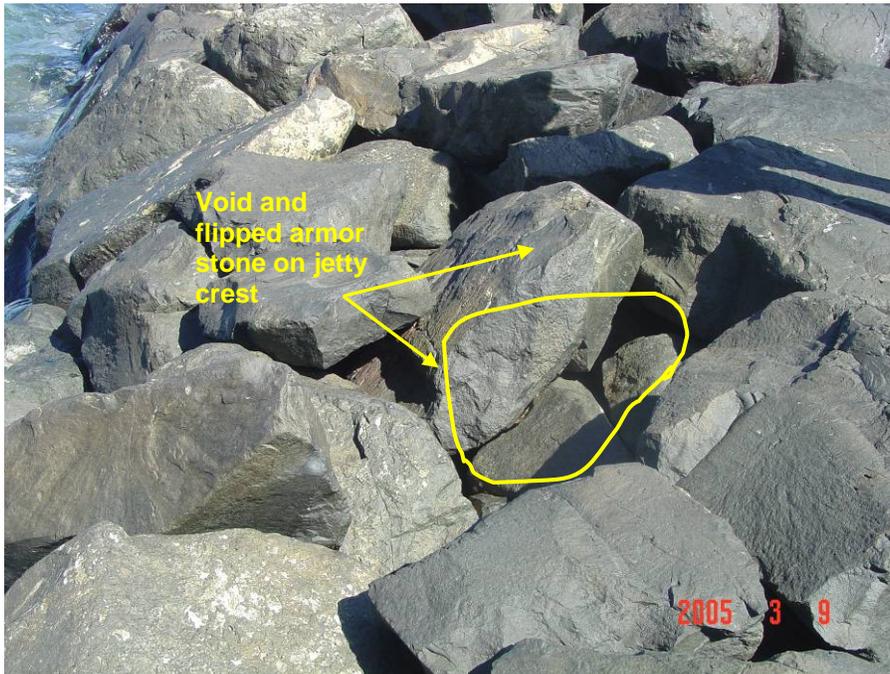
n. Sta 0+47, OS, Void and flipped armor stone near centerline.

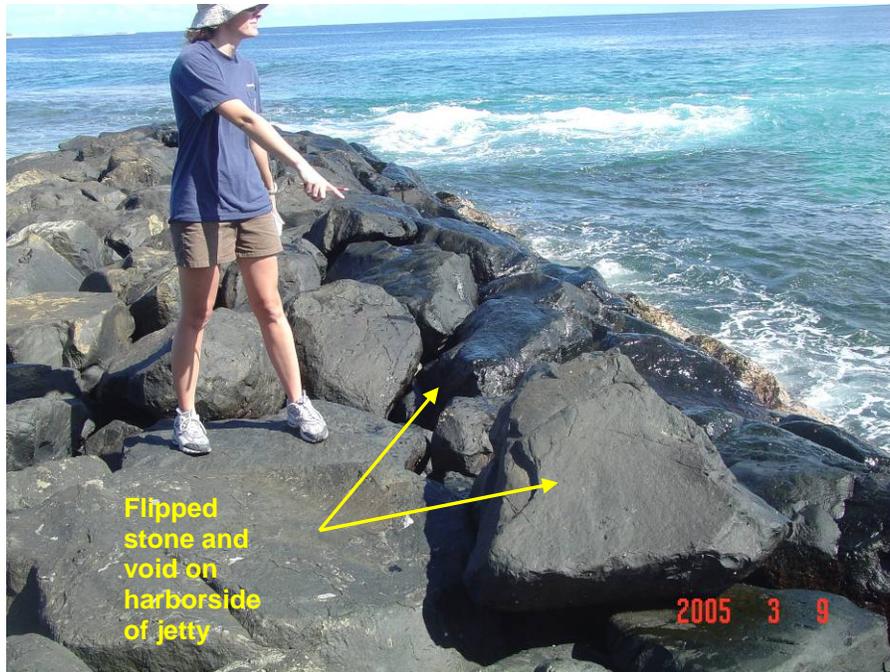
o. Sta 0+48, HS, Flipped armor stone and adjacent void.

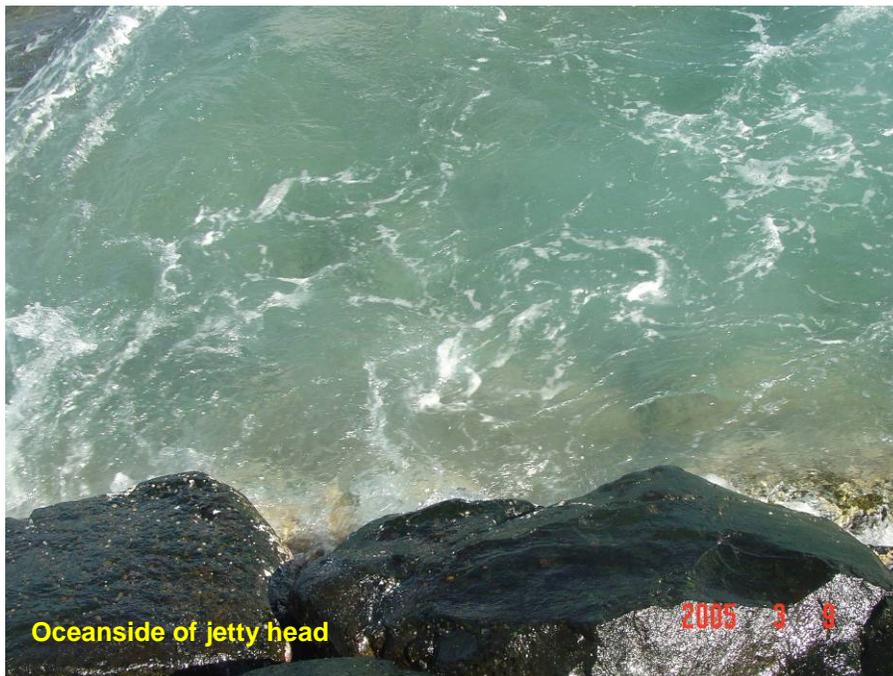
p. Sta. 0+90, OS, Head of jetty is in good condition.

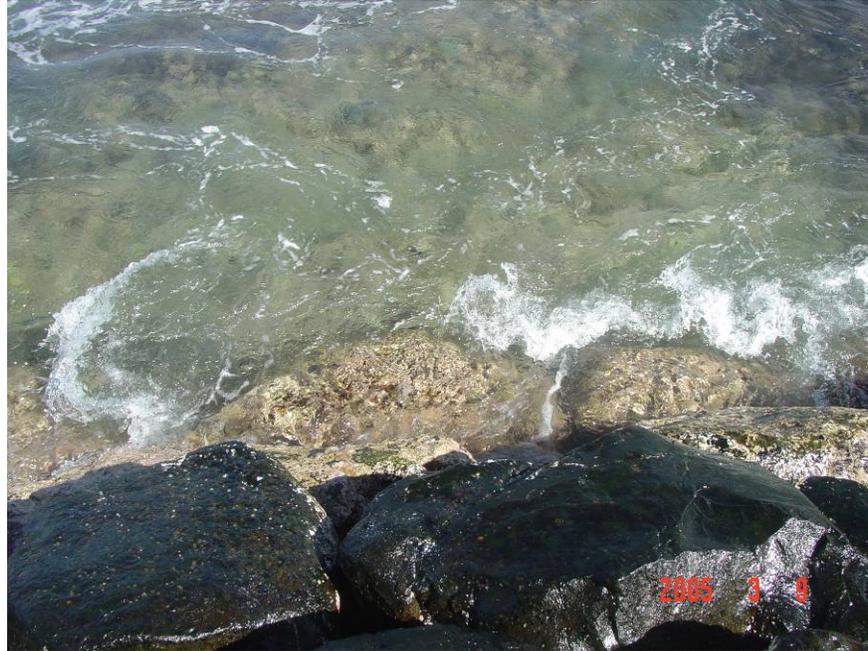
p. Sta. 0+90, HS, head of jetty is in good condition.

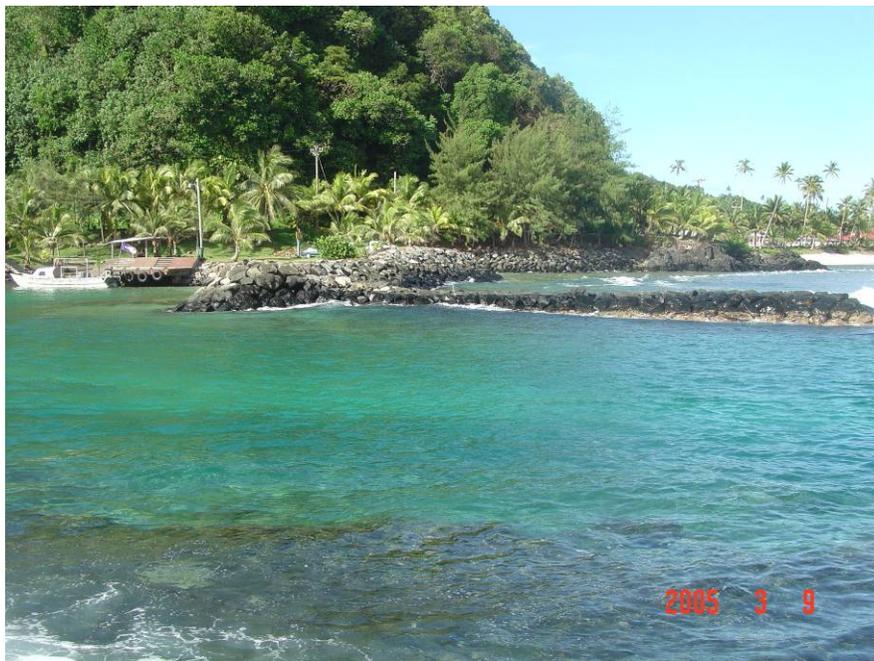
r. Overview of East Revetment/Breakwater and Jetty.

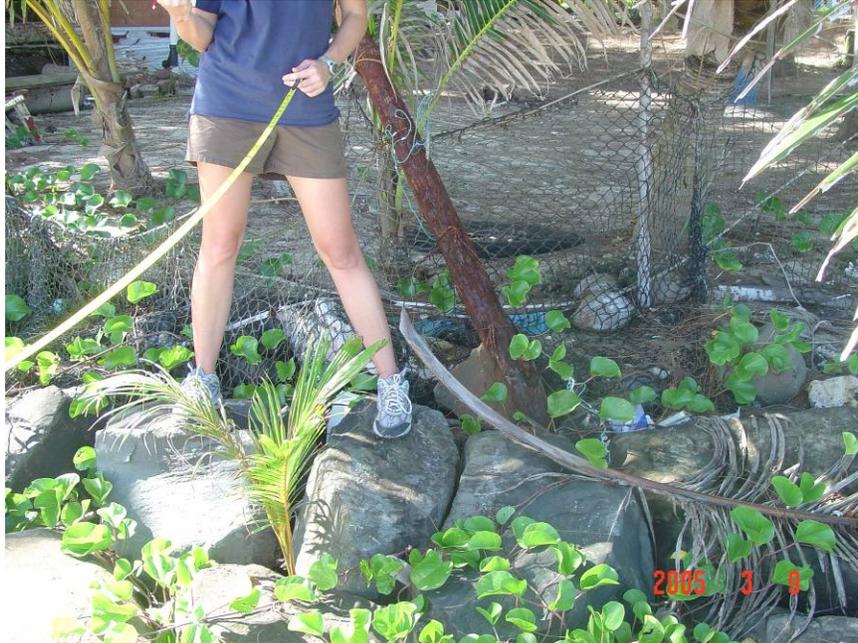
a. Sta. 0+00, Beginning station marked by coconut tree. Some vegetation growth here since last inspection, vines and juvenile coconut trees, remove with herbicide.

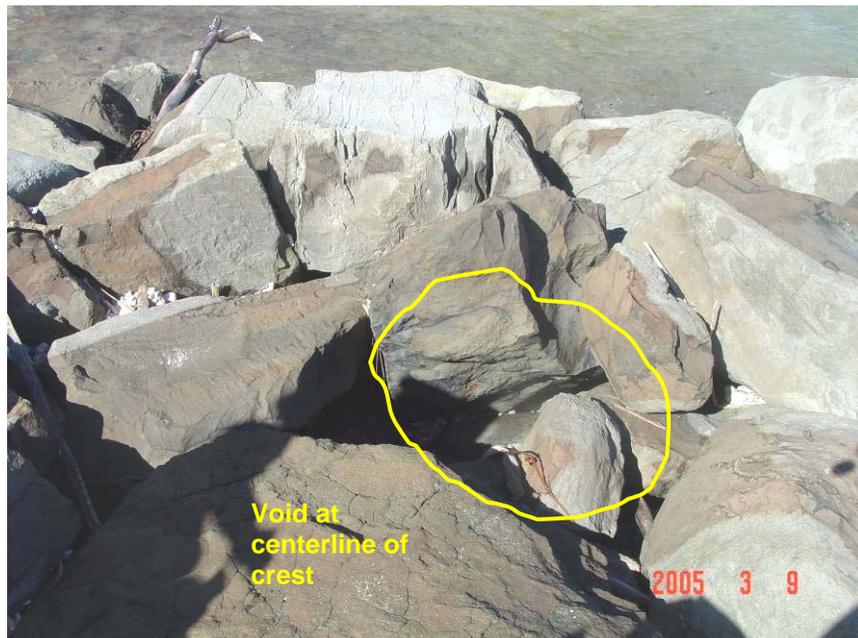
b. Sta. 0+55, Void at centerline of crest, approx. 2'x 2'x 2'. No dislodged stones observed nearby.

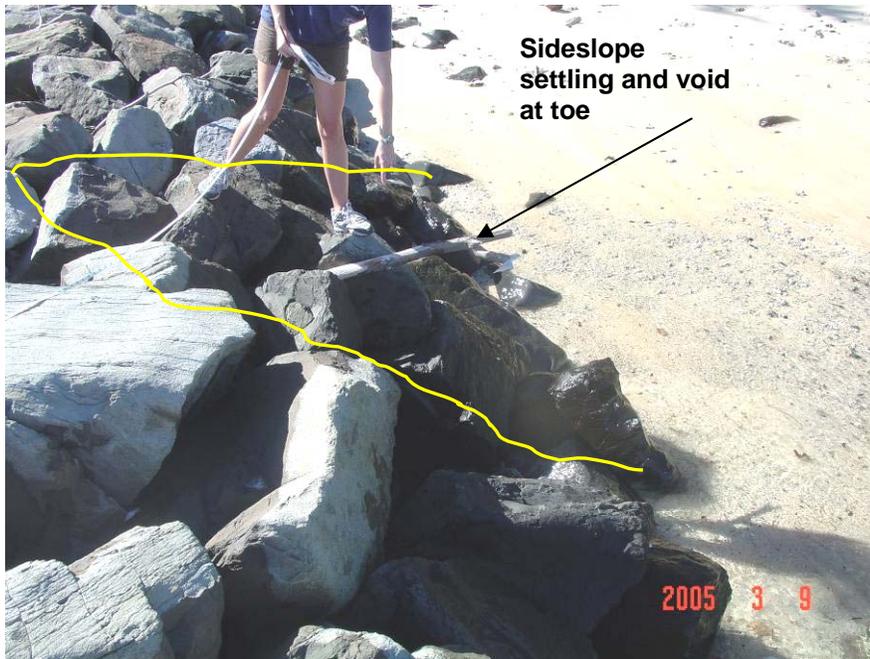
c. Sta. 0+55, HS, Slight sideslope settling (10'x5' area) and void at toe.

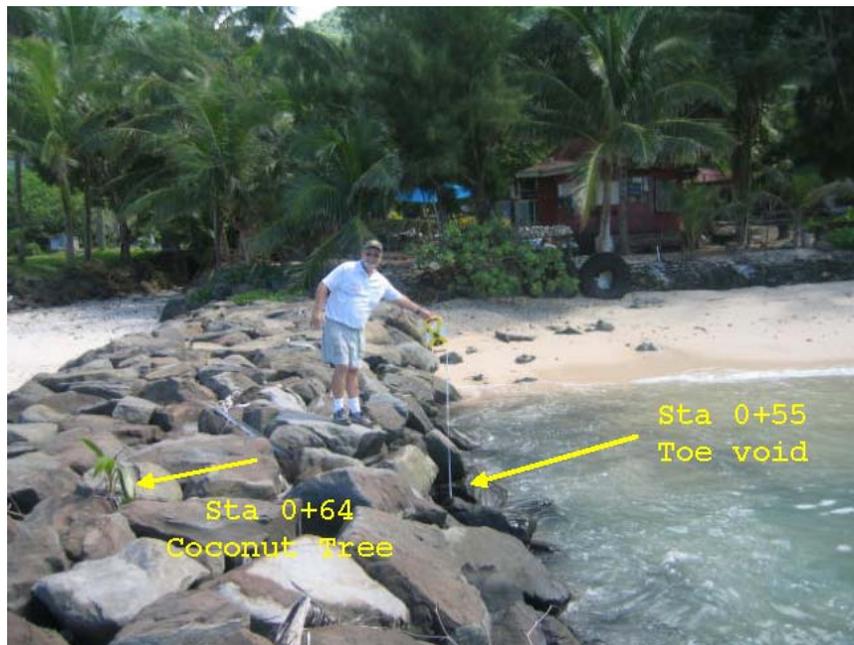
d. Sta. 0+64, CL, coconut tree growing, remove. (2004 Photo)

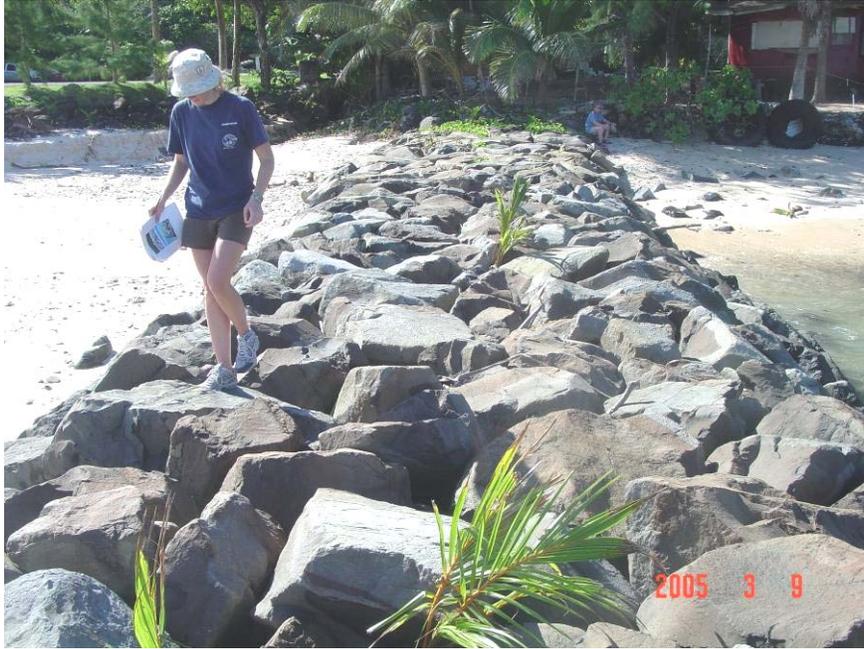
e. Sta. 0+98, Overview facing landward. Several small coconut trees in the area, remove.

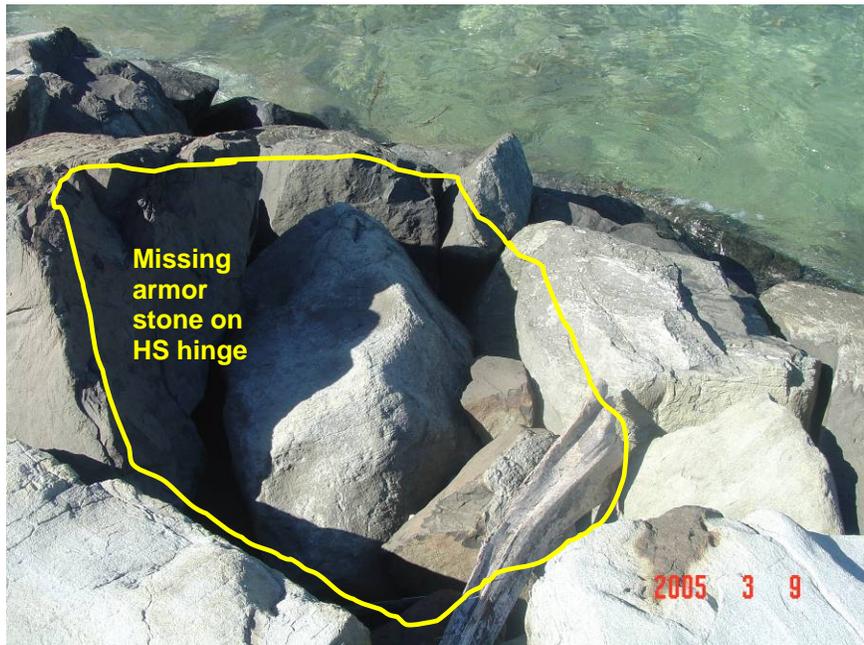
f. Sta 1+08, HS, 1 ea. Missing armor stone at hinge, and some settling of crest.

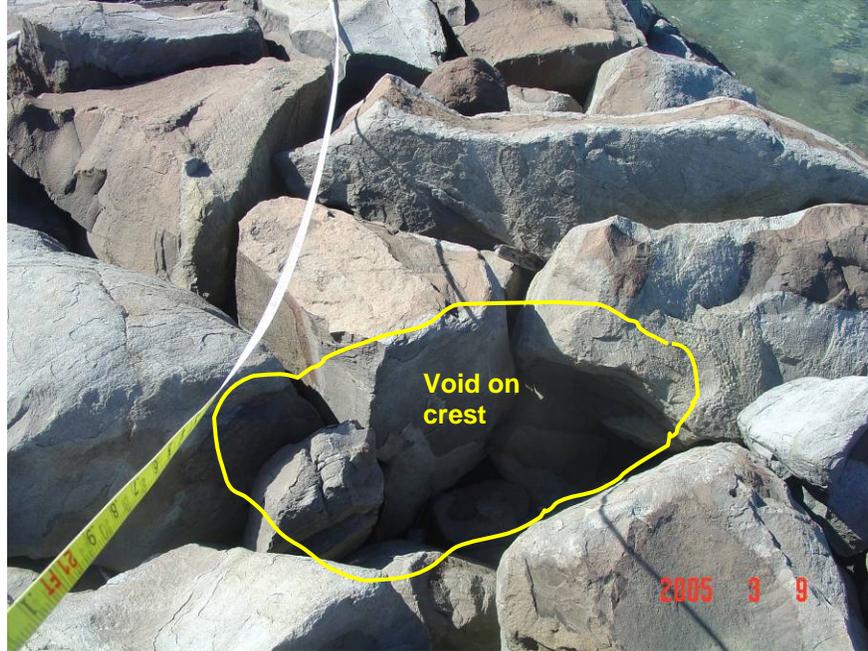
g. Sta. 1+27, Void on jetty crest, underlayer exposed. No visible displaced stone nearby. Void on HS sideslope and bridging (not shown).

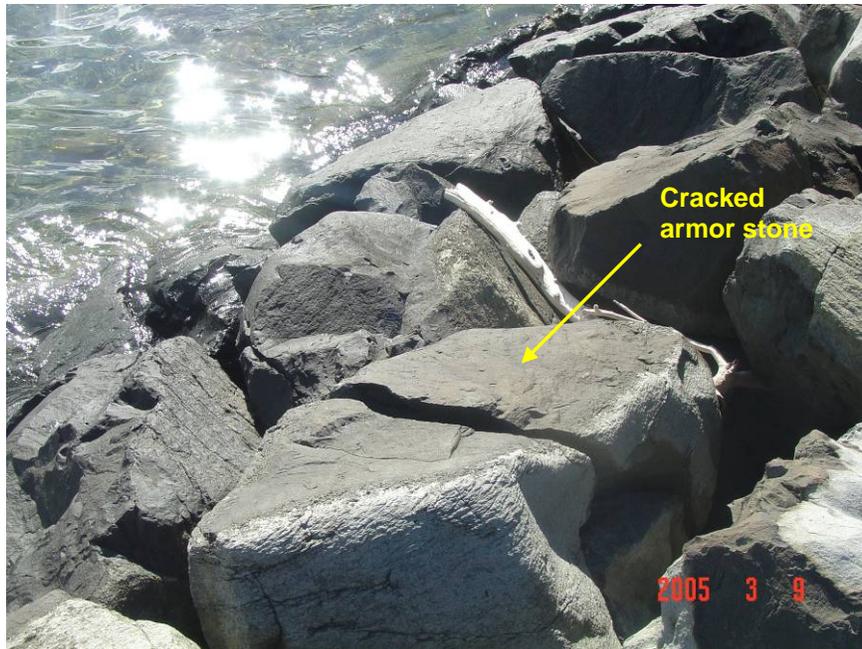
i. Sta 2+79, OS, Cracked armor stone on oceanside and flipped stone on harborside (not shown).

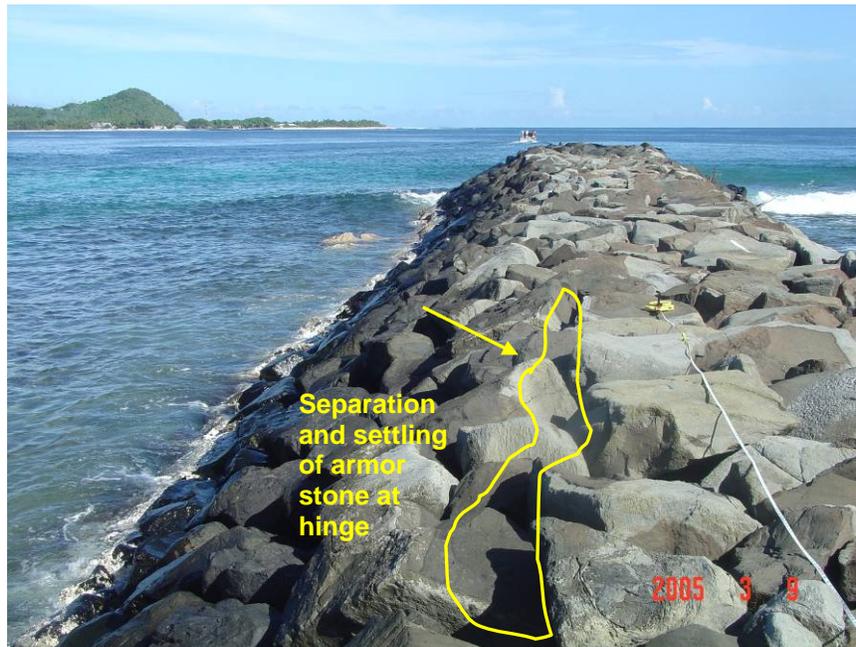
j. Sta 3+07, HS, Sideslope and hinge settling, UL exposed. Centerline armor stone bridging.

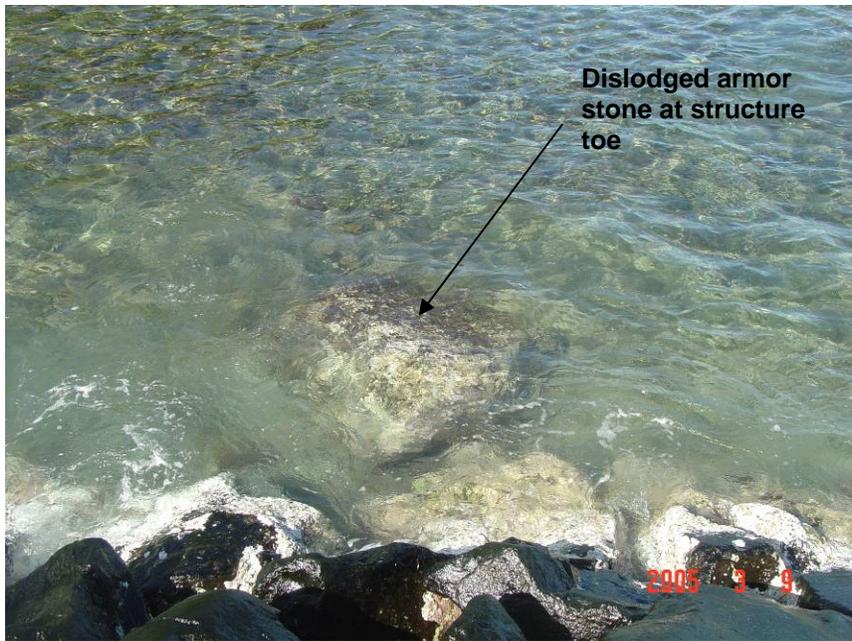
l. Sta. 3+52, HS, 1 dislodged armor stone 2' from toe, no obvious void nearby.

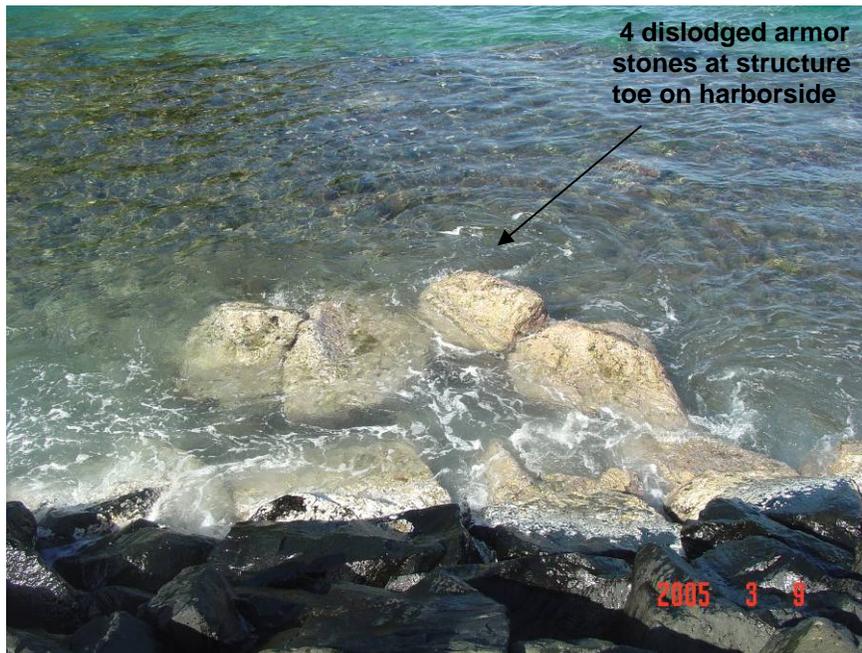
m. Sta. 3+87, HS, 4 armor stones resting 3' from the toe of the structure, no obvious voids.

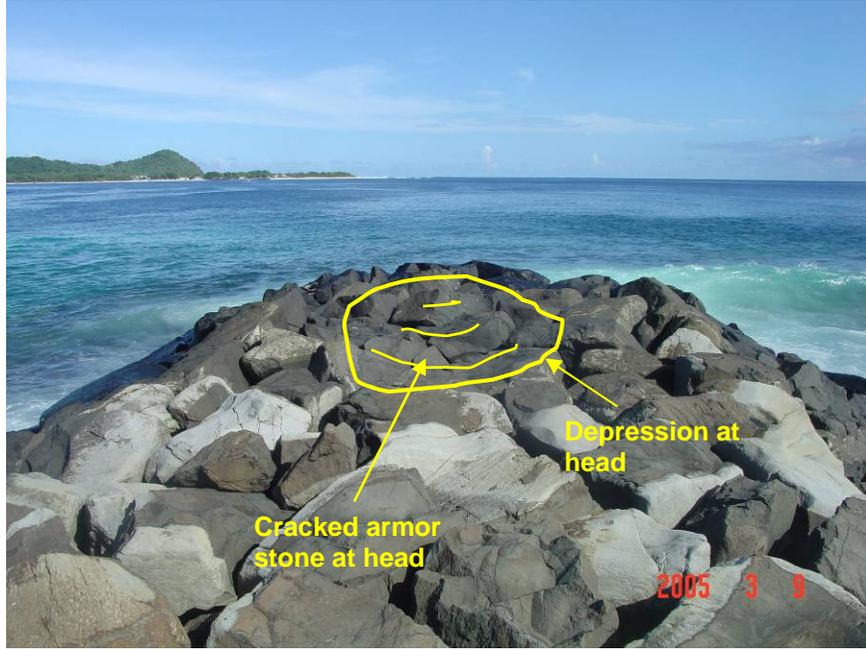
n. Sta 4+16, Armor stone depression at head and cracked armor stone.

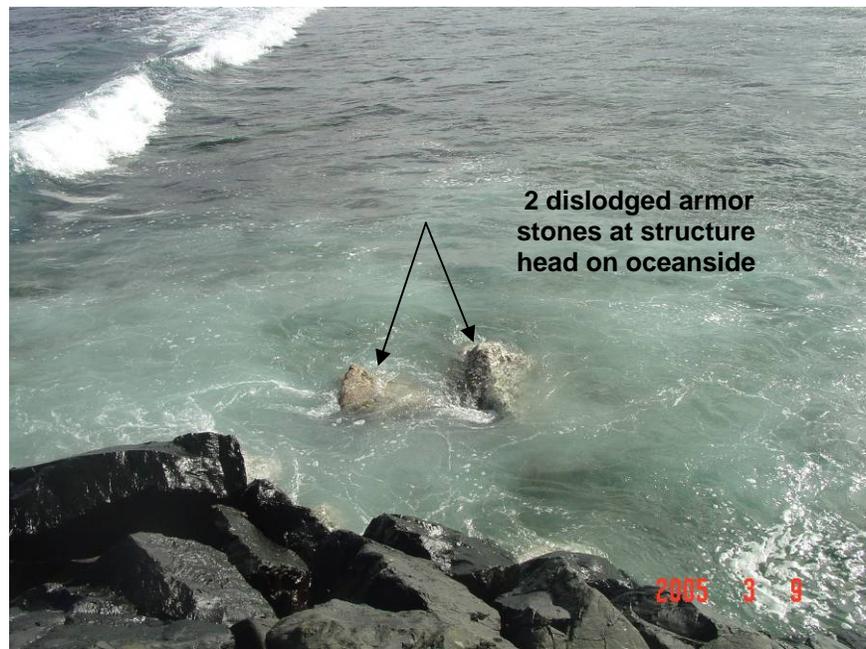
o. Sta. 4+20, OS, 2 dislodged armor stones 3' from head.

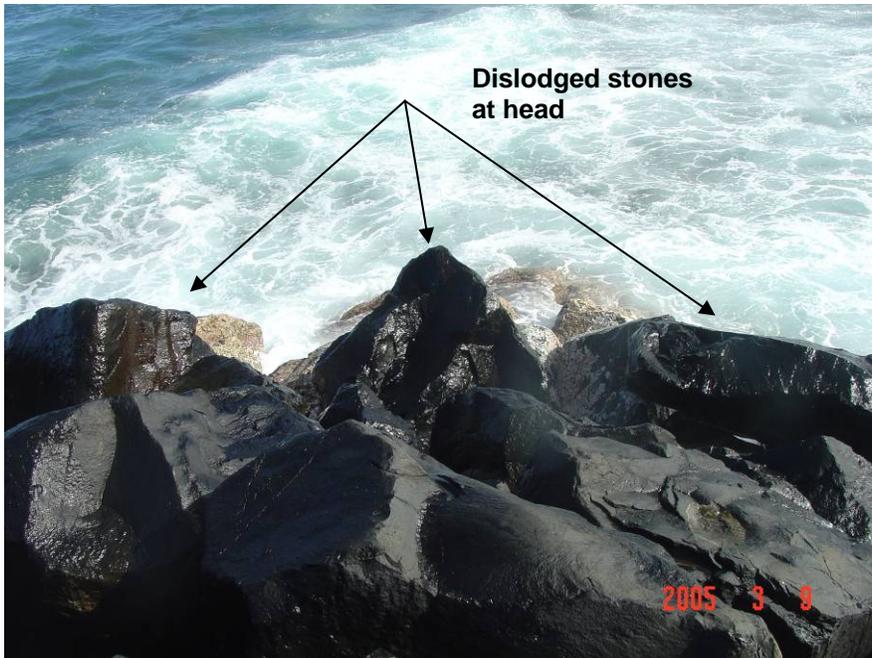
p. Sta 4+30, Head, Voids and resulting dislodged stones on oceanside of head (crest to water level, 0 to 80 degrees).

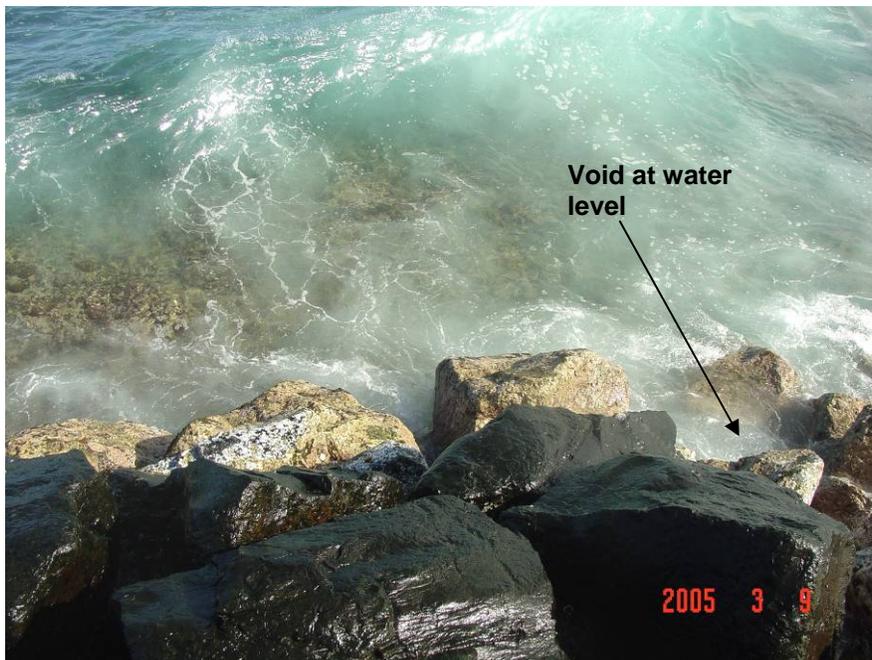
q. Sta 4+30, Head, Void at water level on harborside of head.

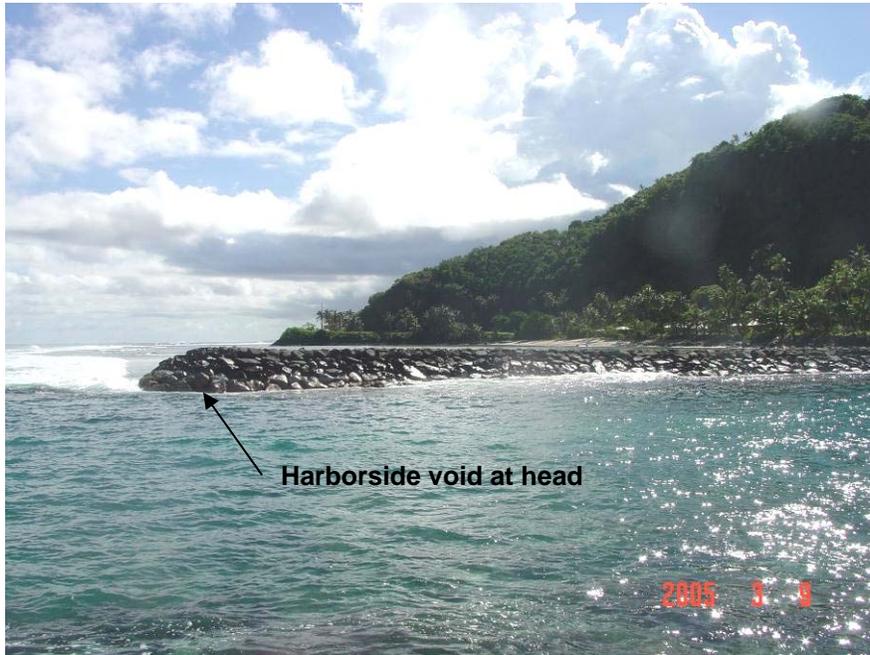
r. Overview of West Jetty, head is damaged, but remains primarily intact.

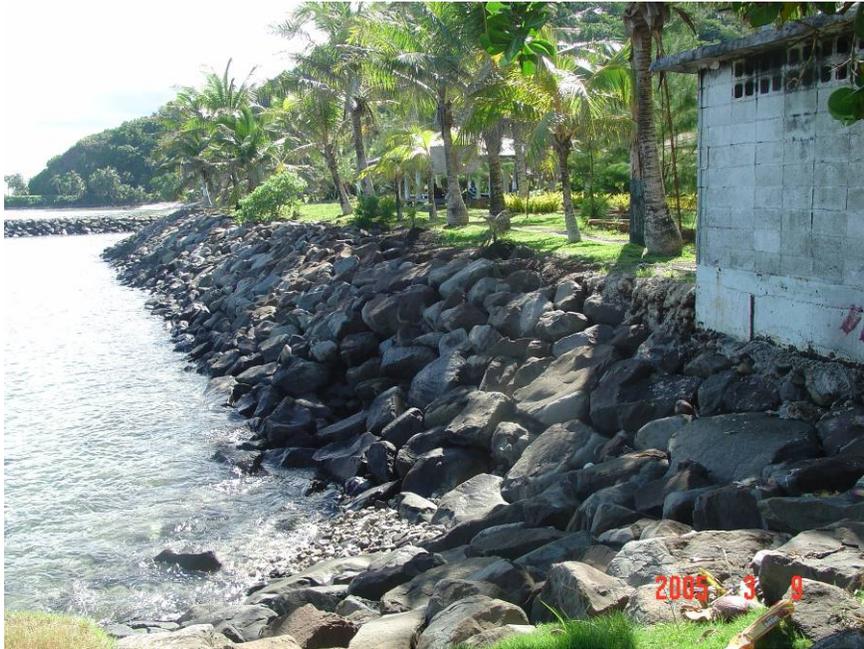
Overview of interior revetment (Non-federal responsibility).
