CONTINUING ELIGIBILITY INSPECTION (CEI) REPORT
FOR HURRICANE & SHORE PROTECTION PROJECTS
Honolulu Engineer District
CEPOH-EC-T

1. Project Name: Afono Shore Protection Project
2. Date of Inspection: March 15, 2005
3. Inspection Personnel:

AFONO AREA, AMERICAN SAMOA

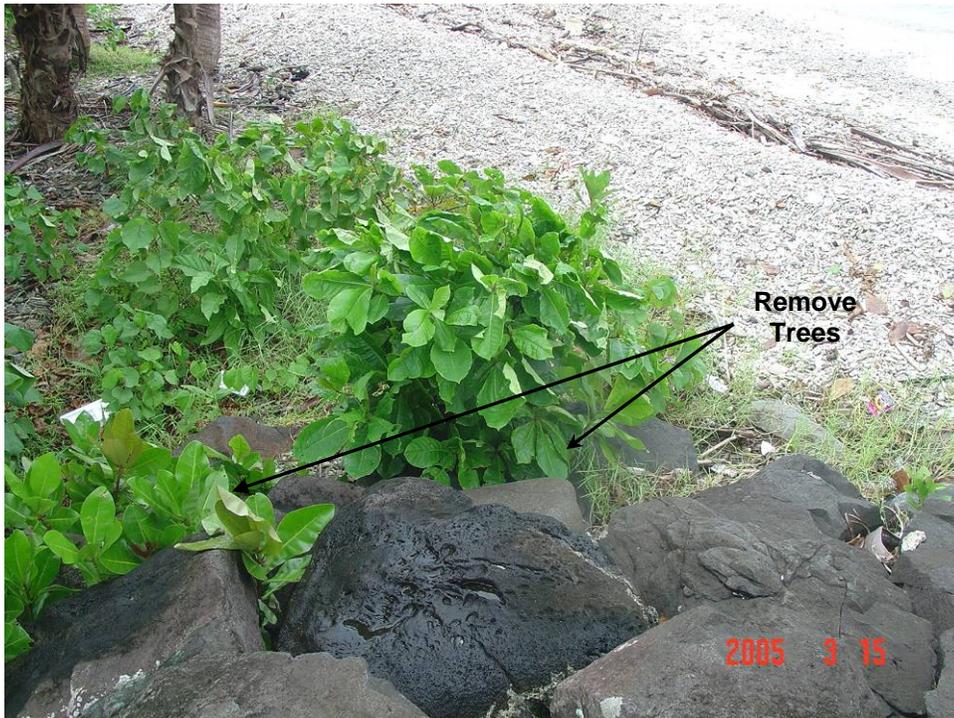
b. Sta. 0+33, Remove juvenile trees from oceanside toe.

The focus of the maintenance required should be directed at vegetation control. Removal or herbicides are recommended in lieu of cutting.

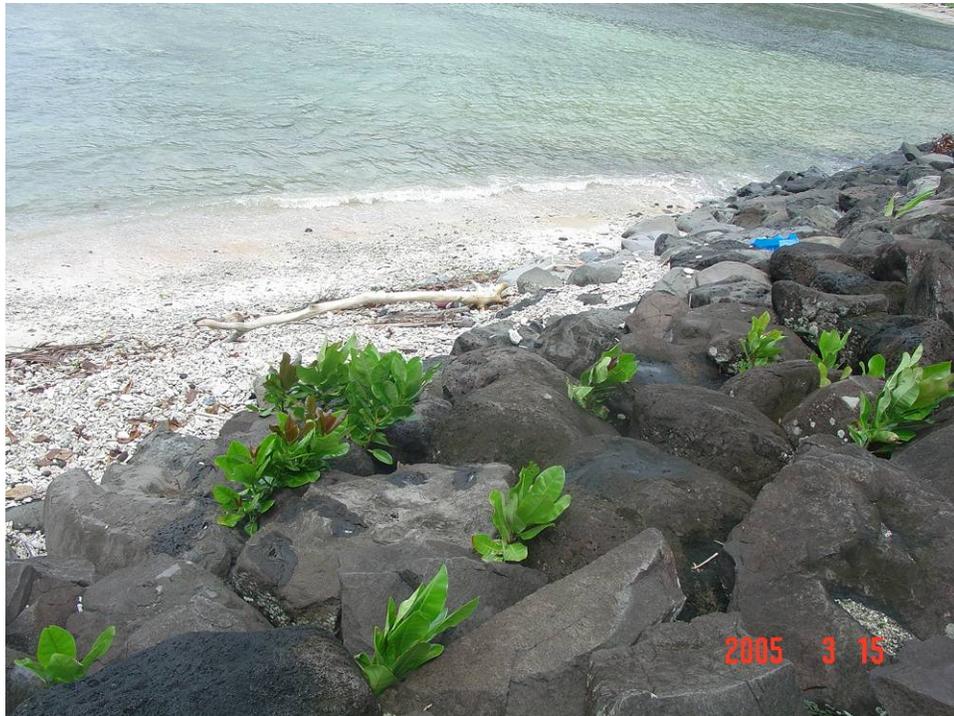
c. Sta. 0+76, Remove juvenile trees at landward edge of structure, increased vegetation here since last inspection. Sta 0+87, Remove vegetation at centerline of crest, spray only (no picture).

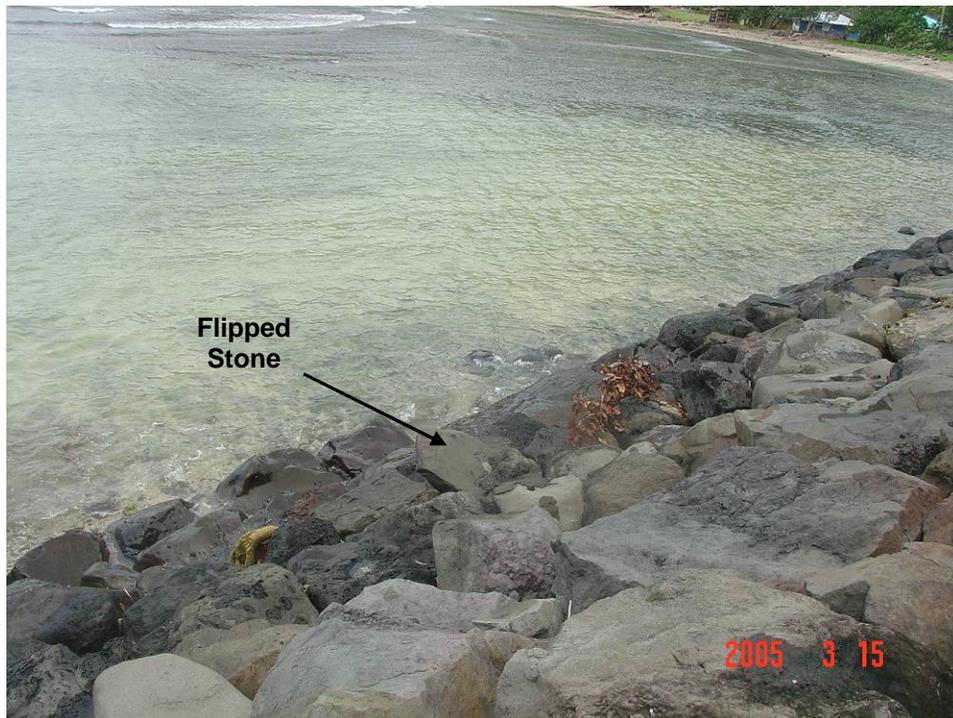
d. Sta. 1+07, Flipped armor stone on sideslope, minor settling at centerline of crest, monitor.

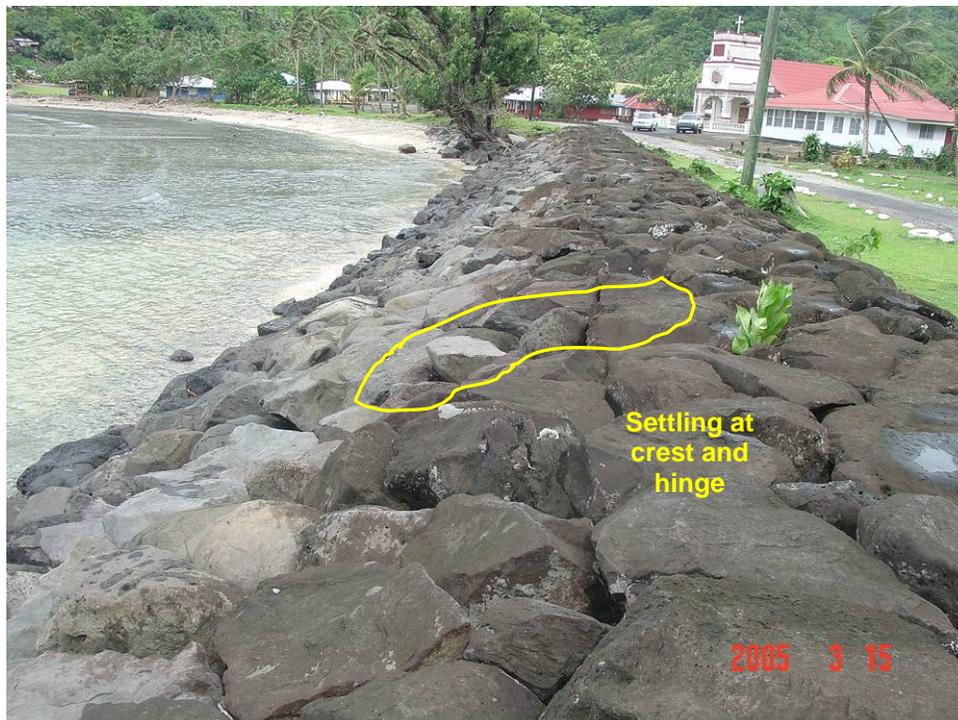
e. Sta 1+37, Settling at crest and hinge, monitor. Minimal vegetation beginning to grow, remove.

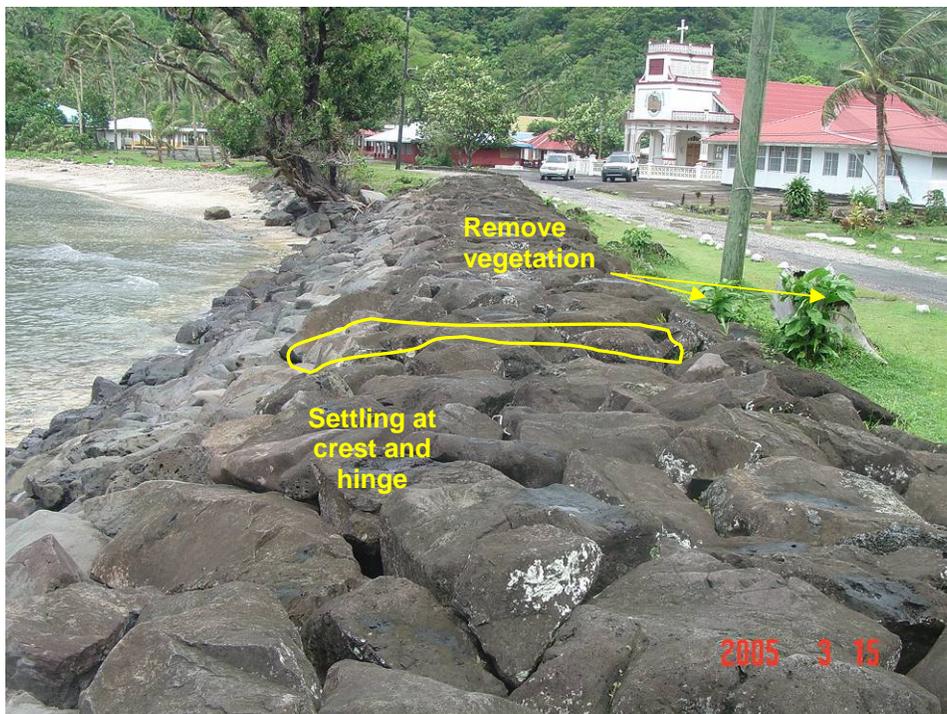
g. Sta. 1+60, settling at hinge, monitor. Vegetation at landward side of structure, remove.

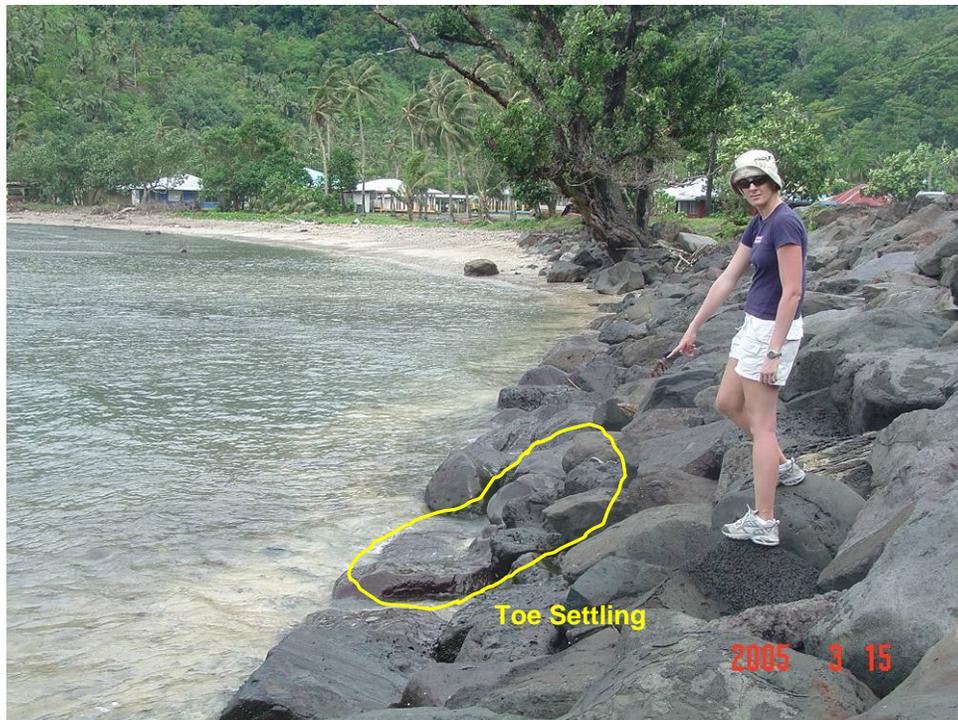
i. Sta. 2+56, Monitor sideslope settling at toe.

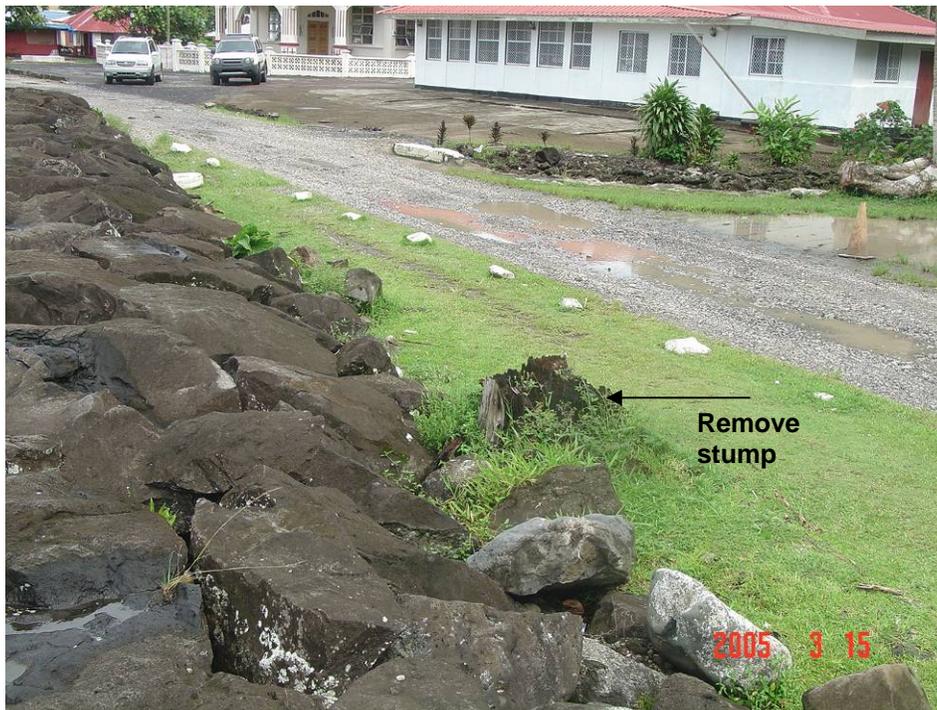
j. Sta 2+56, Remove stump at landward slope of structure.

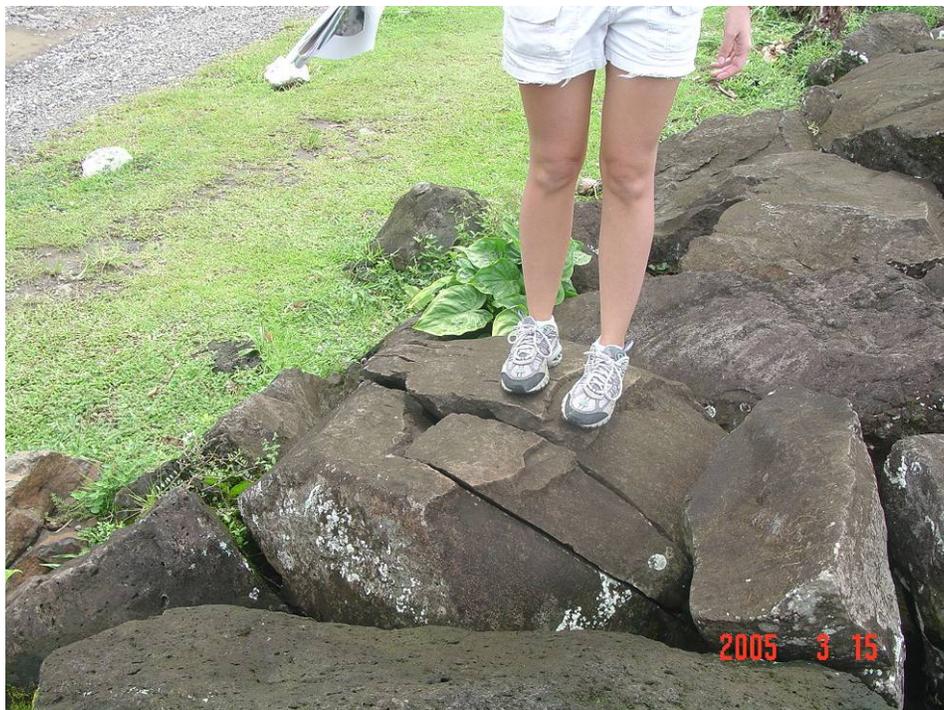
k. Sta 2+78, Split armor stone on landward edge of crest.

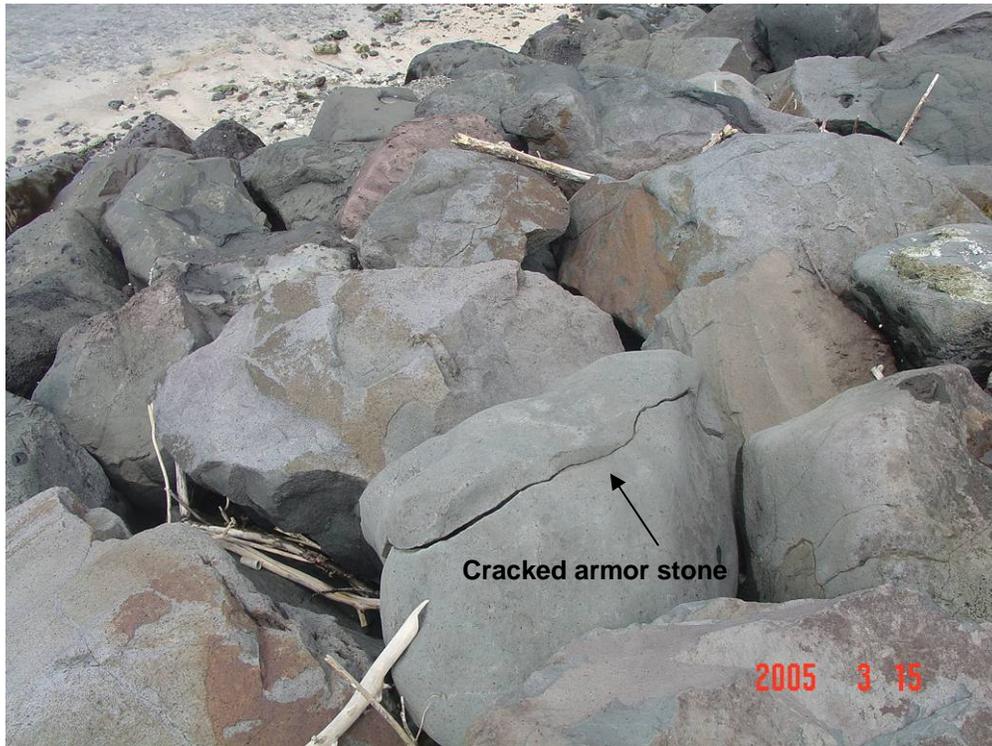
l. Sta 2+81, Cracked armor stone at crest on oceanside hinge.

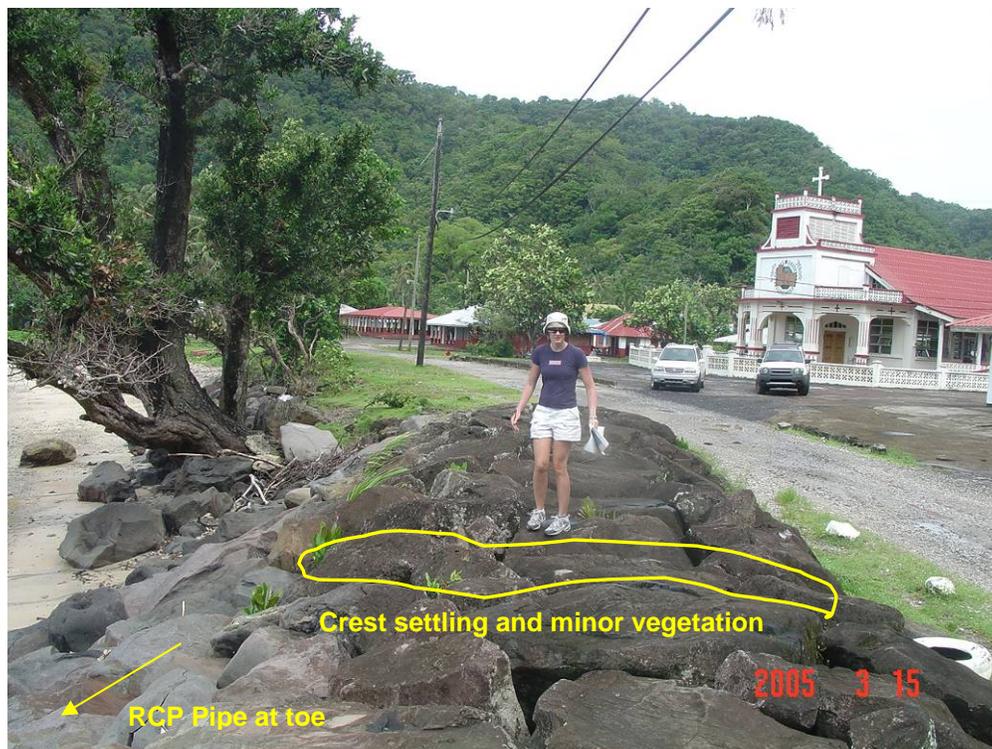
m. Sta 2+86, Monitor settling at crest, remove vegetation, and location of RCP pipe.

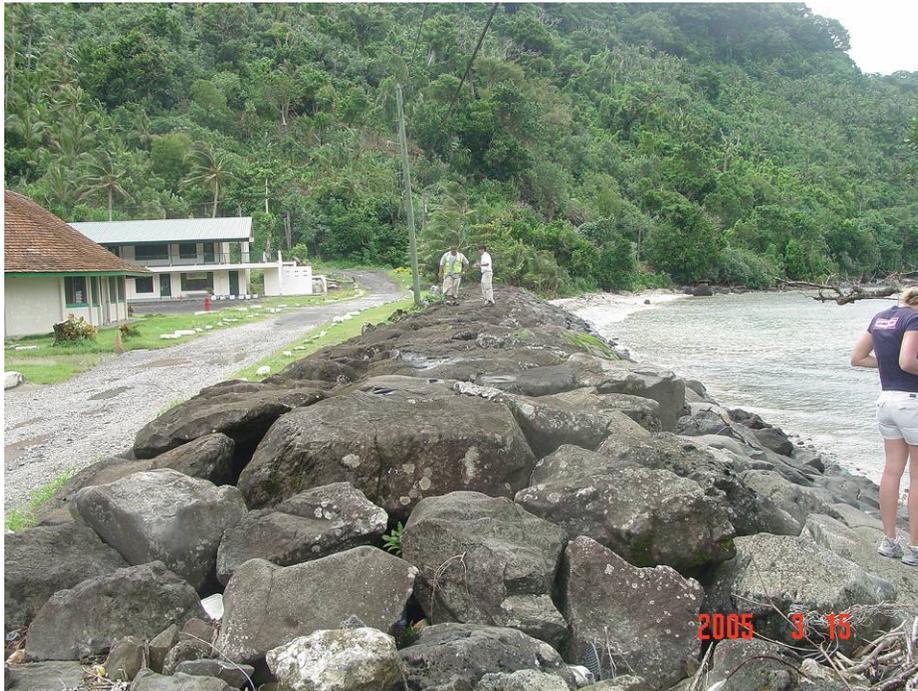
n. Sta 3+30, Overview from end of structure, minor vegetation removal needed.

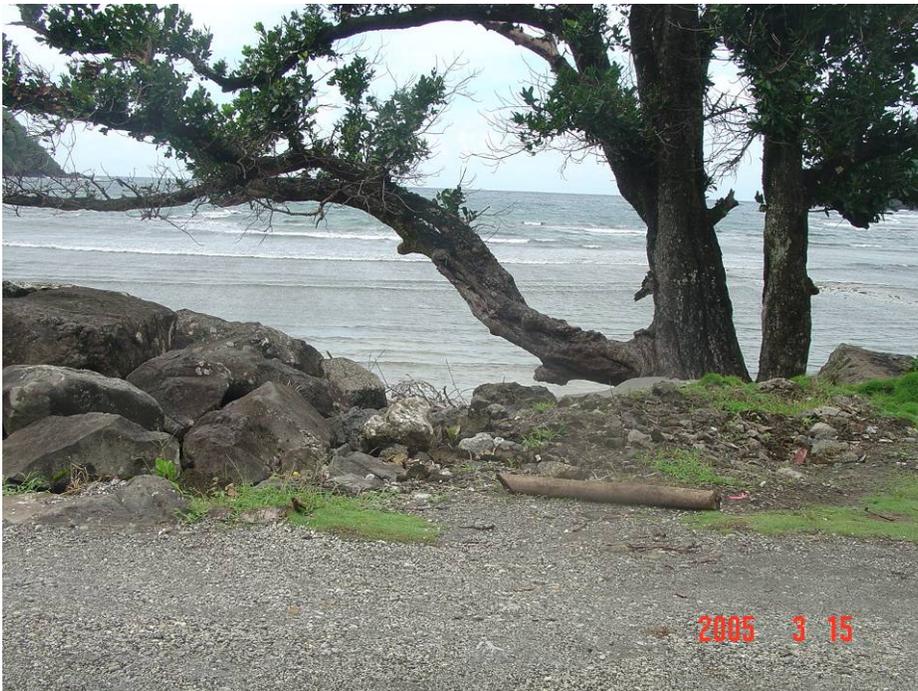
1. Sta 3+30, Juvenile trees noted in last inspection have been removed.
