**CONTINUING ELIGIBILITY INSPECTION (CEI) REPORT**  
**FOR HURRICANE & SHORE PROTECTION PROJECTS**  
Honolulu Engineer District  
CEPOH-EC-T

1. Project Name: Masefau Shore Protection Project

2. Date of Inspection: March 16, 2005

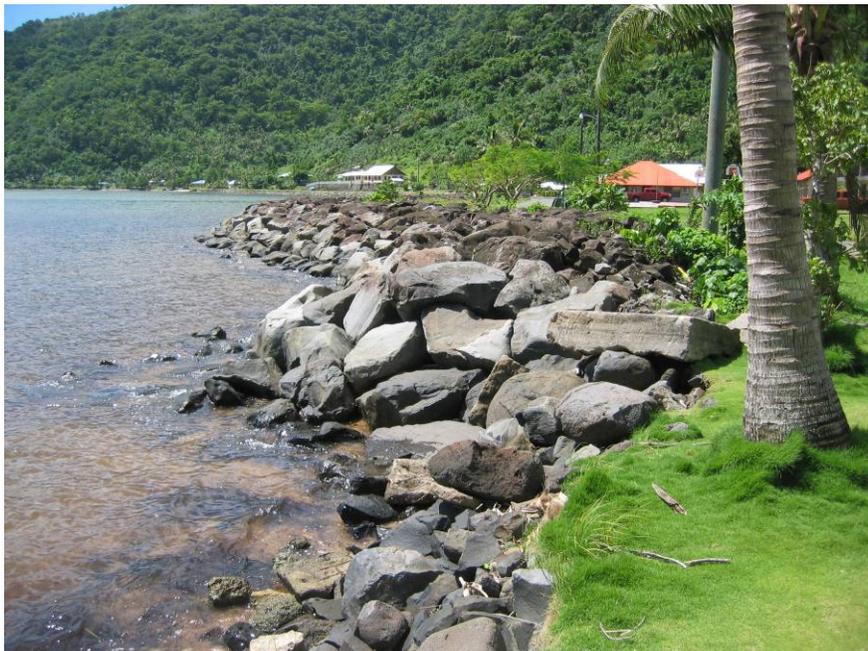
a. Sta. 0+00, Tieback at northern end of project.

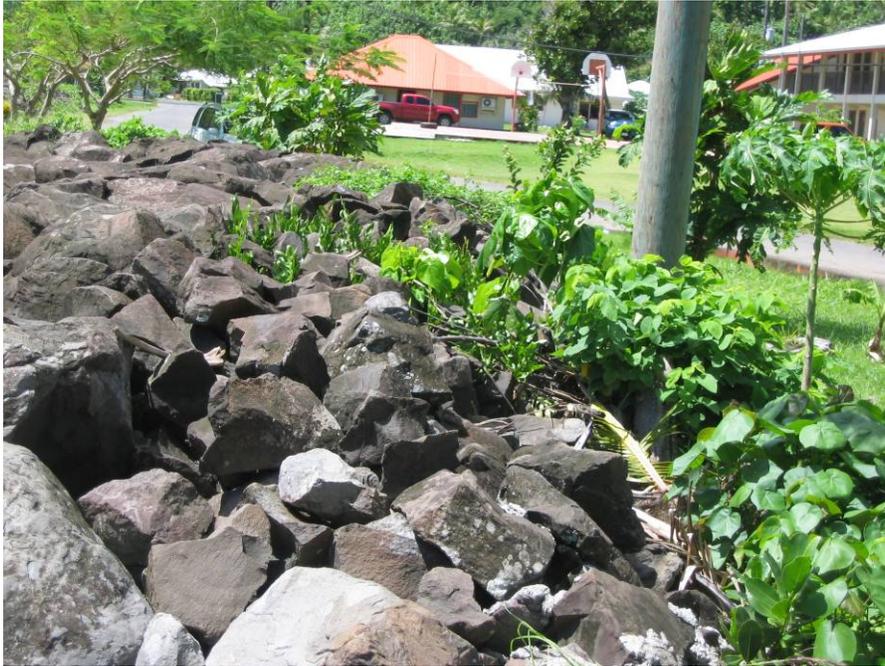
b. Sta. 0+00 - Sta. 0+40 (First Bend), Remove vegetation from interior sideslope of revetment, slight increase in vegetation since previous inspection, possibly newly planted trees. New utility pole at approximately 0+17.

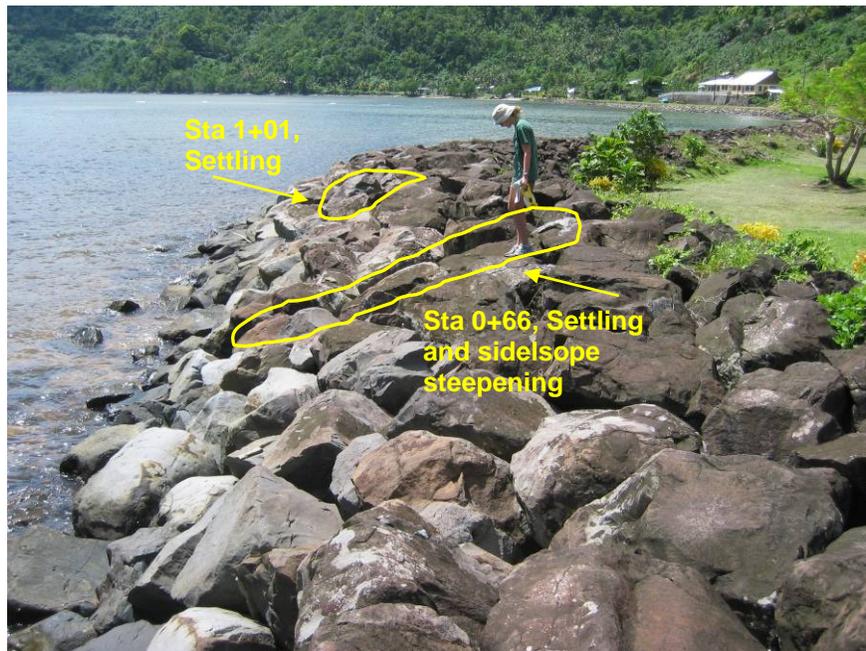
c. Sta. 0+66, Settling, bulging, and steepening at exterior sideslope hinge. Sta. 1+01, Settling at exterior sideslope hinge and centerline of crest (3 stones). Monitor this area.

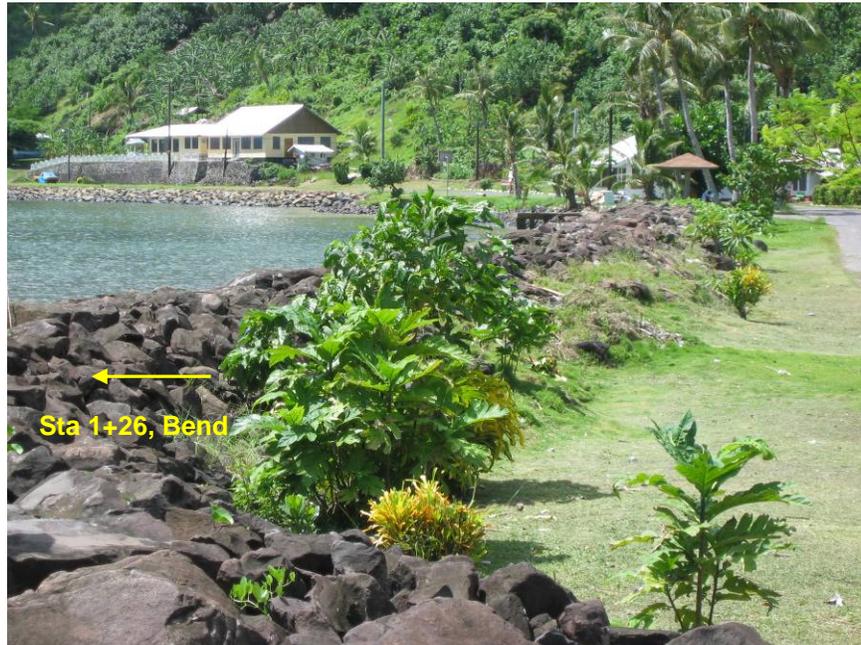
d. Sta 1+26, Vines noted on interior of bend in 2004 inspection have been removed, but trees and shrubs continue to grow. Remove juvenile trees from structure and within 5 feet of interior toe.

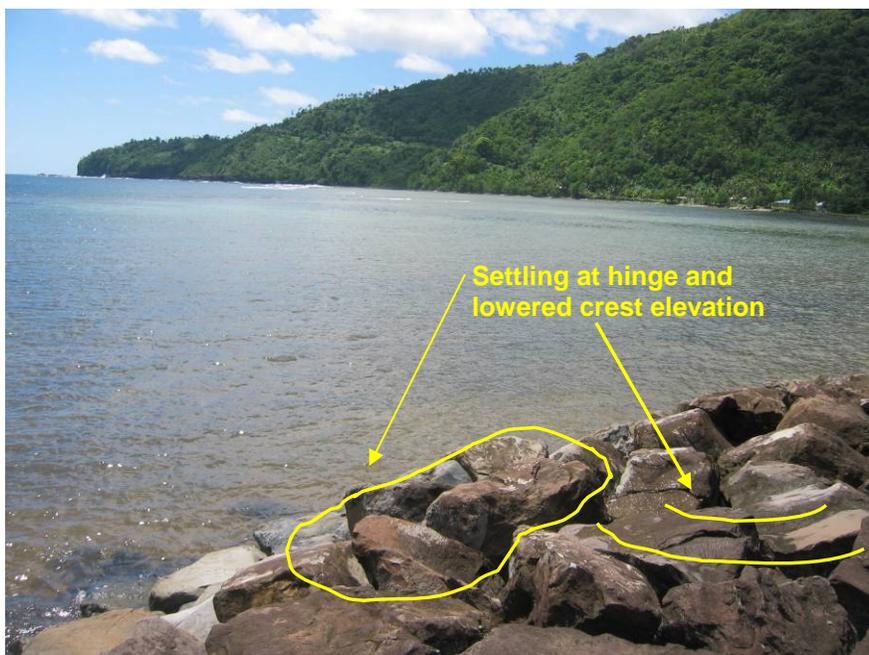
e. Sta 1+26, Some settling at bend in structure on hinge, and lowered crest elevation. Monitor this area.

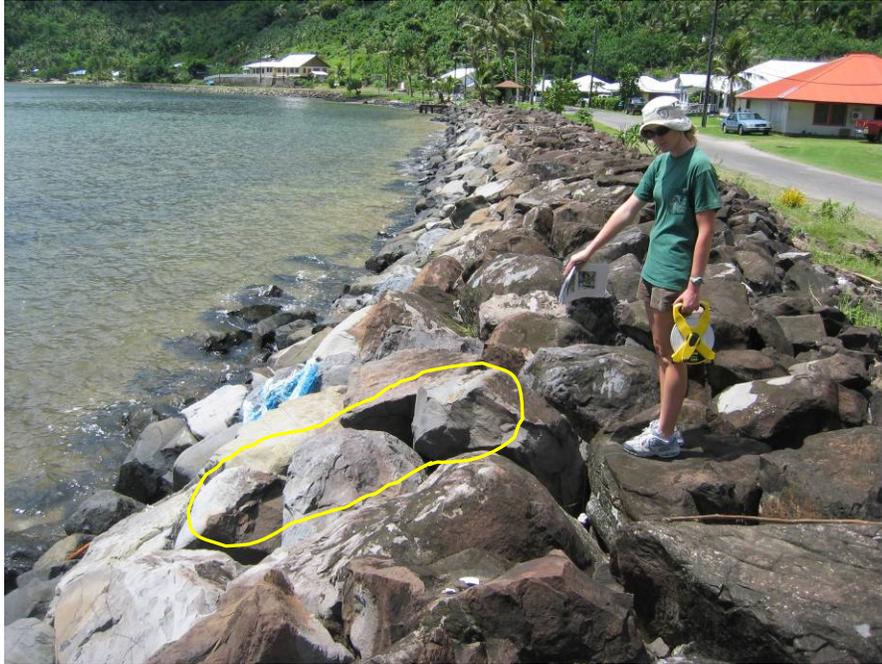
f. Sta 1+67, Minor settling at crest and sideslope. Monitor.

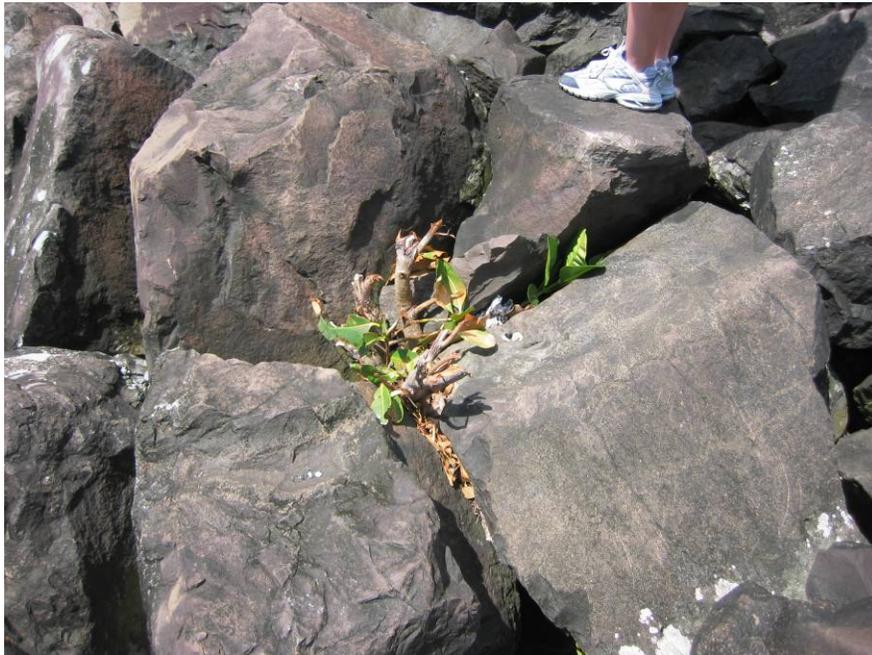
g. Sta. 1+91, Juvenile tree at centerline of crest has been cut but not entirely removed. Remove completely.

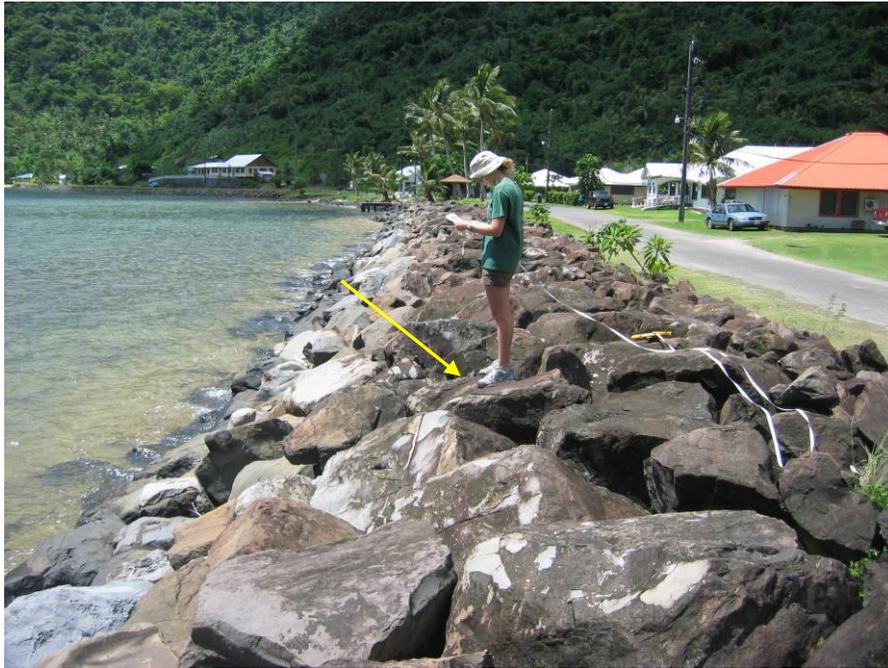
h. Sta. 2+14, Settling of single stone at crest, monitor.

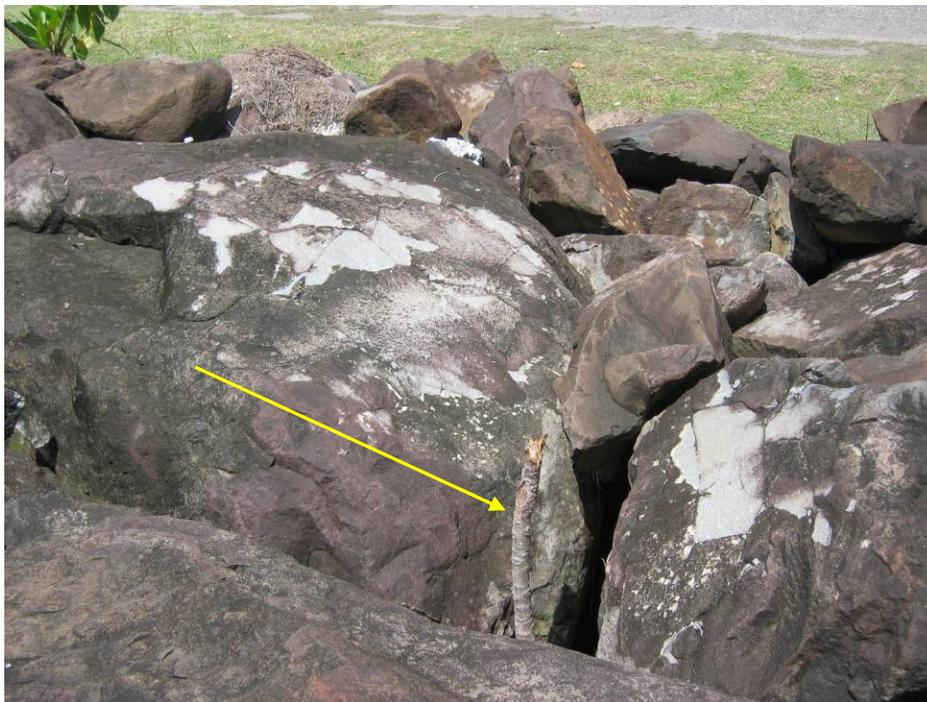
e. Sta. 2+43, Tree at centerline of structure has been cut but not entirely removed.

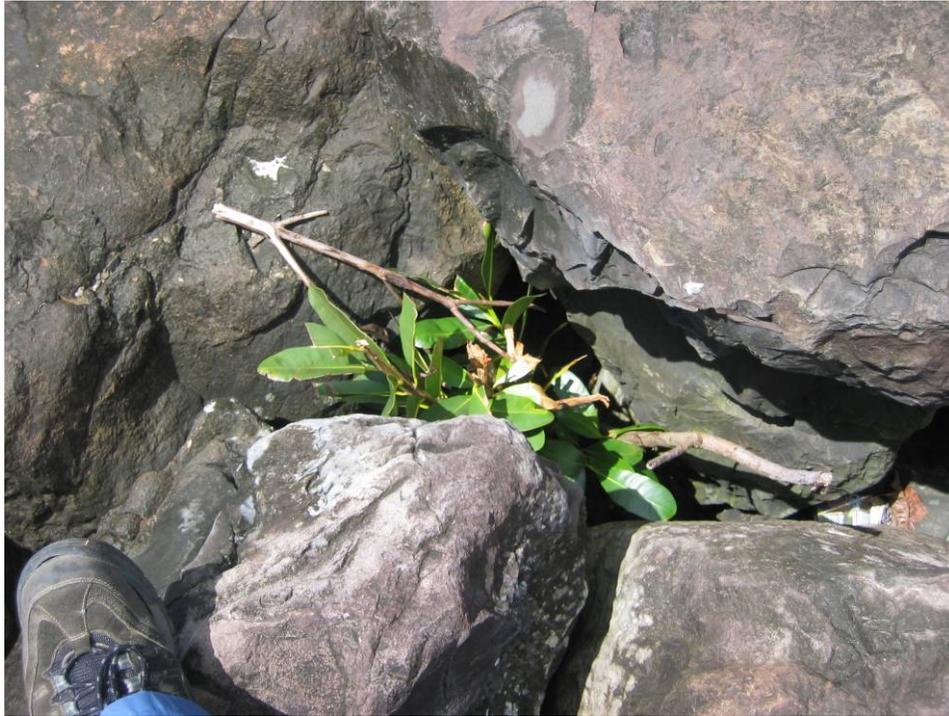
f. Sta. 2+47, Remove small tree on crest.

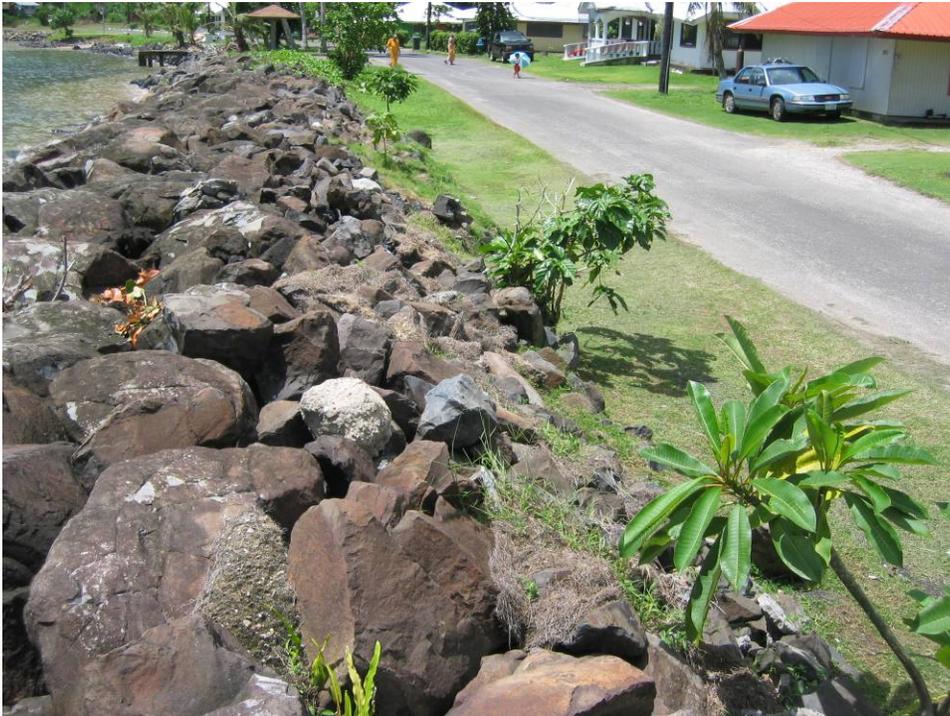
g. Sta. 2+50, Overview of interior side slope. Remove sod/grass on slope and small trees growing at interior of structure.

Structure is in good condition with minimal damage. The focus of the maintenance required should be directed at vegetation control. Removal or herbicides are recommended in lieu of cutting. DPW has been requested to remove all vegetation on interior slope of revetment along its length.

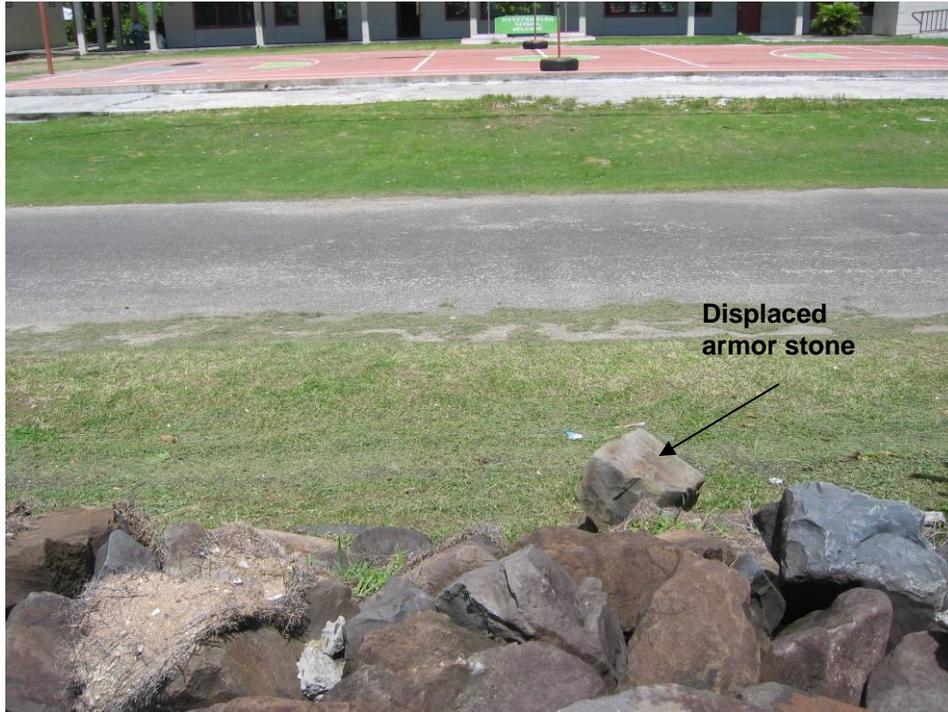
h. Sta. 2+62, Displaced armor stone at interior of revetment. Reset stone.

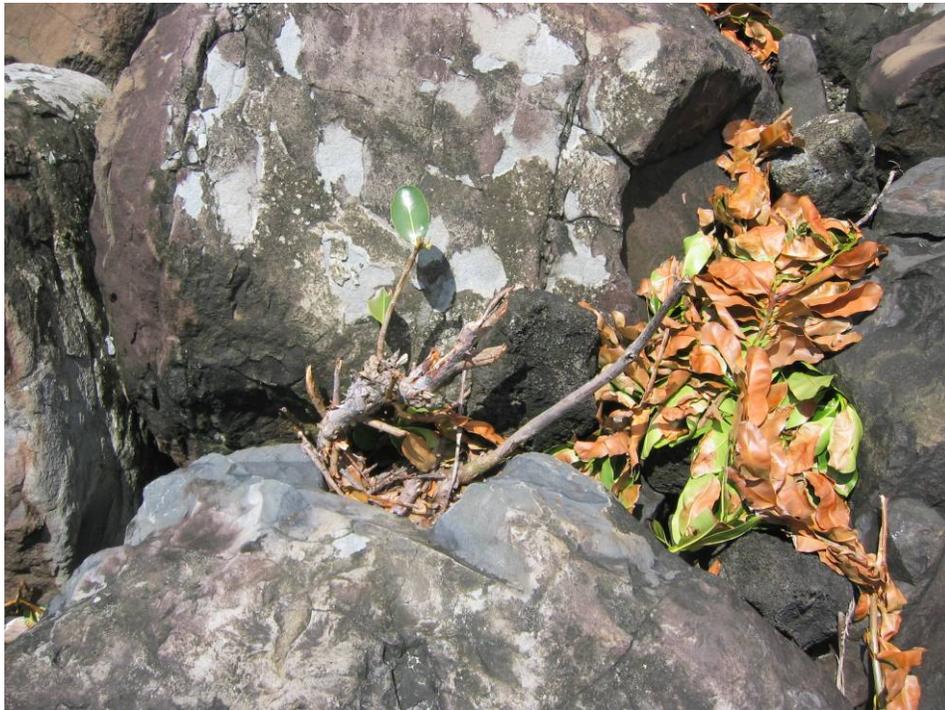
i. Sta. 2+67 to 2+72, Remove vegetation at centerline of crest.

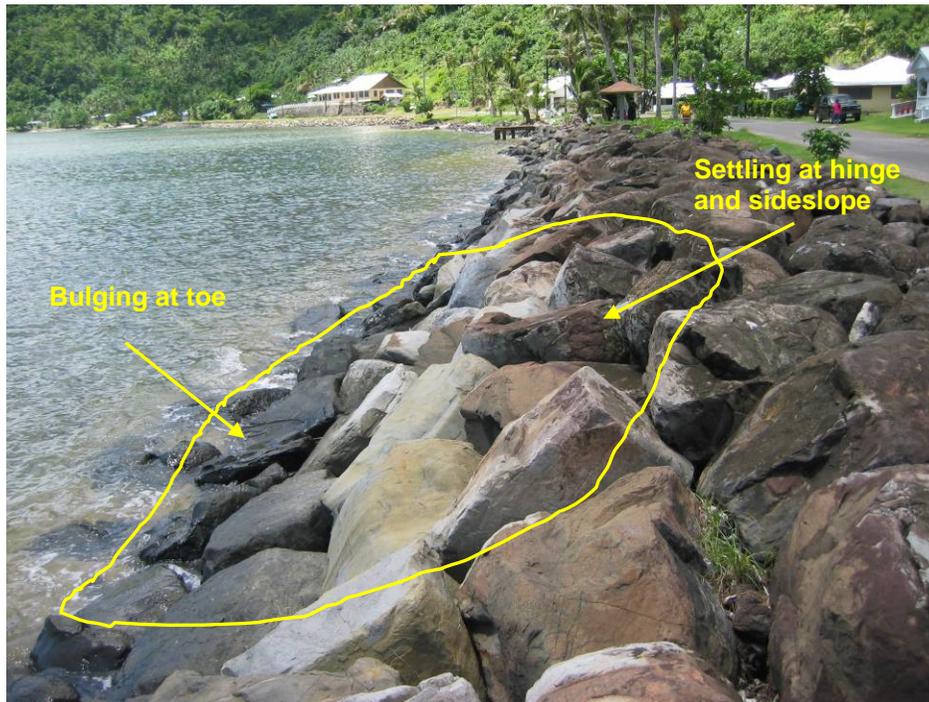
j. Sta. 3+00 to 3+33, Continued settling of armor stones along hinge exterior sideslope, some bulging at structure toe. Monitor.

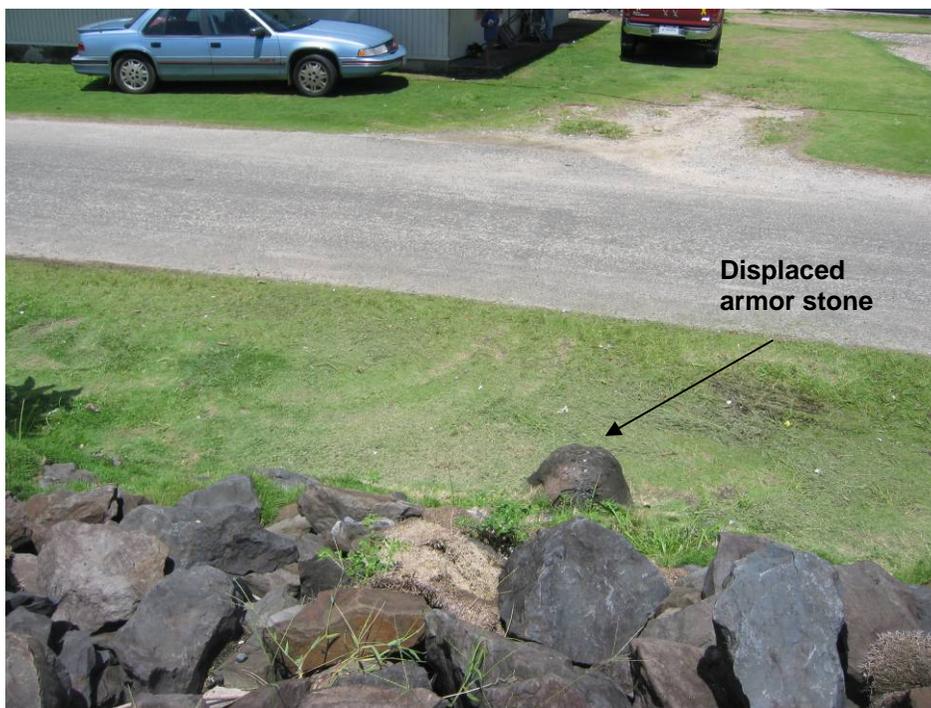
k. Sta. 3+14, Displaced stone at interior of revetment. Reset.

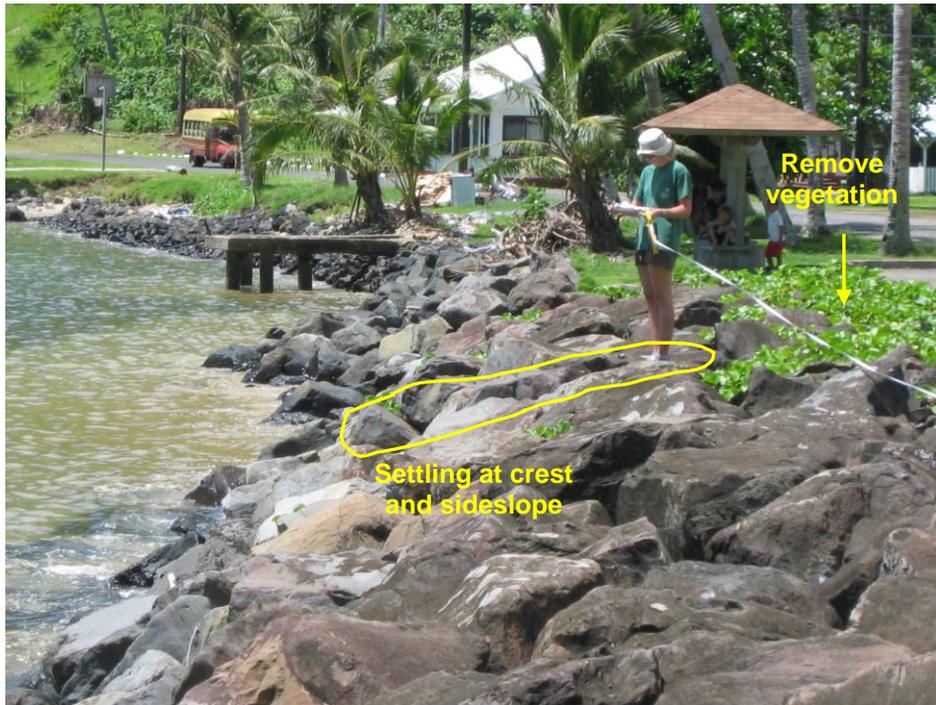
l. Sta. 3+55, Settling at crest and exterior sideslope. Remove vegetation to end of project.

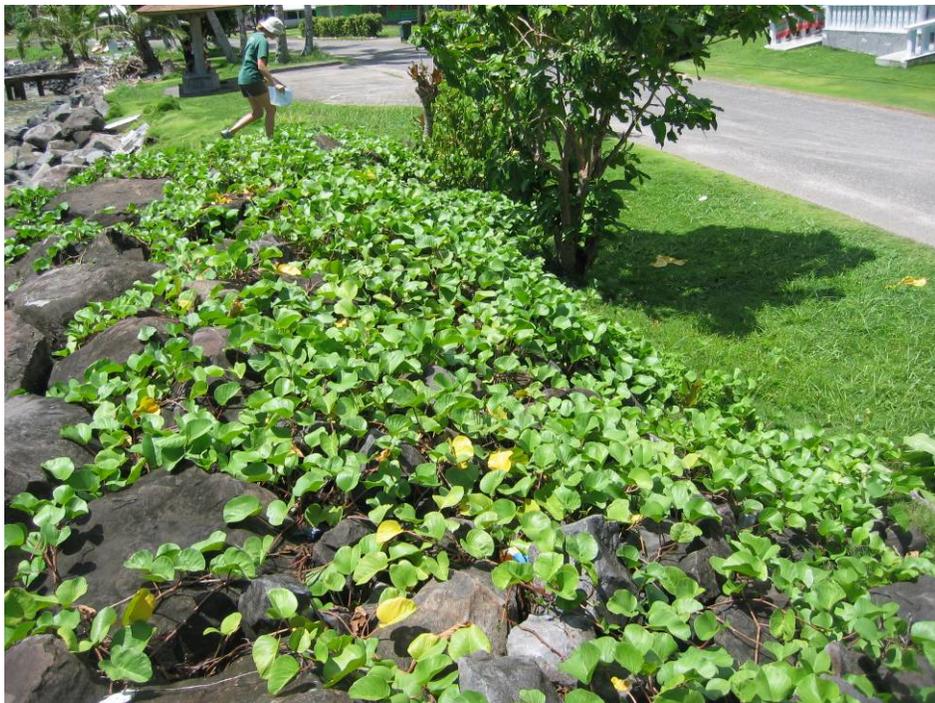
m. Sta 3+87, Remove extensive vegetation at interior of structure.

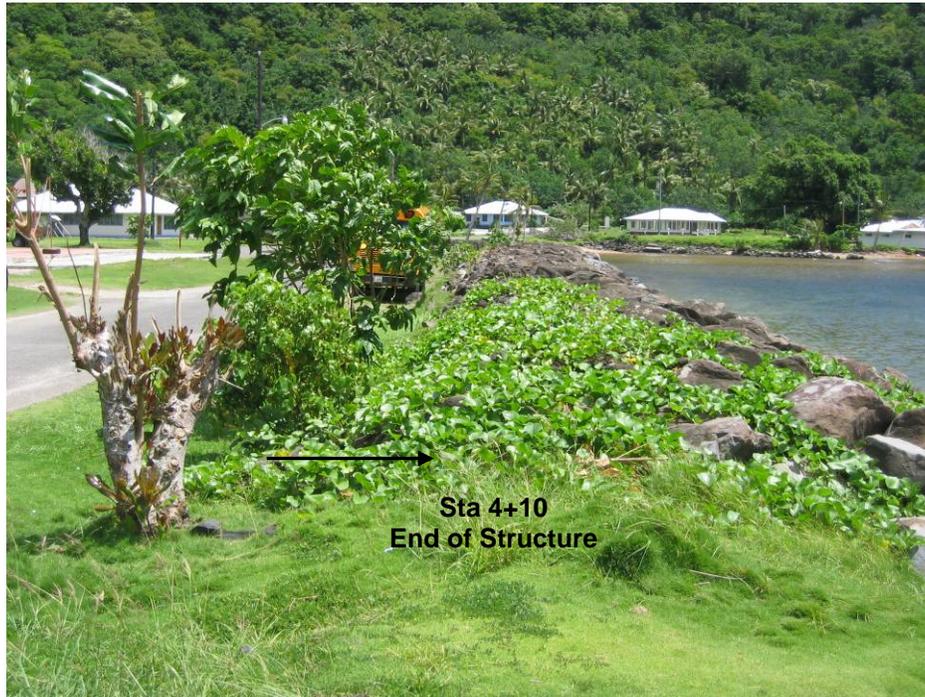
n. View of vegetation from end of structure.

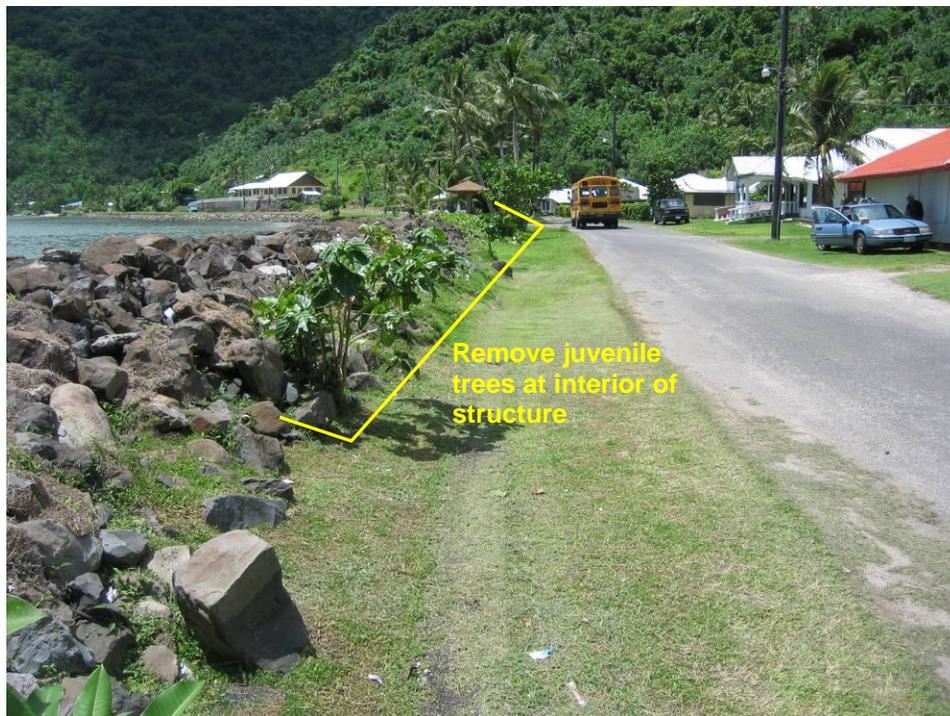
o. Overview of interior of revetment facing south. Remove juvenile trees within 5 feet of structure toe.
