1. Project Name: Agana SBH
2. Date of Inspection: JULY 18, 2007
3. Inspection Personnel:

4. Discussion:

AGANA SMALL BOAT HARBOR, TERRITORY OF GUAM

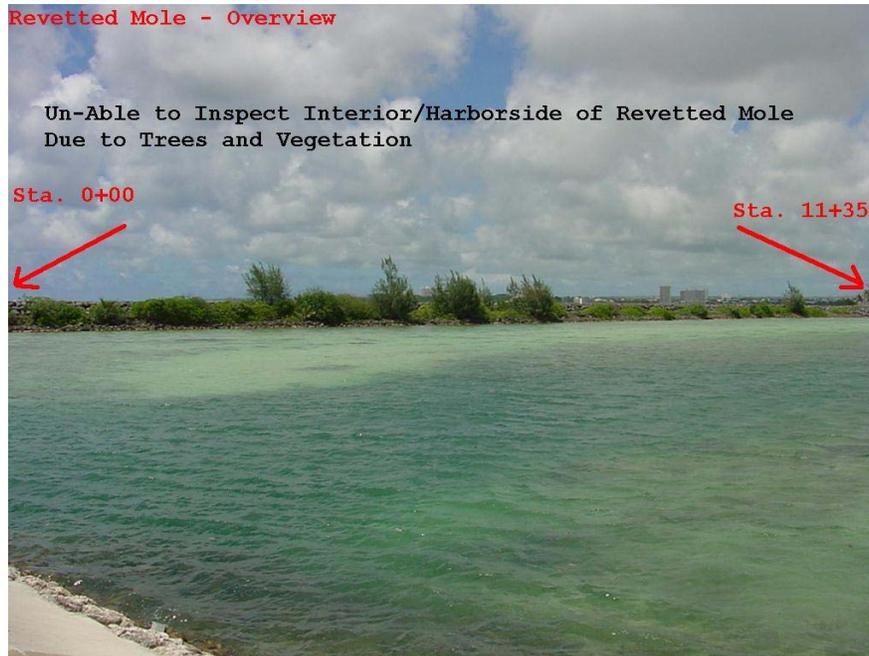
a. Sta. 0+00 to Sta. 11+35, HS, Overview of vegetation to be removed (FY03 photo).

Immediate attention should be given to vegetation removal from both the revetted mole and the wave absorber structures. Armor Stones are being moved on the interior side of the revetted mole by large ironwood trees.

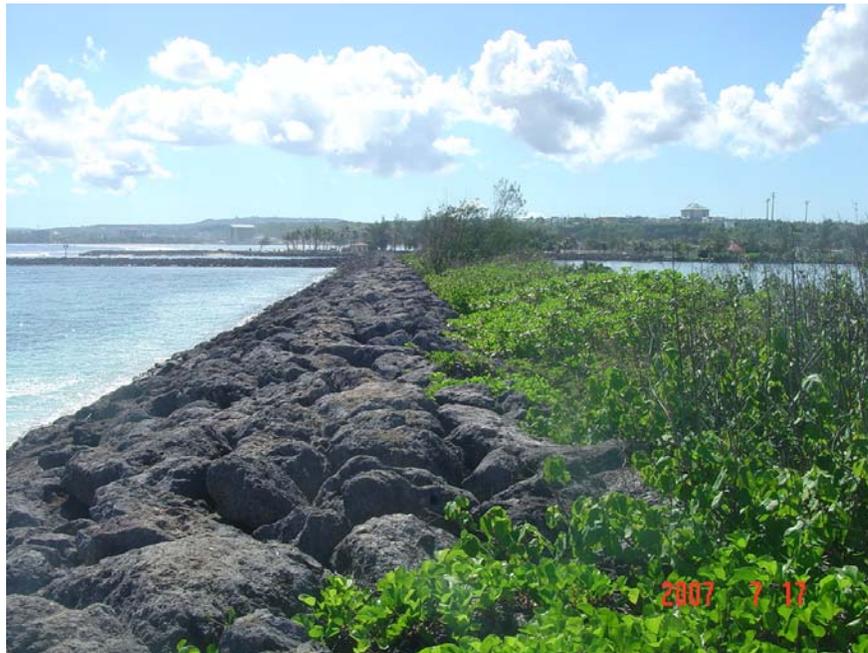
b. Sta. 0+00, Centerline Crest (CL), Remove vegetation on the HS. Unable to inspect.

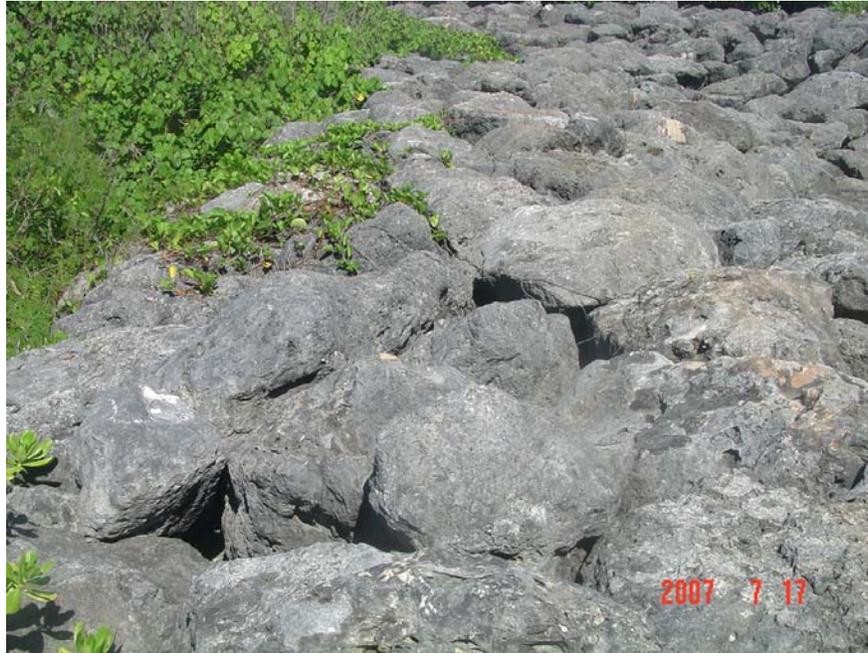
c. Sta. 0+85, CL, Monitor bridging and cracked armor stone.

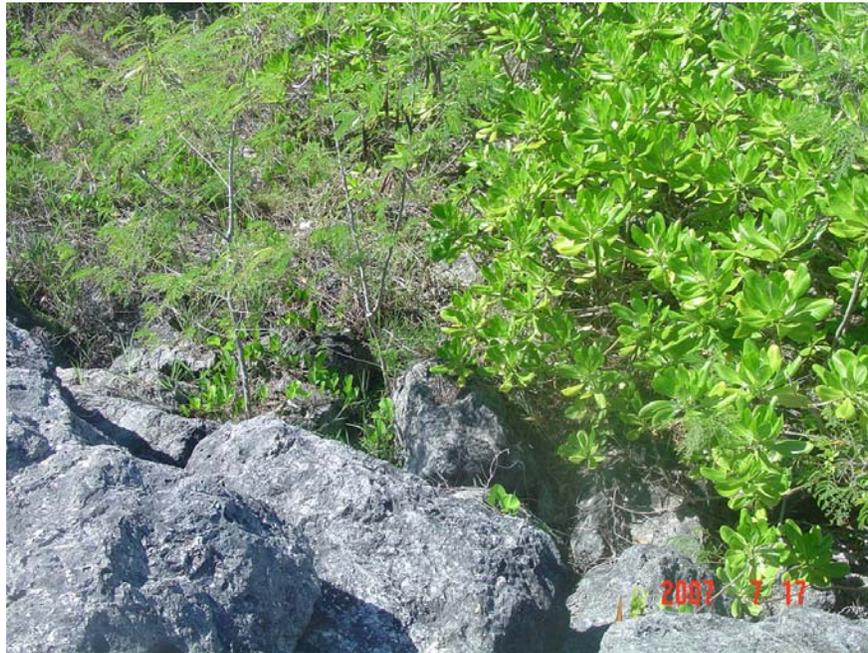
d. Sta. 1+25, HS, Dislocated armor stone resting adjacent to toe.

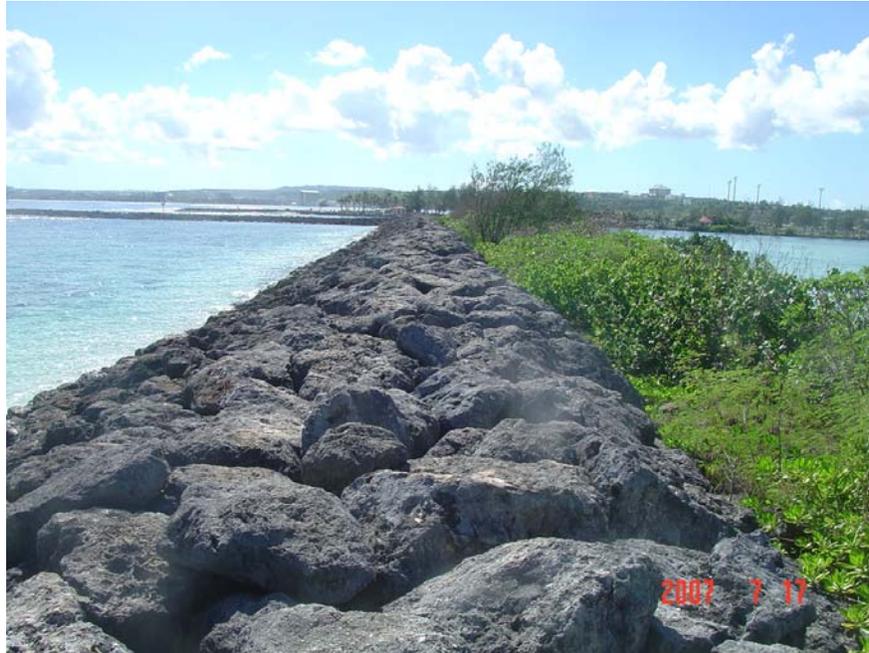
e. Sta. 1+35, Settling Oceanside bulging harborside.

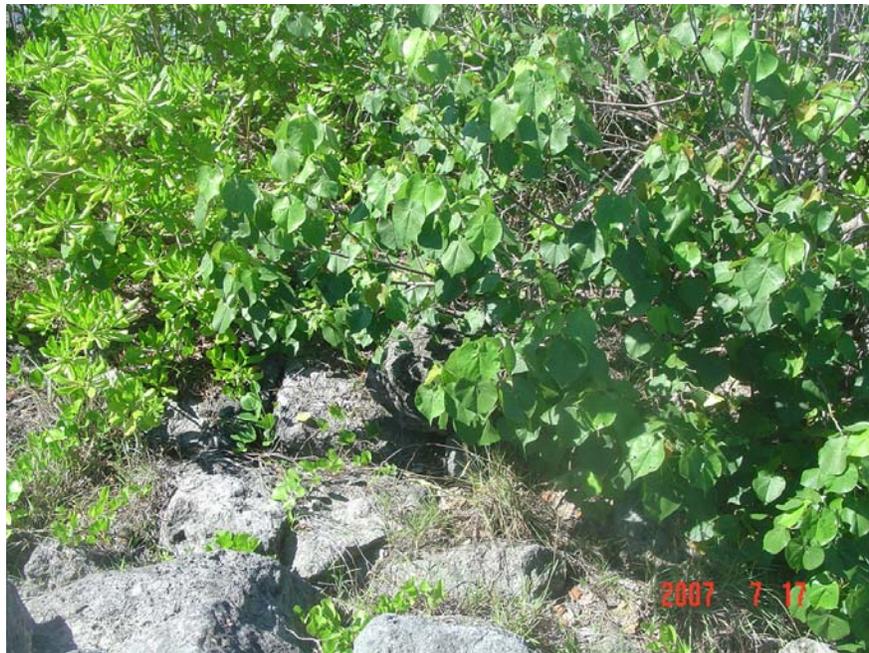
f. Sta. 1+50, HS, Dislocated armor stone resting adjacent to toe w/voids at the crest.

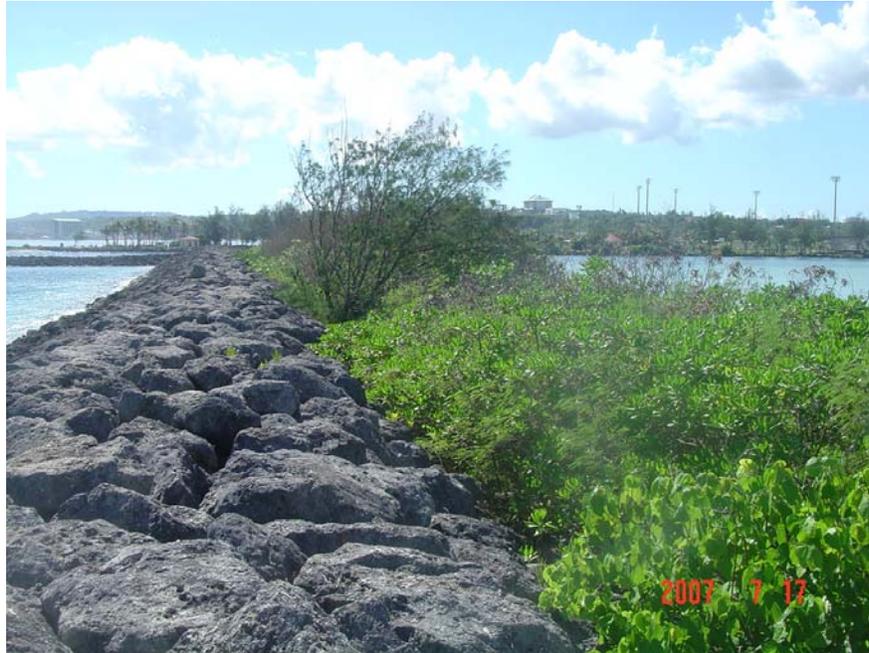
g. Sta. 1+60, HS, Remove trees / vegetation.

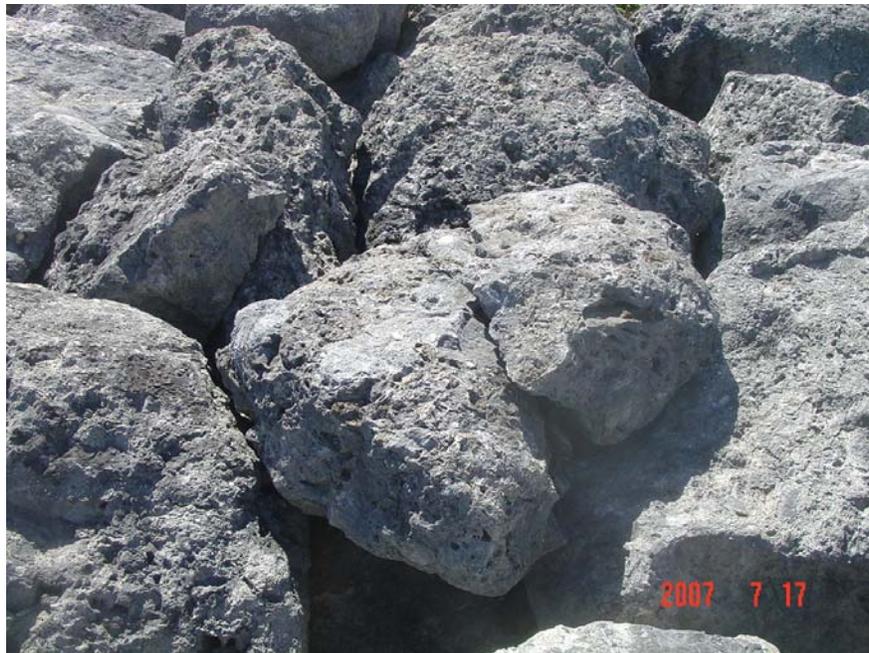
h. Sta. 2+80, cracked armor stone on crest.

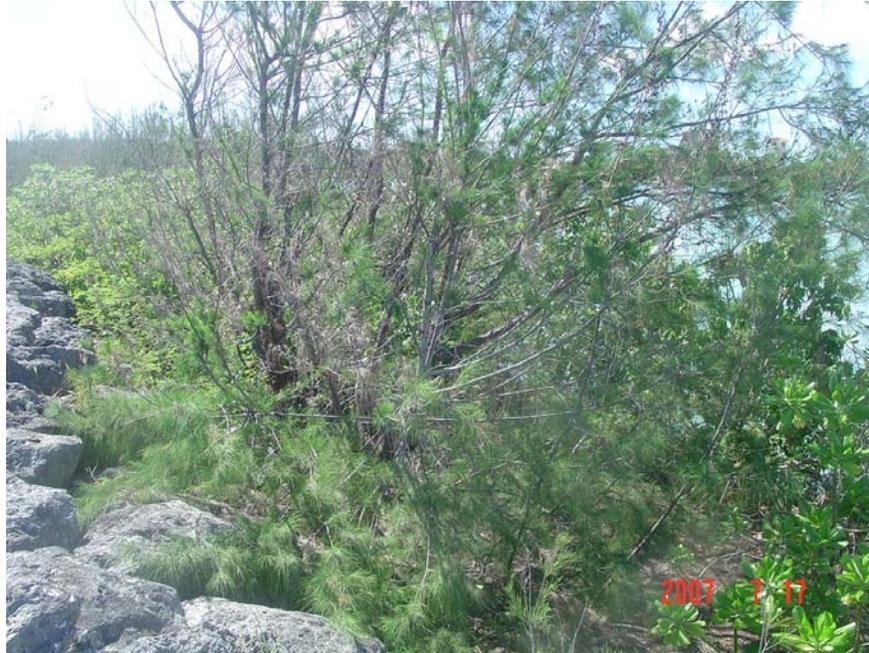
i. Sta. 2+90, HS, Typical Ironwood tree to be removed as they are displace armor stones.

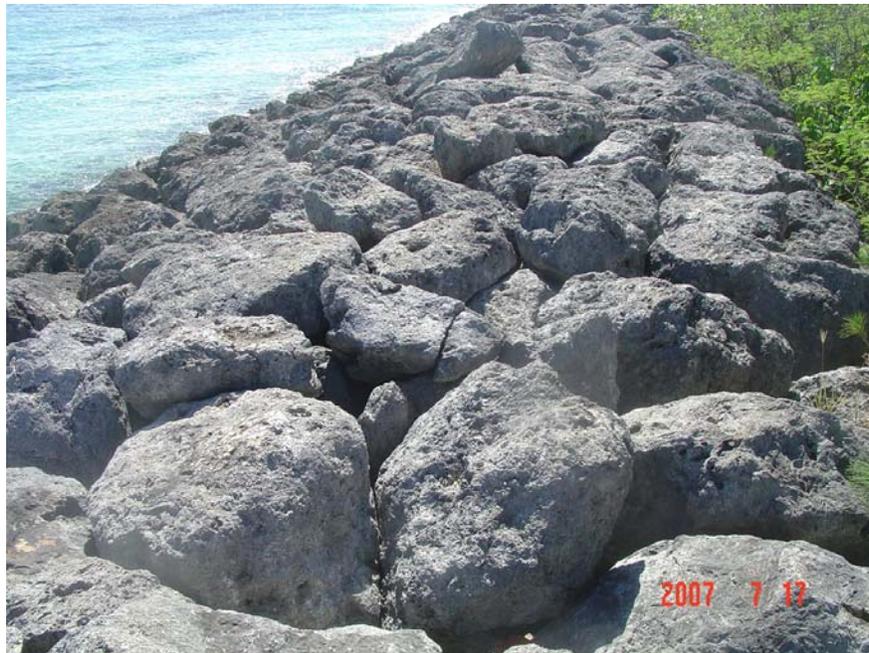
j. Sta. 2+91, CL, 1 ea. Cracked armor stone, still cracked.

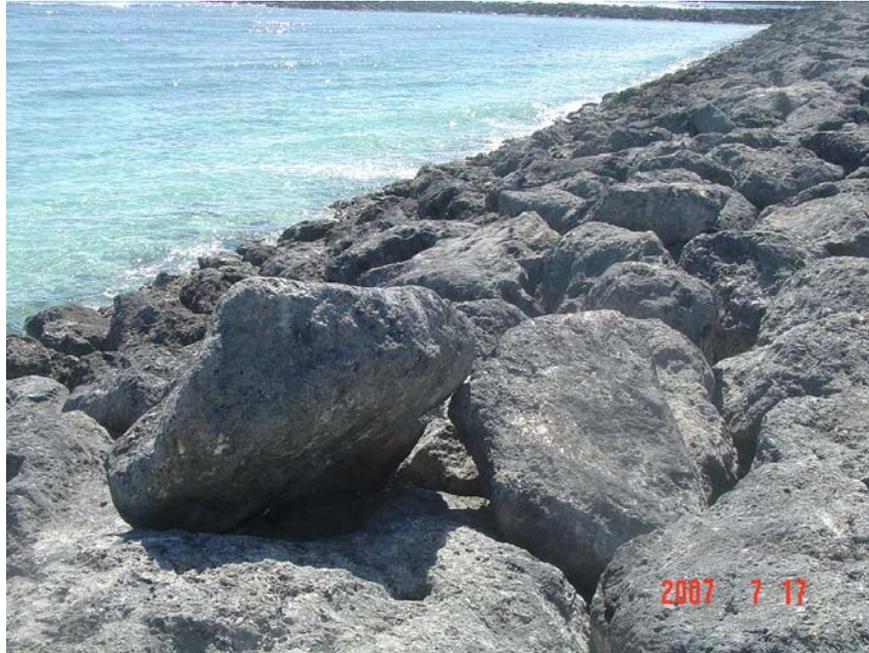
k. Sta. 3+20, OS, Monitor flipped armor stone, changes this year.

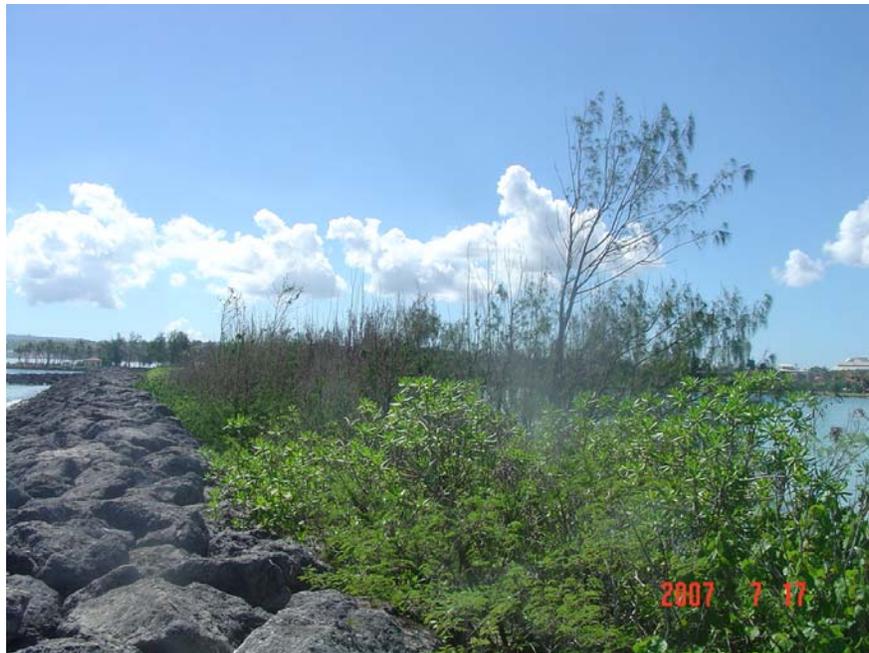
l. Sta. 3+20, HS, Typical of heavy vegetation to be removed.

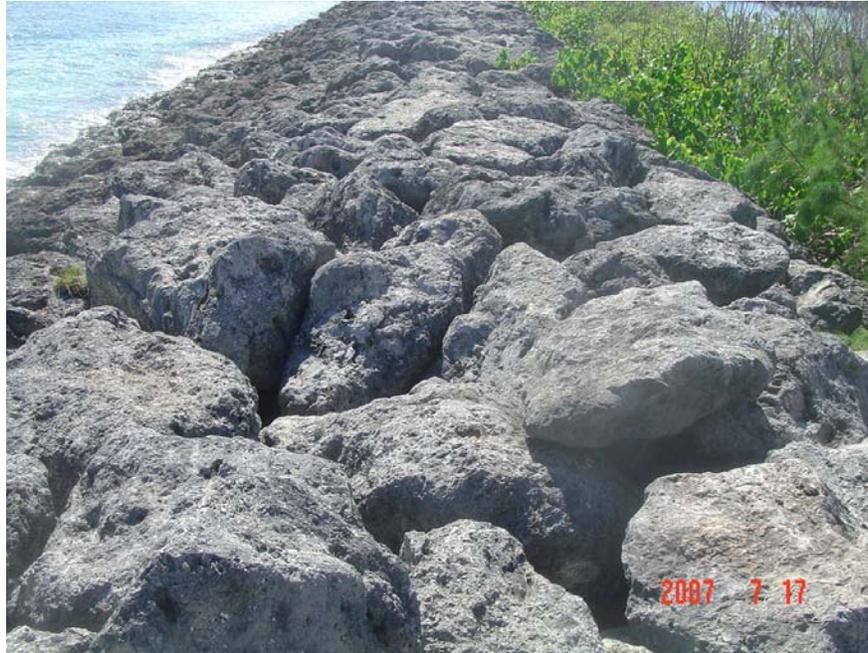
m. Sta. 4+63, CL, 1 each rested, 1 each flipped with void, slight movement this inspection.

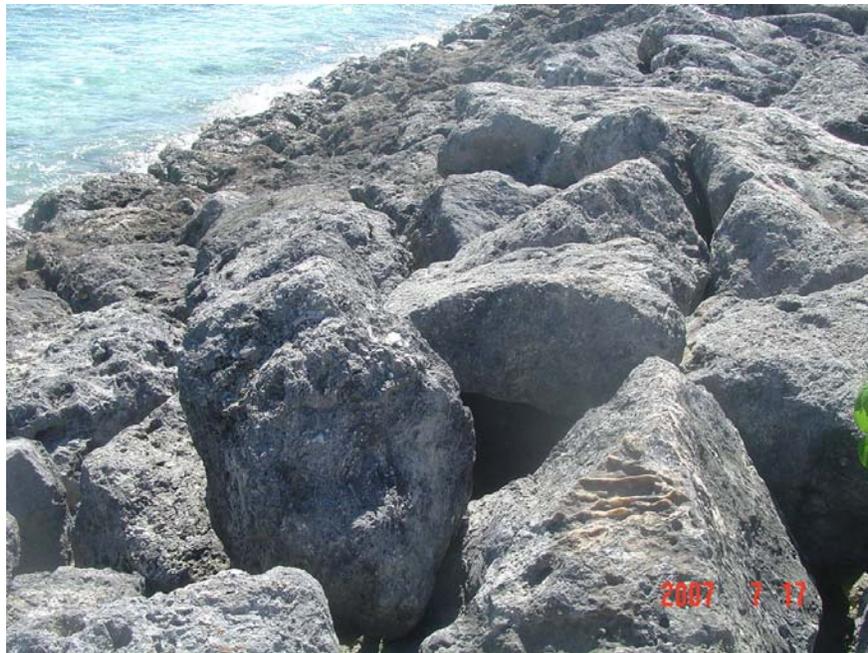
n. Sta. 5+13, HS, Remove tree, 1ea flipped armor stone and bridging, cracked armor stone OS sideslope.

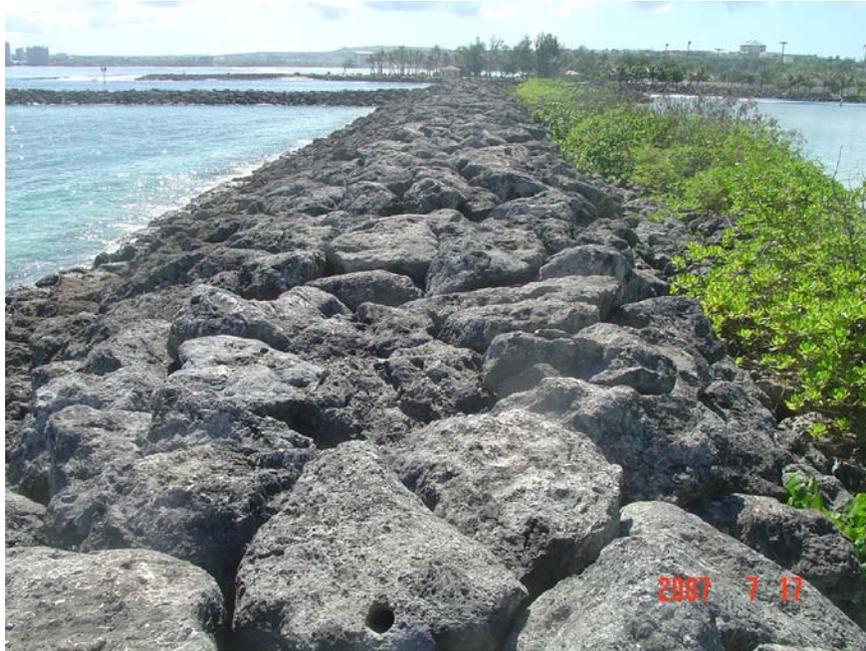
o. Sta. 5+25, HS, Remove vegetation, unable to verify armor placement, Overview of settling at crest.

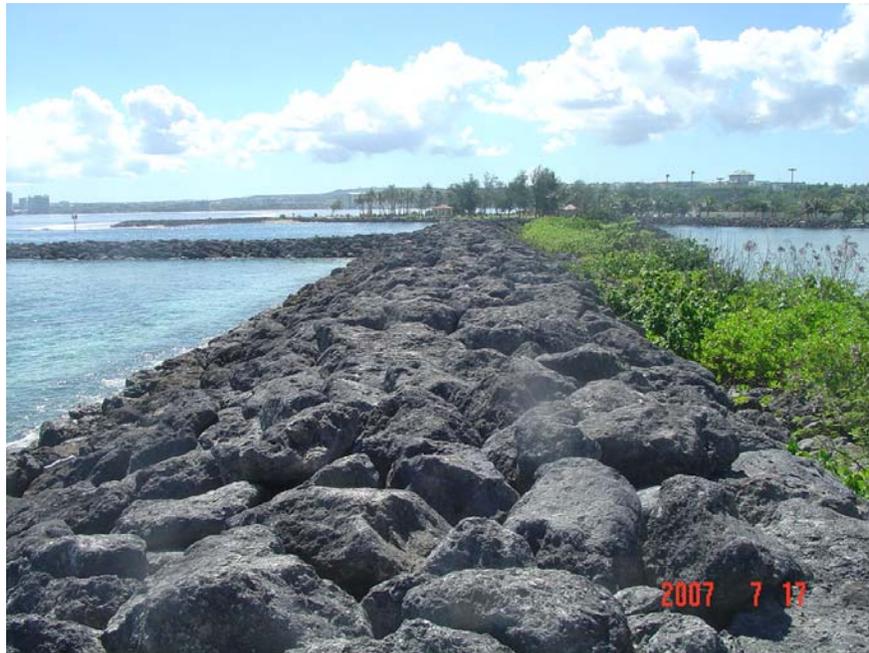
p. Sta. 6+30, Depression on OS sideslope and bulge on HS sideslope (new this year).

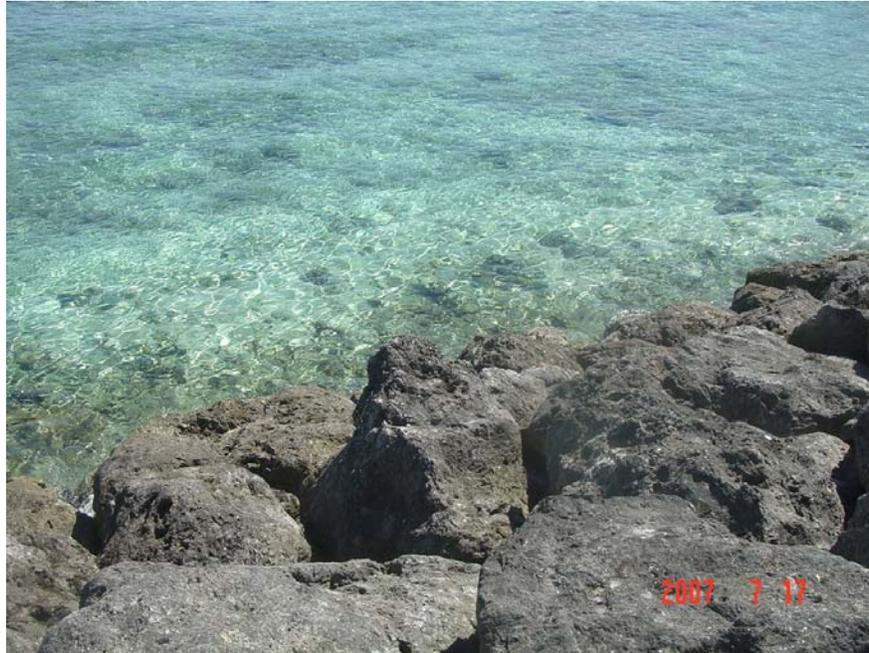
q. Sta. 7+50, OS, Flipped armor stone.

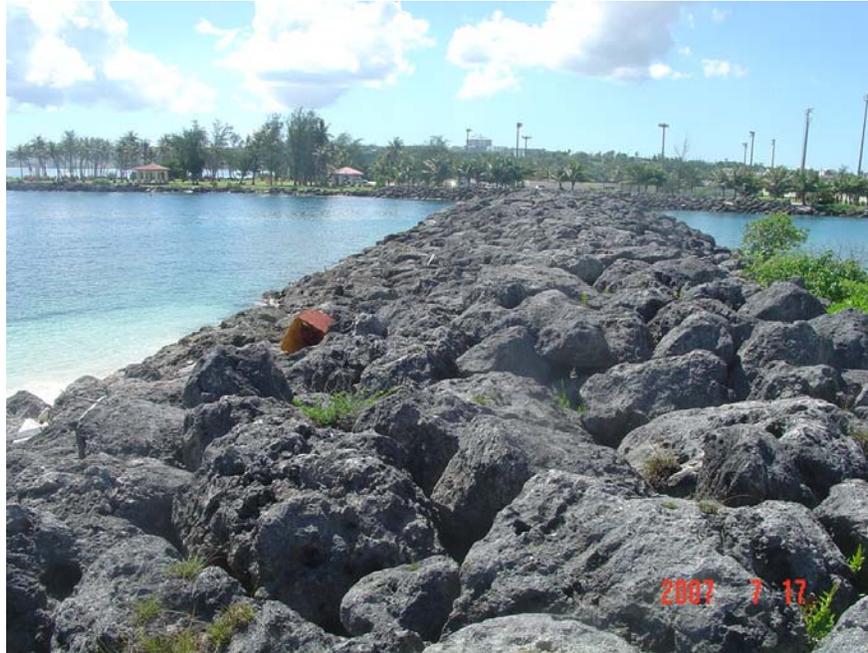
s. Sta. 8+75, CL, Depression in crest, 2 each flipped armor stone on OS sideslope.

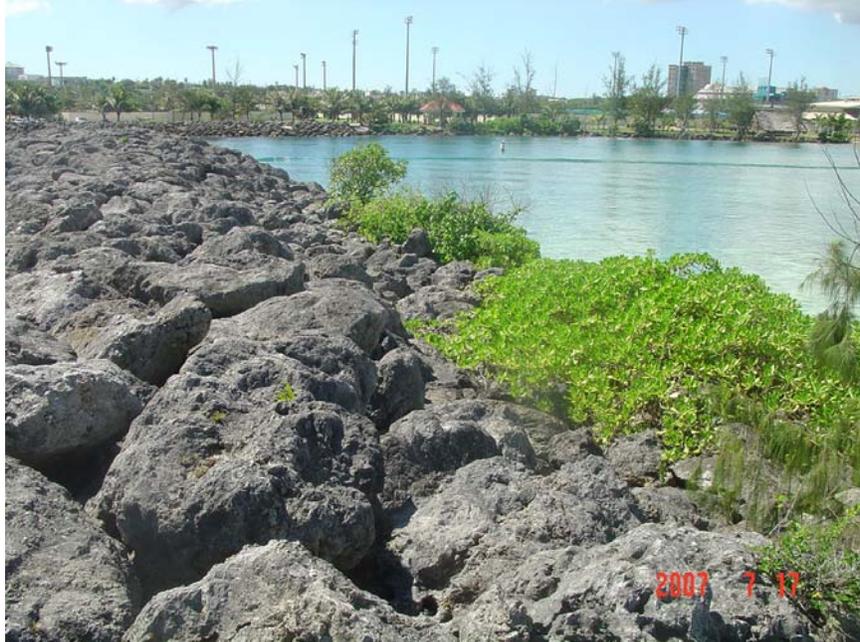
t. Sta. 9+30, HS, Void at hinge and dislocated armor stones at toe.

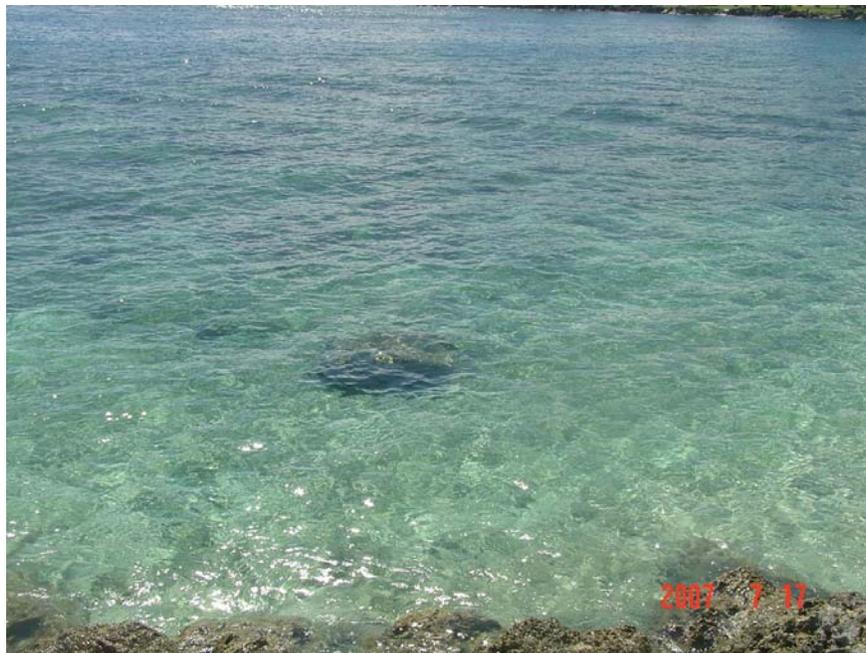
c. Sta. 0+48, HS, 1 ea. Dislodged toe armor stone approx 10' from toe.

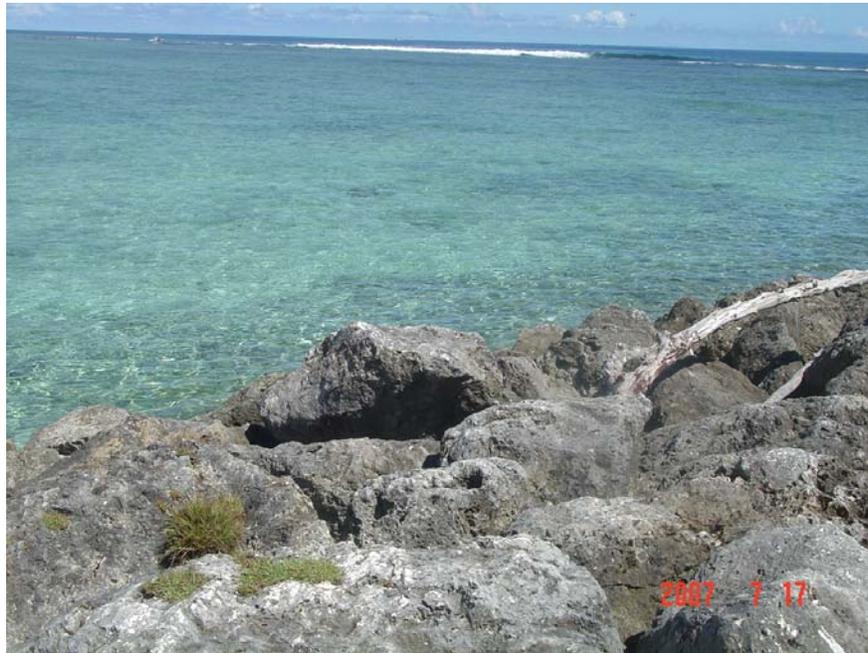
d. Sta. 0+50, OS, Perched armor stone slight movement this inspection.

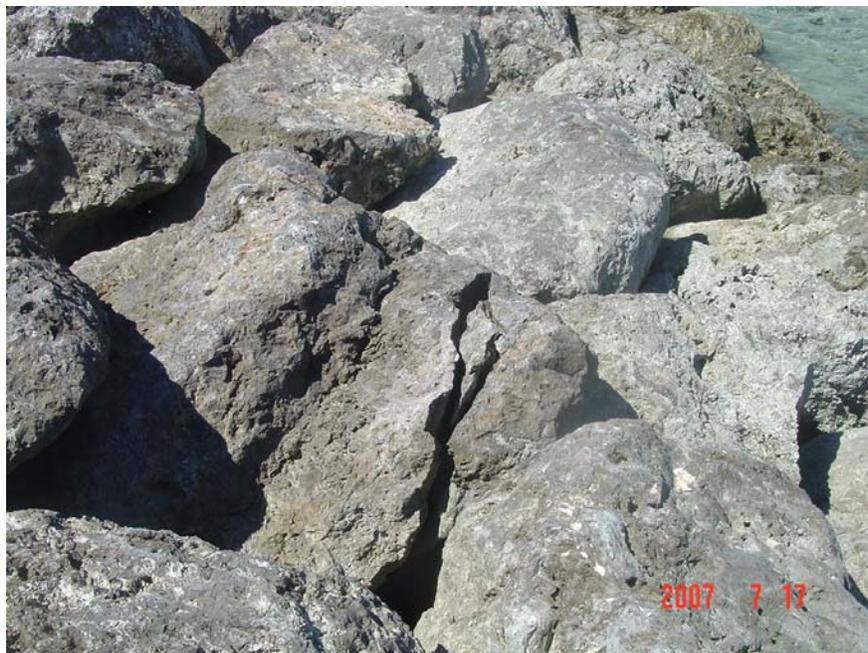
e. Sta. 2+38, OS Sideslope, 1 ea. split armor stone.

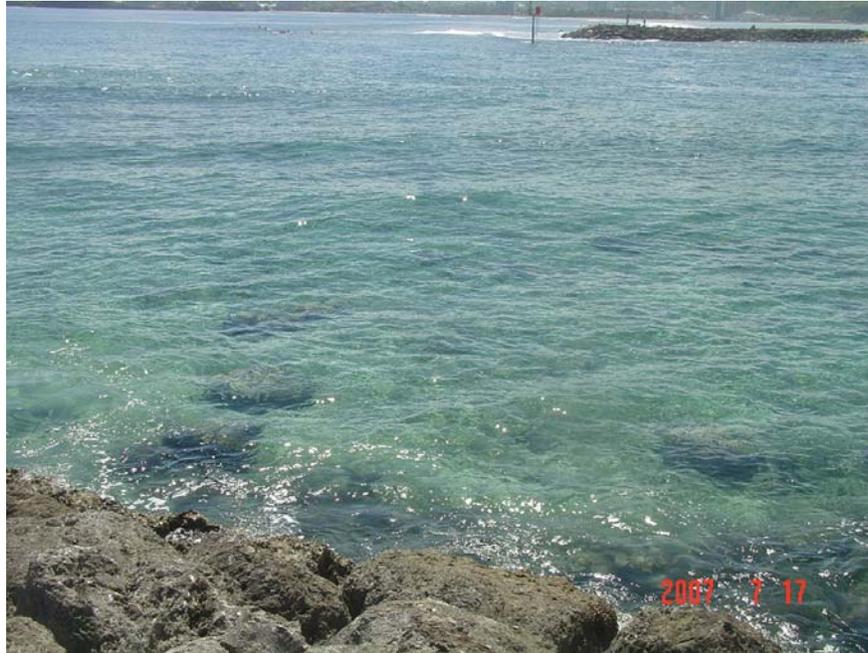
f. Sta. 2+83, HS, Monitor 3 ea. dislodged armor stones, approx. 3' from the toe of the structure.

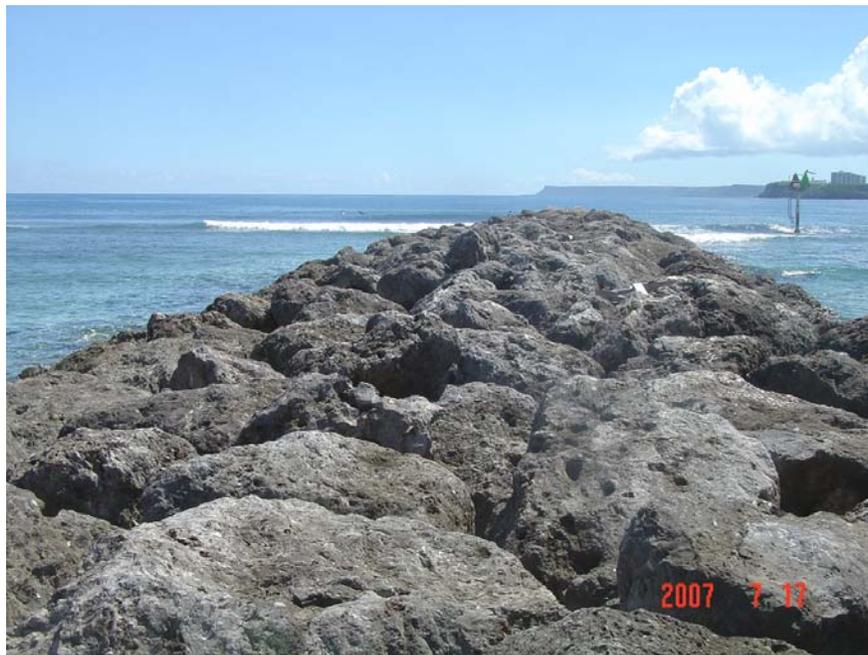
g. Sta. 3+15, CL, 2 ea. Flipped armor stones.

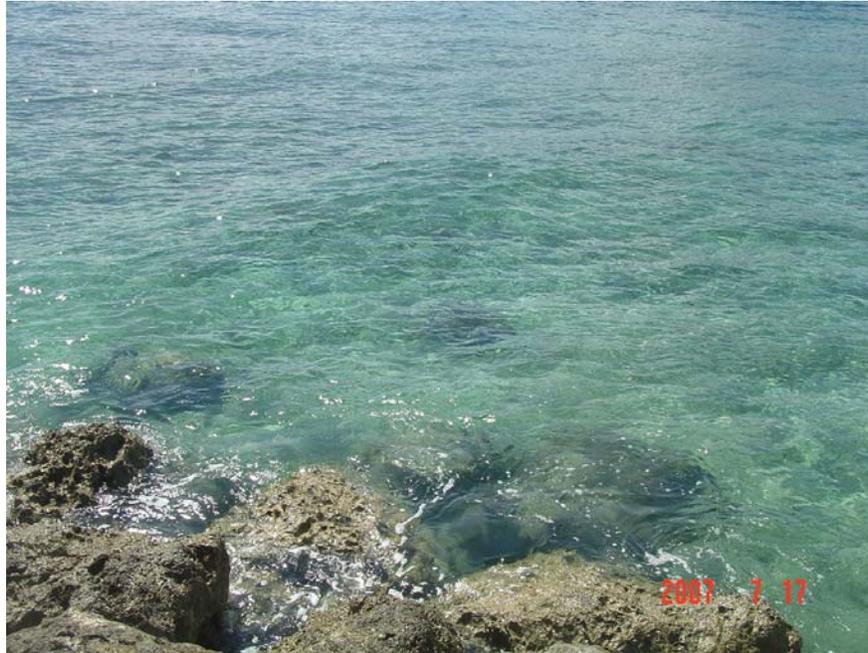
h. Sta. 3+20, HS, Monitor 1 ea. dislocated toe armor stone. One additional armor stone this Year.

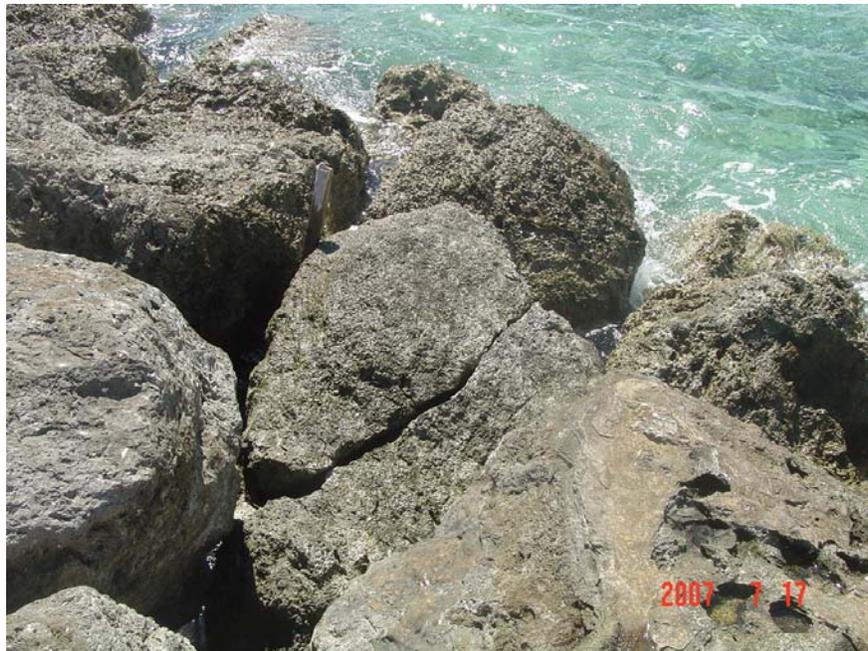
i. Sta. 3+45, HS, 1 ea. Cracked armor stone.

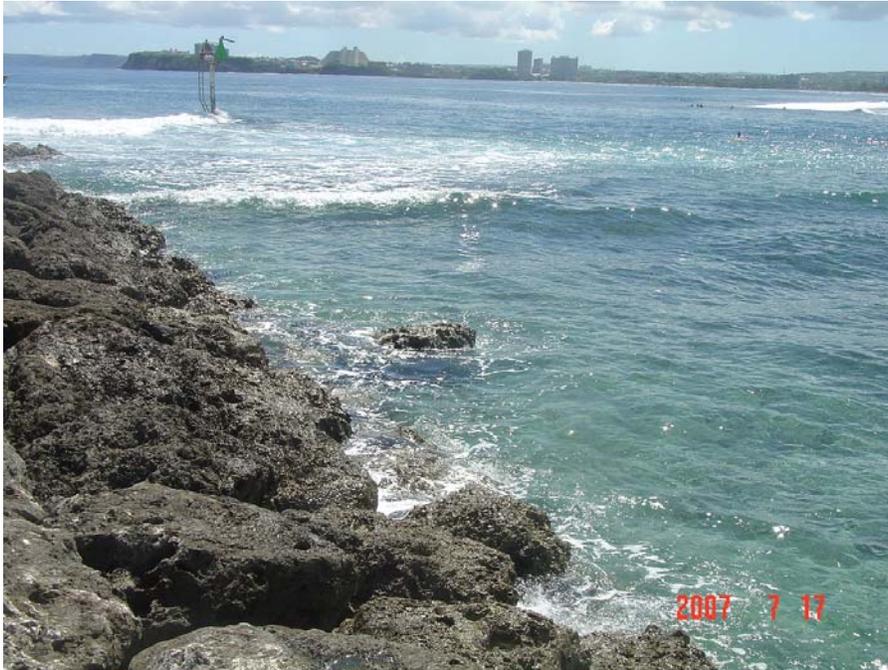
j. Sta. 3+80, HS, Monitor 2 ea. dislocated toe armor stones, no change this year.

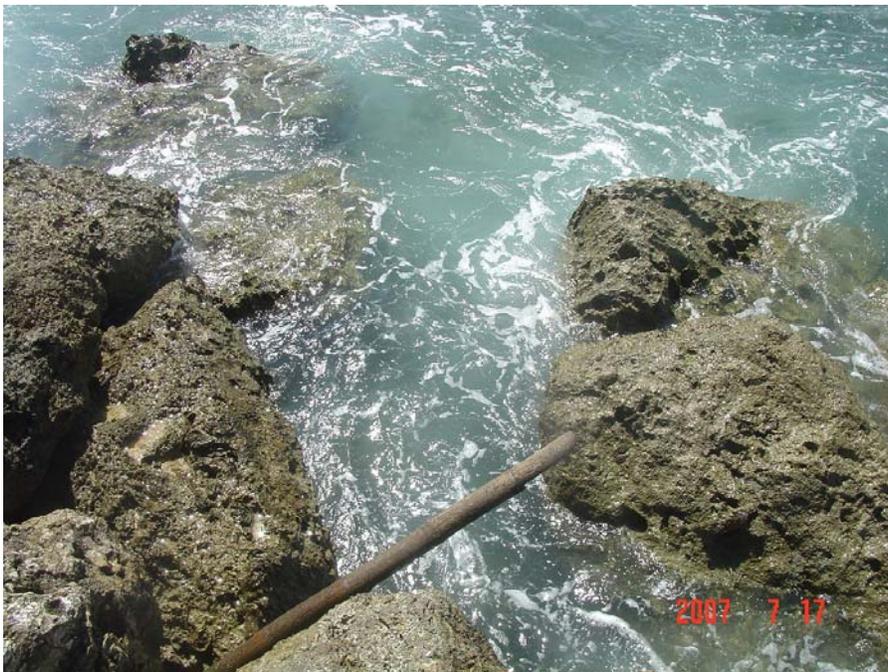
l. Sta. 4+82, HS, Monitor 2 ea. dislocated toe armor stones and void, no underlayer visible. Minor changes this year, continue to monitor.

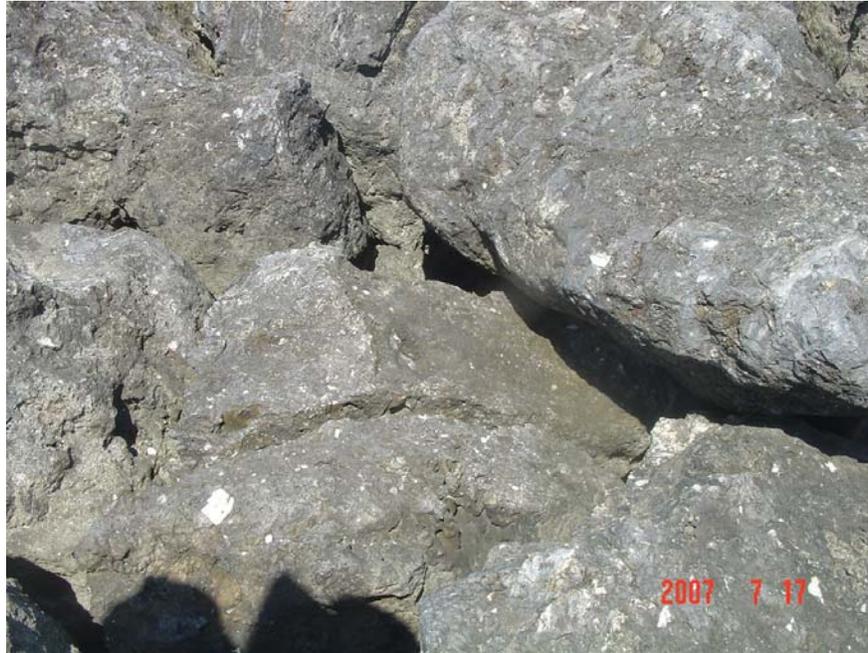
d. Sta. 0+70, CL, 1 each split armor stone at crest, settling new this year.

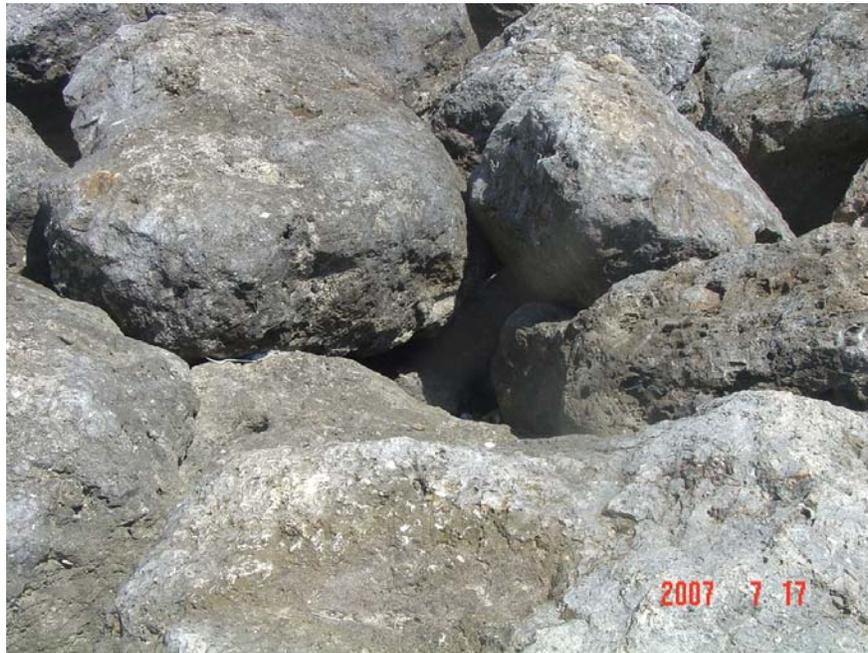
e. Sta. 0+82, CL, Monitor 2 ea. void, underlayer exposed.

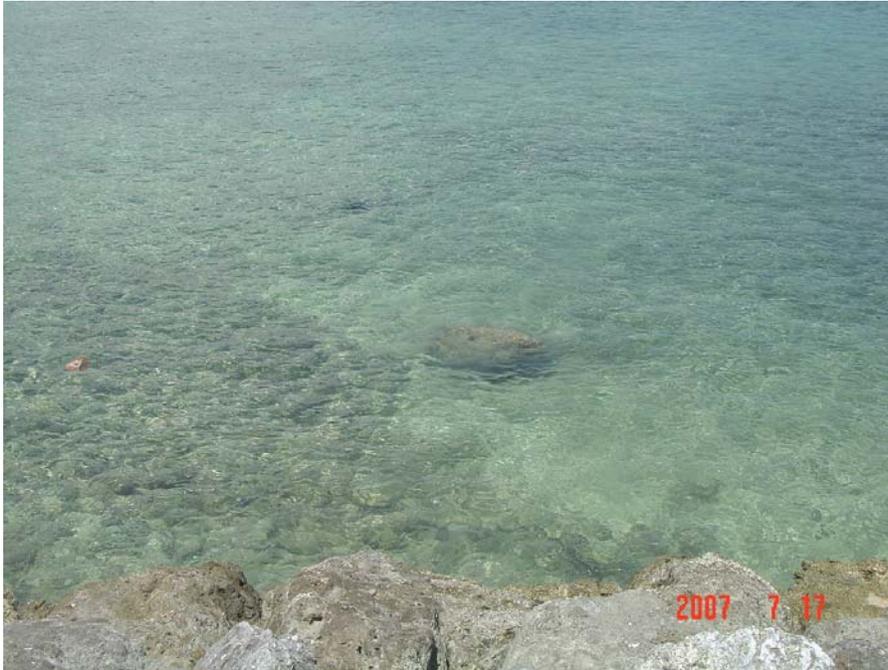
f. Sta. 0+82, HS, 1 each dislodged armor stone approximately 10' from toe of the structure (new this year).

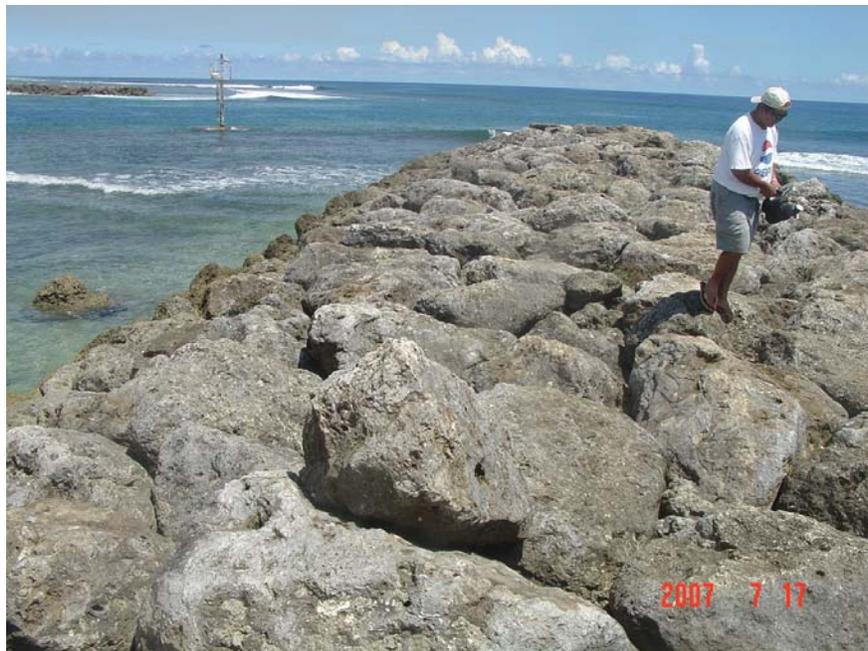
g. Sta. 0+95, CL, 1 ea. armor stone resting on crest with void.

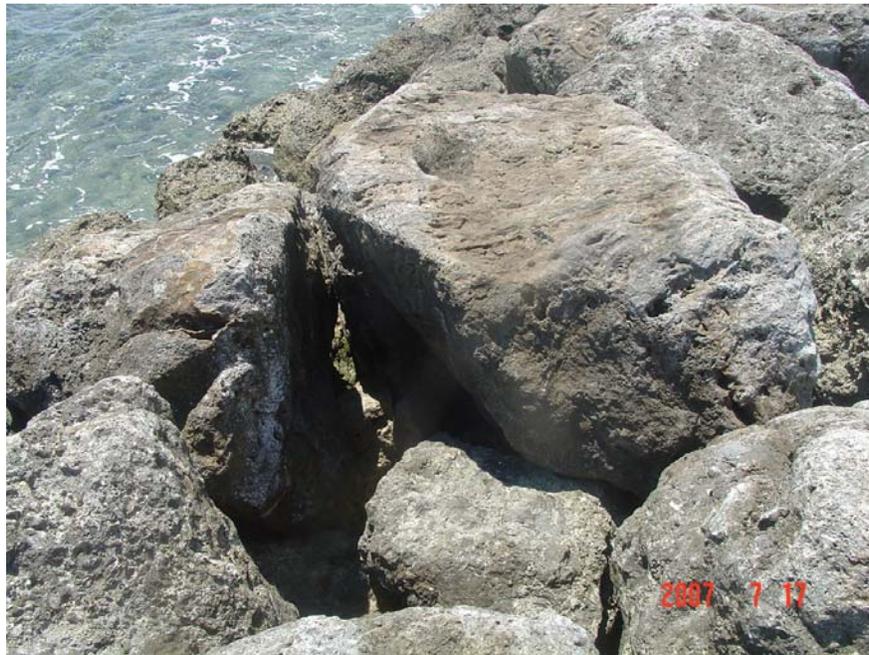
h. Sta. 1+15, OS, Monitor void.

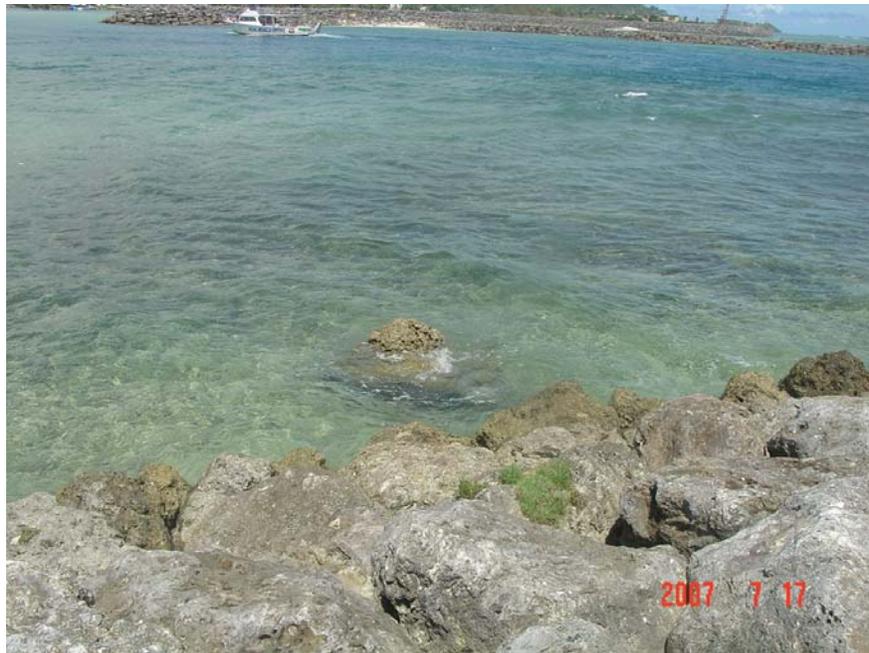
i. Sta. 1+50, HS, 2 ea. dislodged armor stone resting approx. 3' from the toe of the structure, void at Sta. 1+75.

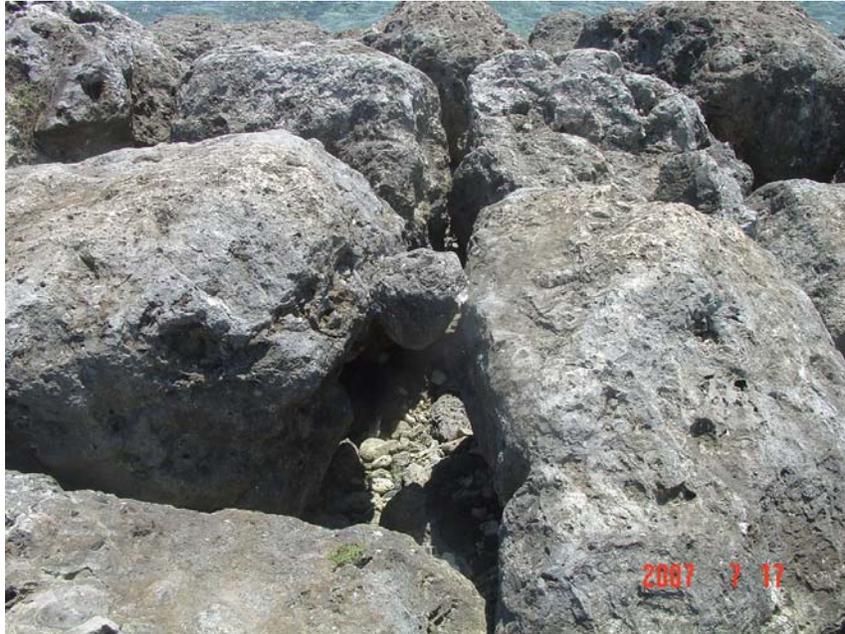
j. Sta. 1+50, CL, Void.

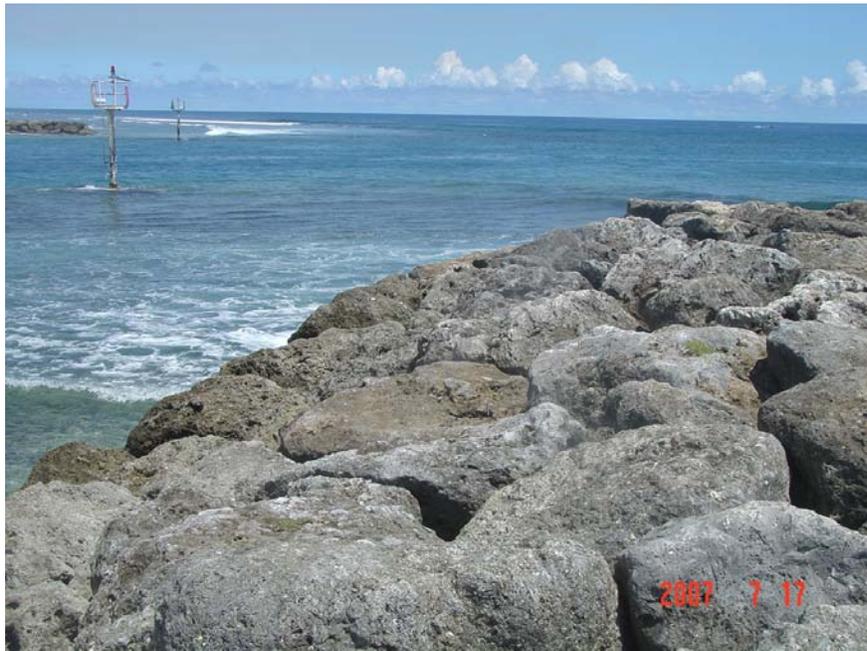
k. Sta. 1+58, HS, Monitor flattening of sideslope, more change this year.

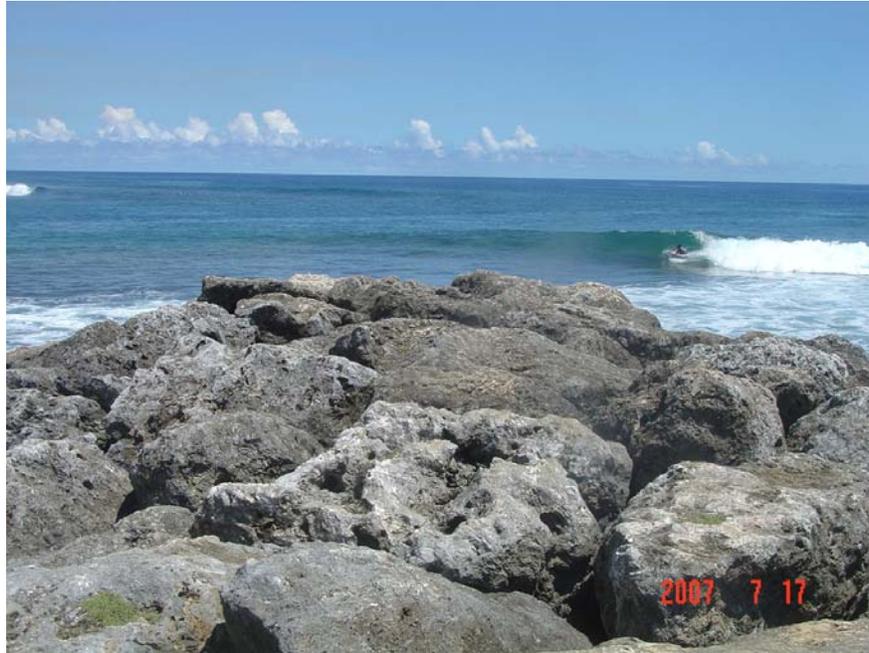
1. Sta. 1+75, CL, Monitor slight depression and void, no change this year.

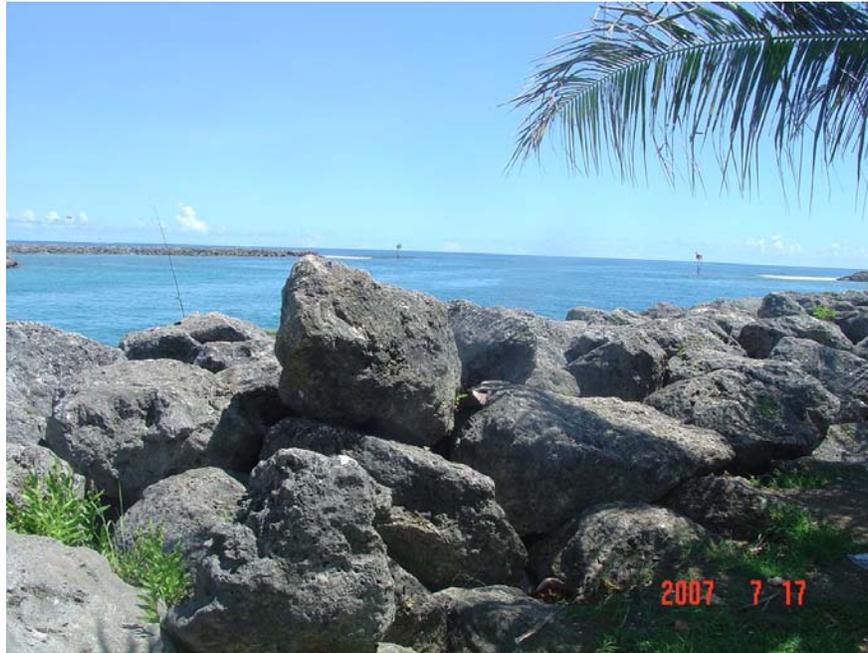
c. Sta. 0+30, CL, lea. armor stone resting on crest, no obvious void, slight movement this inspection.

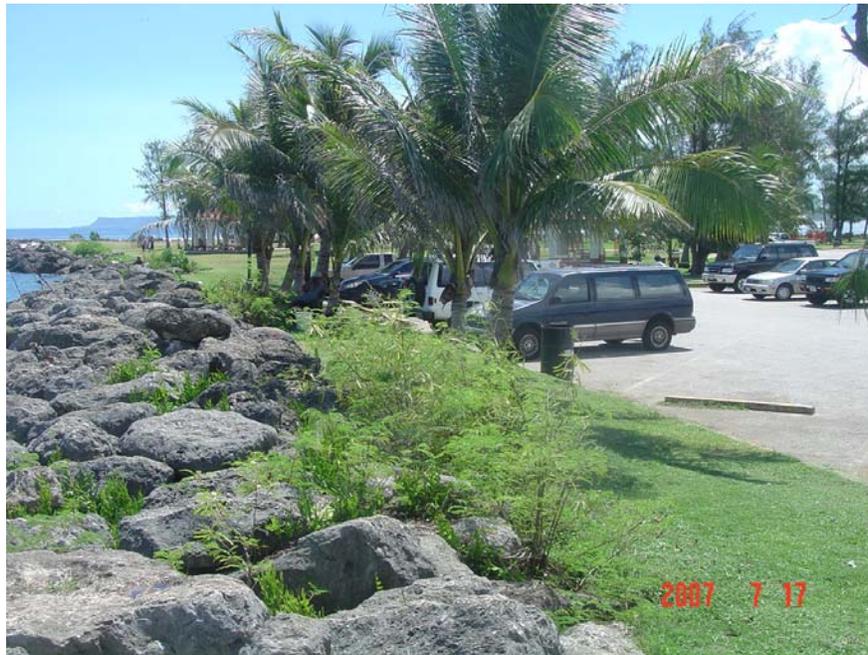
e. Sta. 1+20, Remove juvenile trees / bushes.
