1. Project Name: Agana SBH
2. Date of Inspection: JULY 18, 2007
3. Inspection Personnel:

4. Discussion:

AGANA SMALL BOAT HARBOR, TERRITORY OF GUAM

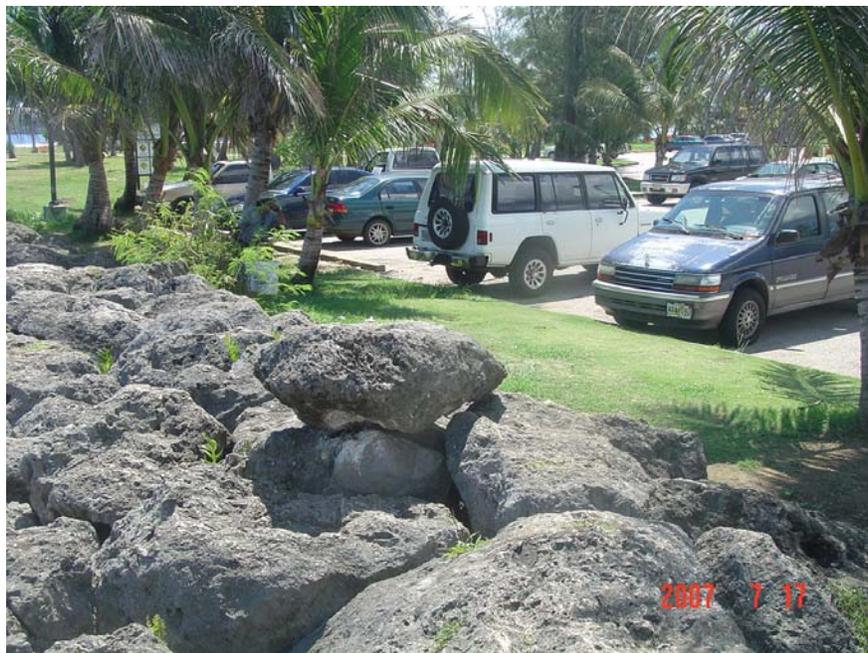
f. Sta. 1+50, HS Hinge, 1 ea. armor stone resting on the crest, remove trees.

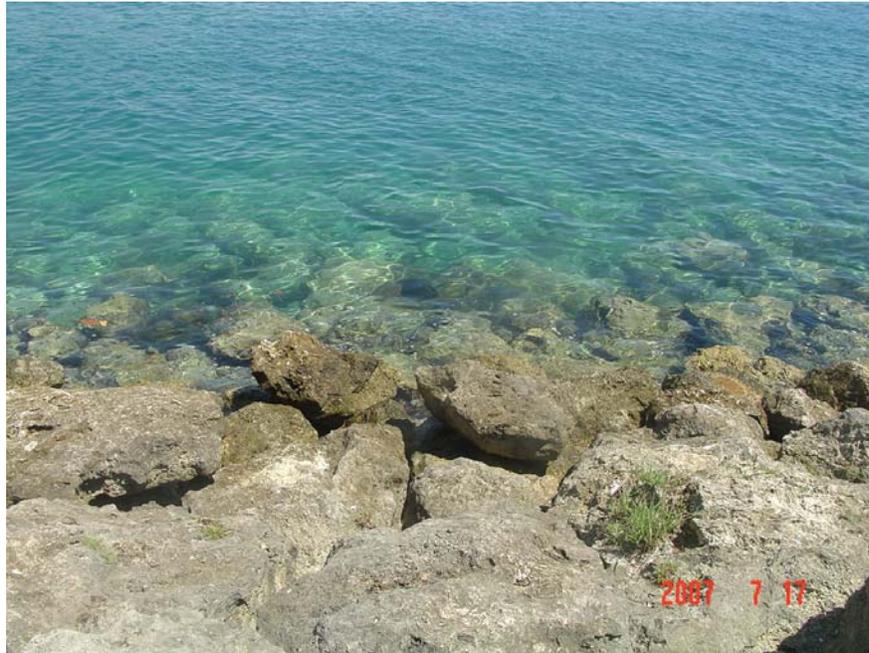
g. Sta. 1+65, HS, Monitor 2ea. armor stones resting on sideslope. No change this year.

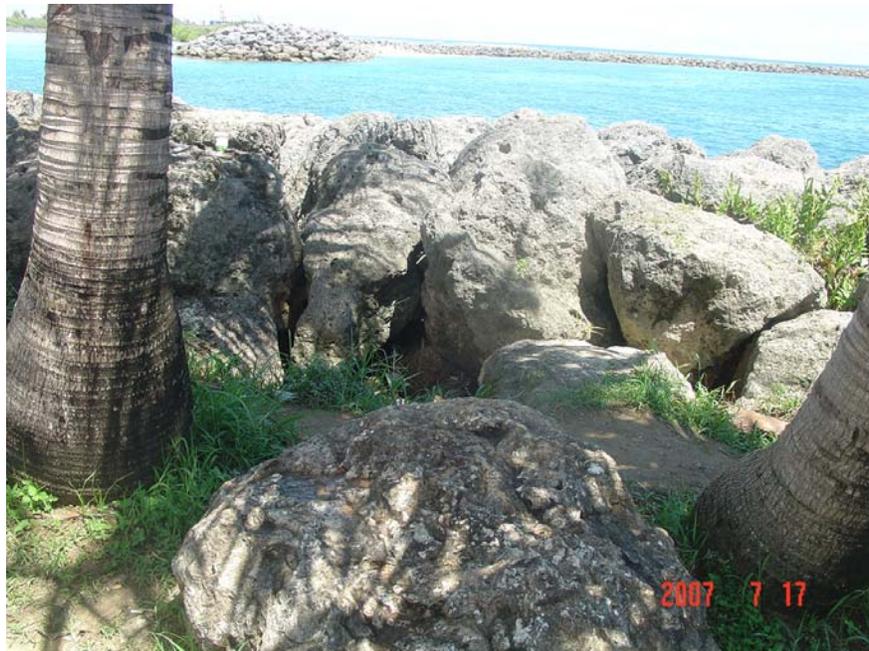
h. Sta. 2+00, 1 ea. Dislodged armor stone and void.

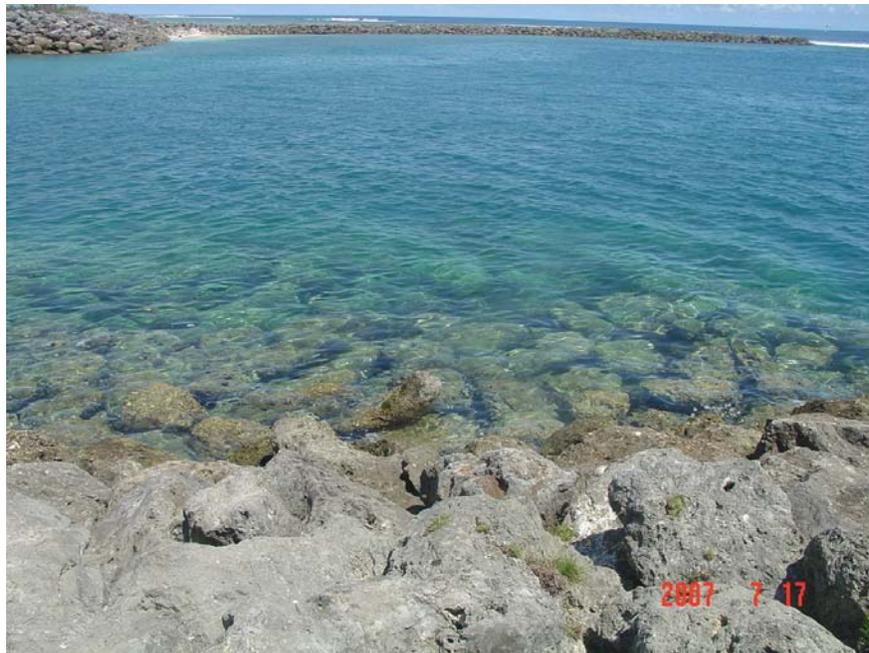
j. Sta. 2+40, HS, Monitor 1 ea. flipped armor stone.
Armor stone no longer there. Minor change this year.
