CONTINUING ELIGIBILITY INSPECTION (CEI) REPORT

FOR HURRICANE & SHORE PROTECTION PROJECTS

Honolulu Engineer District

1. Project Name: Asquiroga SPP
2. Date of Inspection: October 19, 2007
3. Inspection Personnel:

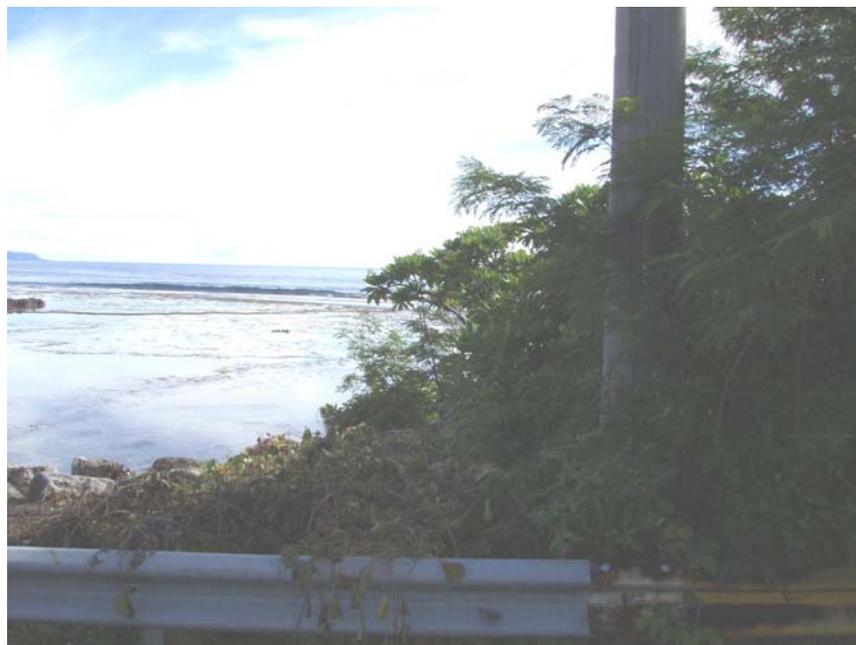
- a. Sta. 0+25, Start of armor stone structure, (South / Talofofoside).

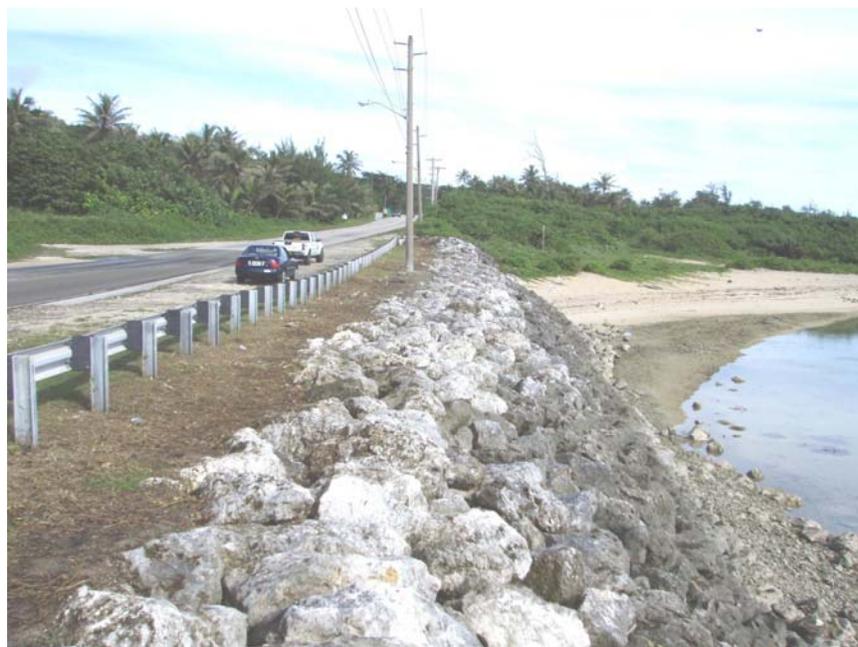
b. Sta. 0+55, Overview of crest and sideslope.

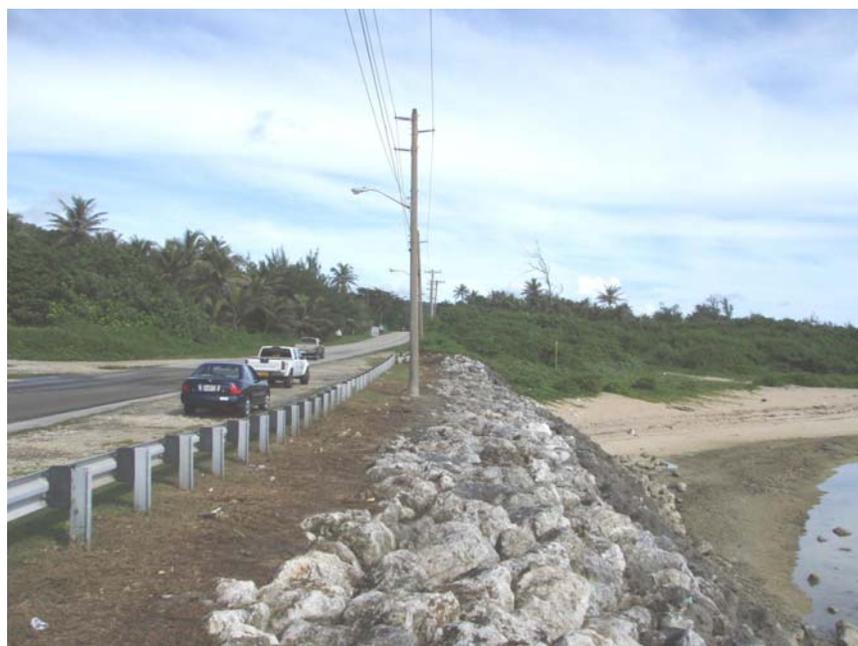
c. Sta. 1+00, Overview of crest and sideslope.

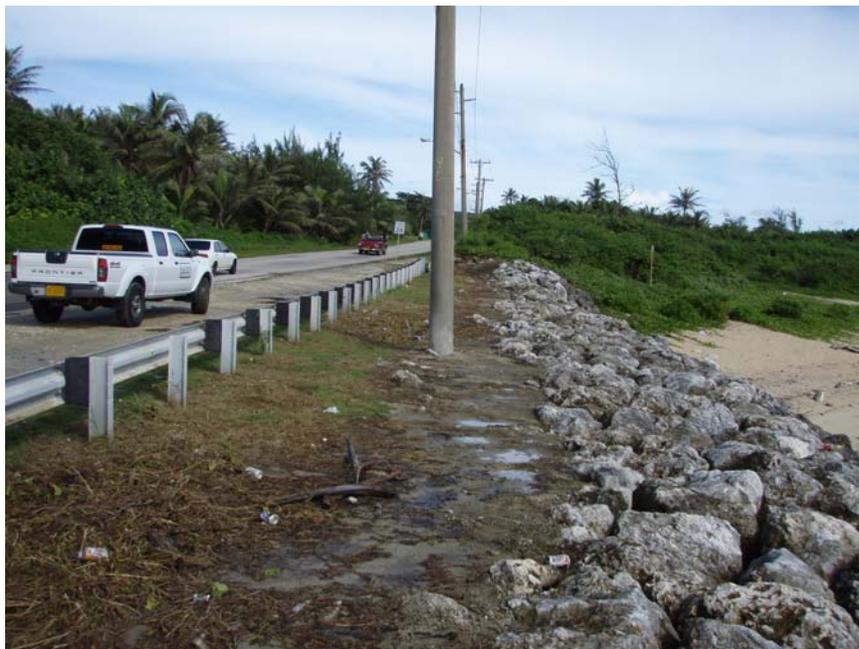
d. Sta. 1+75 Overview.

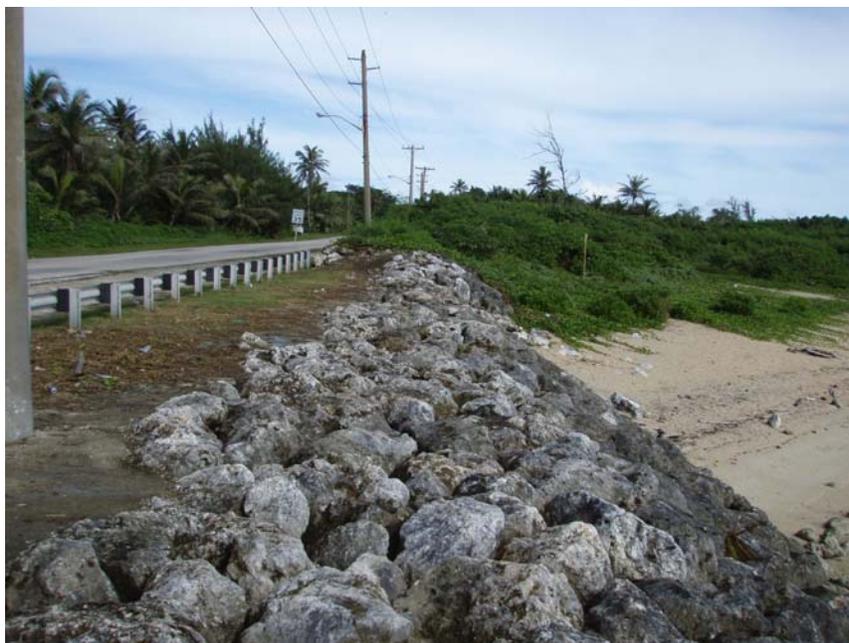
e. Sta. 2+00, Overview.

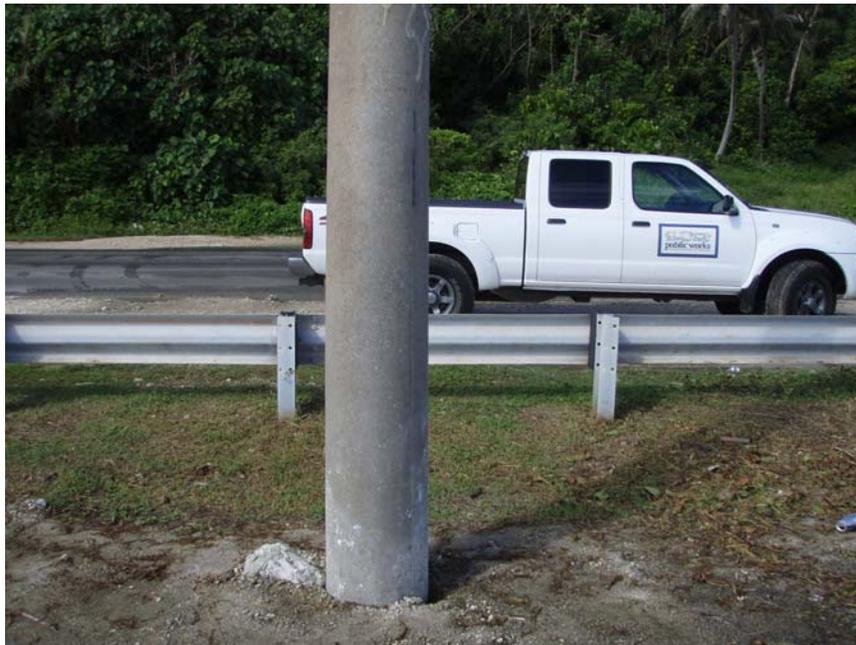
f. Sta. 2+15, Reference power pole.

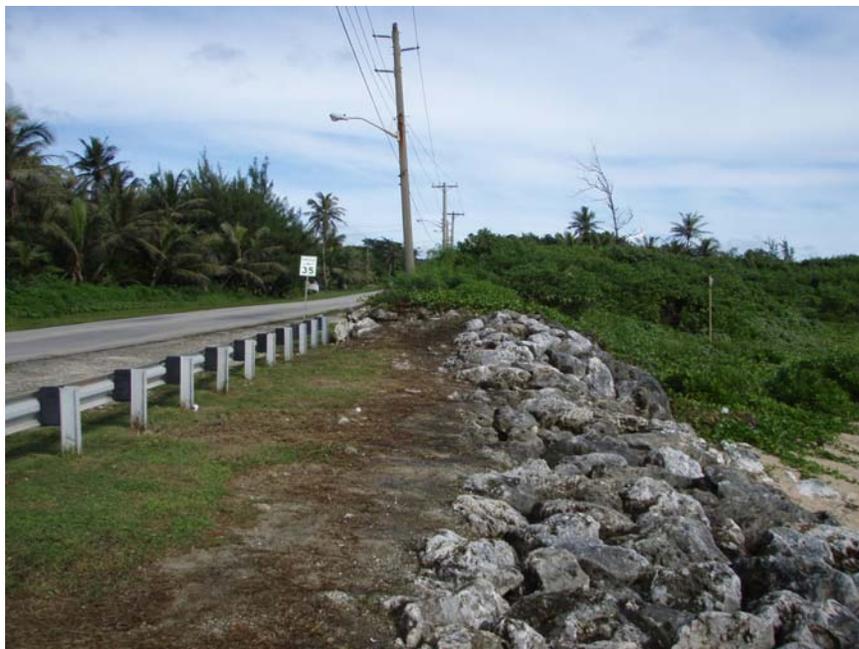
g. Sta. 2+60, bedding material .25 inch to 250 LB has been grouted.

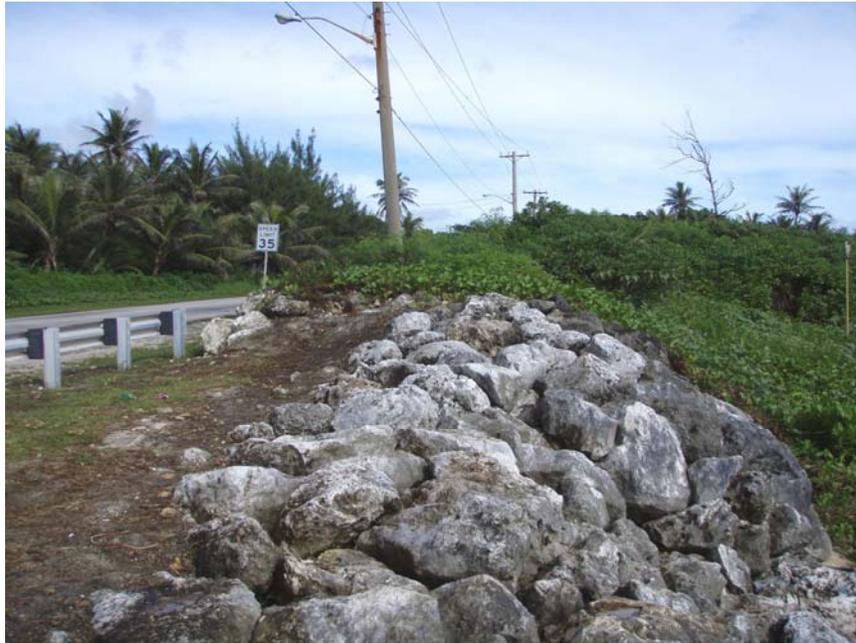
h. Sta. 3+25, End of Federal Project (North-side) there is a transition to the Non-Federal portion of the SPP. The structure beyond Sta. 3+25 in not included in the PL84-99 Program.
