1. Project Name: Hilo Deep Draft Harbor

2. Date of Inspection: May 2, 2005

O&M INSPECTION REPORT FOR NAVIGATION PROJECTS
HILO DEEP DRAFT HARBOR
Honolulu Engineer District
CEPOH-EC-T

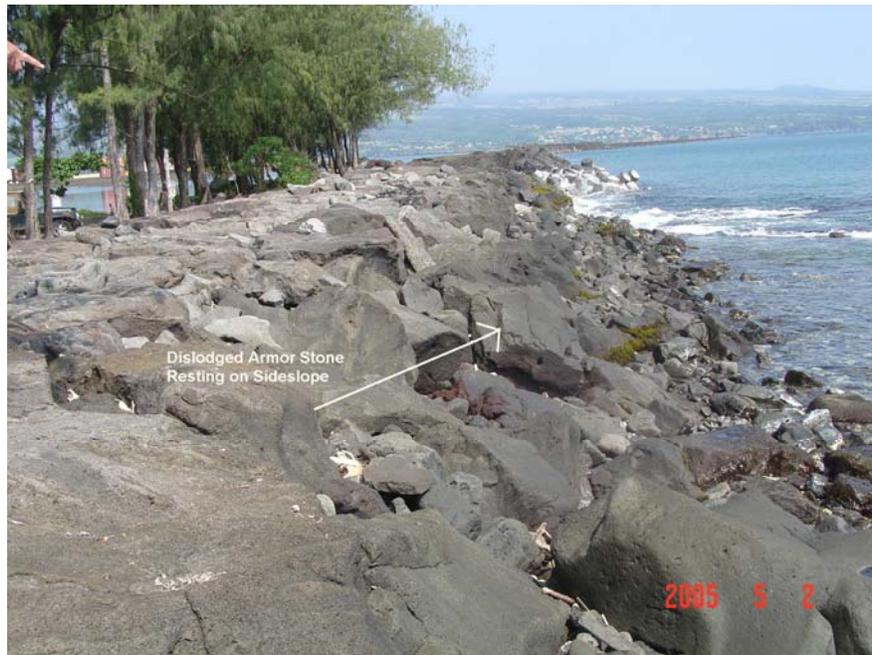
- a. Sta. 0+50 - Sta. 0+70, Armor Stones dislodged from hinge resting on sideslope.

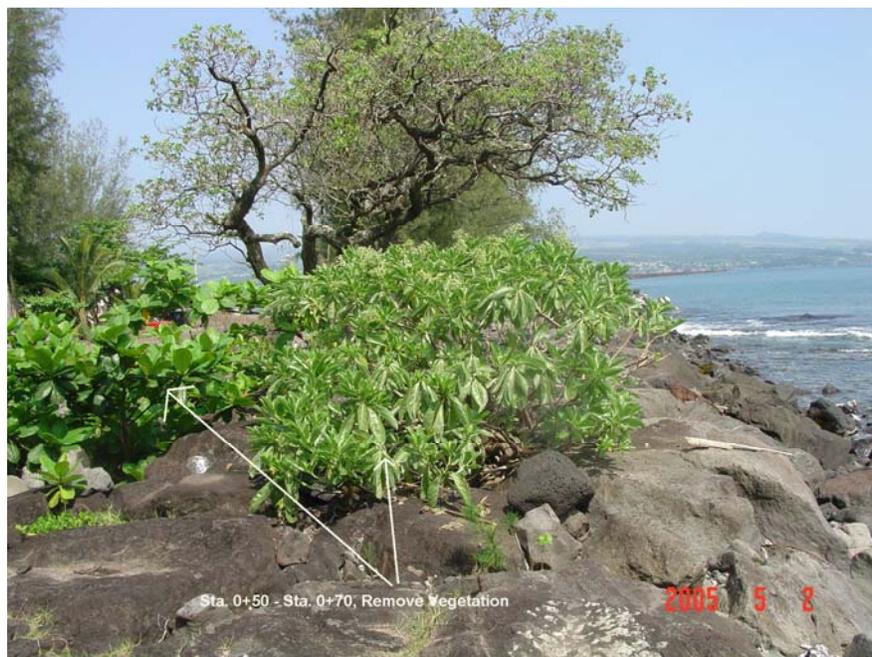
- b. Sta. 0+50 - 0+70, remove vegetation.

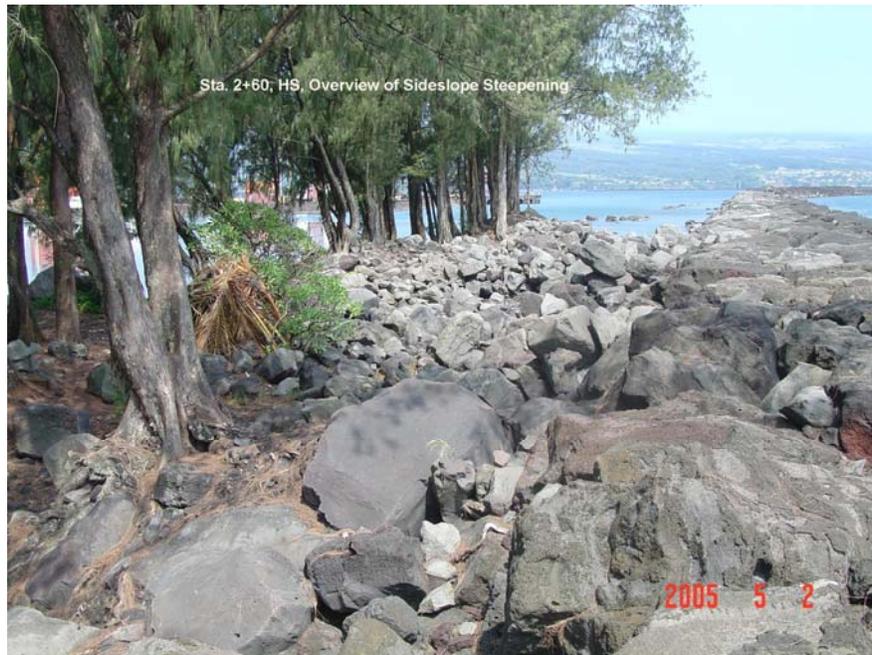
c. Sta. 2+60, interior sideslope deteriorating.

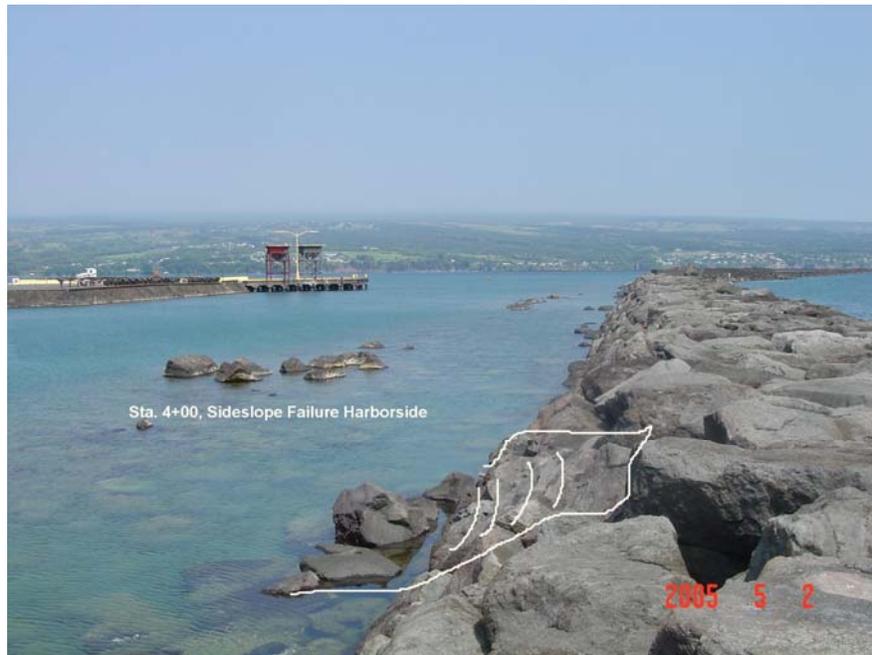
e. Sta. 4+00, harborside (HS) failure of sideslope.

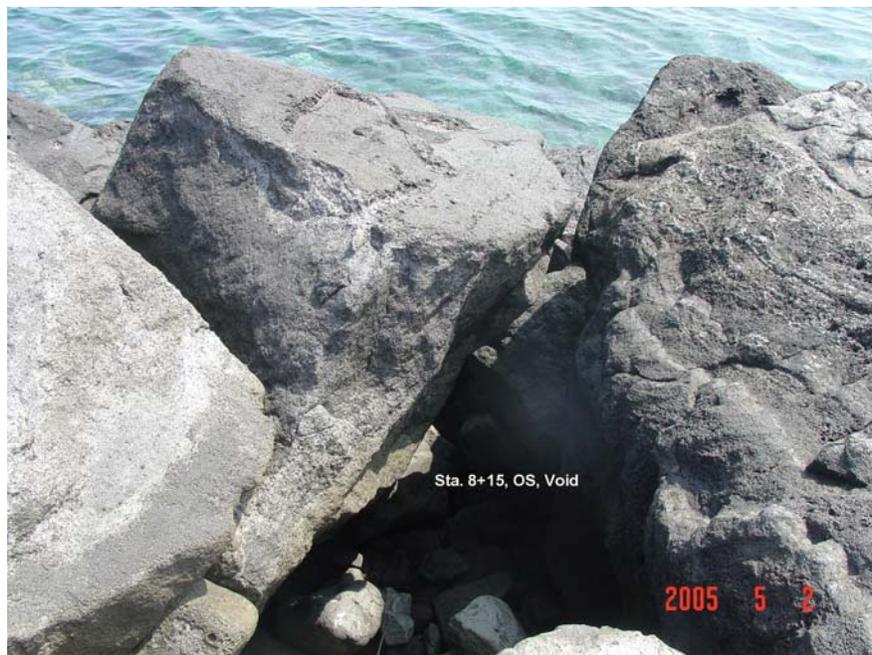
f. Sta. 8+15, OS, void at hinge.

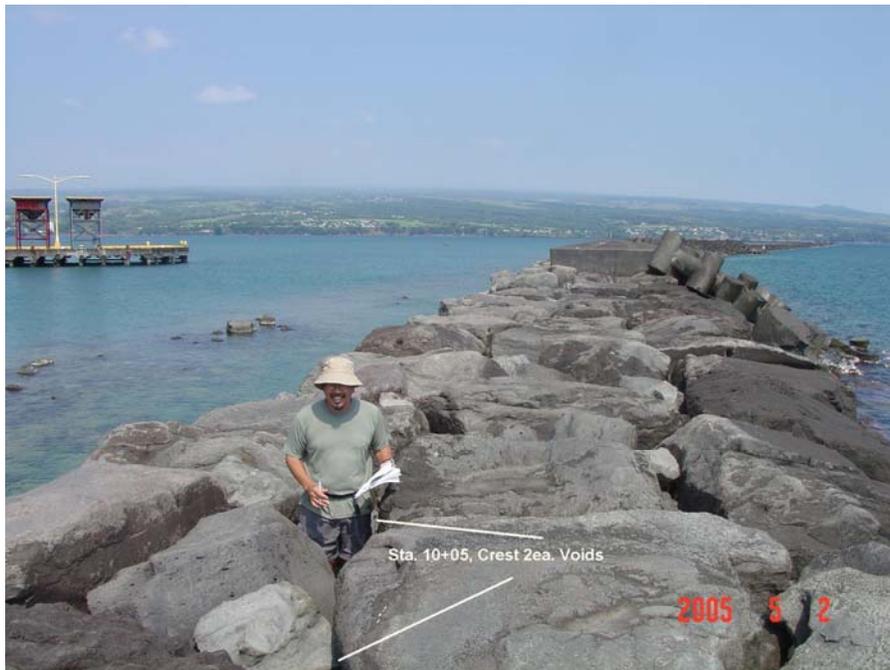
g. Sta. 10+05, 2ea. Voids on crest.

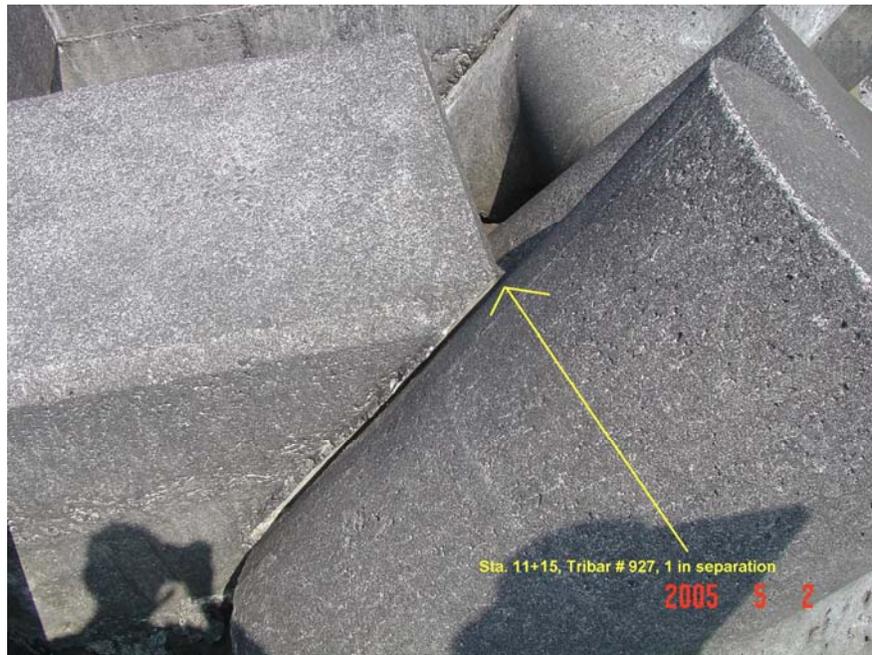
i. Sta. 11+15, OS 1" separation (tribar #927)

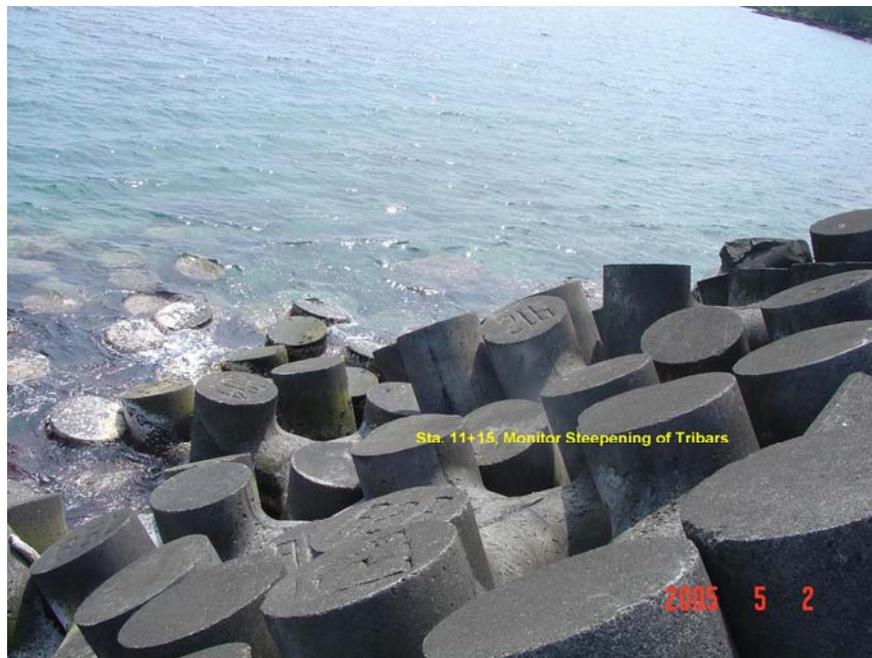
j. Sta. 11+15, OS, Monitor tribar movement.

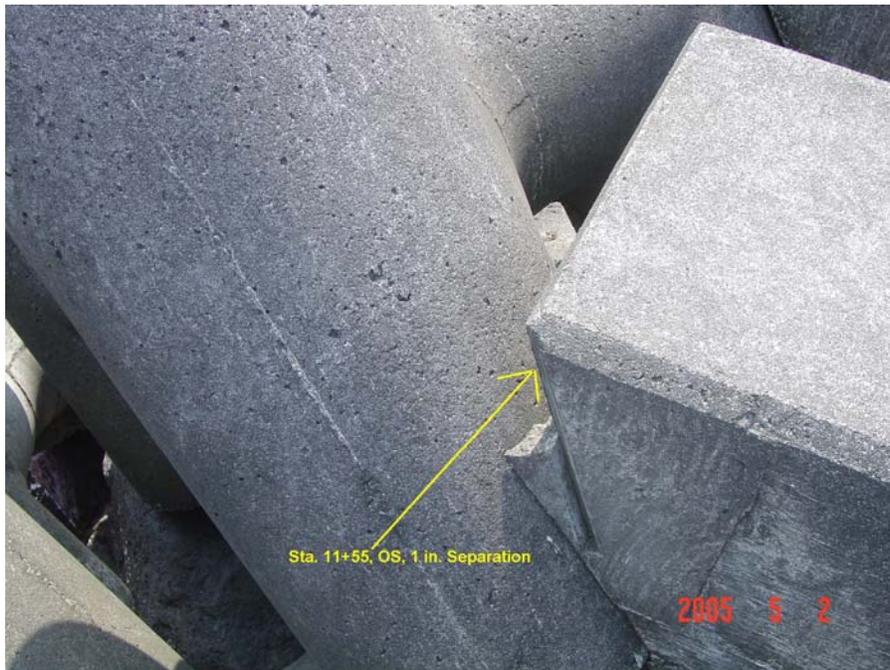
m. Sta. 11+55, OS, 1" separation (tribar #735).

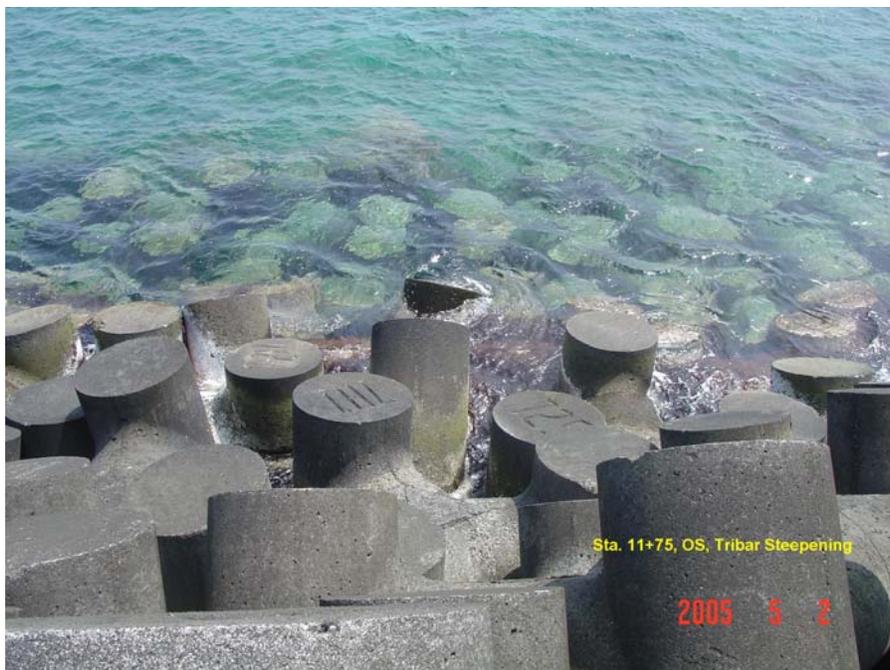
n. Sta. 11+75, OS, Monitor tribar movement.

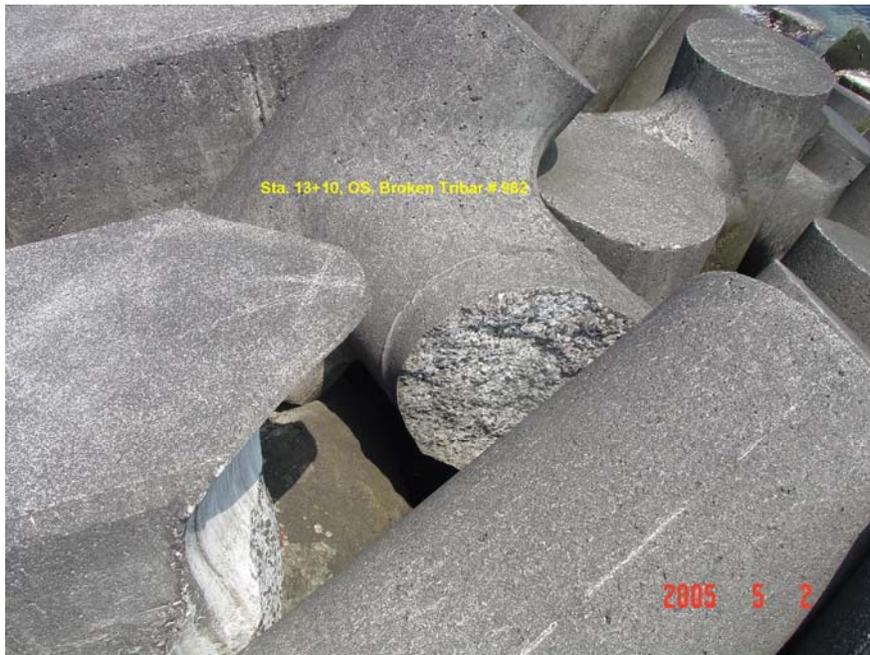
o. Sta. 13+10, OS, Broken Tribar # 982

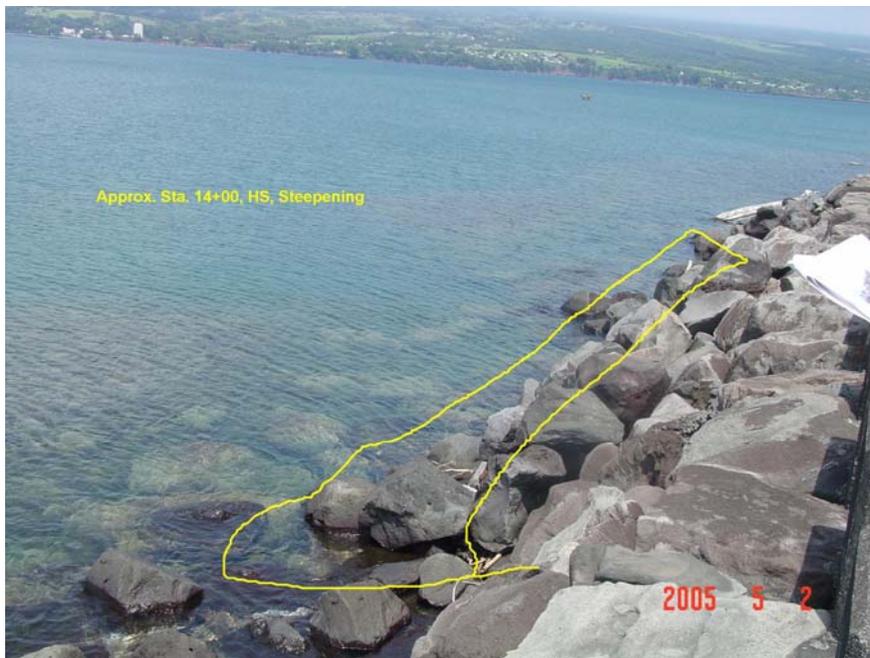
p. Sta. 14+00, HS, sideslope steepening, peeling off see previous report.

Sideslope failure at Sta. 14+00, HS, noted on previous post storm report has not changes. The overall condition of the breakwater is FAIR, however the functionality is GOOD.

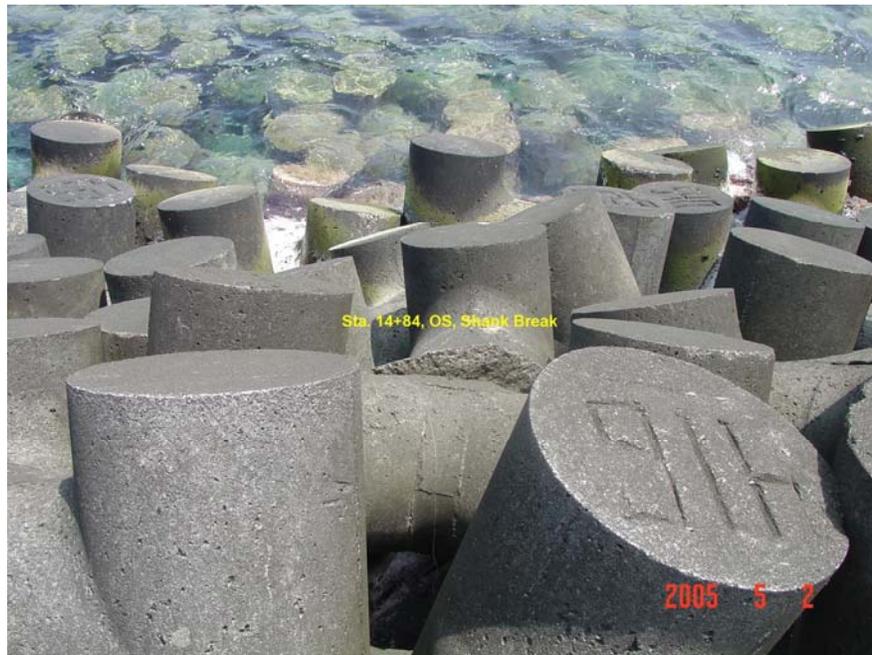
q. Sta. 14+84, OS, Shank Break..

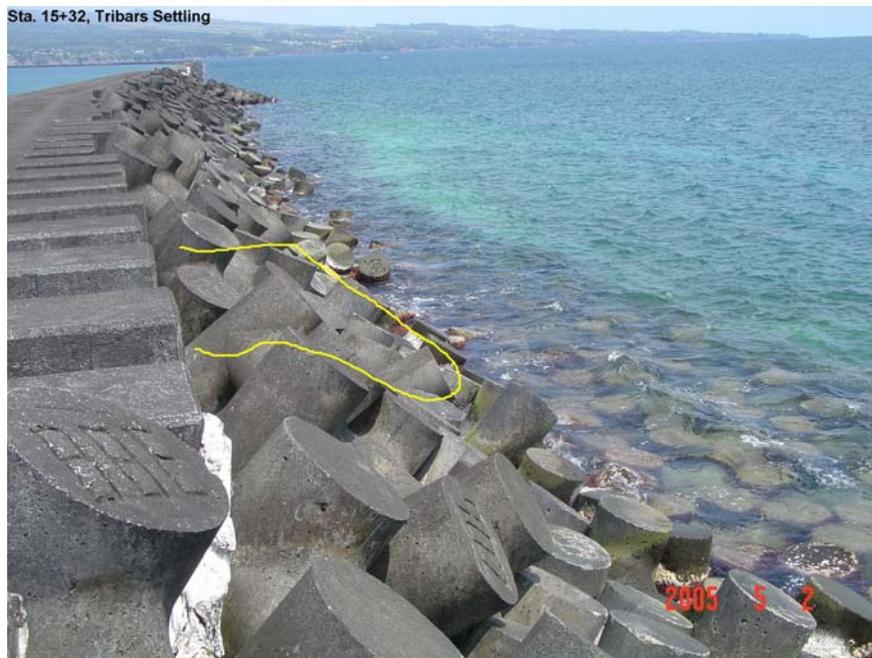
r. Sta.15+30 to 15+56, OS, Monitor tribar movement, settling.

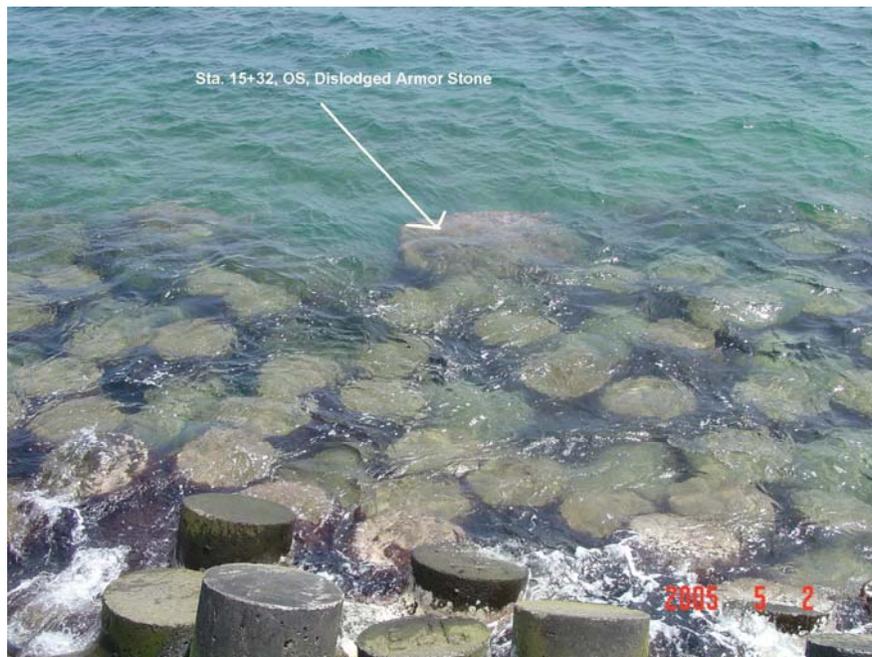
s. Sta. 15+32, OS, Dislodged armor stone, no obvious void.

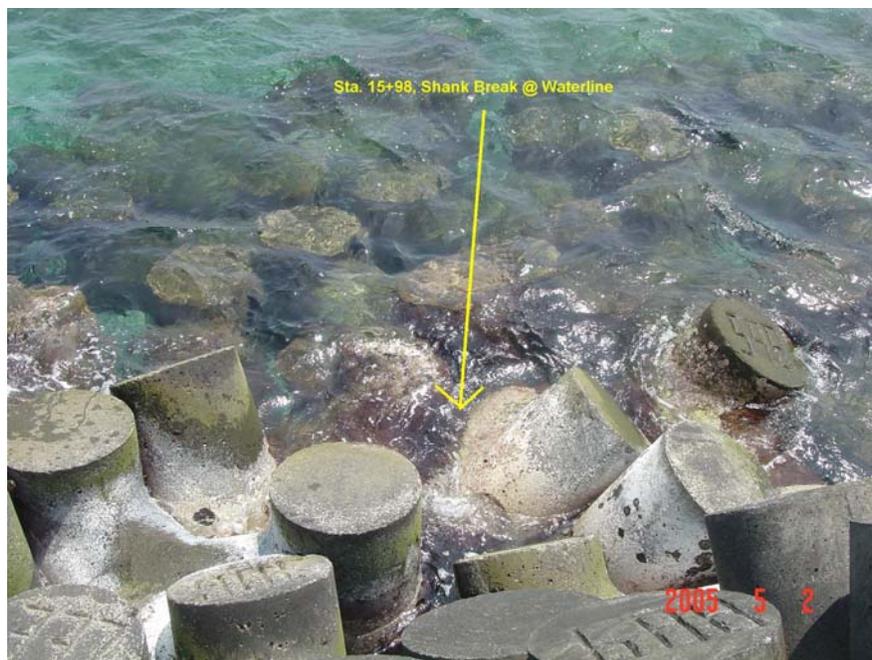
t. Sta.15+98, OS, Monitor shank break at water line.

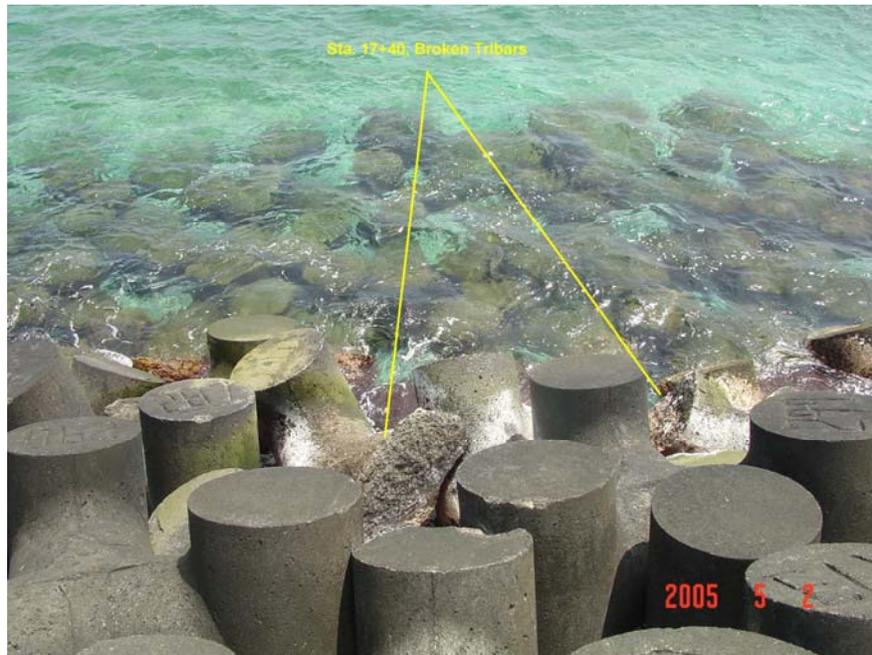
u. Sta. 17+40, OS, Broken Tribars # 317 / 287 / ?

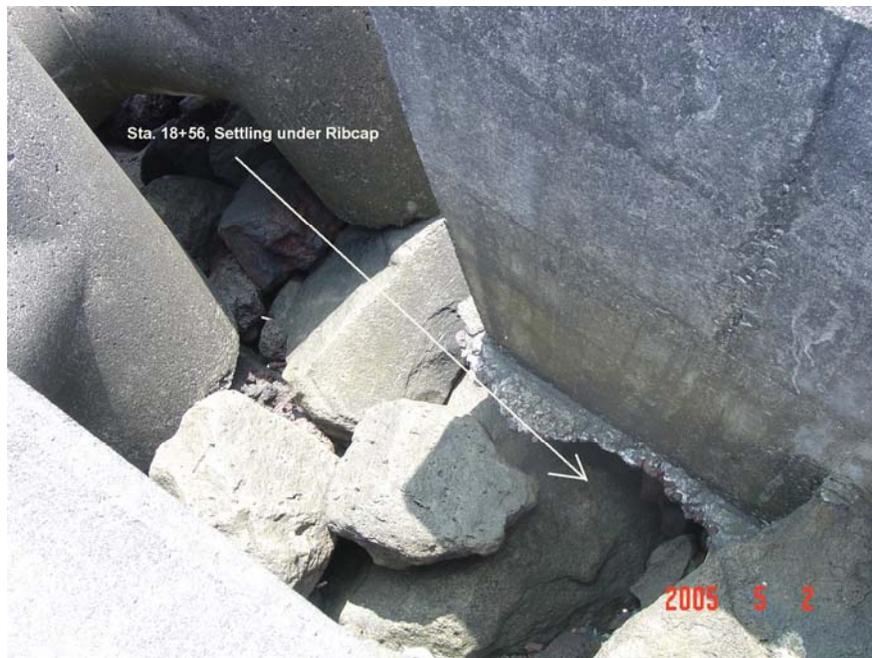
v. Sta. 18+56, OS, settling under tribar at ribcap.

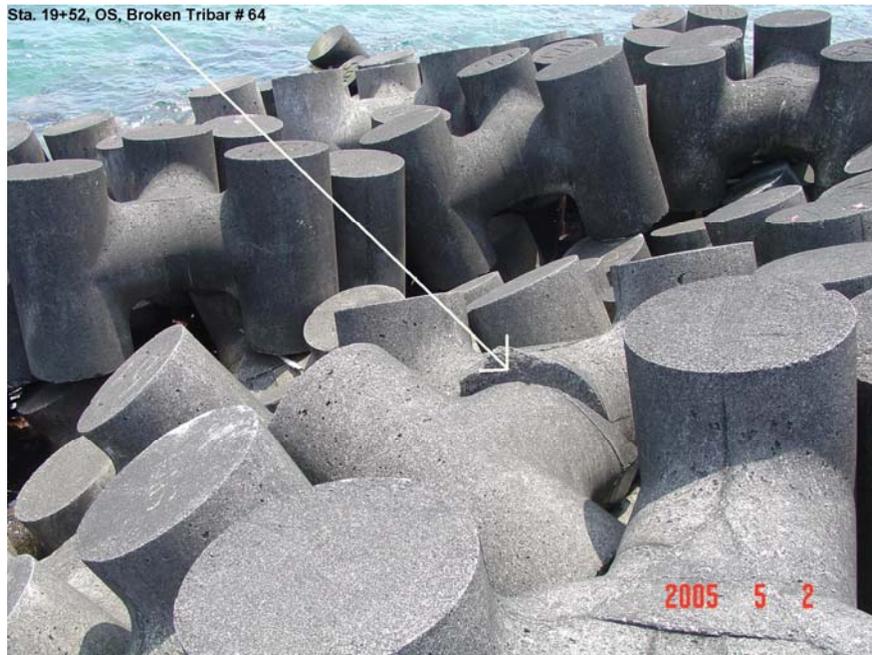
w. Sta. 19+52, OS, Broken Tribars # 64

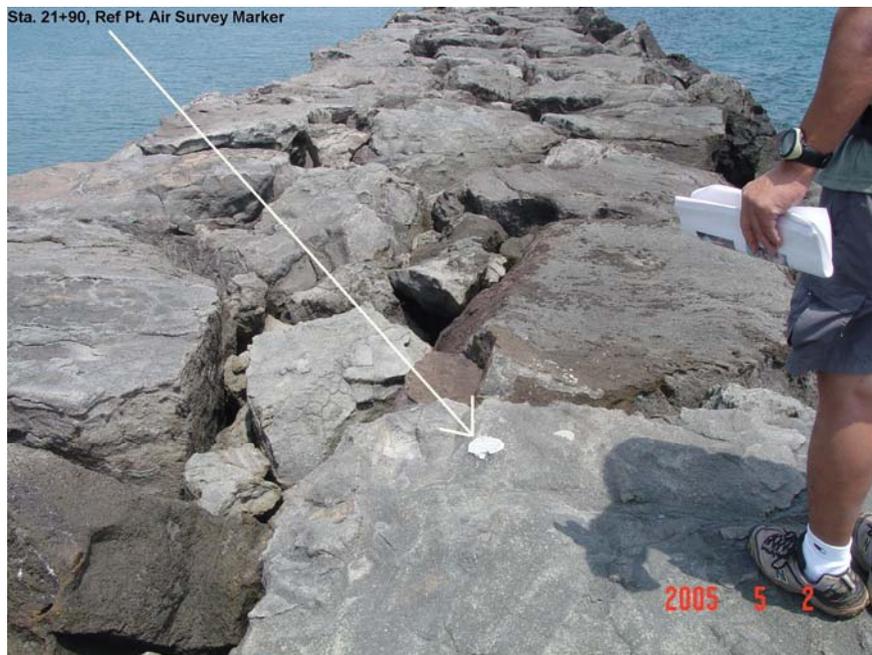
x. Sta. 21+90, Crest, partial air survey marker.

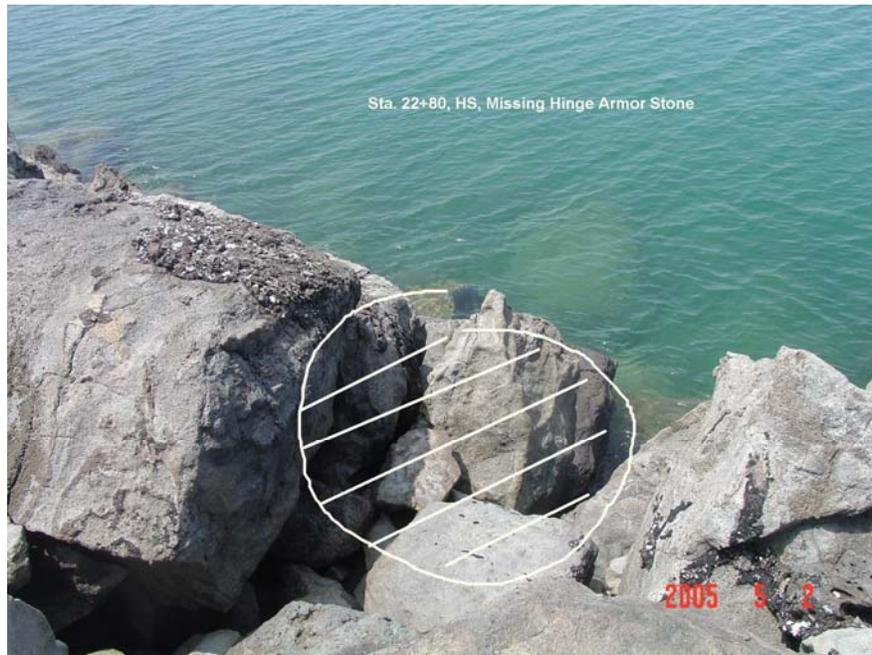
y. Sta. 22+80, HS, missing hinge armor stone.

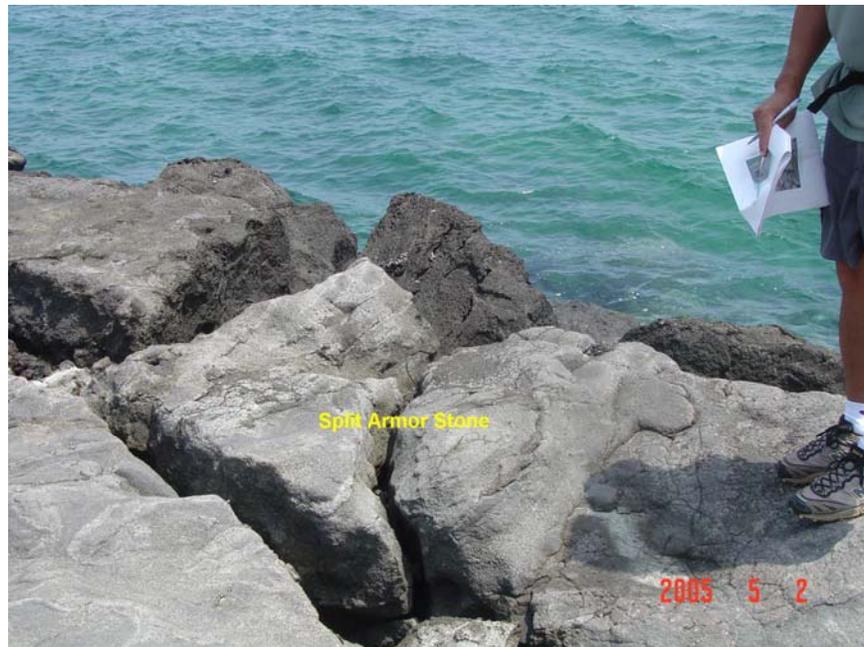
z. Sta. 22+90, OS, Split armor stone.

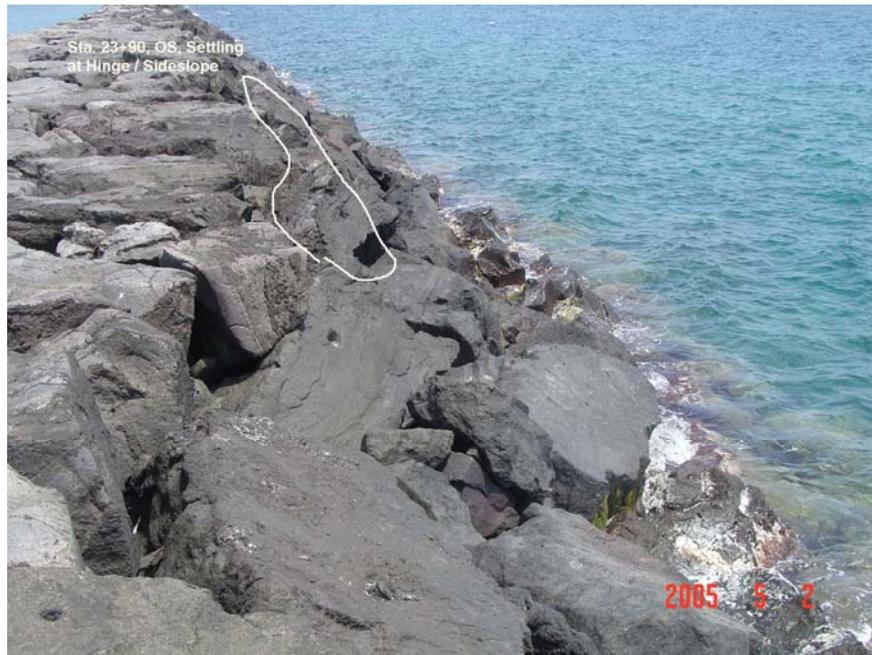
aa. Sta. 23+90, OS, Monitor hinge separation.

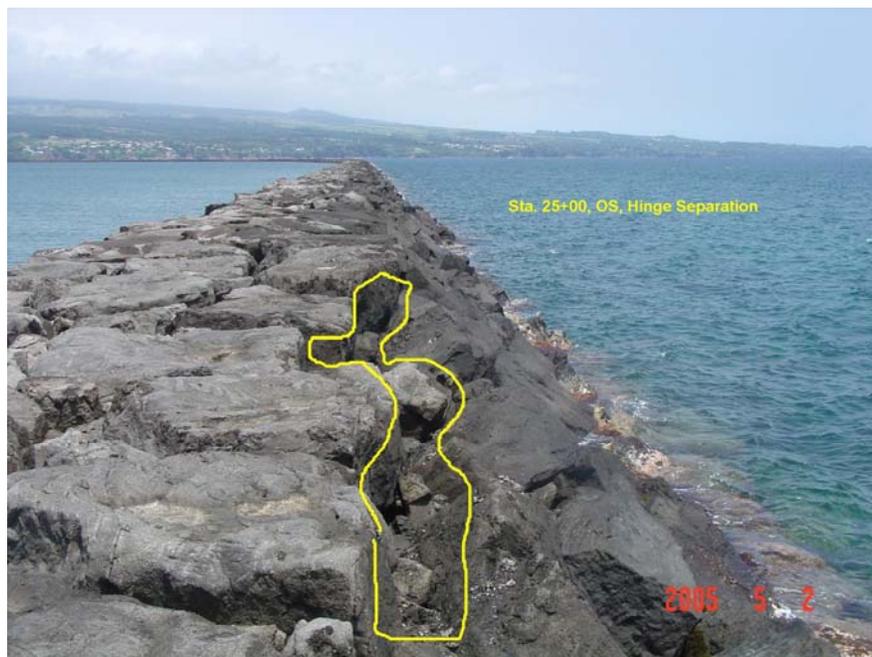
bb. Sta. 25+00, OS, Monitor hinge separation.

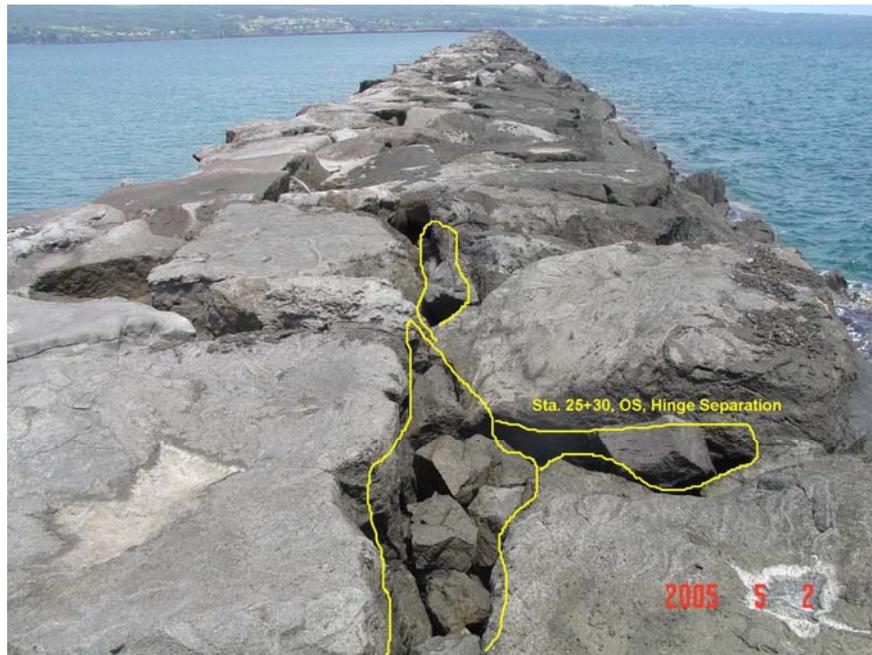
cc. Sta. 25+30, OS, Monitor hinge settling.

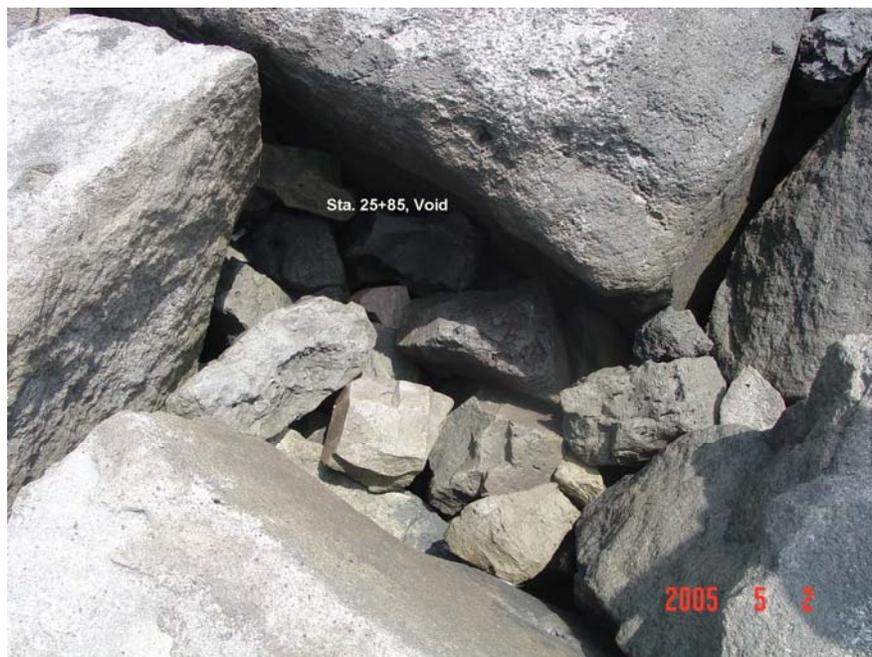
dd. Sta. 25+85, Small void at crest.

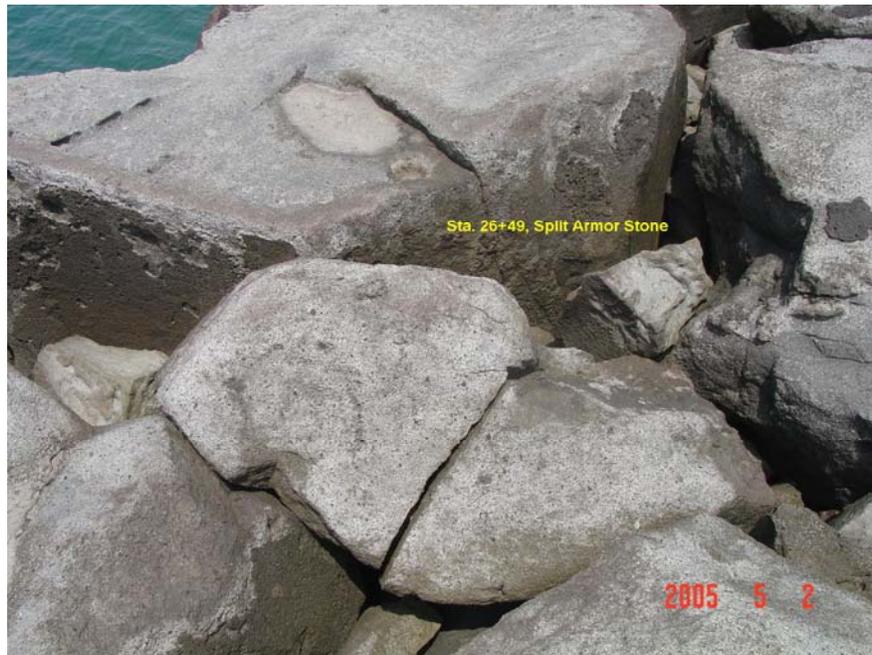
ee. Sta. 26+49, HS, split armor stone at hinge.

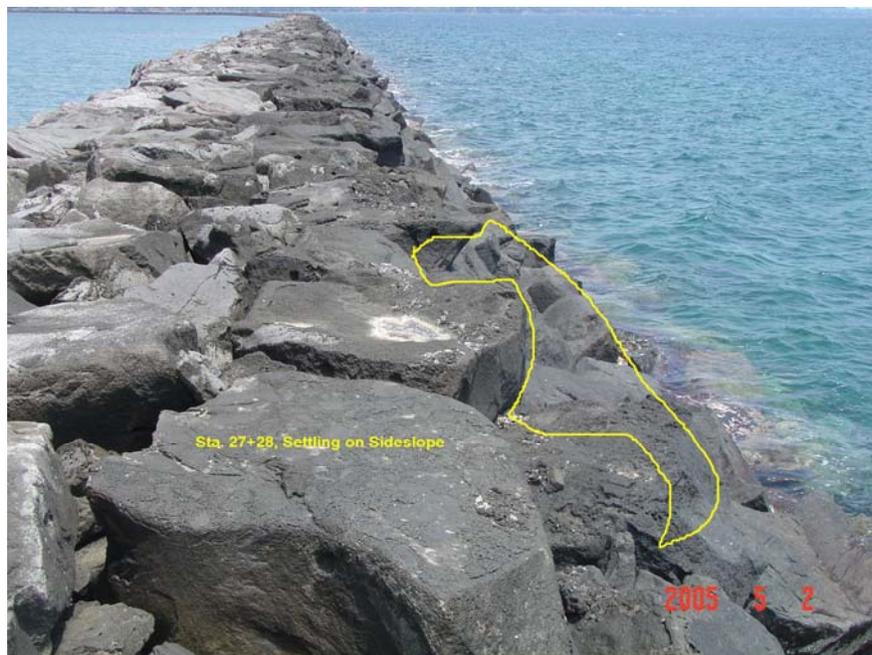
ff. Sta. 27+28, OS, sideslope settling.

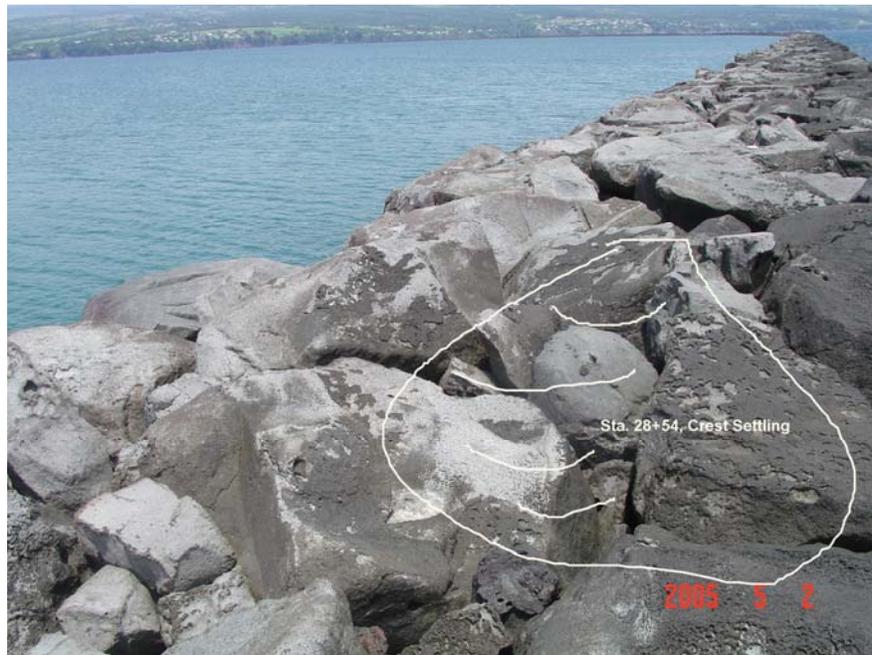
gg. Sta. 28+54, crest settling.

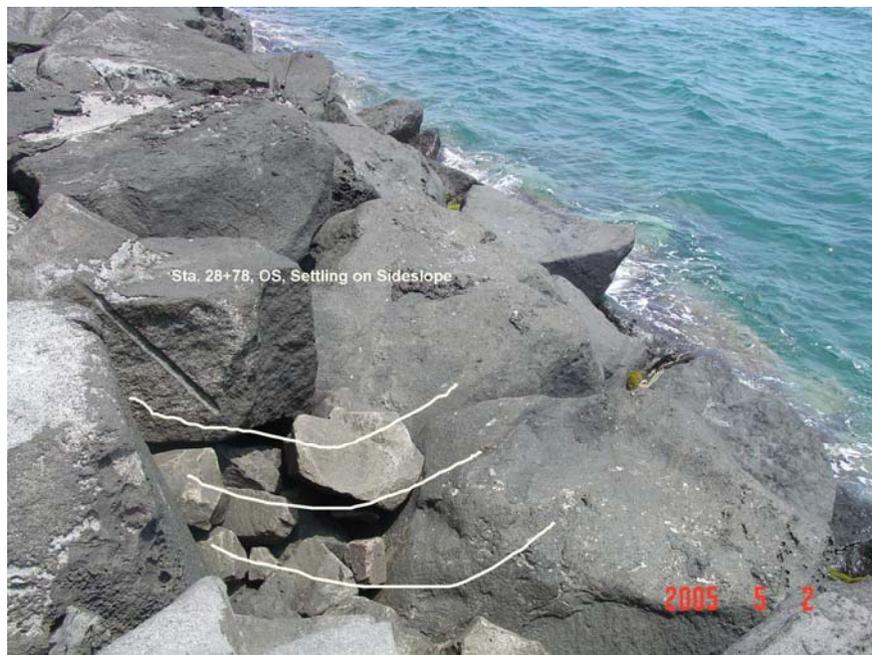
hh. Sta. 28+78, OS, settling at hinge.

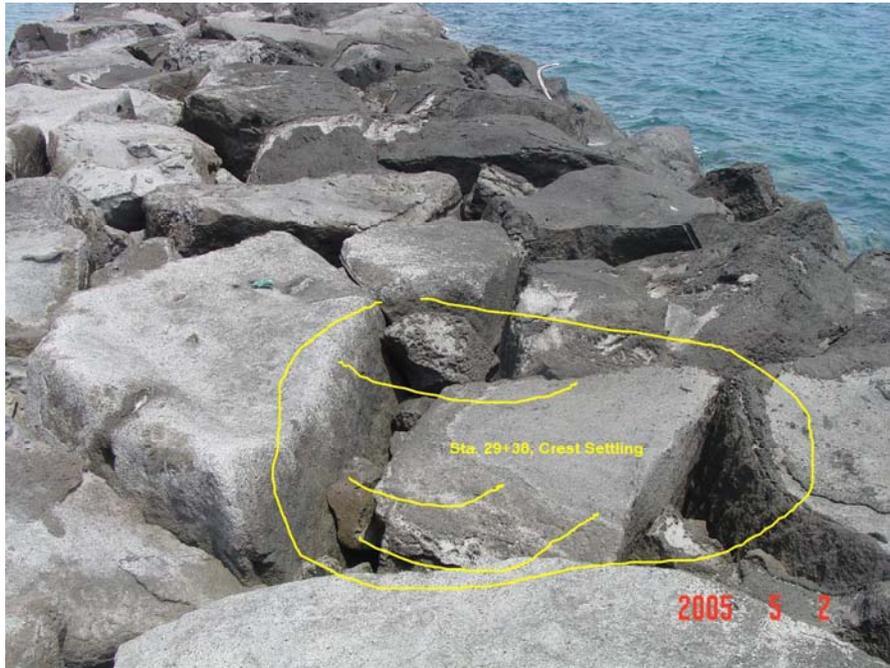
ii. Sta. 29+38, Depression on crest.

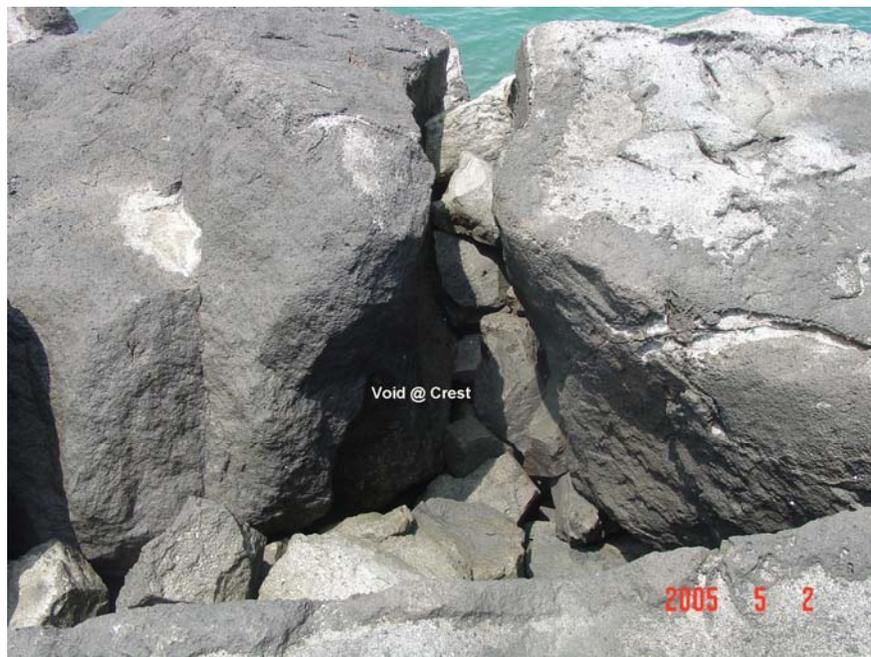
jj. Sta. 32+25, void on crest.

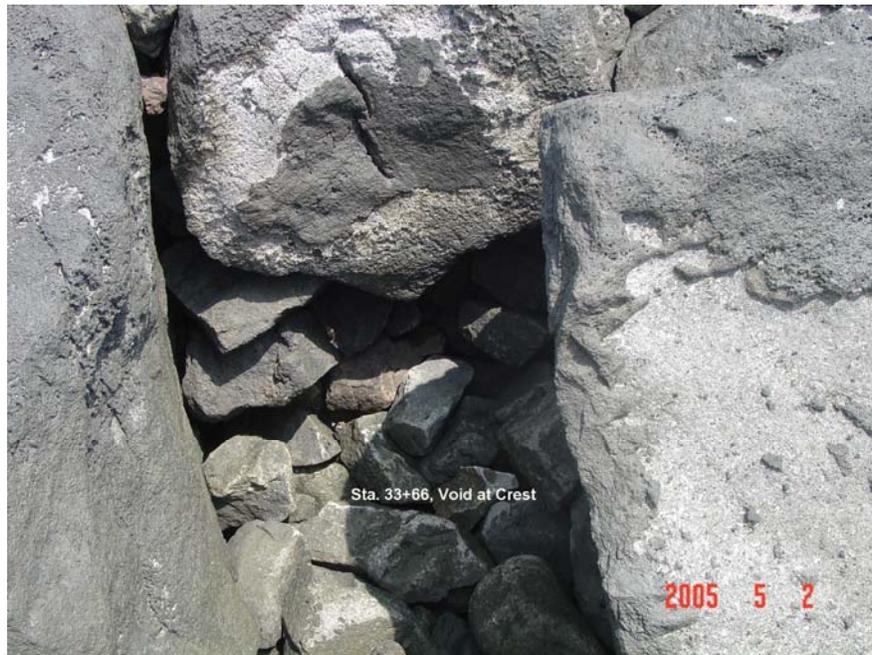
kk. Sta. 33+66, Void on crest.

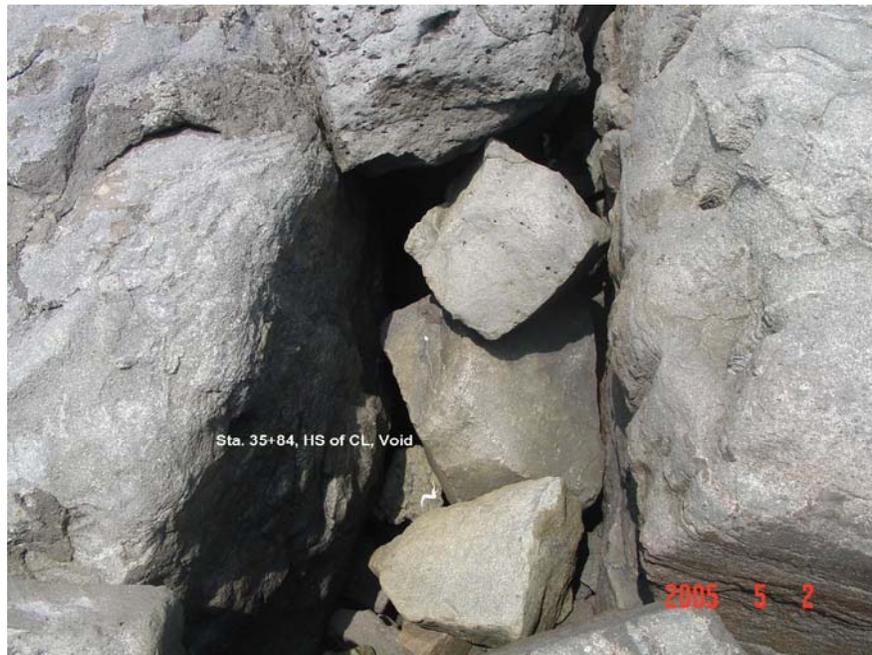
mm. Sta. 35+84, 3' x 4', void at crest.

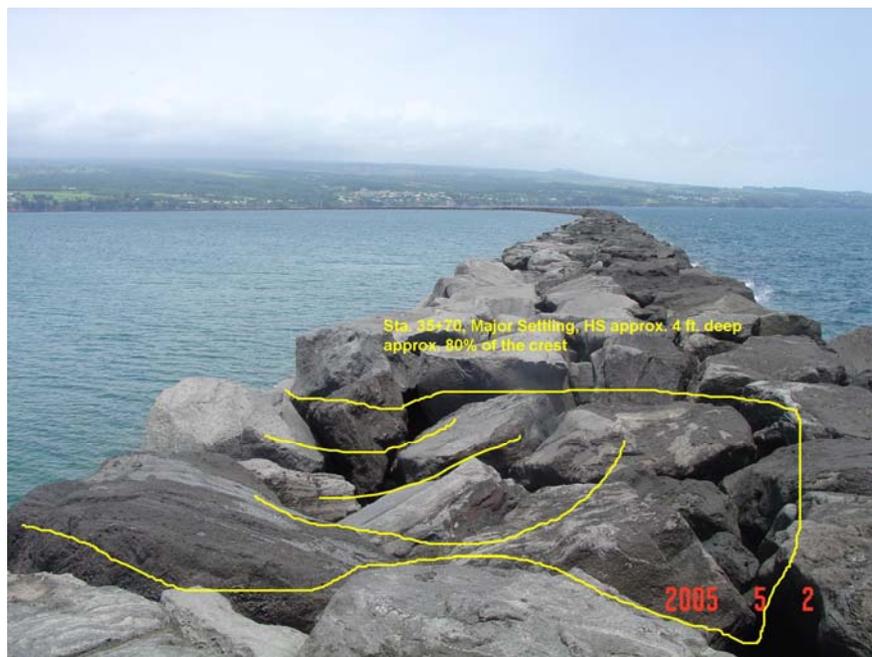
nn. Sta. 36+10, (not Sta. 35+70), HS, Major settling of approx. 90% of crest.

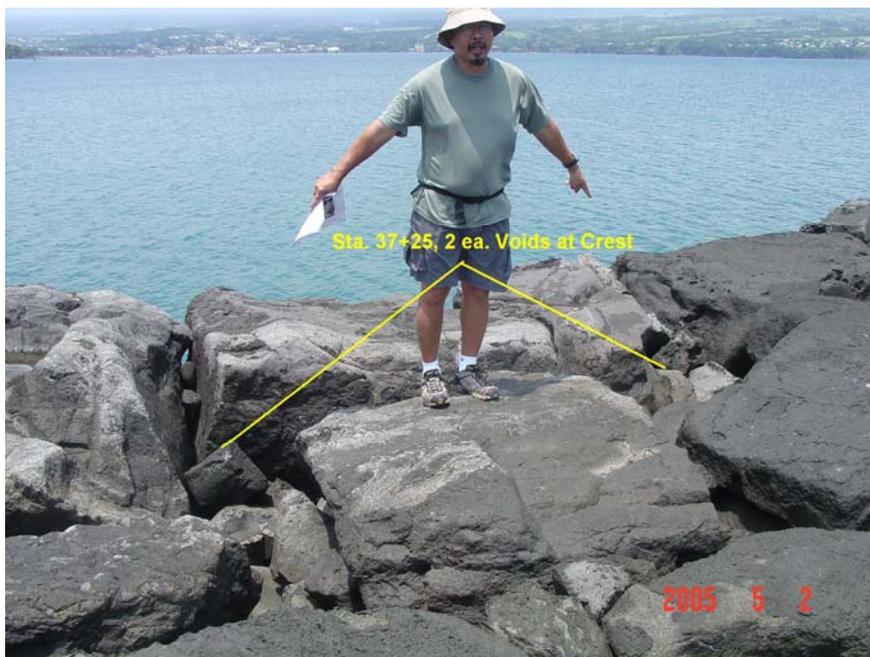
pp. Sta. Sta. 37+25, settling at crest w/2 ea. Voids.

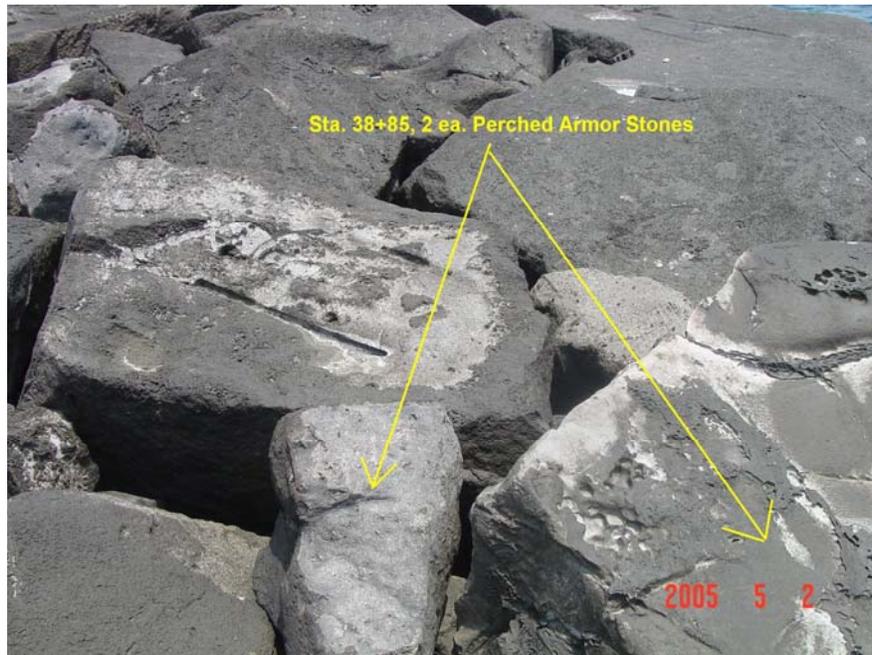
qq. Sta. 38+85, 2ea. perched armor stones.

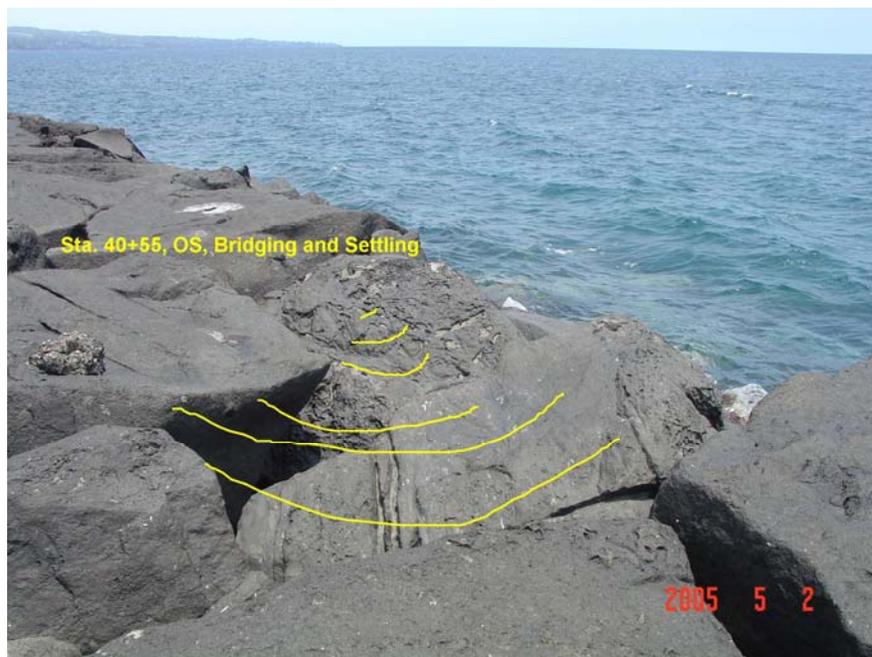
rr. Sta. 40+55, OS, bridging and settling.

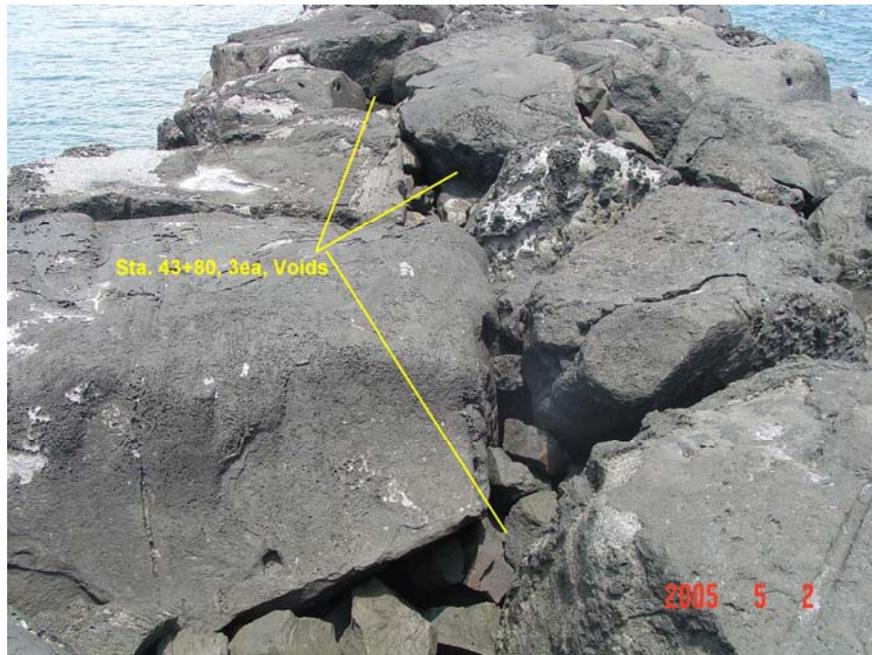
ss. Sta. 43+80, Crest, 3 ea. Voids.
