1. Project Name: Hilo Deep Draft Harbor

2. Date of Inspection: May 2, 2005

O&M INSPECTION REPORT FOR NAVIGATION PROJECTS
HILO DEEP DRAFT HARBOR
Honolulu Engineer District
CEPOH-EC-T

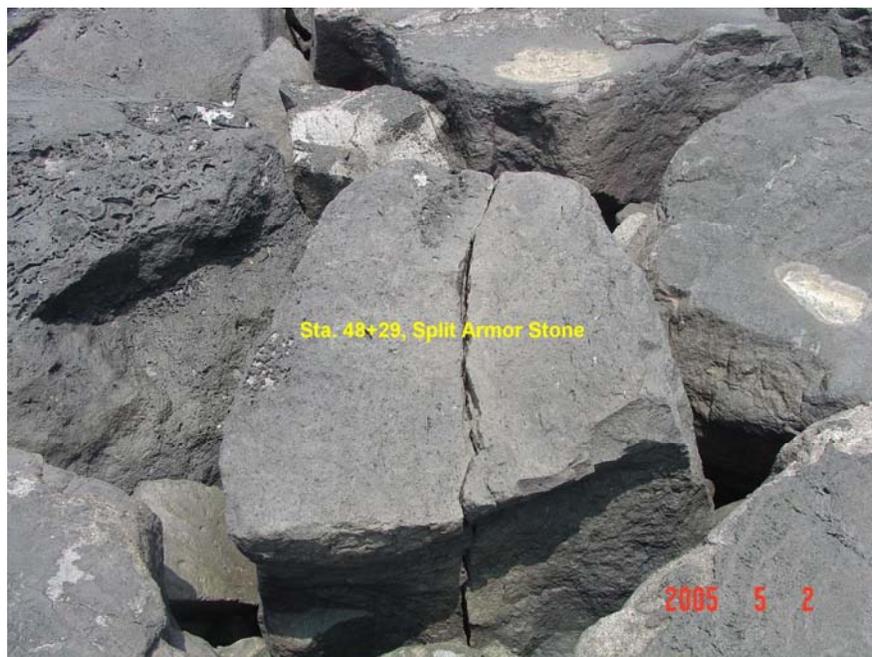
tt. Sta. 48+29, crest , split armor stone.

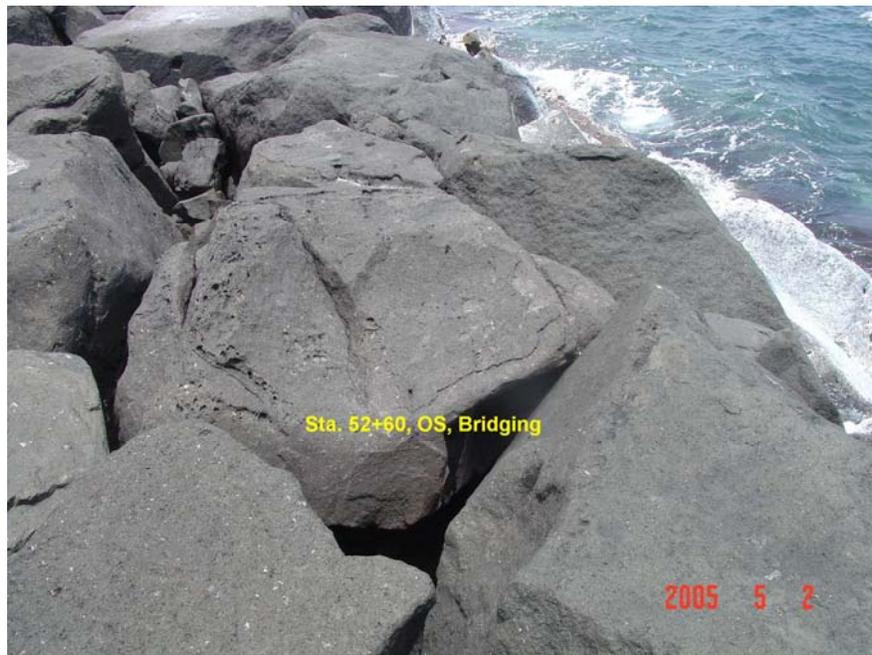
vv. Sta. 52+60, OS, bridging.

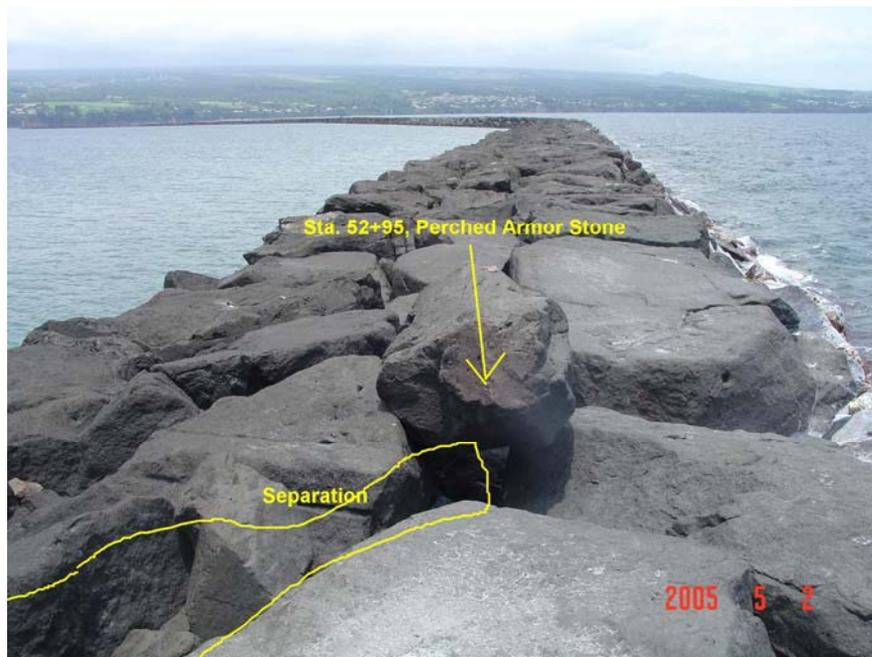
ww. Sta. 52+75 to 52+95, perched armor stone and separation. Small rocks are being forced on the crest by wave action and settling between armor stones causing voids size to increase.

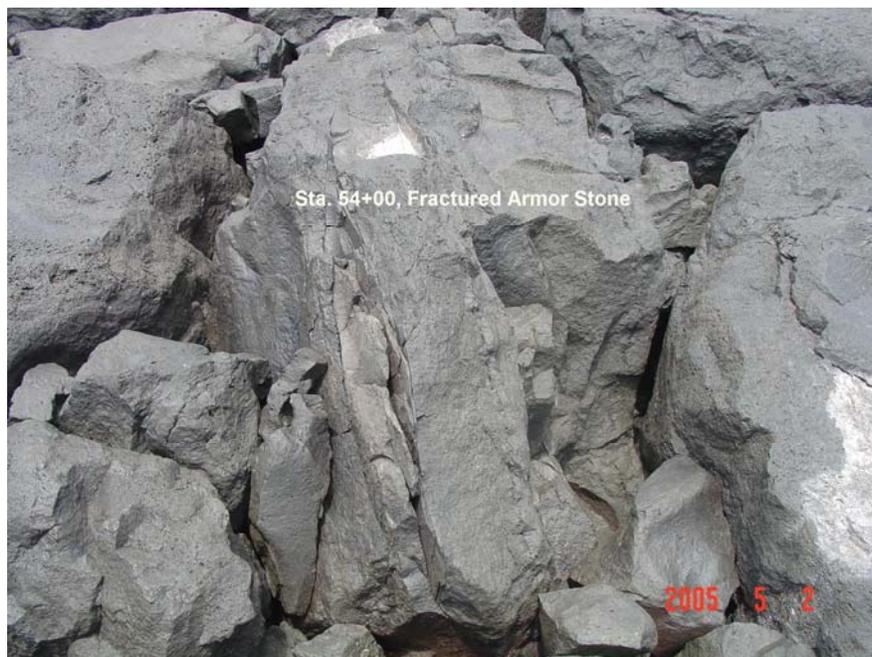
xx. Sta. 54+00, fractured armor stone on crest.

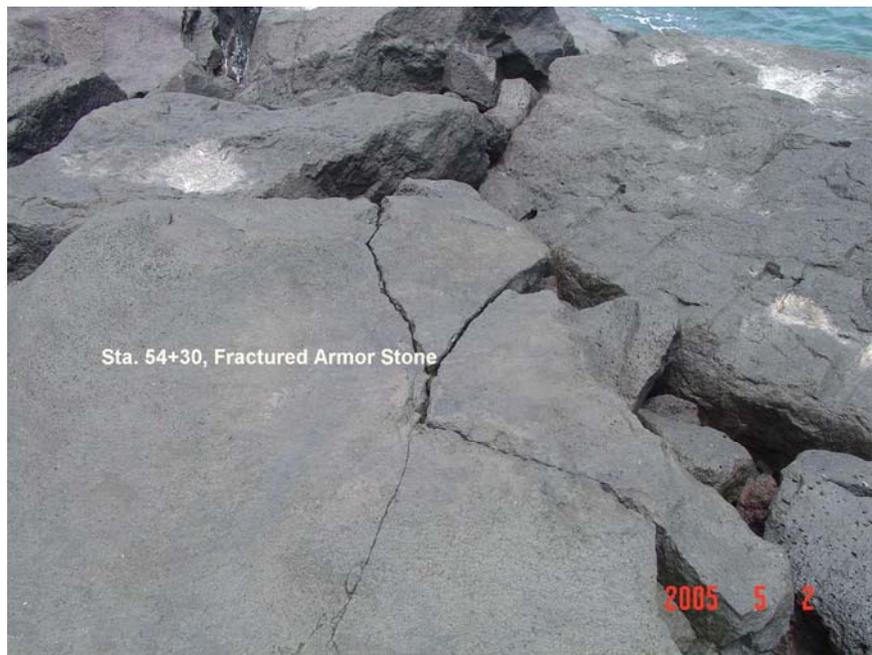
yy. Sta. 54+30, fractured armor stone on crest.

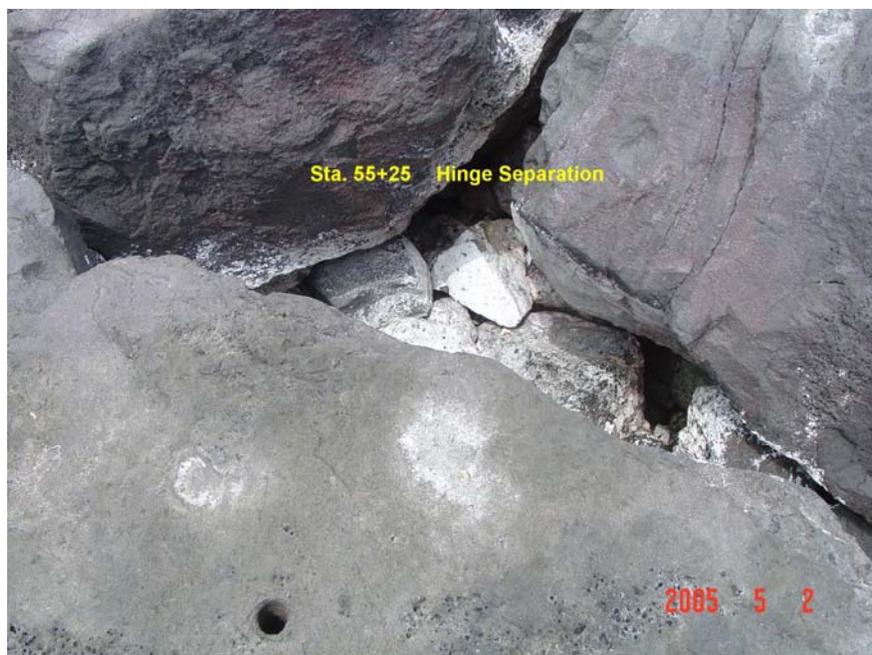
zz. Sta. 55+25, OS, hinge separation.

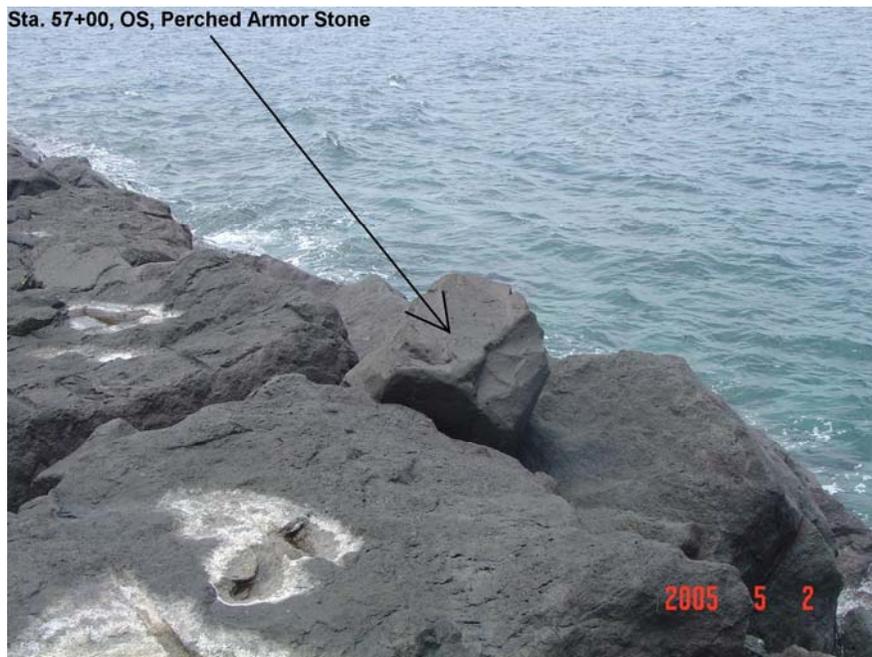
aaa. Sta. 57+00, OS, perched armor stones, several smaller perched stones on sideslope.

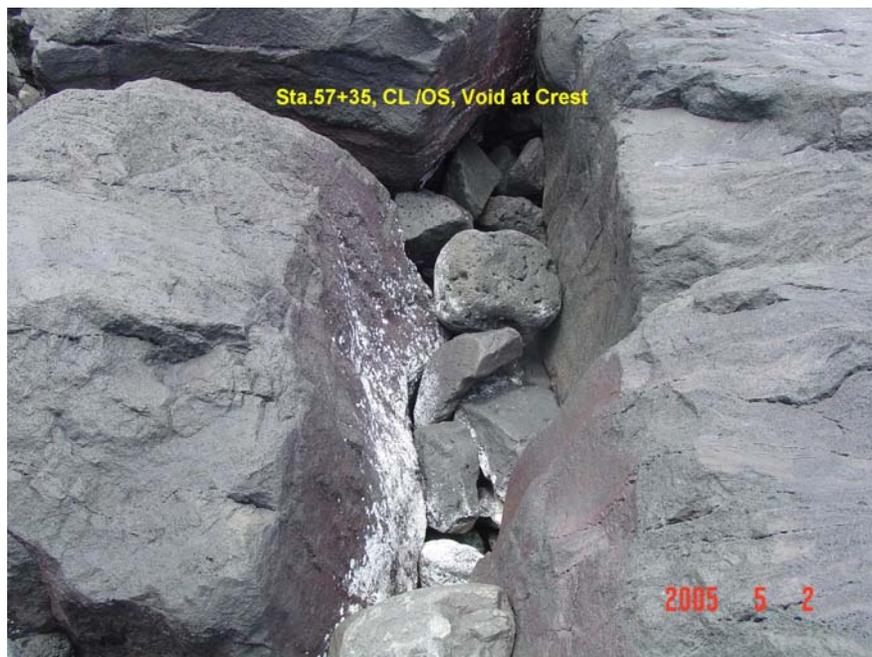
bbb. Sta. 57+35, void at crest, CL of OS, 4' deep 3' wide 4' deep.

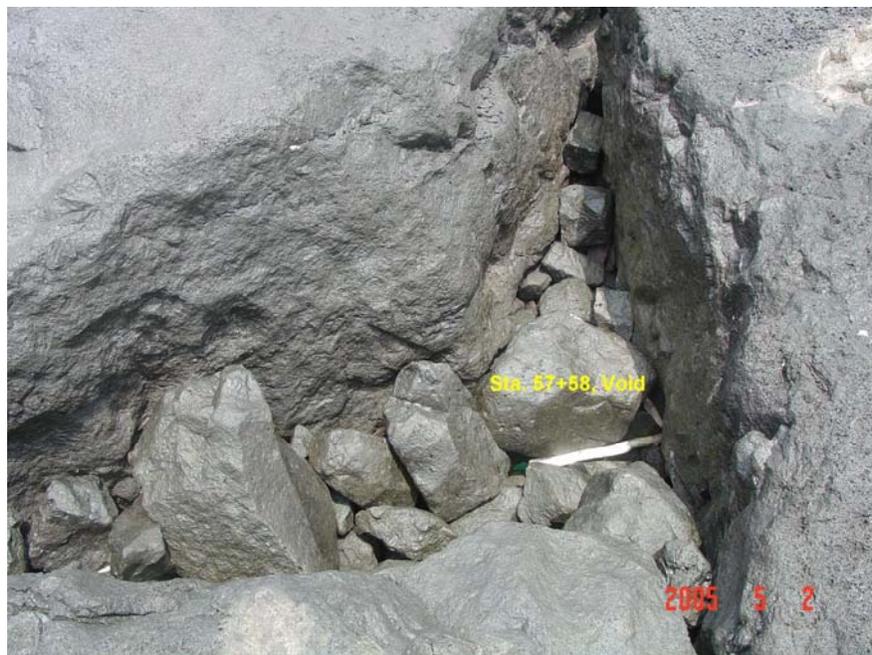
ddd. Sta. 57+58, CL Crest, 2' separation.

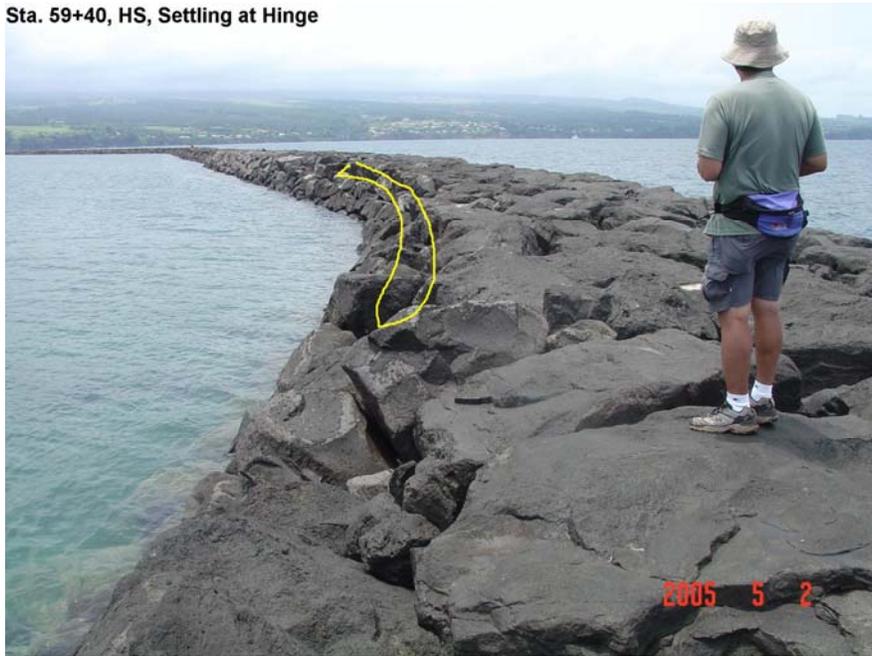
eee. Sta. 59+40, HS, hinge settling.

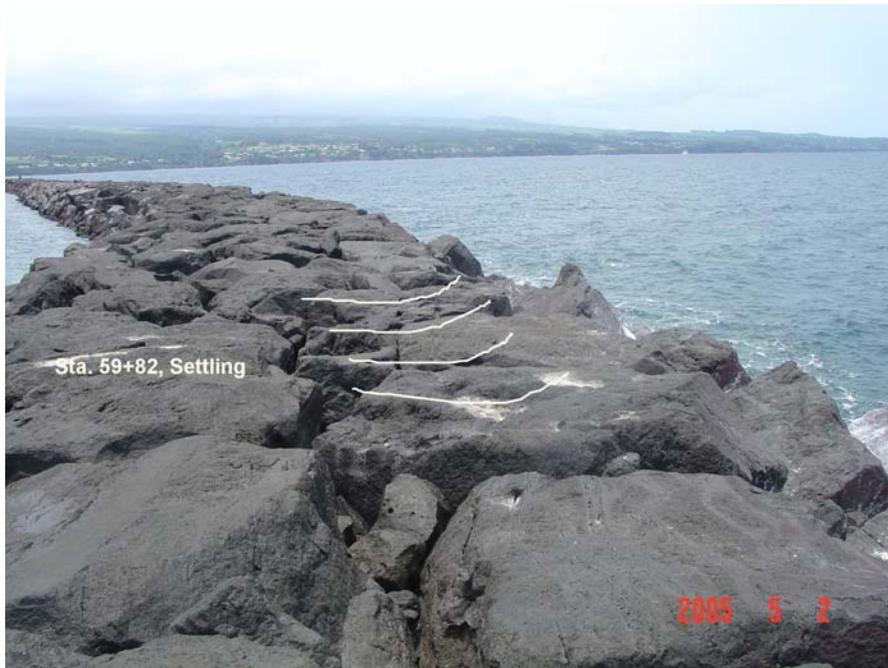
fff. Sta. 59+82, CL crest, settling.

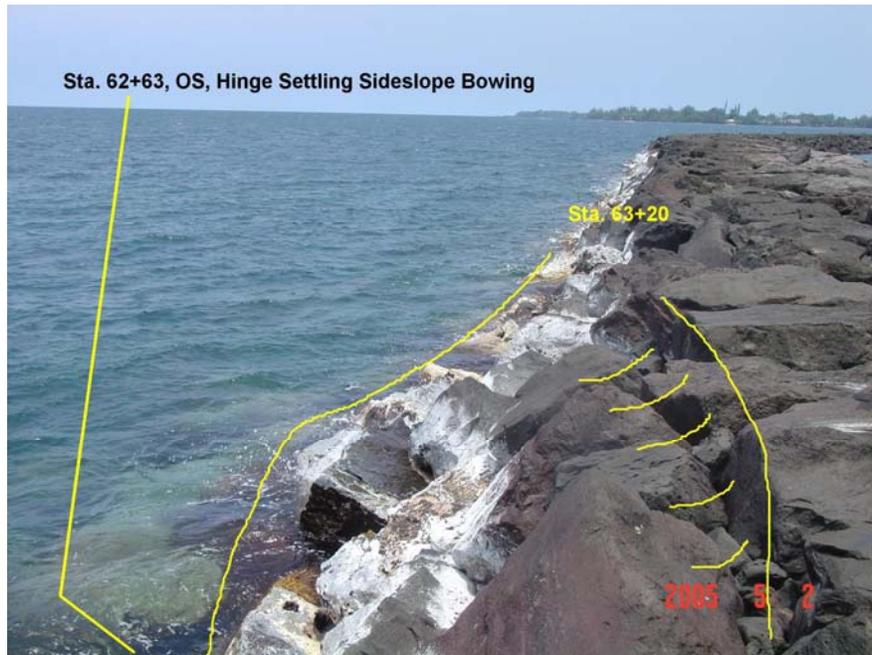
iii. Sta. 62+63, OS, hinge settling & sideslope bowing.

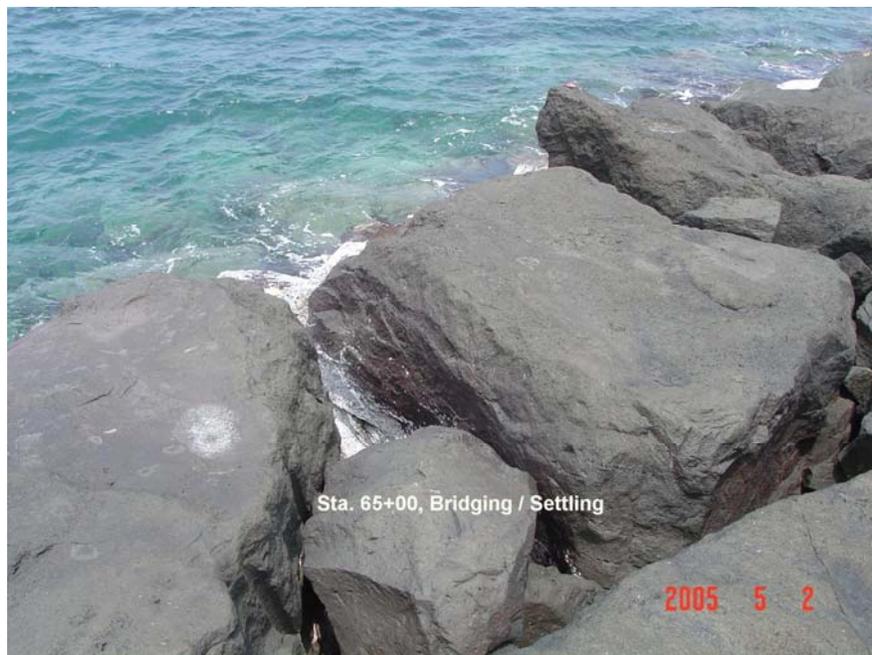
jjj. Sta. 65+00, OS, bridging and settling.

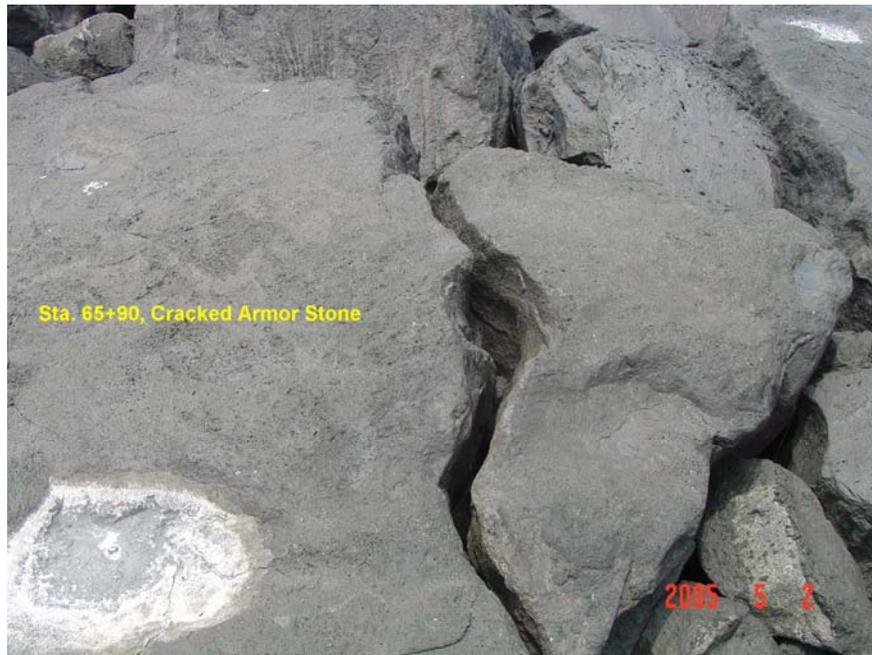
kkk. Sta. 65+90, crest, cracked armor stone.

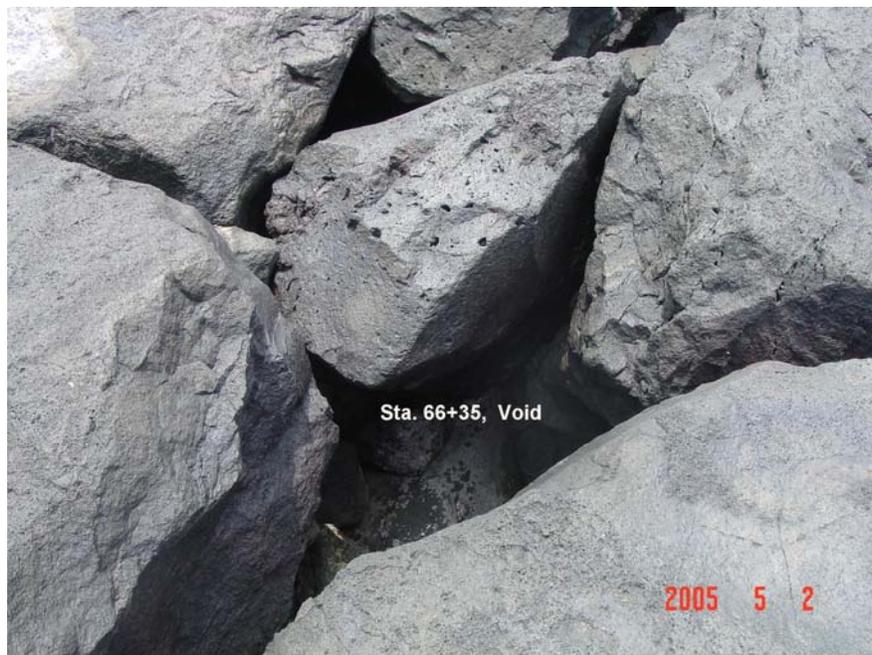
lll. Sta. 66+35, OS crest, 2' void w/ UL exposed.

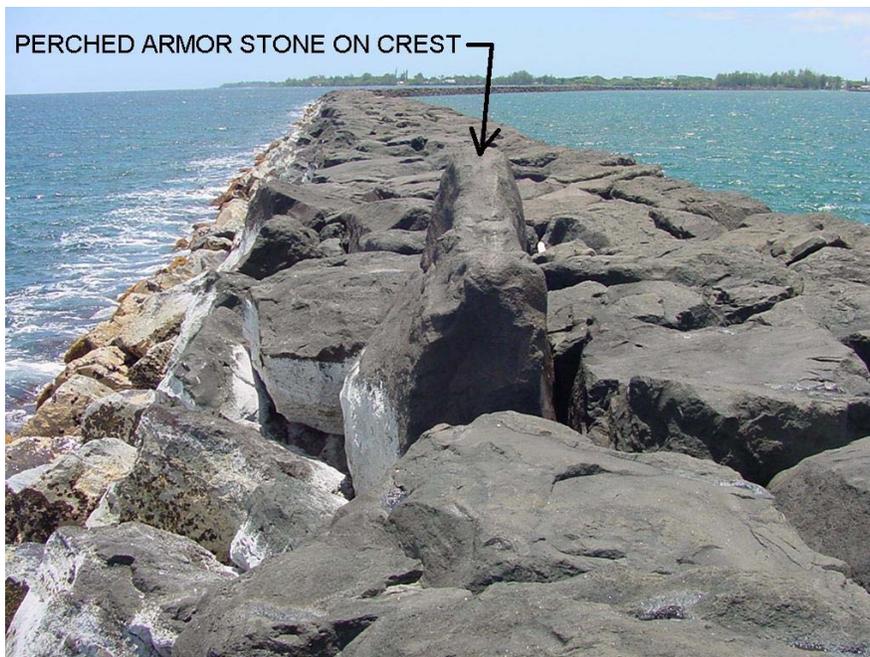
nnn. Sta. 68+00, Perched armor stone resting on crest, "Tombstone".

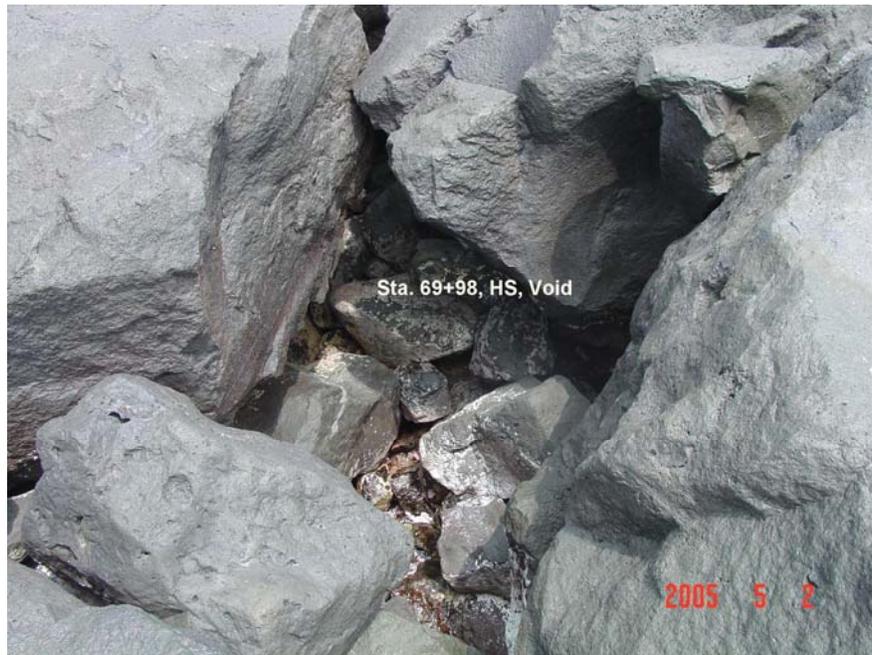
ooo. Sta. 69+98, HS of crest, 3'L x 4'W x 10'D void.

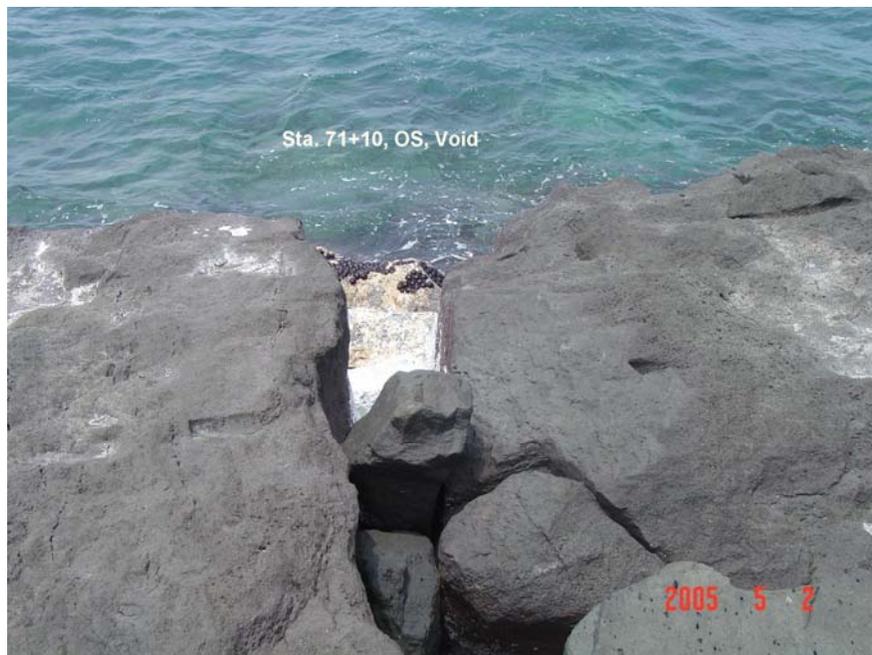
ppp. Sta. 71+10, OS, 3' x 5' void at hinge.

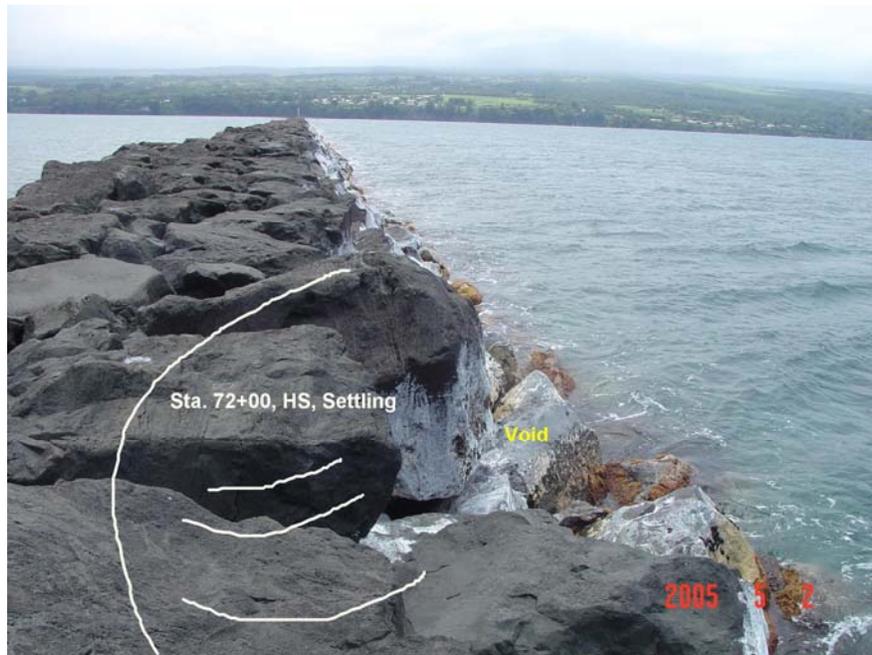
qqq. Sta. 72+00, OS, settling and void.

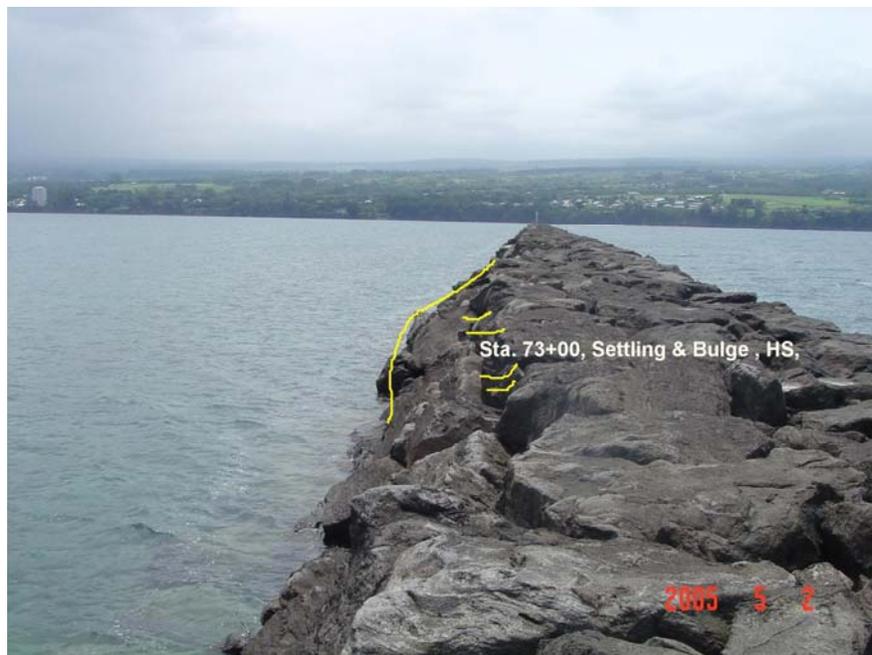
rrr. Sta. 73+00 to Sta. 73+64, HS, Buldge and settling.

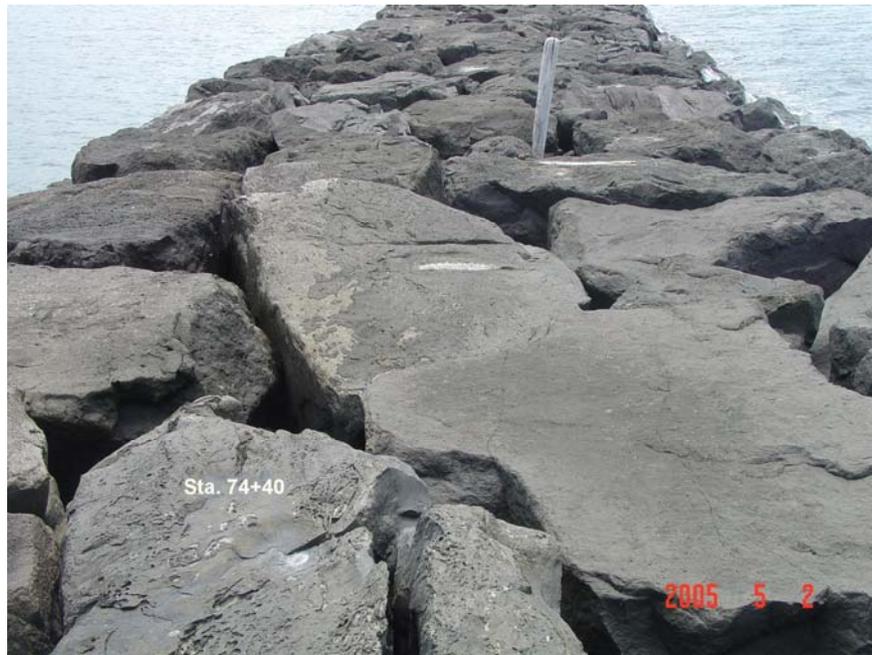
sss. Sta. 74+40, Crest, 1 fractured armor stone (3x).

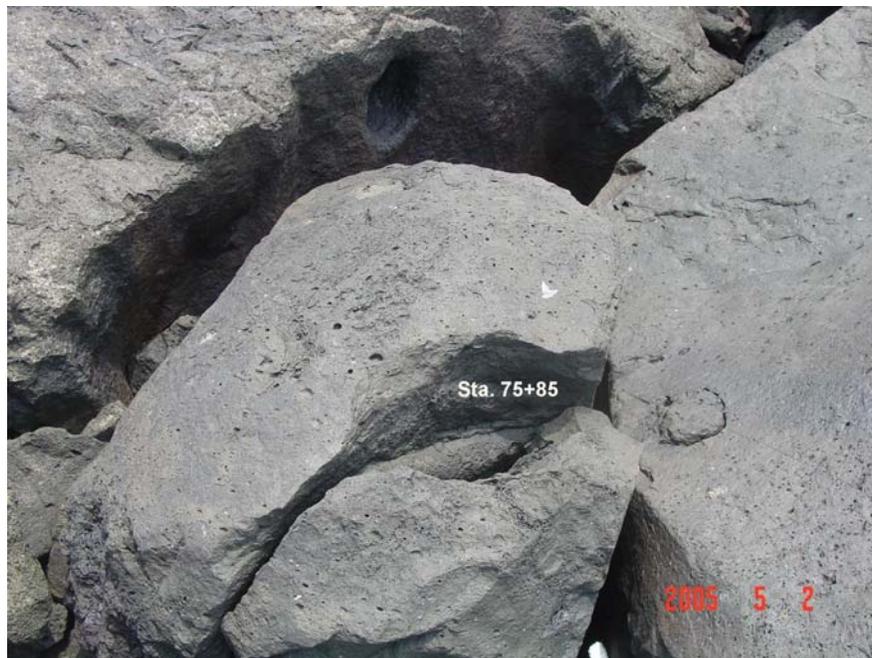
ttt. Sta. 75+85, Crest, 1 fractured armor stone (3x).

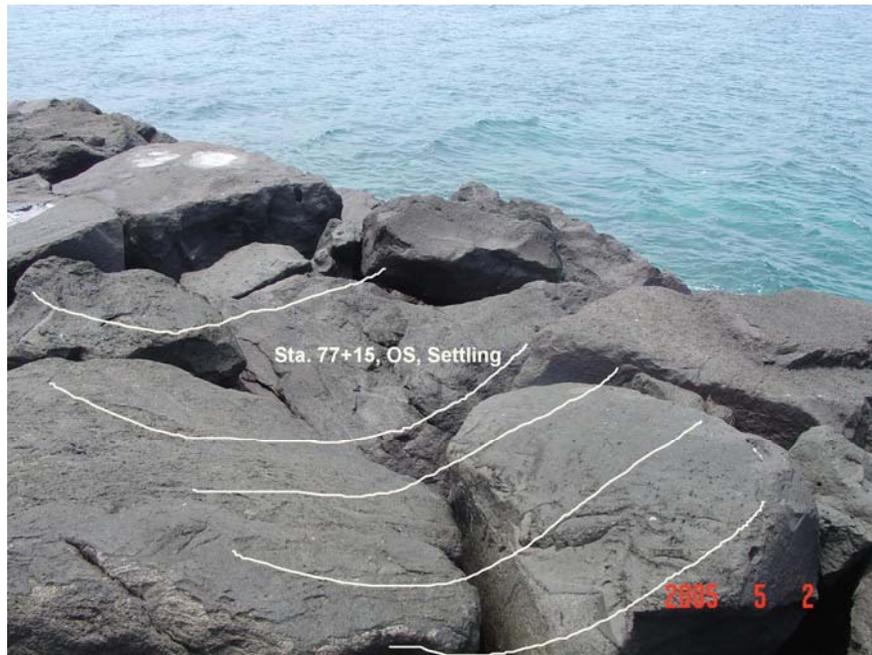
uuu. Sta. 77+15, OS, settling.

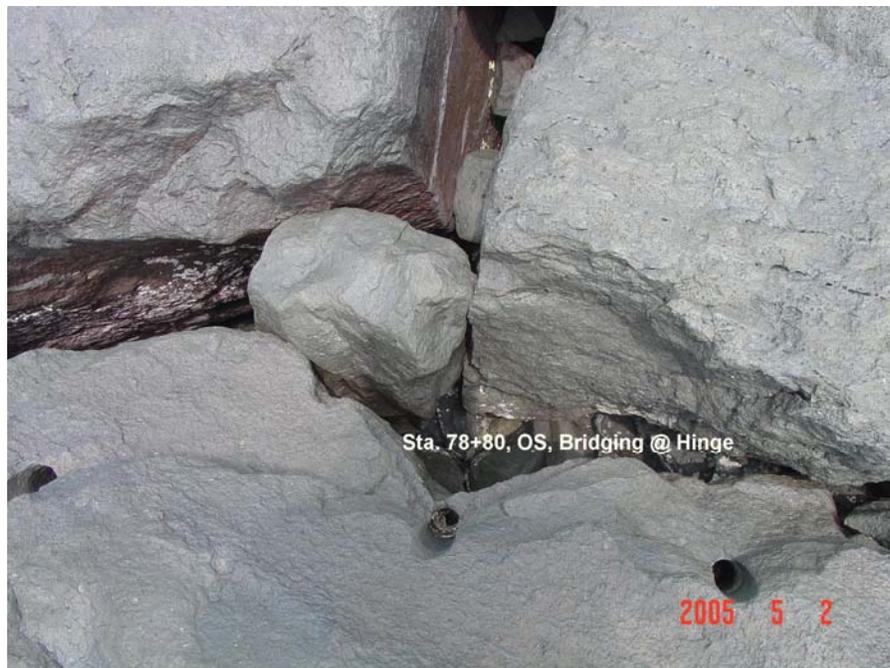
vvv. Sta. 78+80, OS, bridging at hinge.
