1. Project Name: Honokohau SBH
2. Date of Inspection: 4 May 2005
3. Inspection Personnel:

The project consist of:

HONOKOHAU SMALL BOAT HARBOR, HAWAII, HAWAII

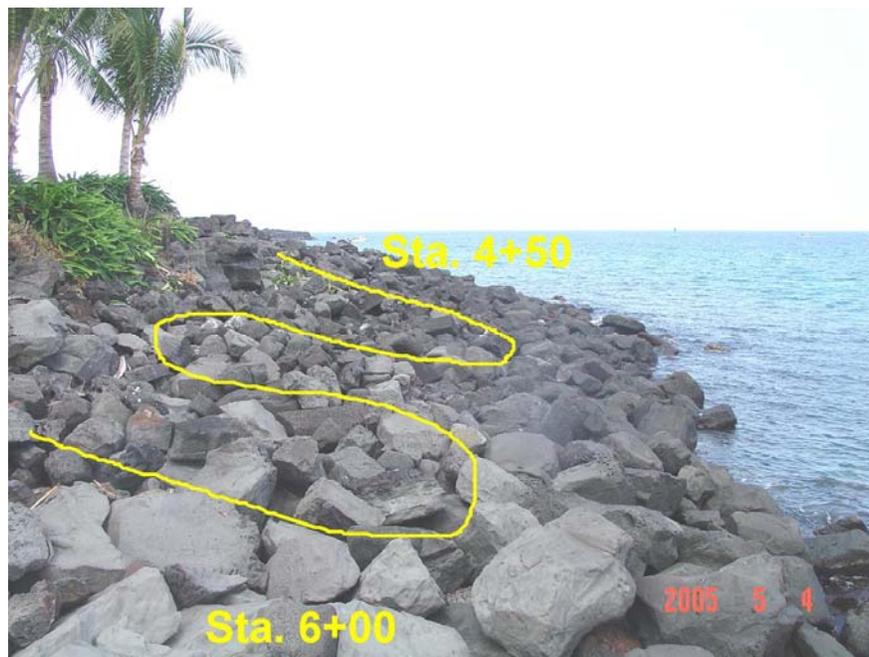
a. South Wave Absorber, Overview

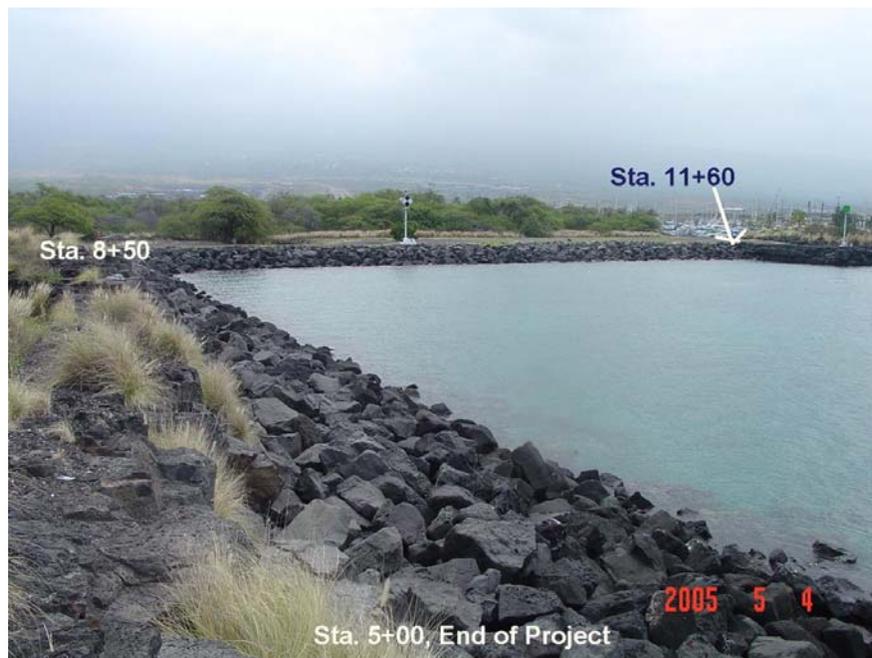
North Wave Absorber Partial Overview

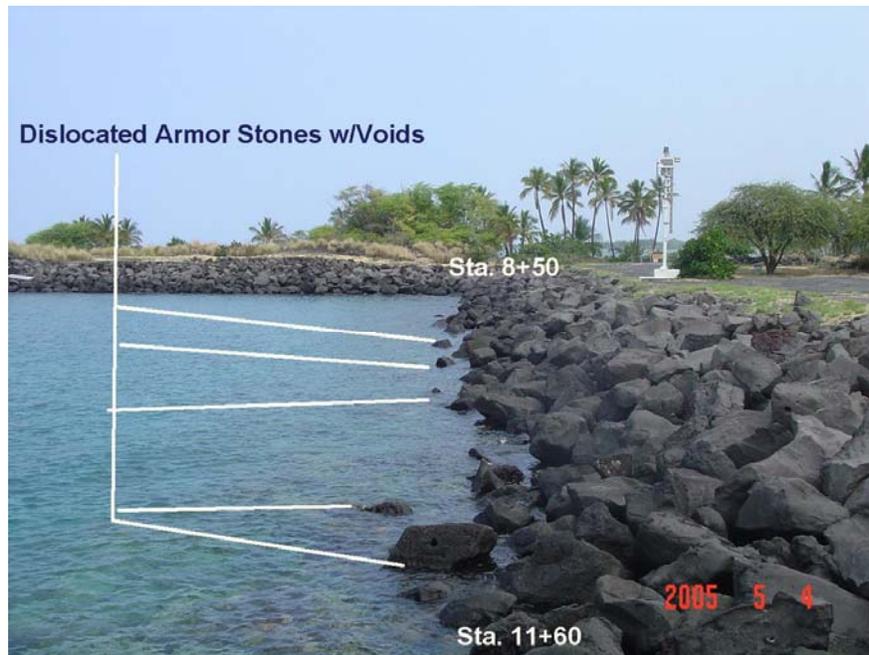
North Wave Absorber Partial Overview

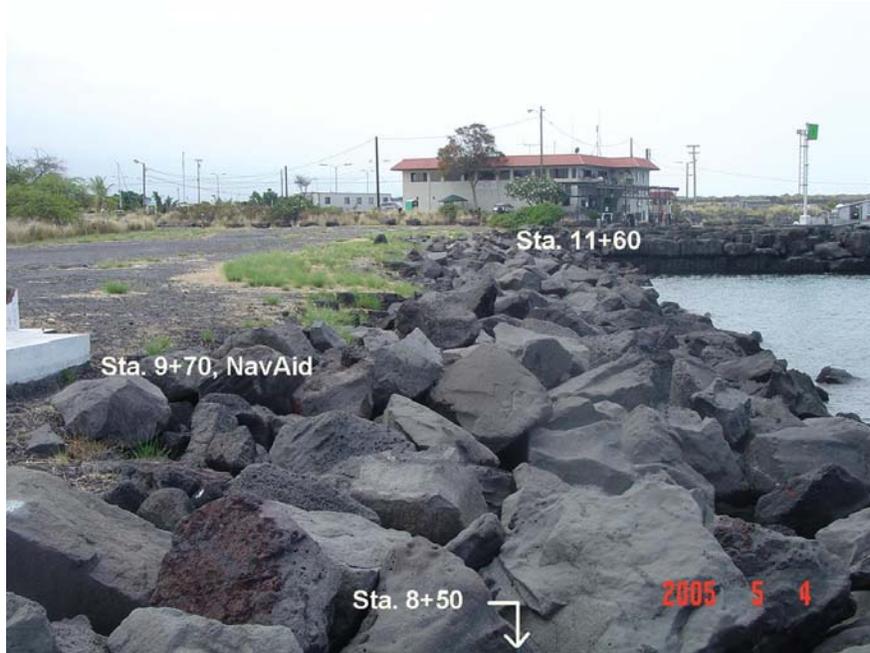
b. Sta. 9+95, dislodged armor stone at the toe. (Sight movement from last inspection).

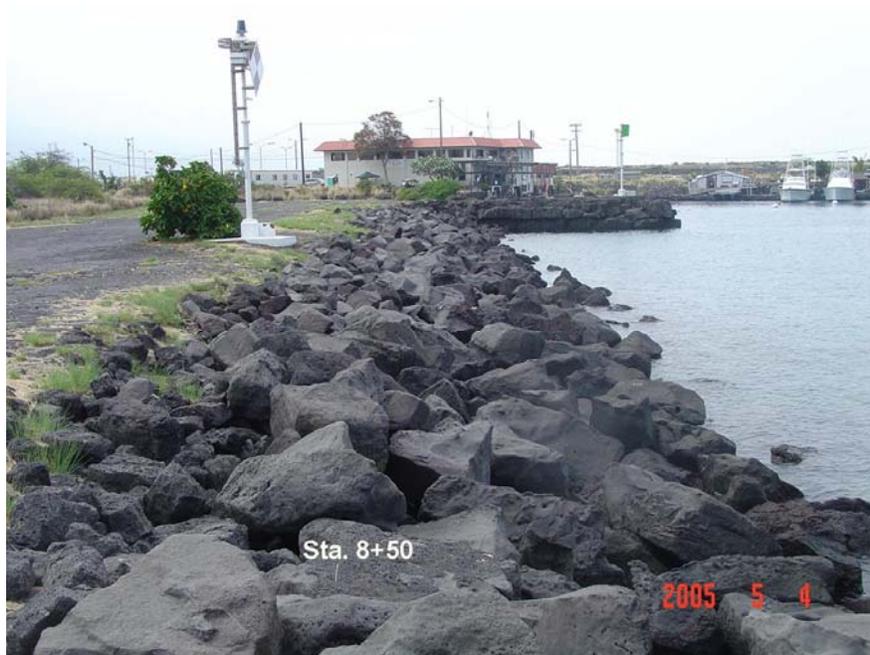
c. Sta. 10+60, Overview from NavAid.

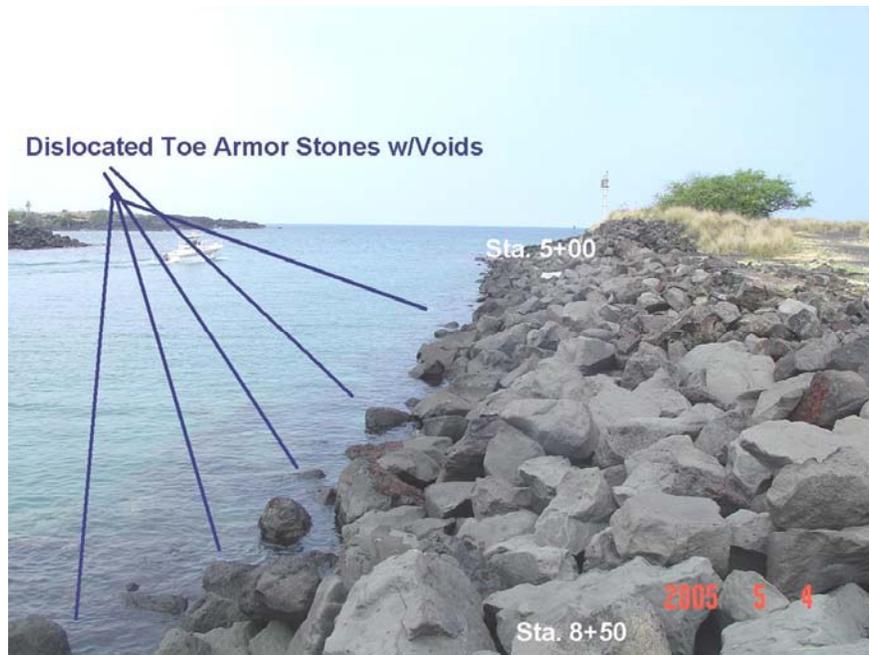
d. Sta. 8+51, Overview (east-side).
