1. Project Name: Pohoiki Bay Navigational Improvements
2. Date of Inspection: May 4, 2005
3. Inspection Personnel:

4. General Note:

Overall, the head and oceanside of the structure are experiencing some settling.

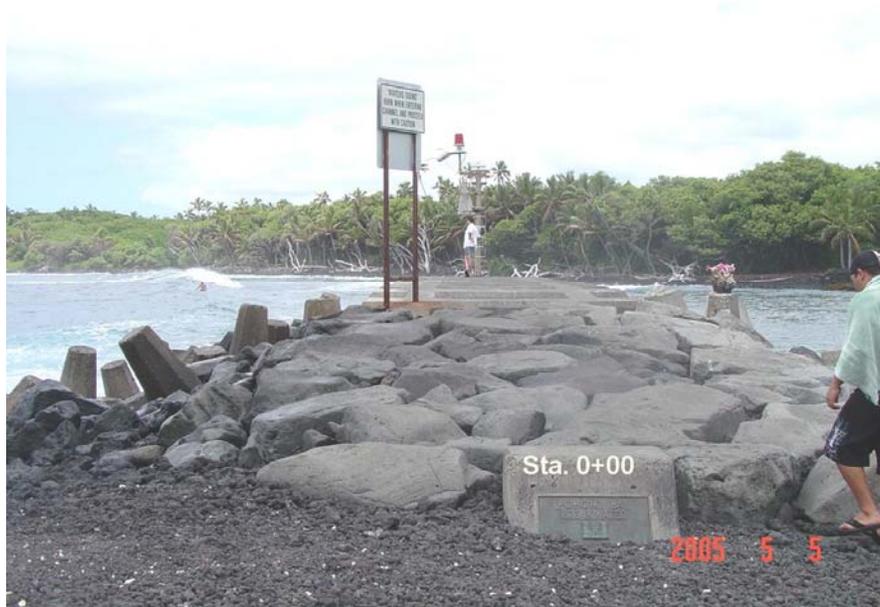
Project Sign, Overview of Root and Cinder Reference Photo

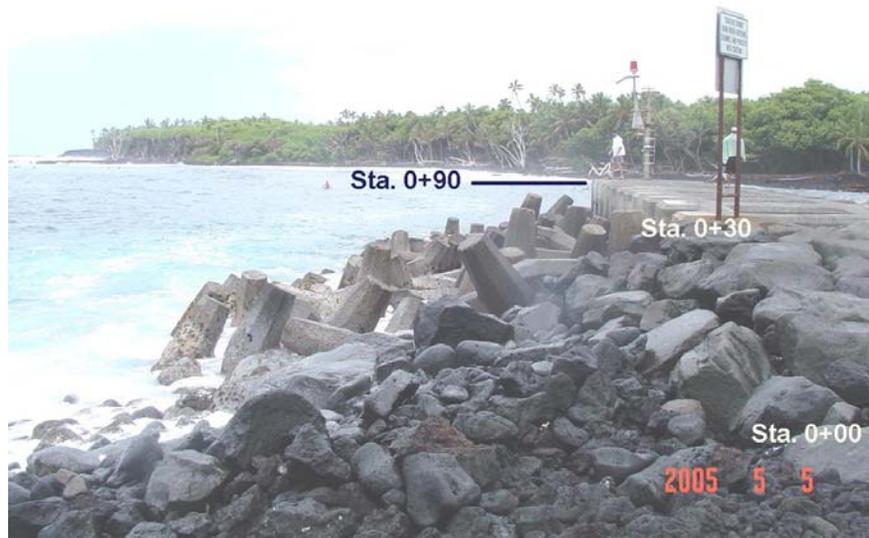
a. Sta. 0+00, OS, Overview of ribcap / dolos.

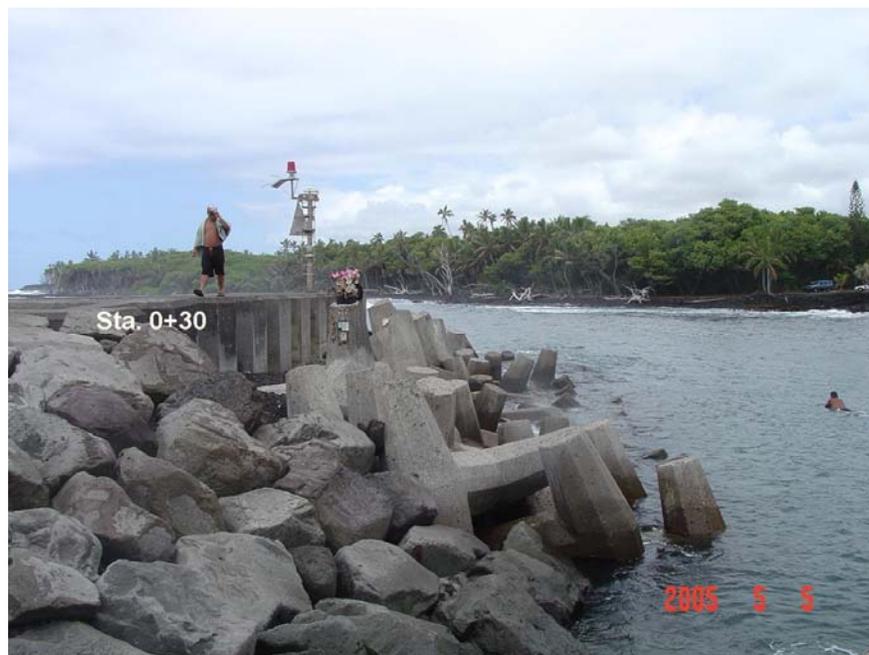
b. Sta. 0+00, HS, Overview of ribcap / dolos.

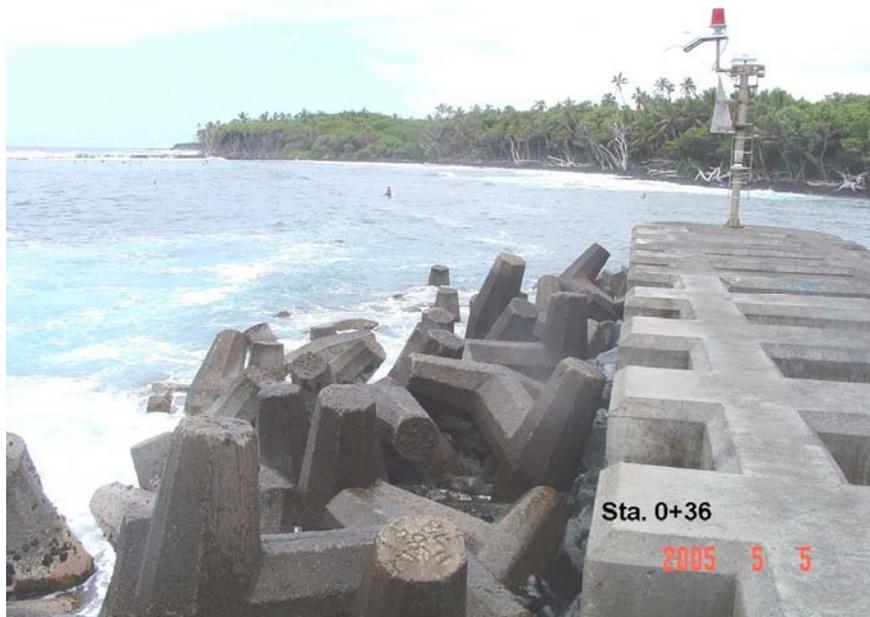
c. Sta. 0+36, OS, Overview of ribcap/dolos.

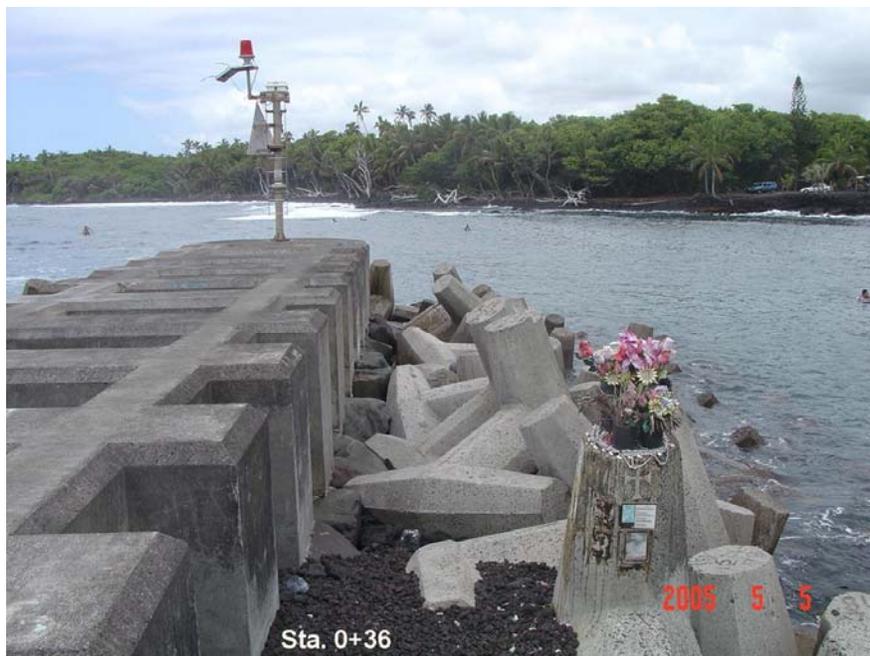
d. Sta. 0+36, HS, dolo # $\frac{11-28}{78}$, fluke shank break (old).

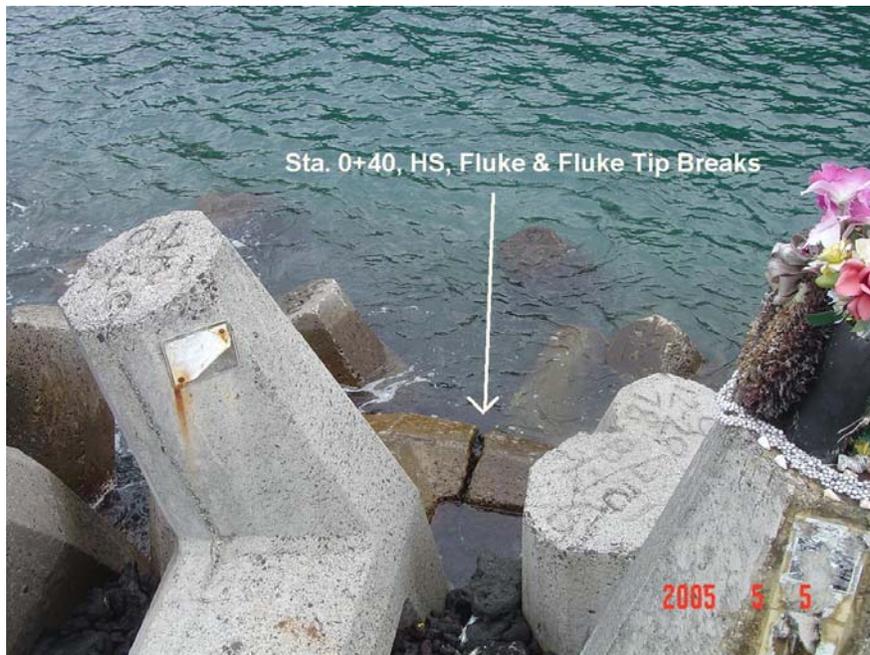
e. Sta. 0+40, HS, dolo # $\frac{11-30}{78}$, fluke tip break (old).
Unchanged since 2004 Inspection.

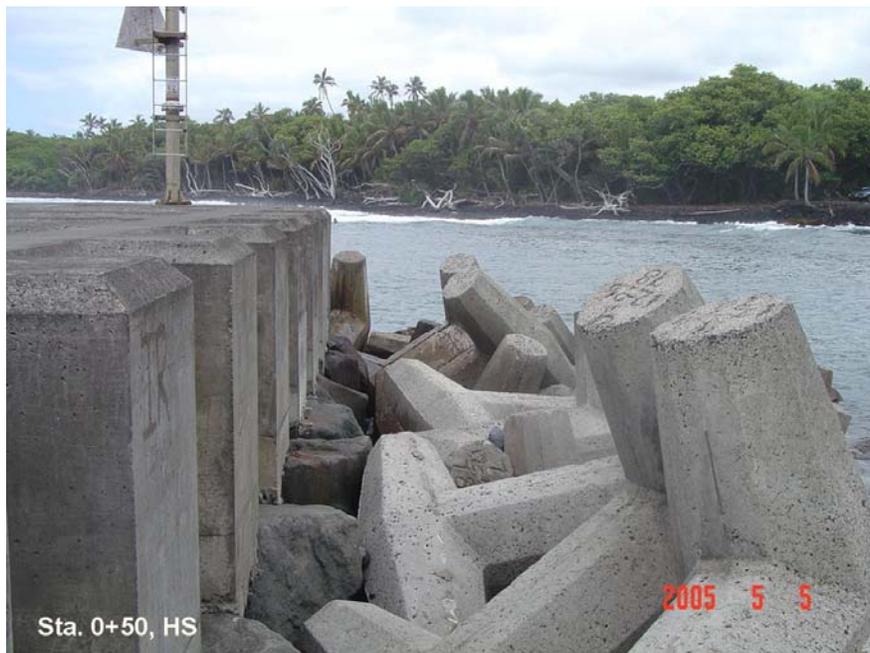
f. Sta. 0+50, HS, Typical of washed-up cinders from oceanside.

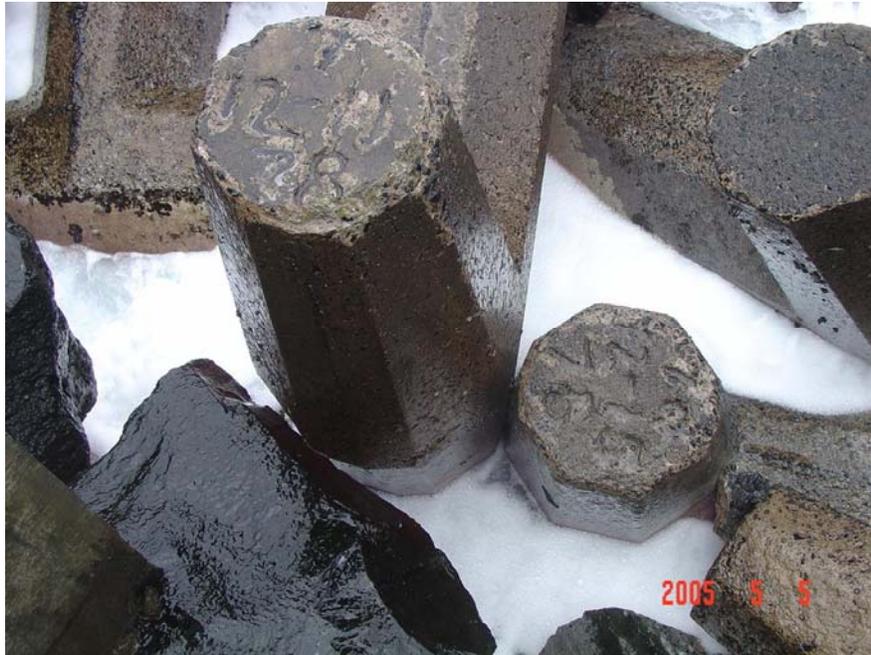
g. Sta. 0+60 to head, possible loss and movement of underlayer below the ribcap. Continue to monitor.

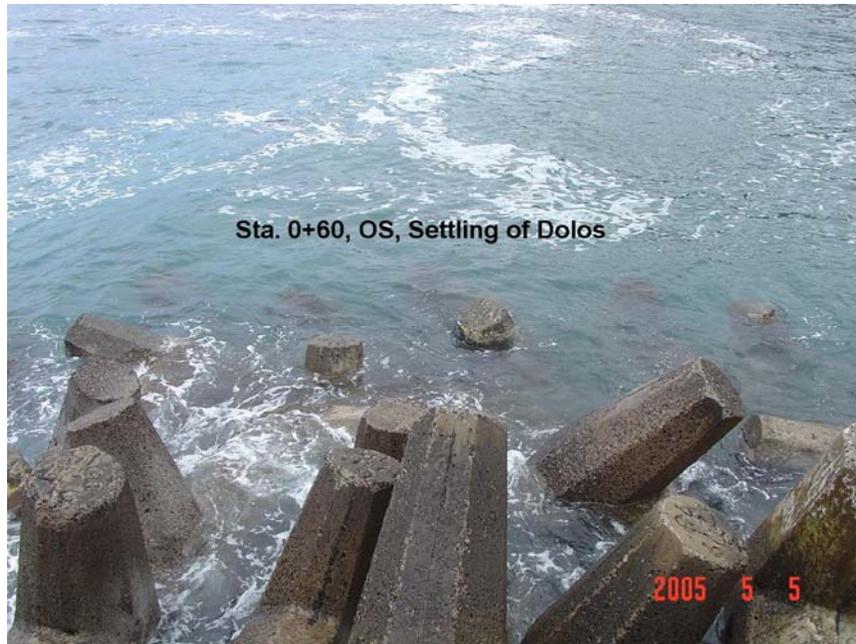
h. Sta. 0+60, OS, Settling of dolos on Oceanside. Continue to monitor.

The breakwater structure is in MARGINAL condition, and should be monitored closely. The center cells of the ribcaps 1-4 (starting at the root) are filling in up to 50%; all other cells have no cinders. Settling of dolos noted primarily on oceanside of the structure.

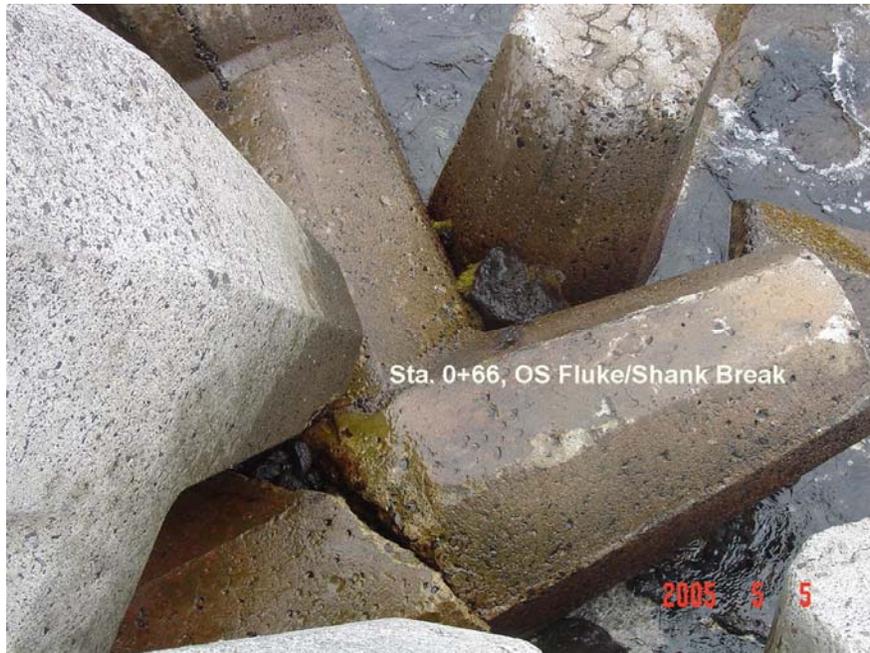
i. Sta. 0+66, HS, fluke shank break.

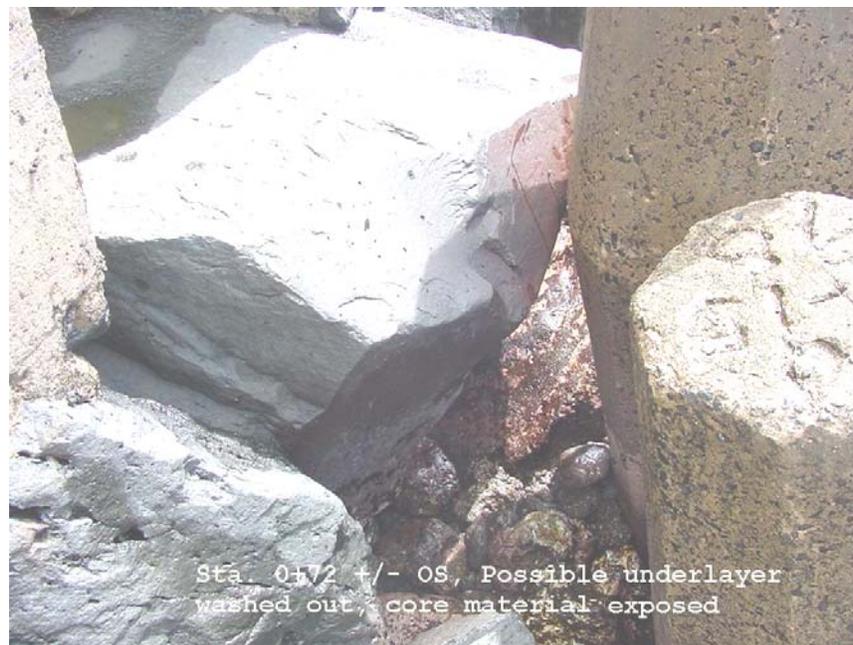
j. Sta. 0+72 (+/-), OS, Possible underlayer washed out, core material visible. (2003 Photo) could not verify due to surf.

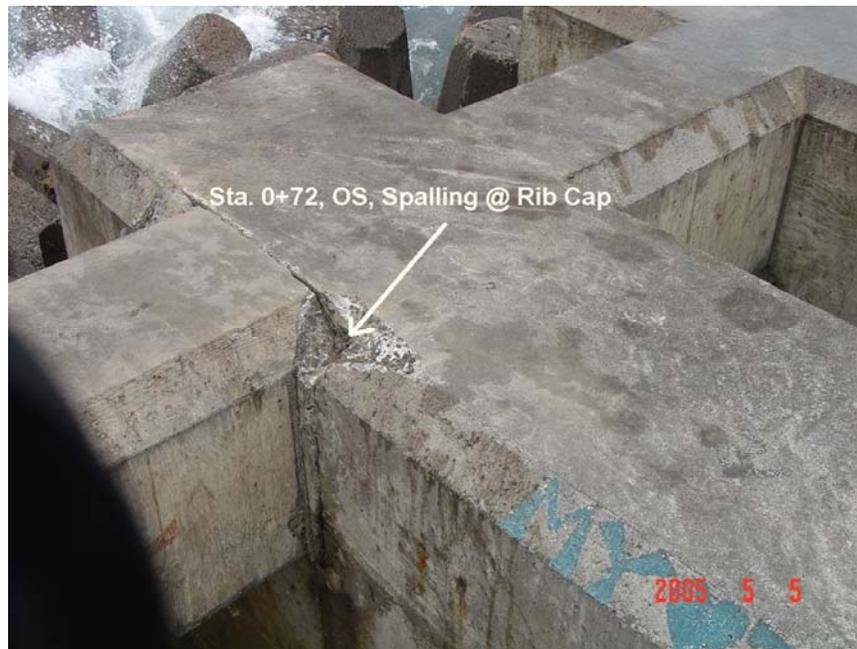
- k. Sta. 0+72, cracks in both longitudinal ribcap beams.

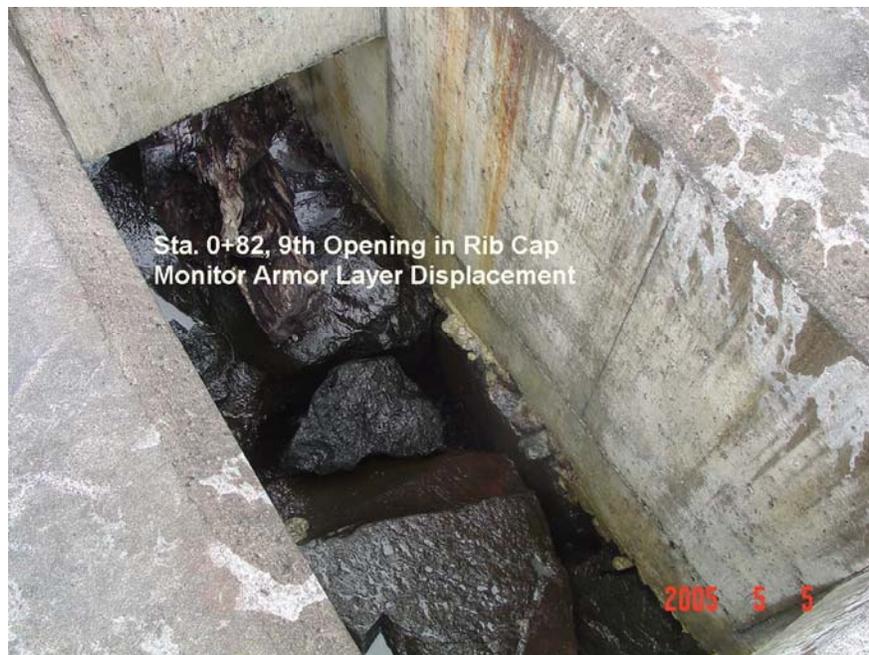
- l. Sta. 0+85, OS, possible washout of underlayer, void noted.
9th opening in Ribcap.

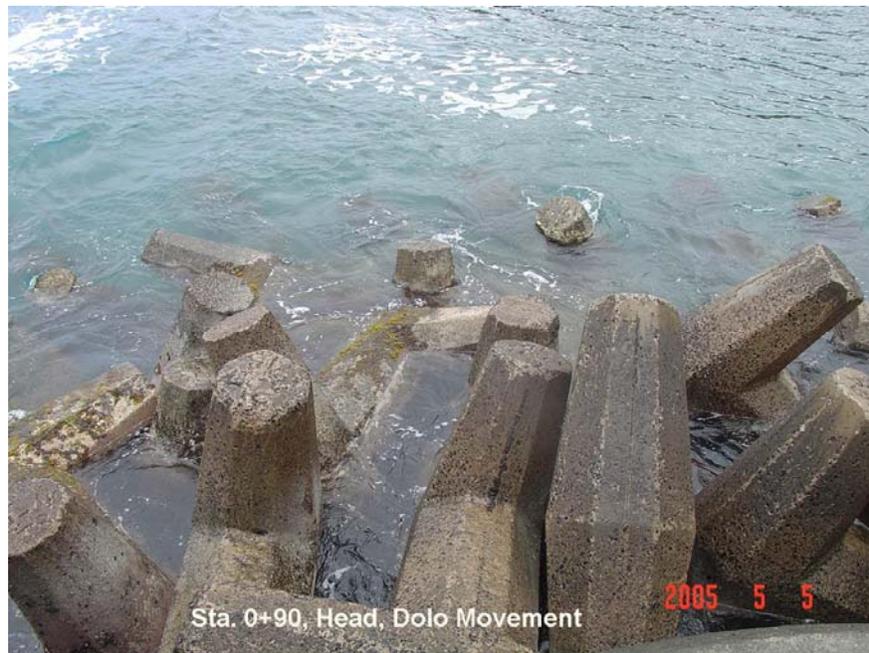
m. Sta. 0+90, at 0 deg off center from the BW head, "rocking dolo", minor change noted during this inspection.

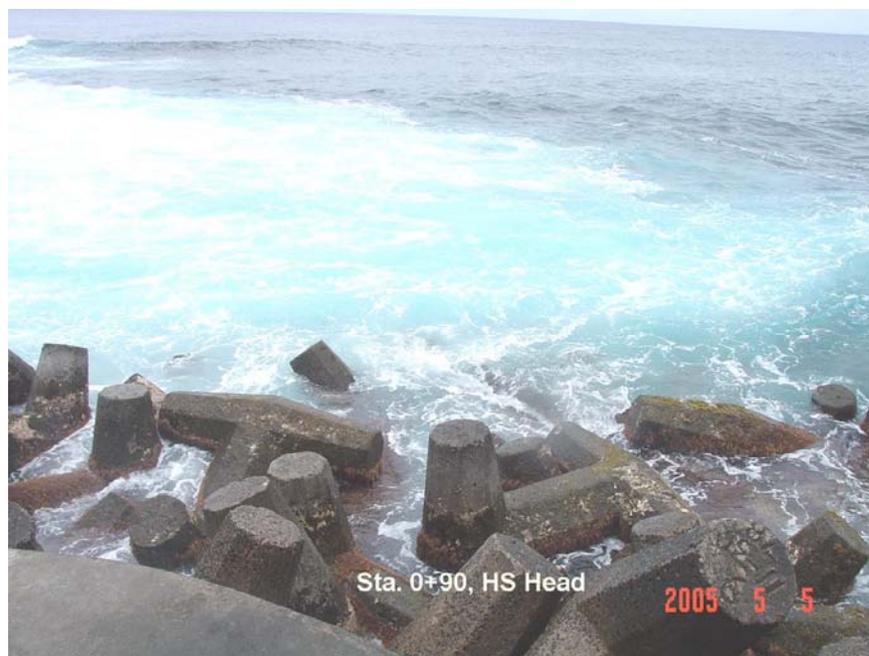
n. Sta. 0+90, at 90 deg HS from the BW head, no change noted during this inspection.

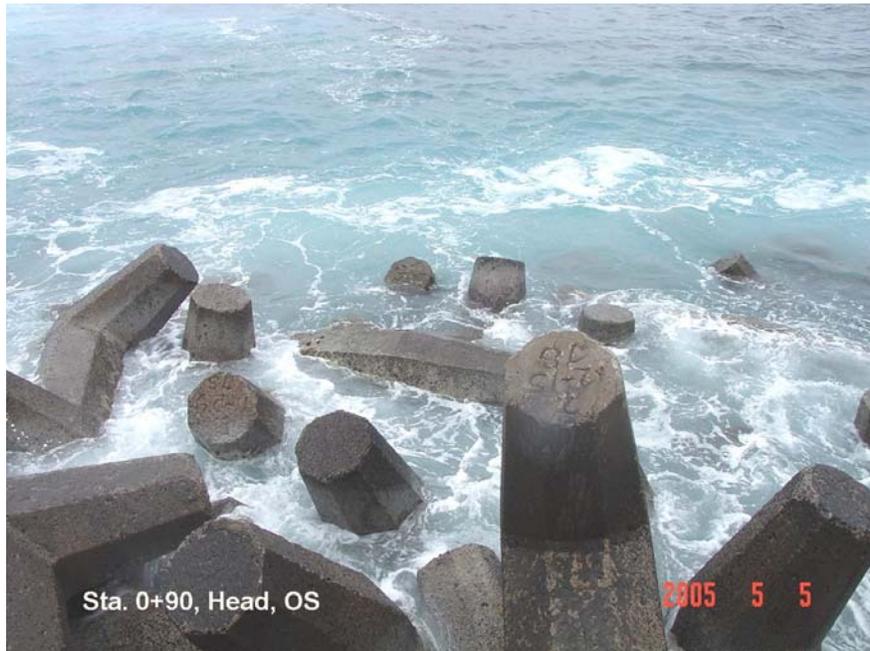
o. Sta. 0+90, at 90 deg OS from the BW head, no change noted during this inspection.

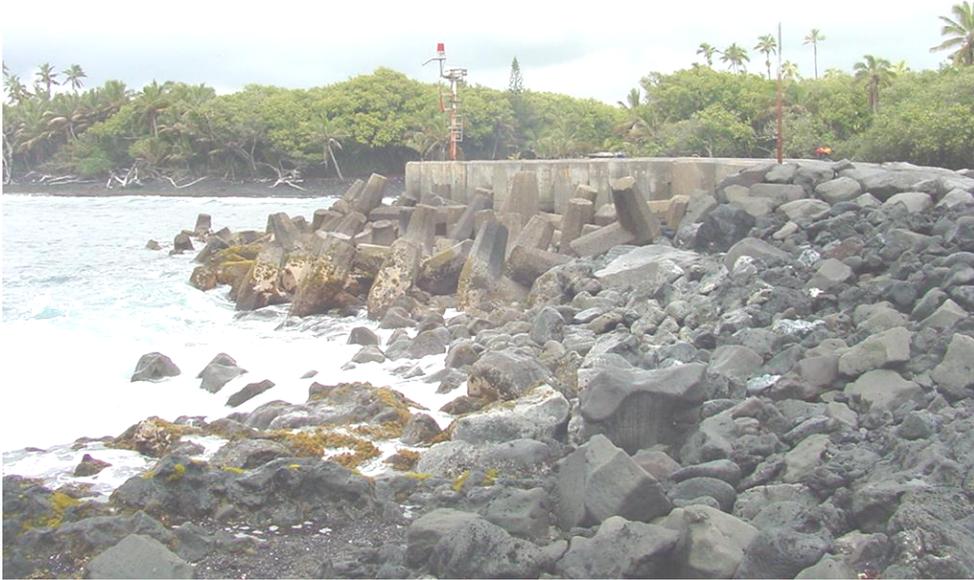
(2003 Photo)

Overview of BW from root on Oceanside
