**CONTINUING ELIGIBILITY INSPECTION (CEI) REPORT
FOR FLOOD CONTROL WORKS
Honolulu Engineer District
CEPOH-EC-T**

1. **Project Name:** Alenaio Flood Control Project

2. **Date of Inspection:** October 17, 2005

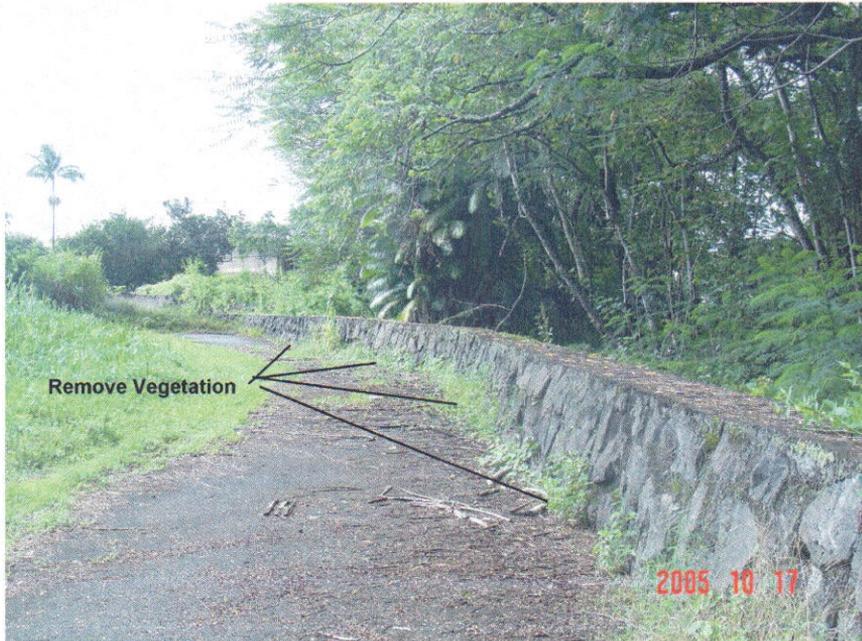
a. Sta. 3+65, Floodwall "A", Remove vegetation from floodwall and access road.

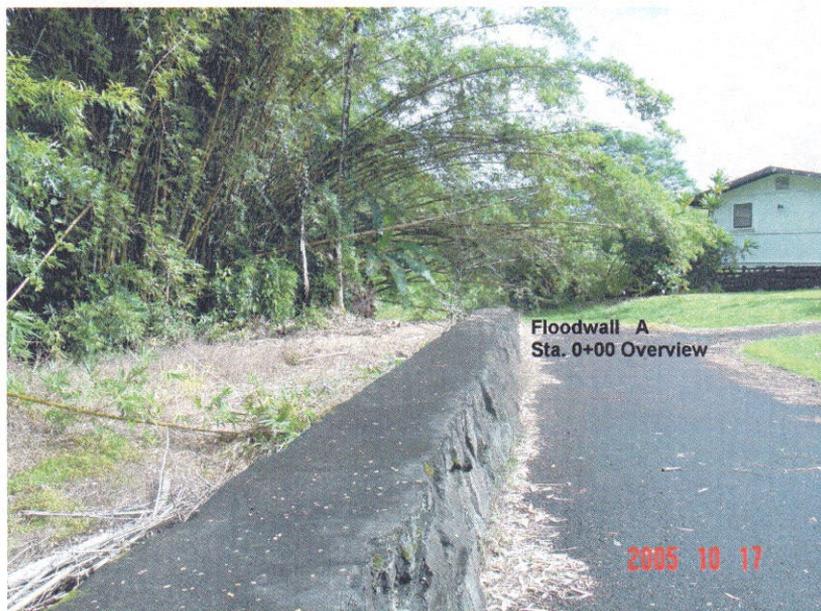
b. Sta. 0+00, Overview of downstream end.

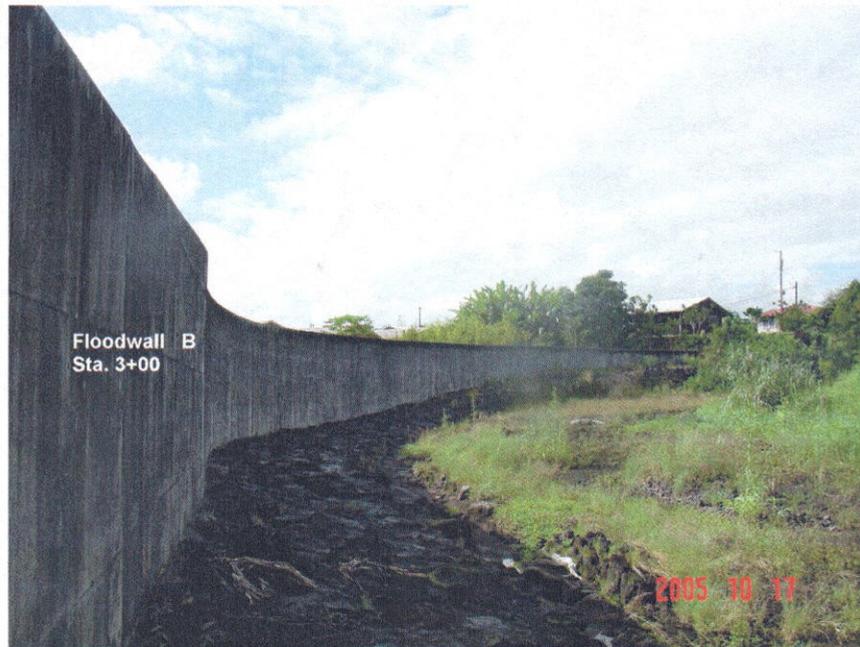
c. Sta. 3+00, Overview continue to remove vegetation.

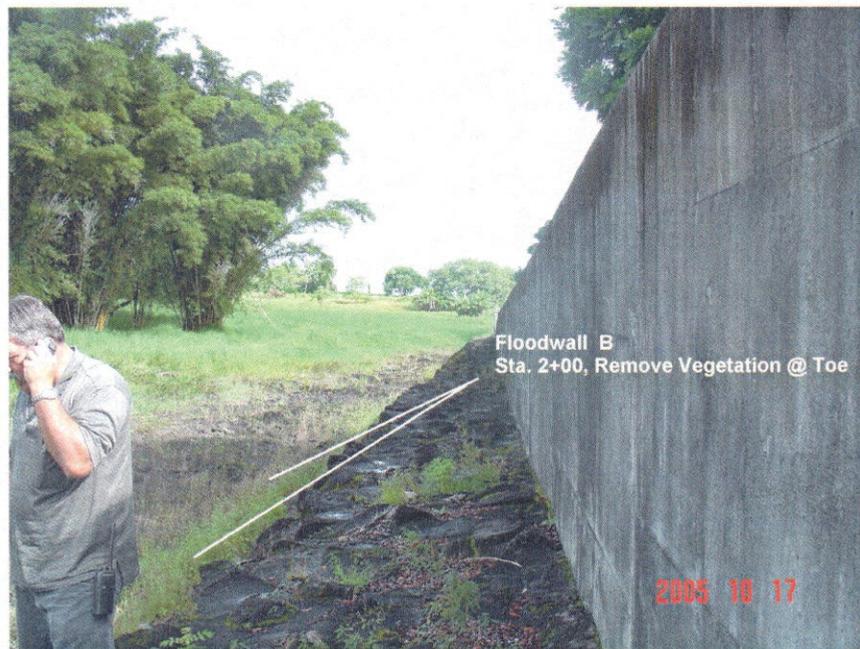
d. Sta. 2+00, Remove vegetation from floodwall and toe protection.

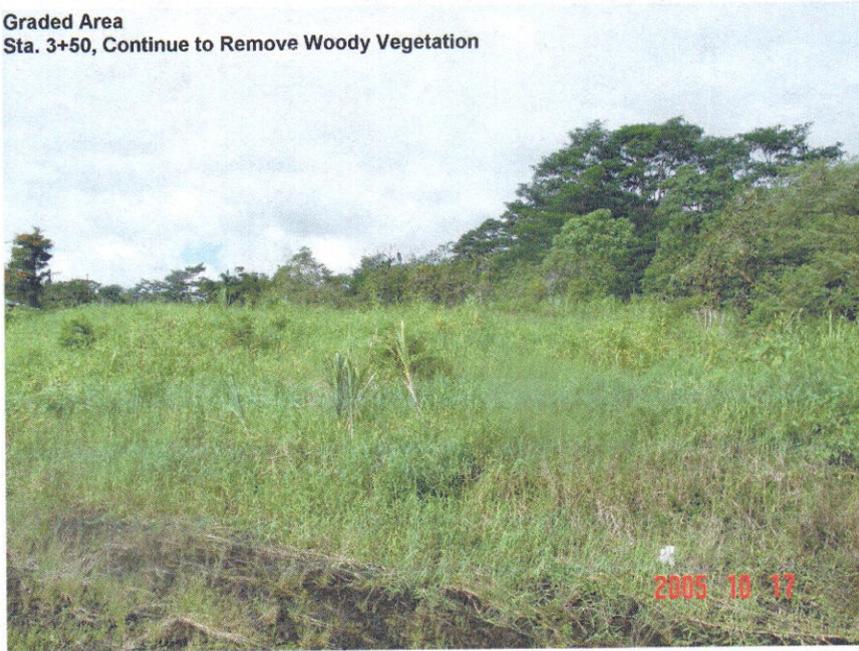
e. Sta. 3+50, Overview of graded area, good maintenance.

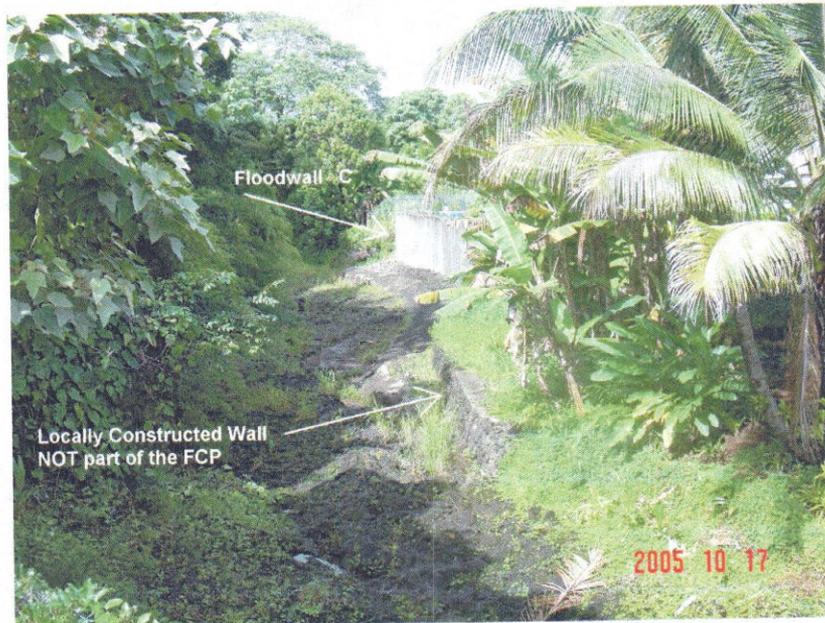
- f. Remove fill material from grouted riprap and restore maintenance access.

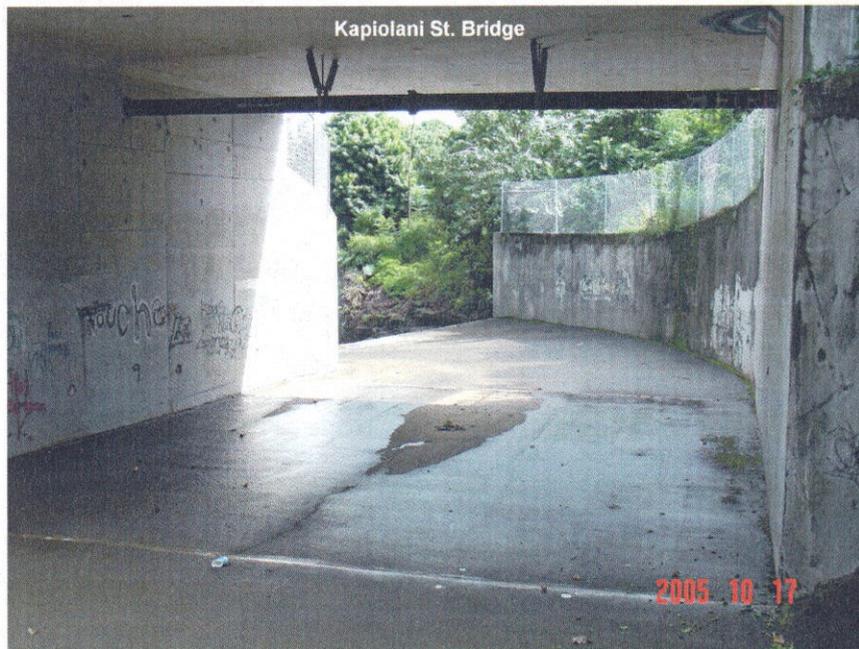
- h. Kapiolani St. Bridge, Replace missing joint caulking and backer strip.

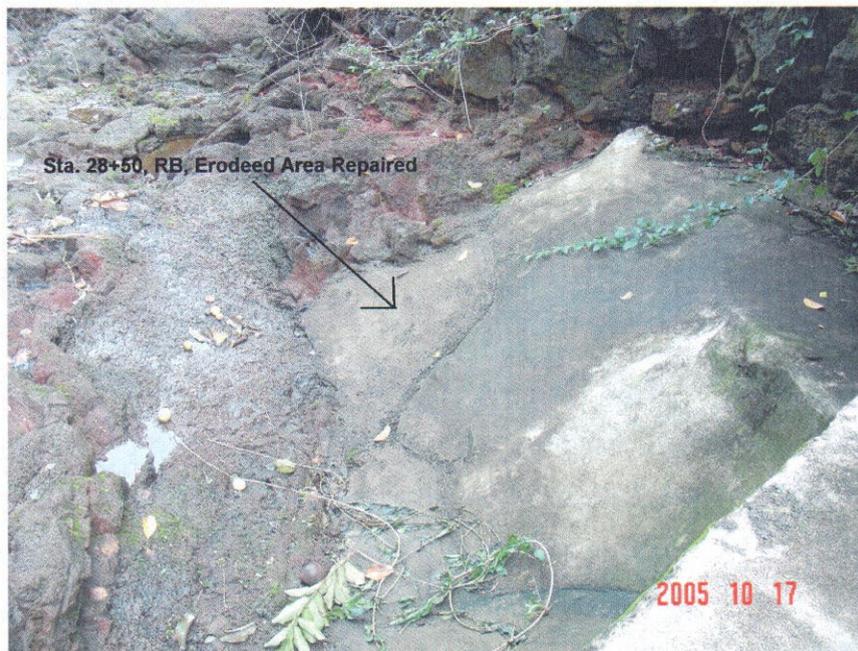
- i. Sta. 28+50, RB, Repair eroded concrete footing.

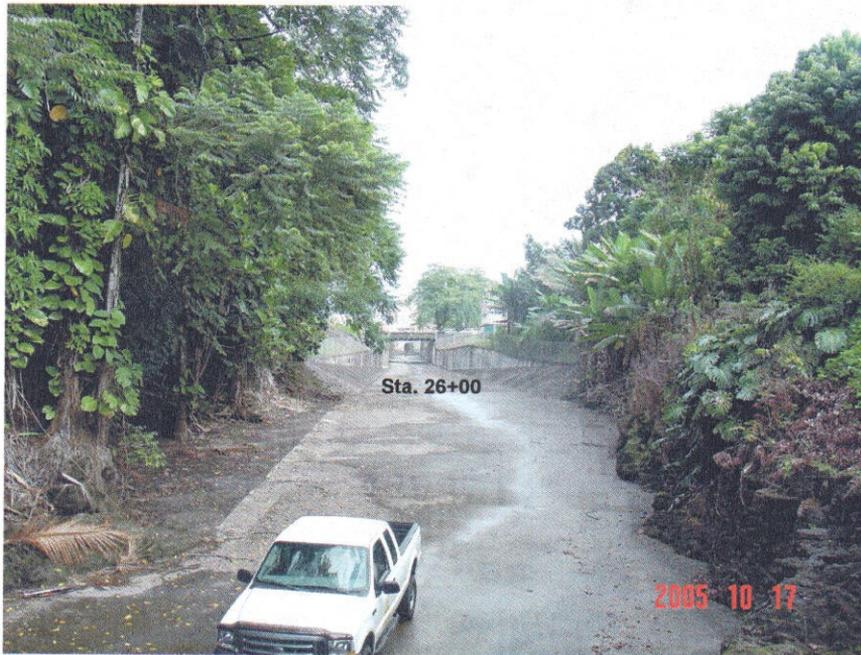
j. Sta. 26+00, Overview of apron end and channel start.

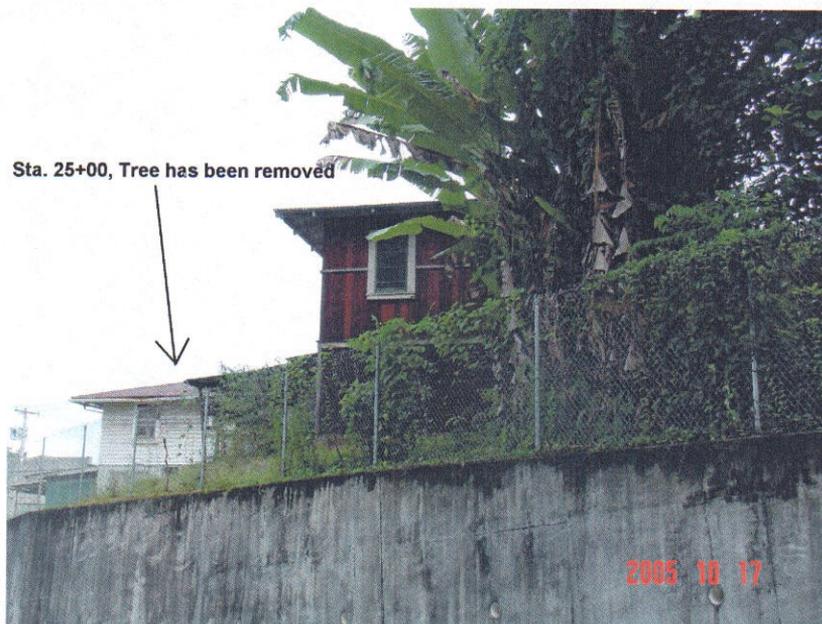
k. Sta. 25+00, Remove juvenile tree from top of channel wall.

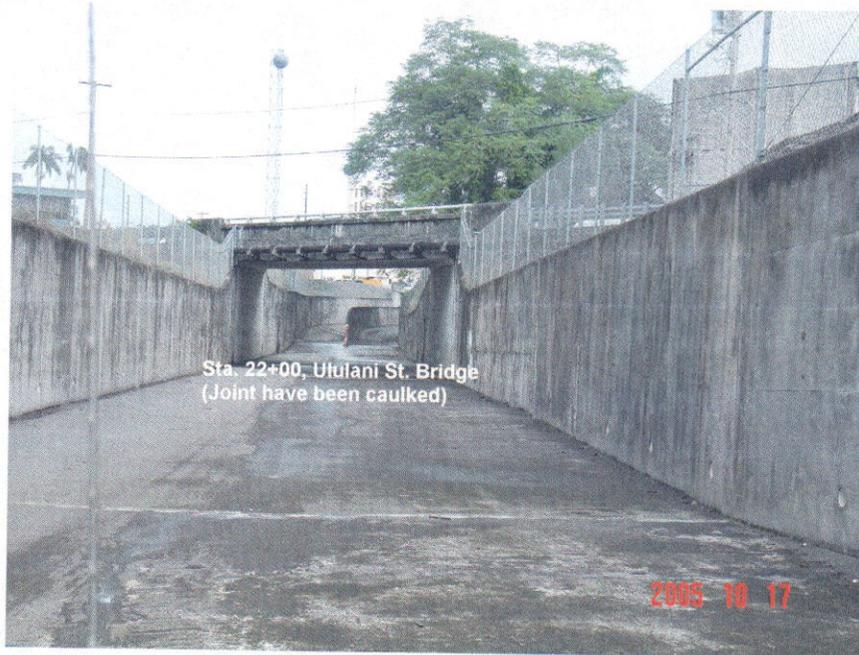
l. Sta. 22+00, Ululani St. Bridge, Splitter wall at Sta. 20+20.

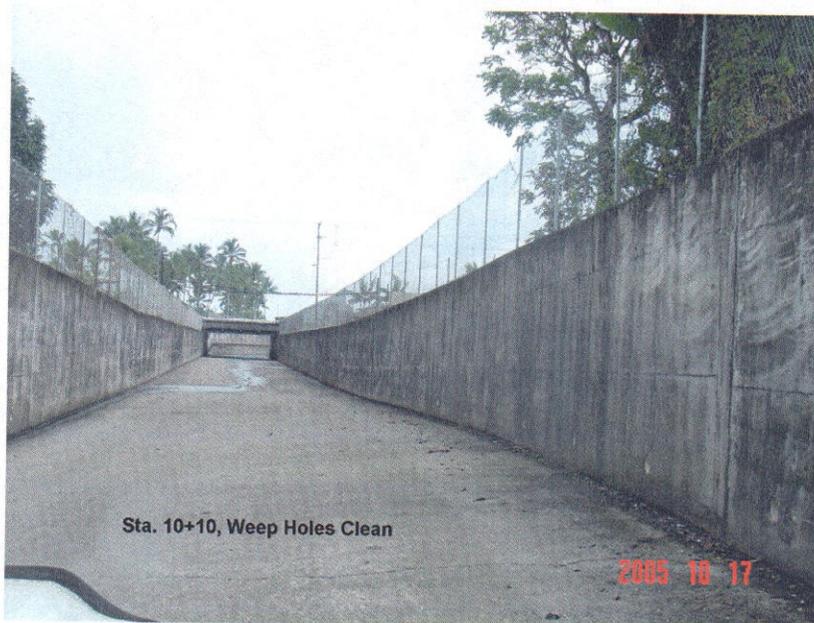
m. Sta. 10+10, Invert vegetation removed from weep holes.

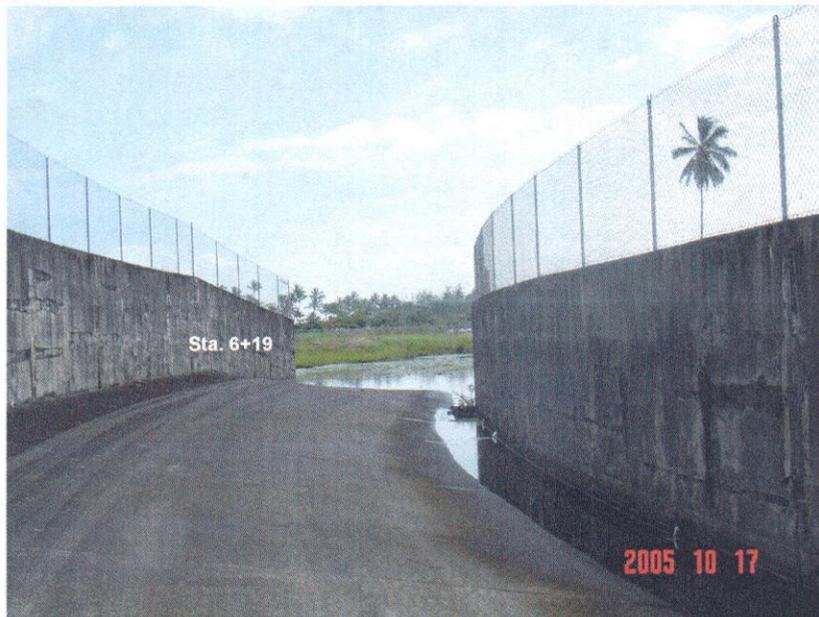
n. Sta. 6+19, Overview, start of concrete lined channel.

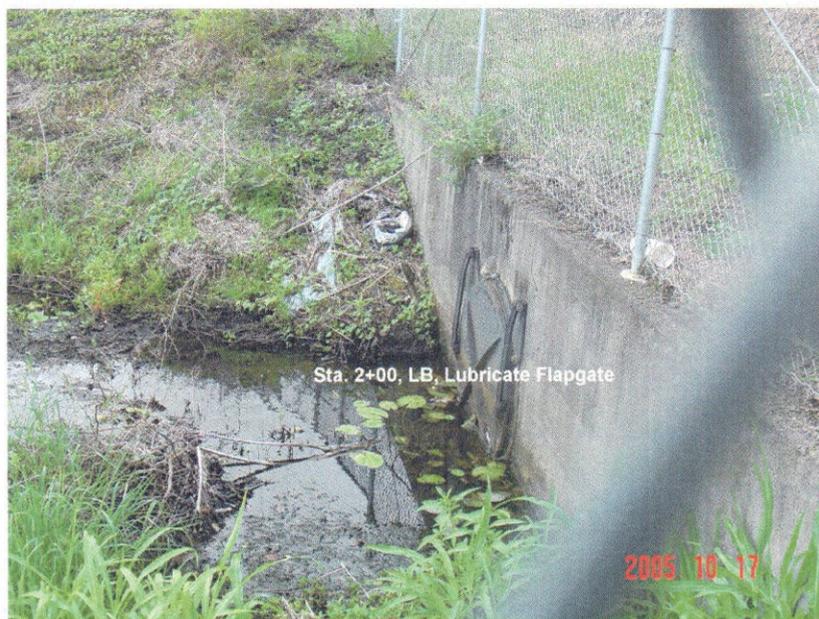
o. Sta. 2+00, LB, Clear and lubricate 42" flapgate.

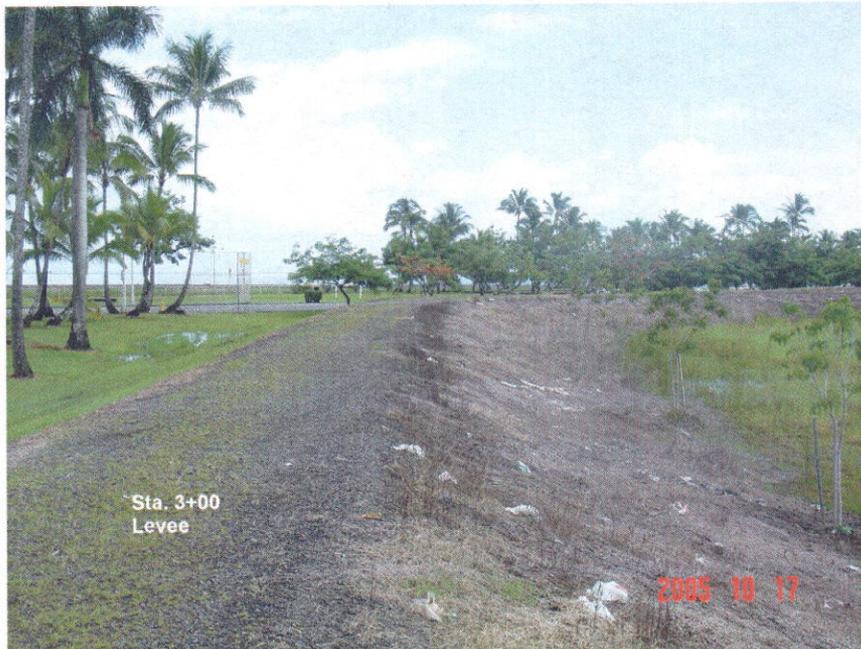
- p. Sta. 3+00, Levee in good condition, excellent maintenance.

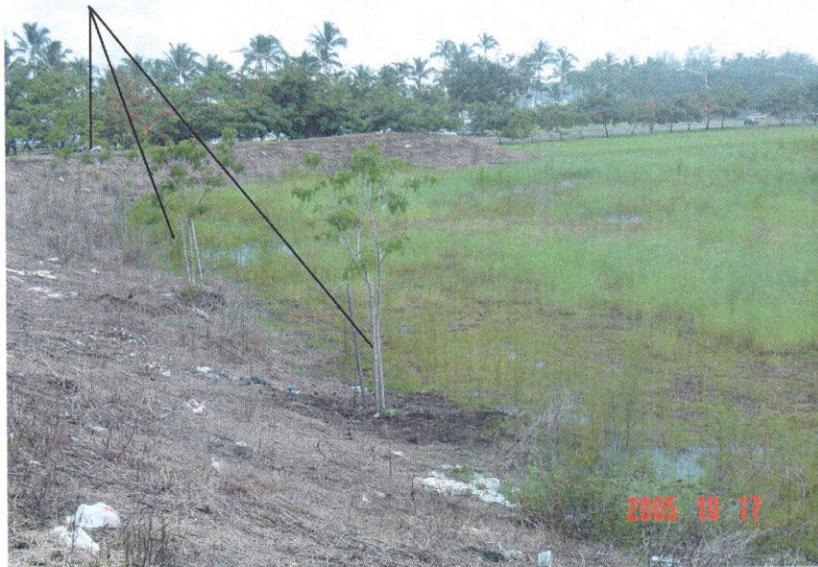
- q. Sta. 3+50, Parkside, Levee Thumb has been removed, relocate newly planted trees from within 5' from the toe of the structure and continue to cut vegetation.
