1. Project Name: Laupahoehoe Navigational Improvements
2. Date of Inspection: June 26, 2007
3. Inspection Personnel:

## LAUPAHOEHOE HARBOR, HAWAII, HAWAII

### CONDITION OF IMPROVEMENT 30 SEPTEMBER 1991

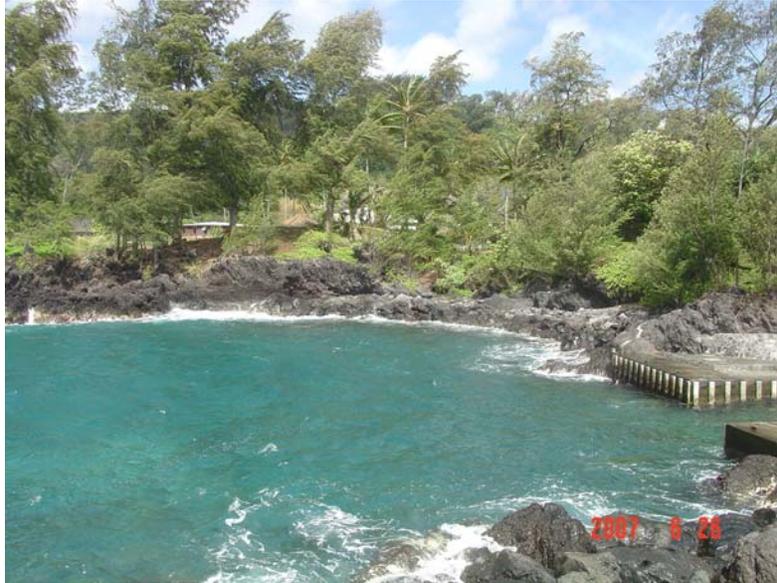
a. Sta. 0+02 to Sta. 0+10, Missing armor stones at the waterline voids.

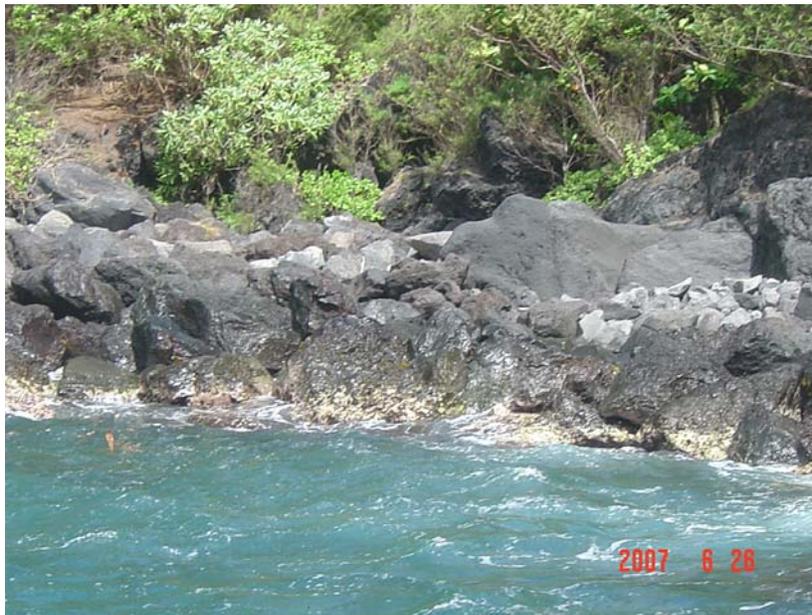
b. Same as Above, no change since last inspection. Some stones at the waterline are missing and voids are present. Monitor.

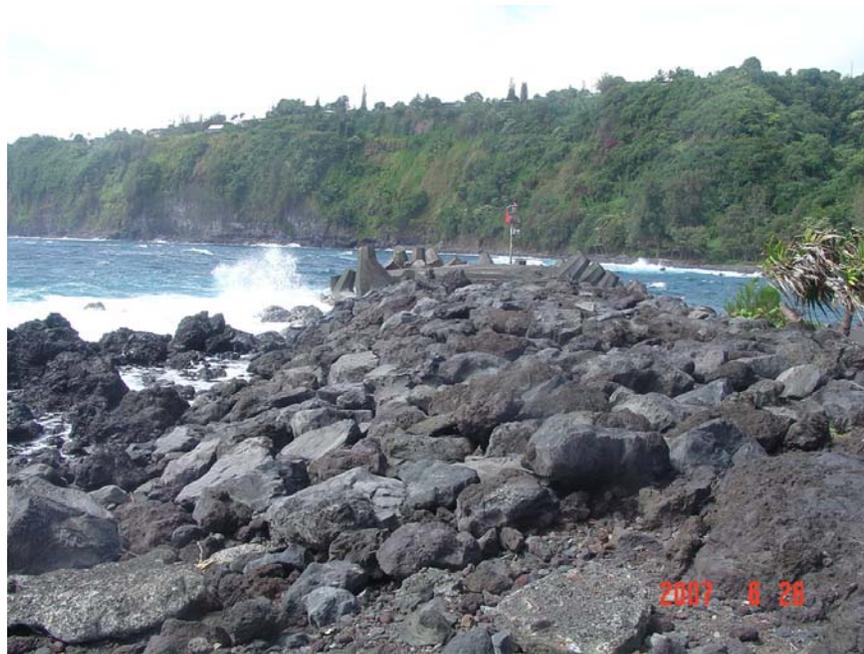
a. Sta. 0+00, Oceanside (OS), Overview of breakwater.

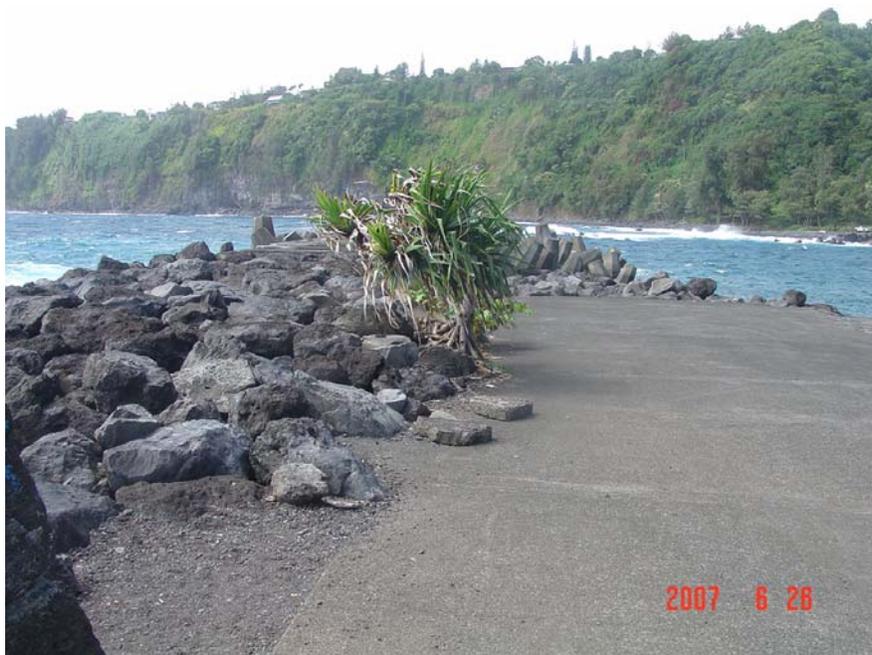
b. Sta. 0+30, HS, Remove tree from armor stones.

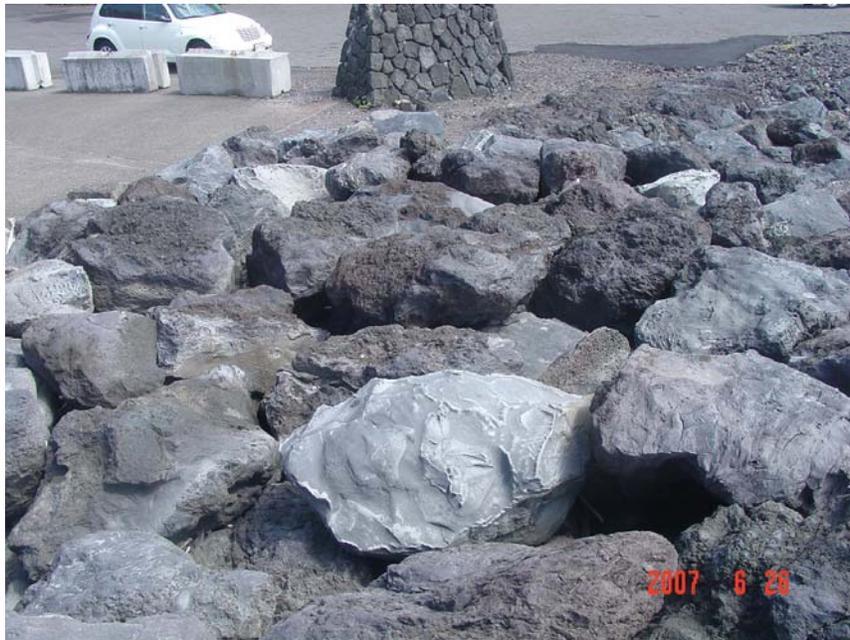
c. Sta. 0+25, 0+26, and 0+28; Voids and missing armor stones.

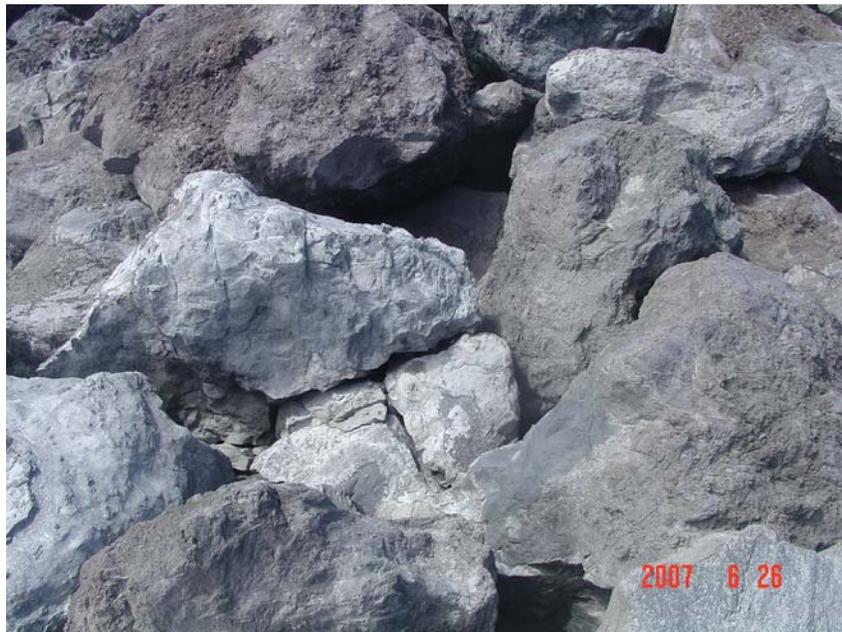
d. Sta. 0+40, Void and cracked armor stone.

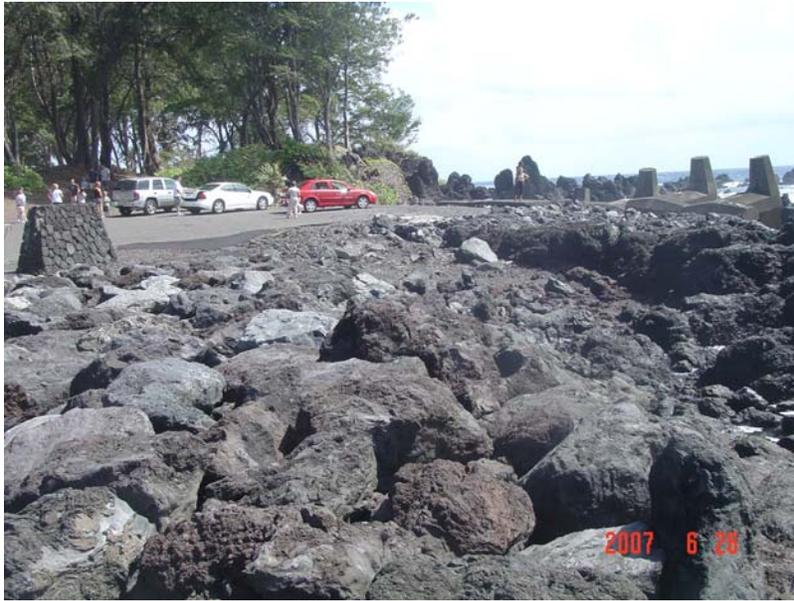
- e. Sta. 0+70, HS, 1 ea. Perched armor stone.
- f. Sta. 0+75, OS, 1 Flipped armor stone, 3 new flipped stones.

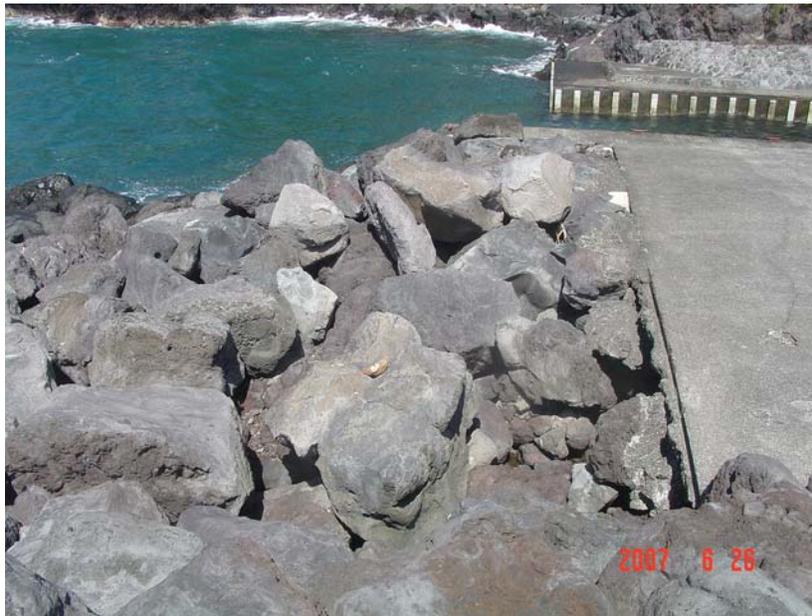
- g. Sta. 0+77, HS, Dislodged armor stones, void present.  
5'L x 20'W x 5'D void from dislodged armor stones; several  
perched stones located adjacent to void. New movement this inspection.

The Breakwater and wave absorber function as designed, however it appears additional material has washed out from under the rib cap cells and should be closely monitored. The void at Sta. 0+77, HS, needs to be monitored, however suggest repairs be planned for the near future as the dislodged armor stones may impact the turning basin. Overall the project is in MARGINAL condition.

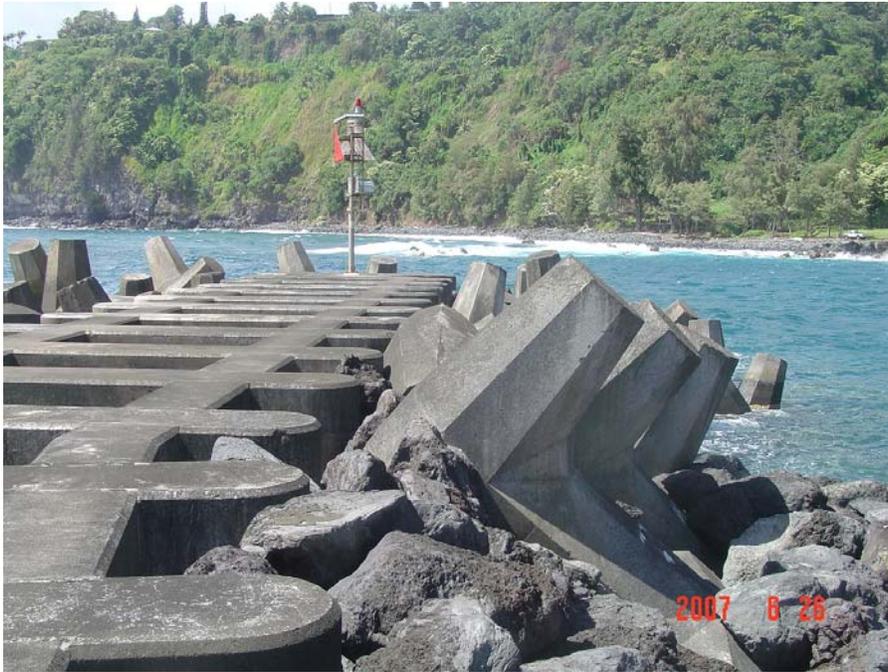
h. Sta. 0+80, HS, Overview of Ribcap / Dolos. Sta. 0+80 to 1+25 (first 6 ribs), HS, 500 pound stones lodged between ribs and dispersed among dolos.

There has been a loss of underlayer material in the cells of the rib cap between the ribs and beams. The typical section depicts two layers of 5 to 7 ton stone directly below the concrete cap and 1 to 3 ton stone underneath. Apparently, the specified stones were replaced with greatly undersized stone during construction. The undersized stone is slowly being washed away, creating a more porous structure that allows more energy into the harbor, and could ultimately threaten the stability of the breakwater.

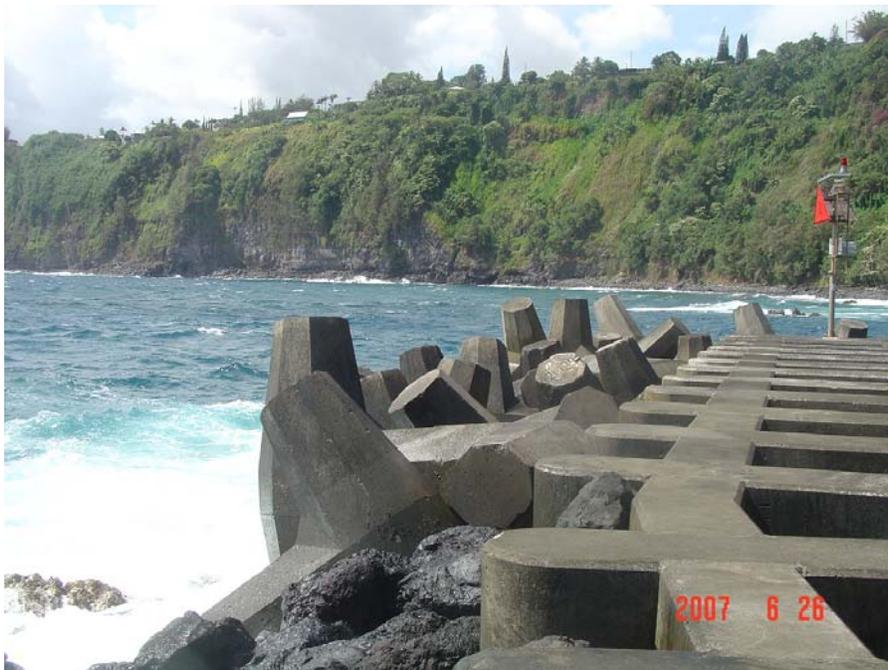
i. Sta. 0+80, OS, Overview of Ribcap / Dolos.

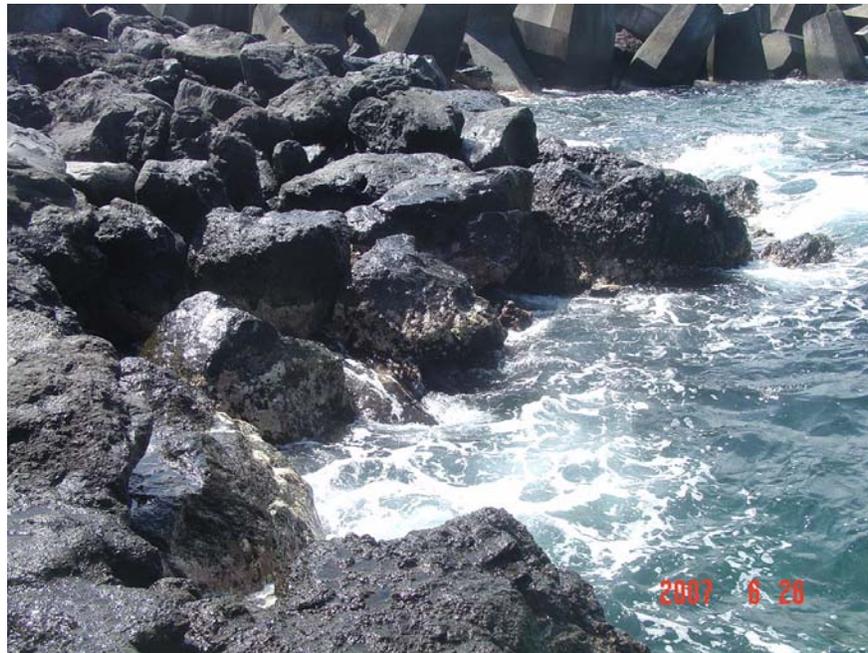
j. Sta. 0+85, HS, missing armor stones adjacent the boat ramp.

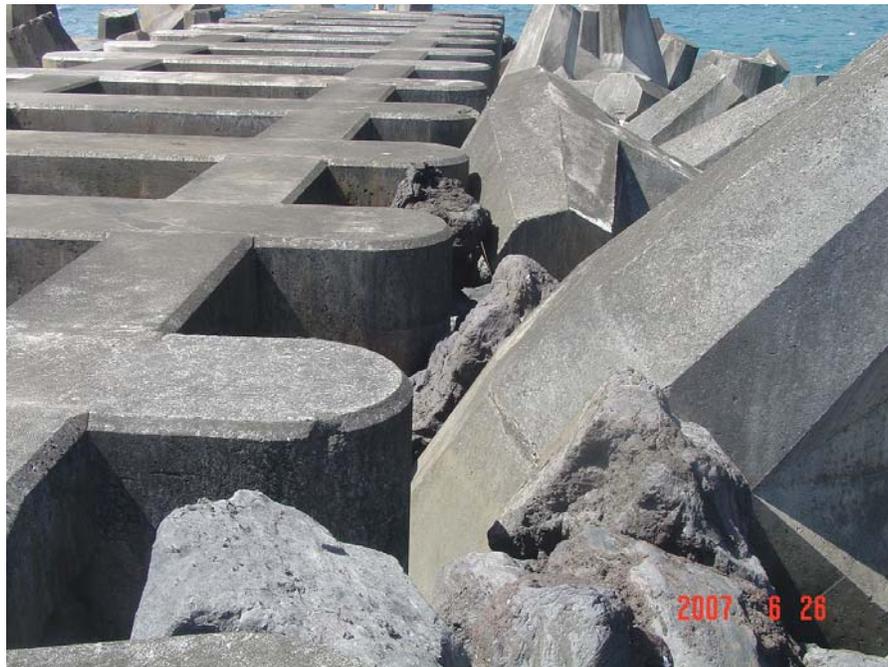
k. Sta. 0+90, HS, Small rocks washed up on dolos.

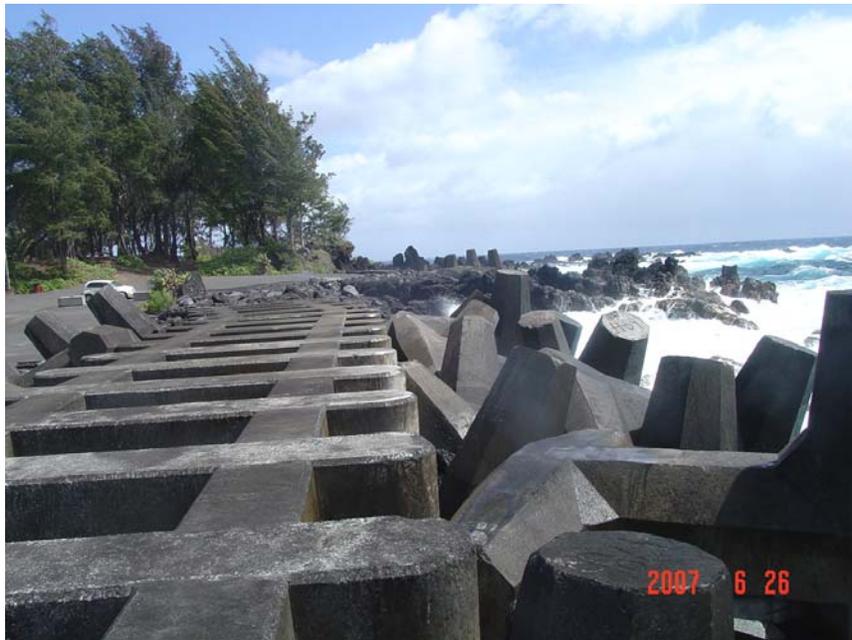
l. Sta. 1+90, OS, Overview.

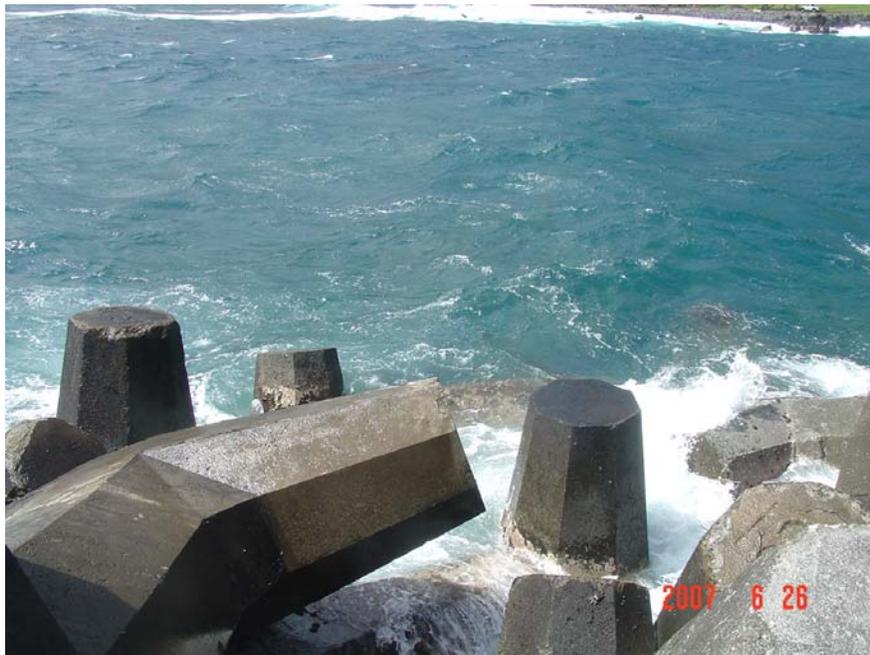
m. Sta. 1+90, Head.

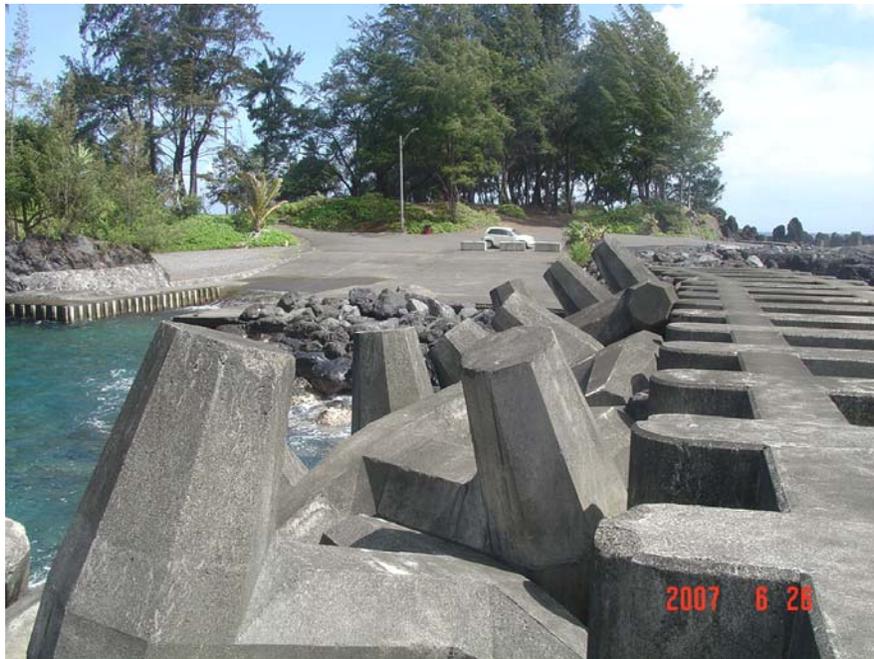
n. Sta. 1+90, HS, Overview.

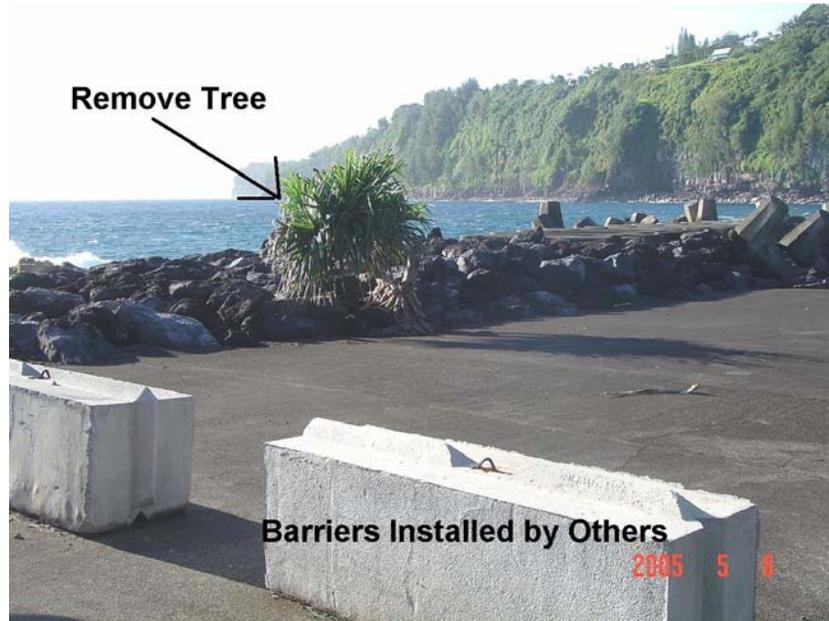
a. Department of Parks and Recreation has placed barriers in front of the concrete slab.

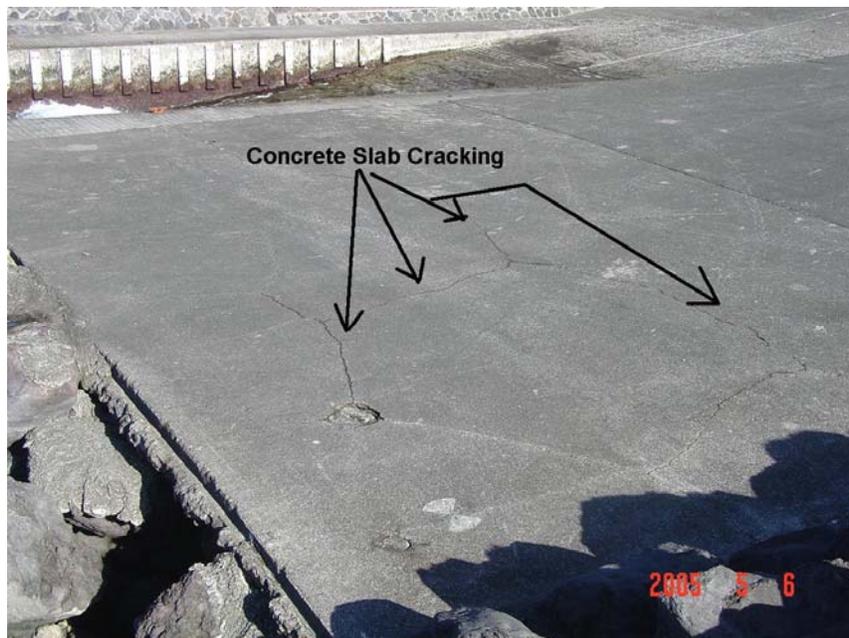
b. Concrete slab adjacent to boat ramp is undermined and cracking due to voids below.

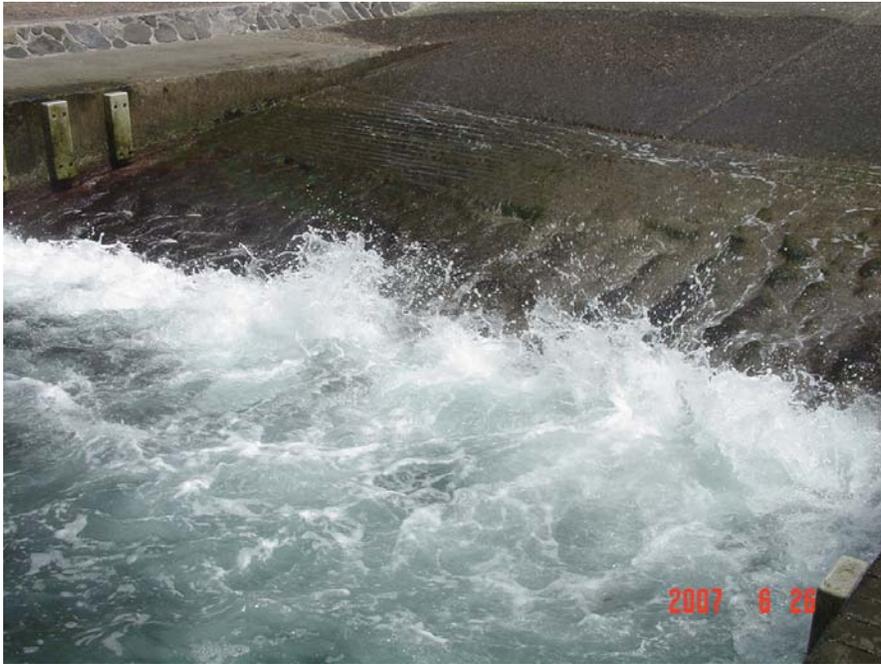
c. Boat Ramp Concrete erosion up to 3 inches.

COMMENT: BOAT RAMP - The precast trapezoidal concrete slab originally installed outlasted the cast-in-place broom finished slab. Small stones in the boat ramp's surf zone have accelerated the erosion of the tremie concrete.

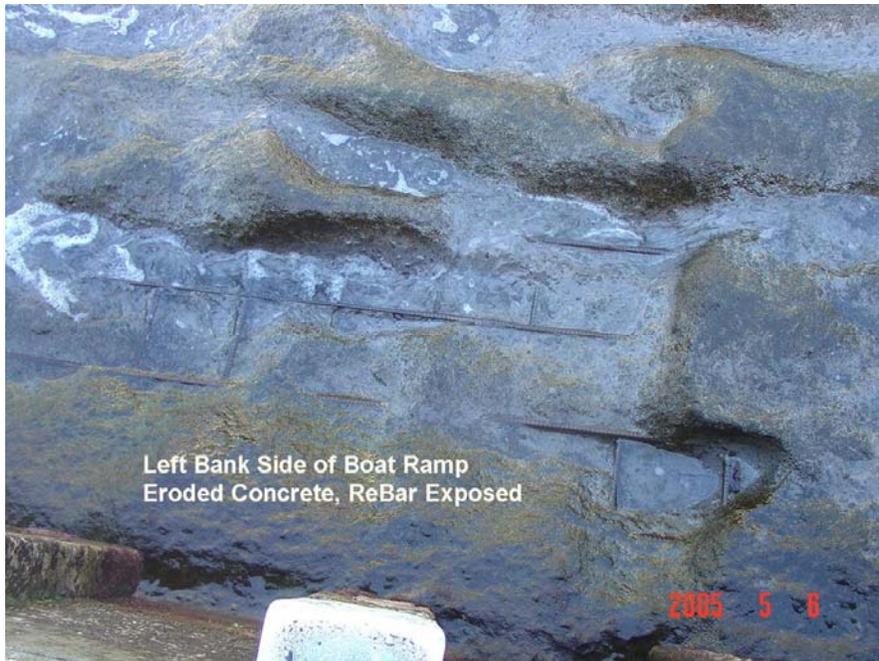
d. ReBar exposed, left side of poured-in-place slab.  
FY05 photo used due to high surf and poor visibility.
