1. Project Name: Kawaihae Deep Draft Harbor
2. Date of Inspection: June 28, 2007
3. Inspection Personnel:

KAWAIHAE DEEP DRAFT HARBOR, HAWAII

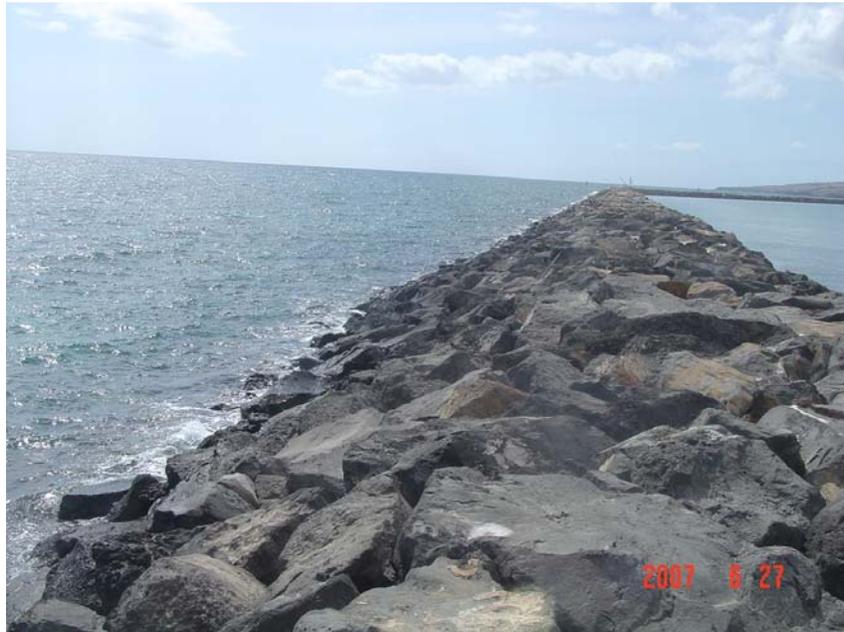
a. Sta. 0+42 to Sta. 1+07, OS, slight depression on the sideslope, no obvious signs of sliding, monitor.

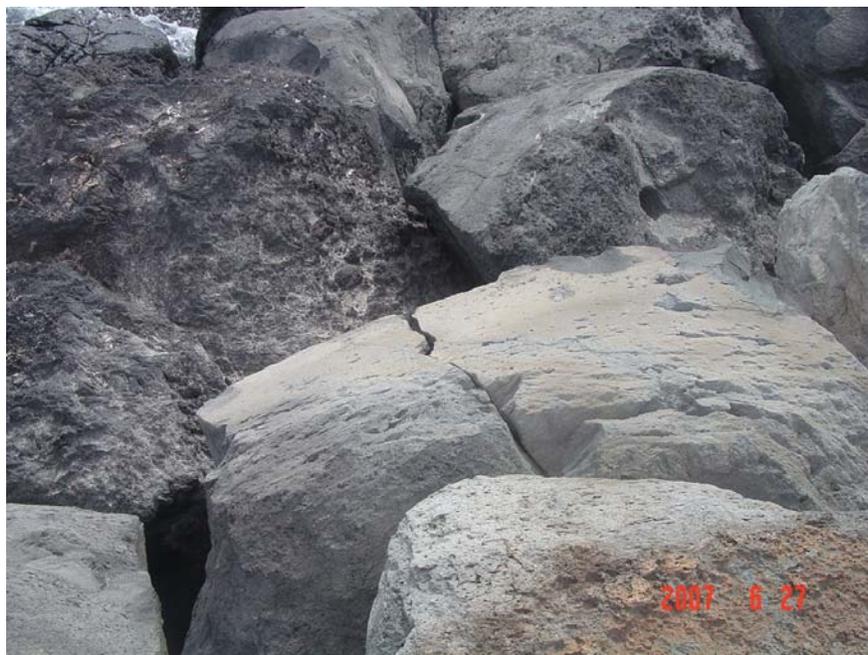
b. Sta. 1+40, OS, cracked armor stone at hinge.

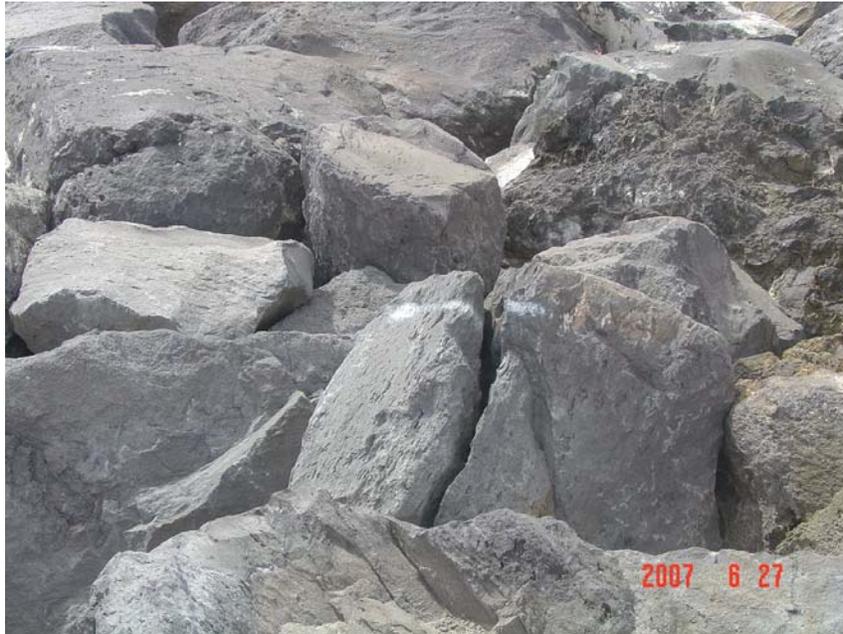
c. Sta. 2+00, OS, cracked armor stone.

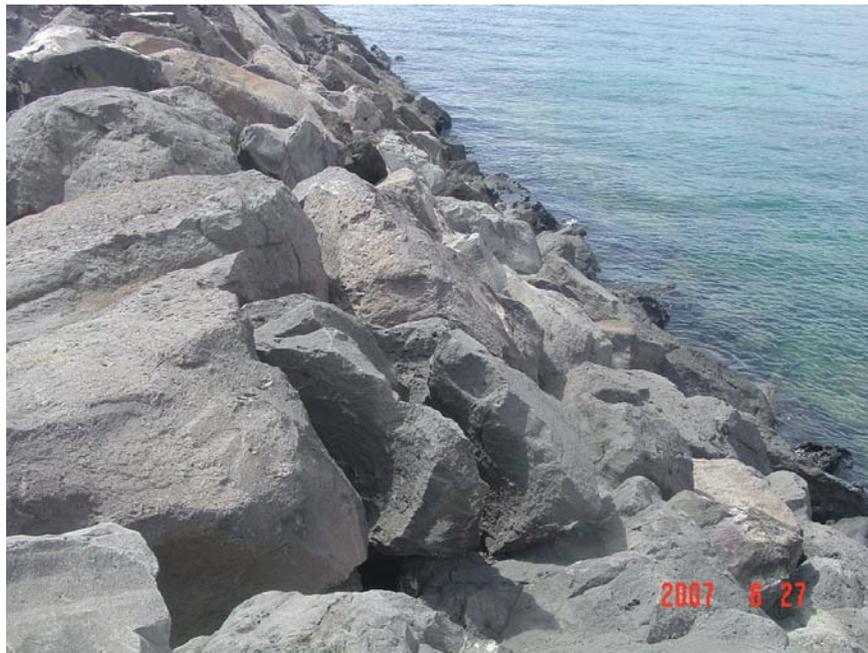
d. Sta. 2+10, HS, cracked armor stone @ hinge (adj. #3 dolphin).

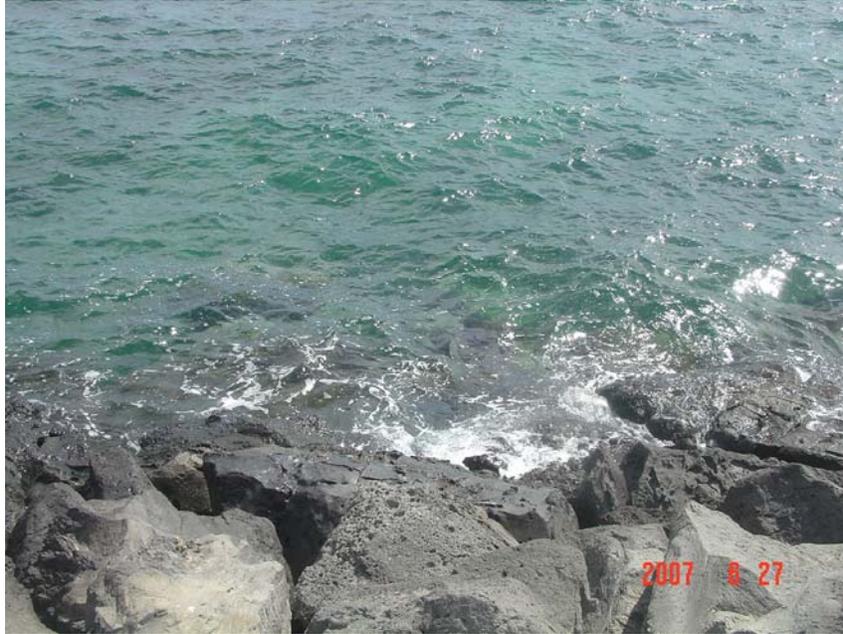
e. Sta. 2+30, OS, 6-8 ea. Armor stones dislodged from structure at waterline, now resting adjacent to the toe of the breakwater.

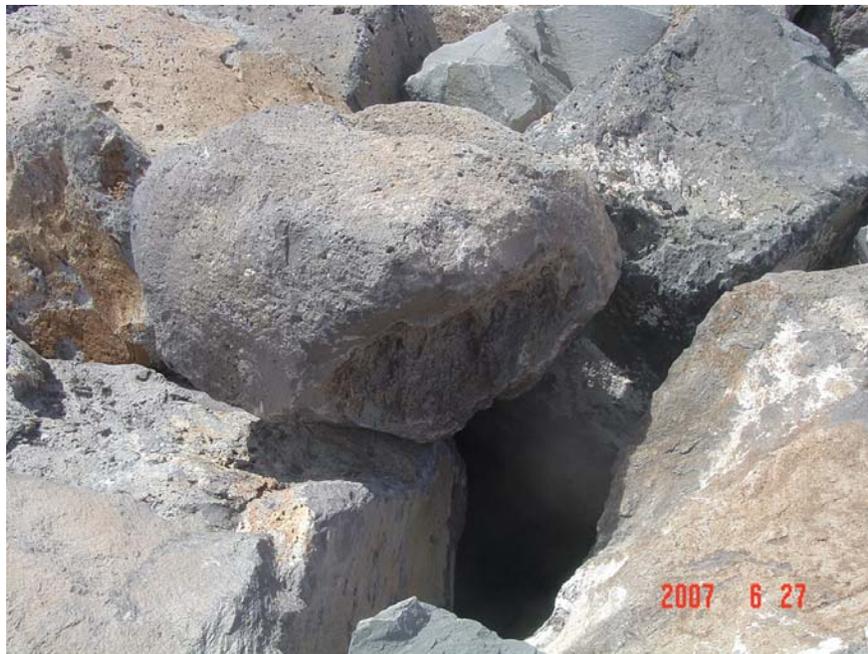
f. Sta. 2+58, void in crest.

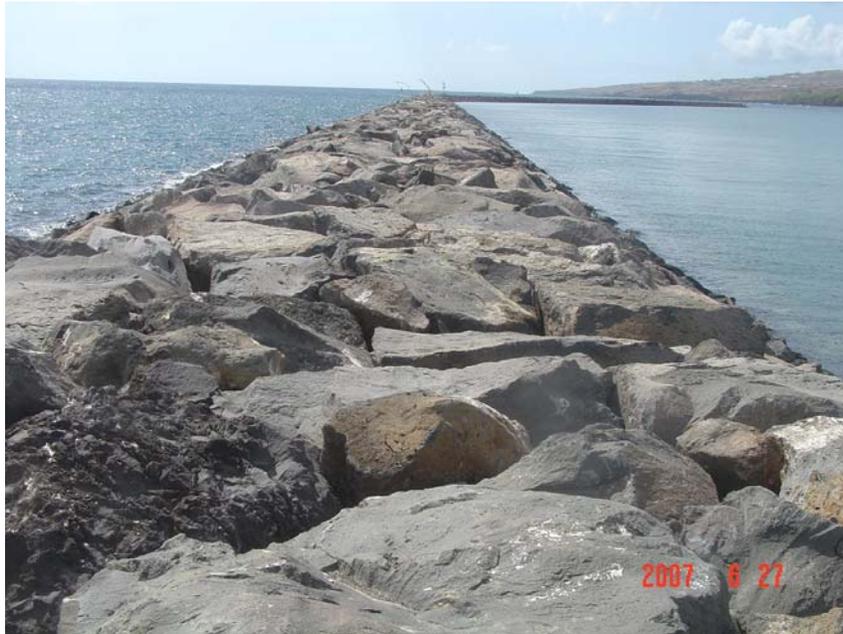
g. Sta. 3+00, CL, depressions extending along centerline.

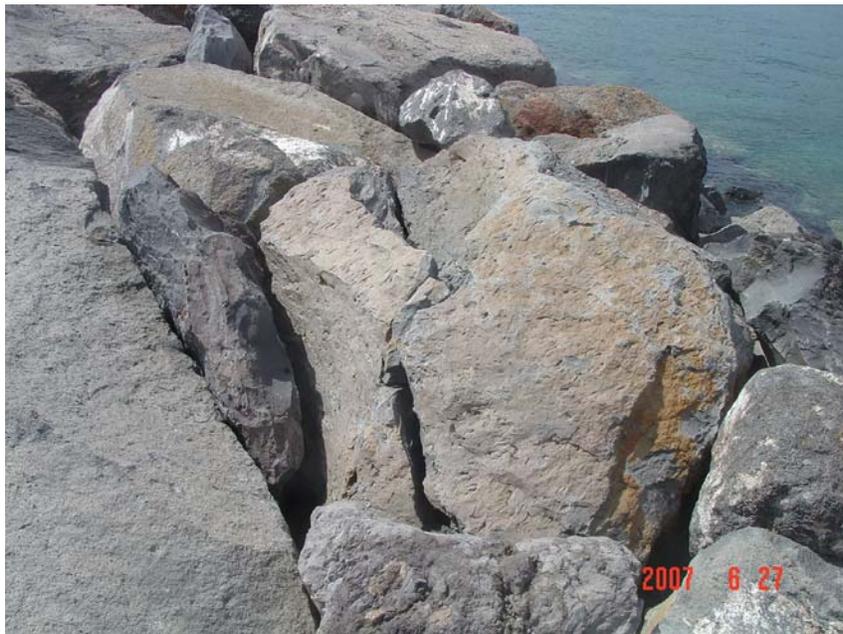
h. Sta. 3+80, CL, cracked armor stone.

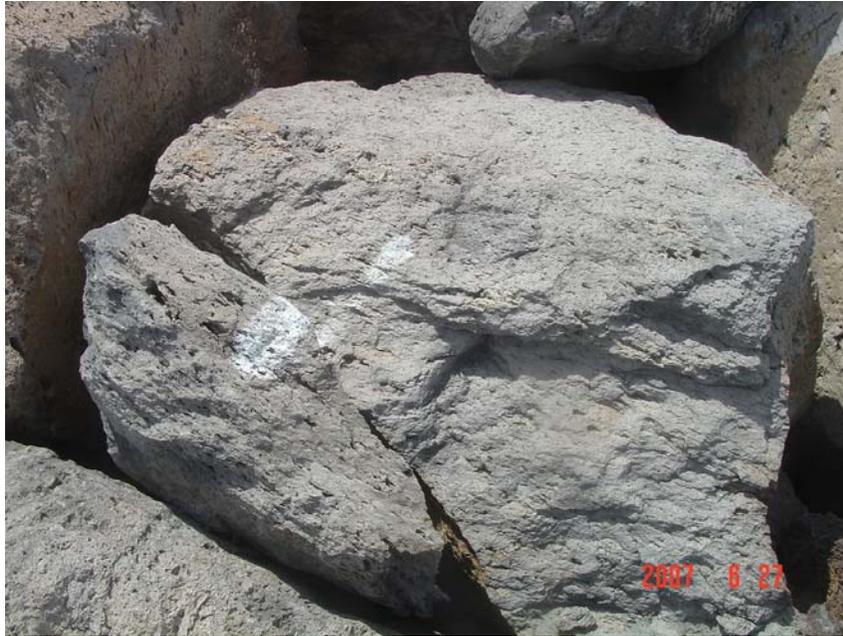
i. Sta. 4+33 to Sta. 4+39, CL, three cracked armor stones at crest. Settling of armor layer along crest and HS hinge. One flipped armor stone on OS.

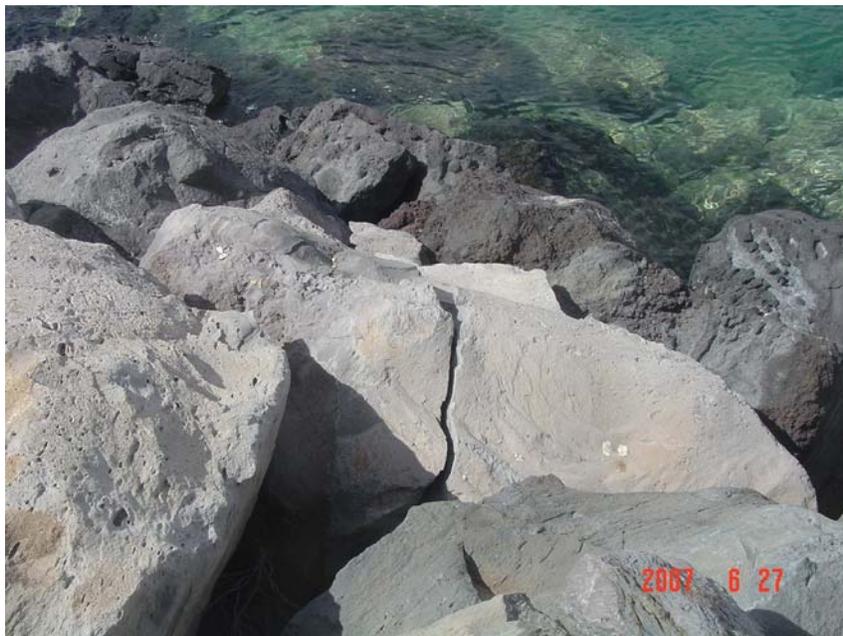
j. Sta. 4+75, HS, cracked armor stone @ hinge.

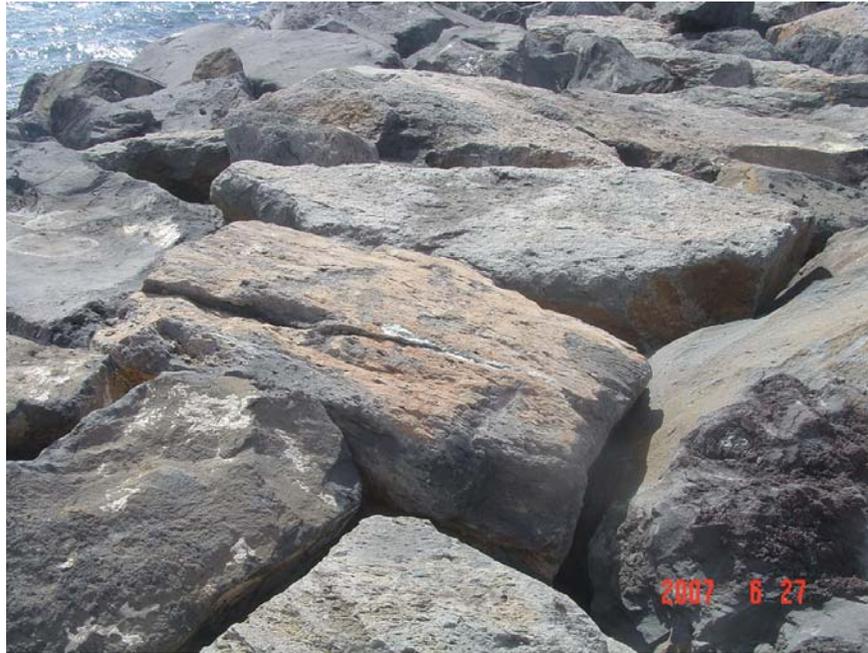
k. Sta. 5+65, CL, cracked armor stone at crest.

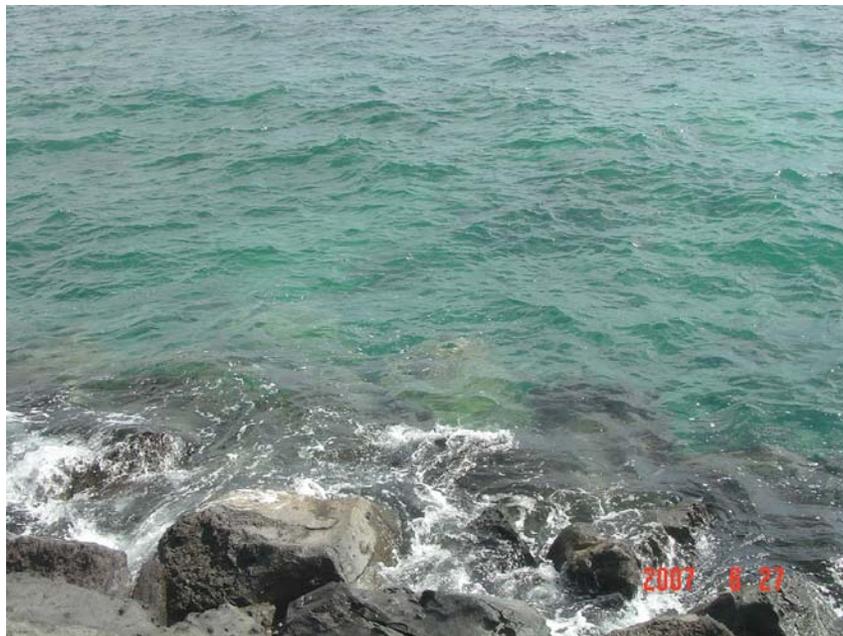
l. Sta. 6+00, OS, 2ea. dislodged armor stones resting 20 feet from toe, no obvious voids in sideslope.

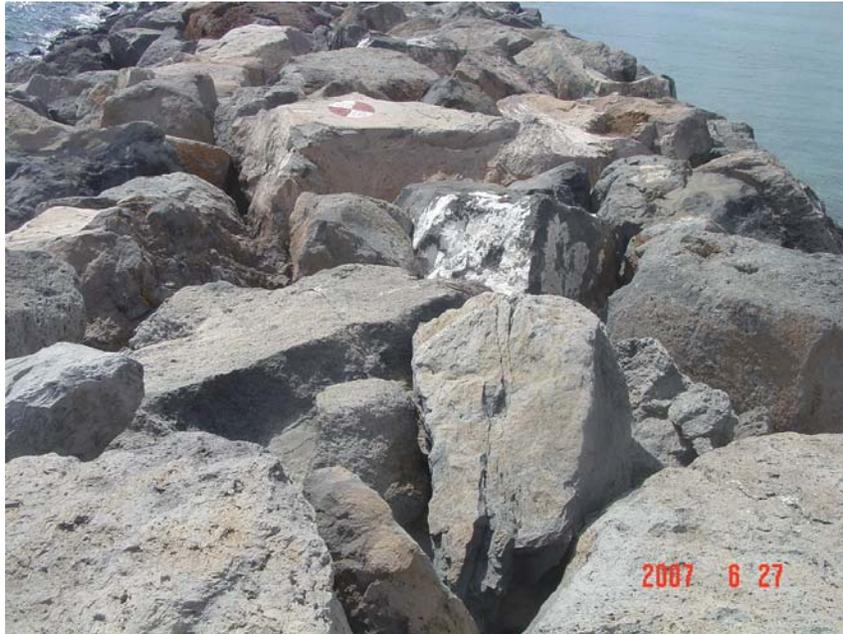
m. Sta. 6+40, cracked armor stone.

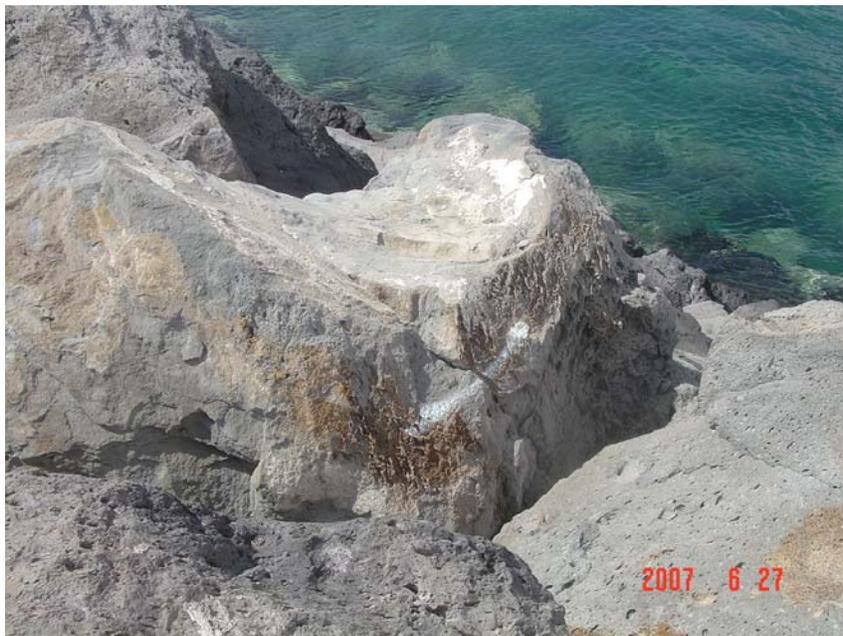
n. Sta. 6+80, HS, Cracked armor stone on sideslope. (2003 Photo)

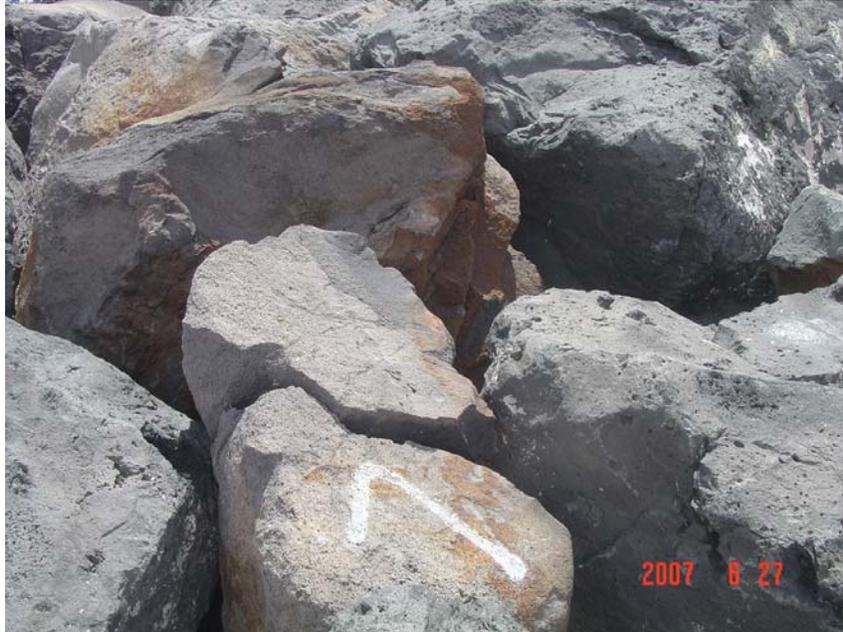
o. Sta. 7+00, cracked armor stone at hinge.

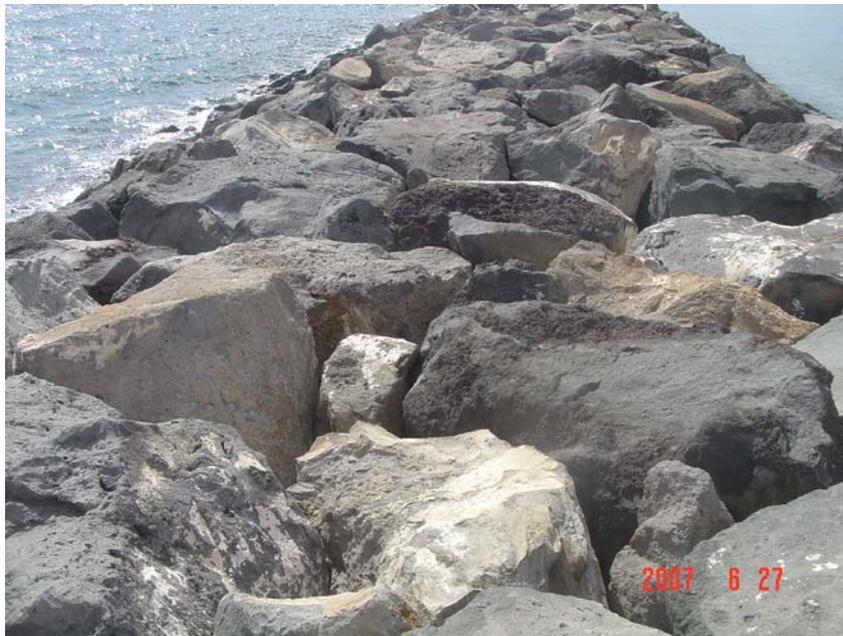
p. Sta. 7+10 to Sta. 7+20, settling at crest.

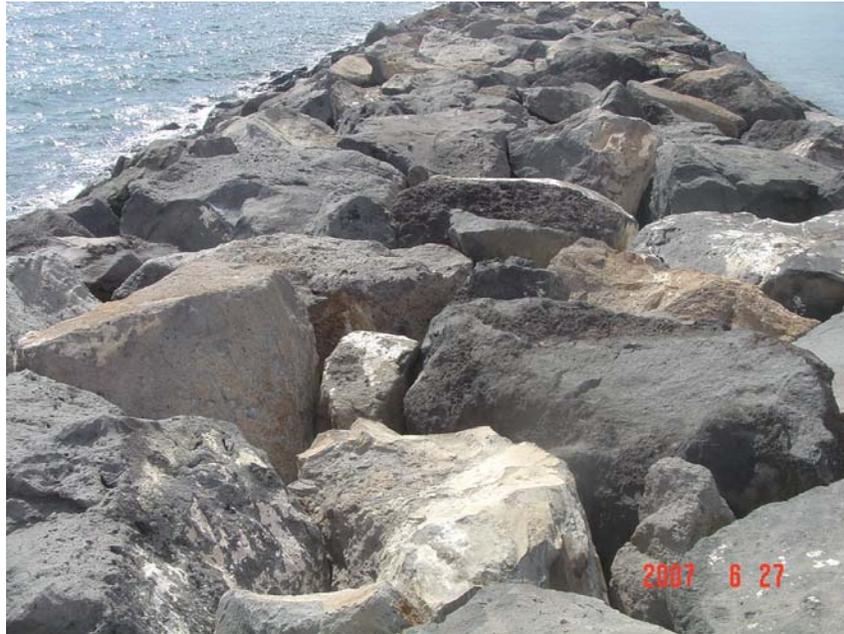
q. Sta. 7+90, CL, settlement.

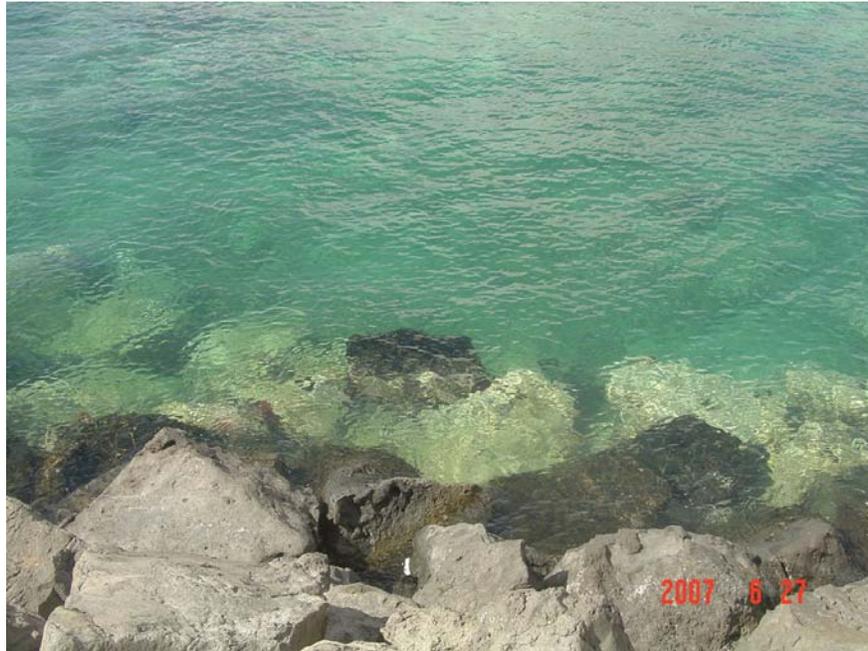
r. Sta. 8+24, HS, dislodge stone at toe, likely from sideslope.

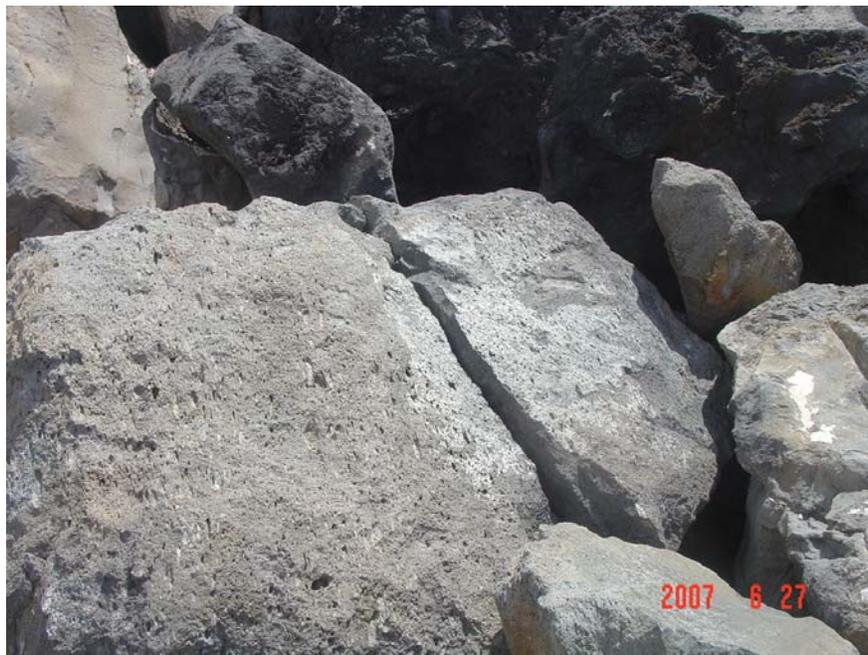
s. Sta. 9+26, CL, cracked armor stone.

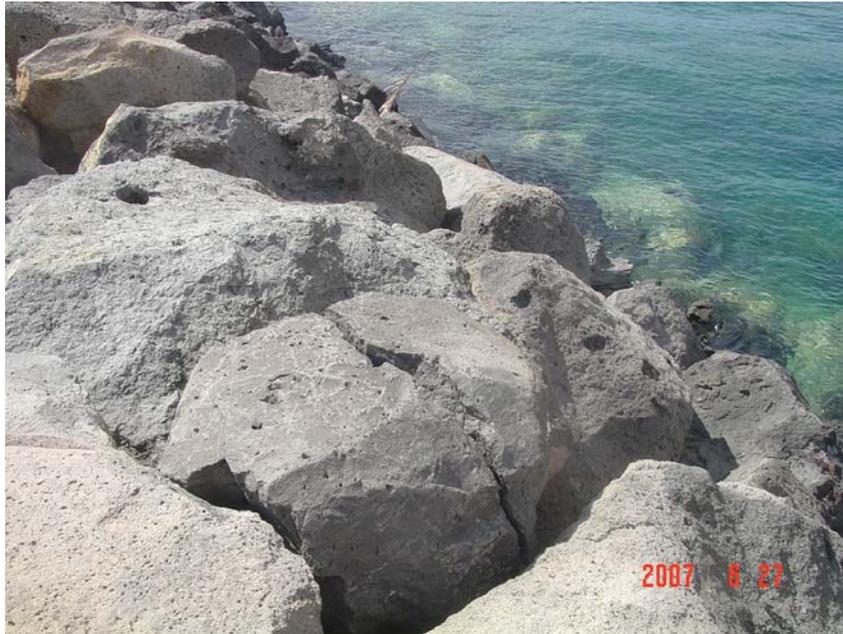
t. Sta. 9+60, Split armor stone @ crest.

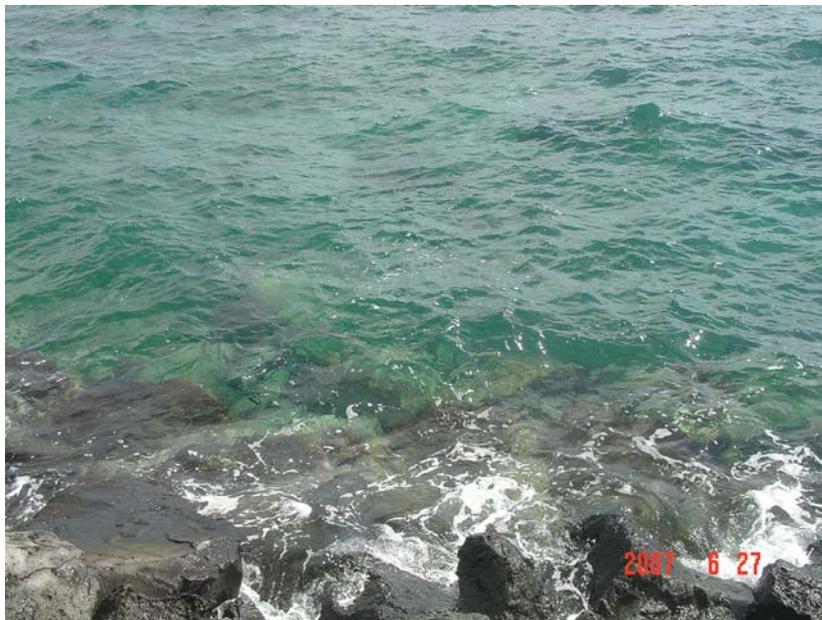
u. Sta. 9+71, OS, three armor stones have rolled off of the structure and into the water. Likely from structure sideslope at waterline.

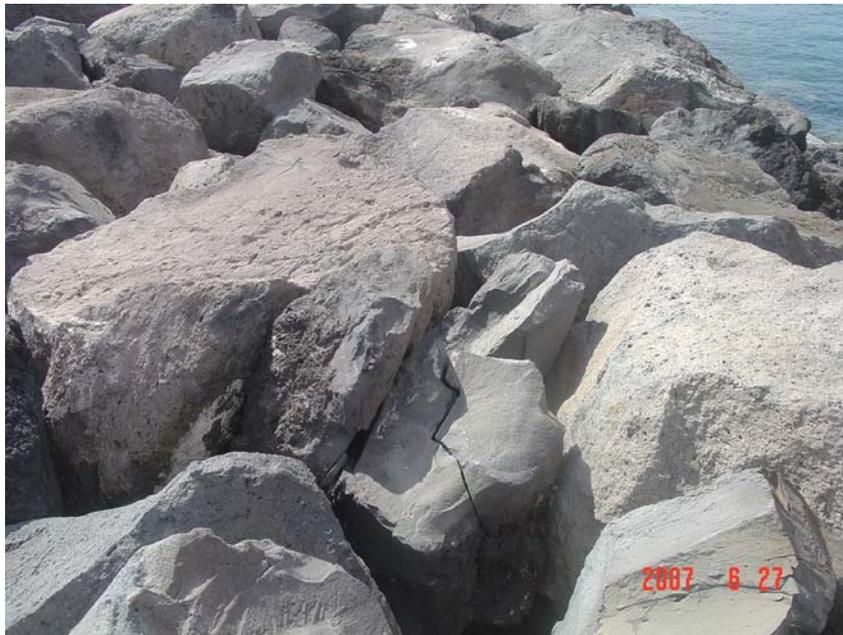
w. Sta. 10+50, CL, cracked armor stone.

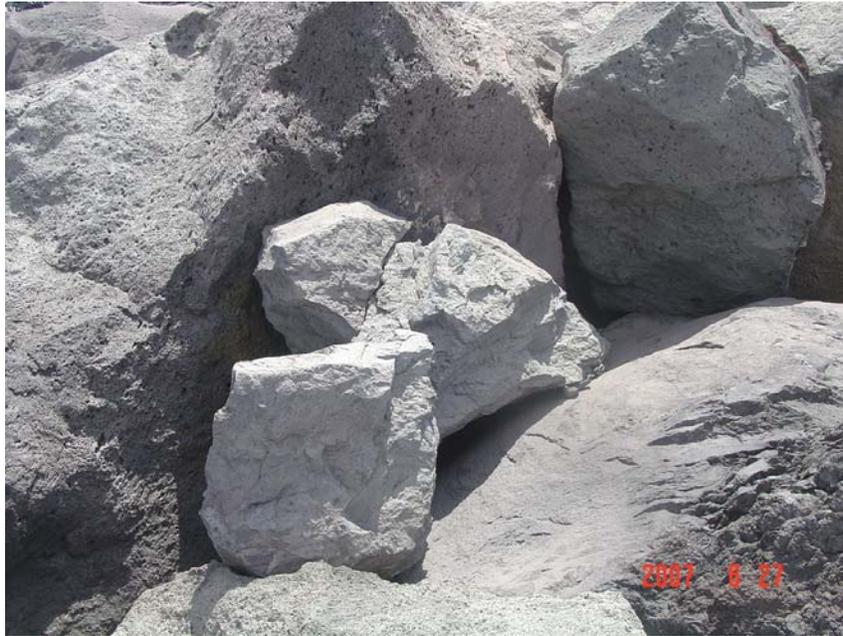
x. Sta. 11+00, CL Crest, Fractured armor stone.

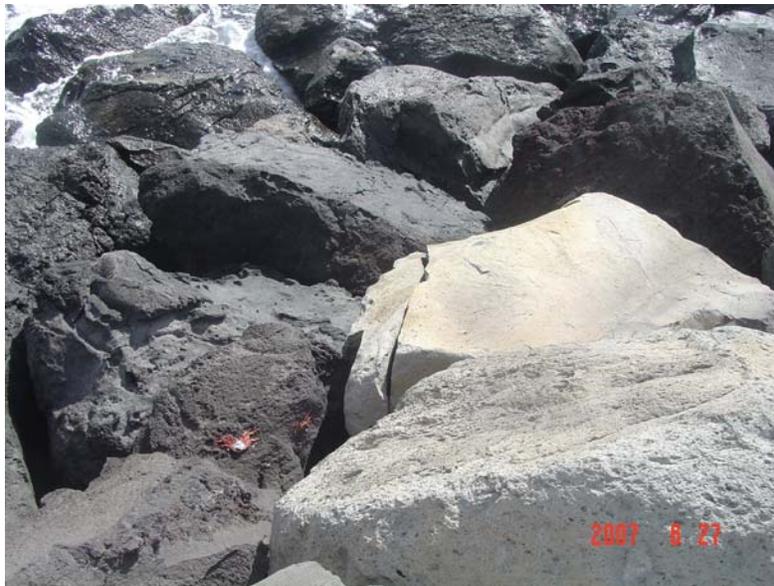
y. Sta. 11+10, OS, split armor stone.

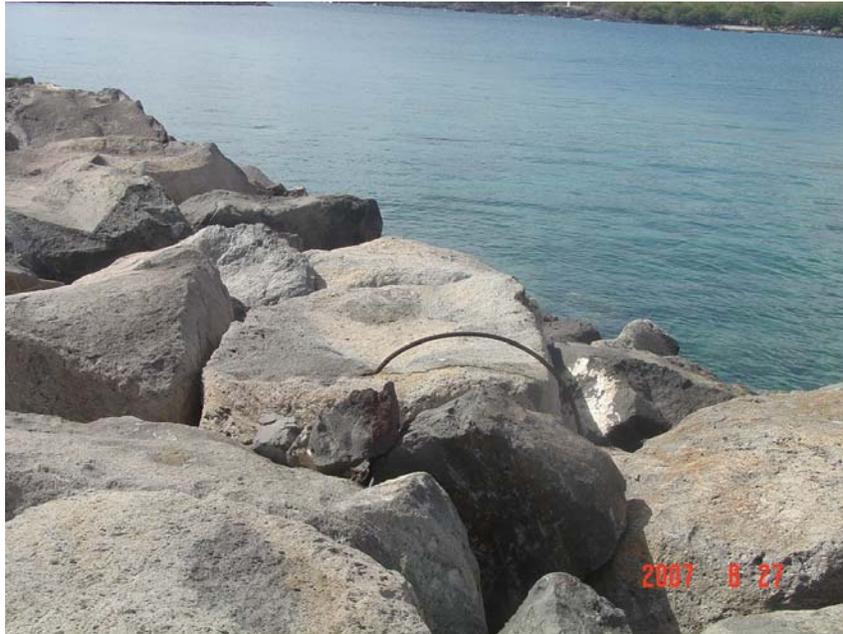
z. Sta. 11+19, CL, wire rope thru armor stone.

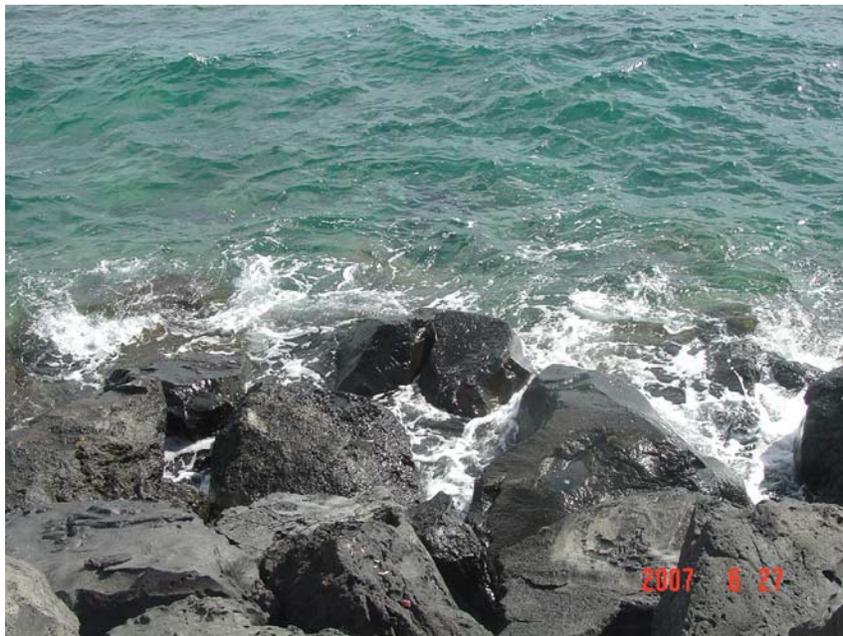
aa. Sta. 11+49, OS, 1 ea. split armor stone, no void. (

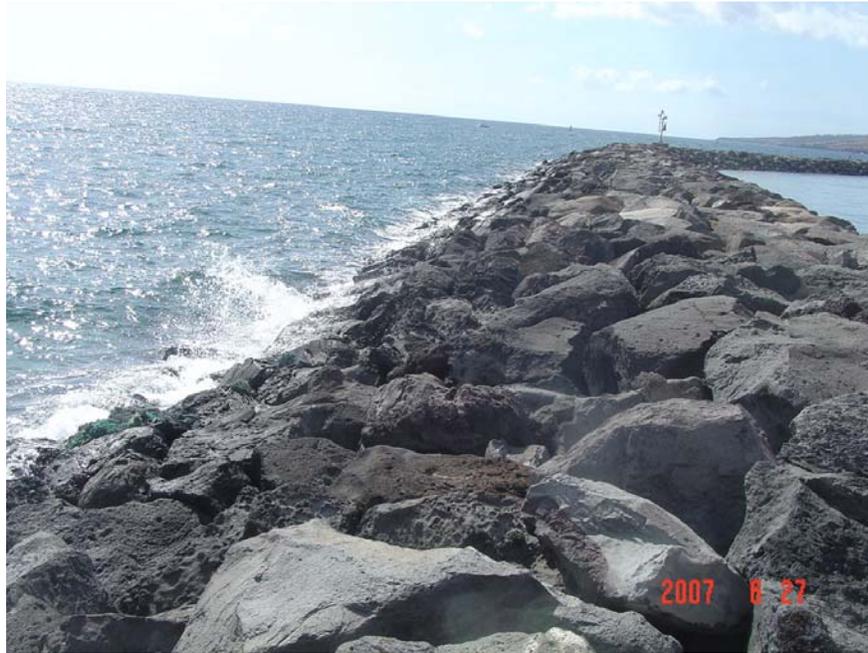
bb. Sta. 11+65, OS hinge, settling approx 20LF.

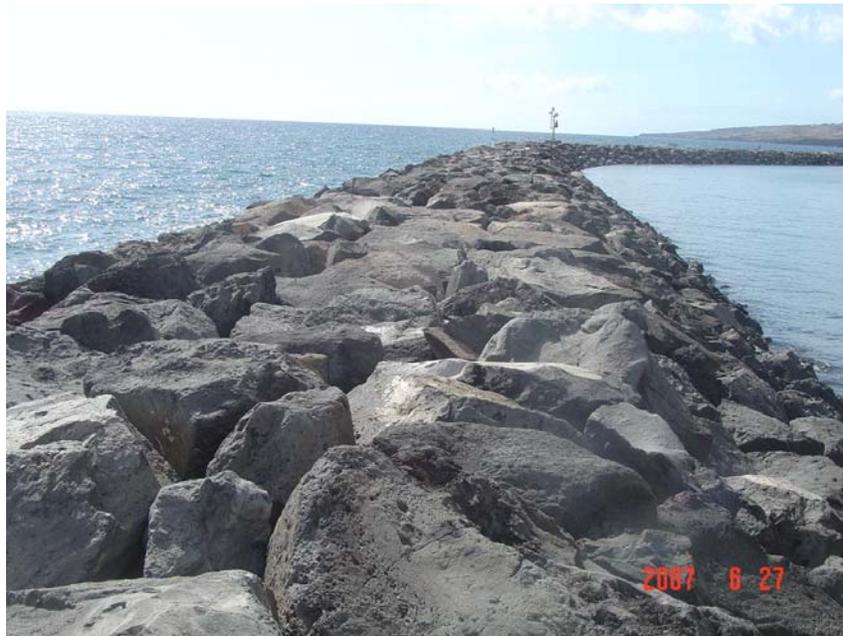
cc. Sta. 12+00, settling at crest.

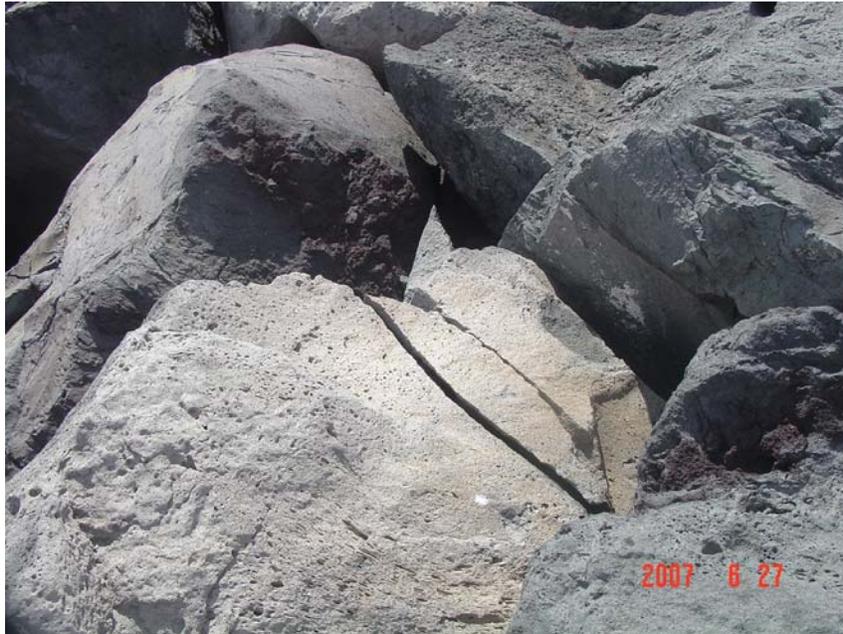
dd. Sta. 14+60, OS, Double split armor stone at hinge.

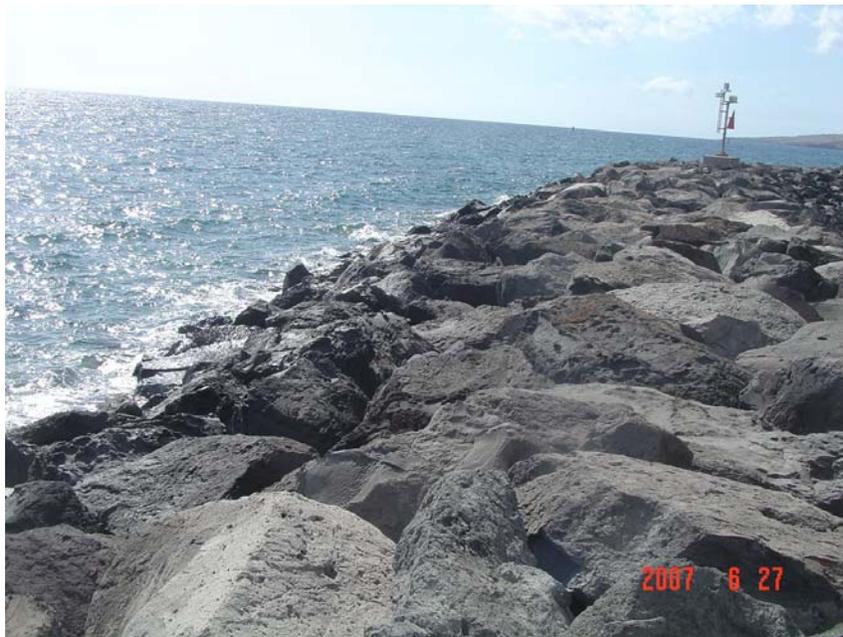
ee. Sta. 14+78 to Sta. 15+10, OS settling, approximately 20 feet of the sideslope.

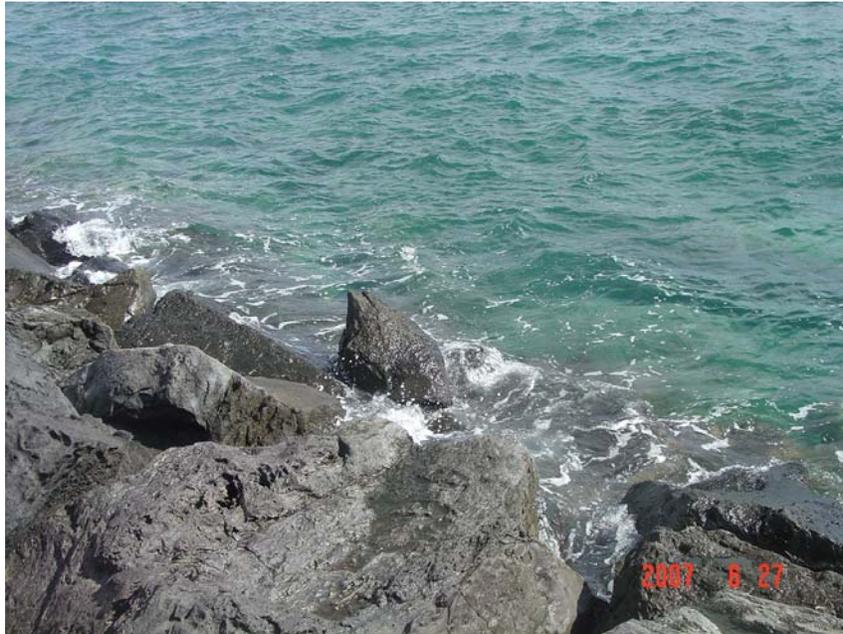
ff. Sta. 15+35, OS, flipped / cracked armor stone at waterline.

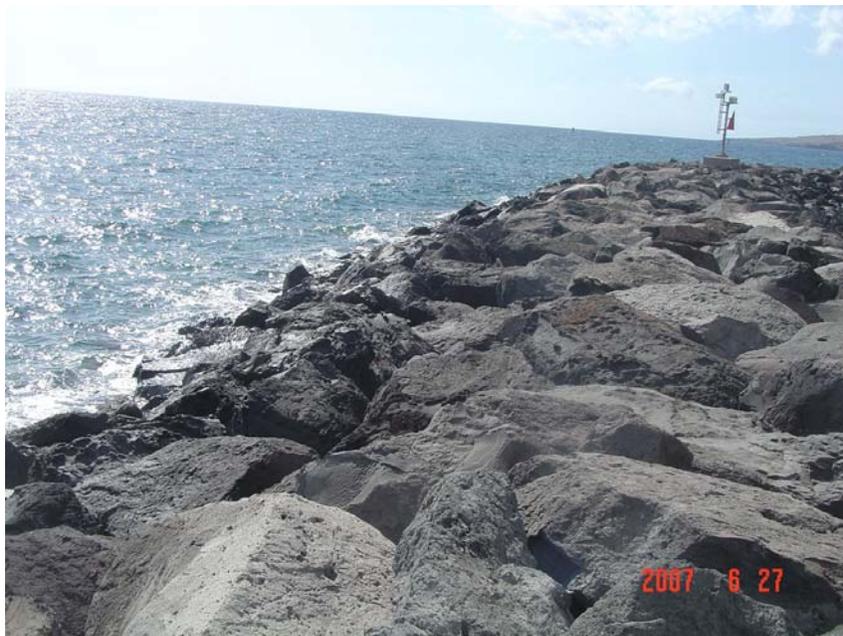
gg. Sta. 17+00, OS, settling along the sideslope.

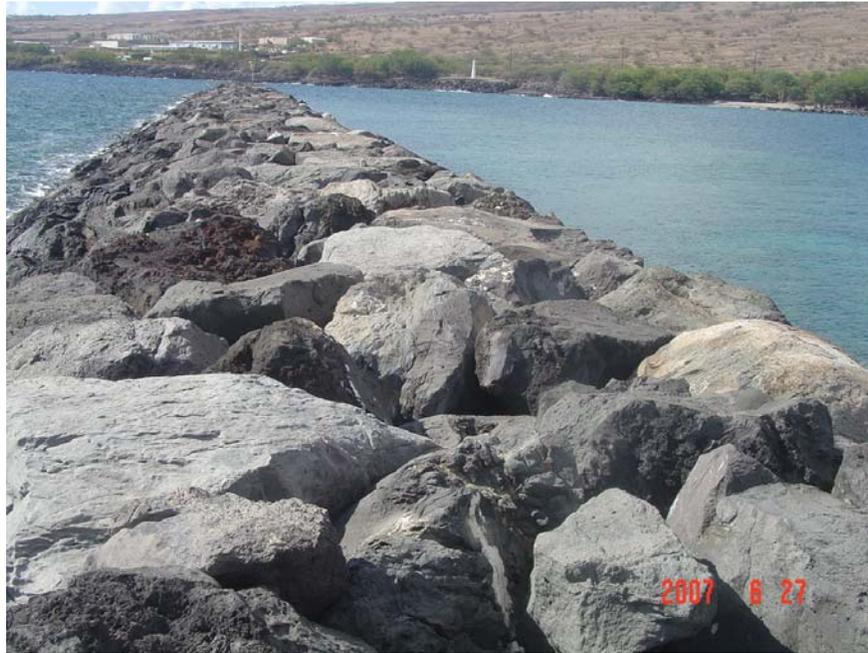
hh. Sta. 17+50 to Sta. 17+79, OS, sideslope and crest settling approximately 20 linear feet.

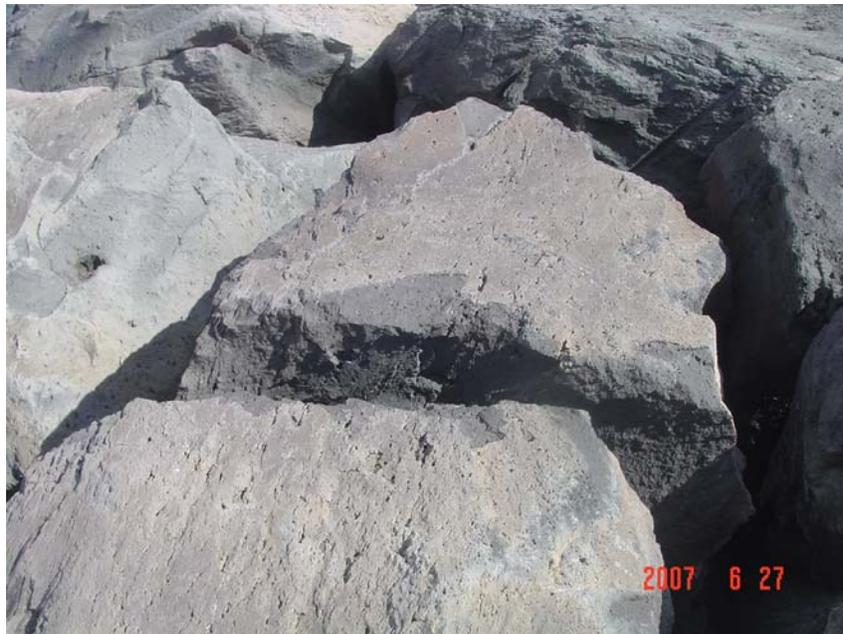
ii. Sta. 18+32, Crest, cracked armor stone.

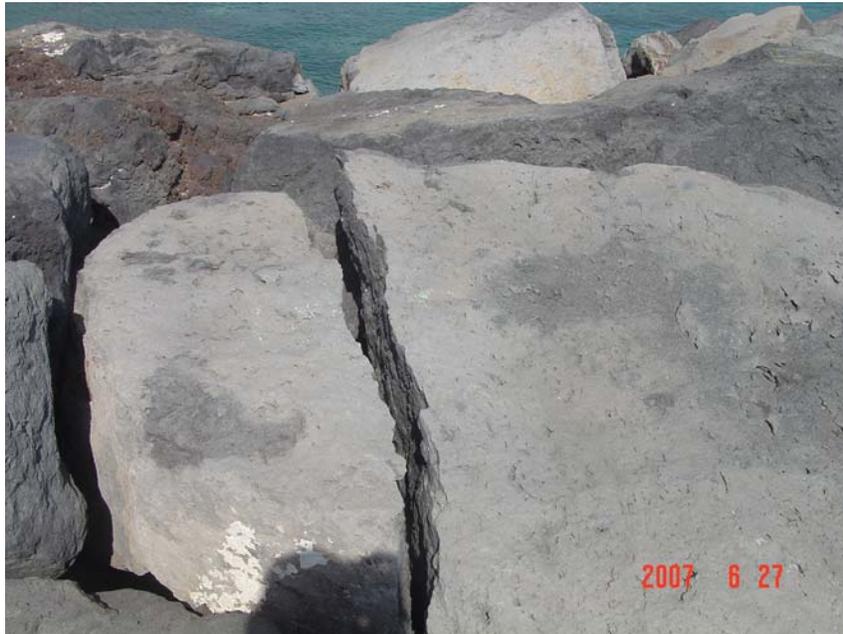
jj. Sta. 18+67, CL, cracked armor stone.

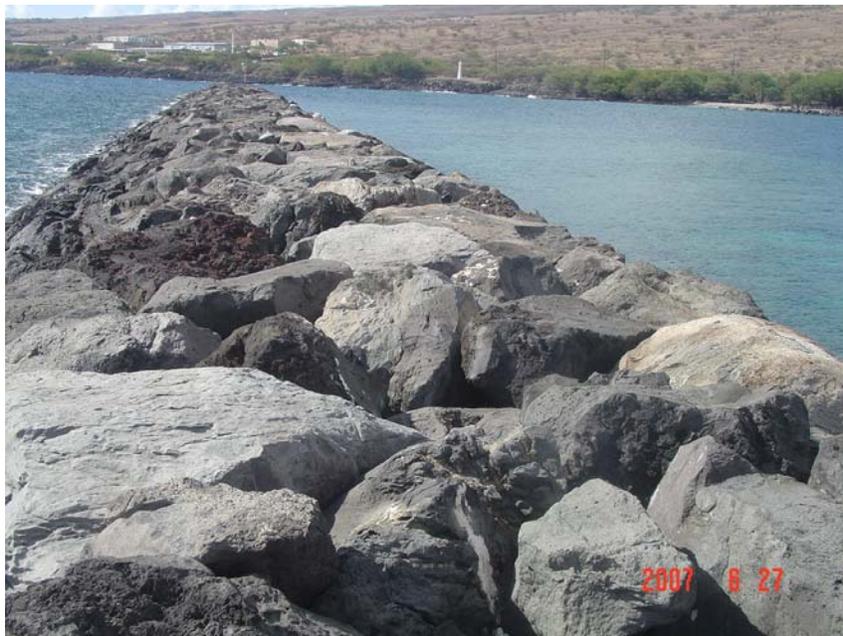
kk. Sta. 18+97, crest settling (3' x 3').

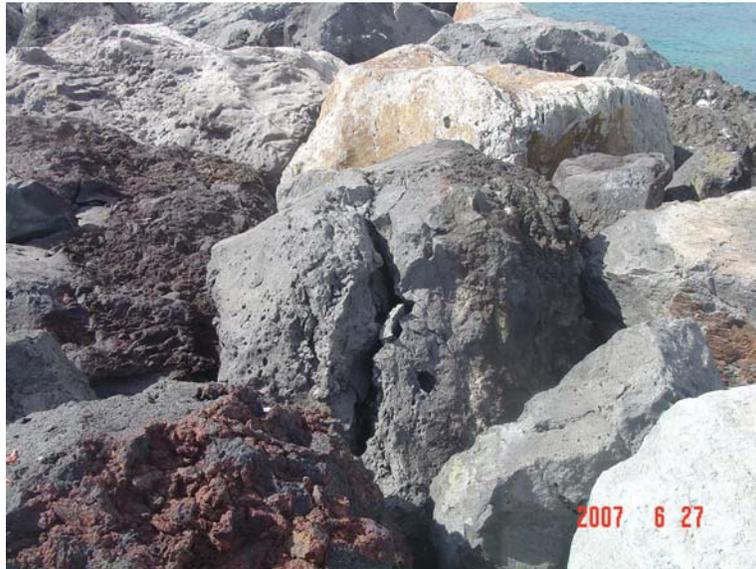
11. Sta. 19+15, Crest, two cracked armor stone.

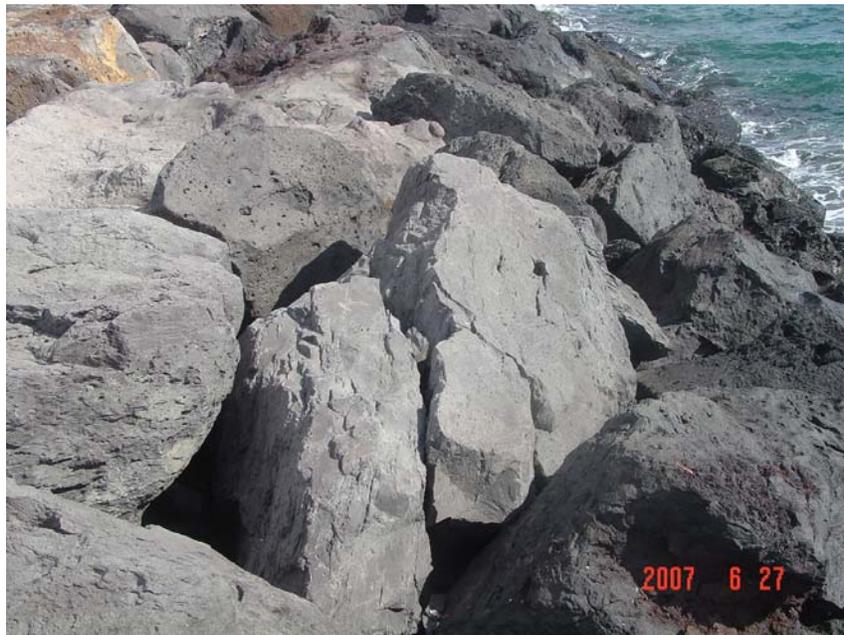
mm. Sta. 19+39, Crest, fractured armor stone.

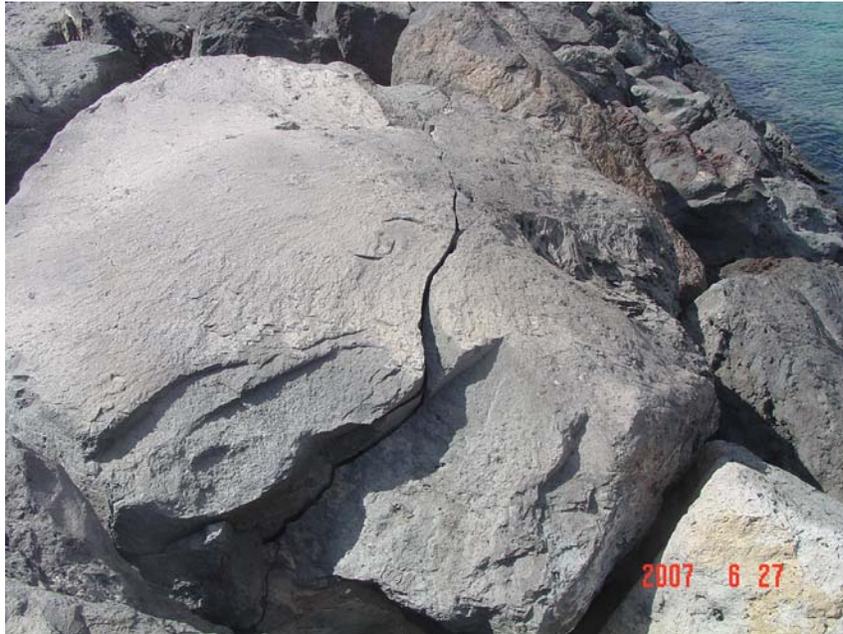
nn. Sta. 20+20, HS, three fractured armor stone (two OS and one HS).

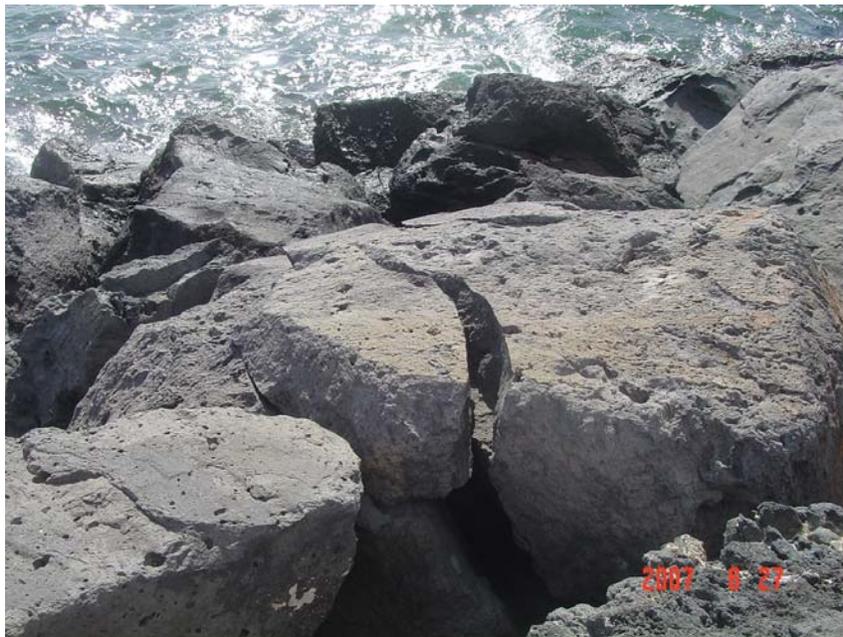
oo. Sta. 20+00, OS, three fractured armor stone (two OS and one HS).

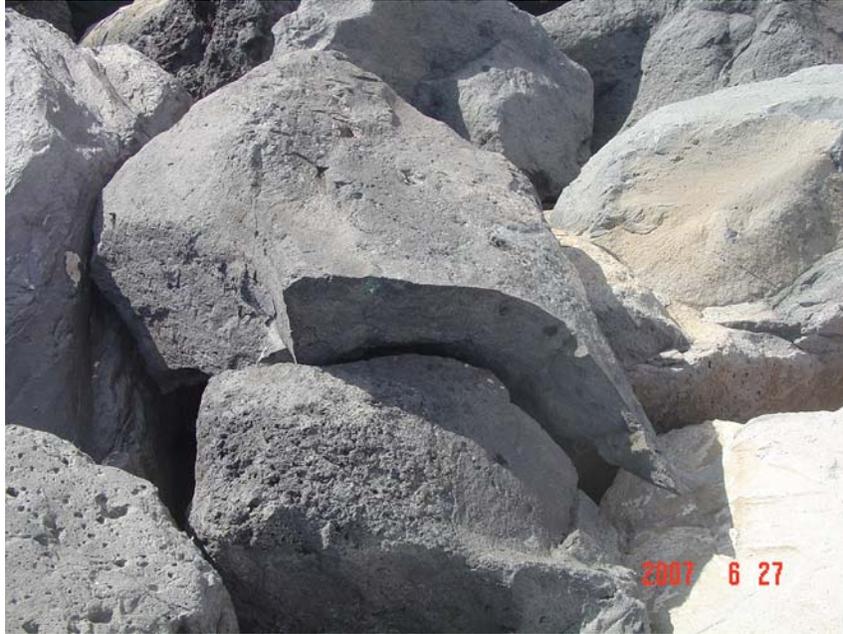
pp. Sta. 20+63, CL, cracked armor stone.

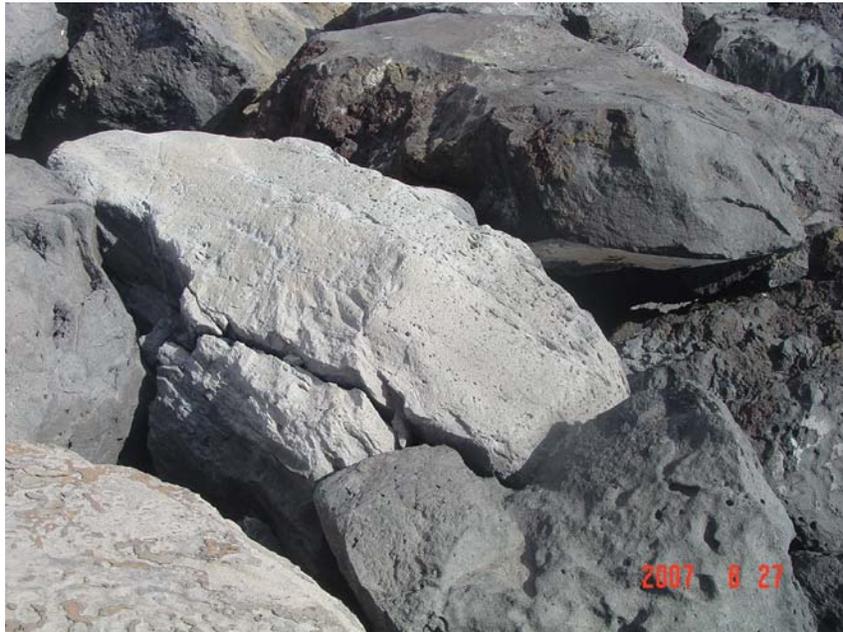
qq. Sta. 20+85, OS, cracked armor stone and minor settling and bridging.
