1. Project Name: Kawaihae Deep Draft Harbor
2. Date of Inspection: June 28, 2007
3. Inspection Personnel:

KAWAIHAE DEEP DRAFT HARBOR, HAWAII

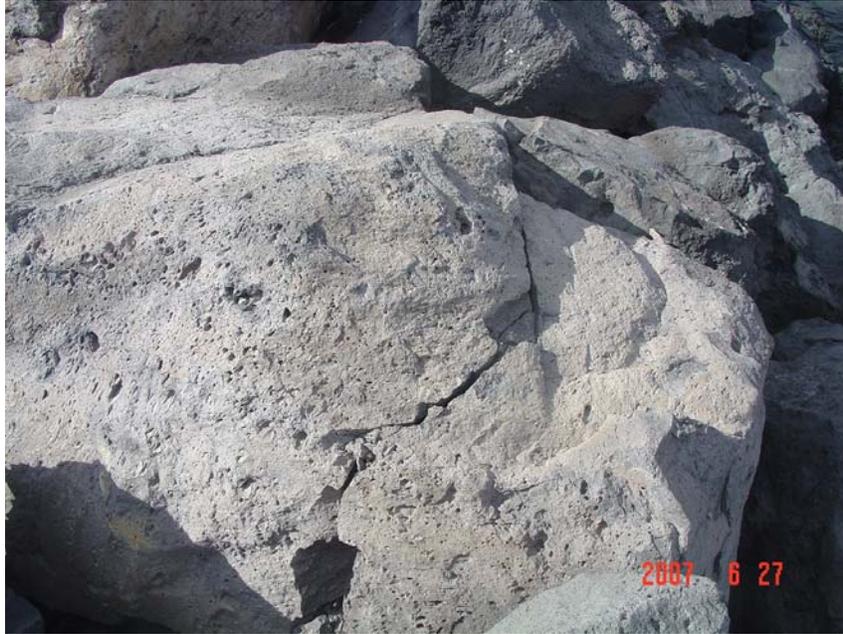
rr. Sta. 22+80, cracked armor stone at the hinge.

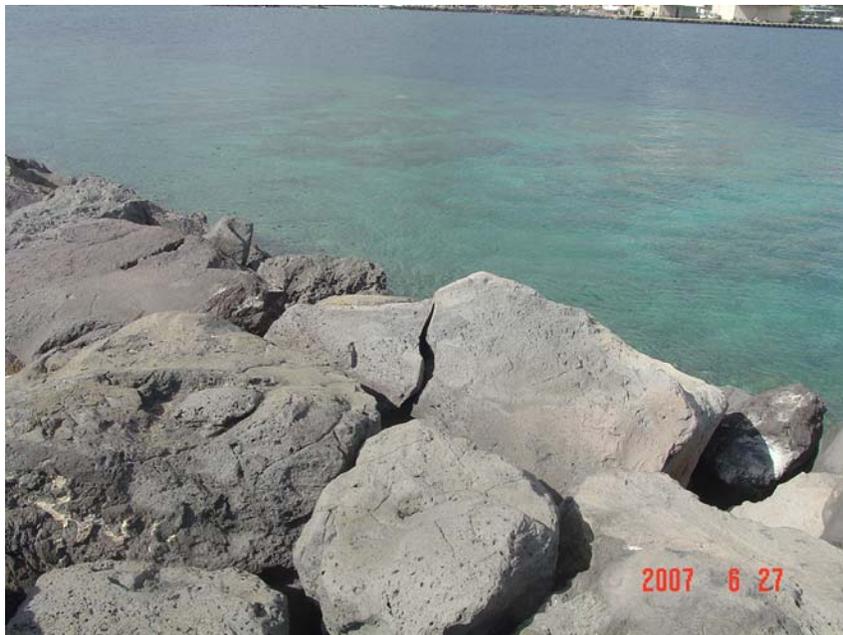
ss. Sta. 23+18, HS, cracked armor stone.

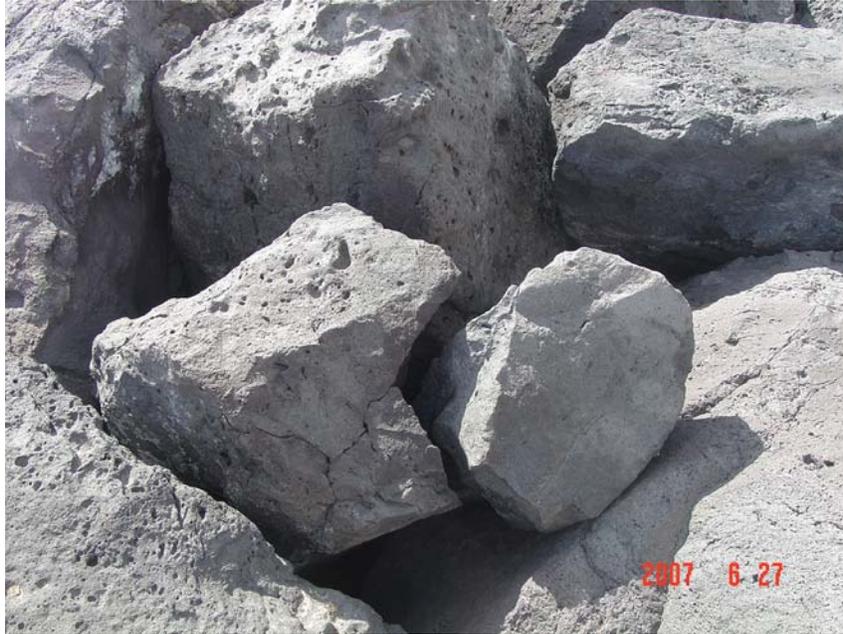
tt. Sta. 23+26, CL, cracked armor stone.

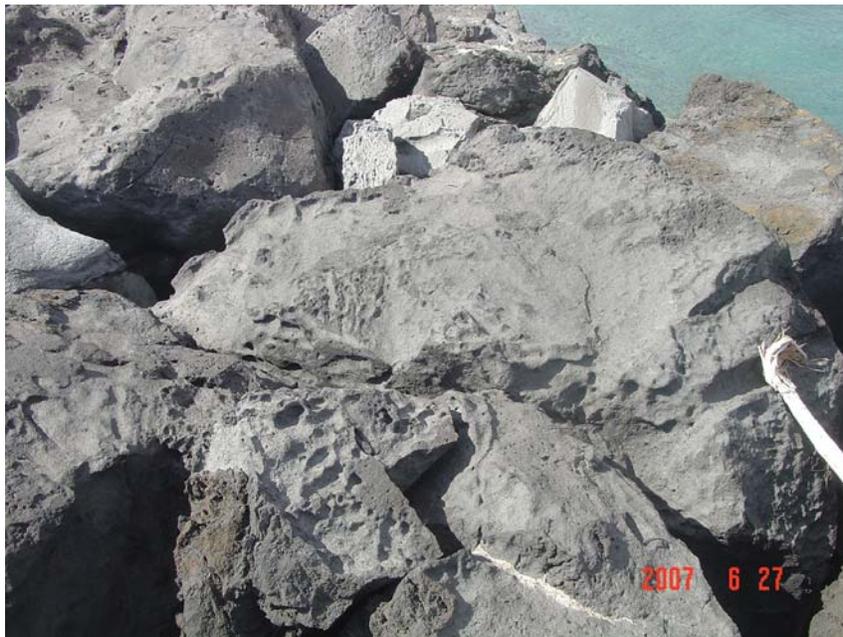
uu. Sta. 24+71, CL, cracked armor stone.

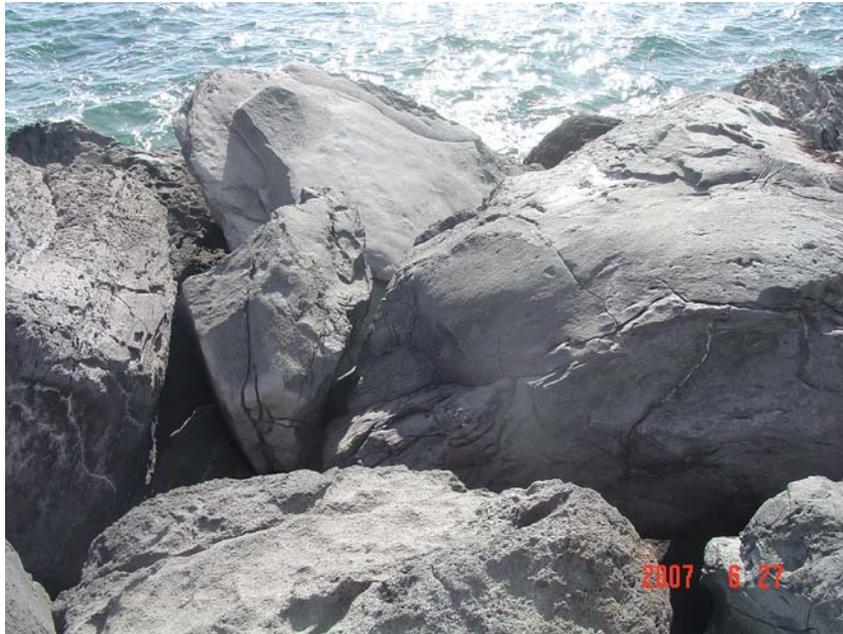
vv. Sta. 25+21, CL, hinge stone settling and three cracked armor stones.

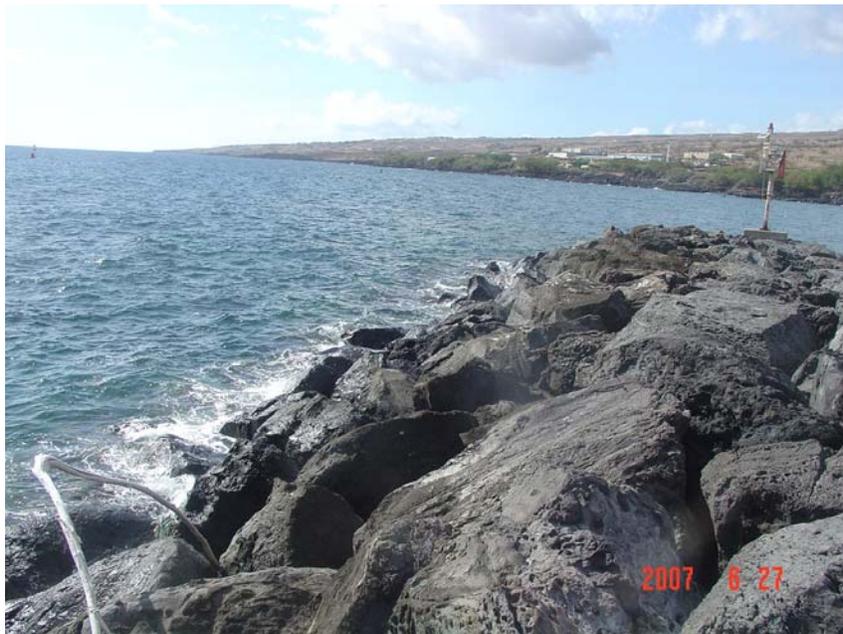
ww. Sta 26+54, OS, Missing toe armor stone (6 ea.), monitor.

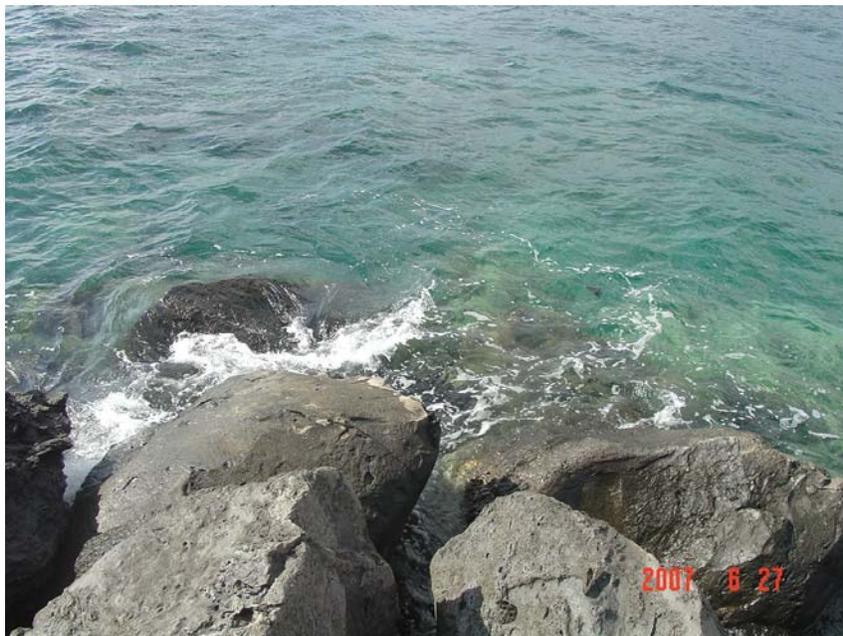
yy. Sta. 26+64, Head, missing armor stones at the waterline.

5. Findings / Conclusions: The primary damages at this structure are at the head, as shown in photographs. Several cracked stones and dislodged toe stones indicate wave action is continuing to deteriorate structure. Continue to monitor. The overall condition of the breakwater is FAIR, and functionality is GOOD. Navigation aids are in good condition.
