## O&M INSPECTION REPORT FOR NAVIGATION PROJECTS

Nawiliwili Small Boat Harbor

Honolulu Engineer District

2. Date of Inspection: June 11, 2007

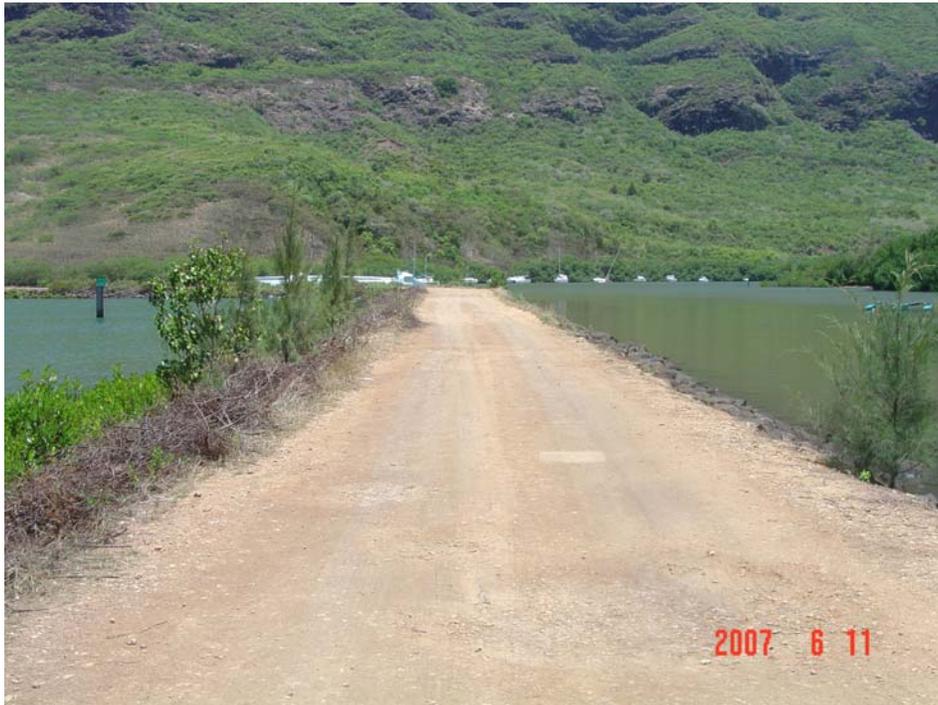
a. Sta. 3+95, Overview, Juvenile trees are well established and should be removed.

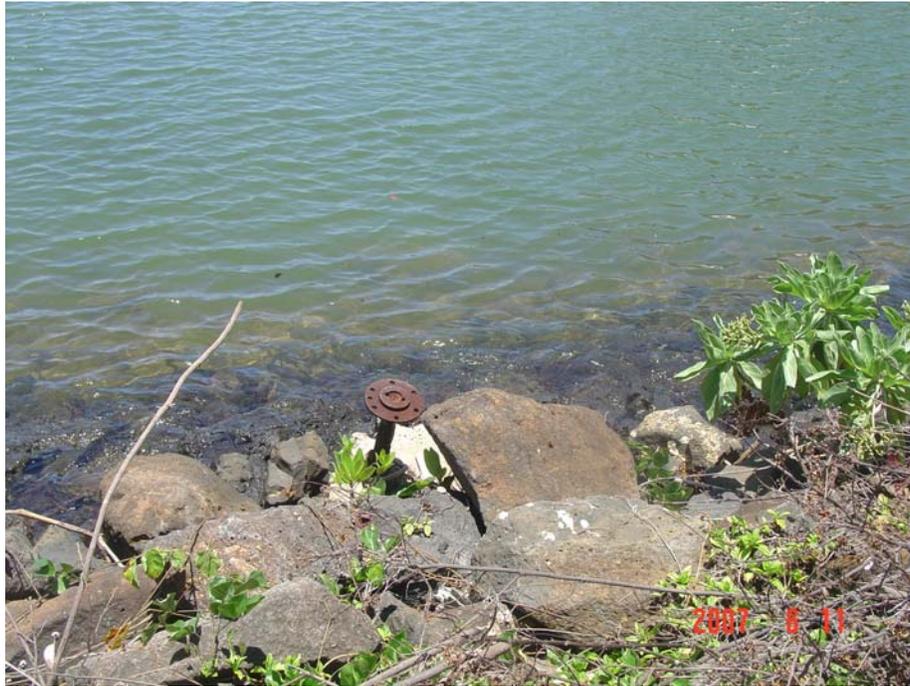
b. Sta. 5+23, HS, remove mooring anchor.

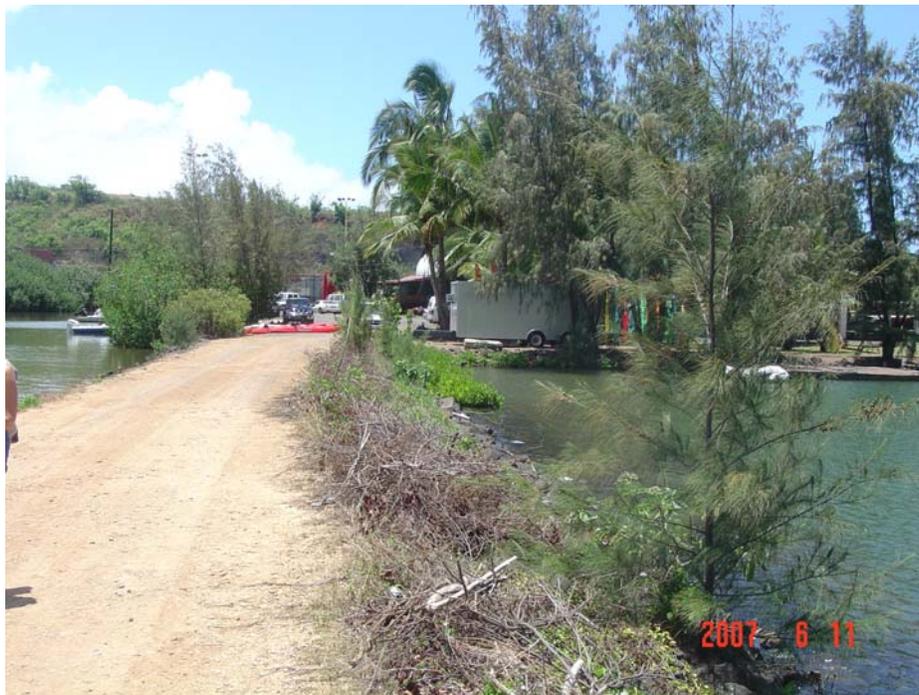
c. Sta.5+50, HS, overview of root.

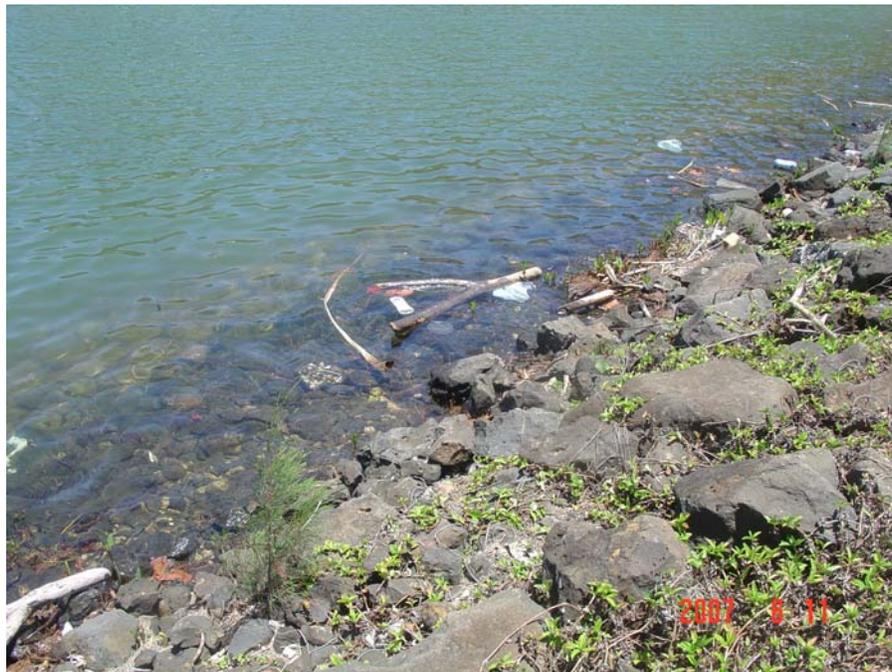
d. Sta. 6+51, HS, Monitor 20' x 4' area of missing armor layer (underwater).

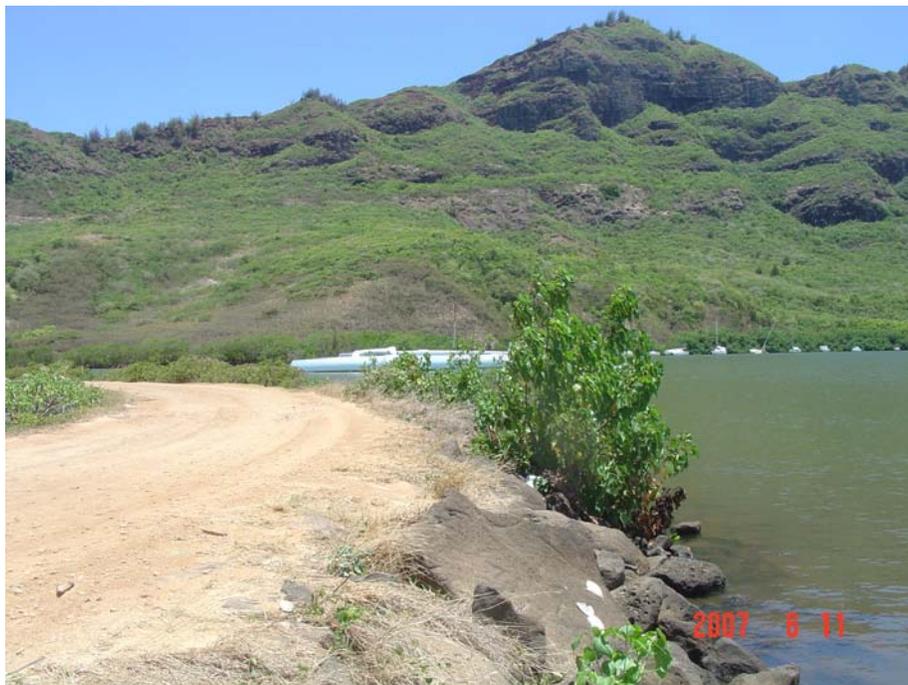
e. Sta. 7+26, OS, flipped armor stone and tree should be removed and crest eroded (potholes).

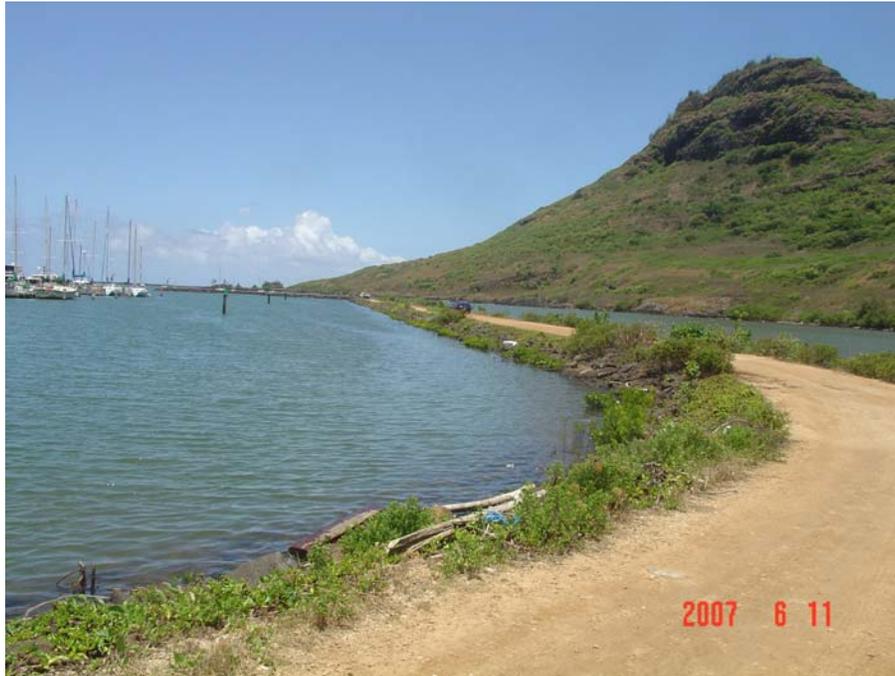
f. Sta. 8+62, Overview, crest eroded (potholes).

Vegetation control needs to be done and the crest of the revetted dike has numerous eroded areas caused by excessive vehicular traffic. Abandoned vehicles have been removed from the structure in the past and during this inspection and questionable activities were being conducted. The rating for FY07 is Fair.

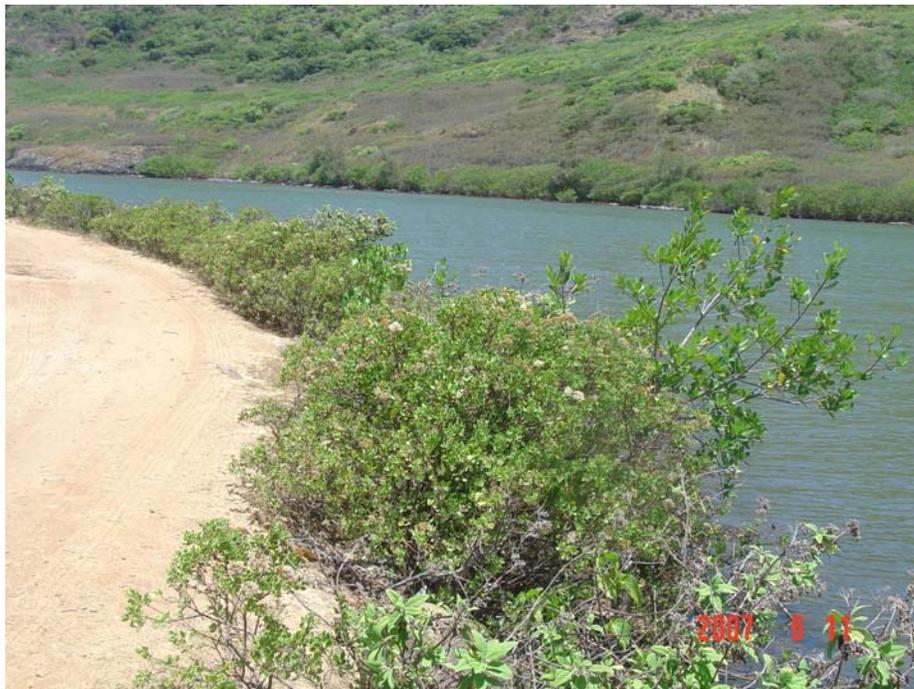
g. Sta, 9+00, OS, remove vegetation, unable to inspect.

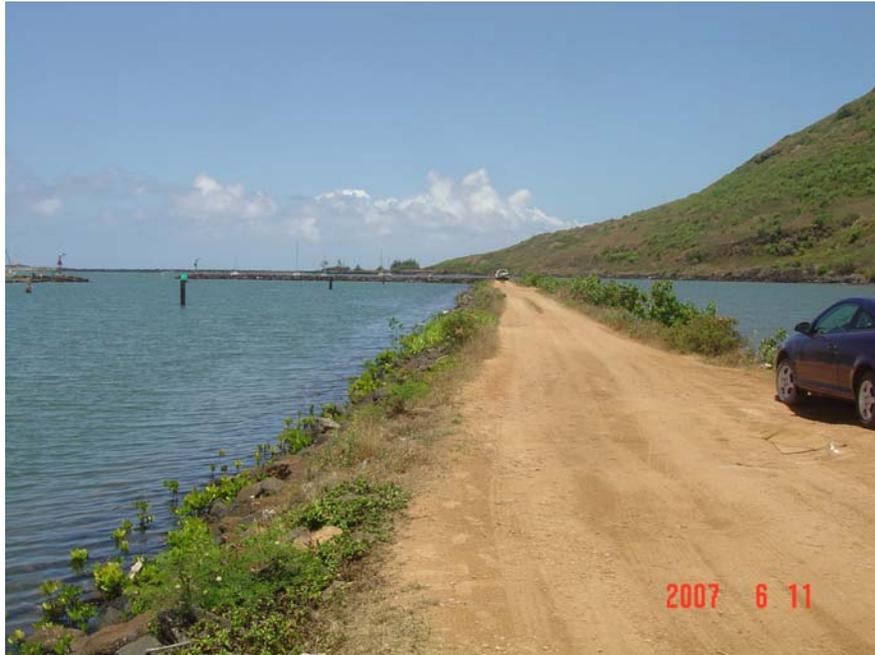
h. Sta. 11+33, HS, overview of sideslope, and crest eroded (potholes).

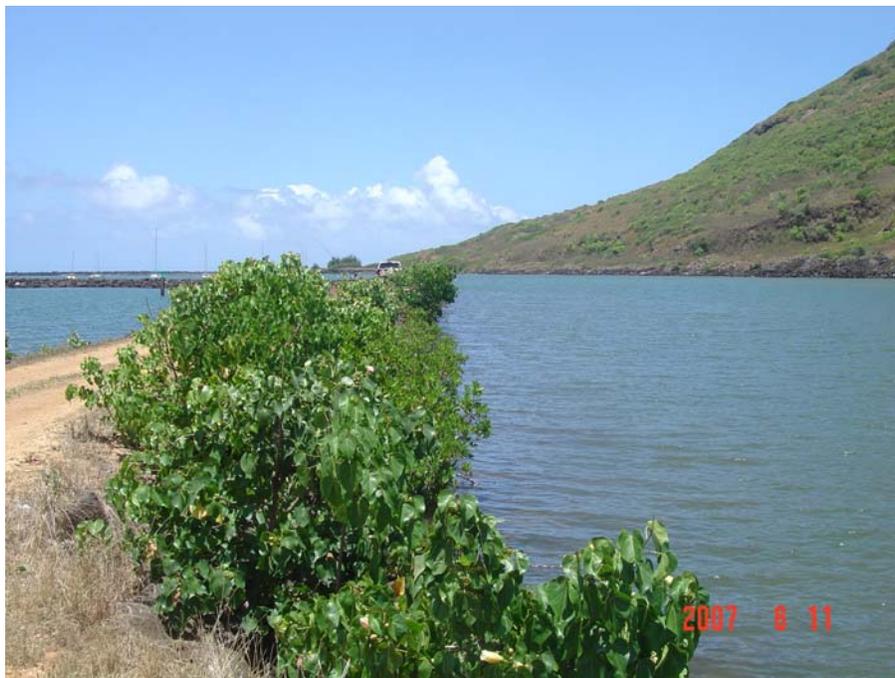
i. Sta. 13+82, OS, overview of sideslope adj. to # 7 green chnl marker.

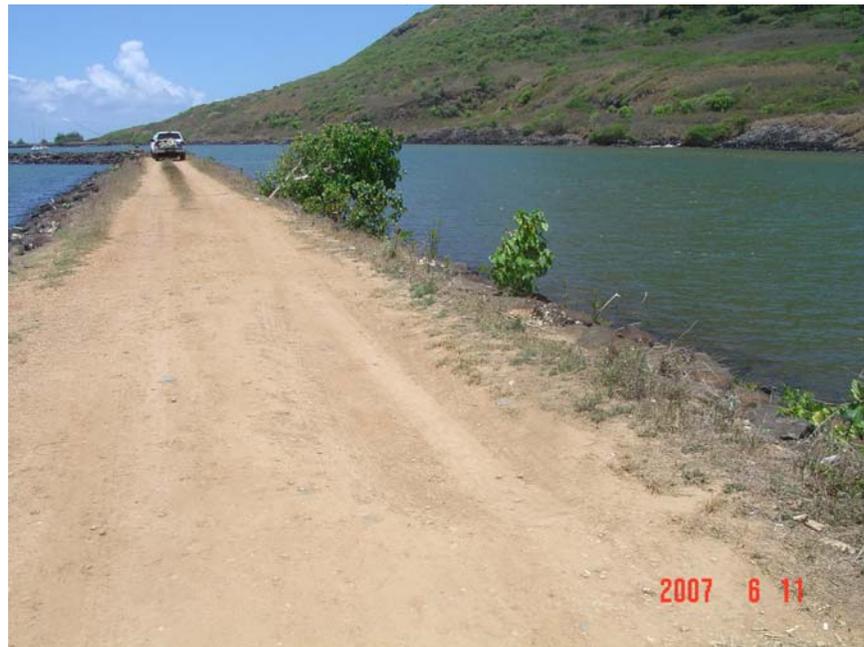
- j. Sta. Sta. 16+10, Crest, fill low spot approximately 8" deep.

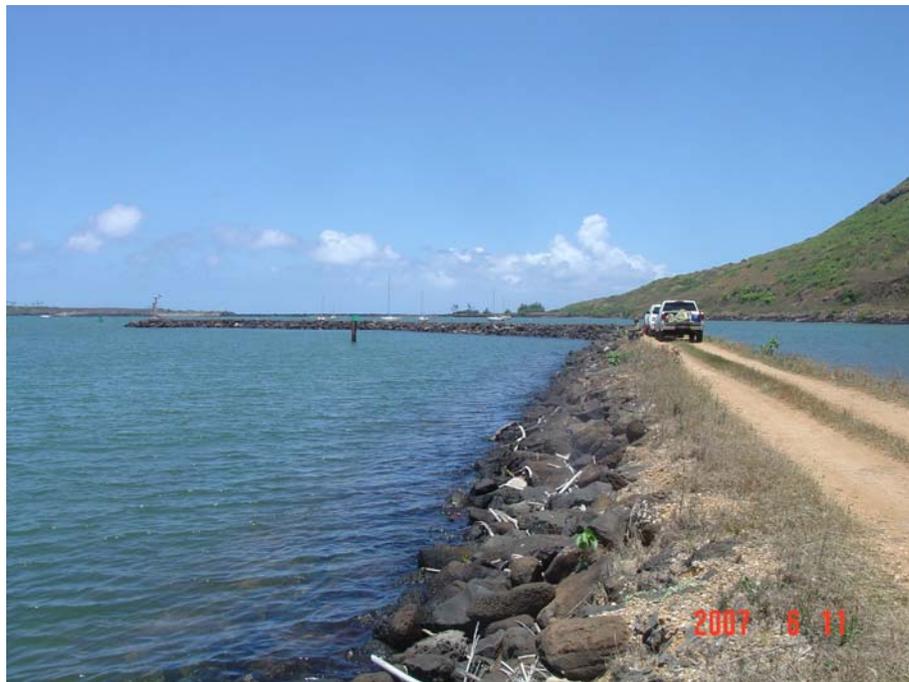
- k. Sta. 16+30, HS, overview adjacent to green chnl marker # 5.

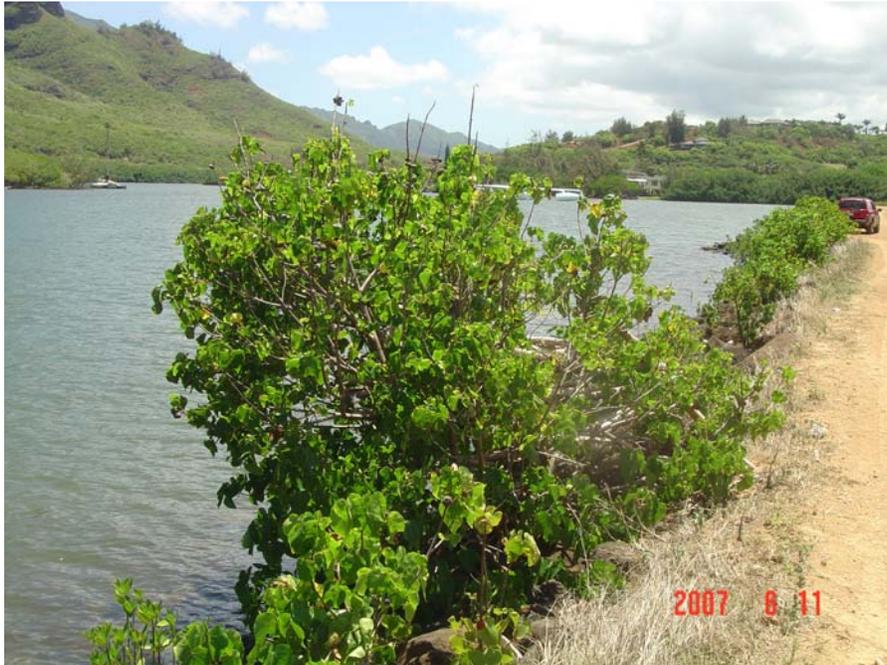
1. Sta. 16+62, OS, remove tree.

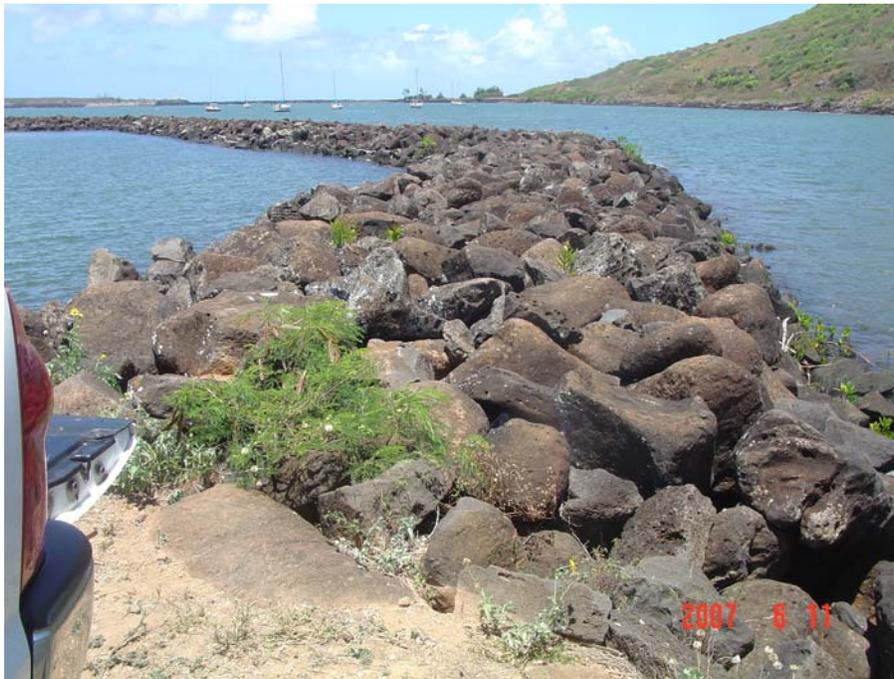
- m. Sta. 18+30, begin breakwater, vegetation starting to take root.

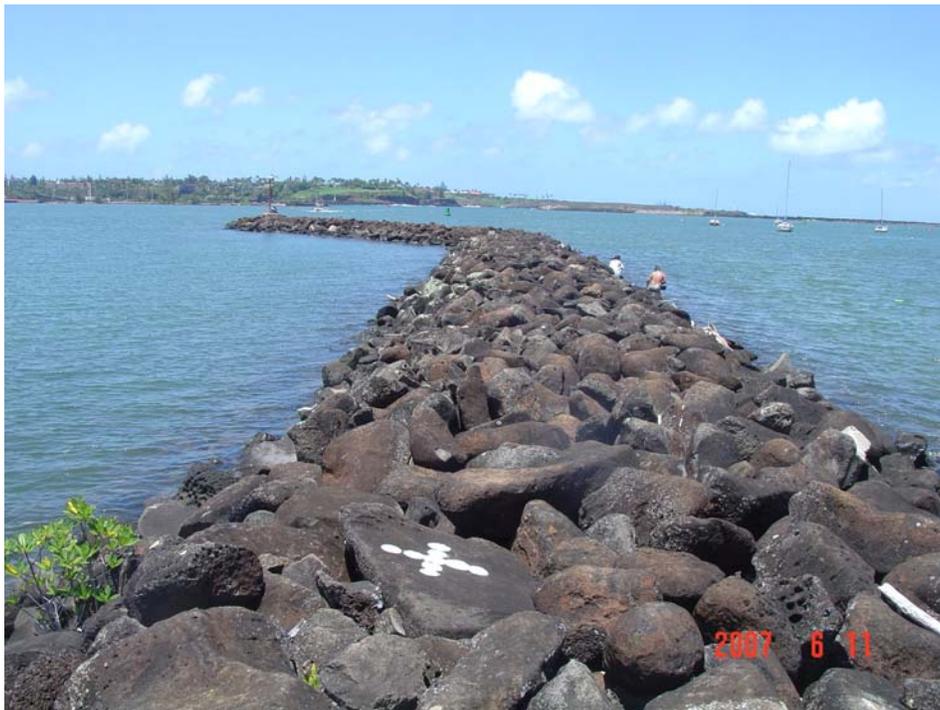
n. Sta. 19+34, overview at 1<sup>st</sup> bend, aerial marker.

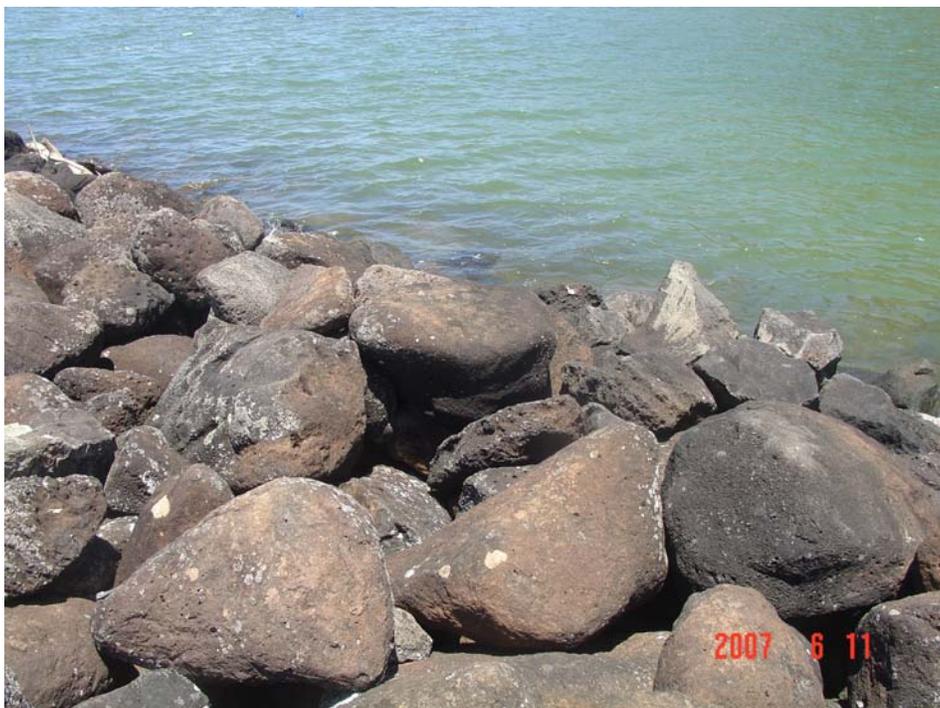
o. Sta. 19+46, crest & hinge voids.

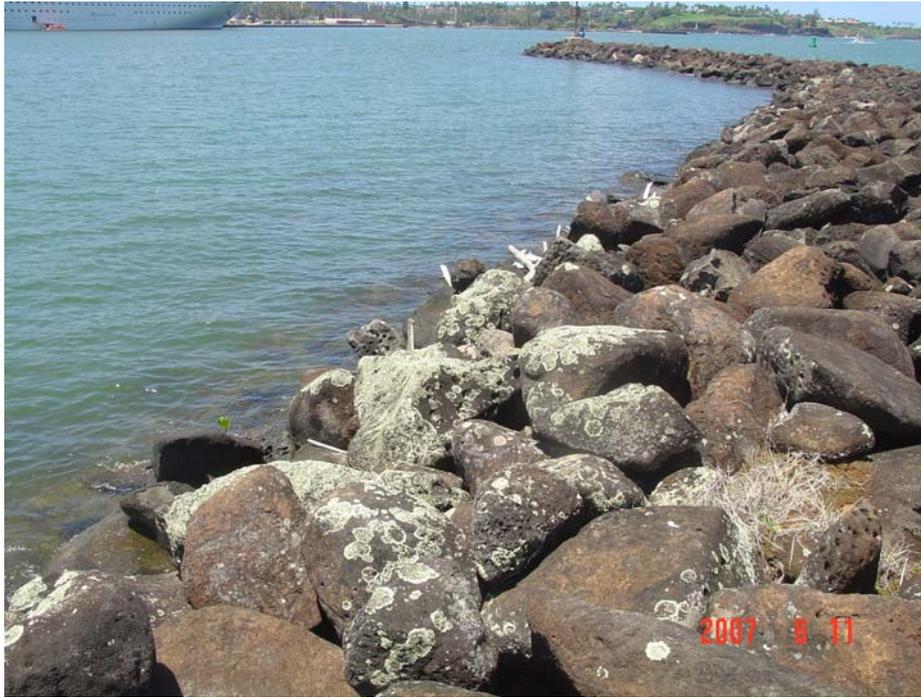
p. Sta. Sta. 20+04, HS, flipped armor stone.

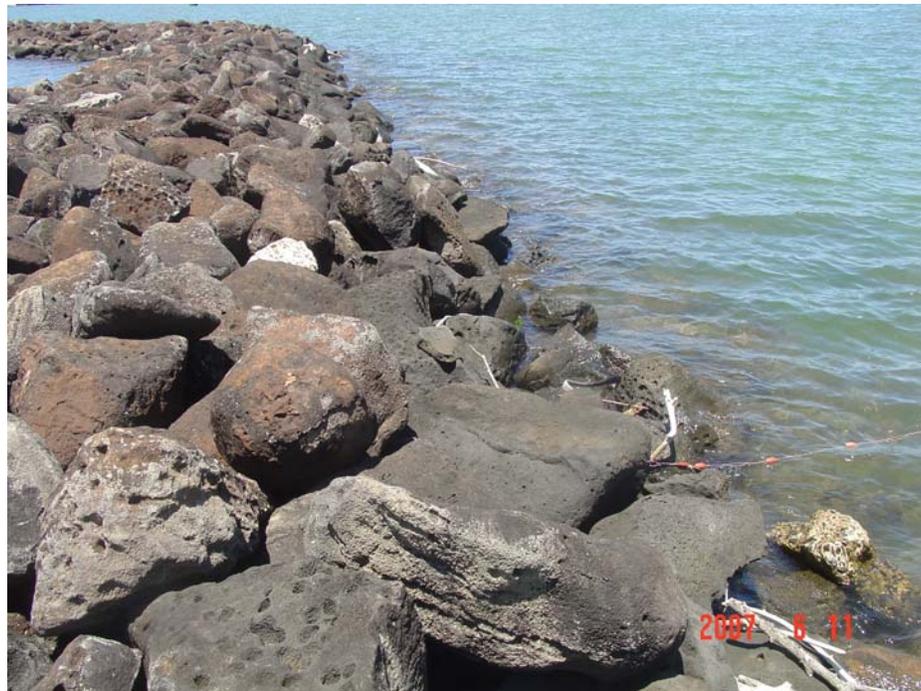
q. Sta. 20+27, OS, scalloped toe area.

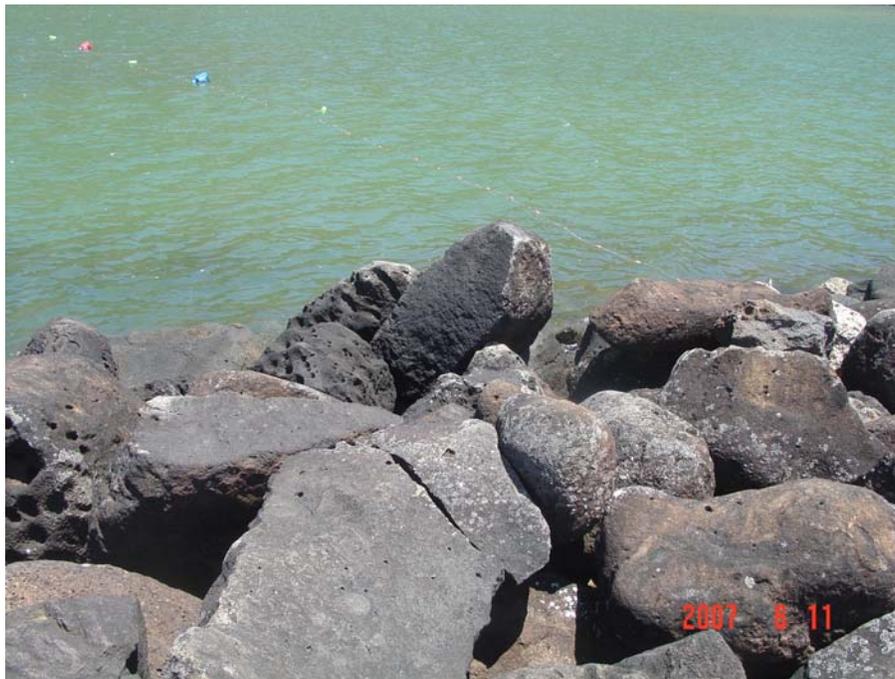
r. Sta. 20+30, OS, cracked armor stone.

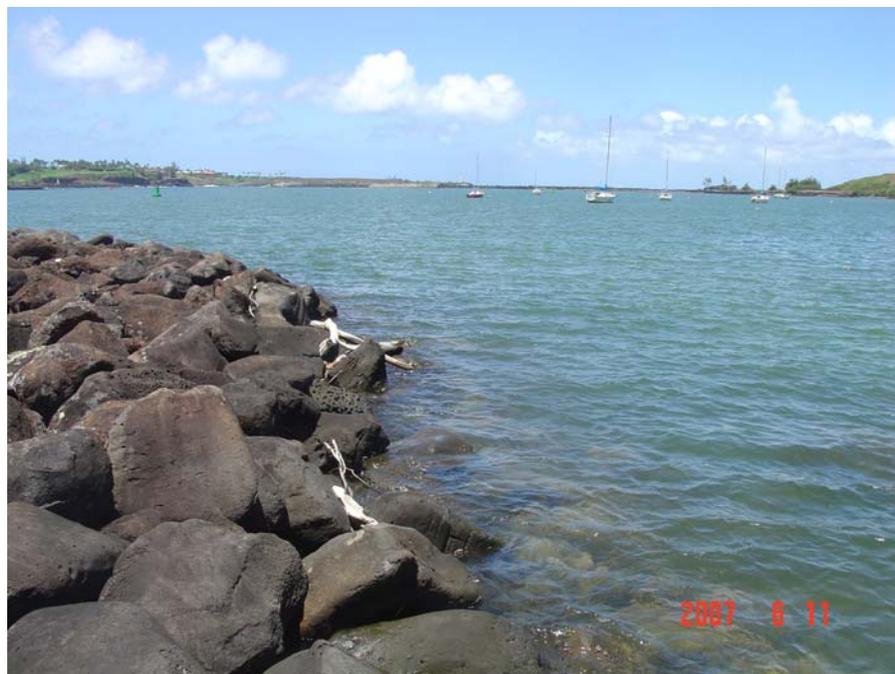
s. Sta. 21+34, OS, overview at second bend.

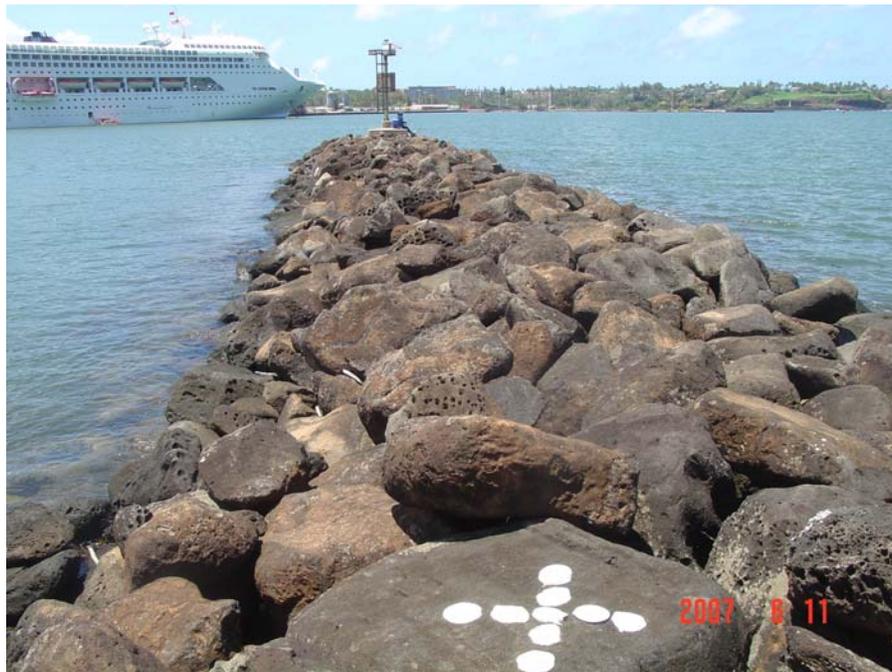
t. Sta. 21+34, Crest, maker "X" at 2<sup>nd</sup> bend.

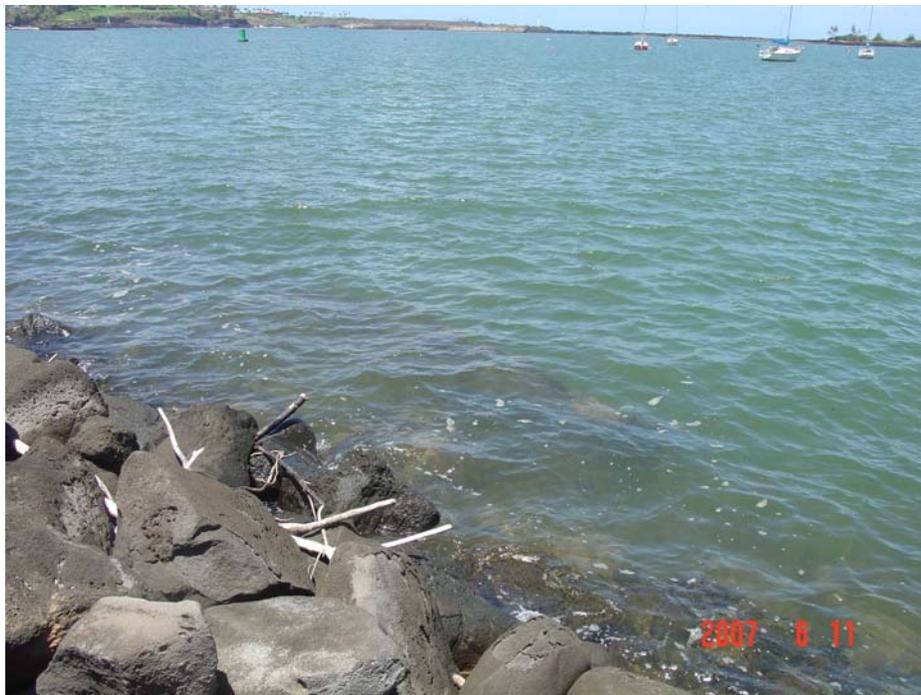
u. Sta. 21+89, OS, sunken boat at toe of structure. No problem.

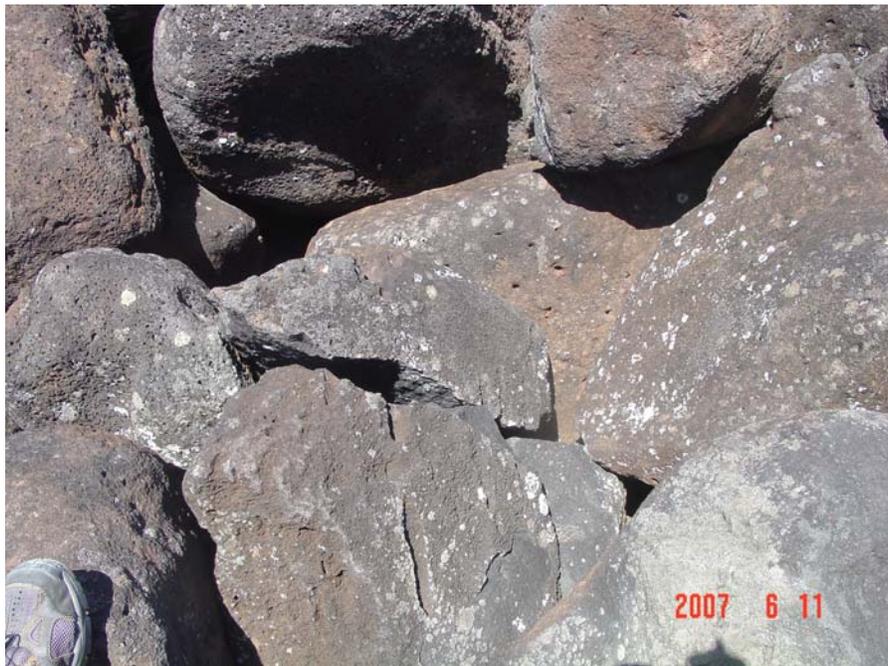
v. Sta. 22+50, CL cracked armor stone.

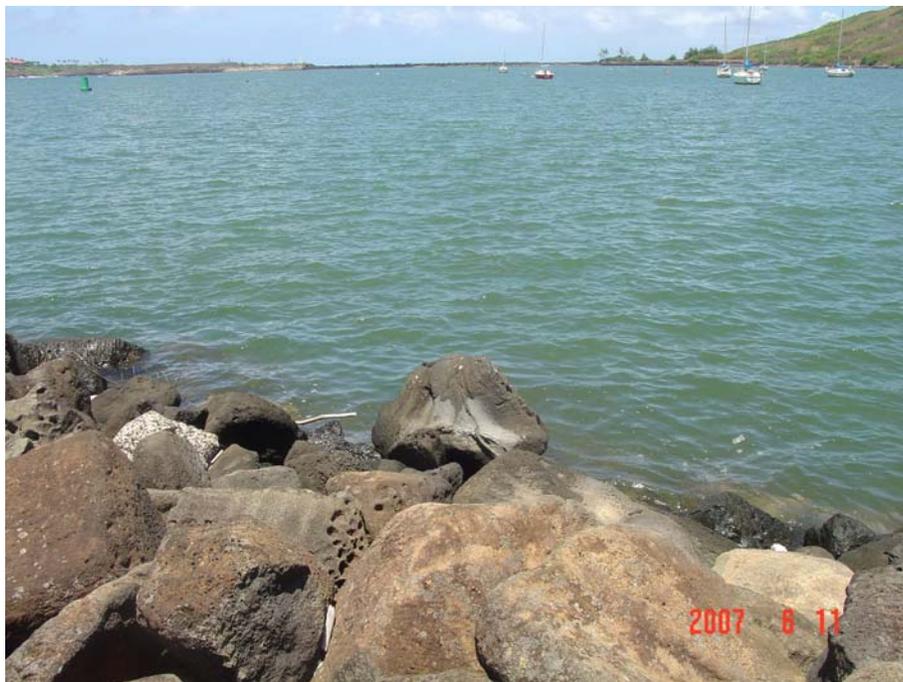
x. Sta. 22+56, OS, monitor scalloped and dislodged armor stone.

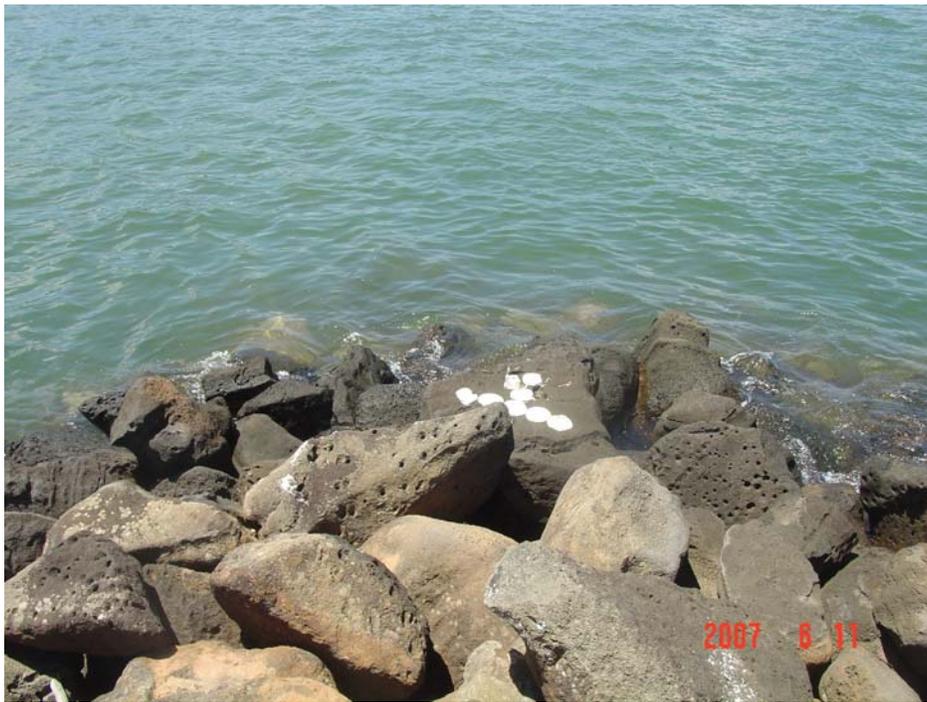
y. Sta. 22+83, head and aerial survey cross, no change since last inspection.

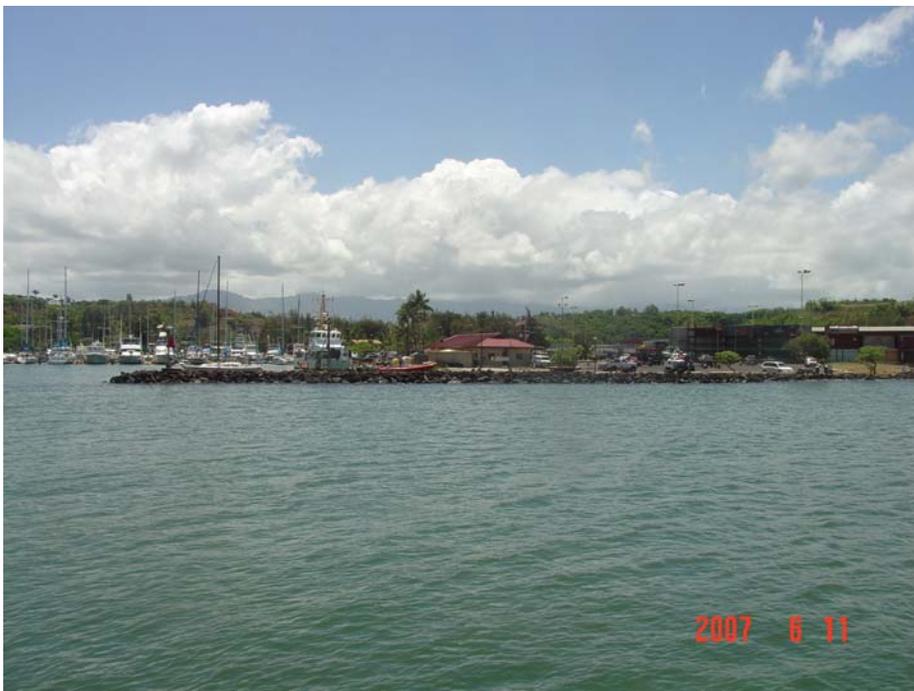
z. Stub Breakwater overview.

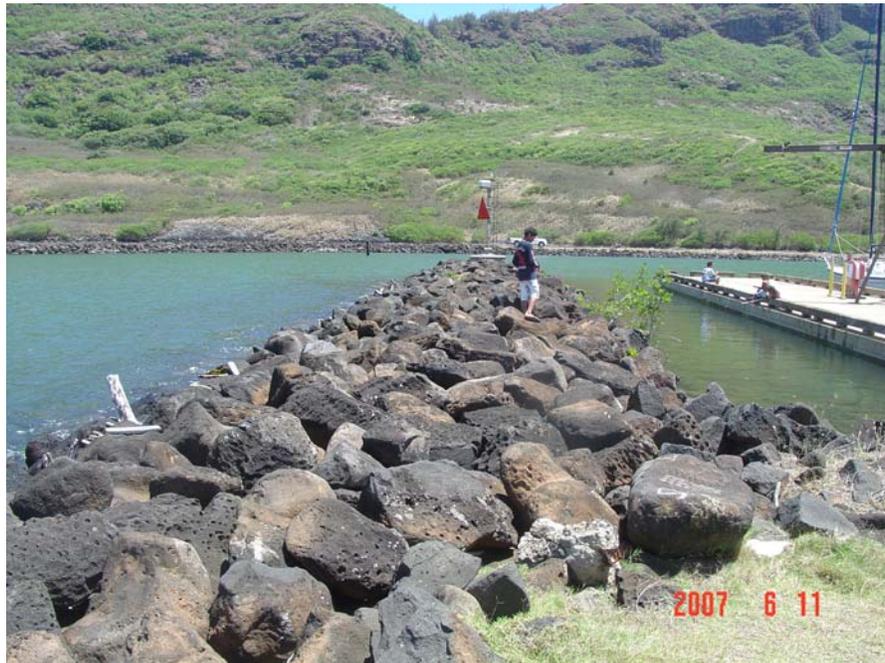
aa. Sta. 3+92, overview of stub breakwater.

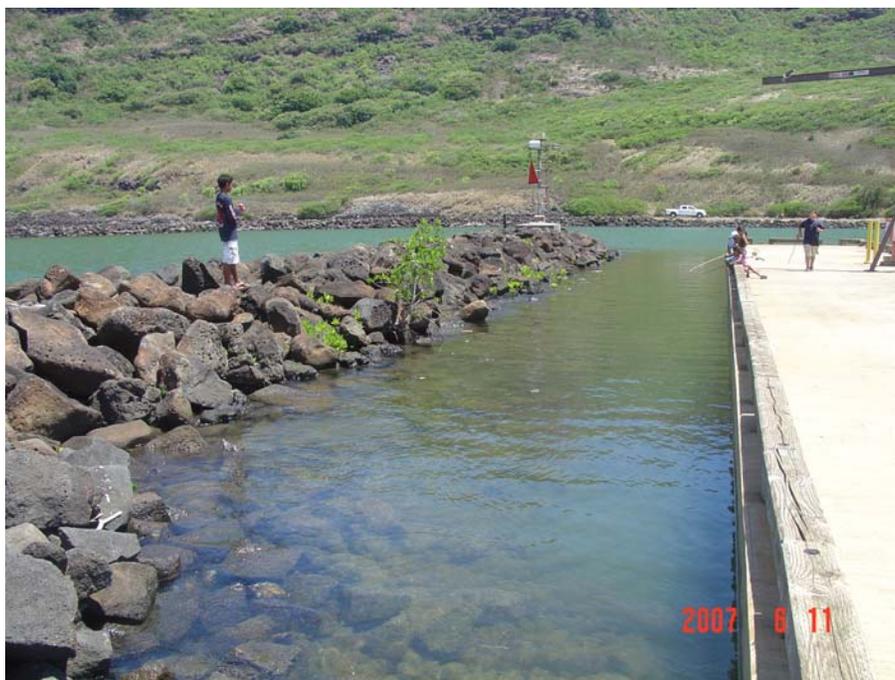
bb. Sta. 4+86, HS, monitor movement of various 100# armor stones slight settling at hinge.

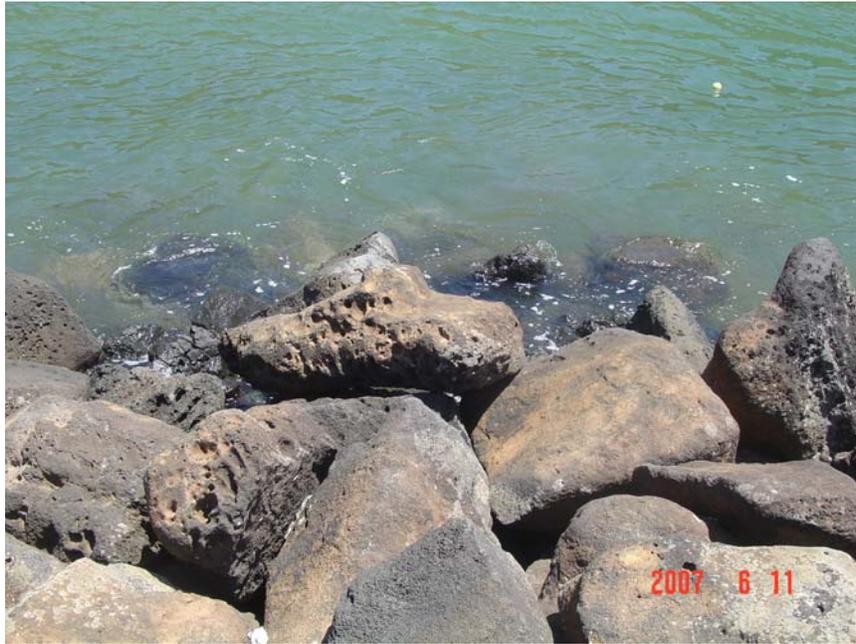
cc. Sta. 5+36, Overview of head.

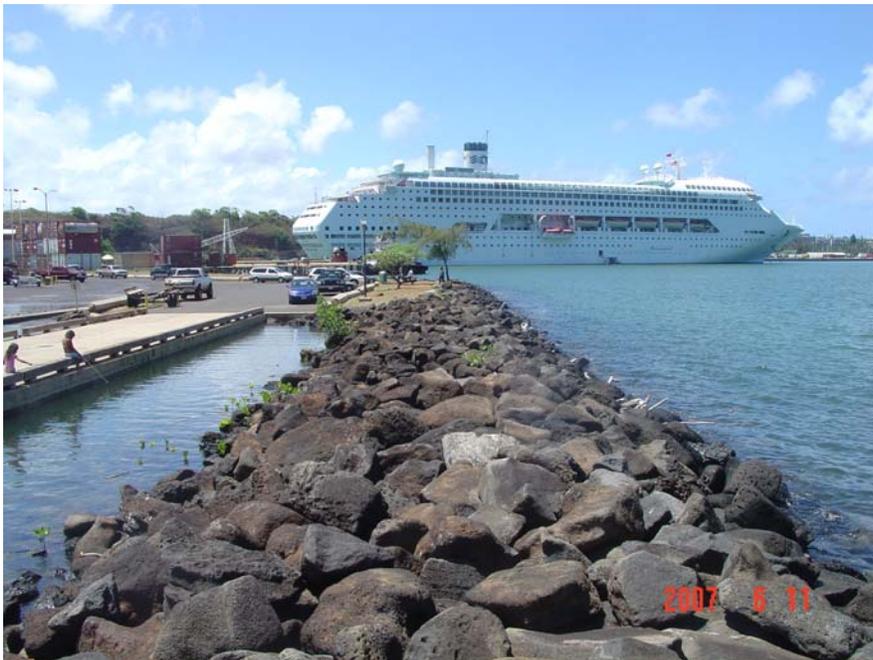
dd. Sta. 5+36, OS, Overview.
