1. Project Name: Kihei Beach SPP

2. Date of Inspection: January 13, 2005

CONTINUING ELIGIBILITY INSPECTION (CEI) REPORT
FOR HURRICANE & SHORE PROTECTION PROJECTS

KIHEI BEACH, MAUI, HAWAII

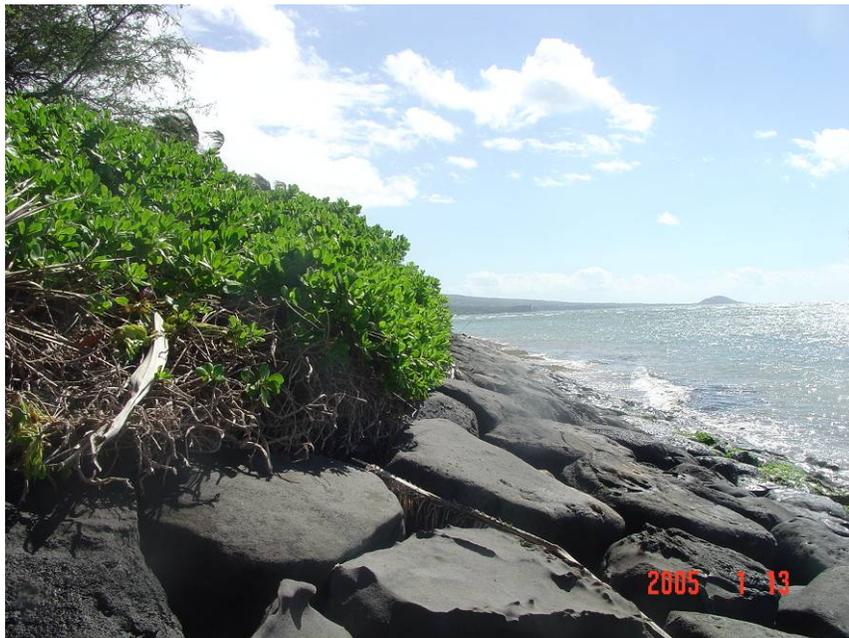
a. Sta. 0+70 to Sta. 0+90, Continue to remove the vegetation from crest and sideslope.

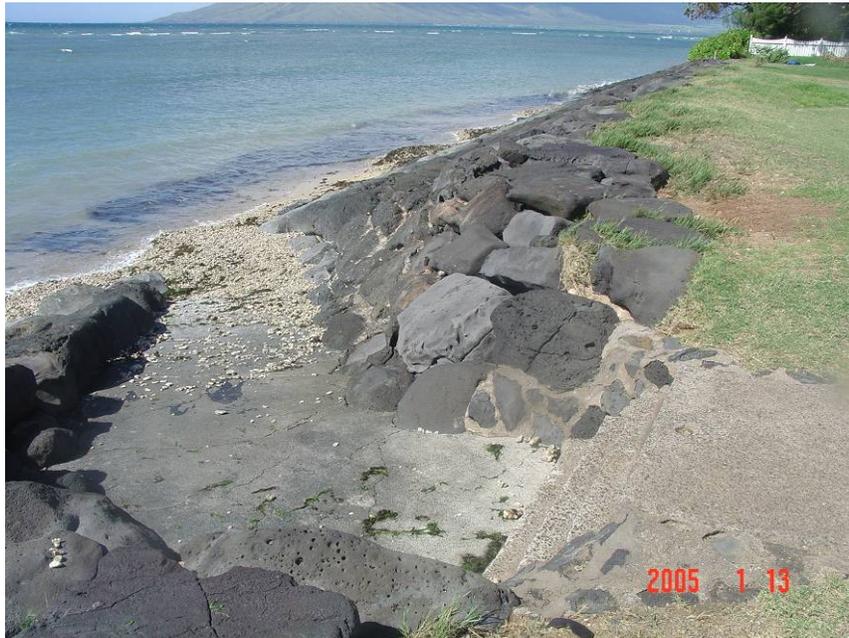
b. Sta. 3+00, 1st Repair cracked access walkway.

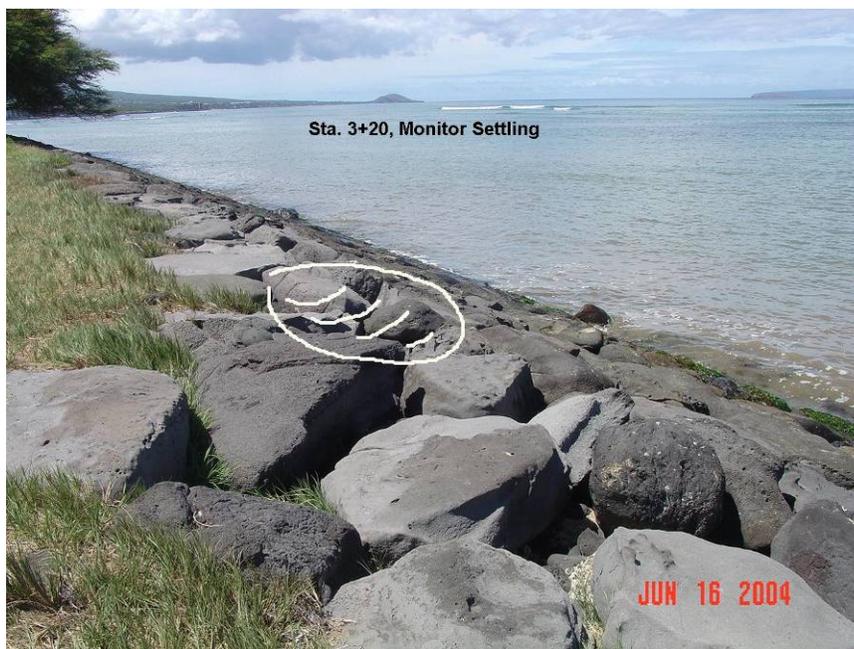
c. Sta. 3+20, Monitor minor settling at hinge. No Change since FY04. FY04 Photo

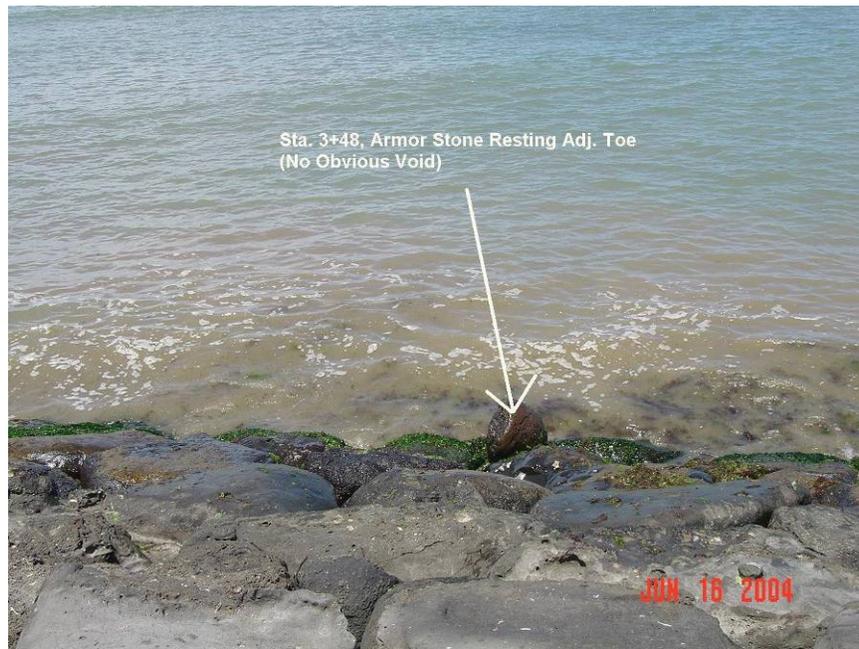
- d. Sta. 3+48, Monitor the armor stone resting adjacent the toe. NO change this year. No obvious voids. No Change since FY04. FY04 Photo

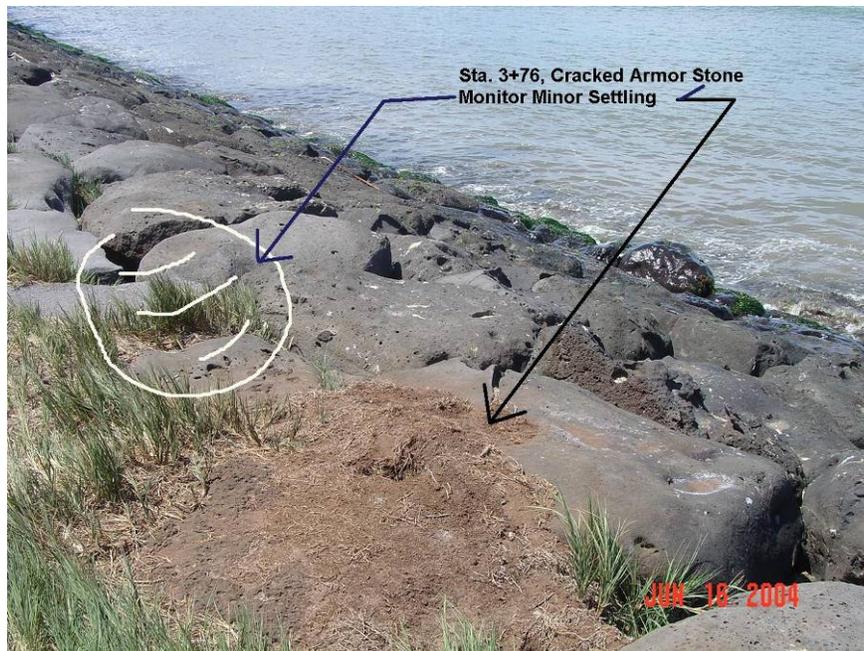
- e. Sta. 3+76, Monitor the area adjacent to cracked armor stone for settling. No Change since FY03. FY04 Photo

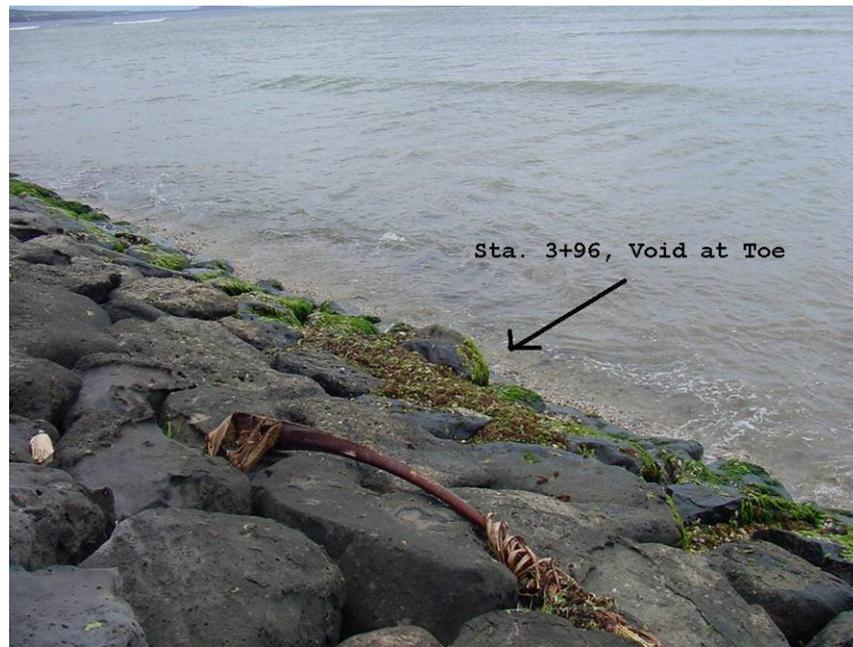
f. Sta. 3+96, 1 ea. Displaced armor stone, void at toe. Monitor Sideslope. FY04 Photo

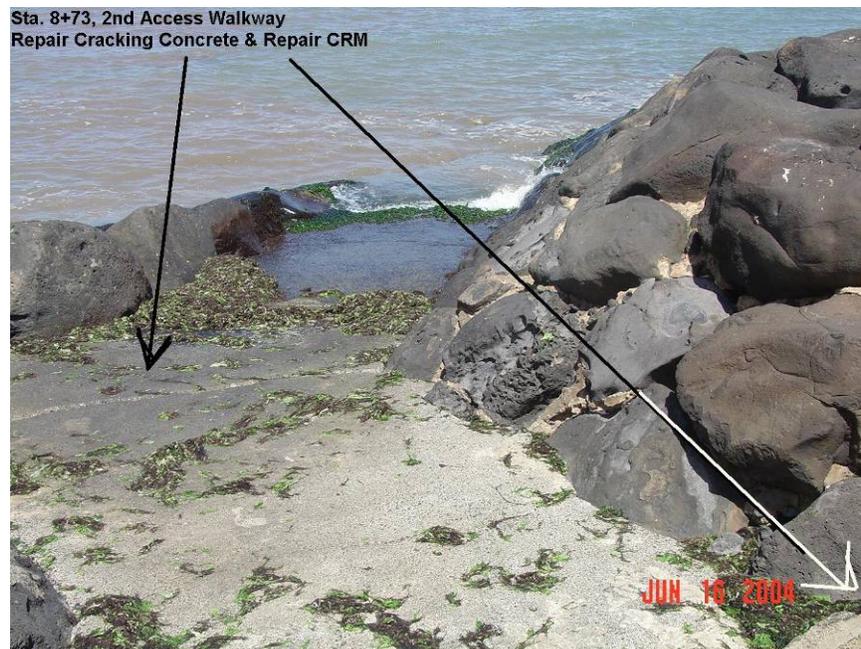
g. Sta. 8+73, 2nd Walkway, repair cracking concrete and CRM. FY04 Photo

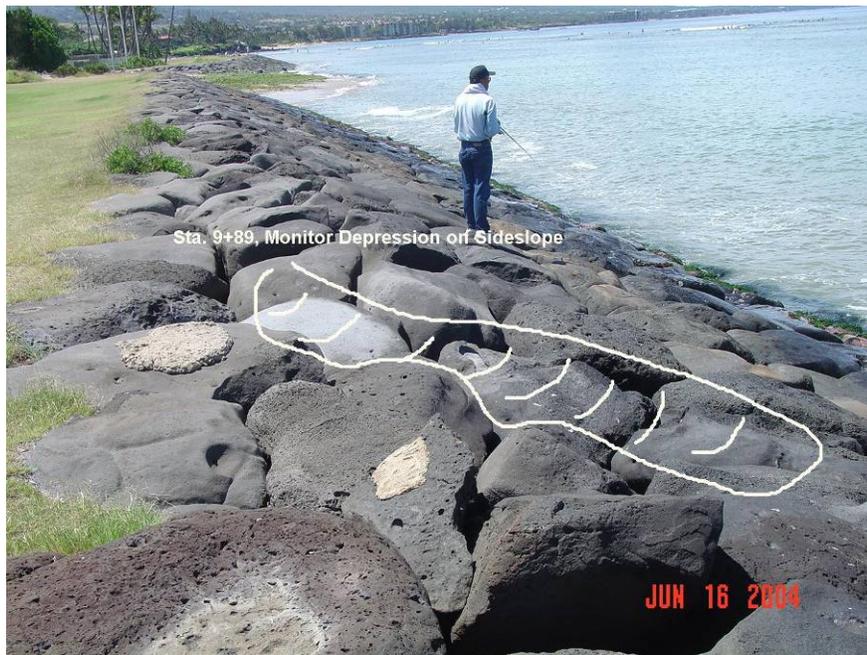
- h. Sta. 9+89, Monitor the depressed area on sideslope. No Change since FY04. FY04 Photo

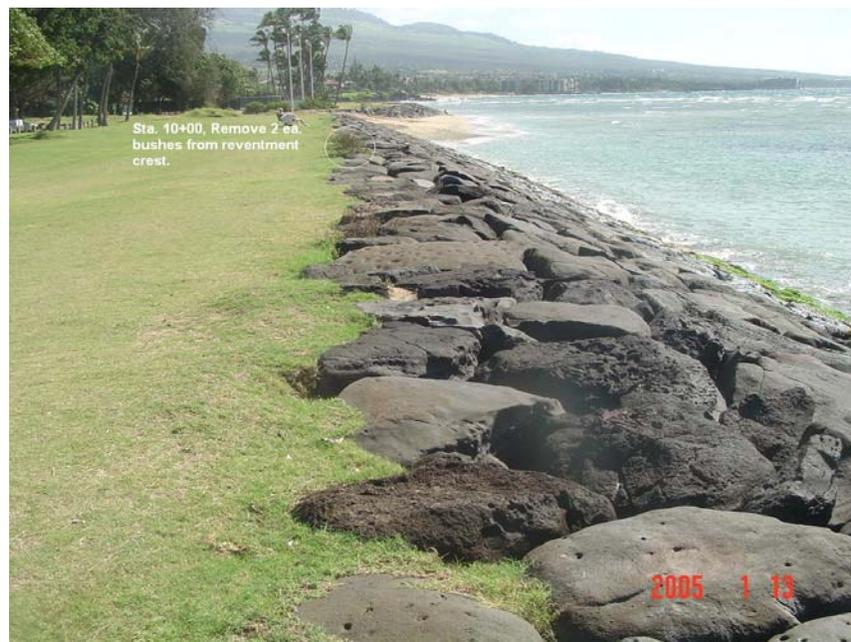
- i. Sta. 10+00, Applied Herbicide has not yet taken full effect.

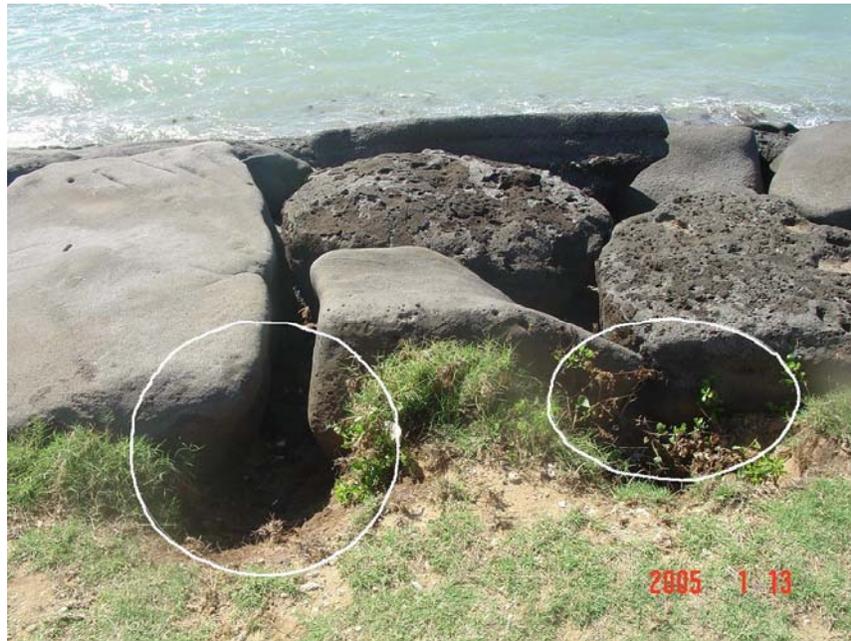
j. Sta. 11+00 Add fill material to eroded area.

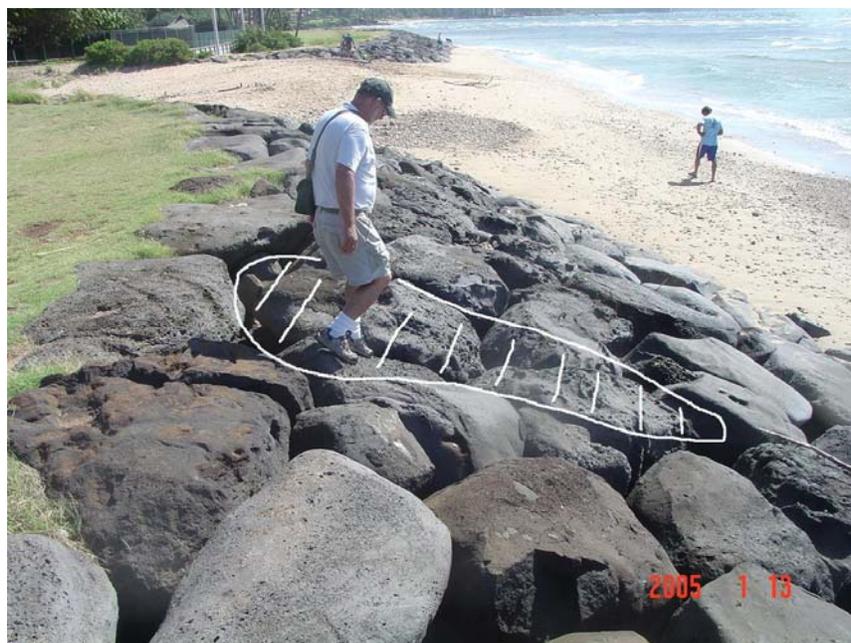
k. Sta. 12+88, Monitor sideslope settling. No change since FY03.

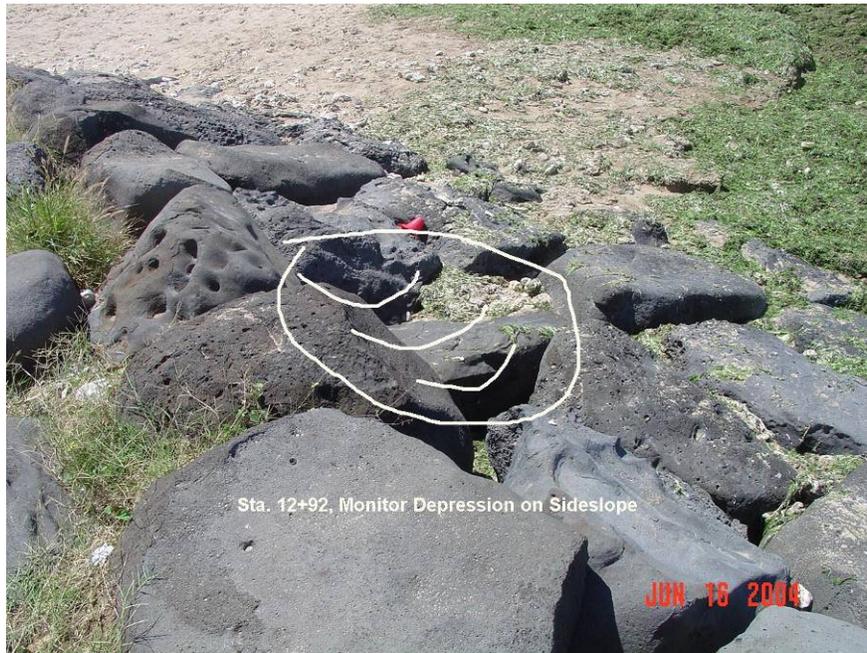
- l. Sta. 12+92, Monitor the depressed area on sideslope. No change since FY03. FY04 Photo

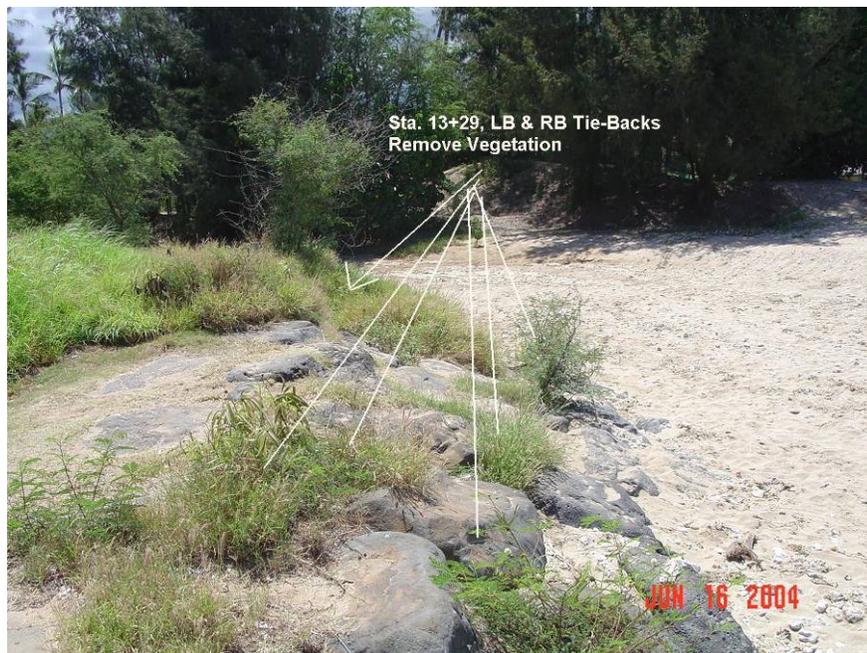
- m. Sta. 13+29, No Change since FY04. Remove vegetation from revetment. FY04 Photo

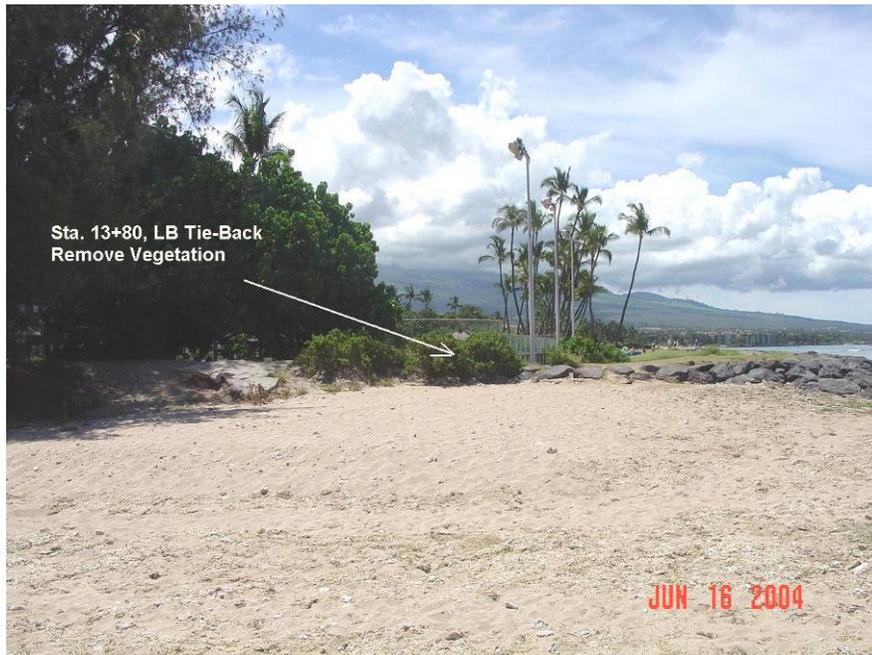
n. Sta. 13+80, No Change since FY04. Remove the vegetation from revetment . FY04 Photo

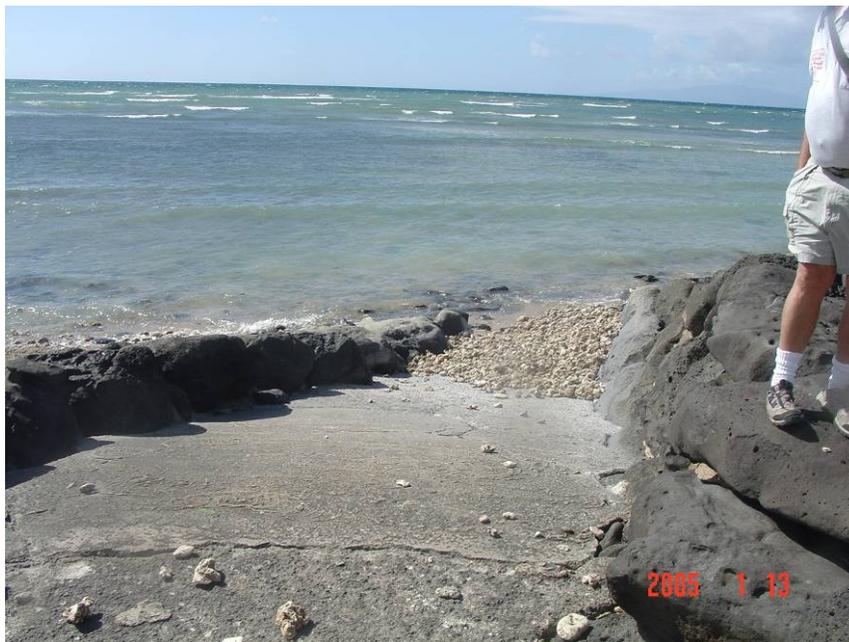
o. Sta. 23+11, 3rd Walkway has been repaired.

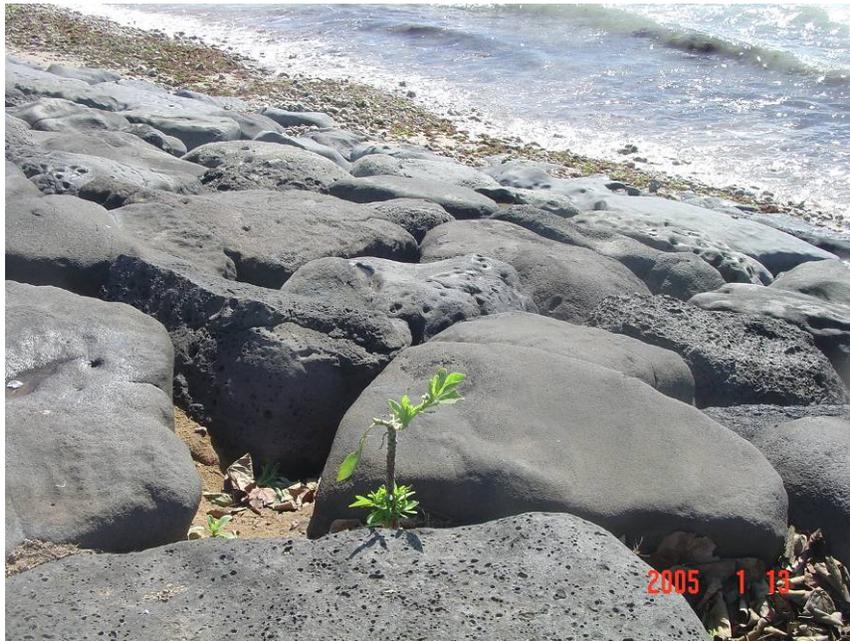
p. Remove juvenile vegetation from reventment. Typical.

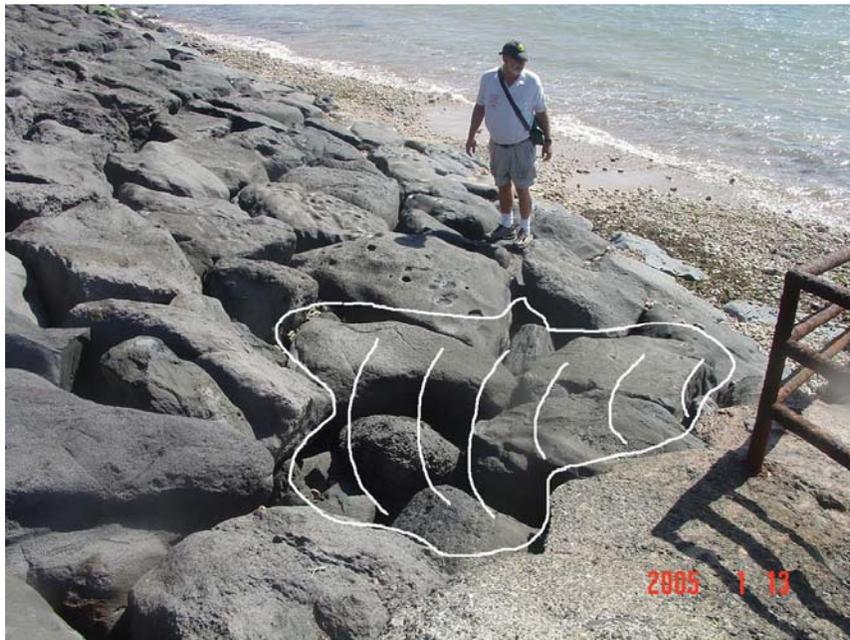
q. Sta. 23+75, Monitor the sideslope settling on the southside of the culvert.
No change since FY03.

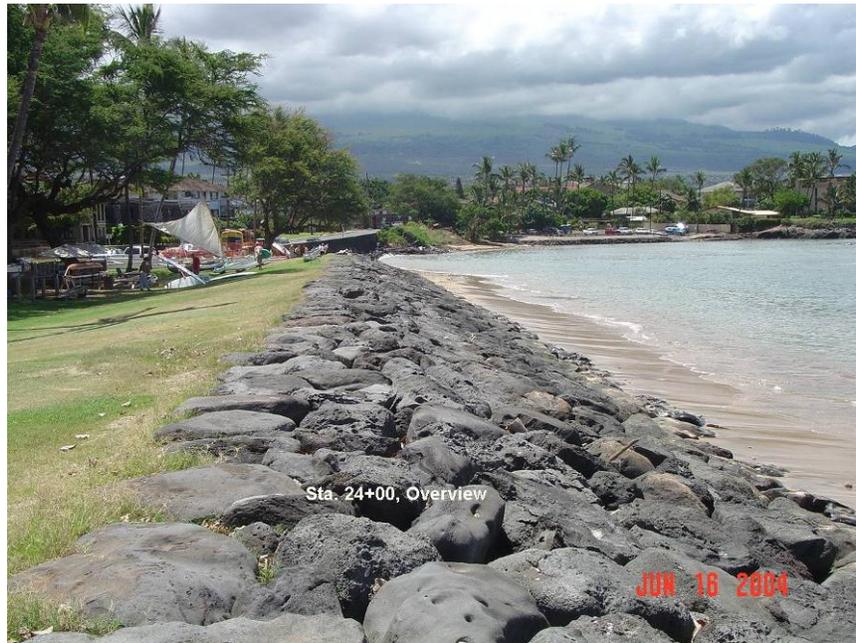
- r. Sta. 24+00, Overview, photo for reference. FY04 Photo
- s. Sta. 25+14, Monitor area for settling.
- t. Sta. 26+06, Monitor sideslope settling in this area.
