## CONTINUING ELIGIBILITY INSPECTION (CEI) REPORT

FOR FLOOD CONTROL WORKS

Honolulu Engineer District

1. Project Name: Iao Stream FCP
2. Date of Inspection: October 30, 2007
3. Inspection Personnel:

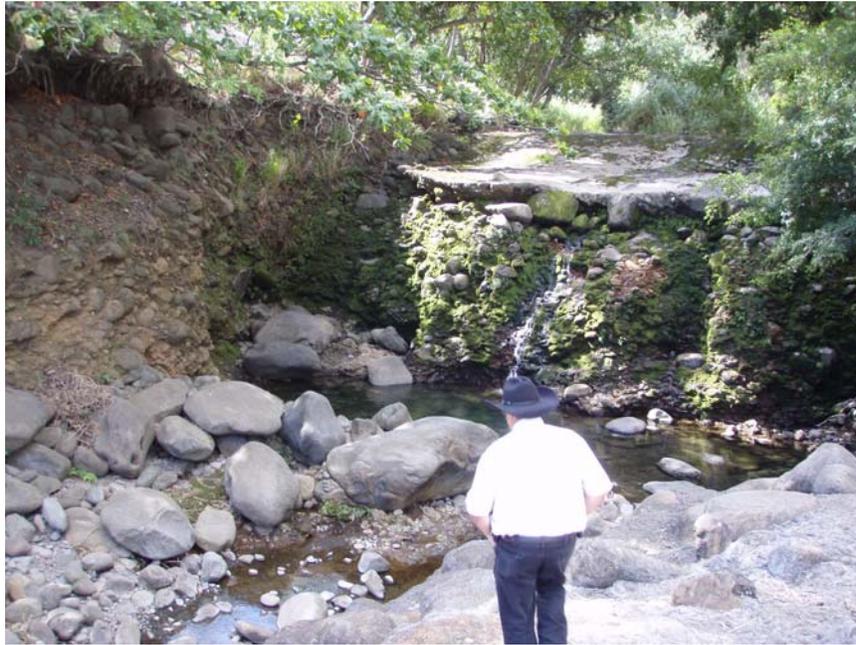
a. Sta. 135+00, Left Bank (LB), upstream of the debris basin, overview of the grouted rock slope protection.

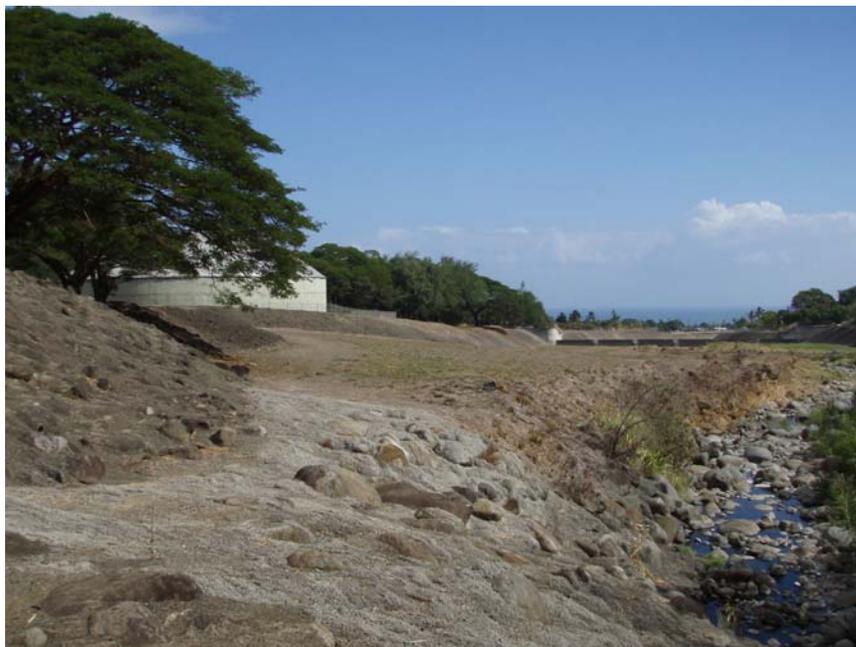
b. Sta. 130+50, LB, Overview of Levee I.

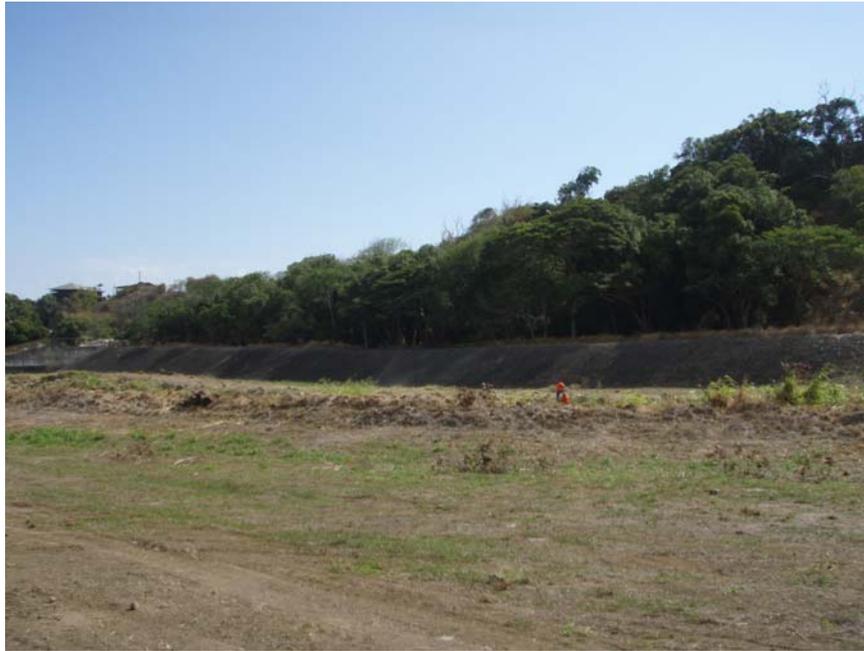
c. Sta. 133+00, Right Bank (RB), vegetation removed from sideslope.

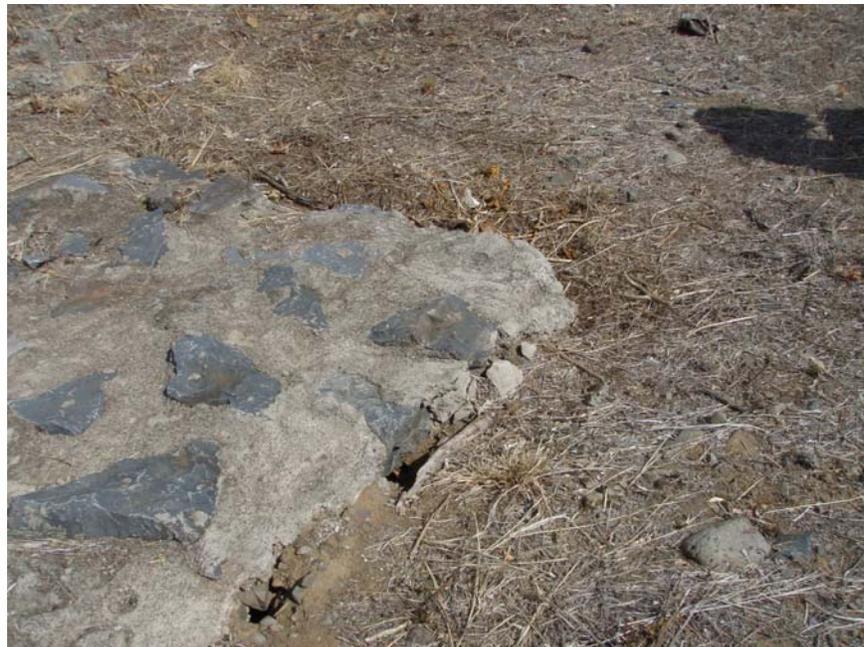
d. Sta. 133+00, LB, add fill material adjacent to splash apron.

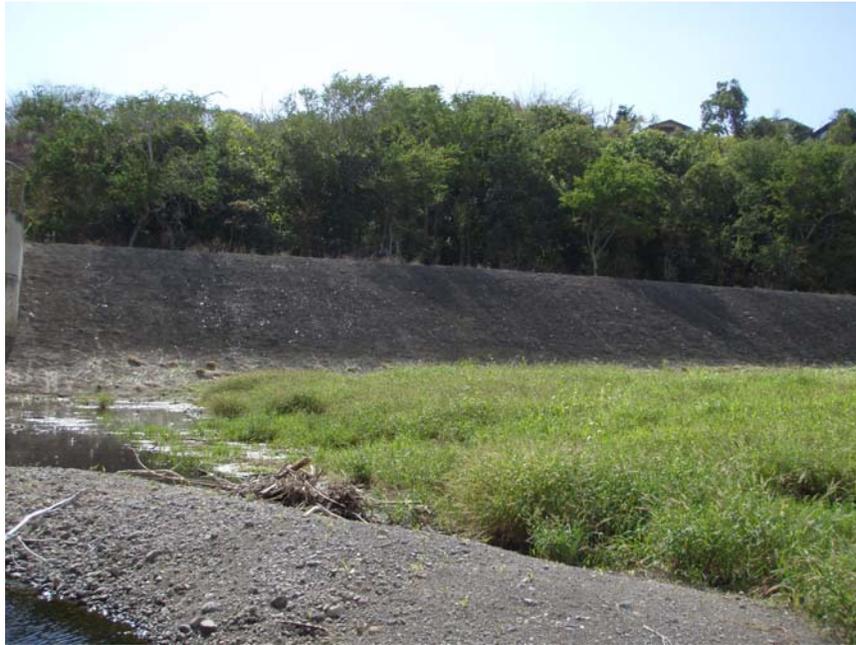
e. Sta. 127+00, RB, remove vegetation and material from debris basin.

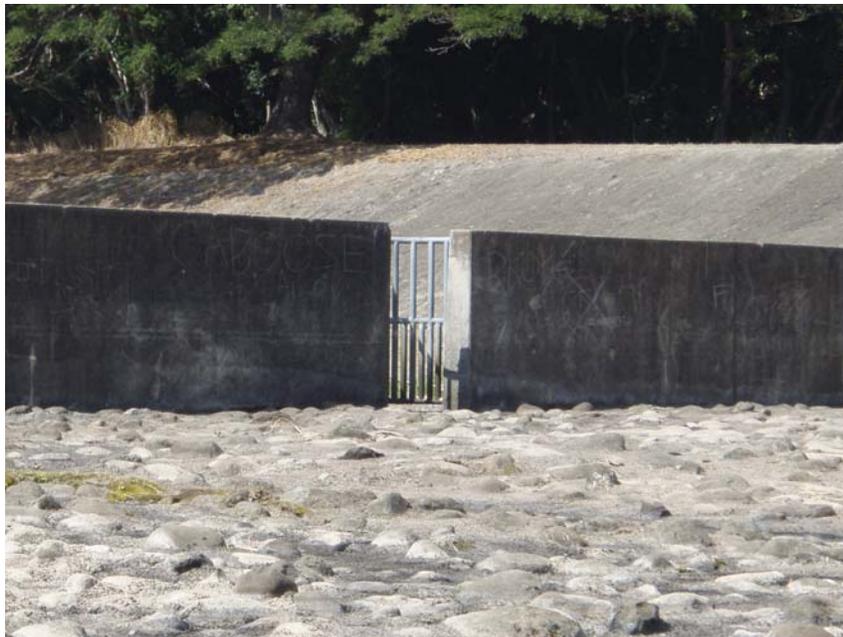
f. Sta. 127+00, repair broken pipes in debris gates.

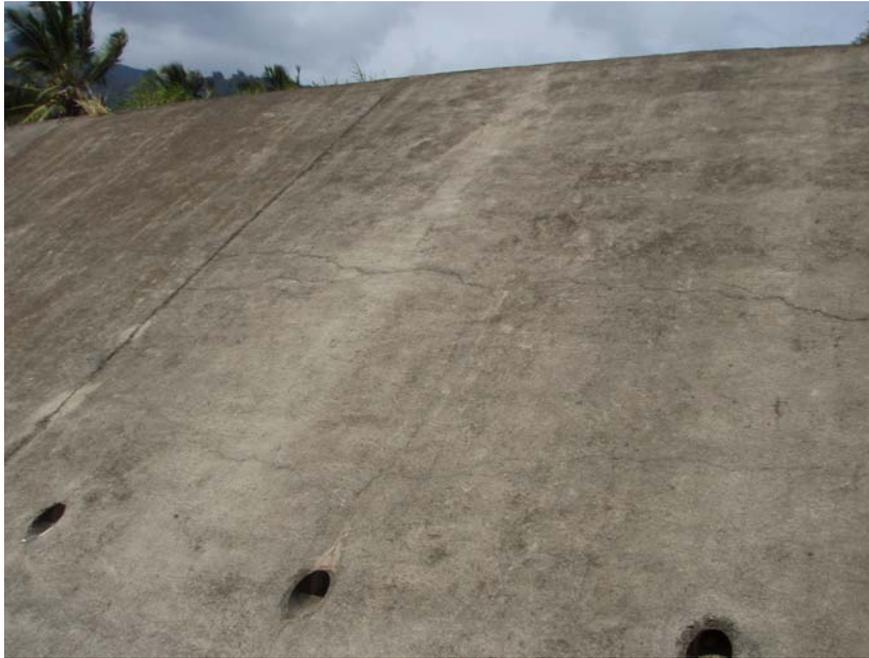
g. Sta. 121+00, LB, Overview of levee, monitor surface cracks in sideslope.

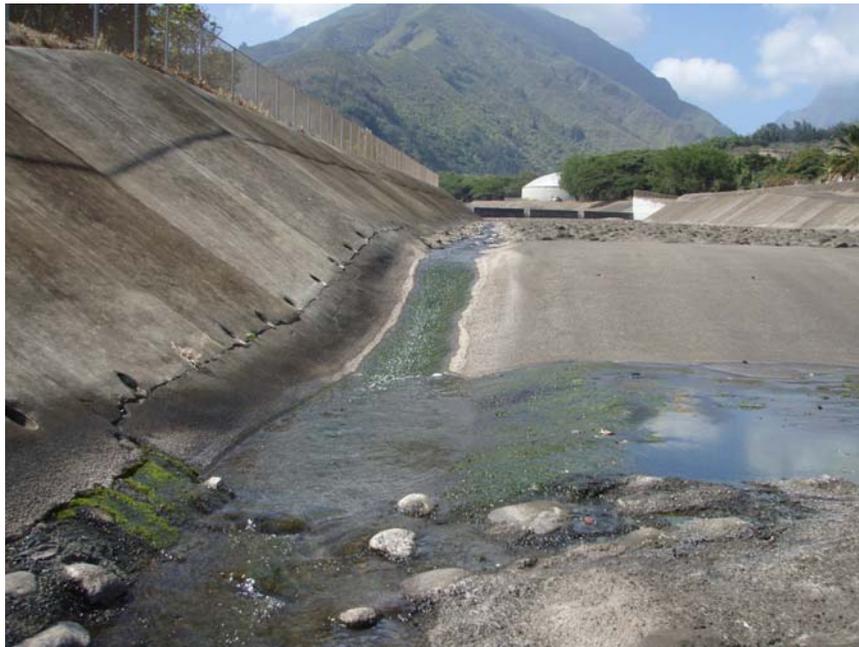
h. Sta. 119+00, RB, repair joints and seal exposed rebar at the toe of the sideslope.

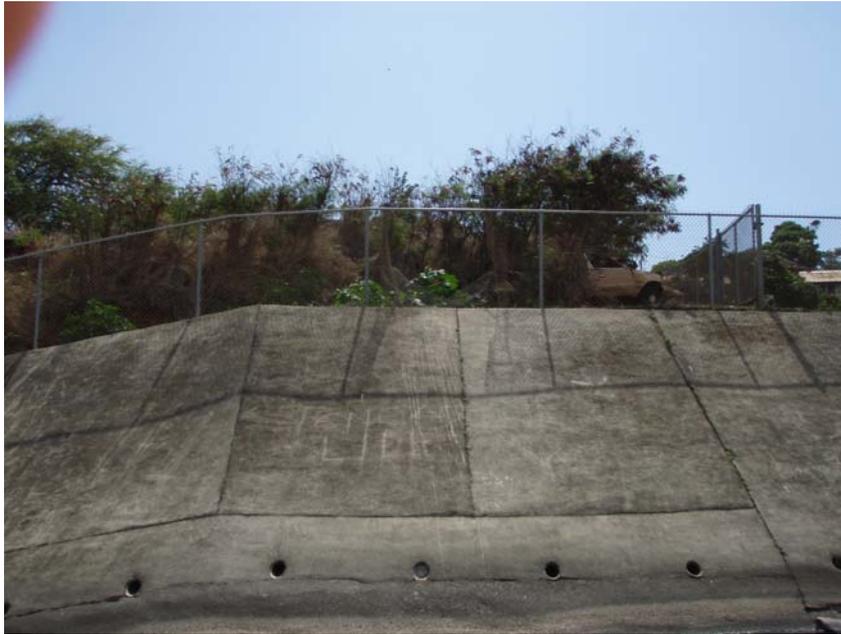
- i. Sta. 114+40, repair 2 ea. holes in fence.

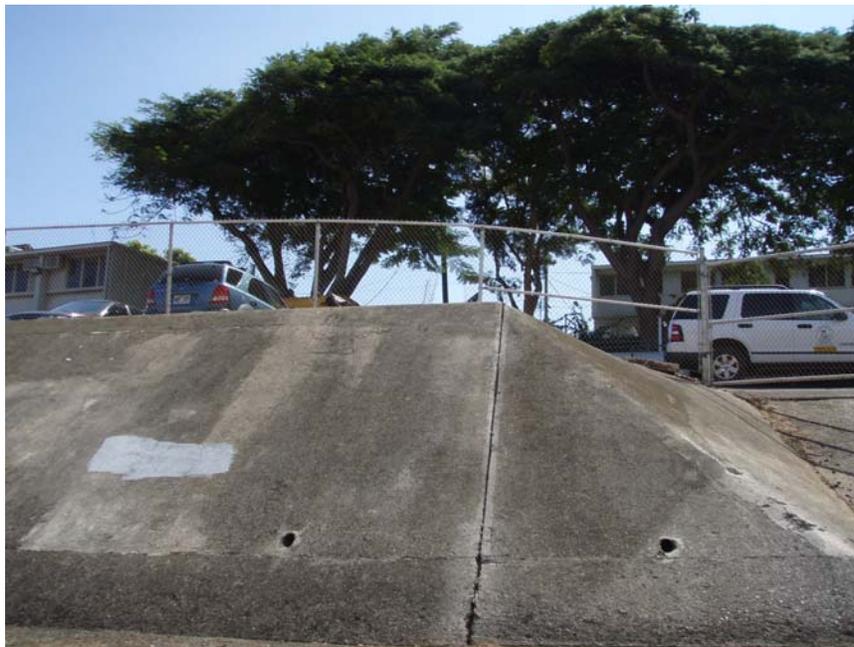
- j. Sta. 105+00, RB, repair fence.

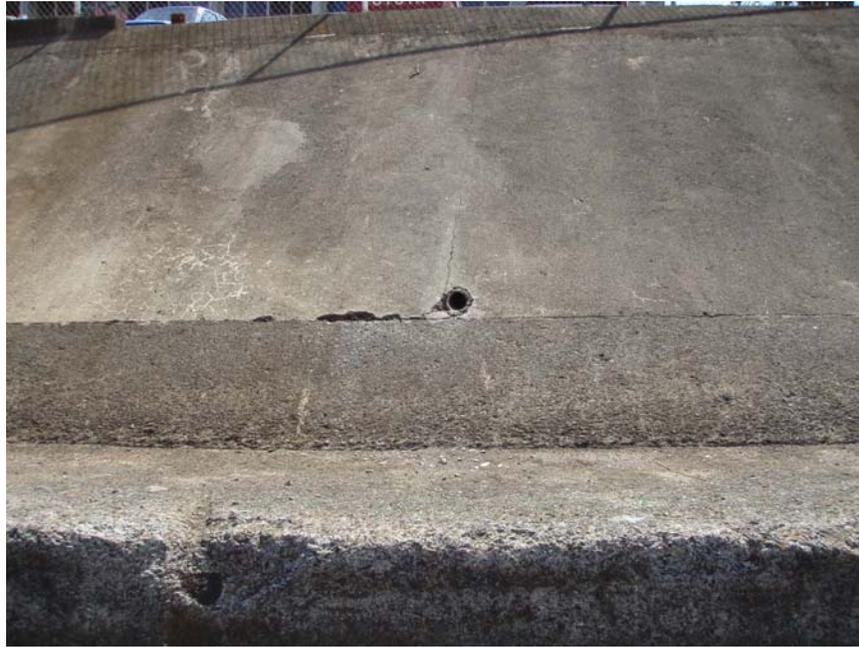
- k. Sta. 104+96, repair hole on face of drop structure.

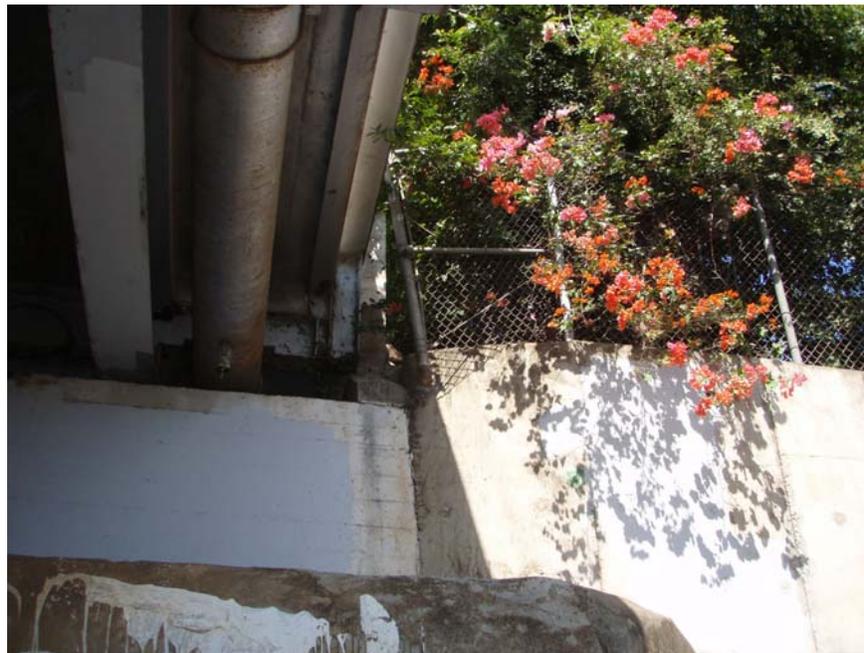
- l. Sta. 100+00, LB, repair concrete and re-install fence.

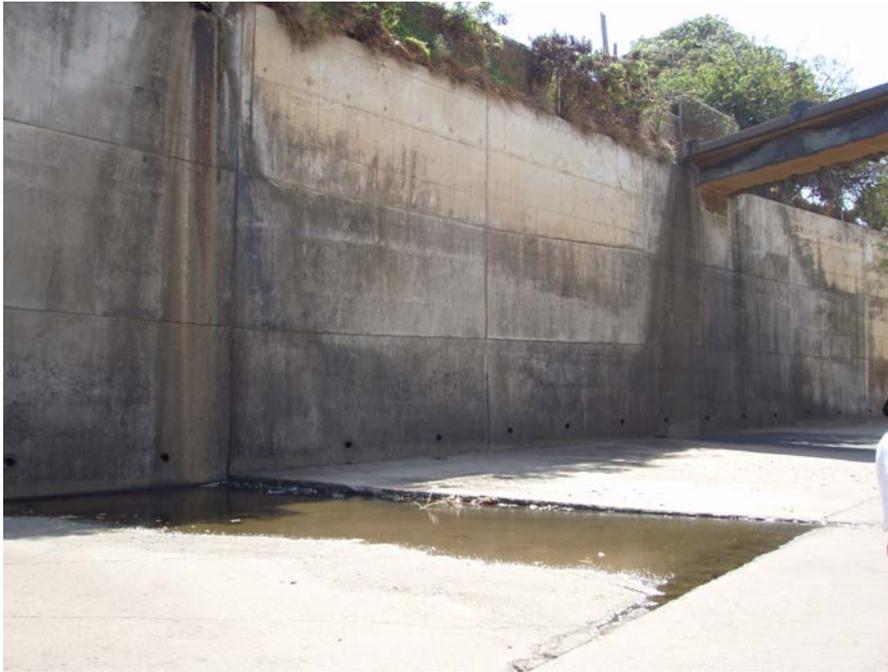
m. Sta. 93+25, RB-side of invert, repair invert and re-establish maintenance right-of-way, behind fence.

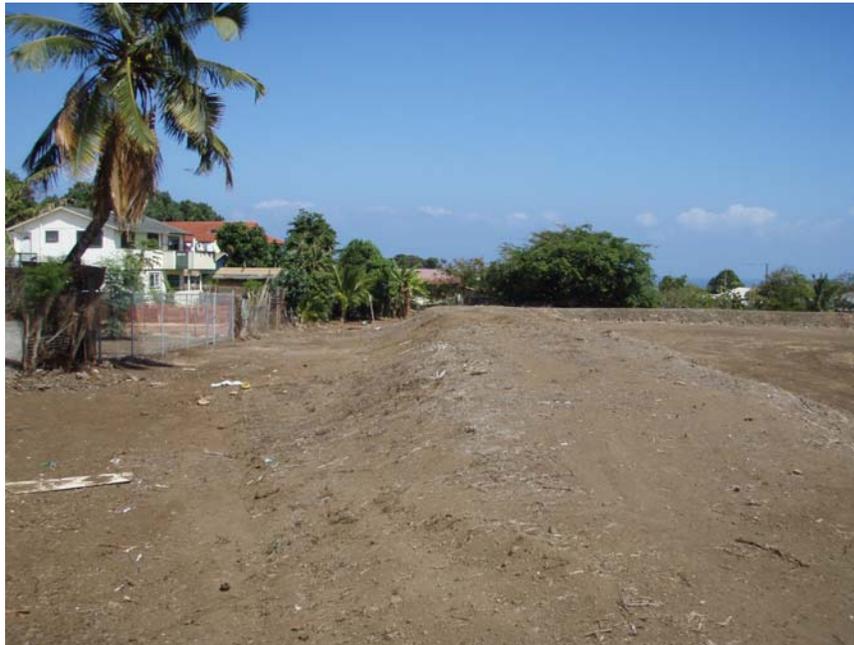
n. Sta. 87+50, LB side of stream, woody vegetation cleared and unauthorized structure removed, establish ground covering.

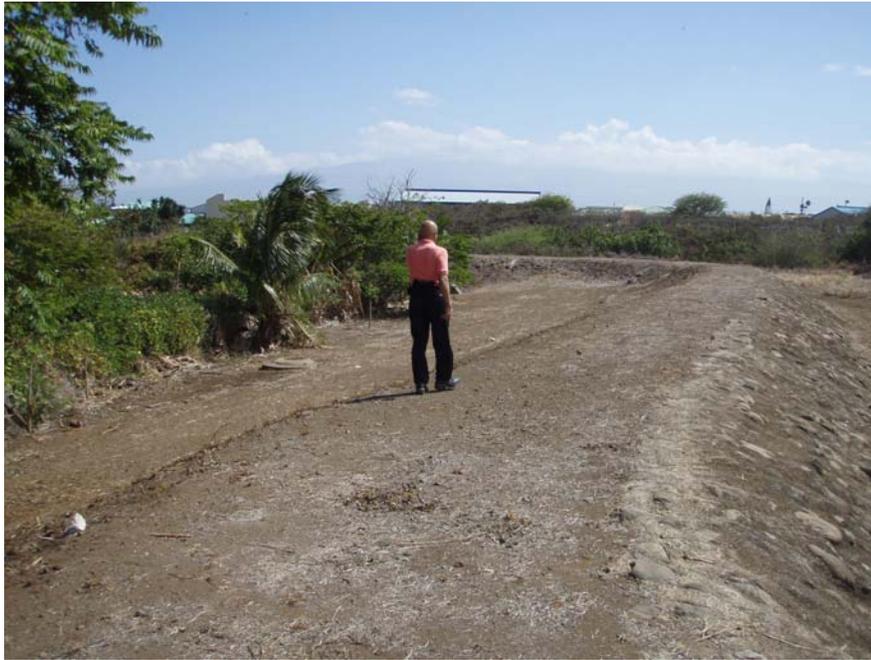
o. Sta. 87+00, trees removed from interior sideslope.

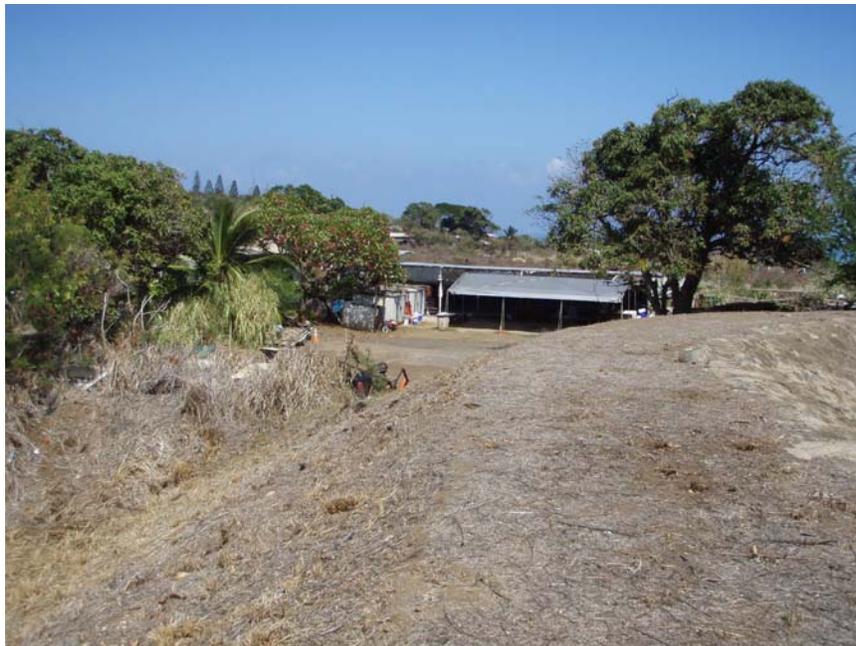
p. Sta. 86+00, remove debris stockpile from town side of levee.

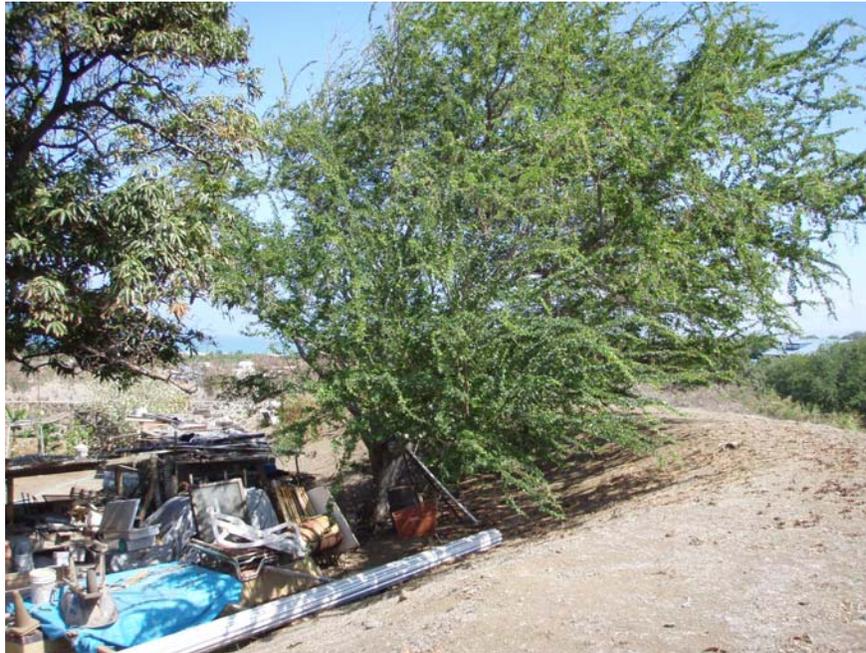
q. Sta. 84+00, LB, remove tree and stockpile of material from town side of levee sideslope.

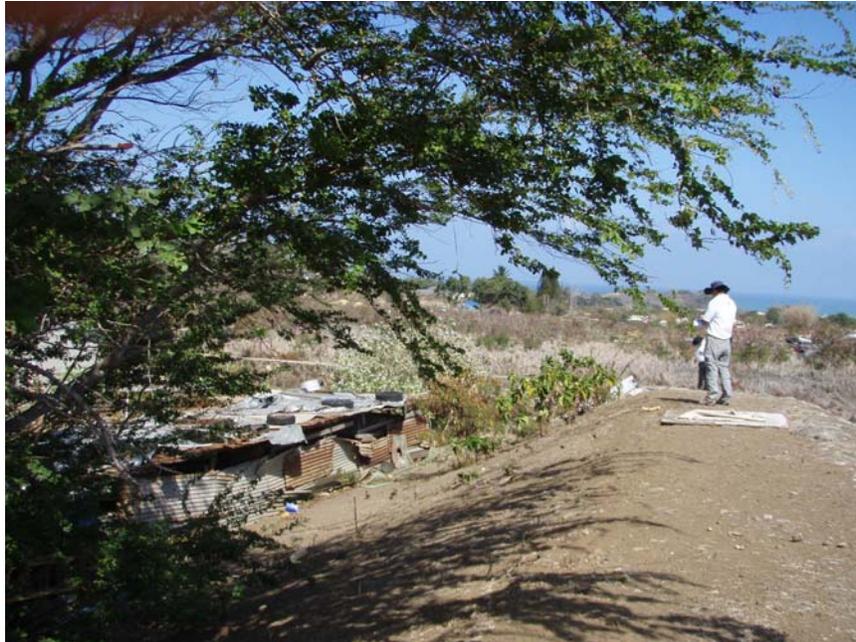
r. Sta. 80+00, RB, remove woody vegetation from levee sideslope and golfing platform from crest.

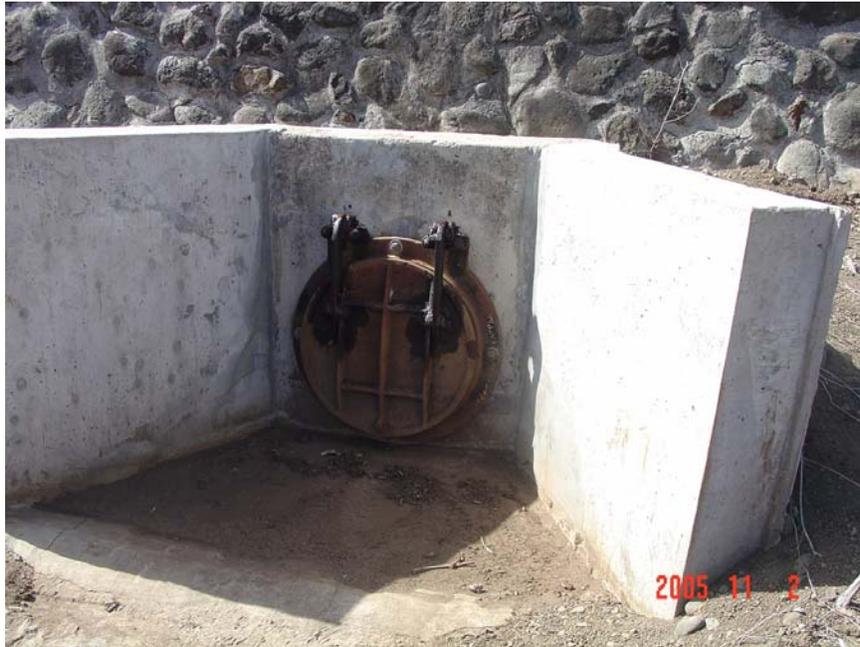
- o. Sta. 79+36, flapgate in good condition adjacent NRCS Channel.

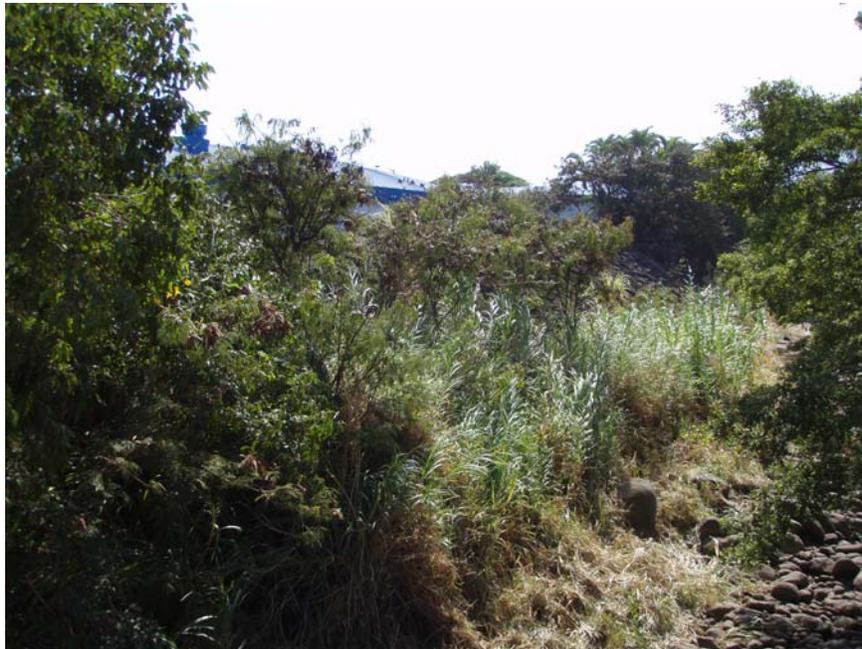
- p. Sideslope of levee, pending repairs, remove woody vegetation from structure and pack boulders at the toe to minimize further erosion.

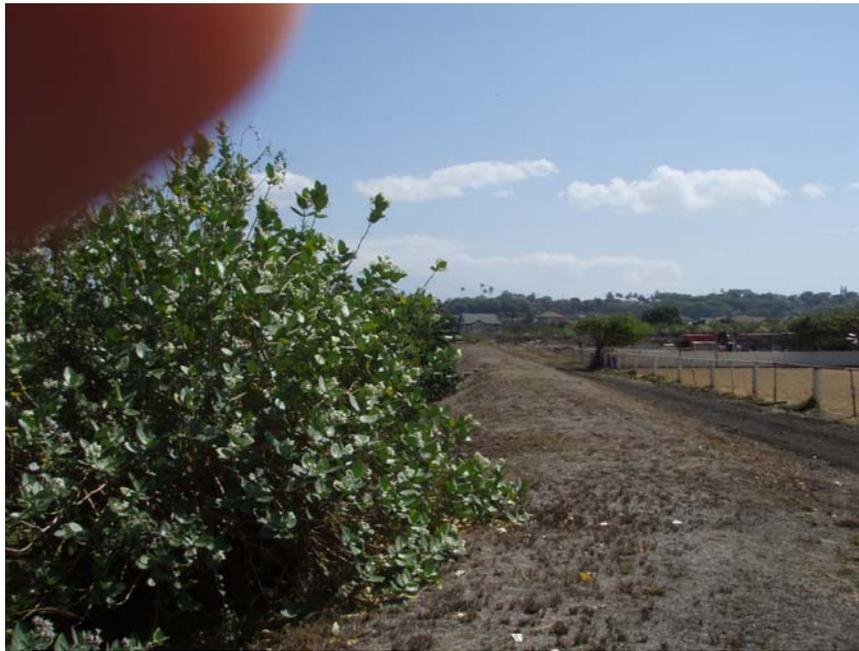
q. Overview, remove woody vegetation and encroachments (storage shed & stairs) from sideslope.

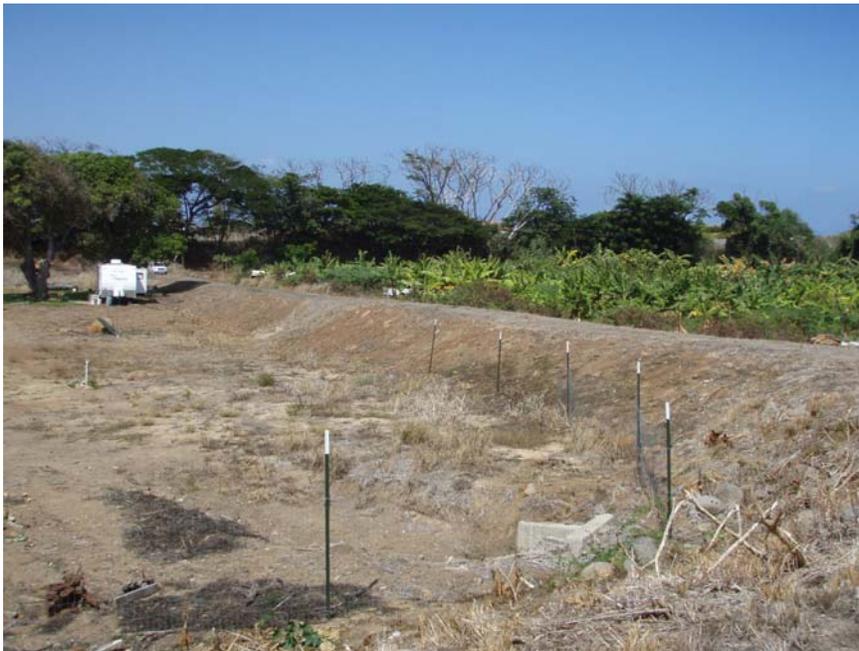
r. Overview, verify easement at toe of structure and remove fence post if within easement.

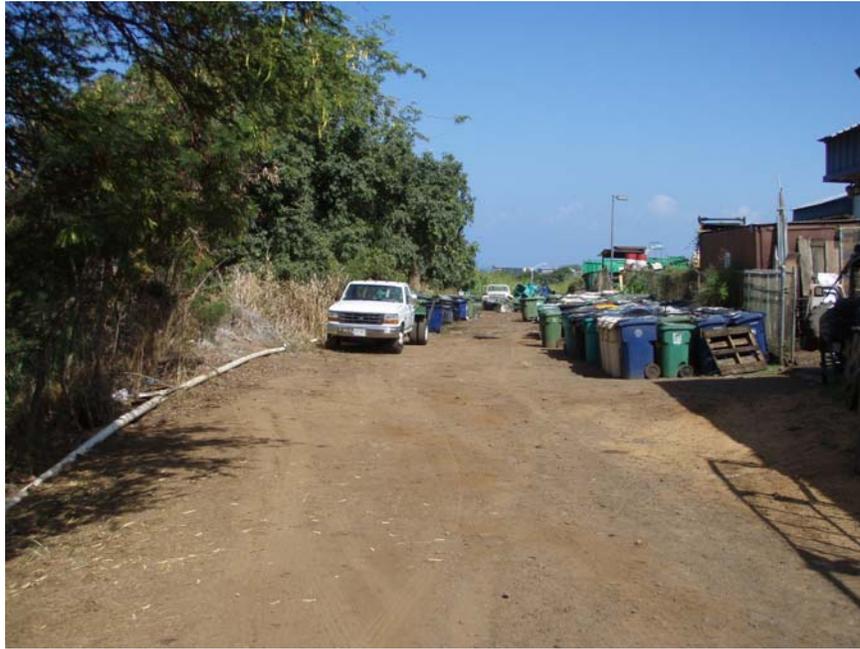
s. Survey and re-establish maintenance access road.

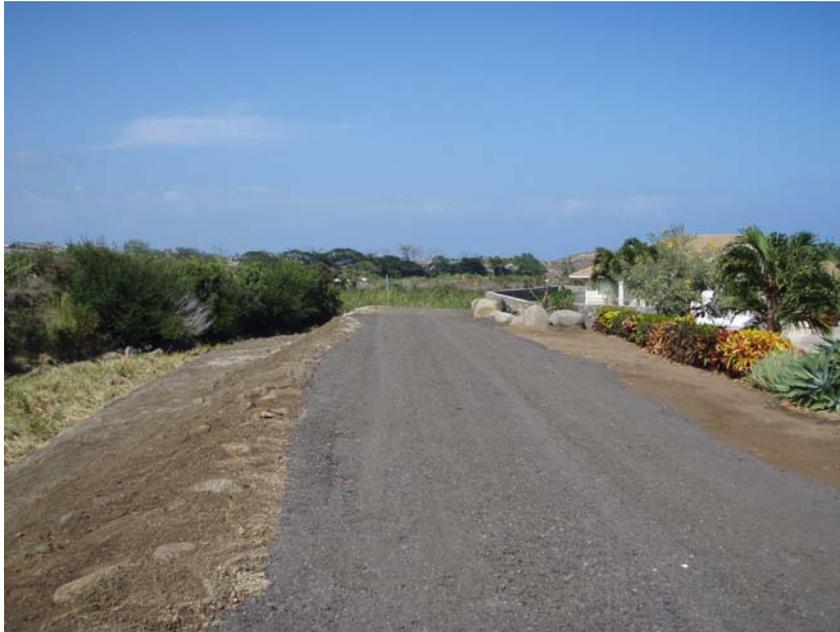
u. Levee "C", survey townside easement to verify maintenance access. Existing maintenance access road has been capped with crushed rock for dust control.

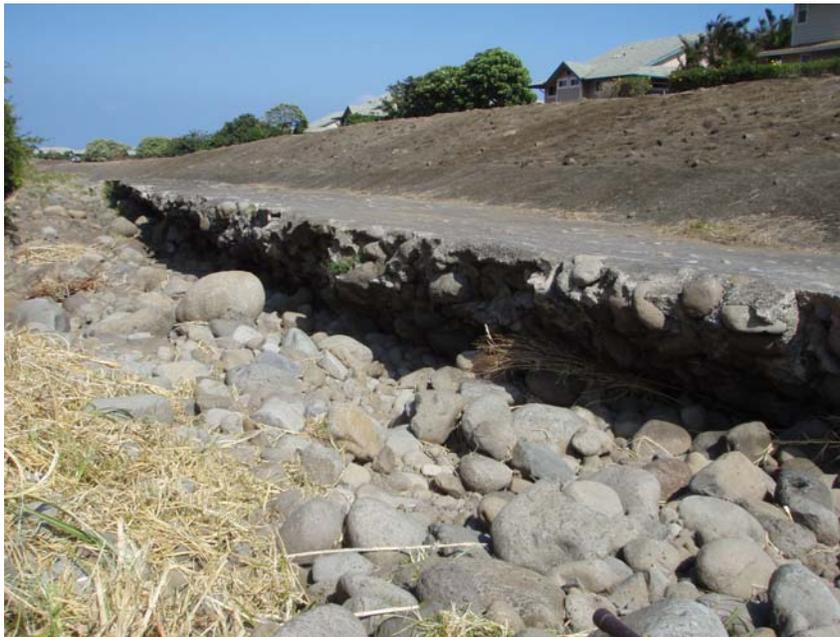
v. Toe of levee, RB, COE levee repairs pending, perform temporary repairs to minimize further erosion and undermining.

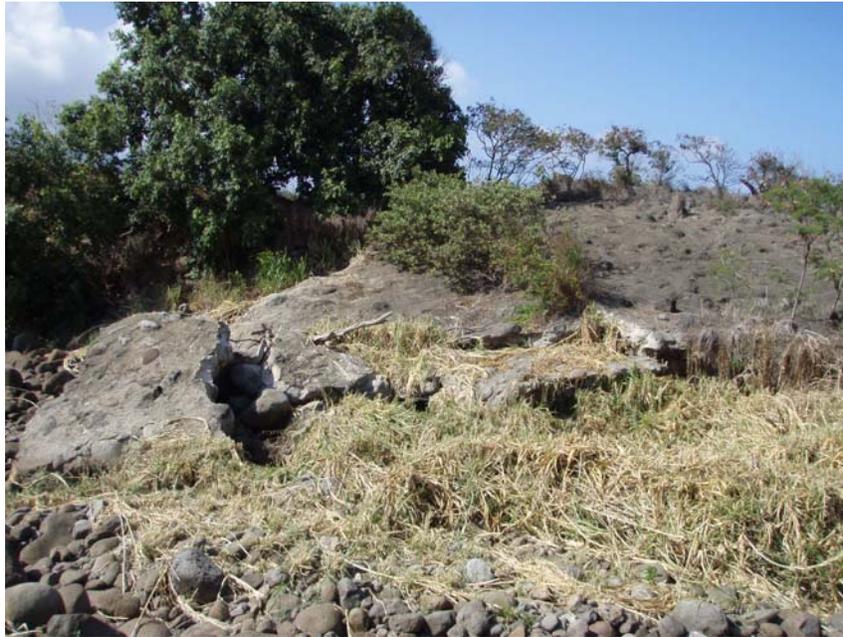
w. LB tie back has failed, COE levee repairs pending, remove woody vegetation from structure and perform temporary repairs to minimize further erosion and undermining.

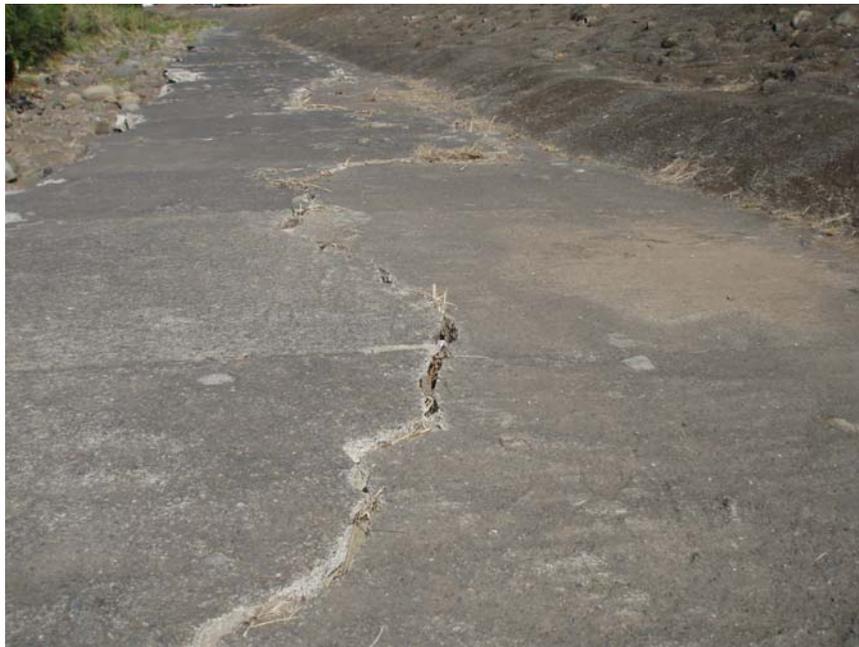
x. RB, COE levee repairs pending, perform temporary repairs to minimize further erosion and undermining.

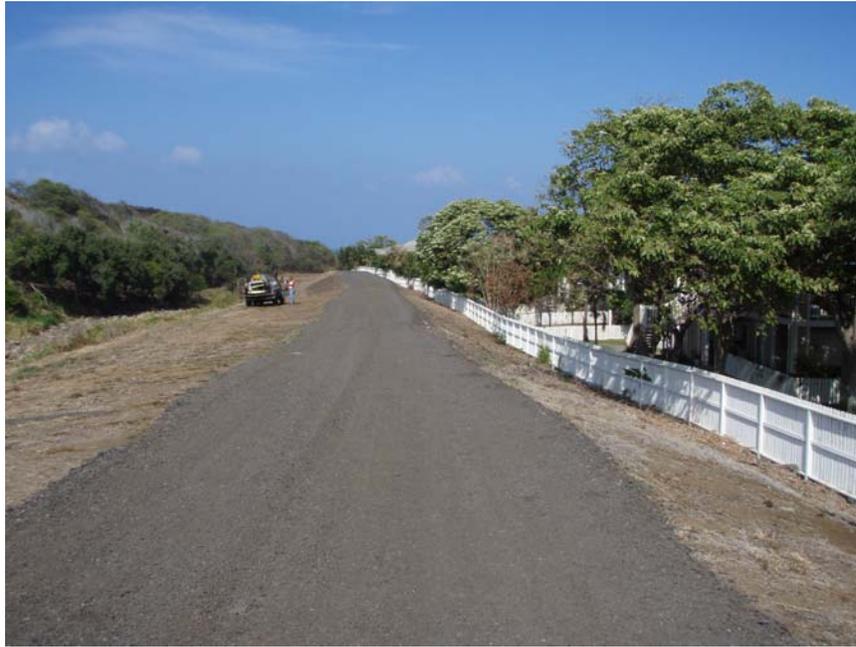
y. RB, levee maintenance access road capped with crushed rock to control dust.

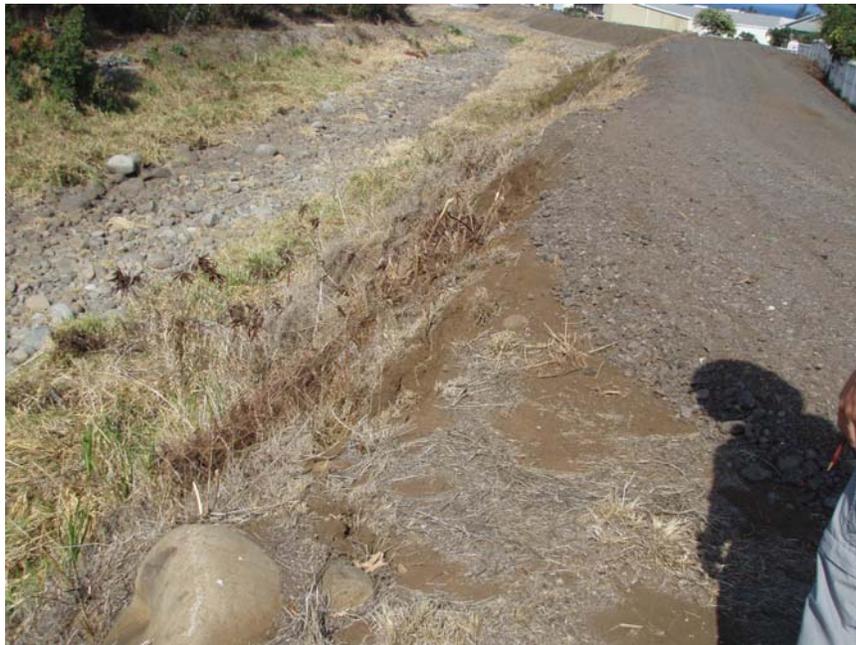
z. RB, levee sideslope steepening and eroding, perform temporary repairs to minimize further erosion.

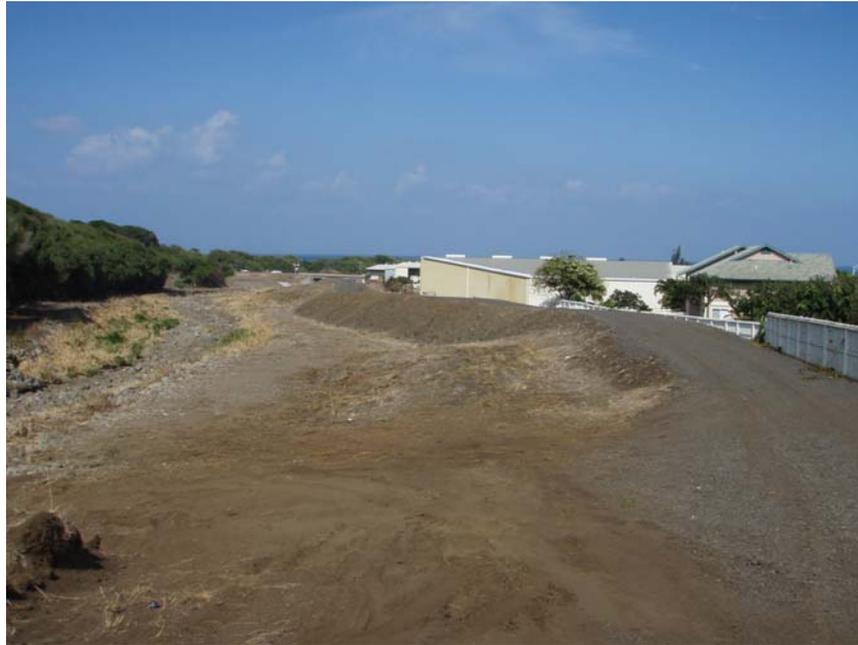
aa. Sta. 21+00, RB, woody vegetation has been removed from the townside of levee.

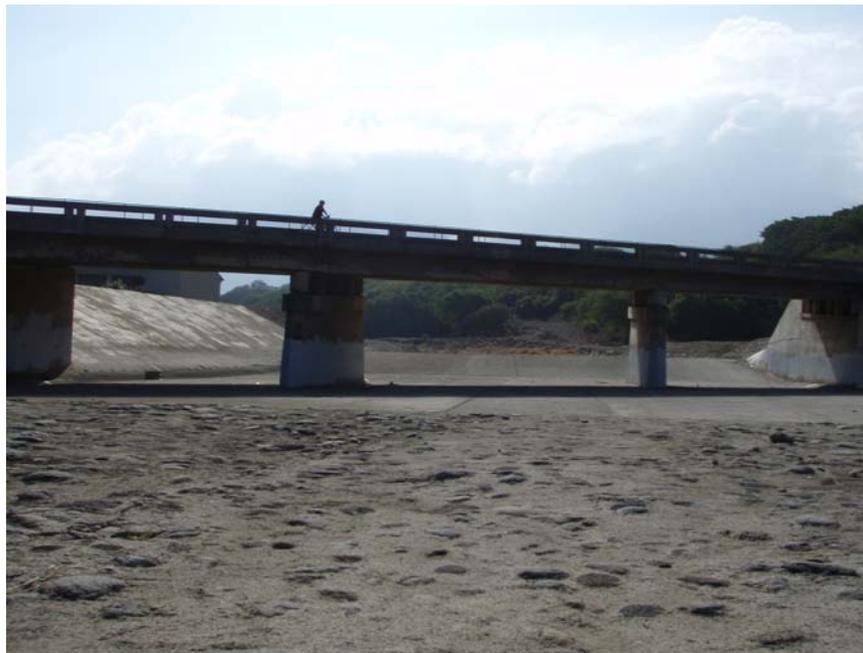
bb. Sta. 19+65, Overview under Waiehu bridge.

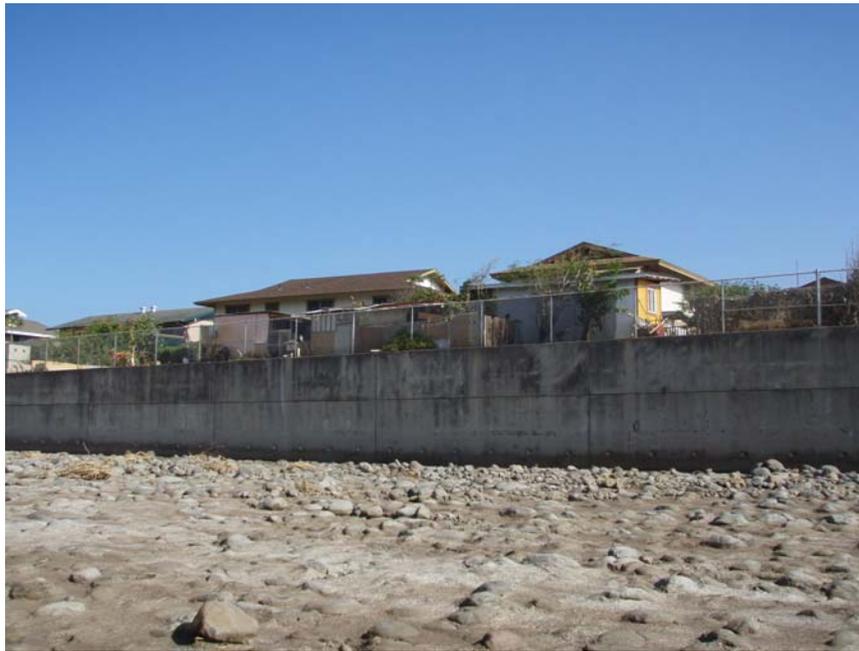
cc. Approximate Sta. 10+00, RB, survey and verify maintenance access.

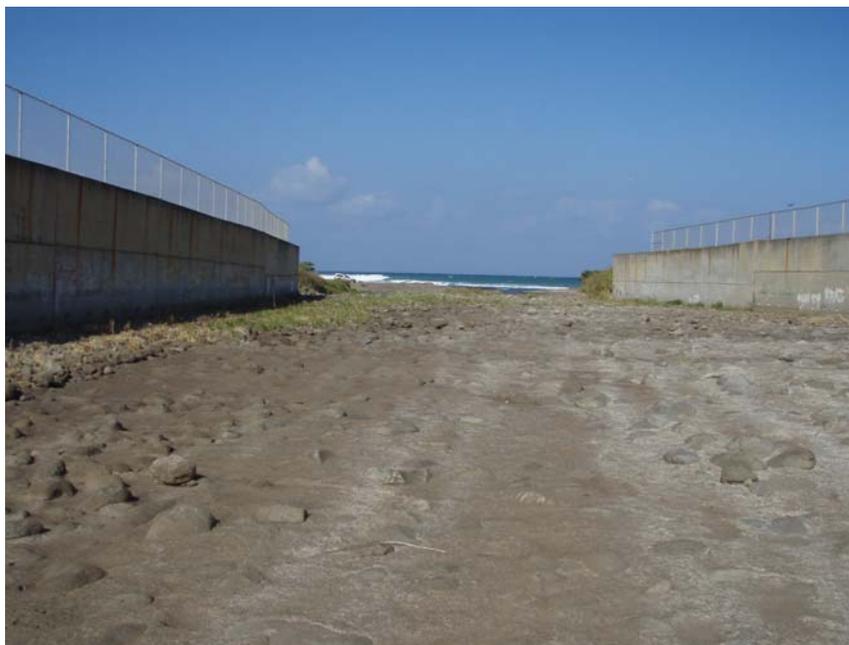
dd. Approximate Sta. 4+76, end of channel bottom. Fencing repaired on LB channel wall.
