**CONTINUING ELIGIBILITY INSPECTION (CEI) REPORT
FOR FLOOD CONTROL WORKS
Honolulu Engineer District
CEPOH-EC-T**

1. Project Name: Kawainui Marsh Flood Control Project
2. Date of Inspection: November 7 & 14, 2007
3. Inspection Personnel:

4. Ratings for FY08
Project Rating: **"MS, Marginally Satisfactory"**
Project Condition Code: **"MA, Minimally Acceptable"**
Project Status: **"Active"**
5. Discussion:

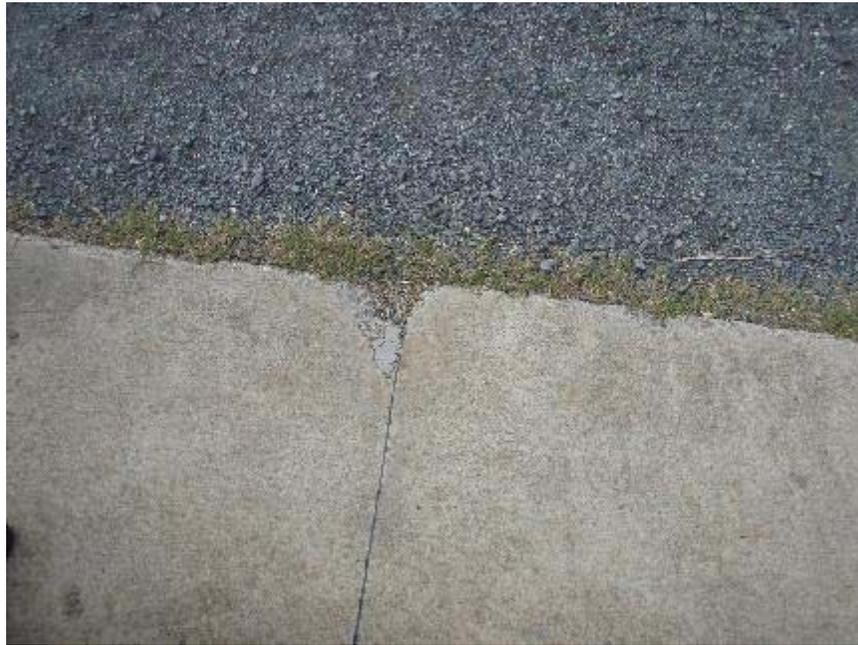
g. Sta. 32+50, MS, repair cracked concrete.

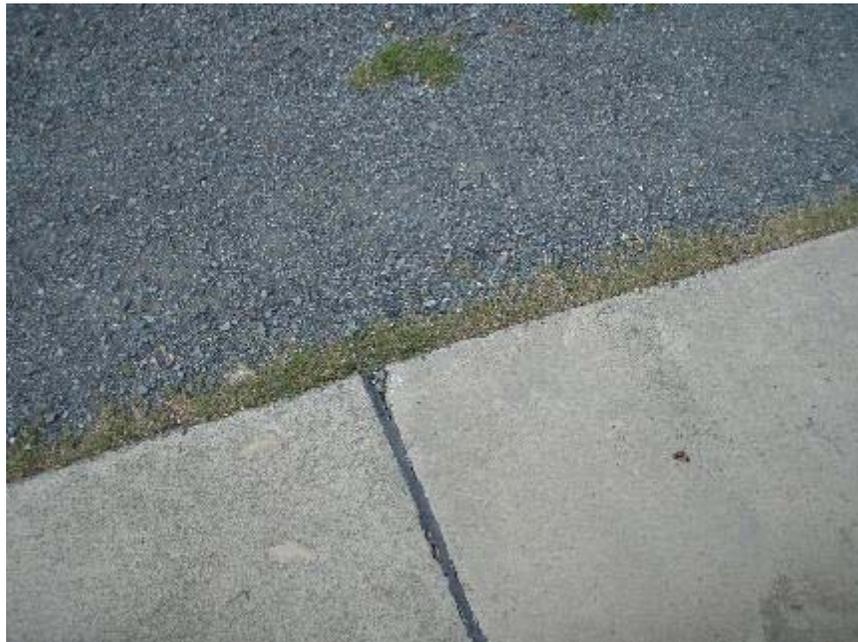
h. Sta. 42+10, MS, patch concrete.

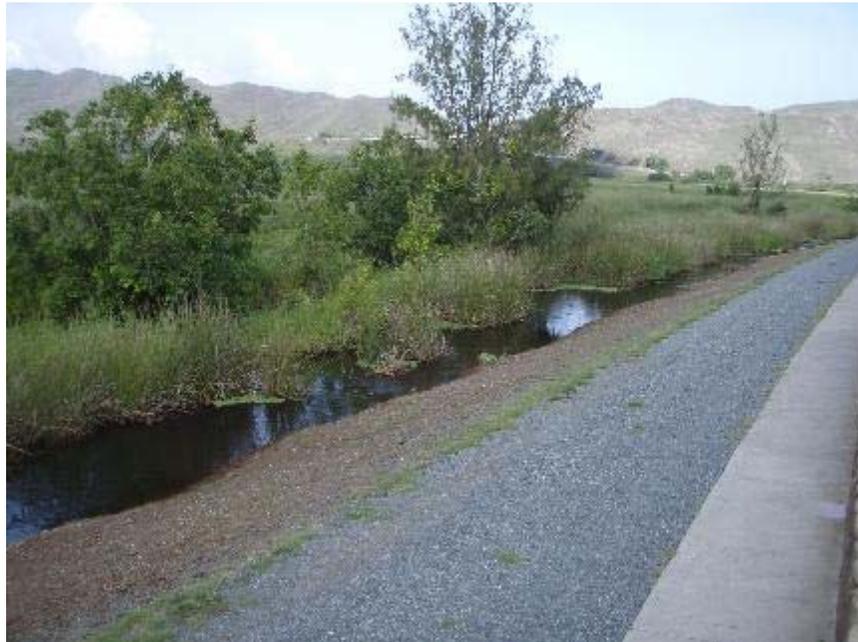
i. Sta. 46+00, MS, repair eroded toe.

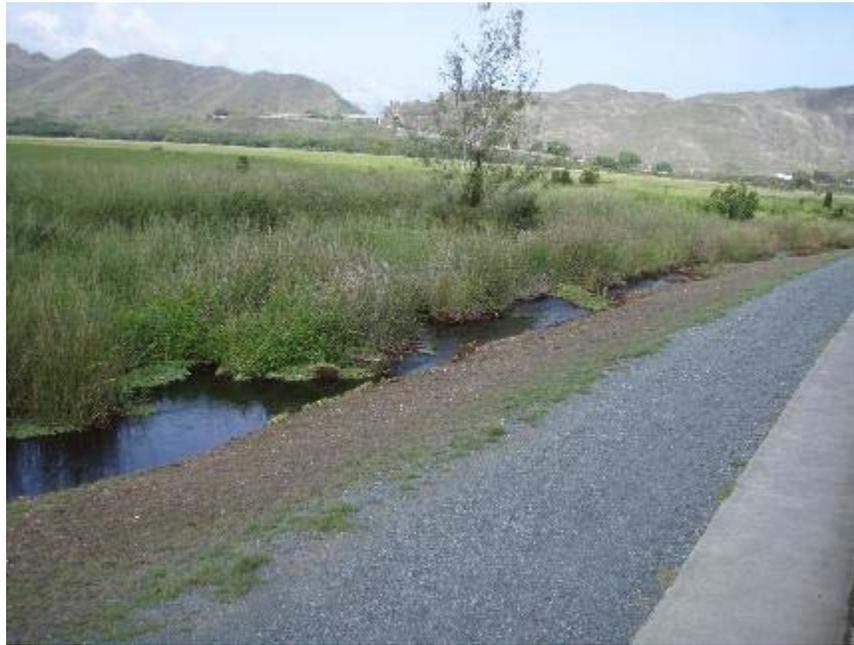
j. Sta. 48+00, MS, repair eroded toe.

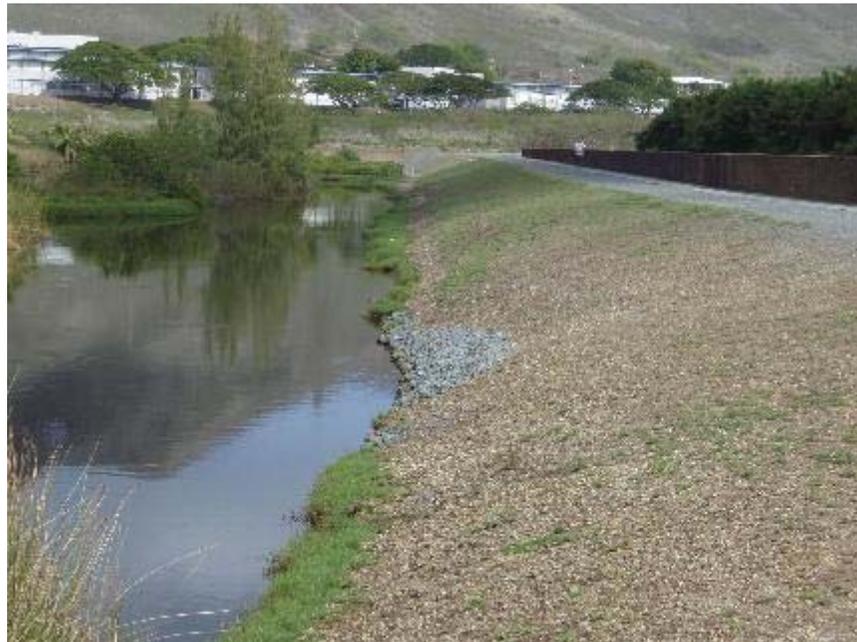
k. Sta. 55+20, MS, erosion at the toe of the side slope was repaired.

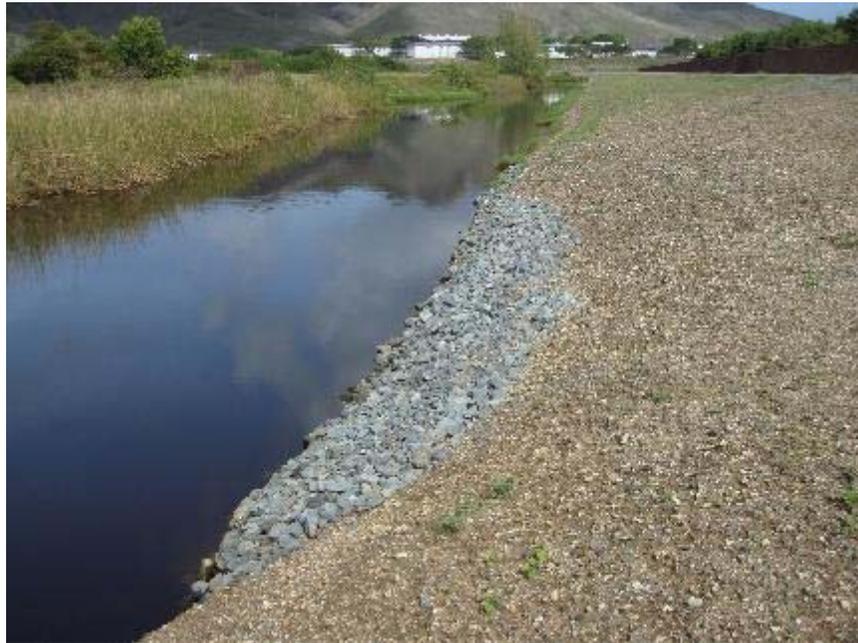
1. Sta. 57+00, MS, facing north, erosion at the toe of the side slope repaired.

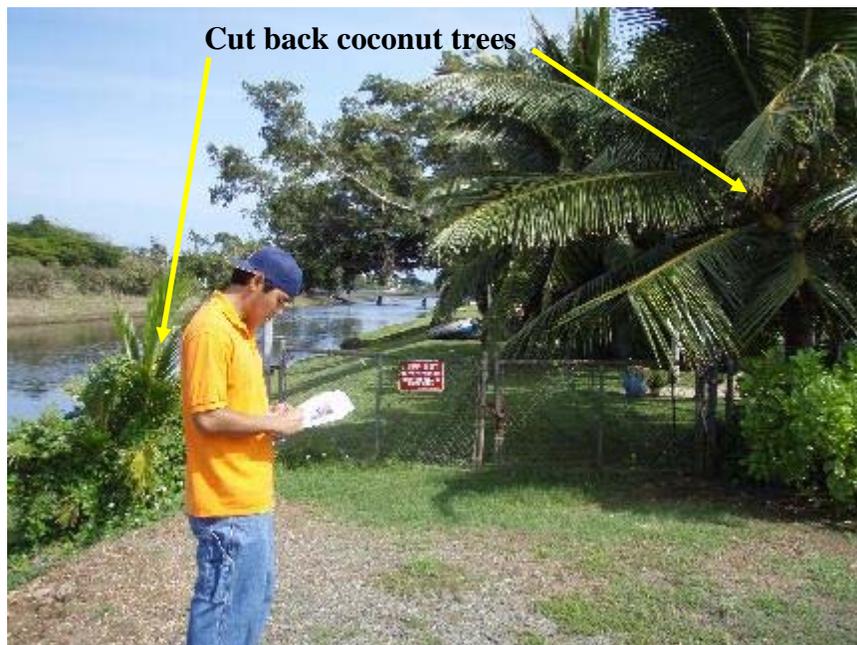
b. Sta. 93+00, RB, cutback coconut trees within maintenance easement and repair gate.

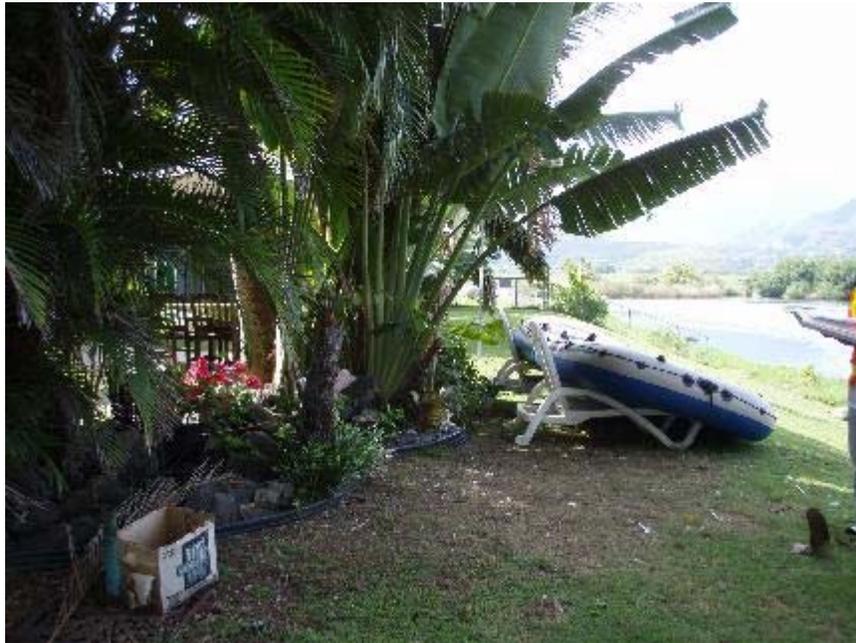
c. Sta. 90+00, RB, remove all unauthorized encroachments within the maintenance easement.

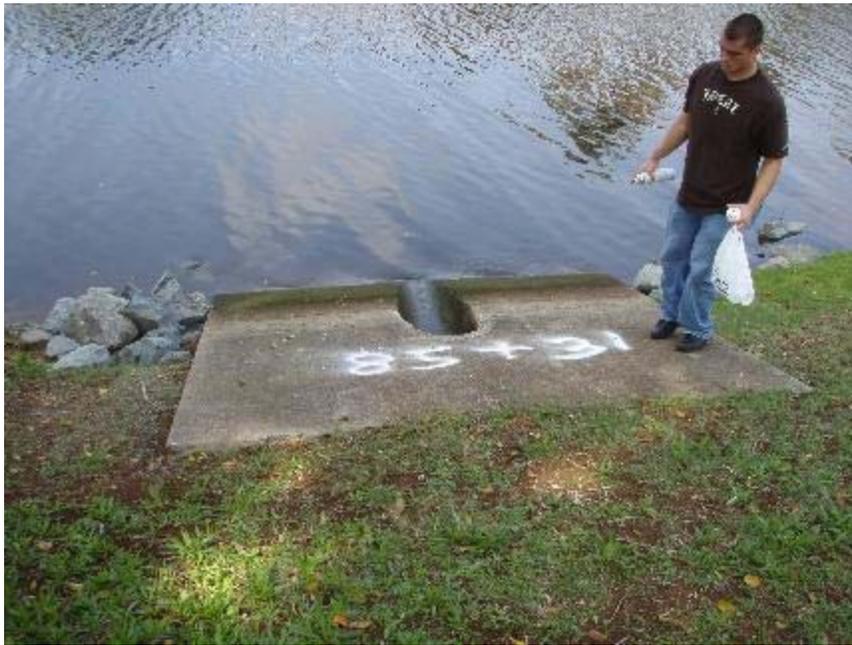
k. Sta. 85+31, RB, 18" pipe outlet, side slope repaired on both sides of the outlet.

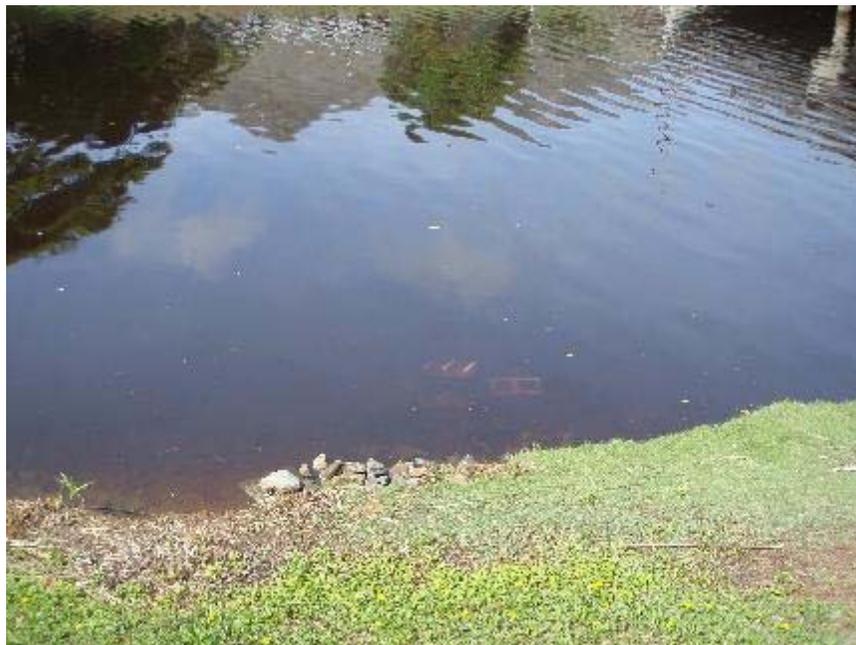
l. Sta. 83+78, RB, unauthorized concrete steps removed.

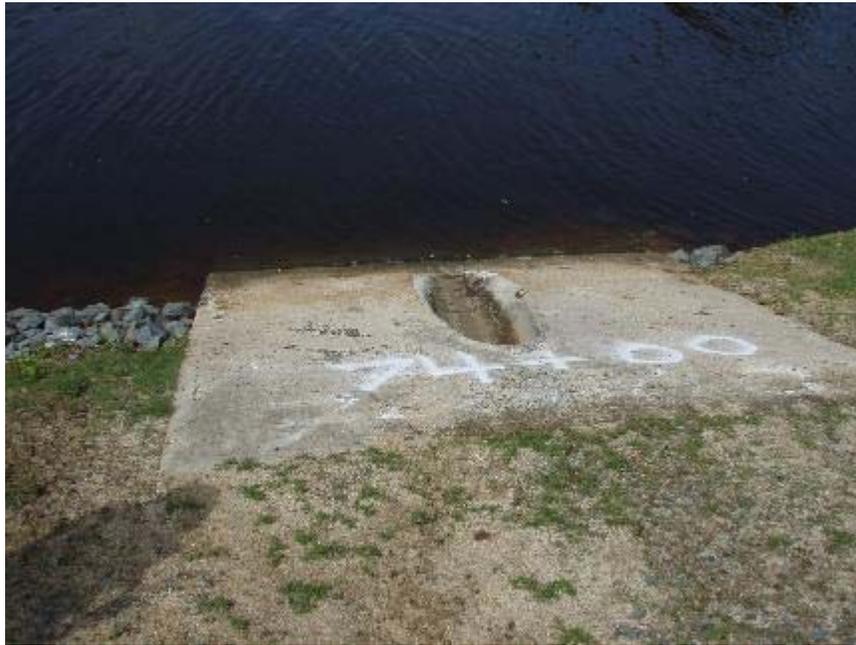
v. Sta. 74+30, RB, 18" Pipe Outlet, erosion around the outlet has been repaired. Repaint station on culvert to show 74+30.

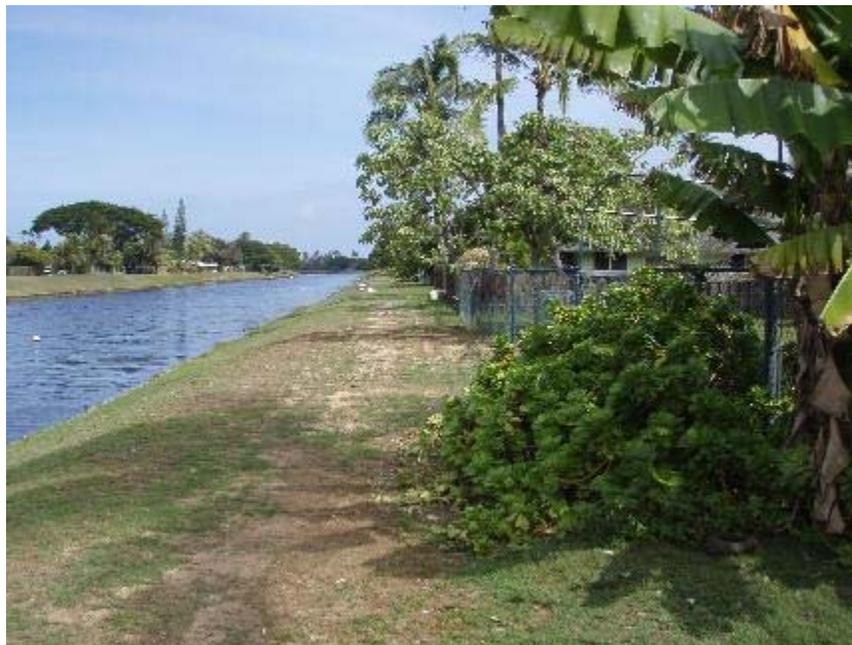
w. Sta. 72+00, RB, remove woody vegetation within maintenance easement.

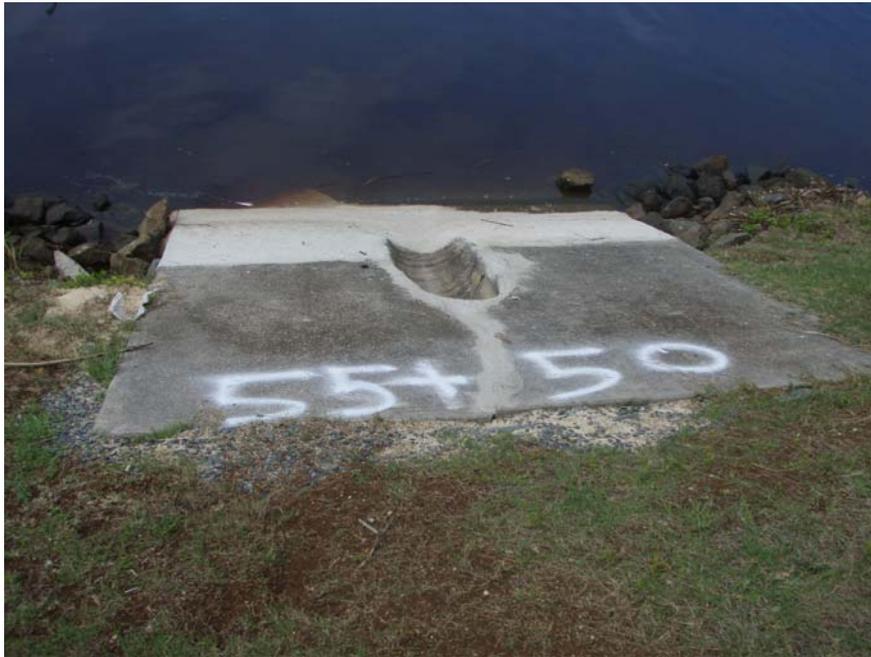
ff. Sta. 55+50, RB, 18" Pipe Outlet, concrete at the toe repaired.

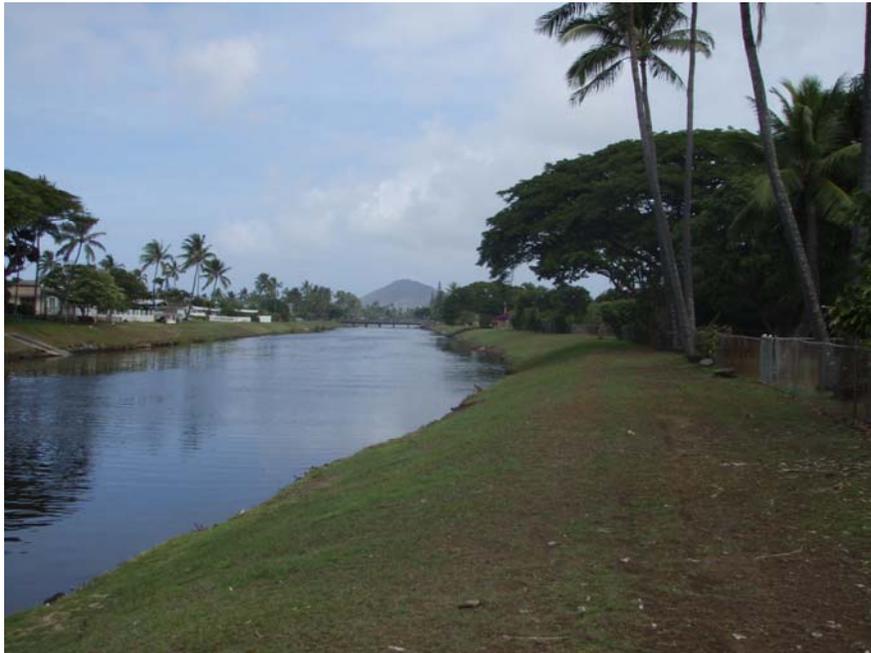
gg. Sta. 55+51, RB, overview, woody vegetation along side slope removed.

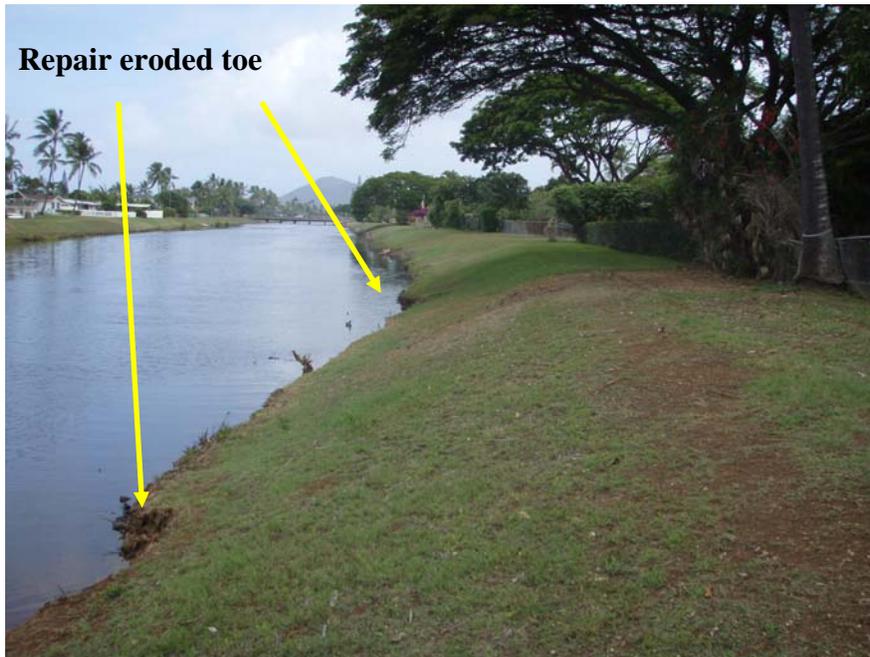
hh. Sta. 55+00, RB, repair eroded toe (2 areas).

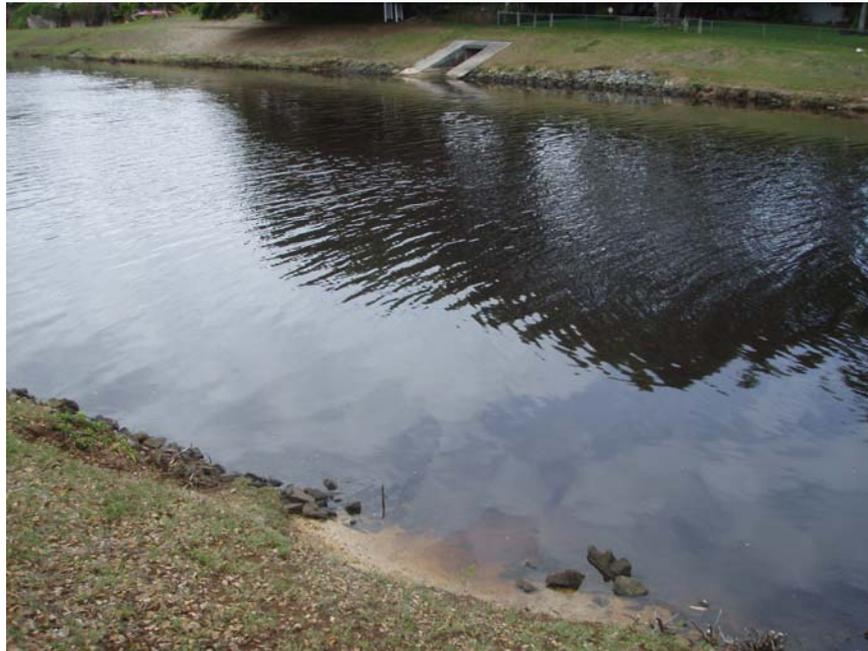
ii. Sta. 53+00, RB, repair toe damage.

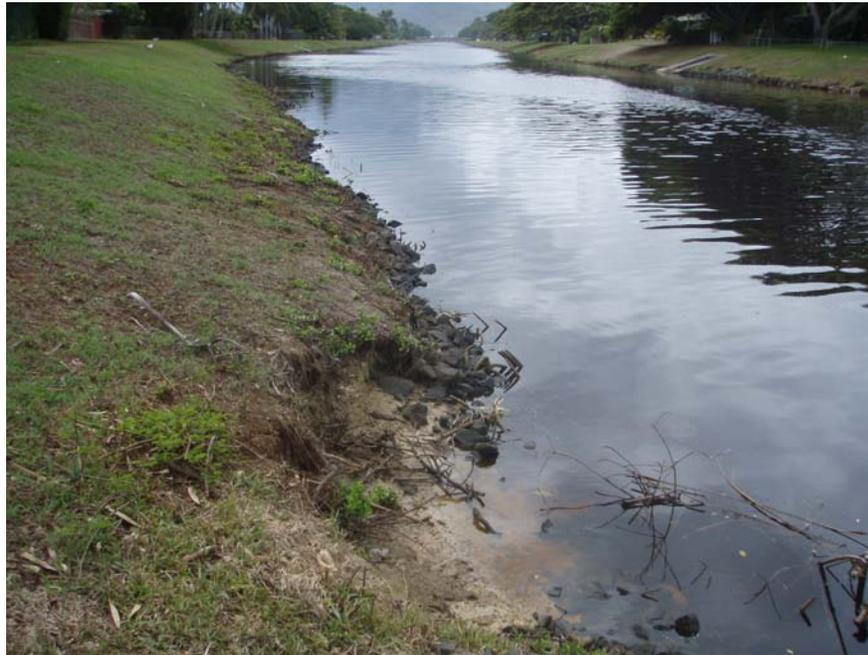
jj. Sta. 52+00, RB, repair eroded toe.

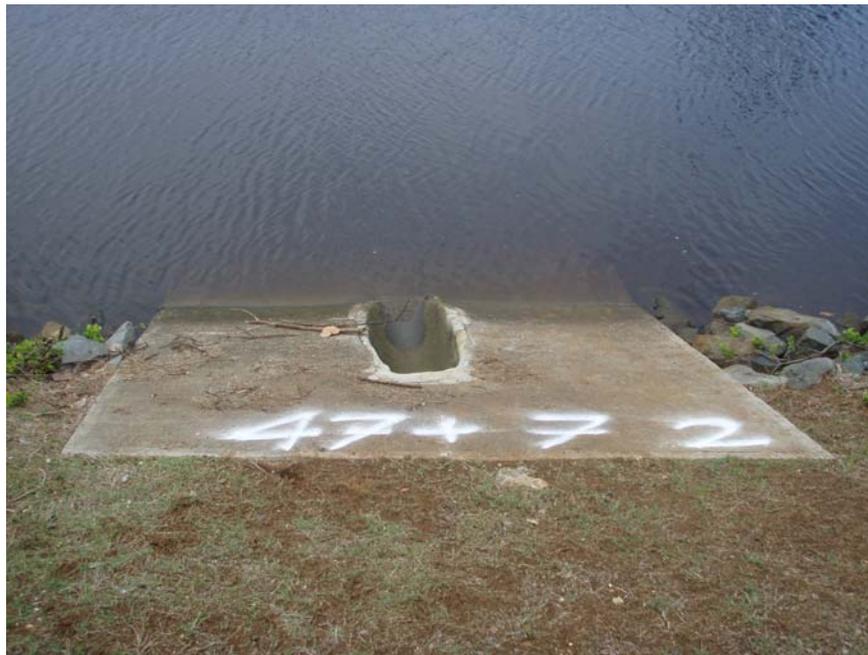
kk. Sta. 47+72, RB, 18" Culvert, woody vegetation removed around culvert.

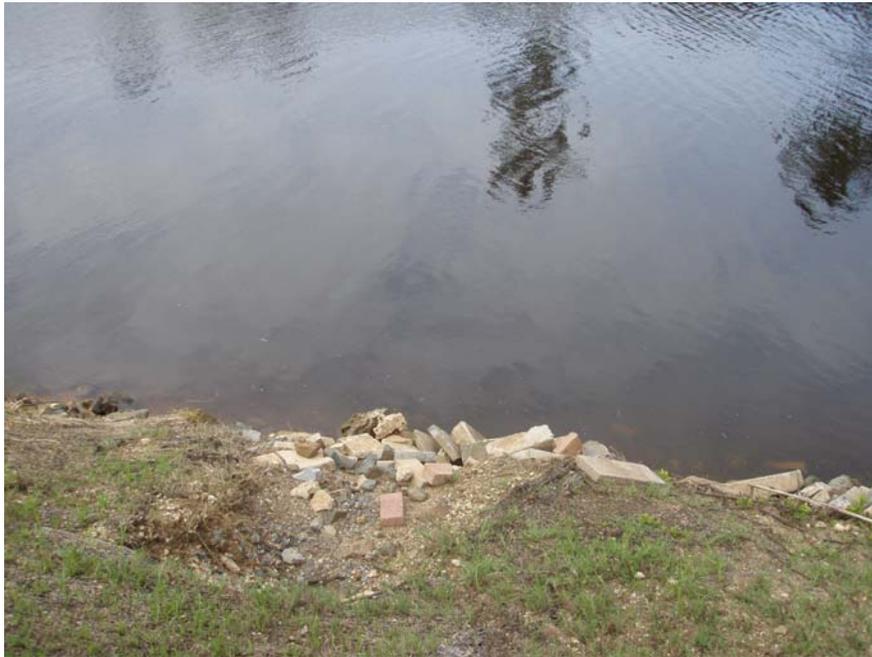
11. Sta. 46+72, RB, steps removed, backfill needed on side slope.

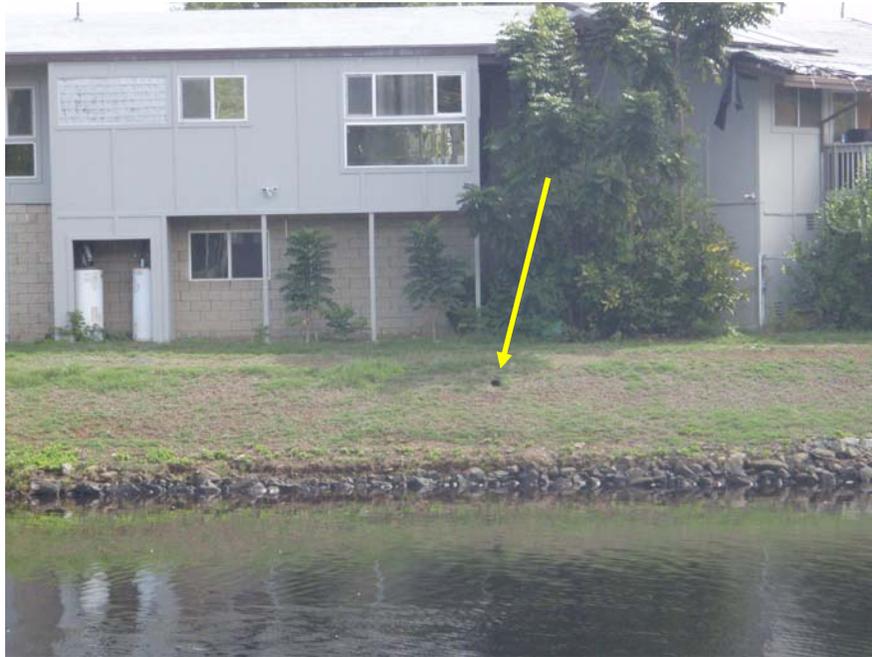
nn. Sta. 41+58, RB, remove unauthorized encroachment, drain pipe, and restore side slope.

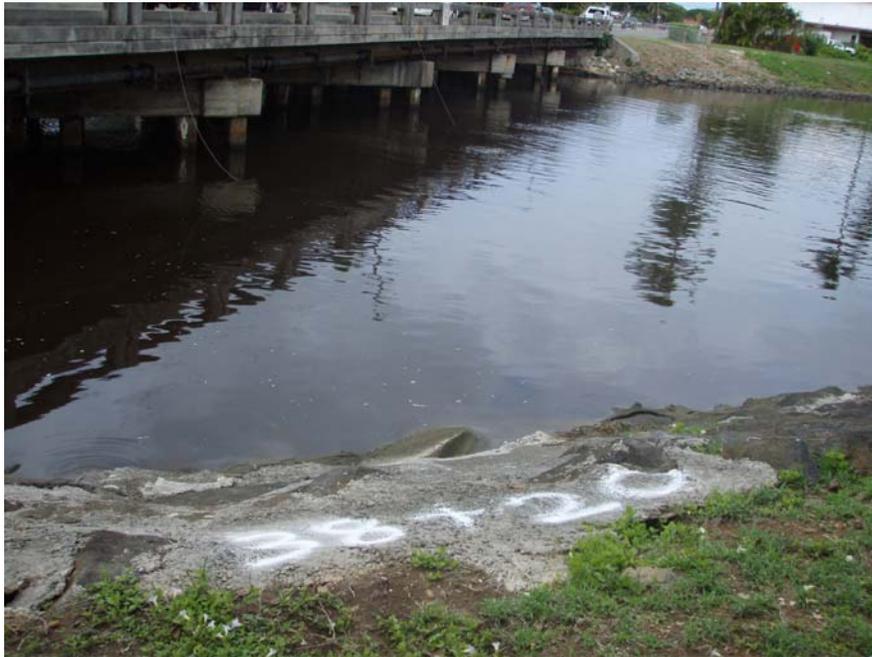
rr. Sta. 38+20, RB, 24" Ditch Outlet.

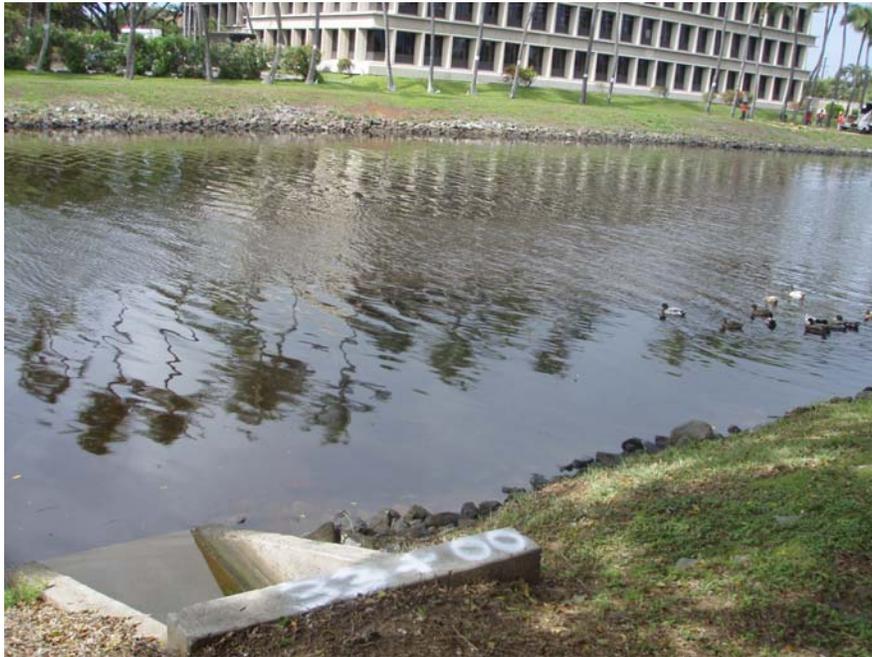
tt. Sta. 33+00, RB, 24" Pipe Outlet.

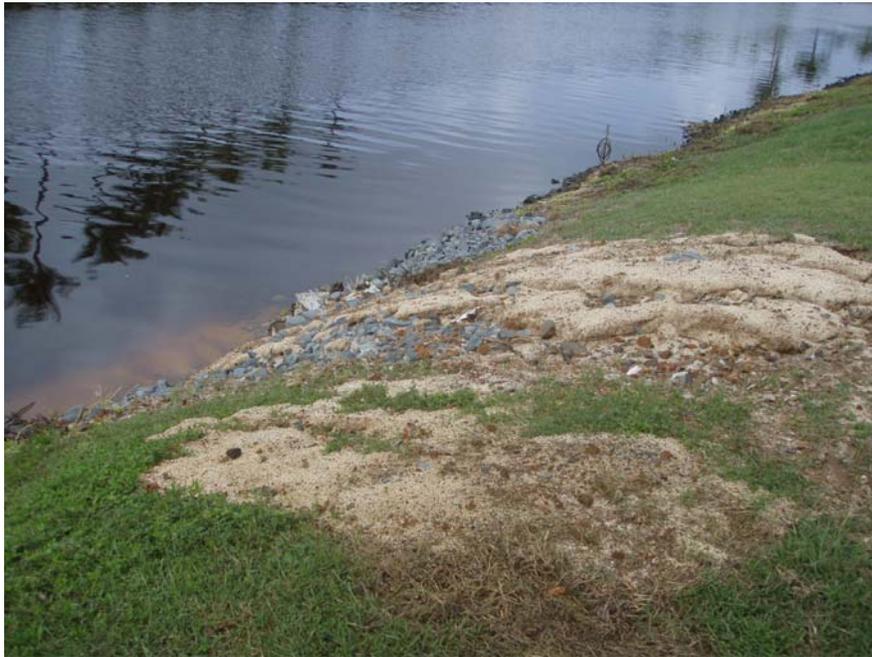
vv. Sta. 31+25, RB, unauthorized concrete ramp removed, maintain side slope.

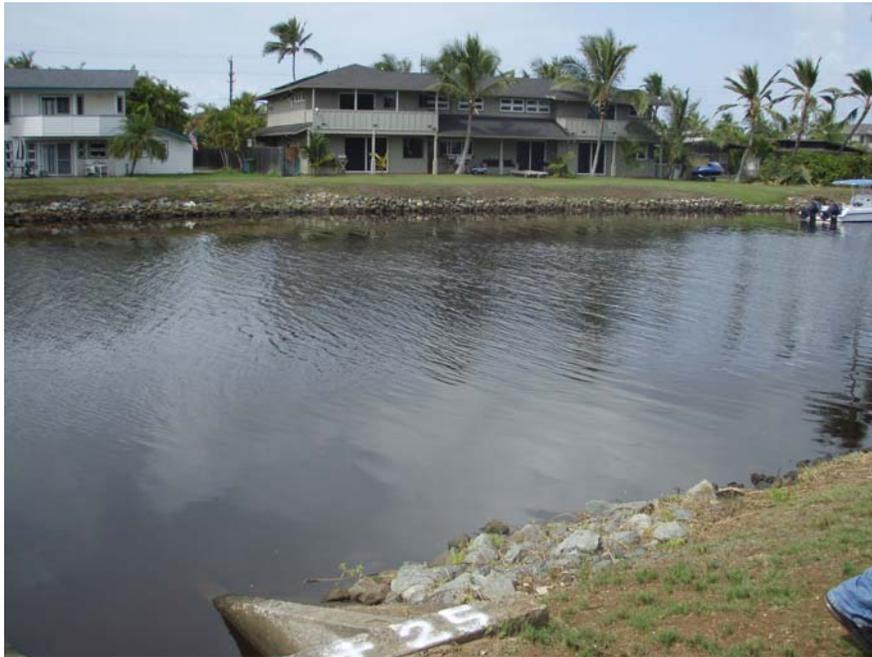
xx. Sta. 29+25, RB, 24" Culvert.

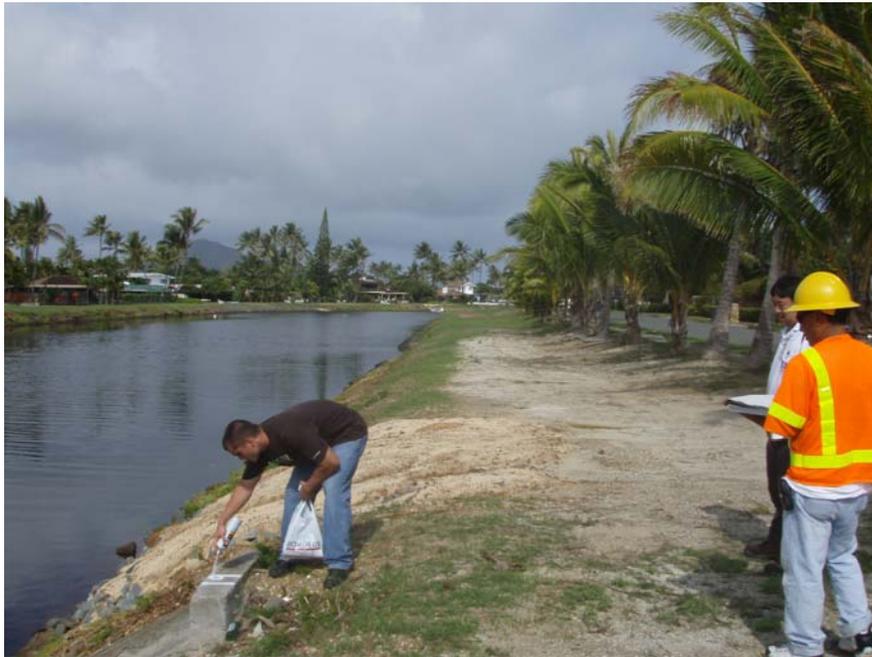
bbb. Sta. 19+00, RB, Overview, 24" Pipe Outlet, unauthorized boat ramp and woody vegetation removed.

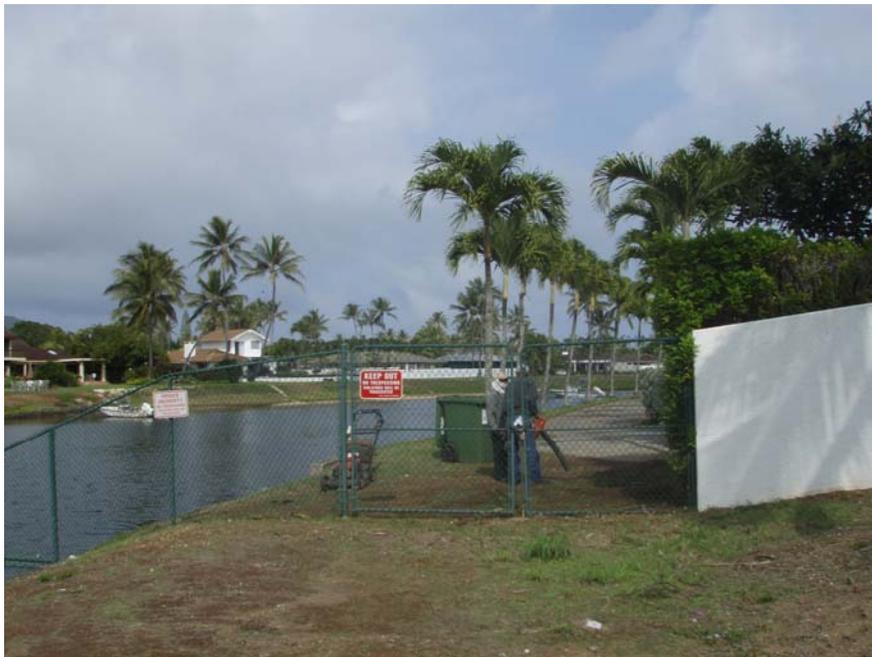
ccc. Sta. 13+00, RB, maintenance easement road gate.

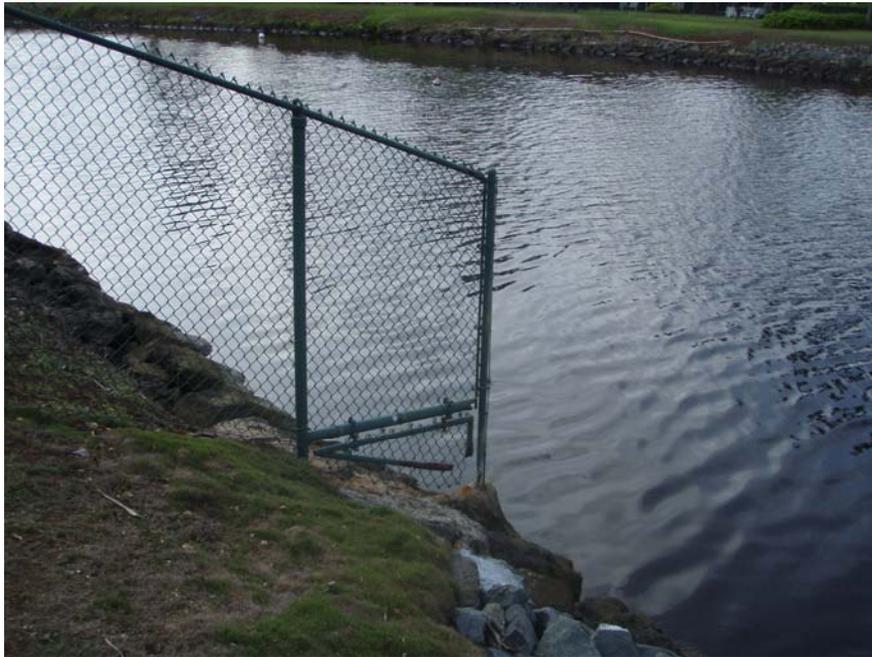
ddd. Sta. 13+00, RB, looking towards the marsh, repair triangle flap gate.

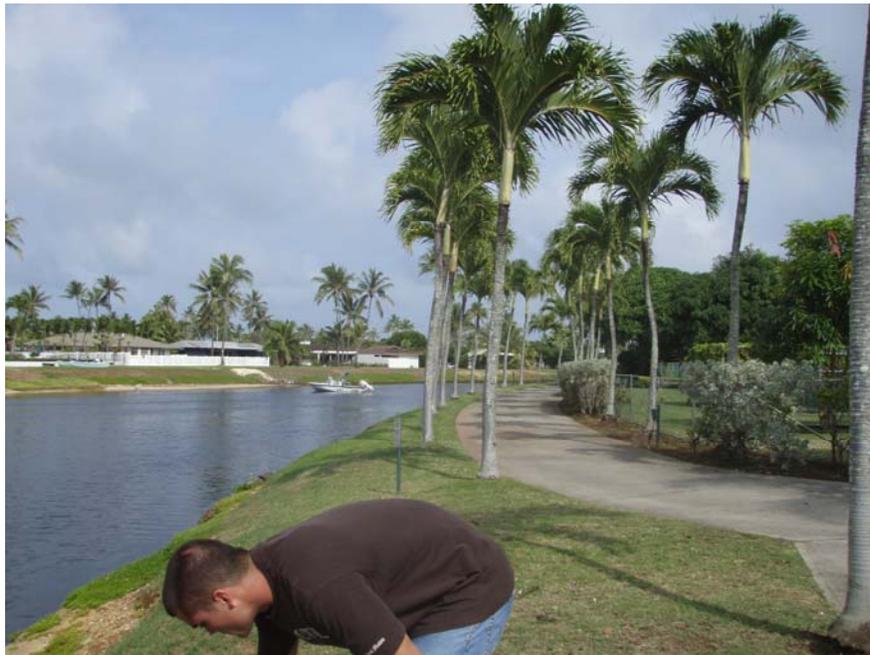
eee. Sta. 12+90, RB, concrete culvert, remove all trees within maintenance right of way and restore maintenance easement.

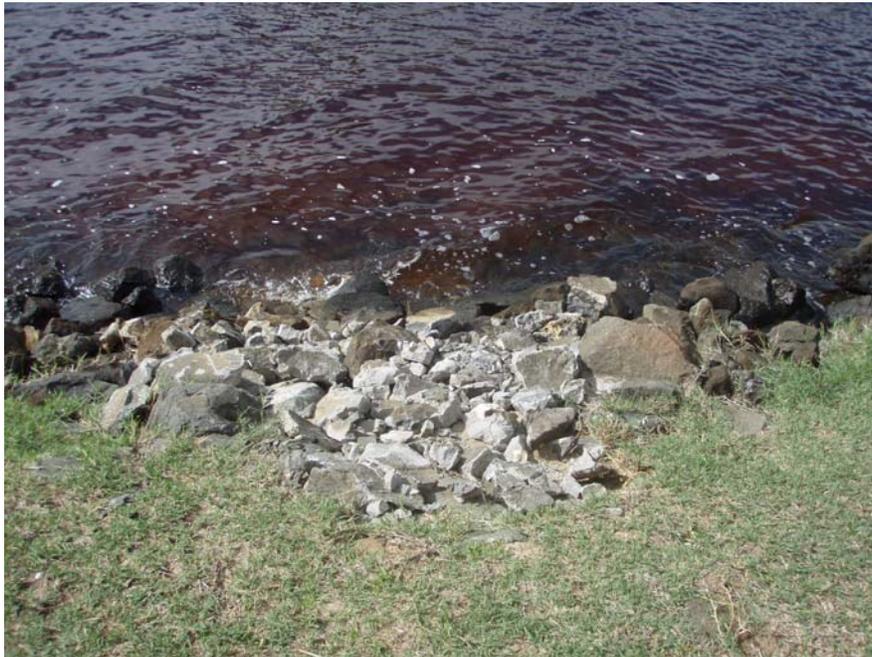
c. Sta. 6+10, LB, unauthorized stairs removed.

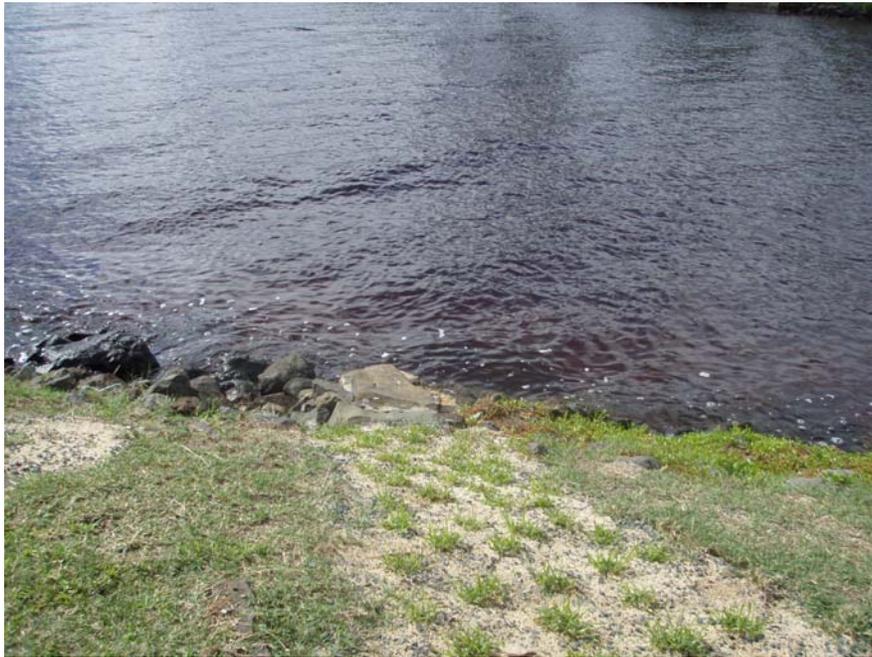
e. Sta. 6+50, LB, stairs removed.

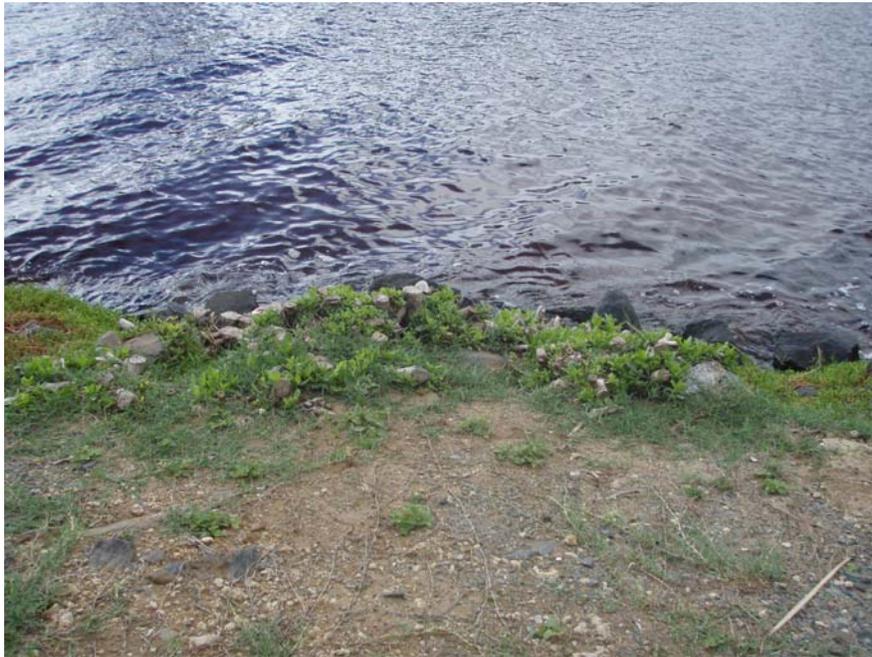
g. Sta. 7+13, LB, remove naupaka plant at toe.

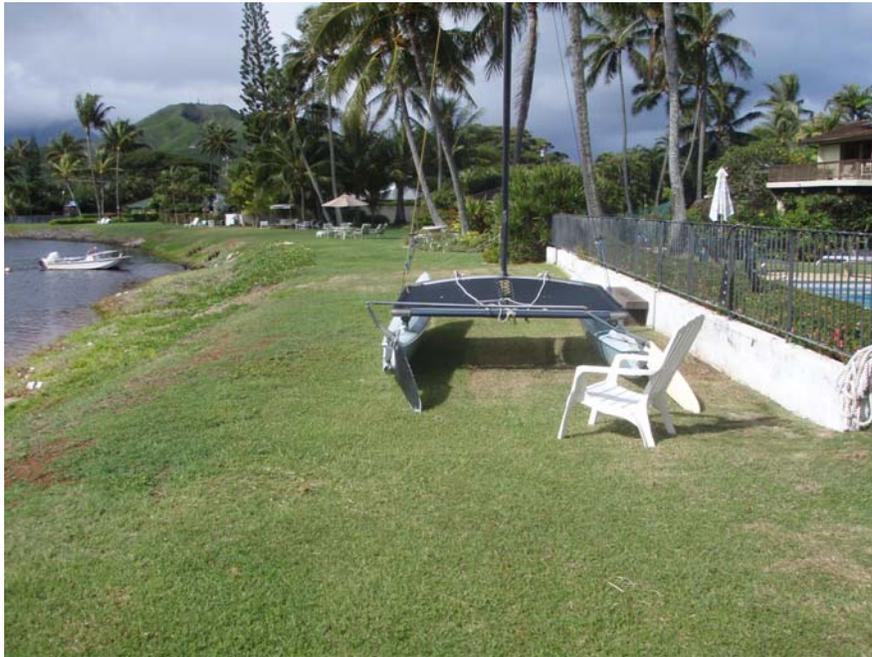
- i. Sta. 9+80, LB, remove unauthorized encroachment within maintenance easement.

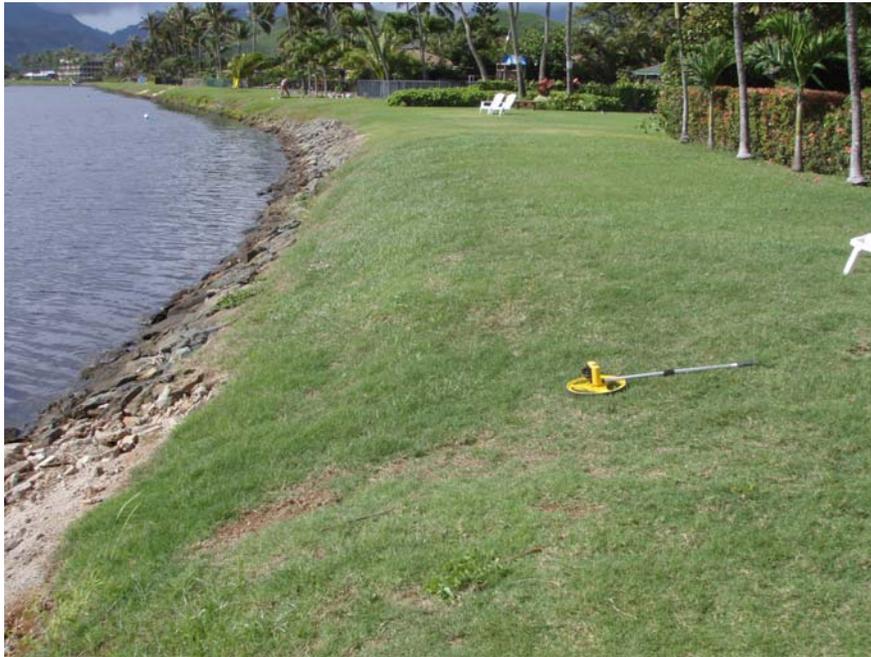
m. Sta. 12+67, LB, restore crest elevation and side slope.

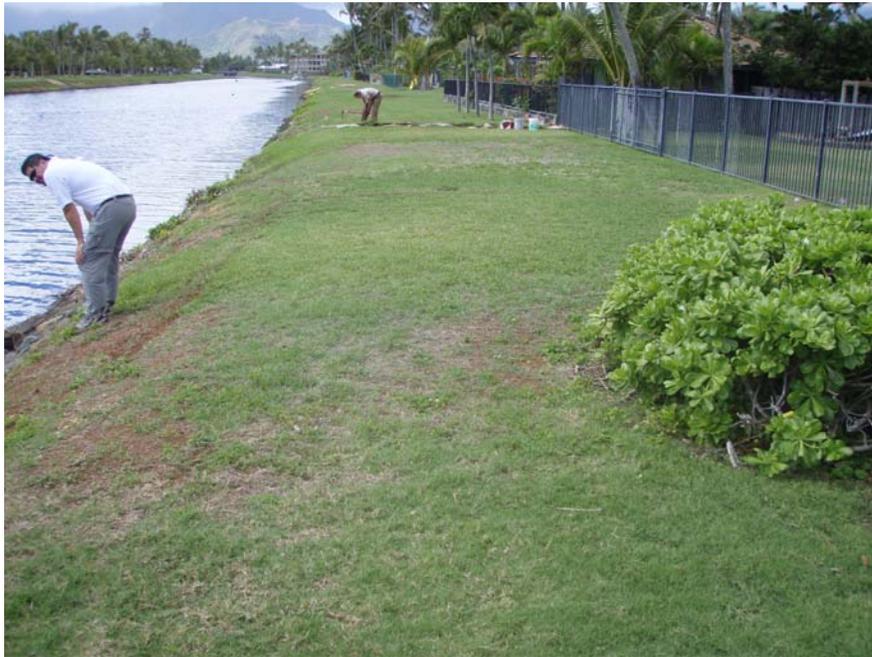
o. Sta. 14+19, LB, remove all unauthorized encroachments, woody vegetation and sprinkler system, within maintenance easement.

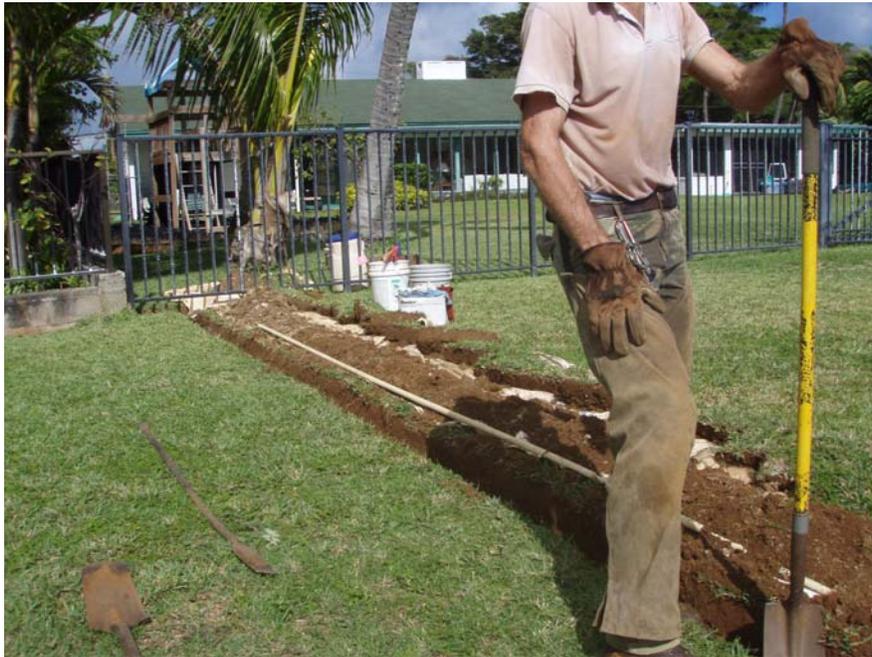
q. Sta. 15+06, LB, remove unauthorized encroachment, sprinkler system, and restore existing maintenance easement.

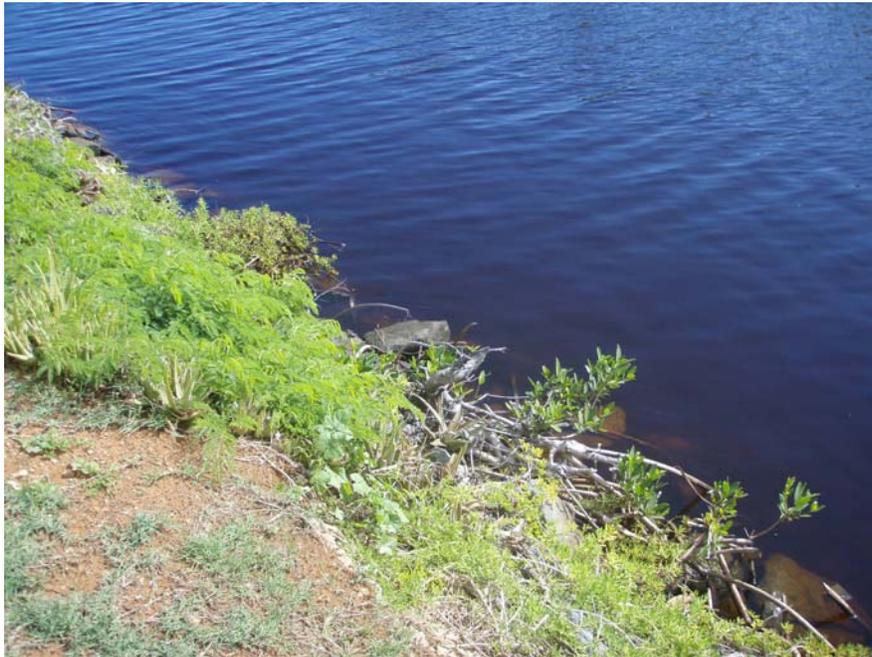
s. Sta. 16+78, LB, remove mangrove plant on side slope.

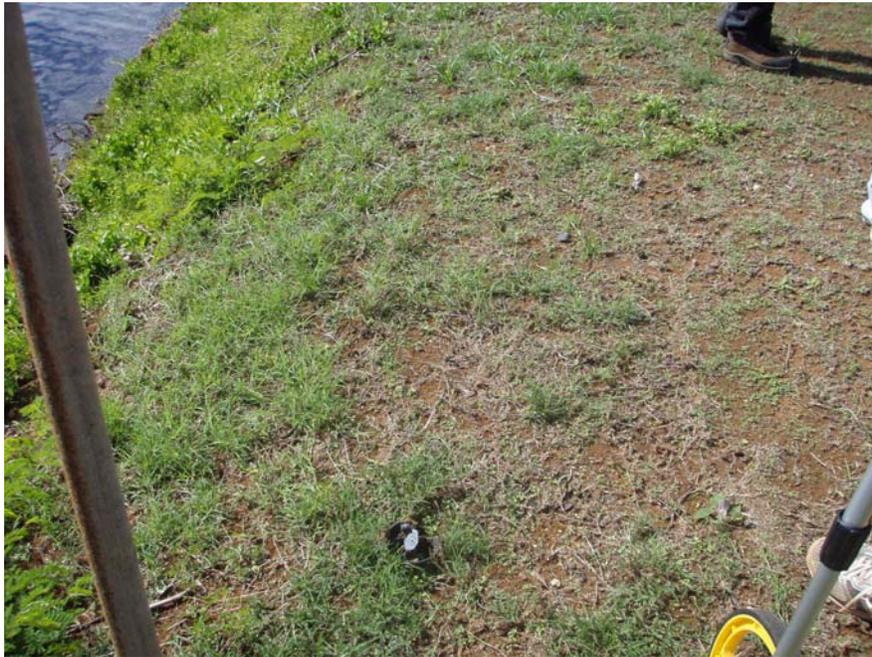
u. Sta. 17+98, LB, remove unauthorized encroachments, ramp and sprinkler system, within maintenance easement and restore side slope.

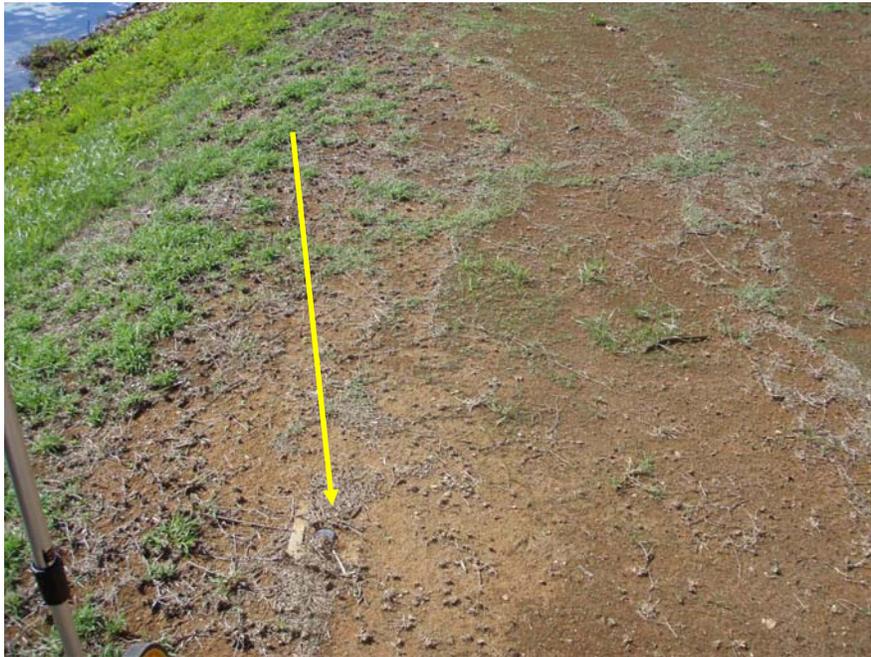
w. Sta. 23+15 - 23+90, LB, remove unauthorized encroachment, sprinkler system, and restore ground cover vegetation.

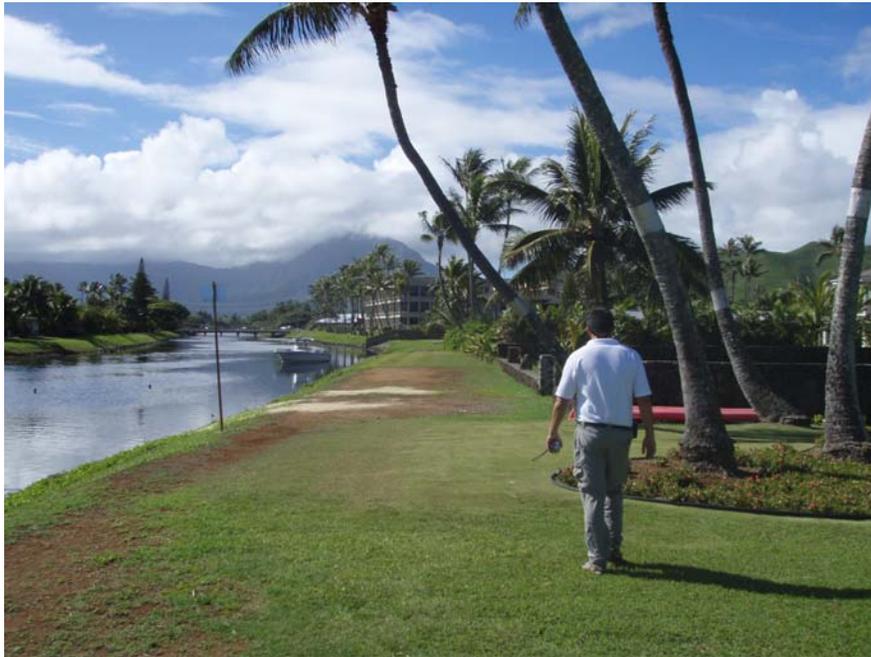
y. Sta. 26+32, LB, remove coconut tree(s) and unauthorized encroachments within maintenance easement.
