**CONTINUING ELIGIBILITY INSPECTION (CEI) REPORT
FOR FLOOD CONTROL WORKS
Honolulu Engineer District
CEPOH-EC-T**

1. Project Name: Kawainui Marsh Flood Control Project
2. Date of Inspection: November 7 & 14, 2007
3. Inspection Personnel:

4. Ratings for FY08
Project Rating: **"MS, Marginally Satisfactory"**
Project Condition Code: **"MA, Minimally Acceptable"**
Project Status: **"Active"**
5. Discussion:

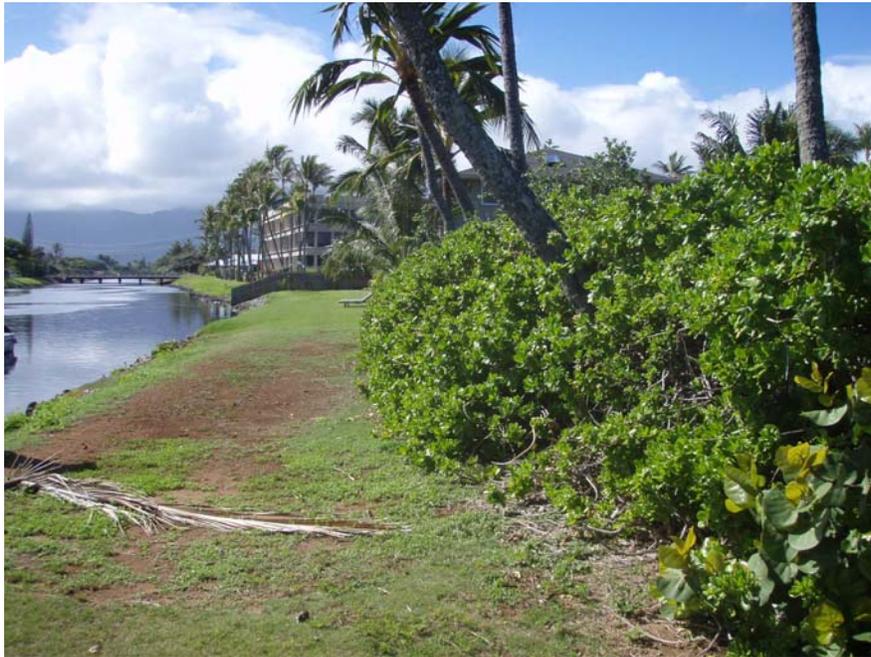
aa. Sta. 28+46, LB, remove woody vegetation within maintenance easement.

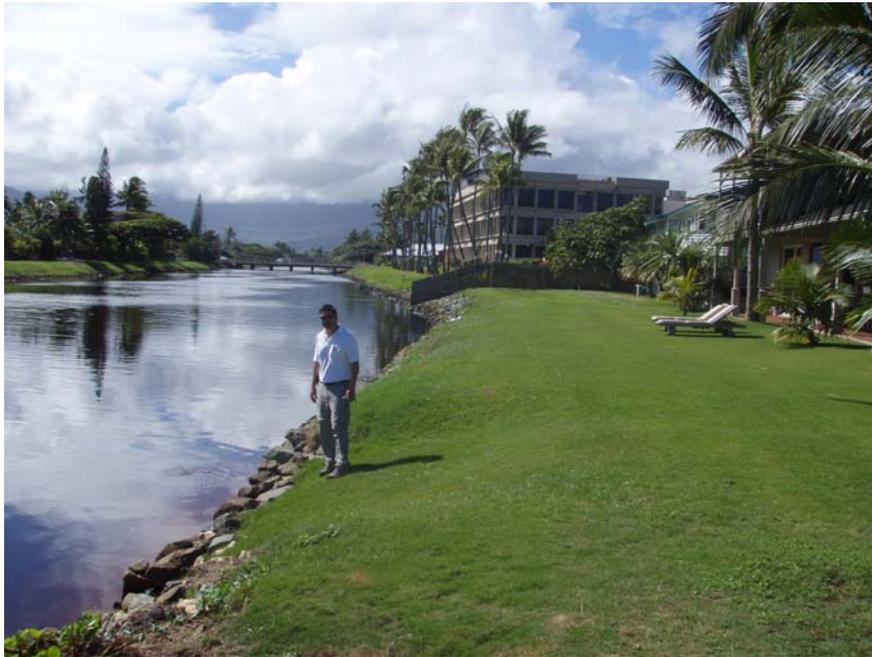
cc. Sta. 29+42, LB, unauthorized earthen boat ramp, restore depressed channel side slope and maintenance easement to original condition. Place 1-man rock at toe to prevent erosion.

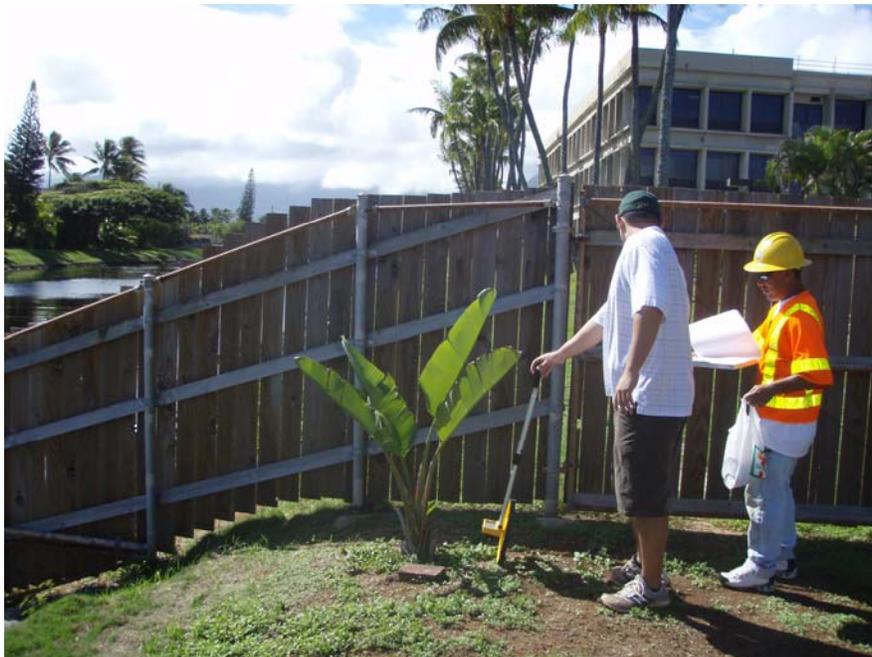
dd. Sta. 31+41, LB, remove banana tree.

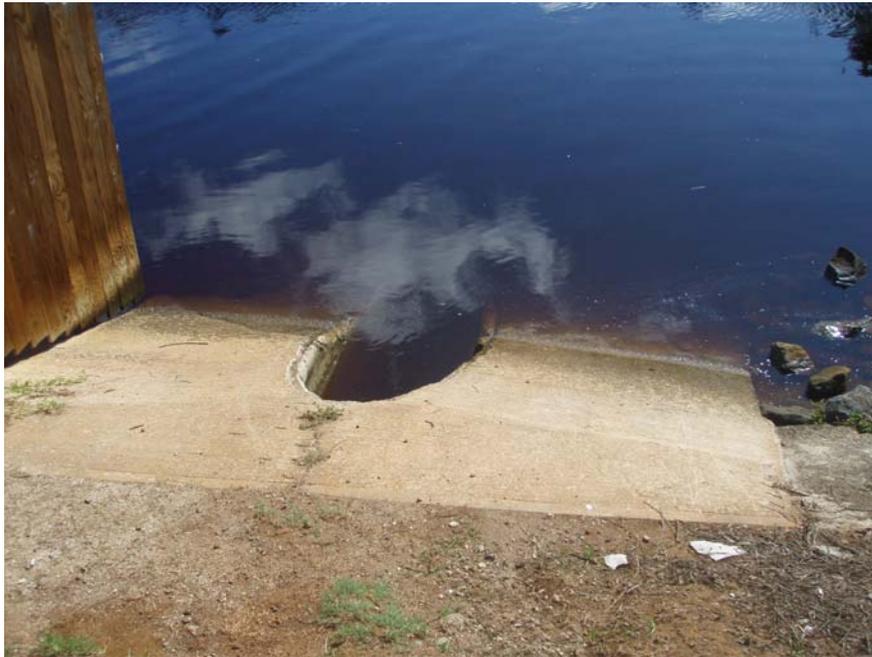
ee. Sta. 31+50, LB, pipe outlet.

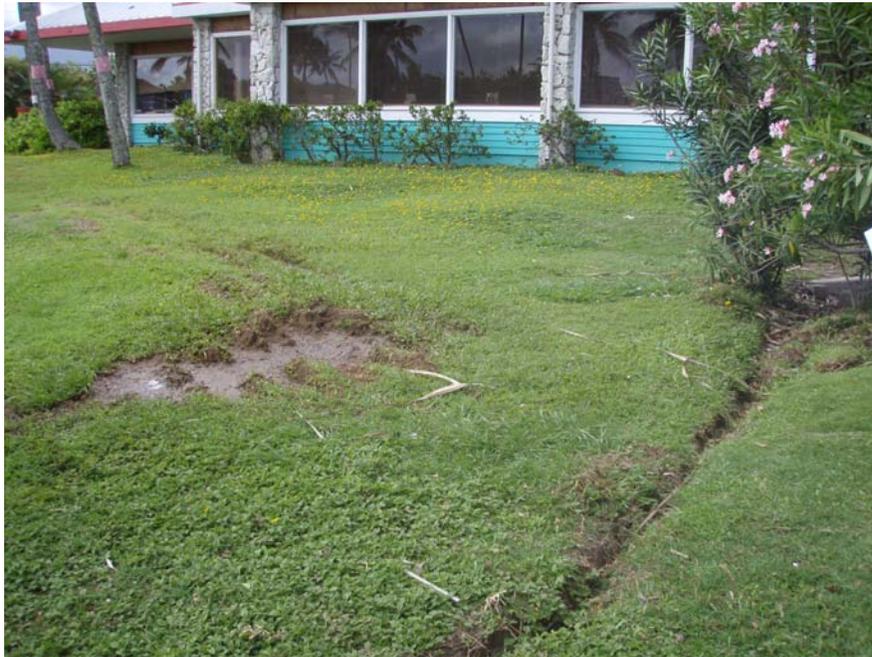
gg. Sta. 36+78, LB, restore crest elevation.

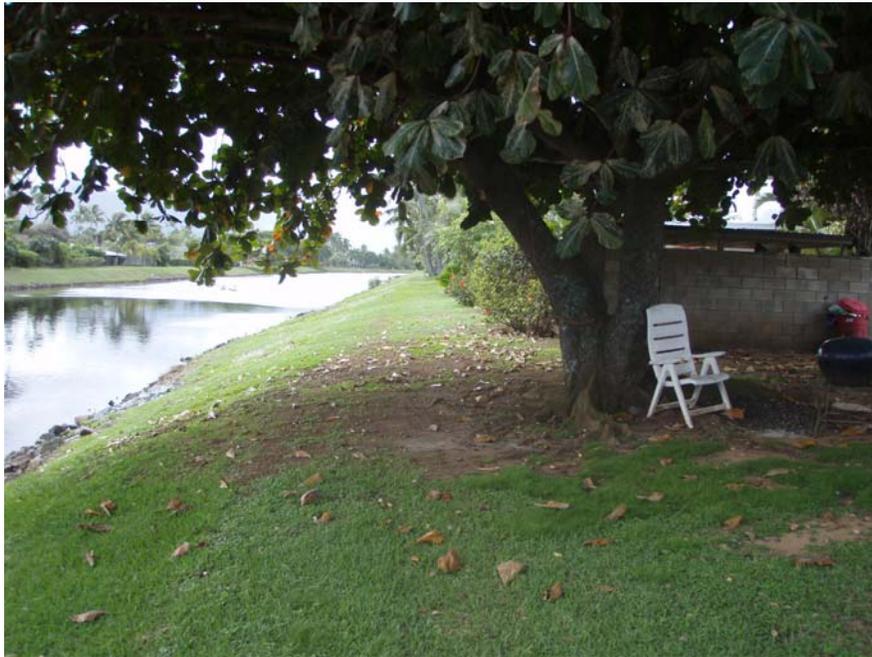
ii. Sta. 38+64, LB, remove tree within maintenance easement.

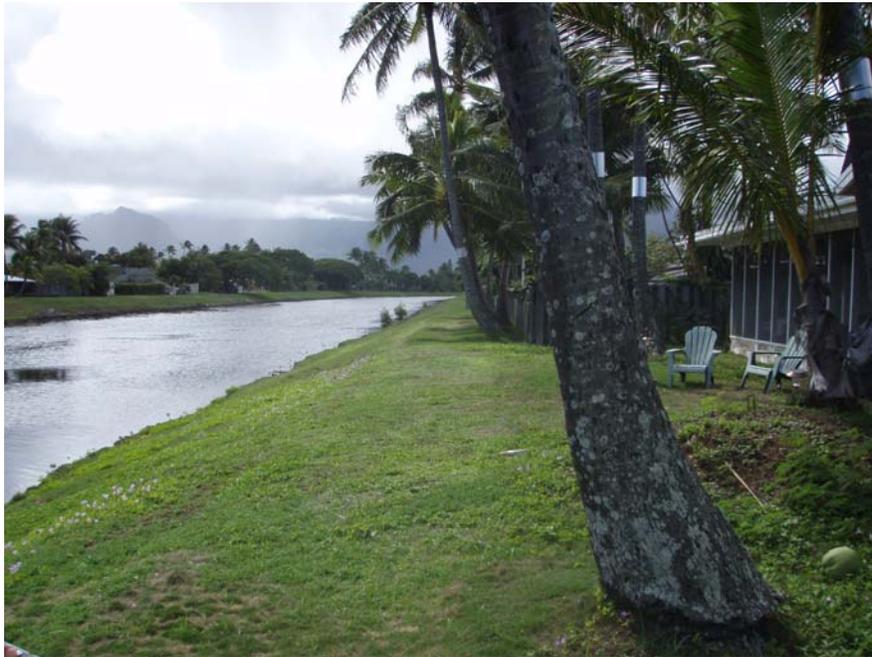
kk. Sta. 40+65, LB, remove coconut trees within maintenance easement.

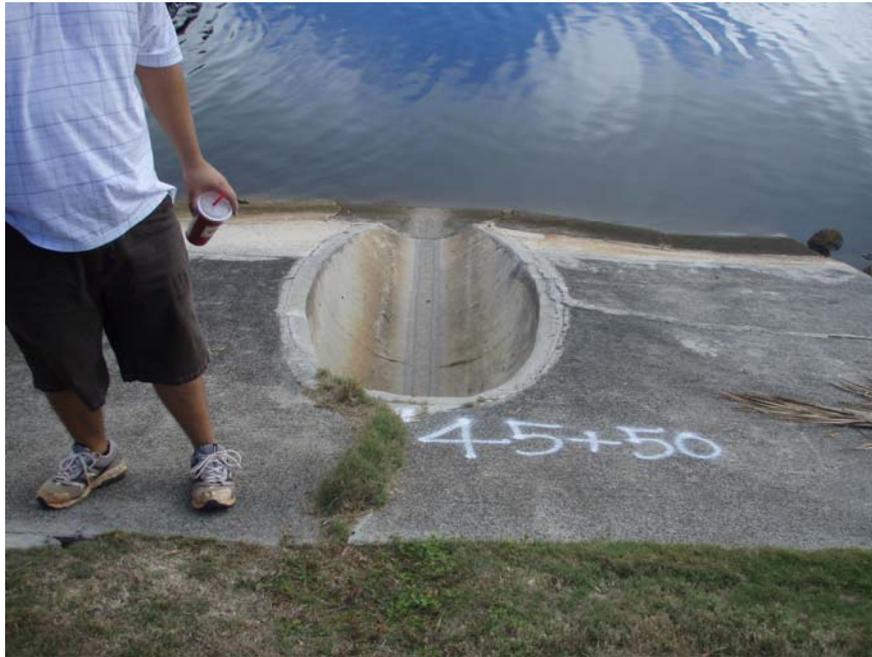
oo. Sta. 45+50, LB, concrete culvert, cut grass and repair crack.

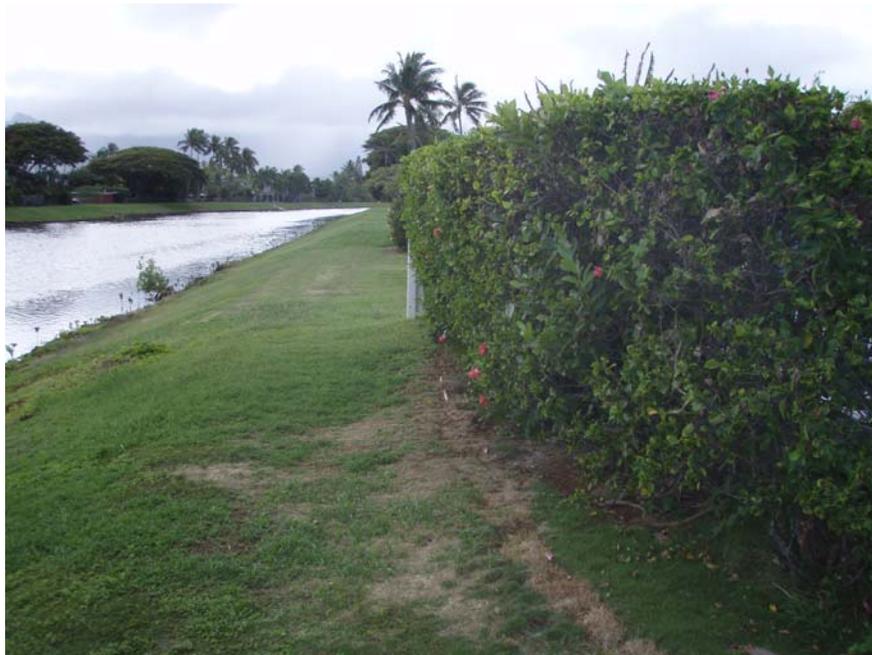
pp. Sta. 46+37, LB, remove unauthorized encroachments: fence, bush and sprinkler system, within maintenance easement.

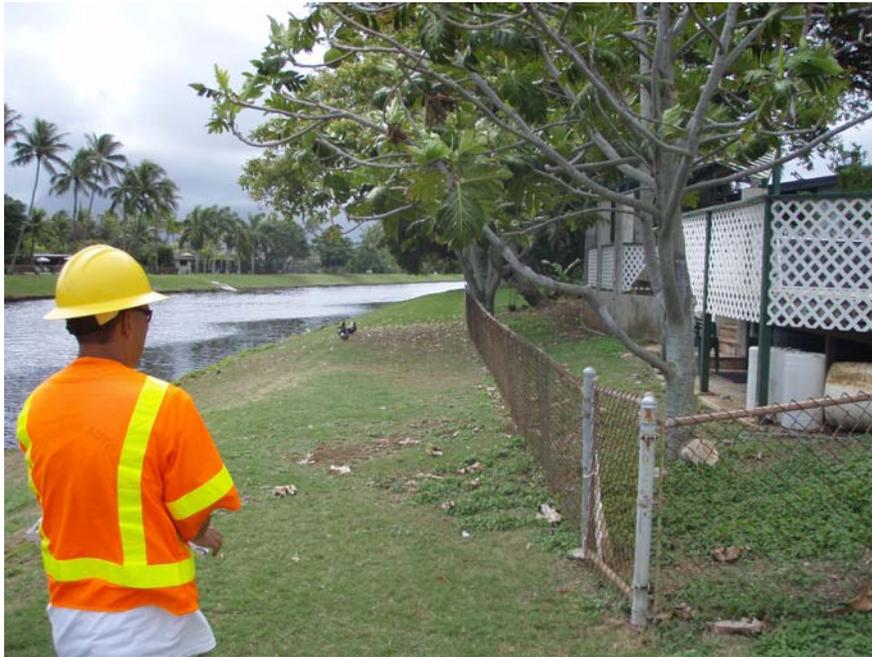
qq. Sta. 51+18, LB, remove unauthorized fence and tree within maintenance easement.

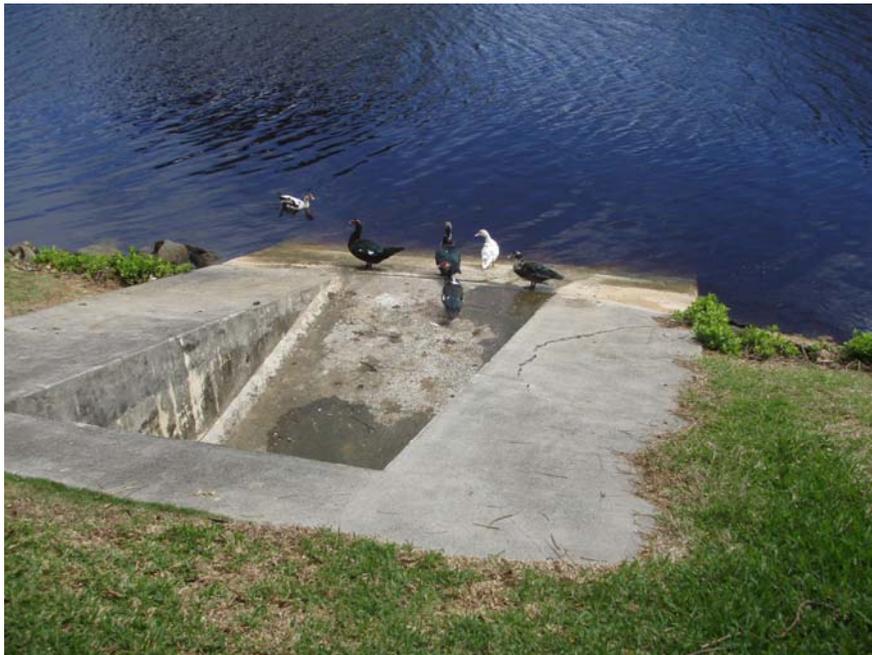
rr. Sta. 52+75 (verify station), LB, 4' x 6' Box Culvert, remove woody vegetation and repair cracks in the concrete.

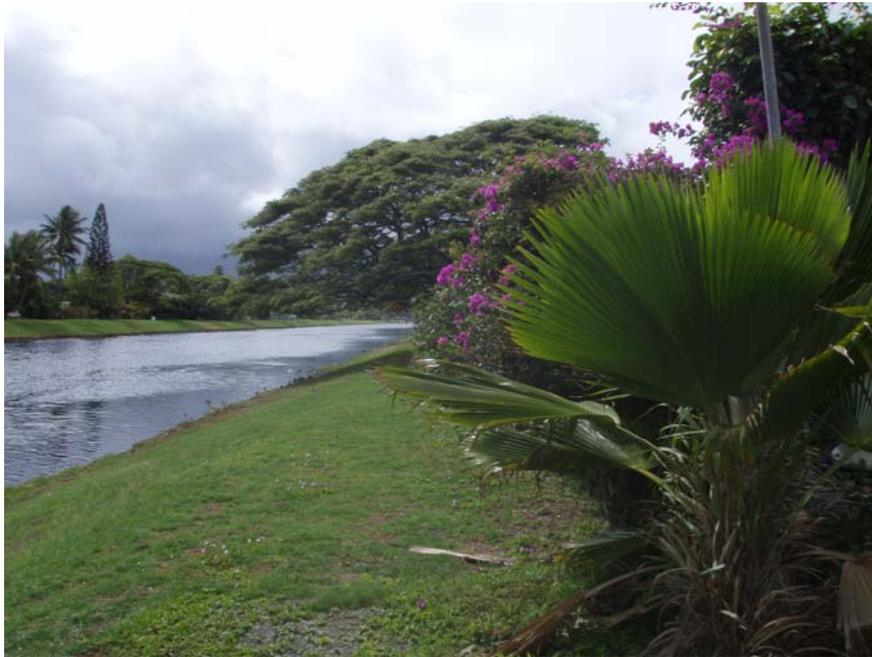
ss. Sta. 54+44, LB, cut back woody vegetation within maintenance easement.

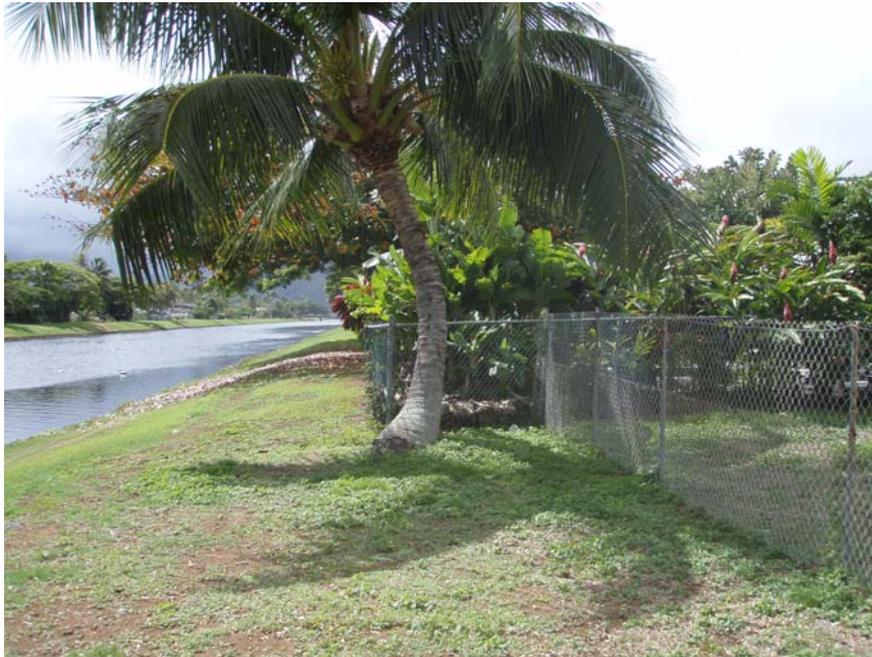
uu. Sta. 57+00, LB, verify maintenance easement. Remove tree and fence if within the easement.

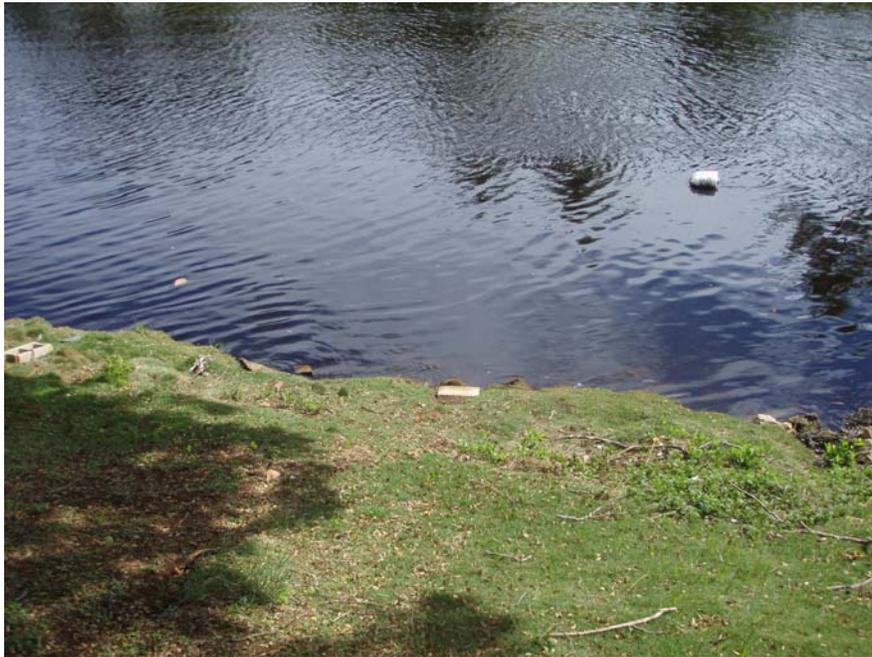
ww. Sta. 58+75, LB, remove unauthorized concrete block at toe.

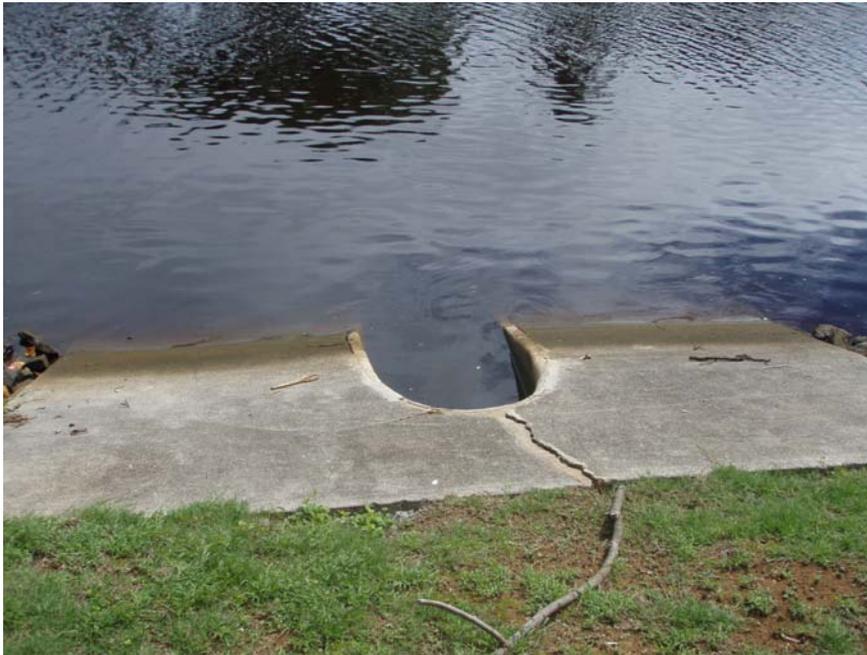
yy. Sta. 60+85, LB, 42" Drain outlet, repair cracks in concrete.

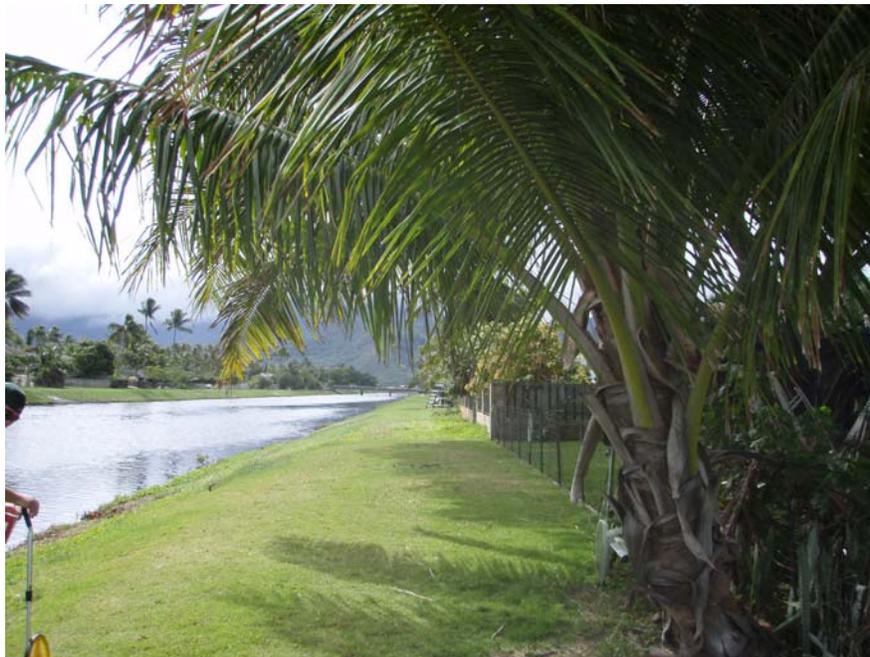
zz. Sta. 63+87, LB, remove palm tree within maintenance easement.

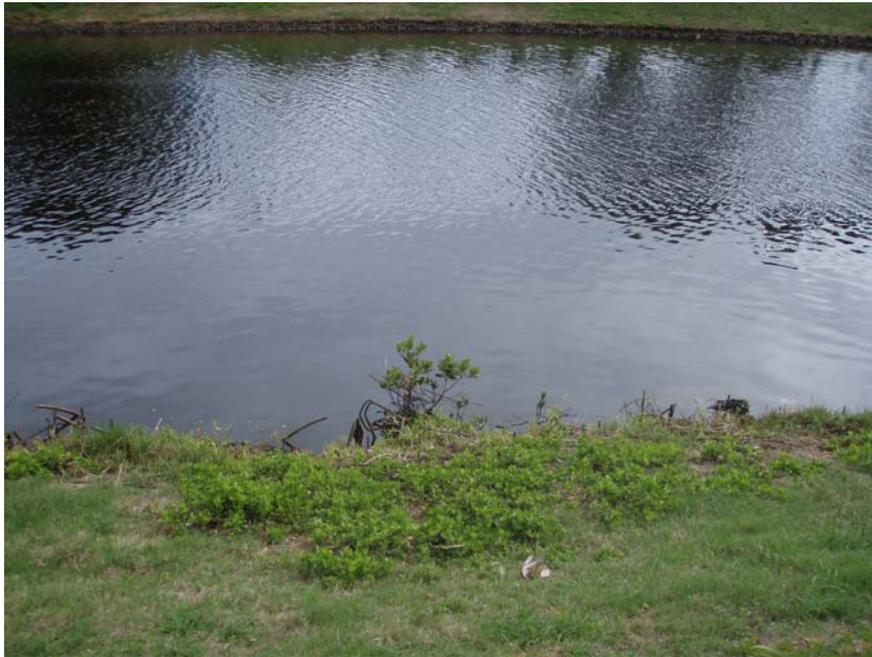
aaa. Sta. 64+13, LB, remove mangrove plant.

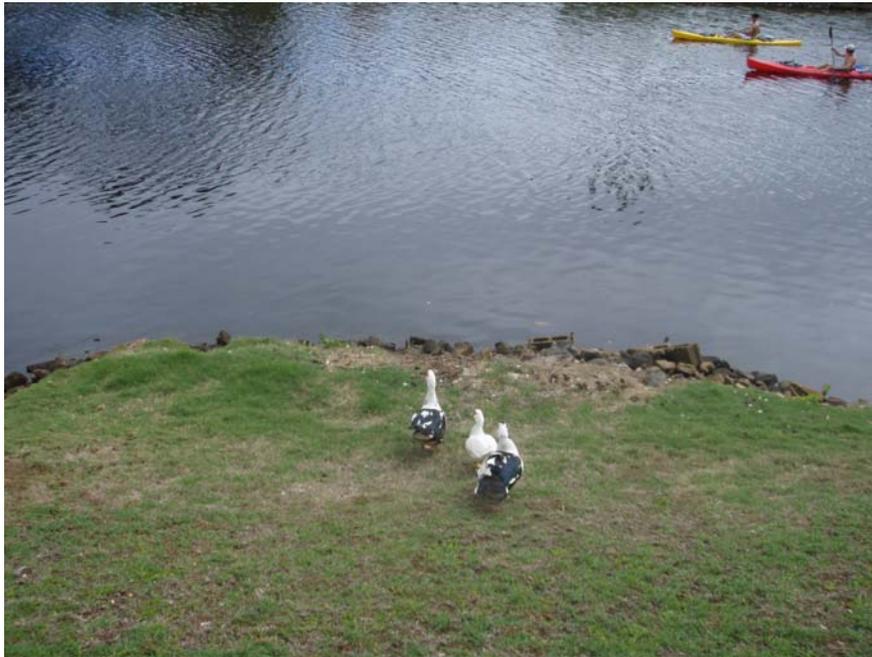
ccc. Sta. 66+63, LB, remove unauthorized fill and restore to match existing.

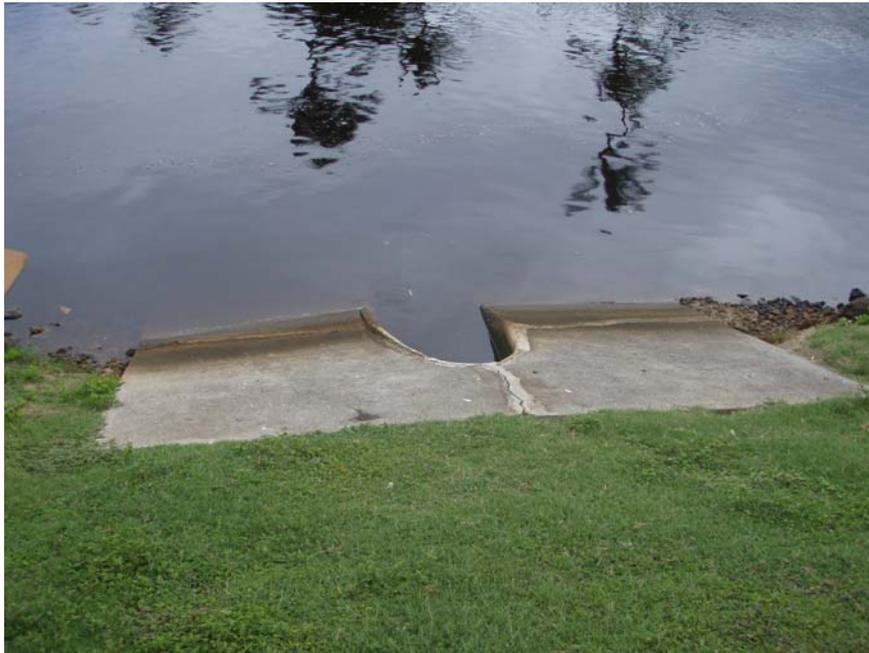
ddd. Sta. 69+60, LB, 36" pipe outlet, monitor settlement and repair cracks in the concrete.

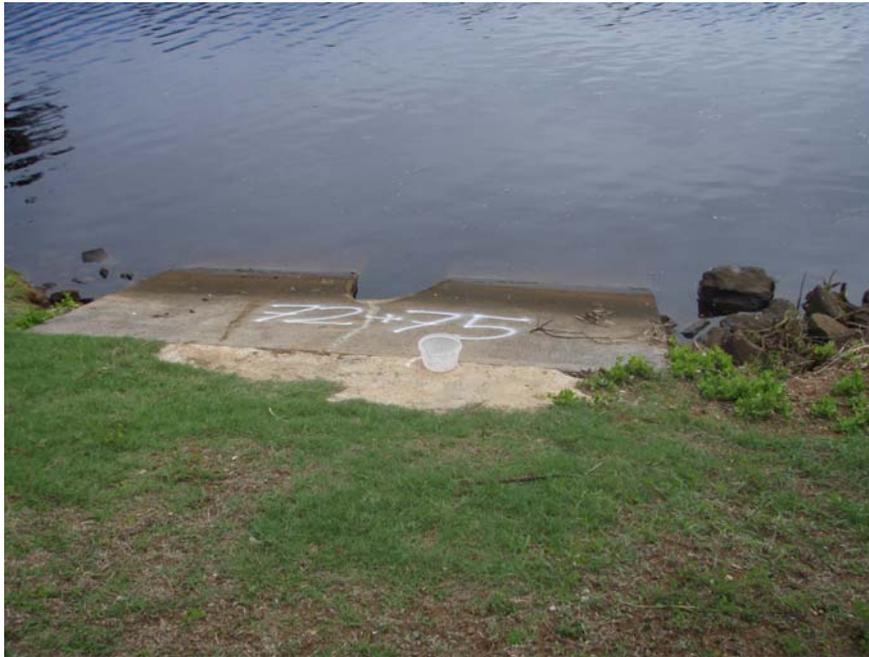
eee. Sta. 72+75, LB, 24" Pipe outlet, add material to scoured area around the outlet.

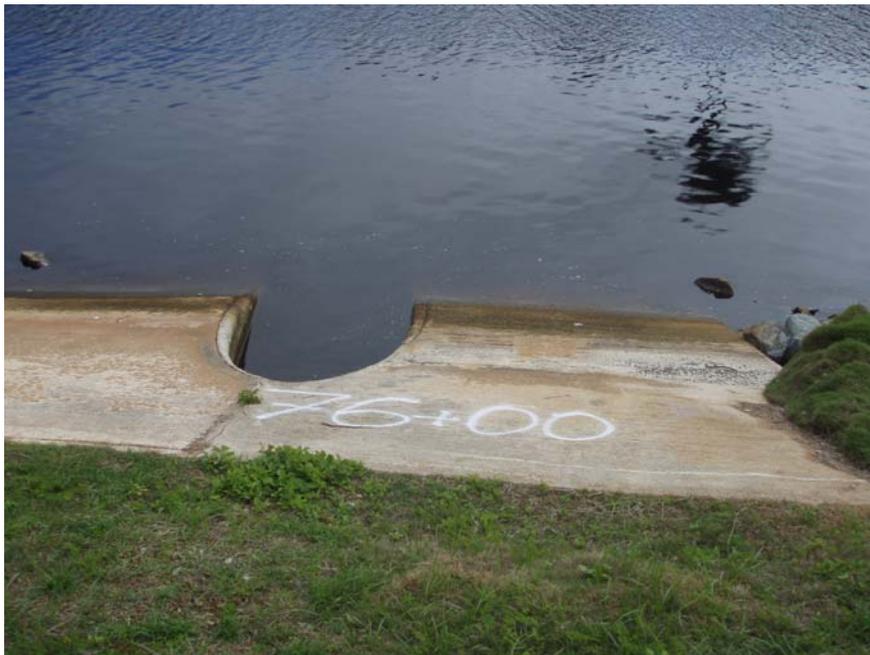
hhh. Sta. 76+00, LB, 42" drain outlet, repair cracks in the concrete.

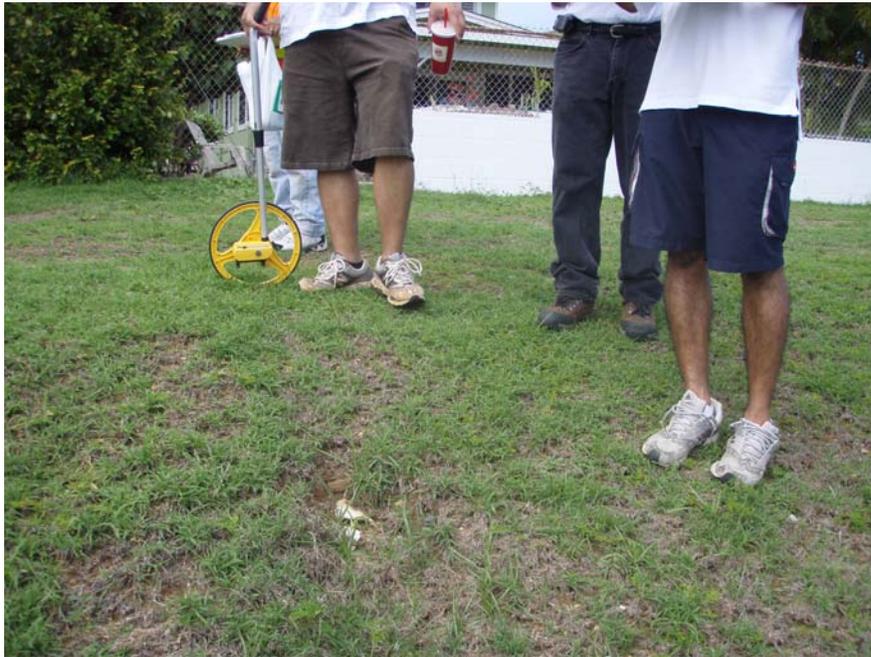
iii. Sta. 77+37, LB, remove unauthorized encroachment, 4" PVC pipe.

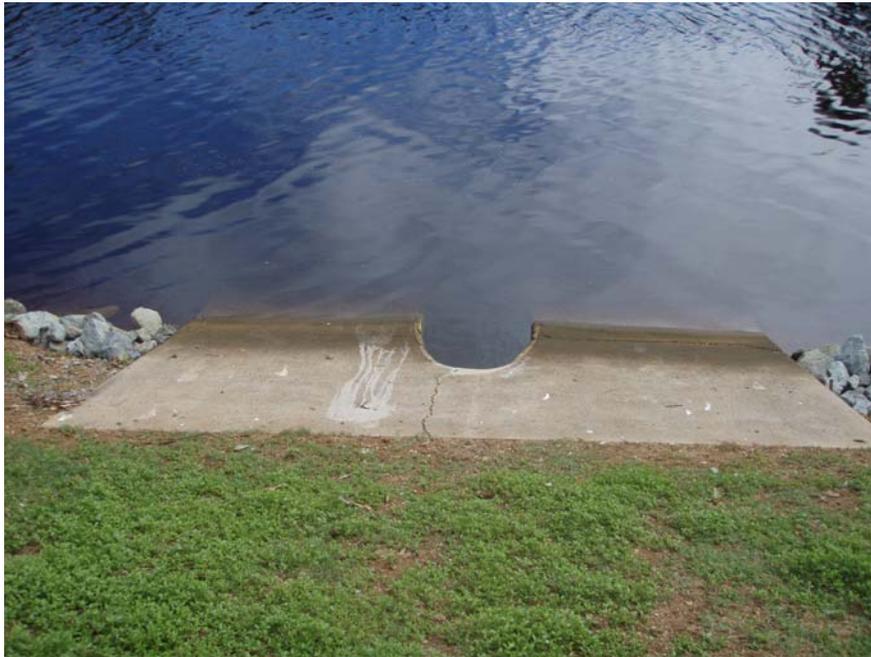
kkk. Sta. 80+78, LB, repair cracking culvert face.

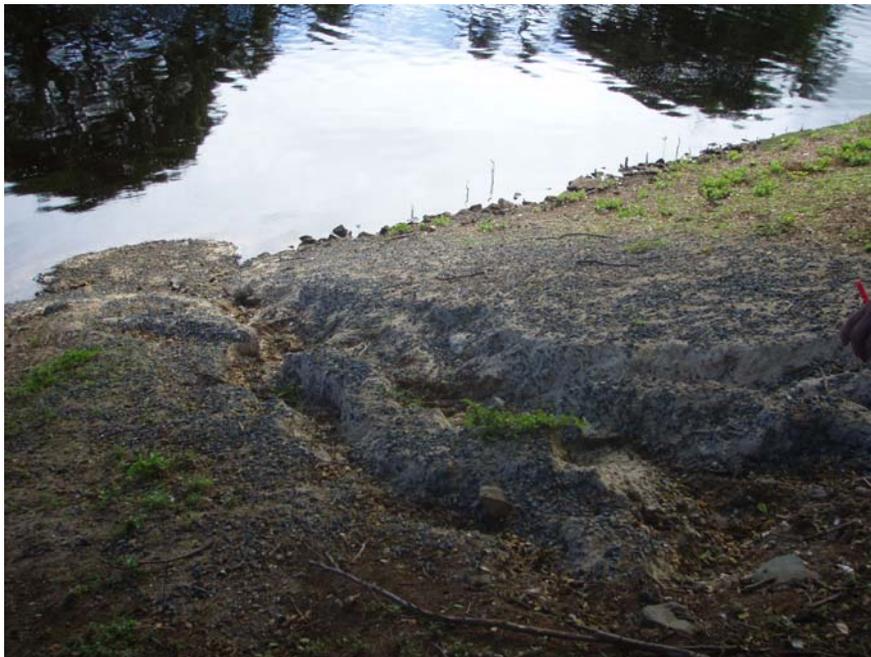
lll. Sta. 83+81, LB, re-establish eroded side slope.

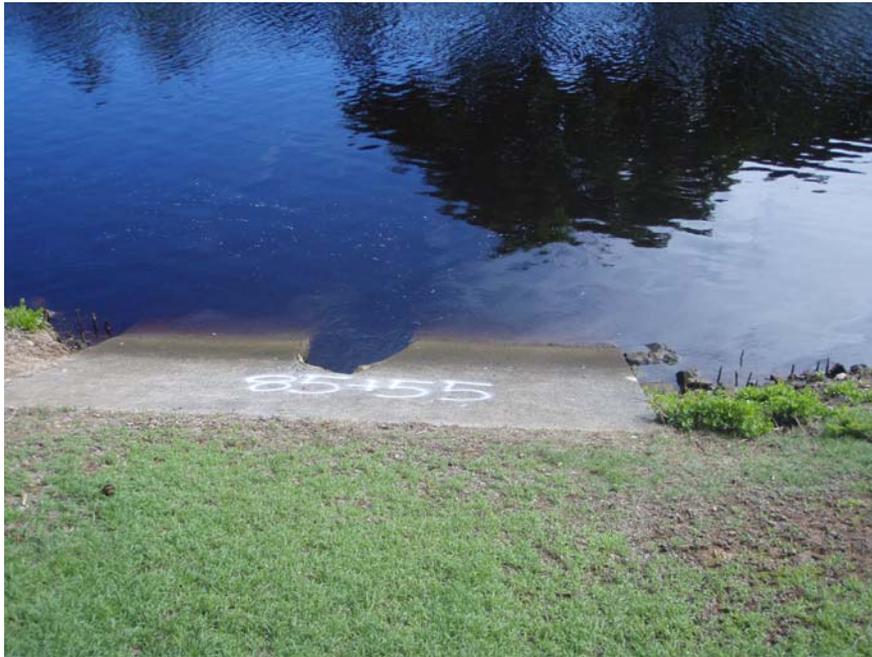
mmm. Sta. 85+55, LB, 36" Pipe Outlet, repair cracked concrete.

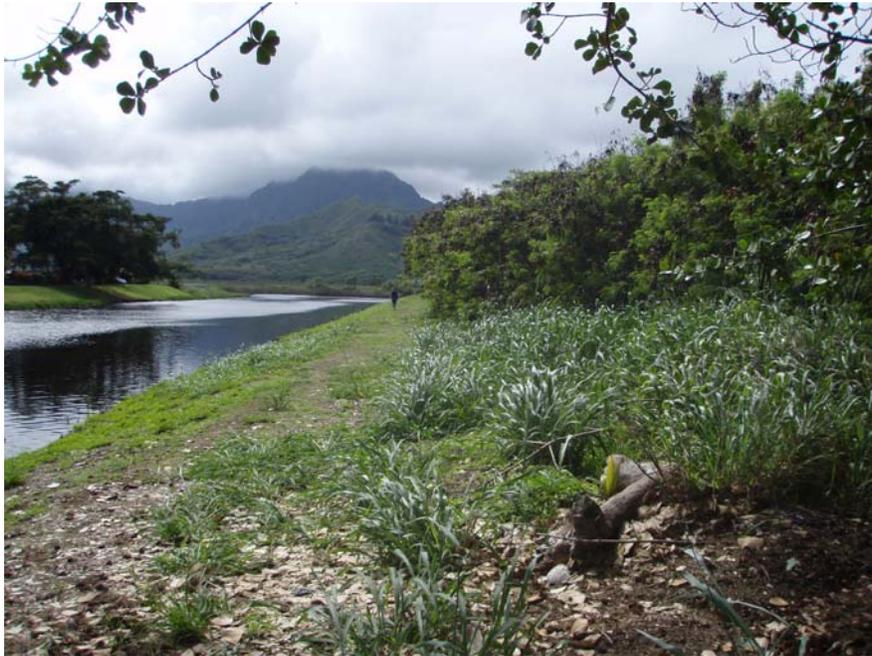
nnn. Sta. 86+40, LB, end of project. Verify maintenance easement and re-establish.
