POST STORM EVENT REPORT - TYPHOON PONGSONA

FOR SHORE PROTECTION PROJECT

Honolulu Engineer District

1. Project Name: Asquiroga SPP
2. Date of Inspection: December 22, 2002
3. Inspection Personnel:

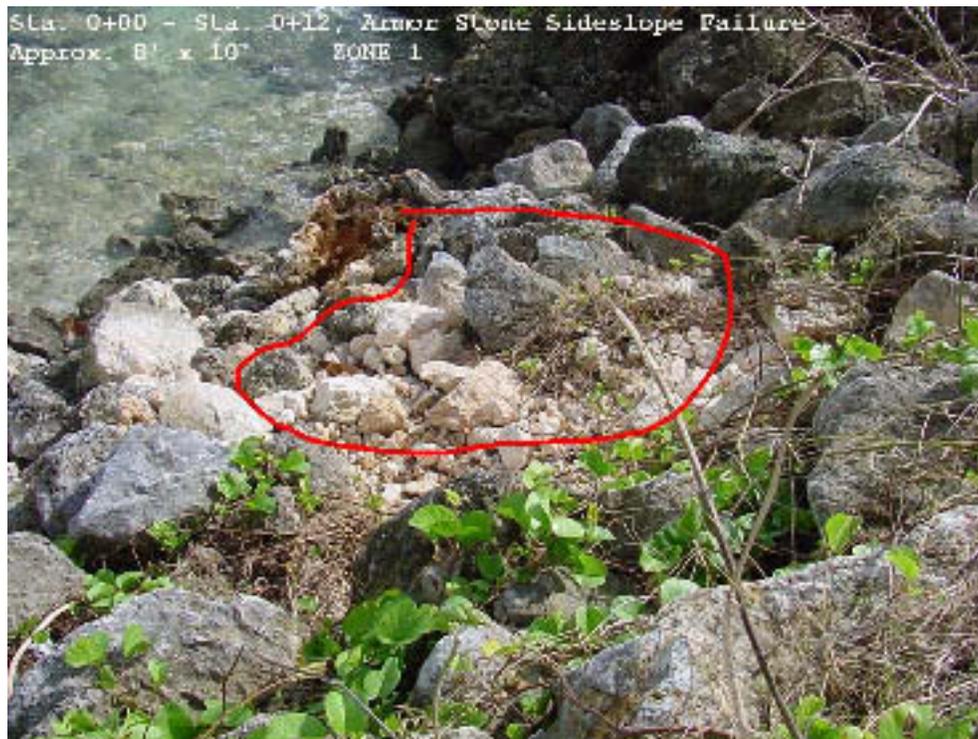
a. Sta. 0+00 - Sta. 0+12, Armor Stone missing, Sideslope Failure (SSF), Zone # 2.

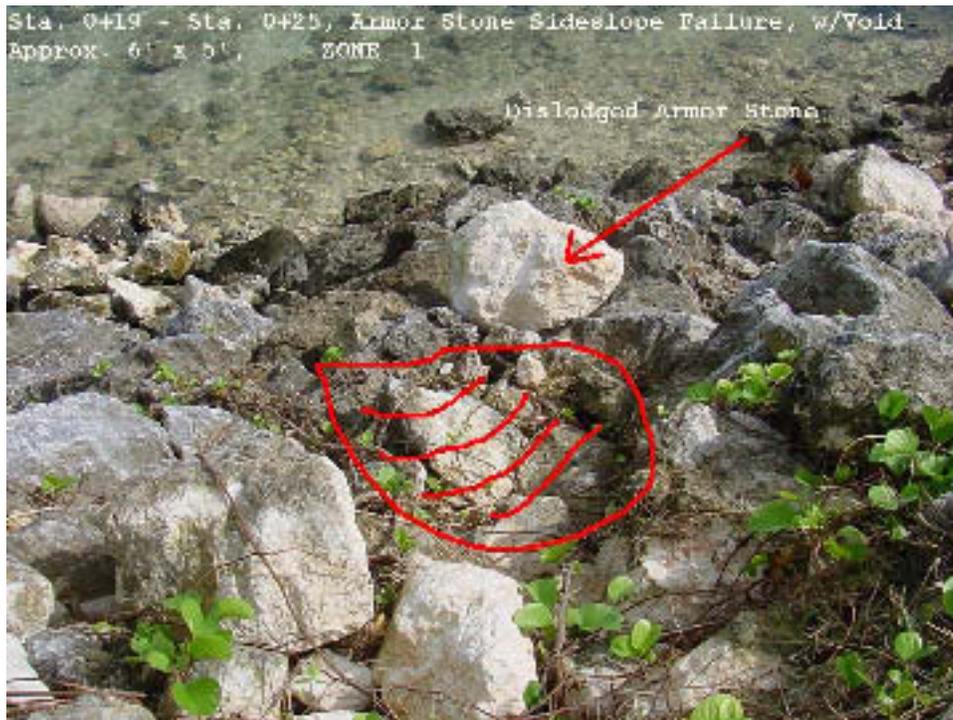
b. Sta. 0+19 - Sta. 0+25, SSF dislodged armor stone and void Zone # 2.

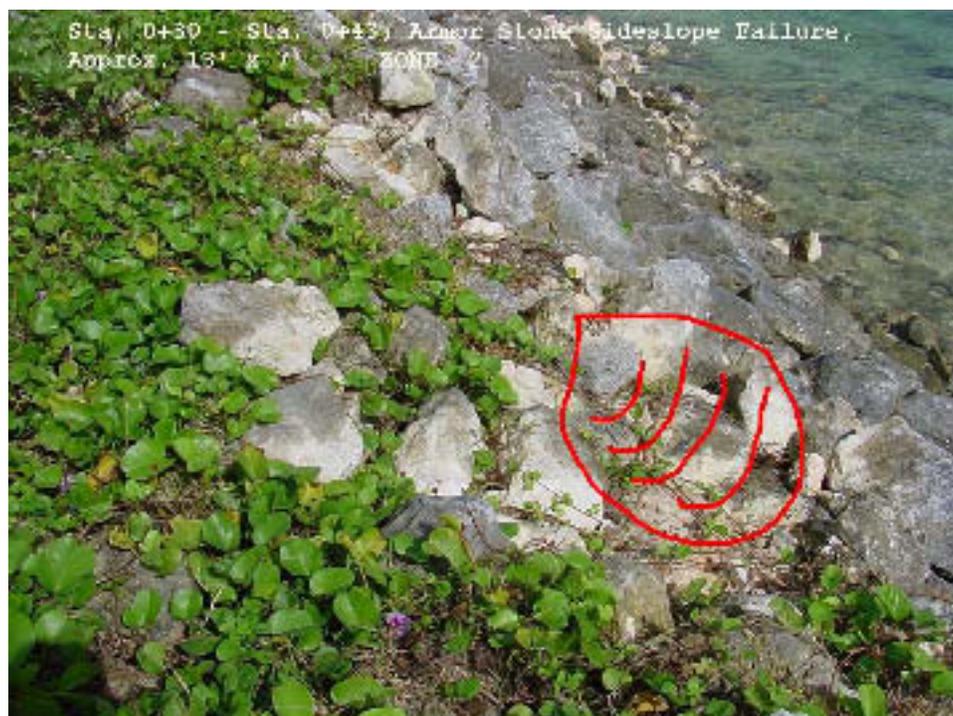
c. Sta. 0+30 - Sta. 0+43, SSF dislodged armor stone and void,

Zone # 2.

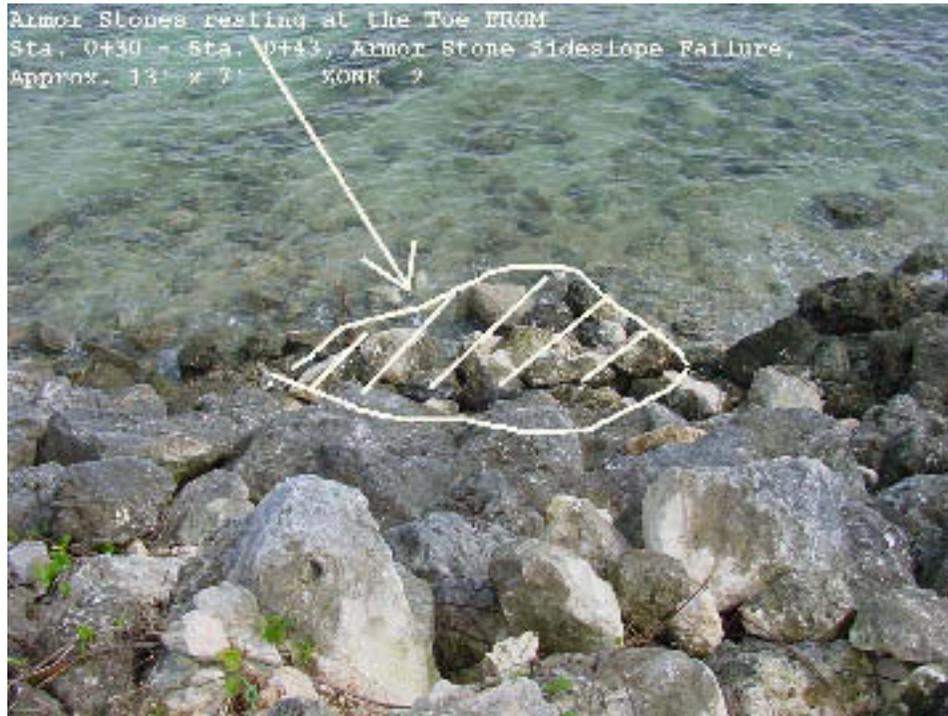
c-1. Material from above SSF location, Zone # 3.

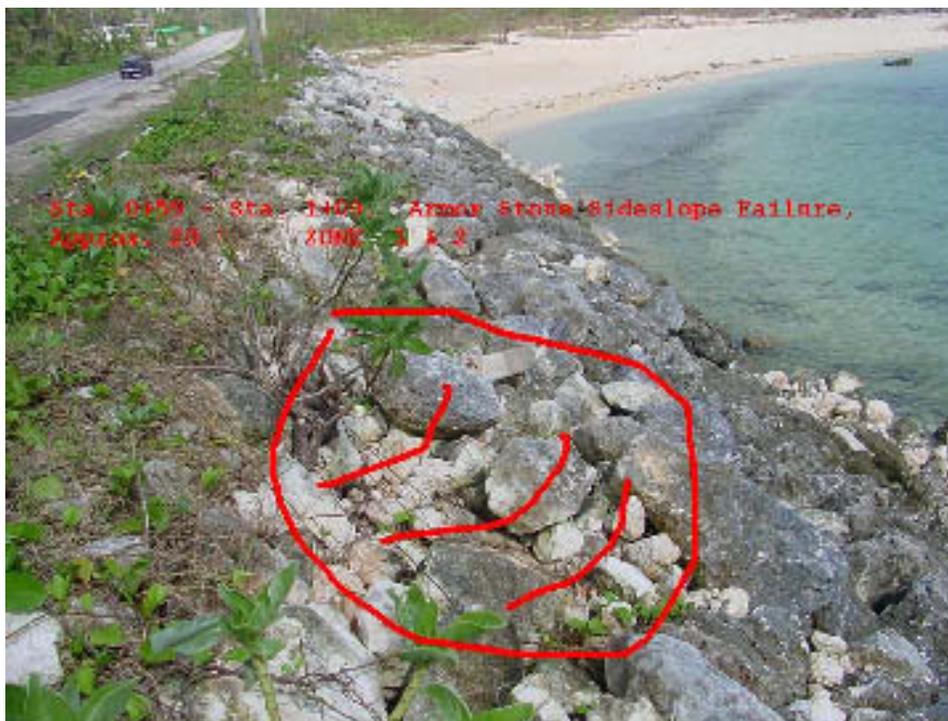
d. Sta. 0+59 - Sta. 1+09, SSF, Zone # 1.

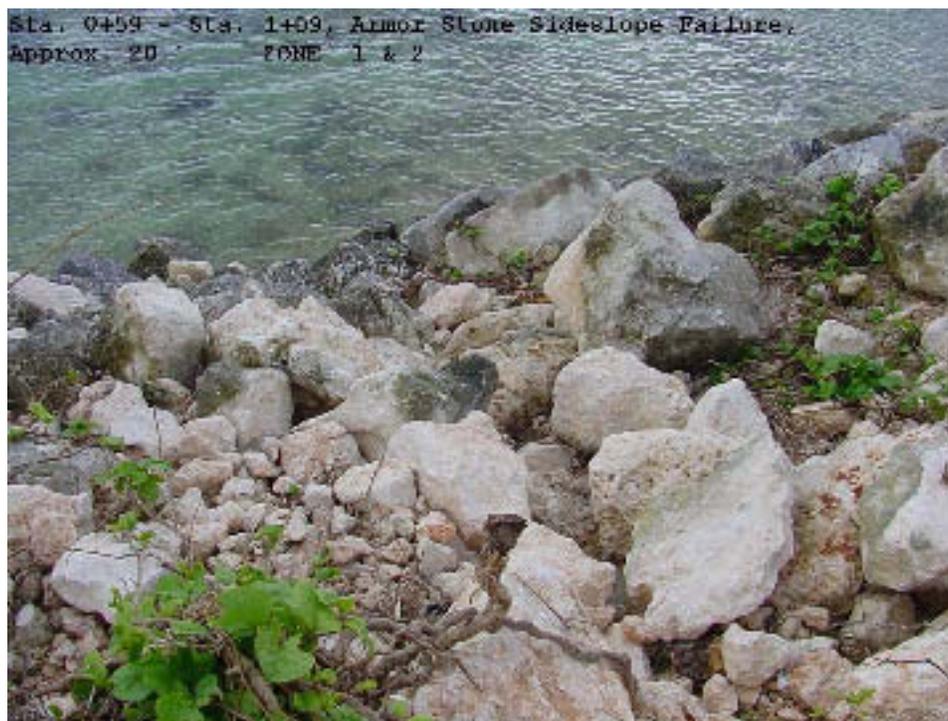
e. Sta. 0+59 - Sta. 1+09, SSF, Zone # 2.

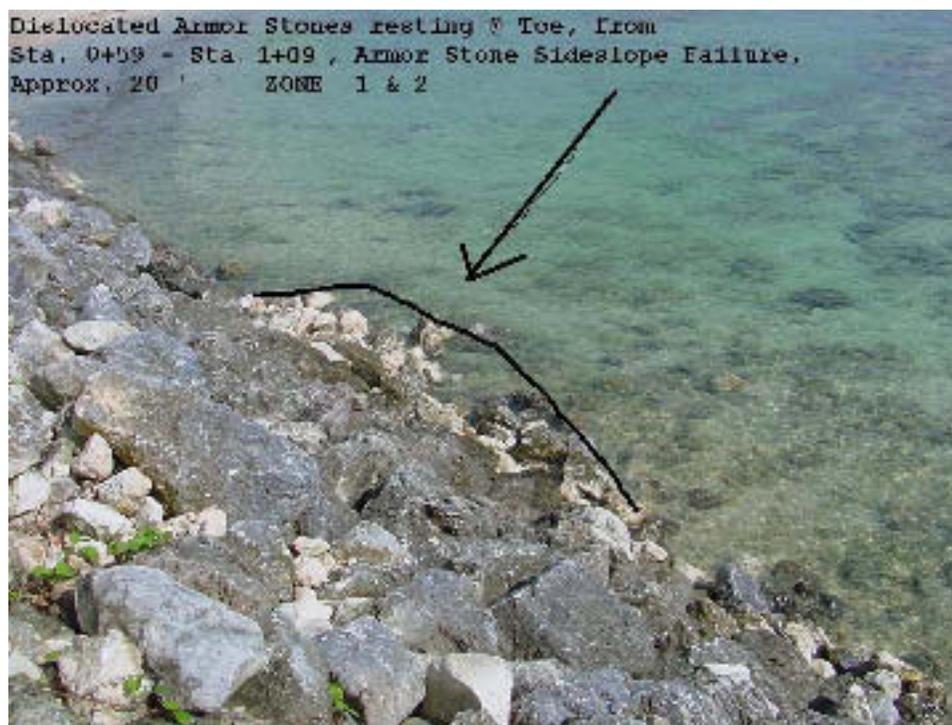
e-1. Material from above SSF location, Zone # 3.

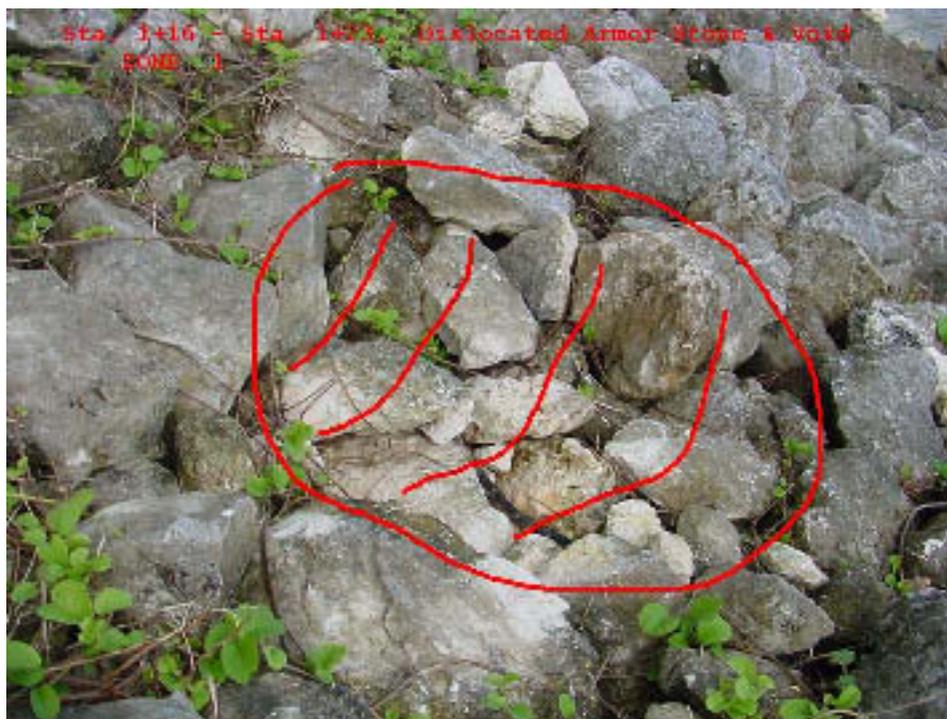
f. Sta. 1+16 - Sta. 1+23, SSF, Armor stone missing, void, Zone # 1.

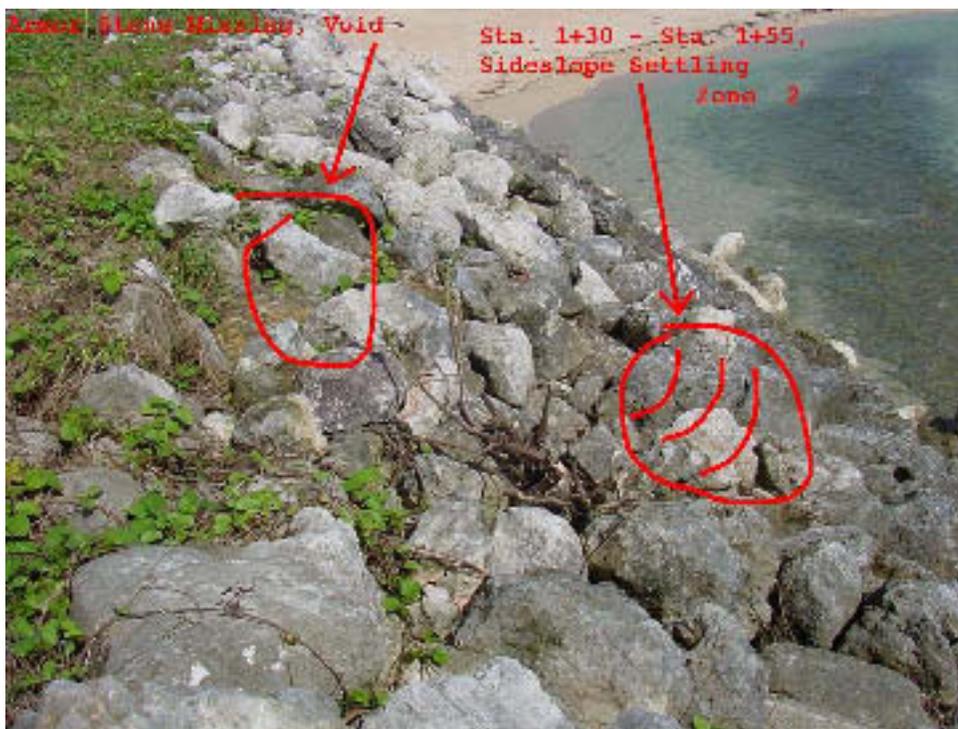
g. Sta. 1+30 - Sta. 1+55, Void in Zone # 1; Sideslope Settling

in Zone # 2.

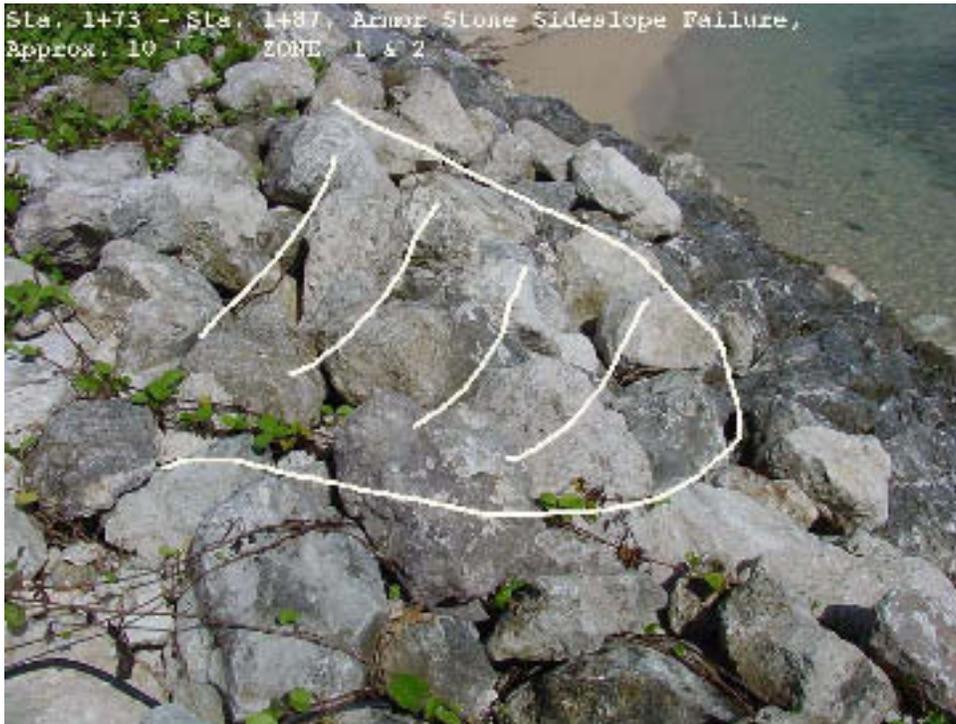
Sta. 1+73 - Sta. 1+87, Armor Stone Sideslope Failure,
Approx. 10' ZONE 1 & 2

h. Sta. 1+73 - Sta. 1+87, SSF, Zone #s 1 & 2.

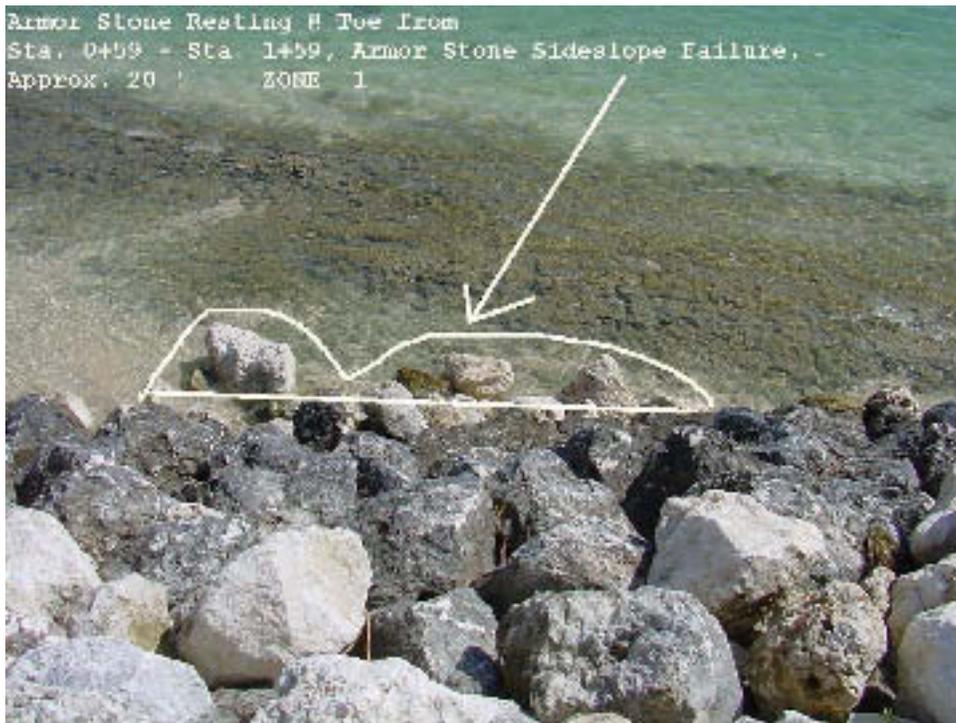
Armor Stone Resting # Toe from
Sta. 0+59 - Sta. 1+59, Armor Stone Sideslope Failure, -
Approx. 20' ZONE 1

h-1. Material from above SSF location, Zone # 3.

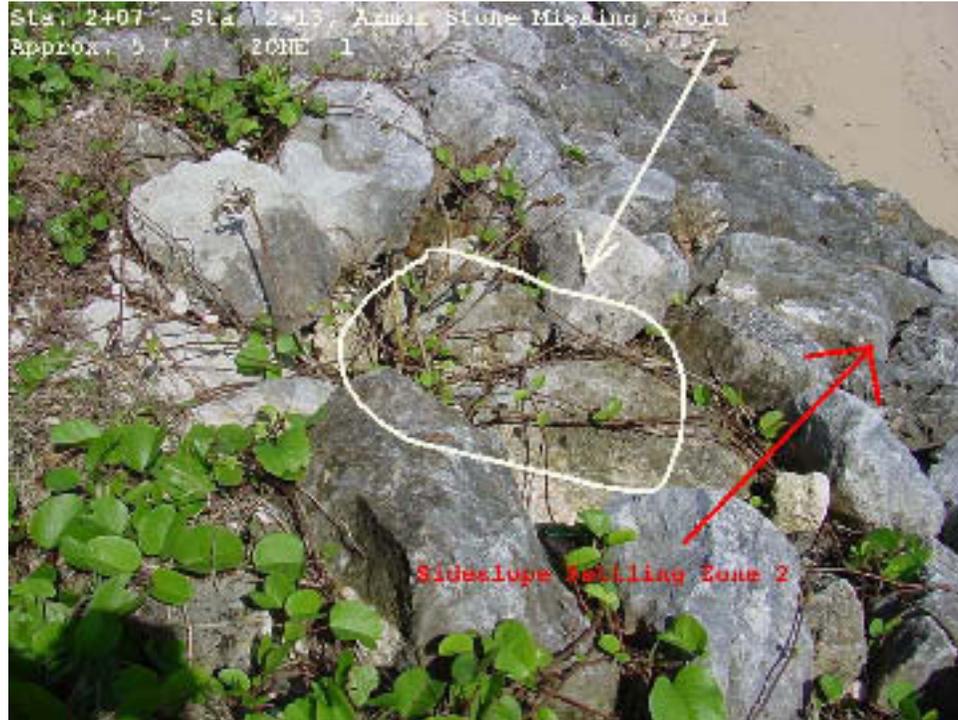
i. Sta. 2+07 - Sta. 2+13, Missing armor stone, void, Zone # 1;
Sideslope Settling Zone # 2.

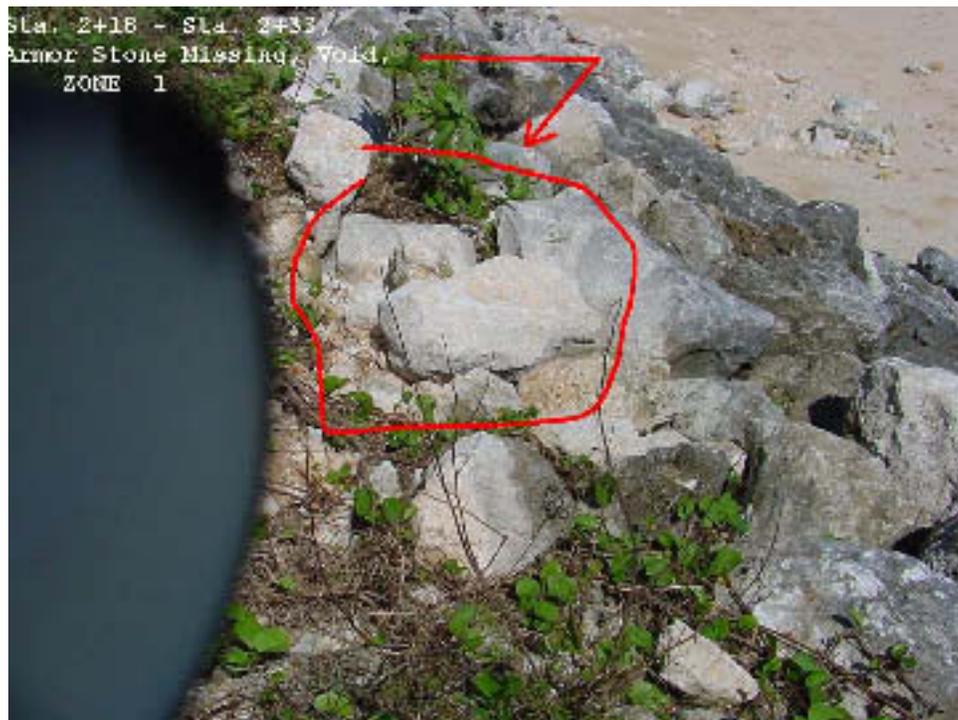
j. Sta. 2+18 - Sta. 2+33, Missing armor stone, Zone # 1.
Sta. 2+61 - Sta. 2+87, Armor Stone Sideslope Failure, BREACH
Approx. 26' ZONE 1, 2, & 3

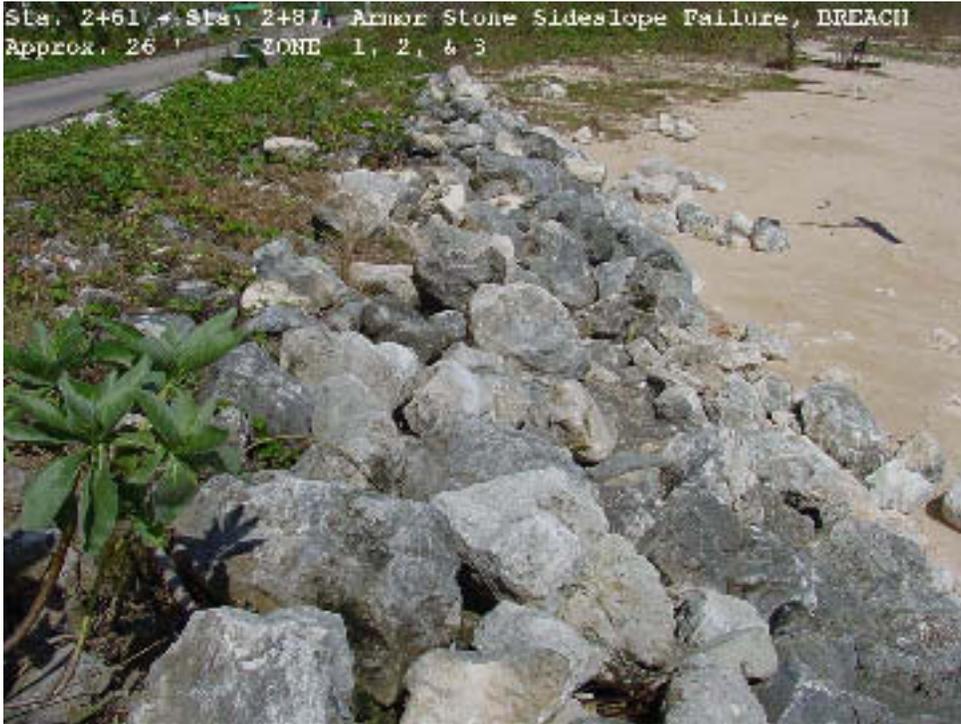
k. Sta. 2+61 - Sta. 2+87, Breach, SSF, Zones 1, 2 & 3.

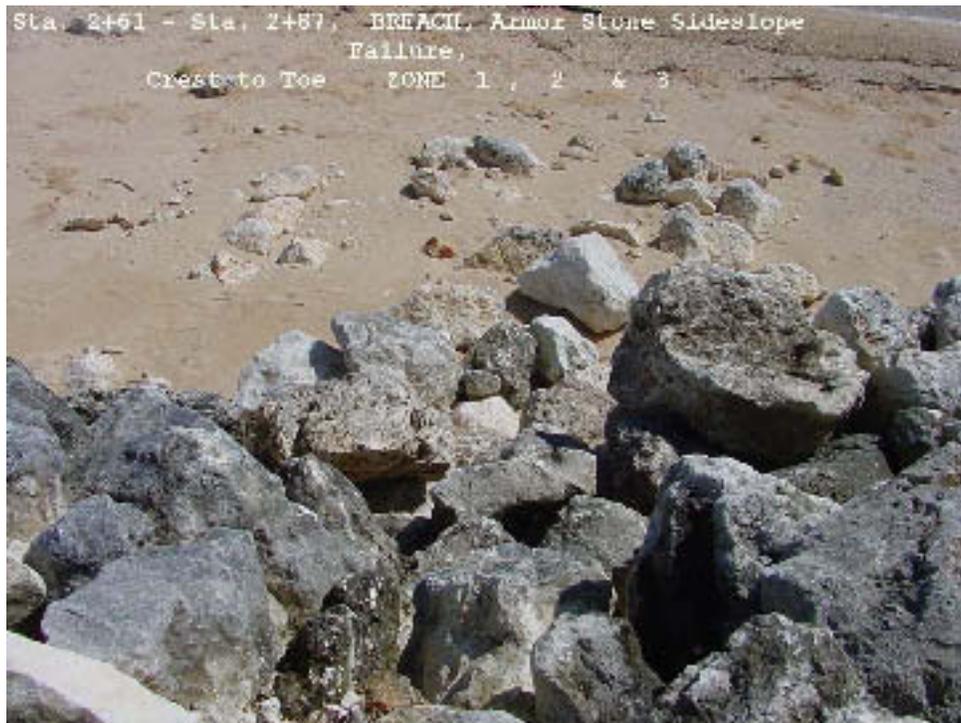
k-1. Material from above SSF location, Zone # 3.

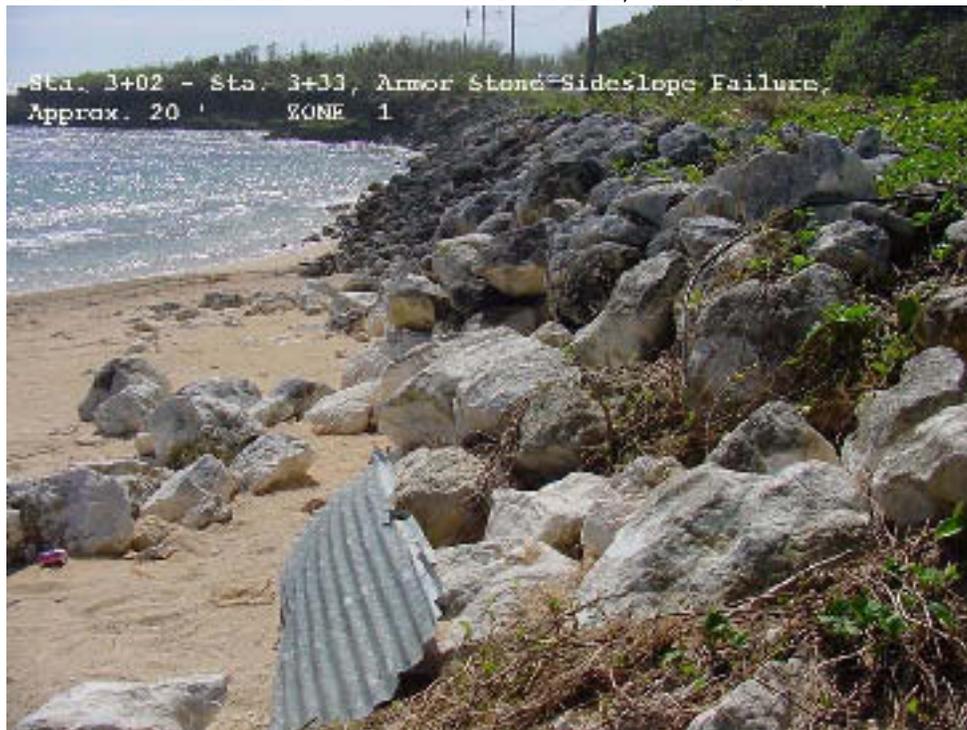
1. Sta. 3+02 - Sta. 3+33, SSF, Zone # 1.
