## CONTINUING ELIGIBILITY INSPECTION (CEI) REPORT

FOR FLOOD CONTROL WORKS

1. Project Name: Kahoma Stream FCP

2. Date of Inspection: October 31, 2003

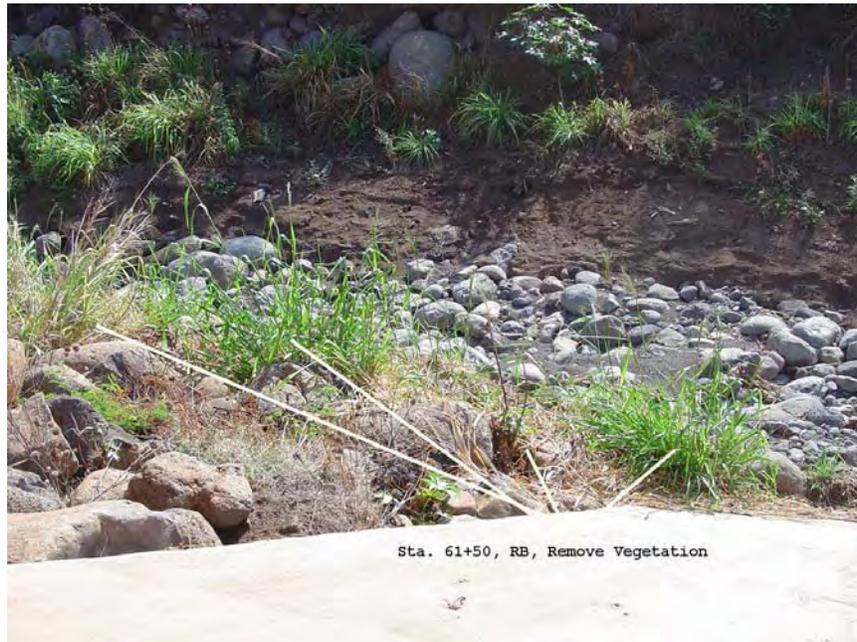
- a. Sta. 61+50, remove vegetation from debris basin.

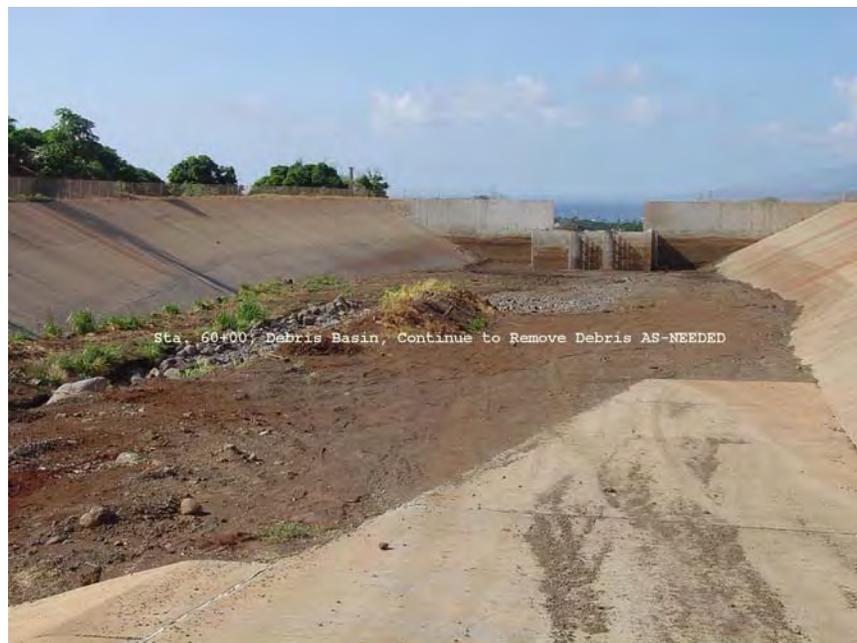
- b. Sta. 60+00, debris basin, re-grade eroded channel toe and remove sediment pileup from basin.

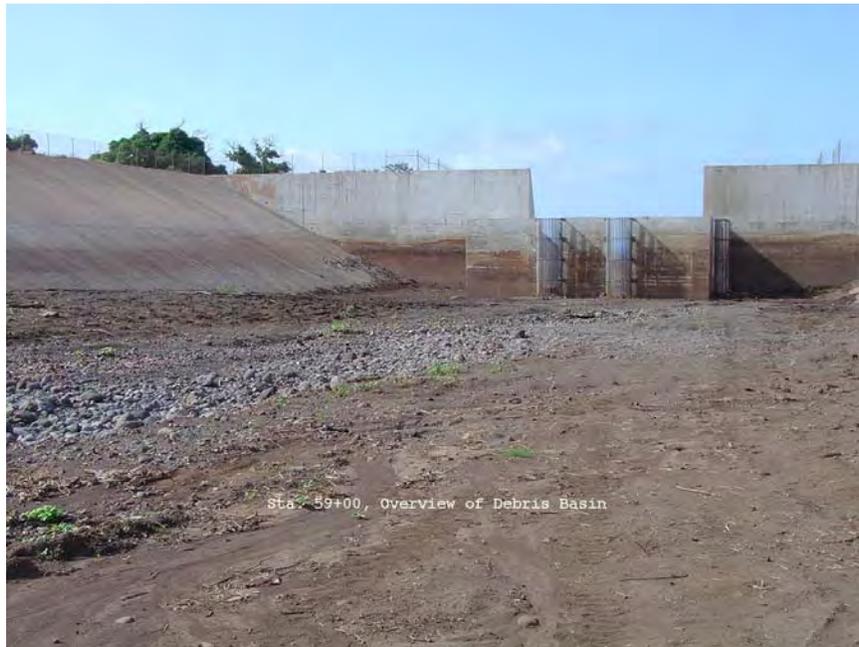
c. Sta. 59+00, debris basin, overview.

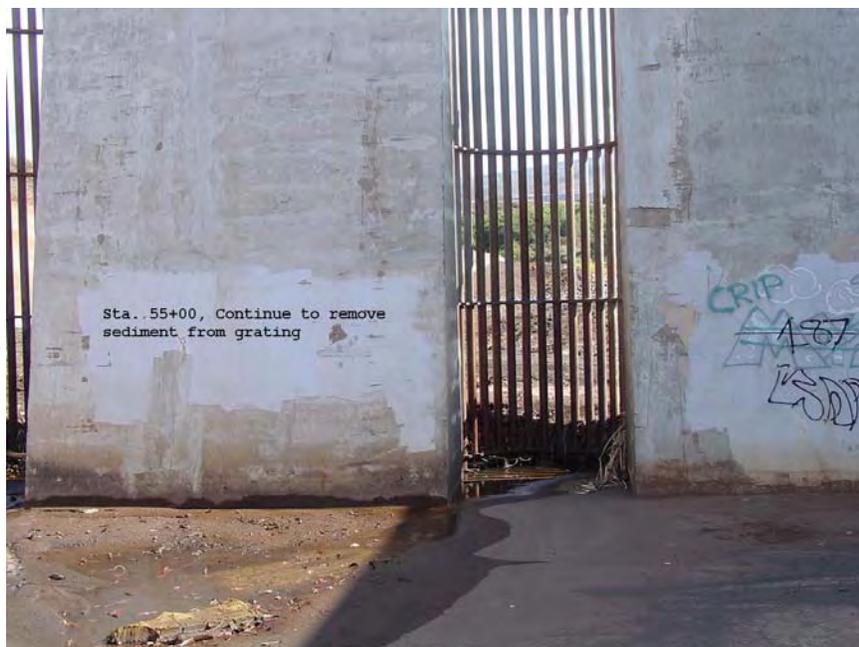
d. Sta. 55+00, debris basin, remove sediment from grating (typical).

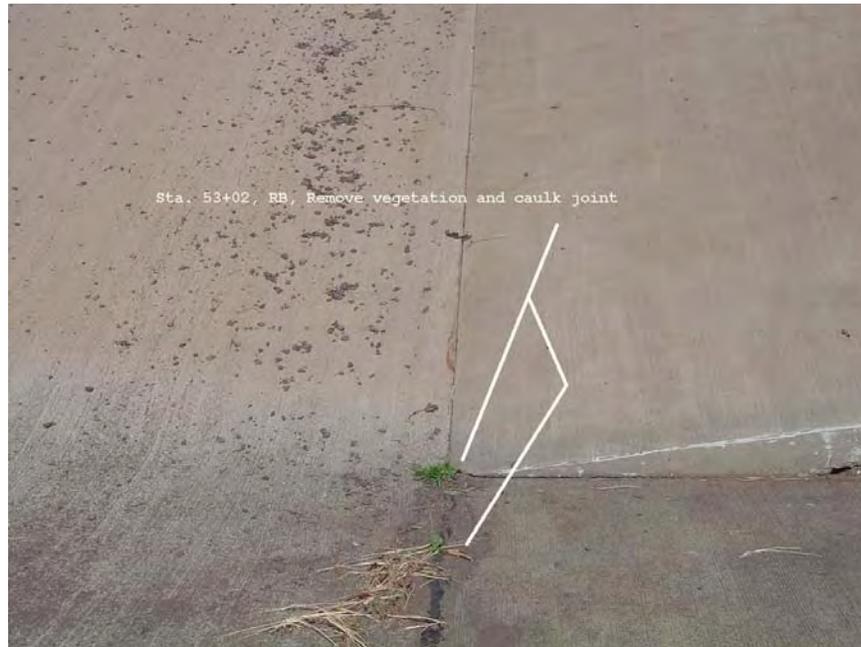
e. Sta. 53+02, remove vegetation and caulk concrete channel joint.  
(reference point)

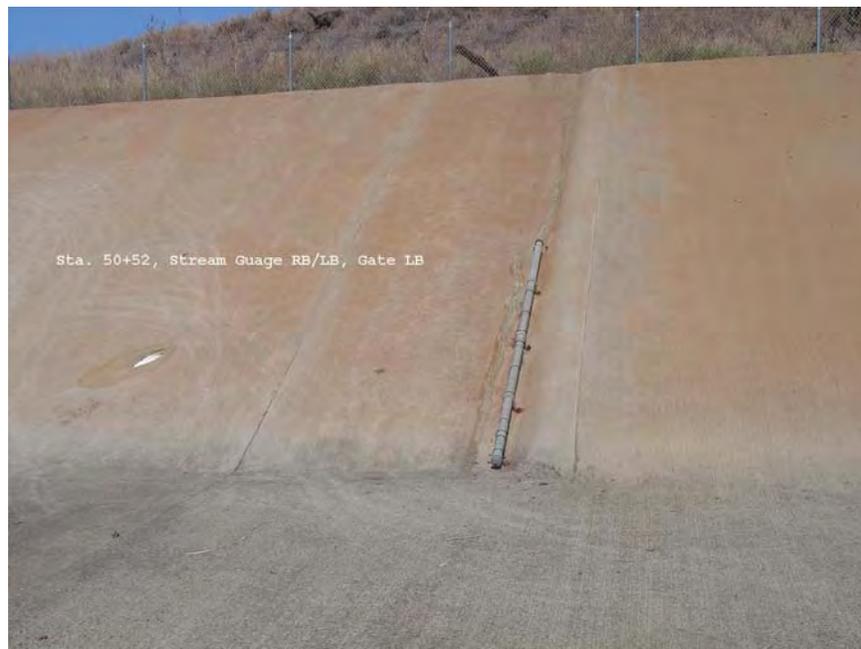
f. Sta. 50+52, Right Bank (RB), fence gate (LB) and stream gage  
reference point.

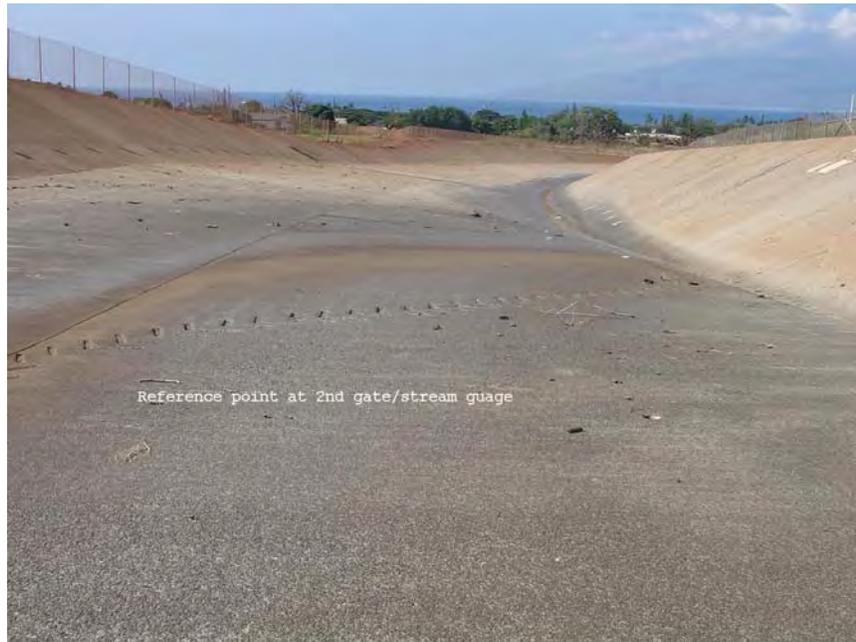
g. Sta. 49+00, Left Bank (LB), second stream gage and fence gate reference point.

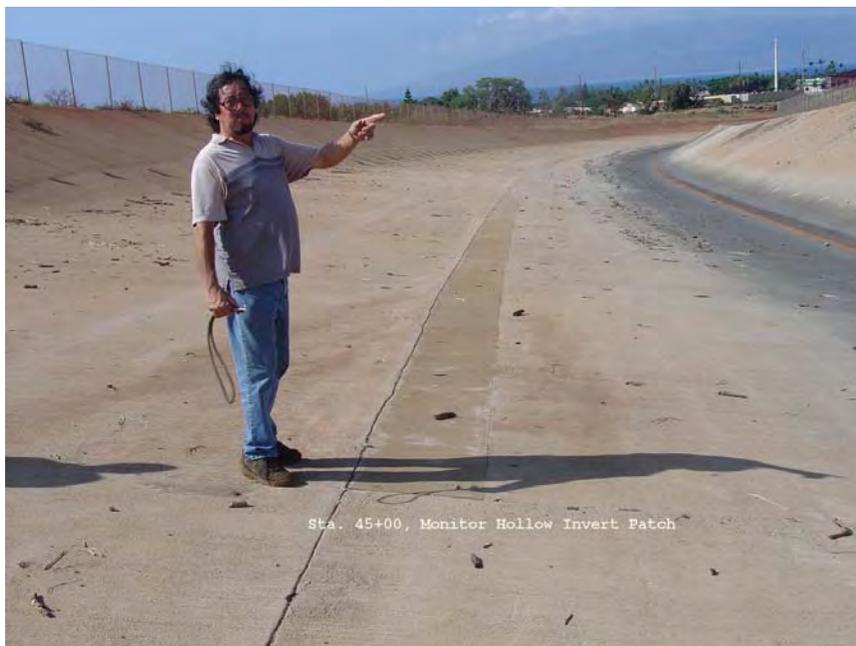
i. Sta. 45+00 to 42+49, channel, monitor hollow invert patch. Patch may have been a result of construction work to correct a late design change; moving grooved concrete swale.

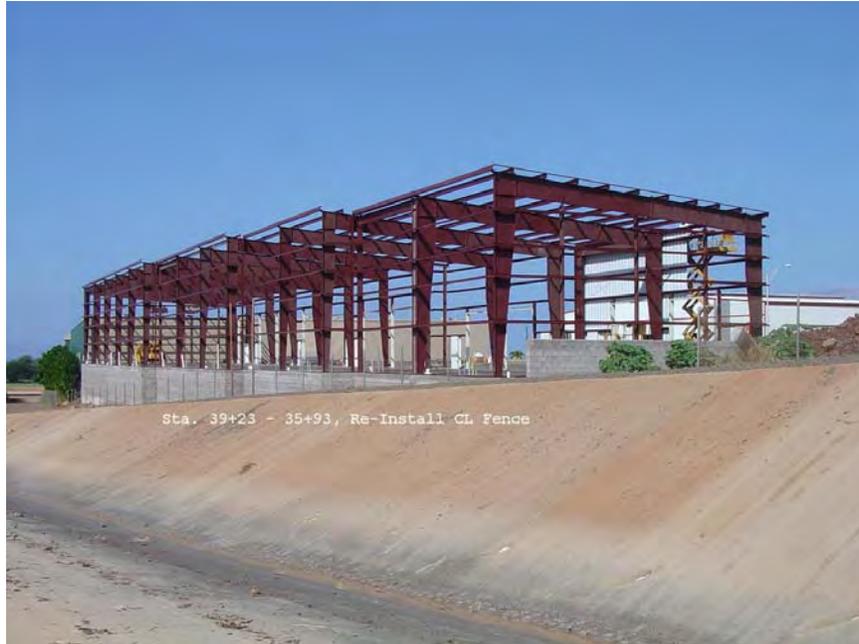
j. Sta. 39+23 to Sta. 35+93, RB, reinstall fencing as required.

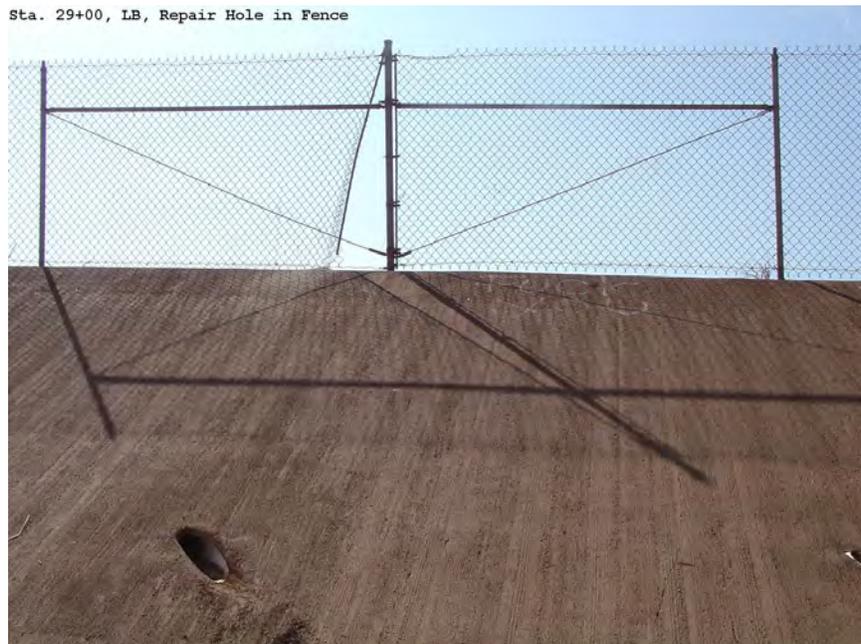
k. Sta. 29+00, LB, Re-hang Fencing.

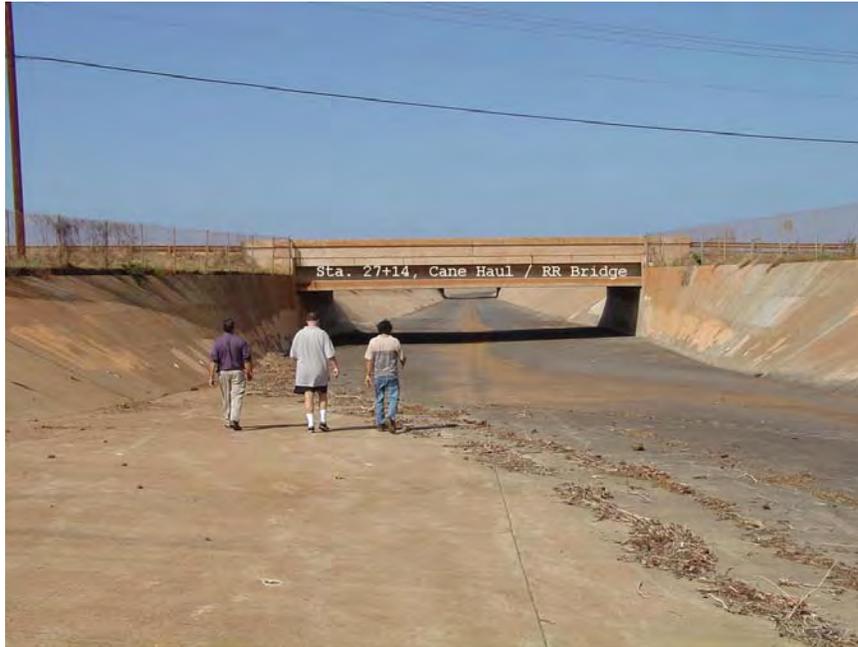
l. Sta. 27+14, Cane Haul Rd. Bridge. (reference photo)

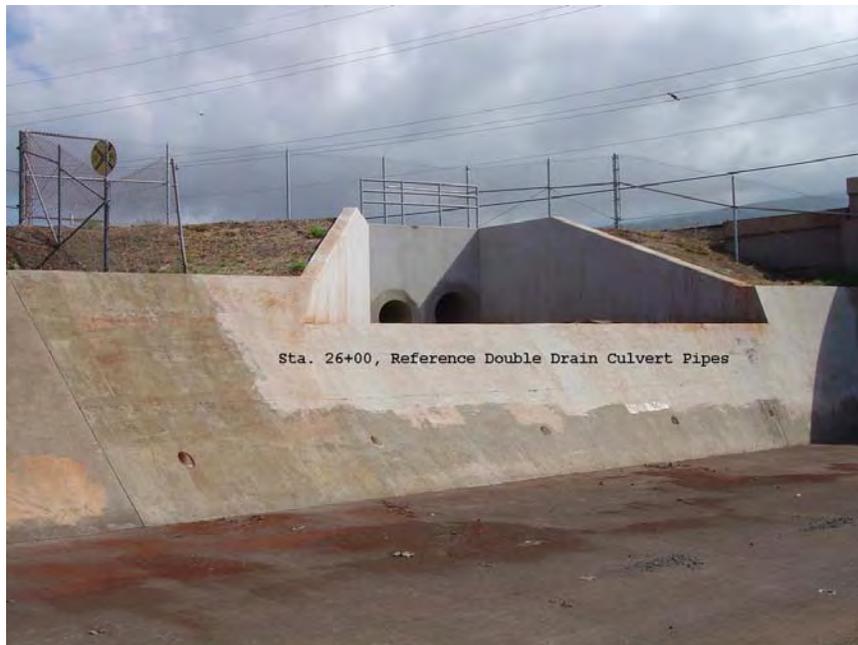
m. Sta. 26+00, RB, reference point of double drain pipes (RCP).

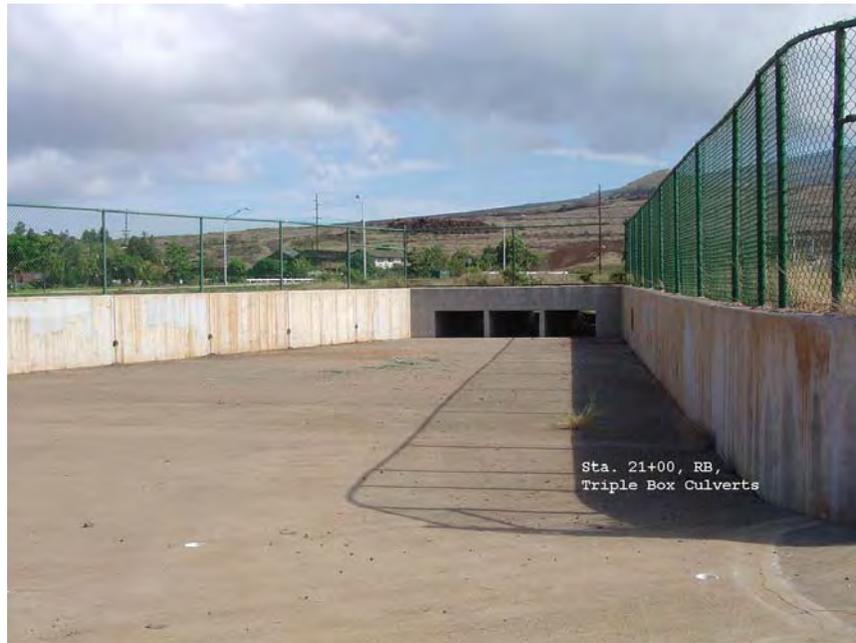
n. Sta. 21+00, RB, Triple Box Culvert, clean of debris.

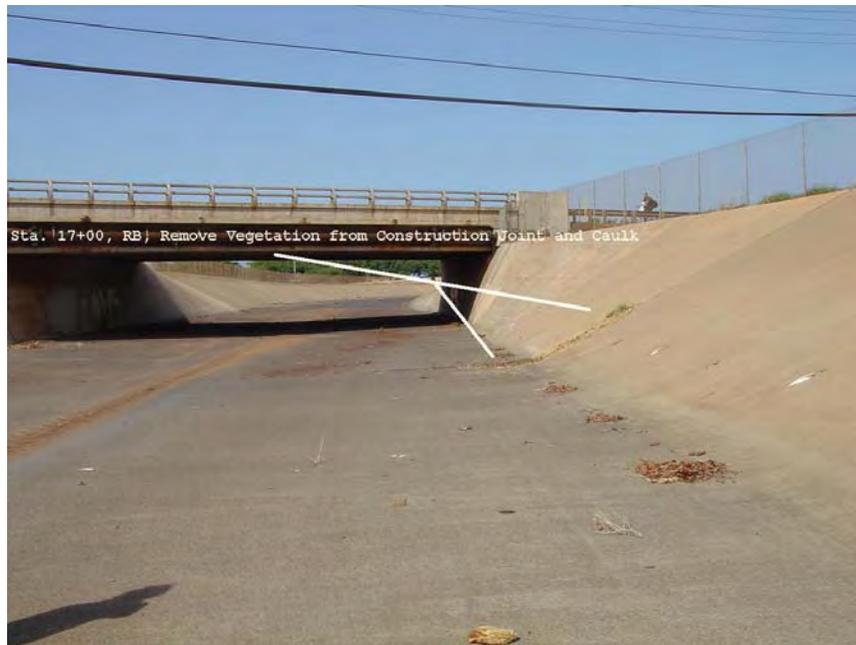
o. Sta. 17+00, RB Invert, Remove vegetation and caulk joint.

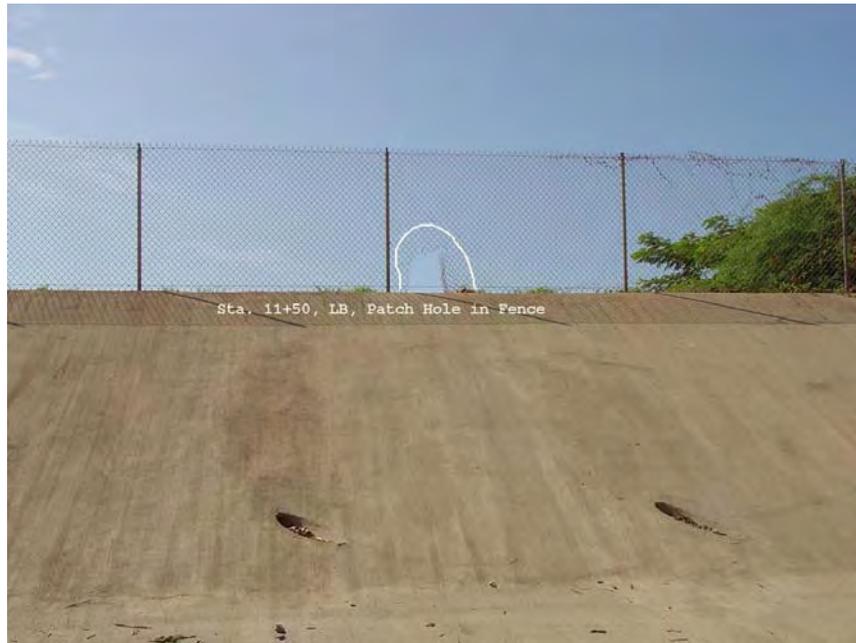
p. Approximate Sta. 11+50, LB, repair 2' diameter hole in fence.

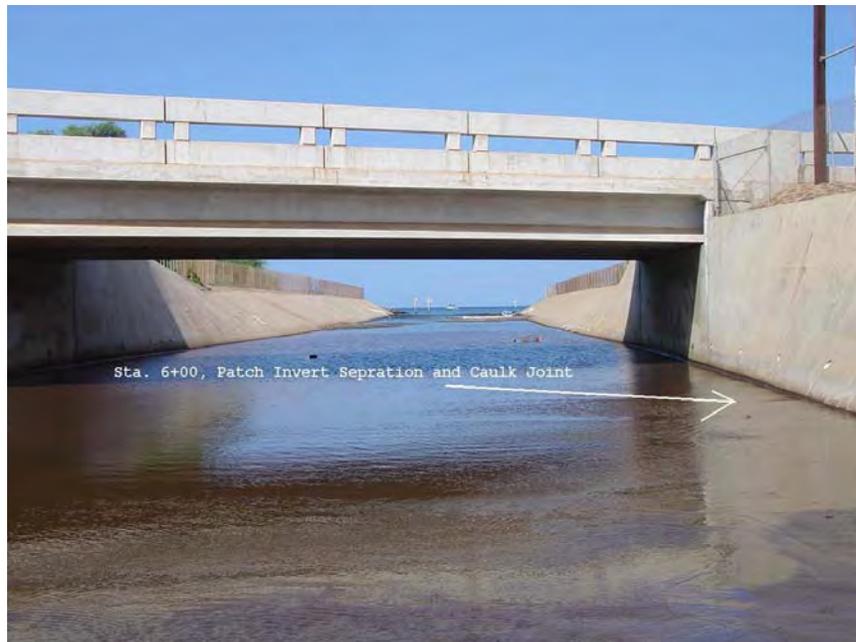
q. Sta. 6+00, RB, patch invert of channel separation and monitor closely.

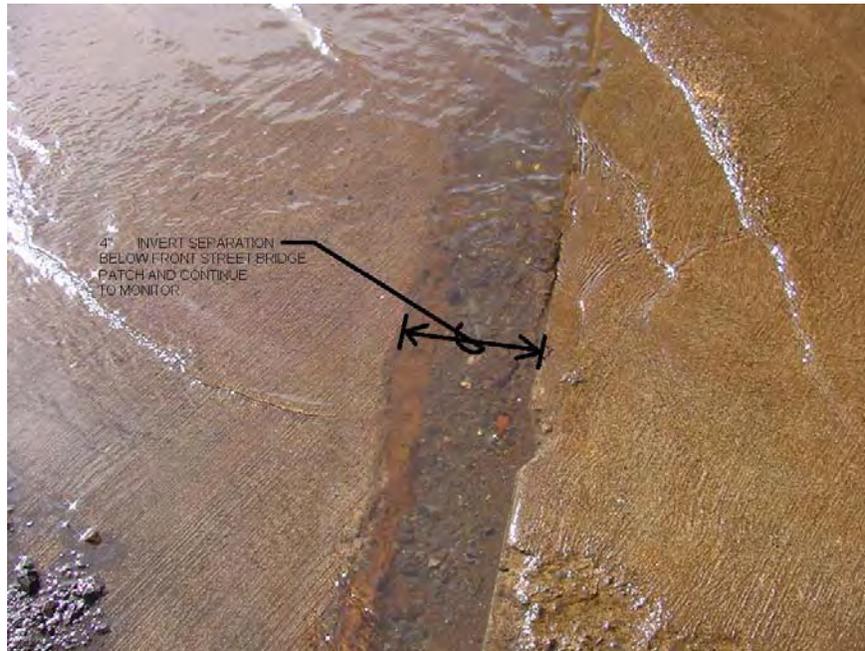
r. Sta. 6+00, RB, close up view of 4" separation under the Front Street Bridge. Patch and monitor. FY03 Photo

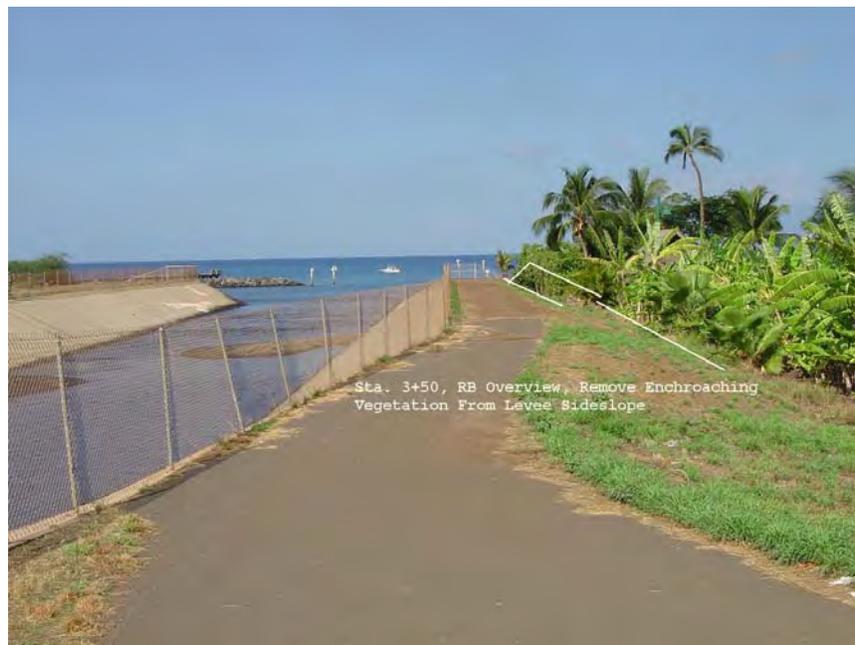
s. Approximate Sta. 3+50, remove vegetation from levee sideslope.

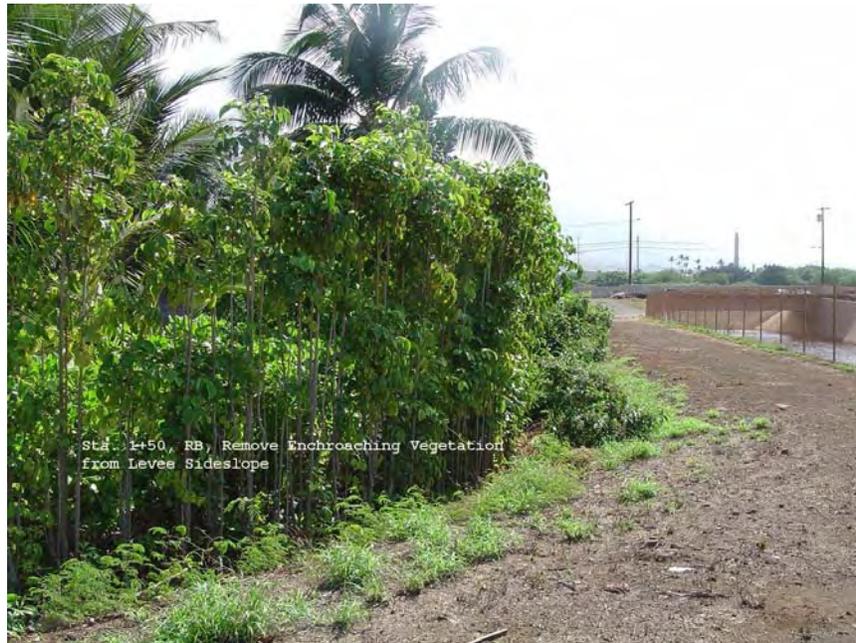
t. Approximate Sta. 1+50, RB, remove vegetation from top of bank and sideslope on townside.

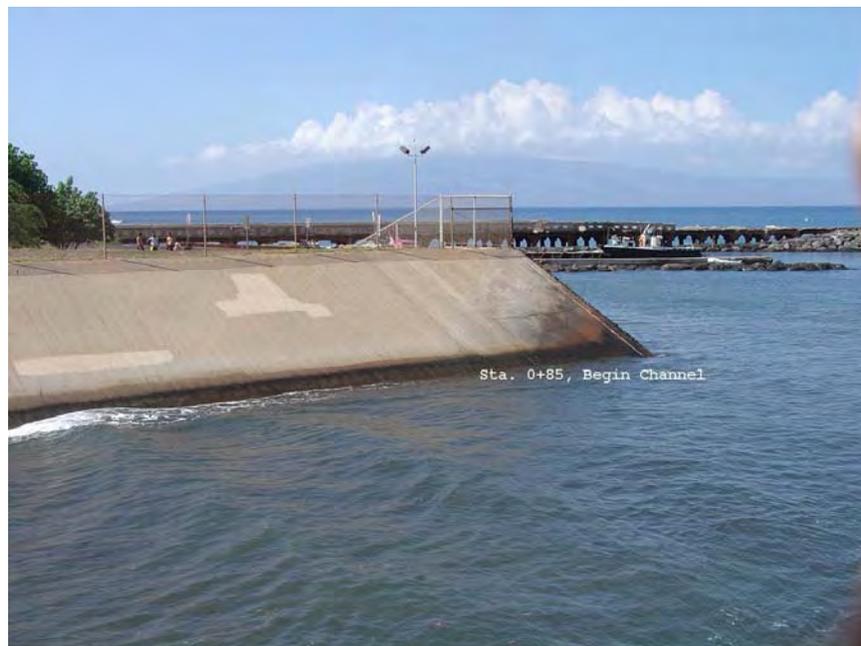
u. Sta. 0+85, LB, Beginning of concrete channel.
