1. Project Name: Kihei Beach SPP
2. Date of Inspection: June 16, 2004
3. Inspection Personnel:

CONTINUING ELIGIBILITY INSPECTION (CEI) REPORT
FOR HURRICANE & SHORE PROTECTION PROJECTS

KIHEI BEACH, MAUI, HAWAII

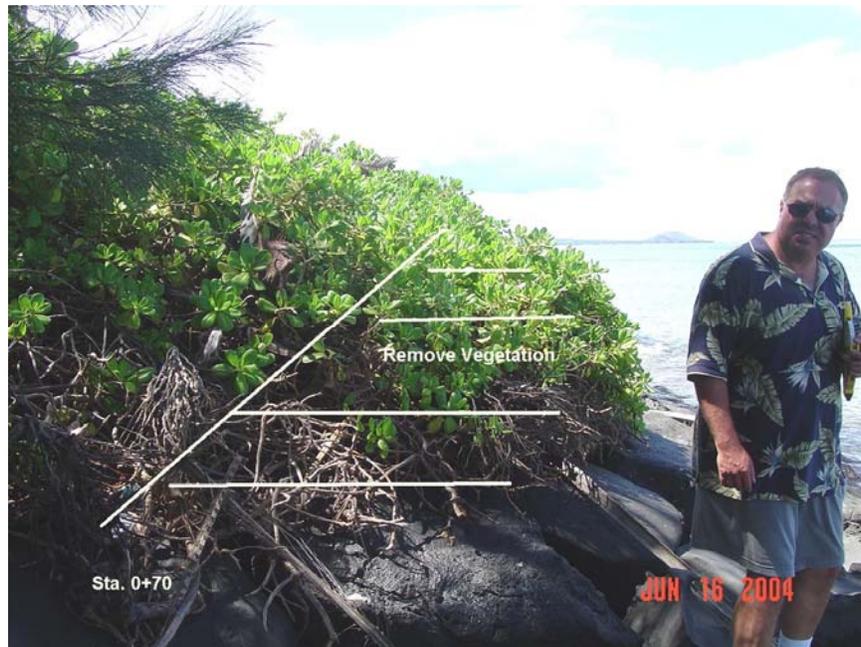
- a. Sta. 0+70 to Sta. 0+90, Continue to remove the vegetation from crest and sideslope.

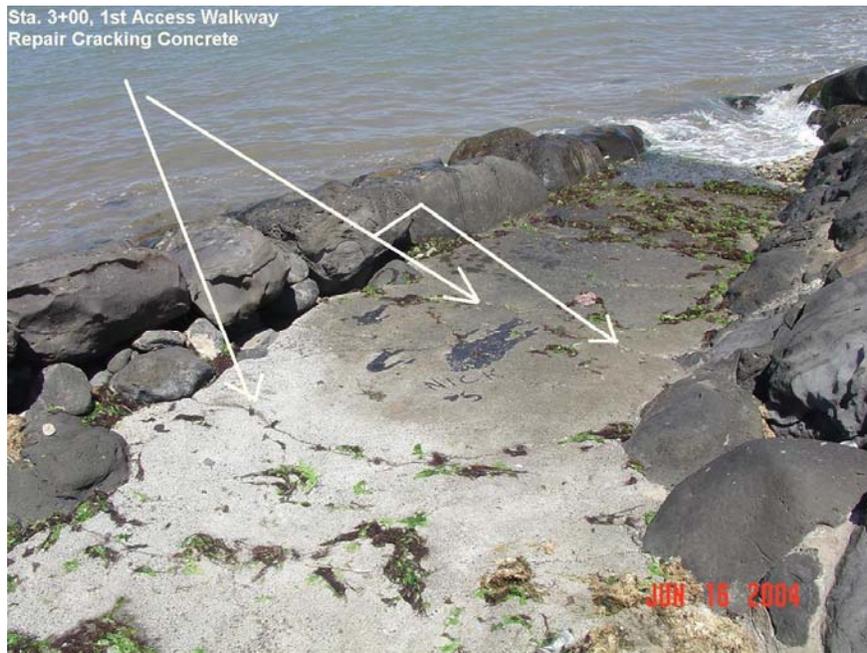
b. Sta. 3+00, 1st Repair cracked access walkway.

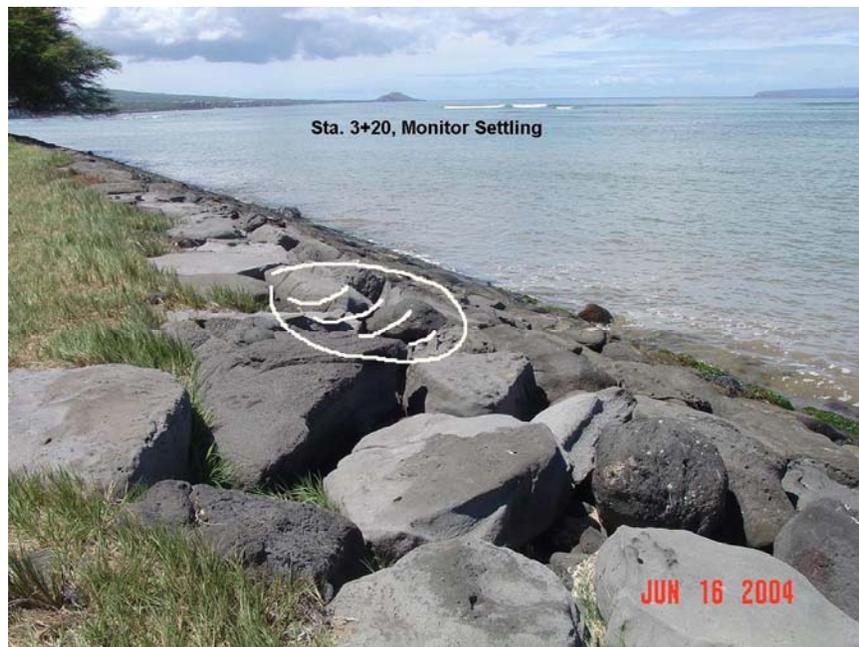
c. Sta. 3+20, Monitor minor settling at hinge.

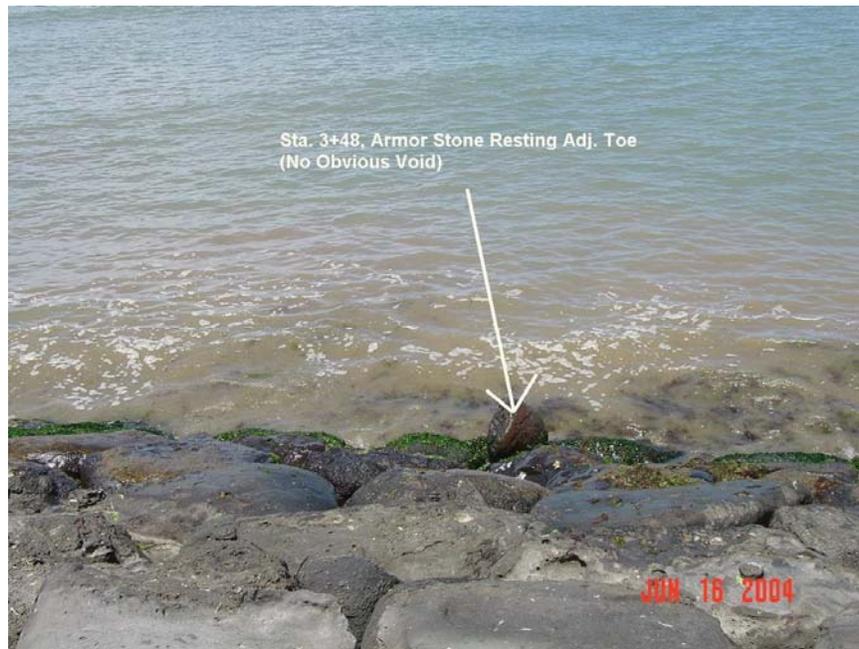
- d. Sta. 3+48, Monitor the armor stone resting adjacent the toe. NO change this year. No obvious voids.

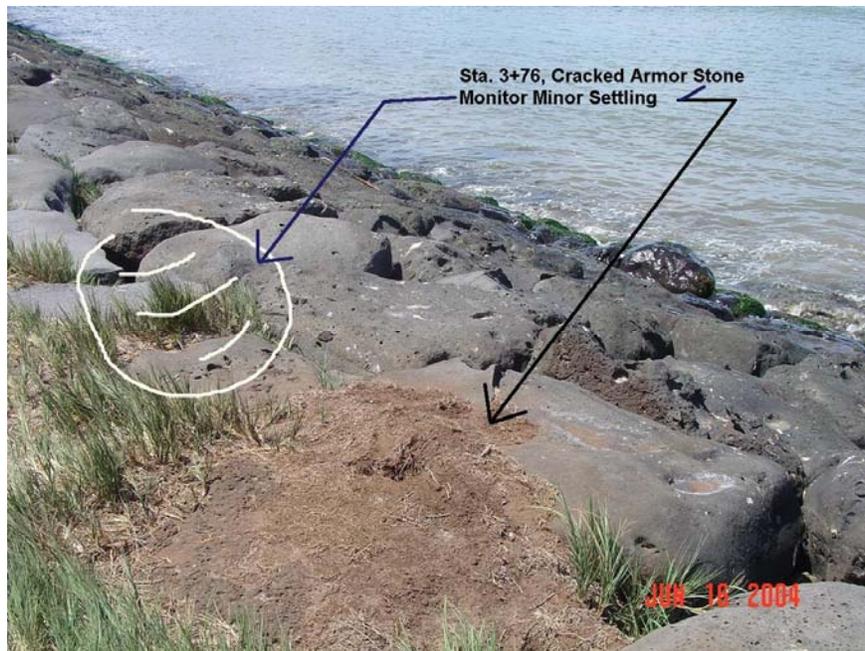
- e. Sta. 3+76, Monitor the area adjacent to cracked armor stone for settling. No change this year.

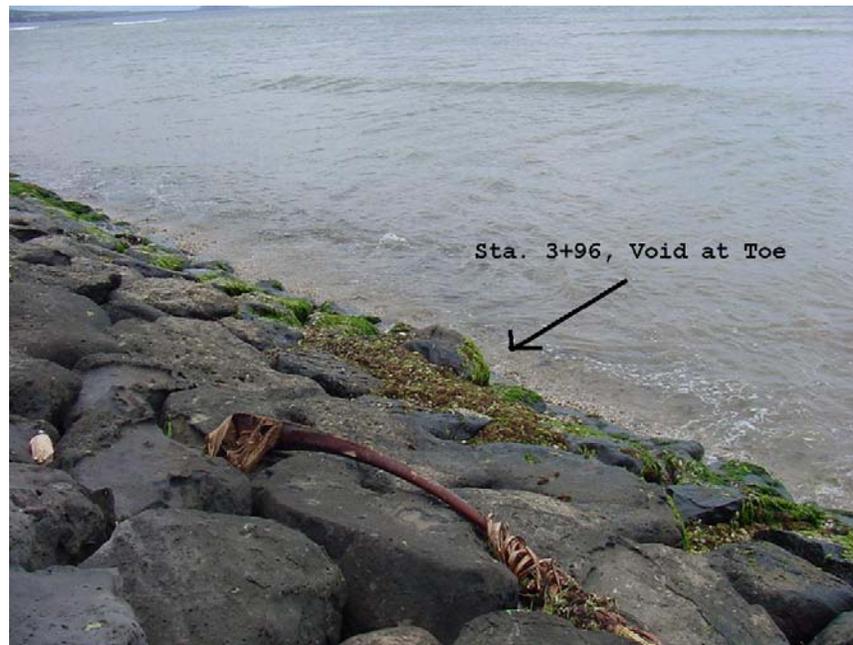
- f. Sta. 3+96, 1 ea. Displaced armor stone, void at toe.

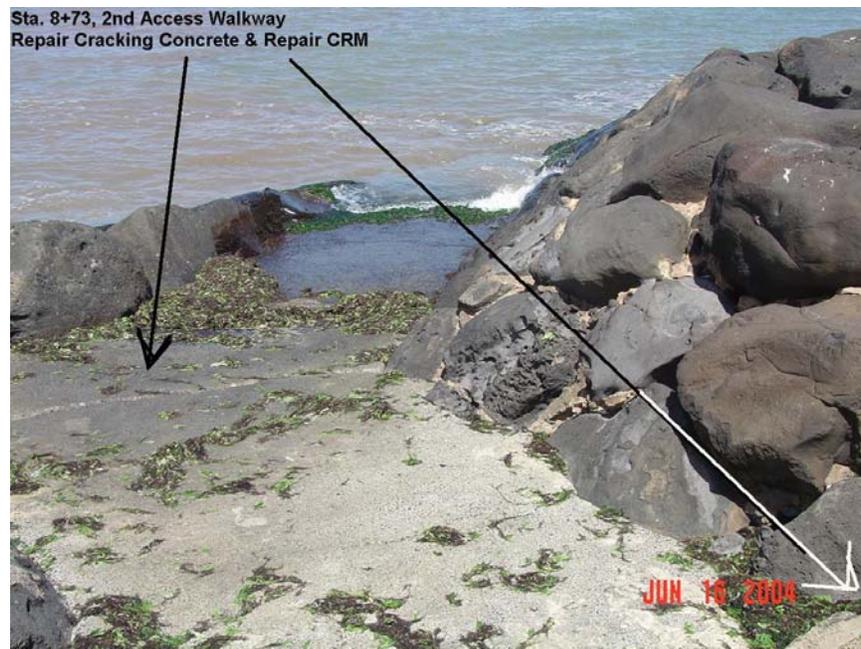
- g. Sta. 8+73, 2nd Walkway, repair cracking concrete and CRM.
(Dislodged armor stone at Sta. 8+41 has shifted to Sta. 8+65 last year.)

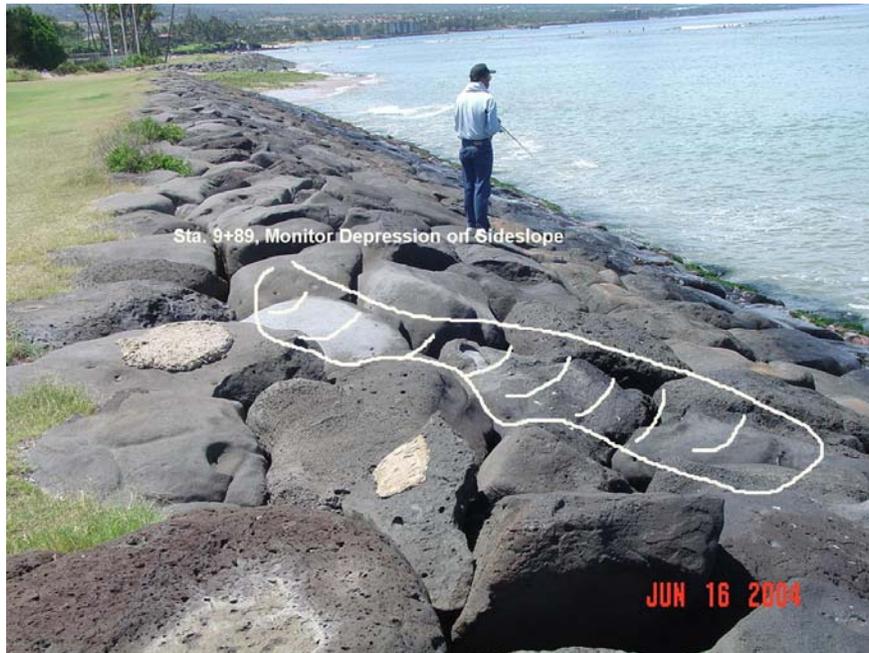
- h. Sta. 9+89, Monitor the depressed area on sideslope.

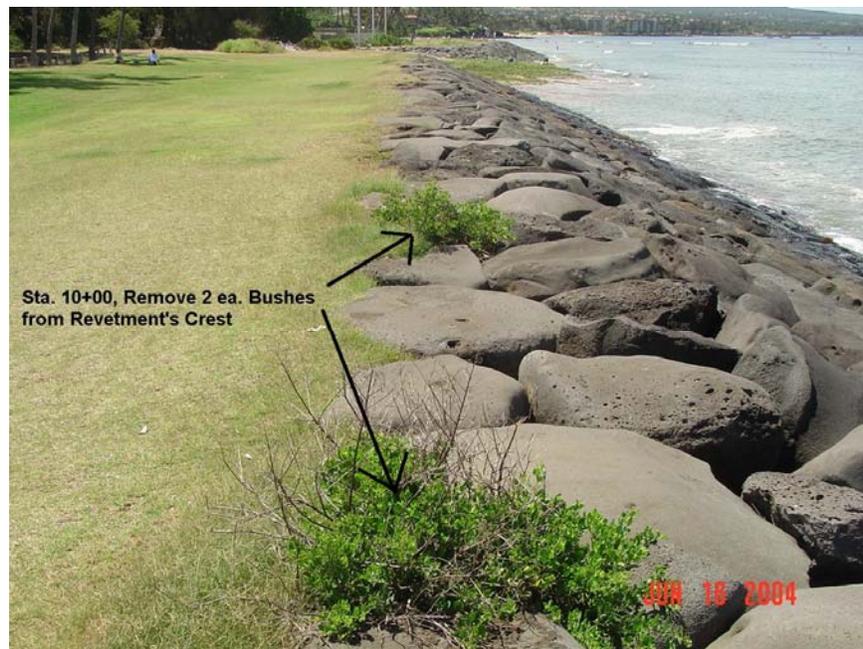
- i. Sta. 10+00, Remove 2ea. bushes from revetment crest.

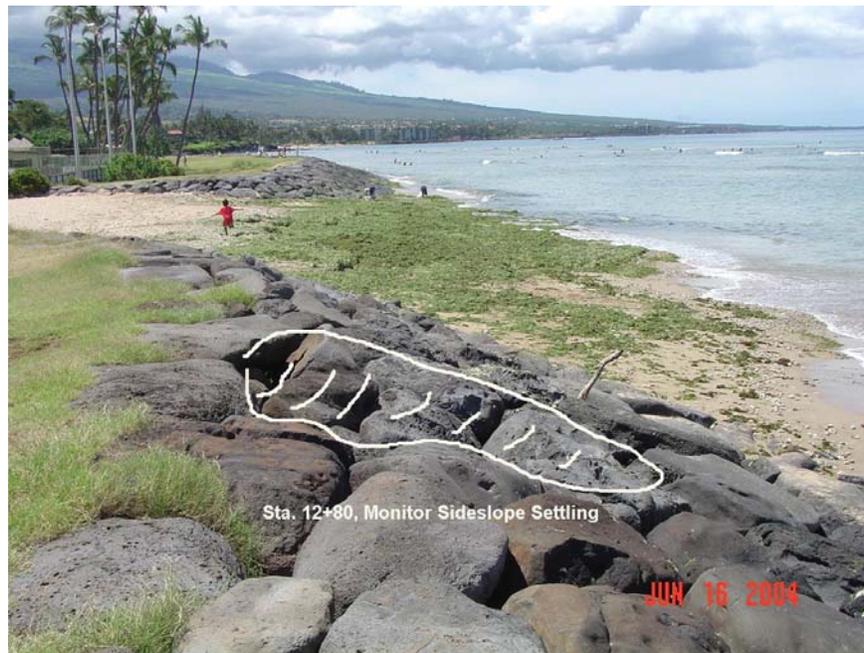
- j. Sta. 12+88, Monitor sideslope settling. No change this year.

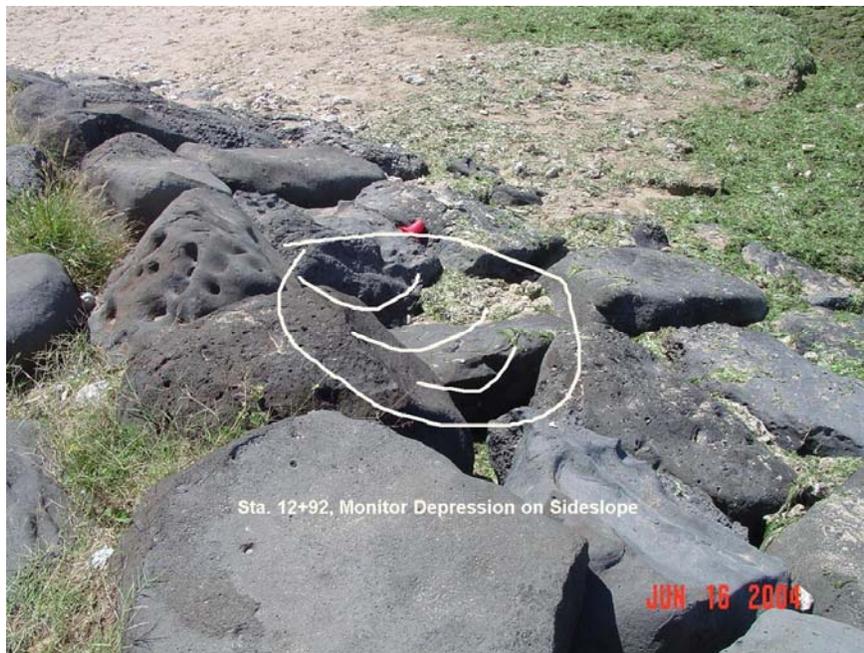
- k. Sta. 12+92, Monitor the depressed area on sideslope. No change this year.

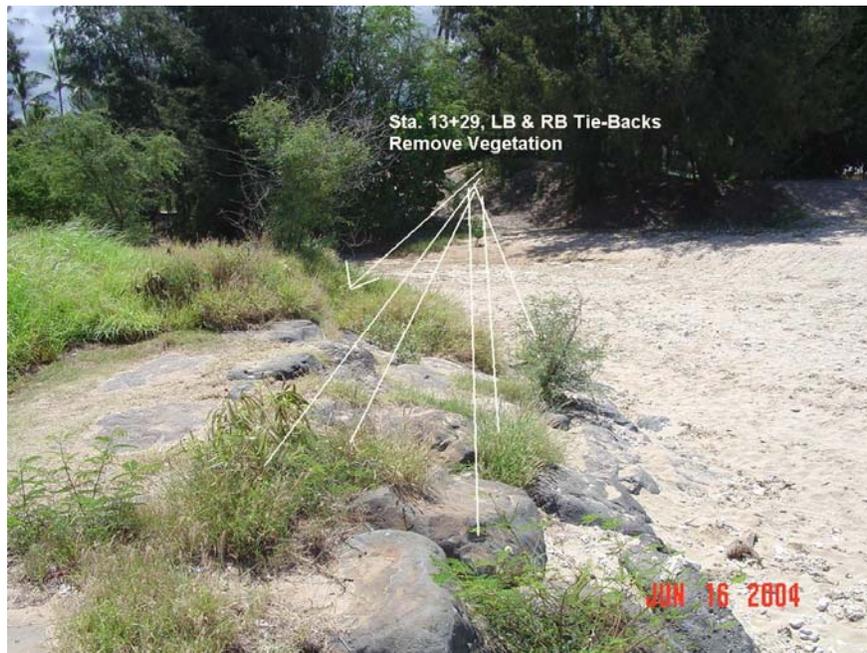
- l. Sta. 13+29, Remove vegetation from revetment.

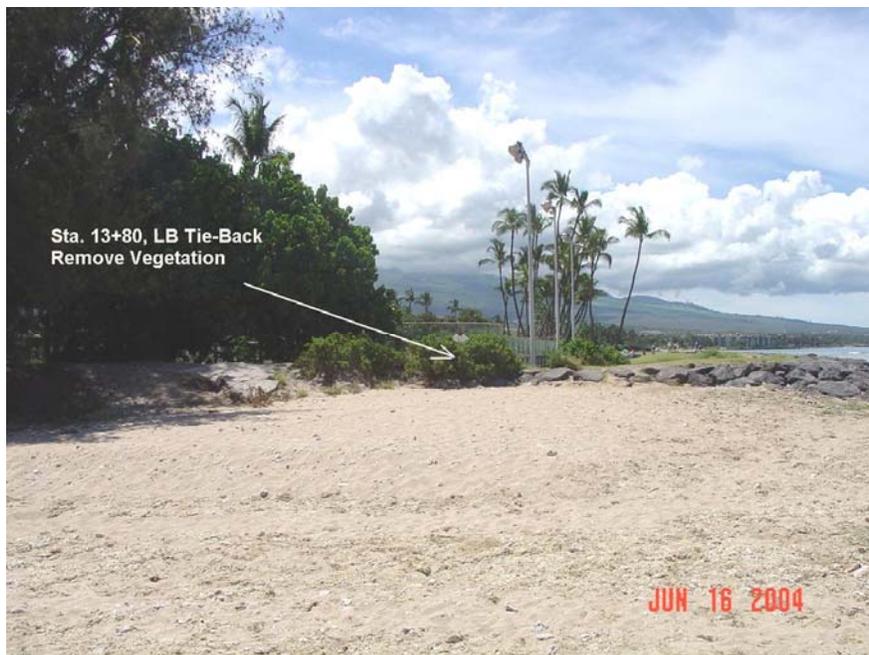
- m. Sta. 13+80, Remove the vegetation from revetment .

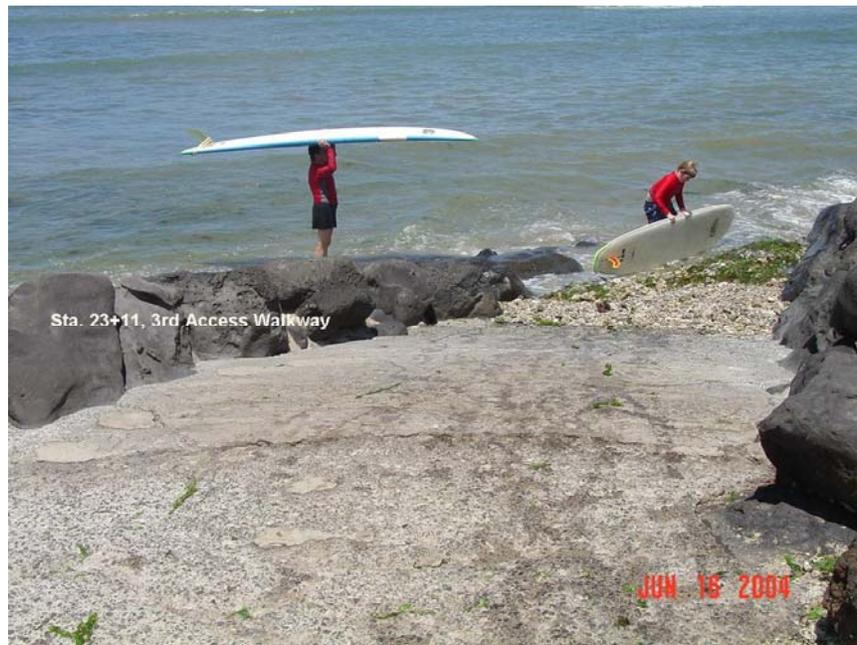
- n. Sta. 23+11, 3rd Walkway, repaired.

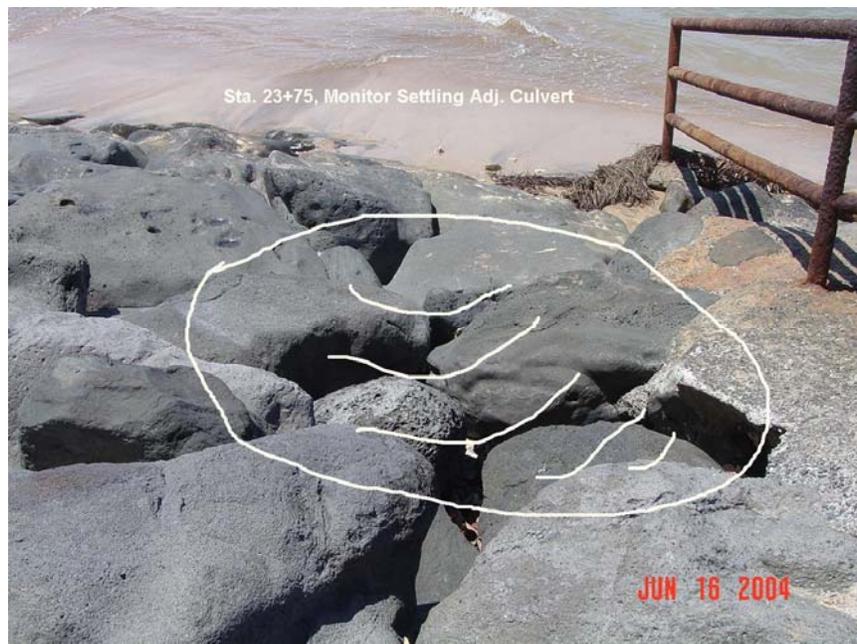
- o. Sta. 23+75, Monitor the sideslope settling on the southside of the culvert.
No change this year.
