O & M INSPECTION REPORT
FOR NAVIGATION AND SHORE PROTECTION PROJECTS

1. Project Name: Laupahoehoe Navigational Improvements
2. Date of Inspection: May 1, 2002
3. Inspection Personnel:

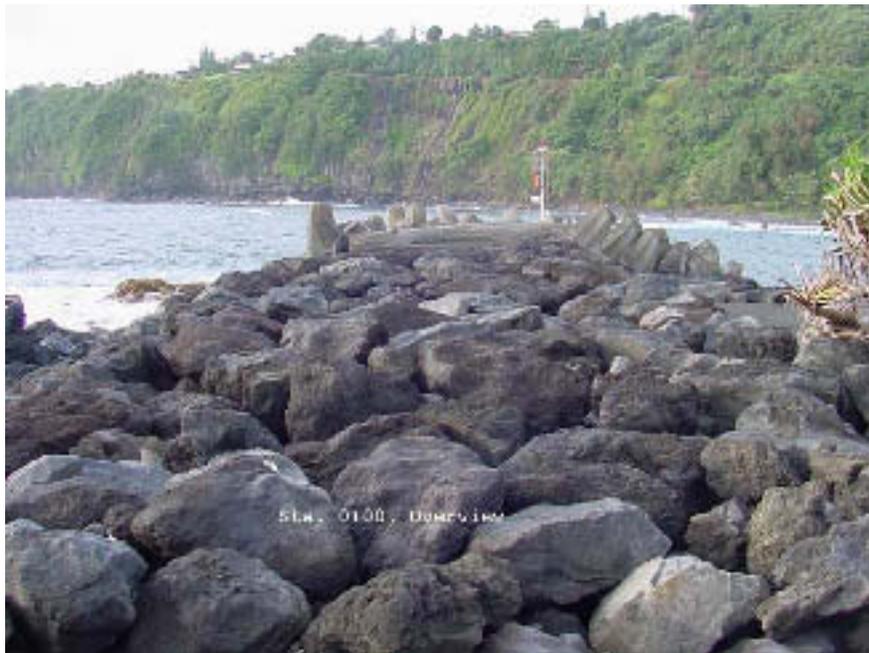
Sta. 0+00, Overview of breakwater.

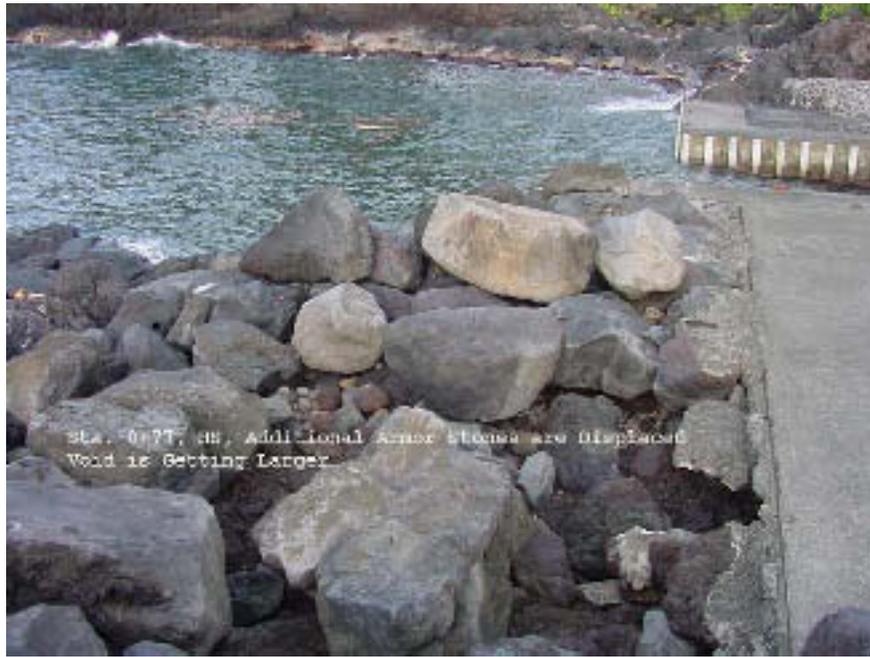
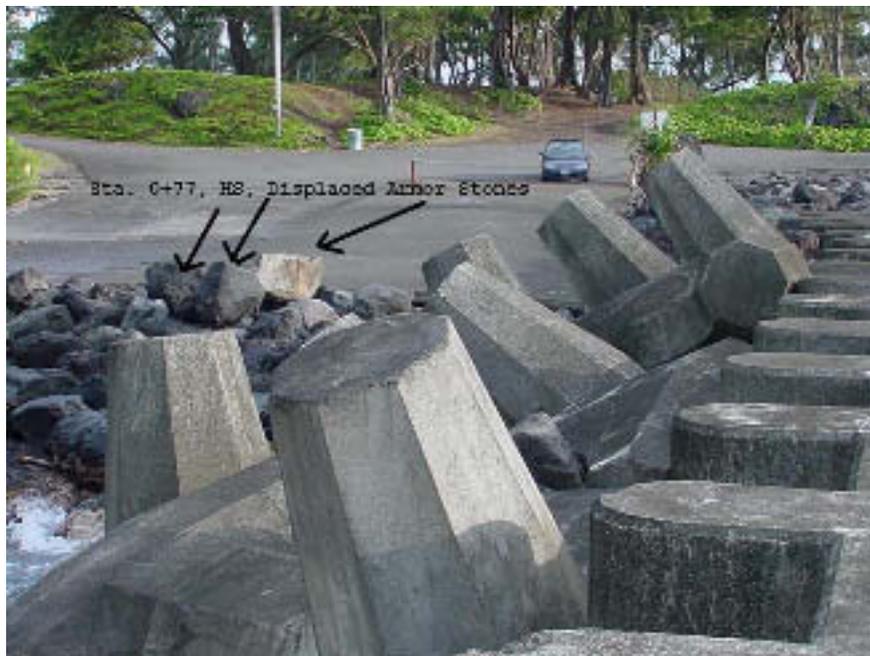
Sta. 0+77, harbor side (HS), 5'L x 20'W x 5'D void from dislodged armor stones; several perched stones located adjacent to void.

The Breakwater and wave absorber function as designed however it appears additional material has washed out from under the rib cap cells and should be closely monitored. The void at Sta. 0+77, HS, is getting worse, additional armor stones have been displaced. Overall the project is in GOOD condition, however suggest repairs be planned for the near future as the dislodged armor stones may impact the turning basin.

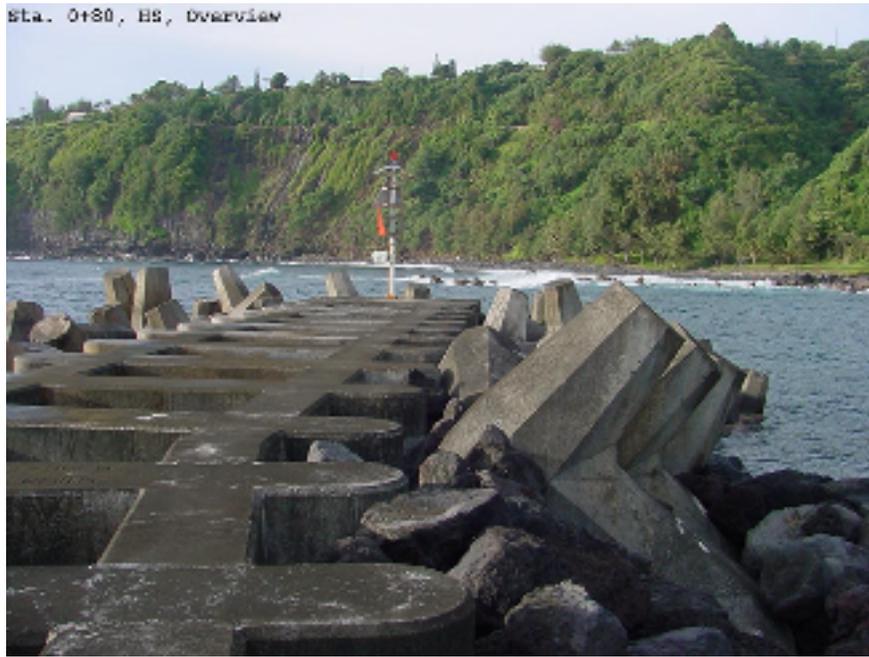
Sta. 0+80, HS, Overview of Ribcap / Dolos. Sta. 0+77 to 1+25 (first 6 ribs), HS, 500 pound stones lodged between ribs and dispersed among dolos;

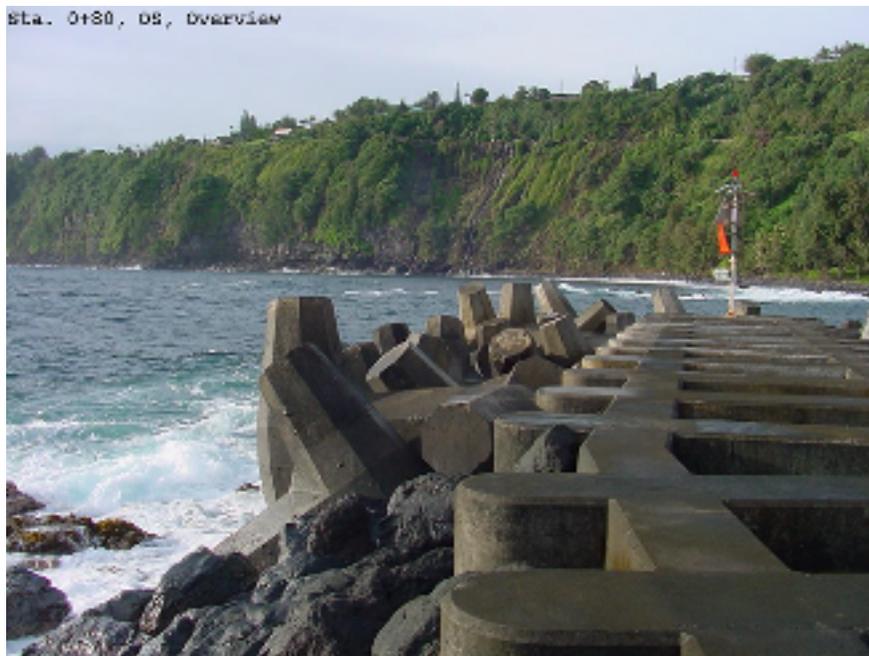
Sta. 0+80, OS, Overview of Ribcap / Dolos.

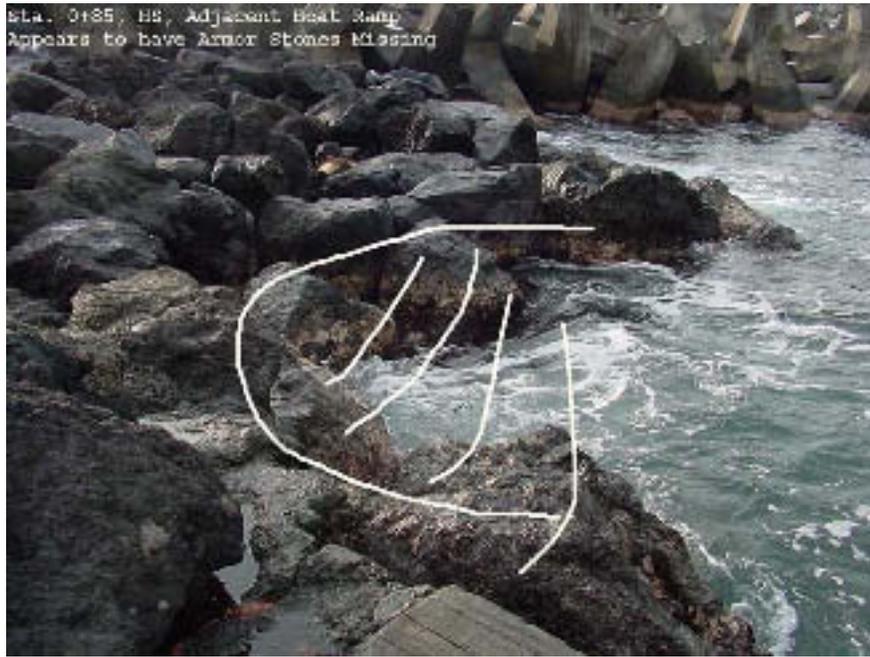
Sta. 0+85, HS, Appears to missing armor stones adjacent the boat ramp.

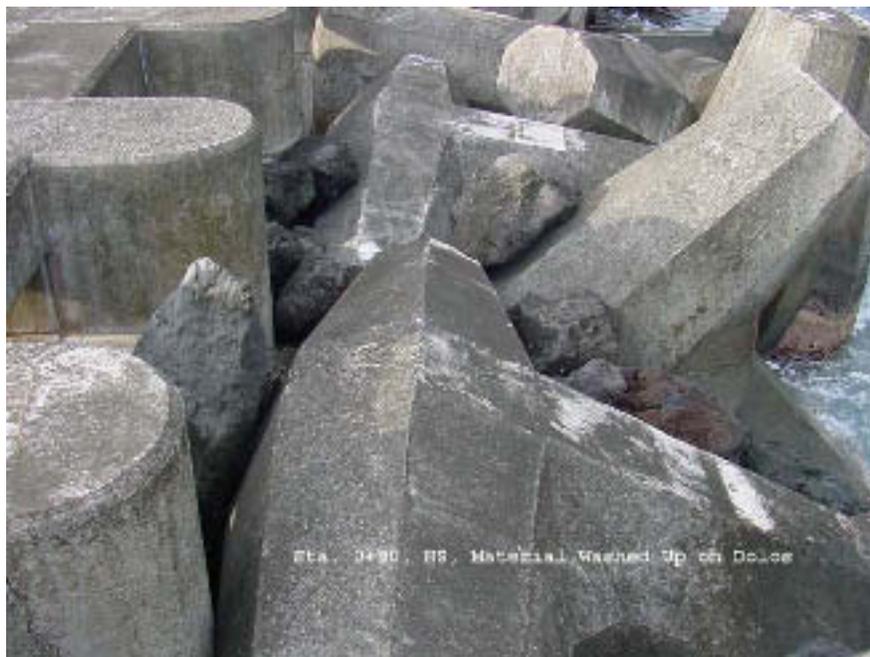
Sta. 0+90, HS, Small rocks washed up on dolos (reference photo).

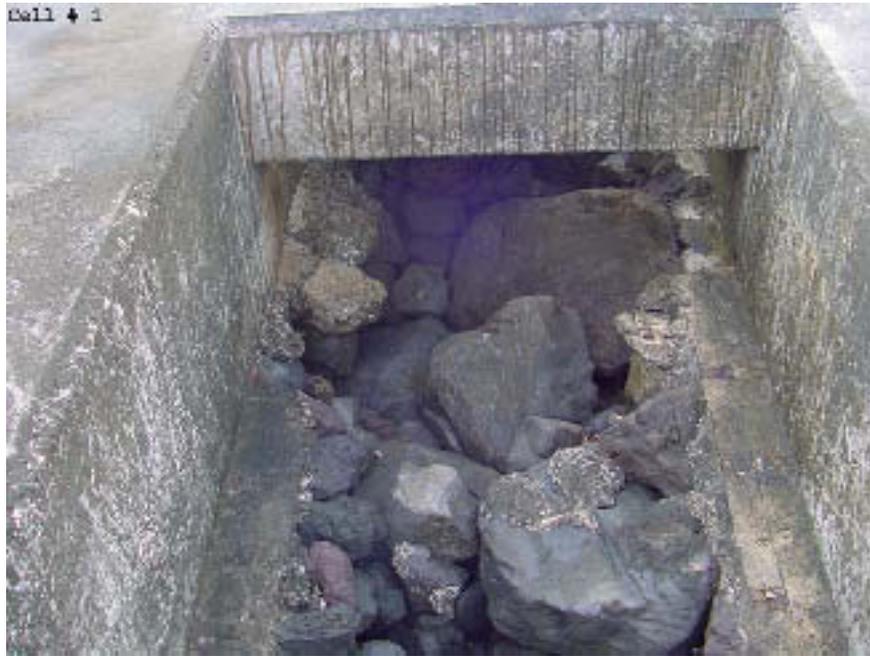
Cell 1 - Minor underlayer loss

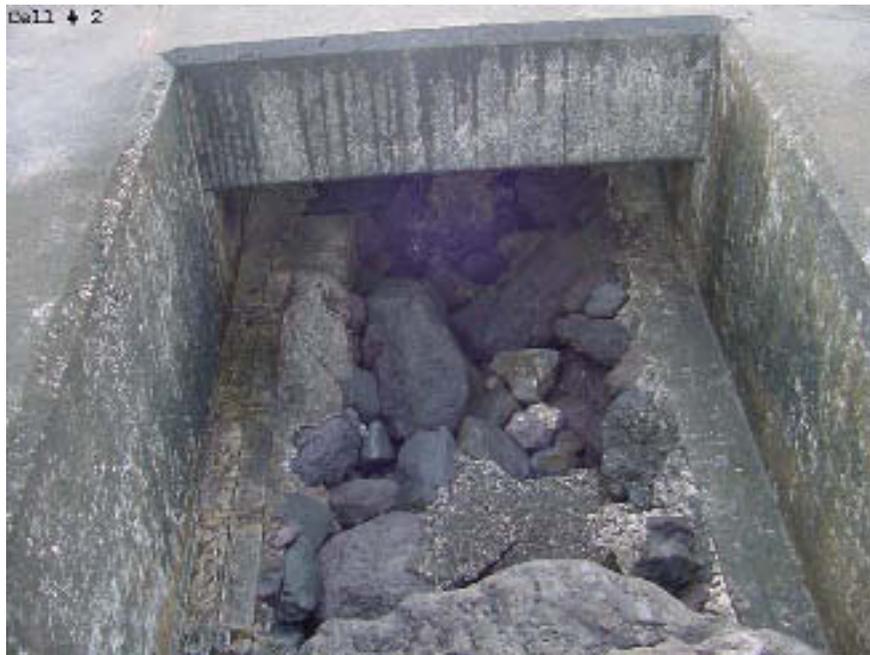
Cell 2 - Minor underlayer loss. Large armor stone on HS.

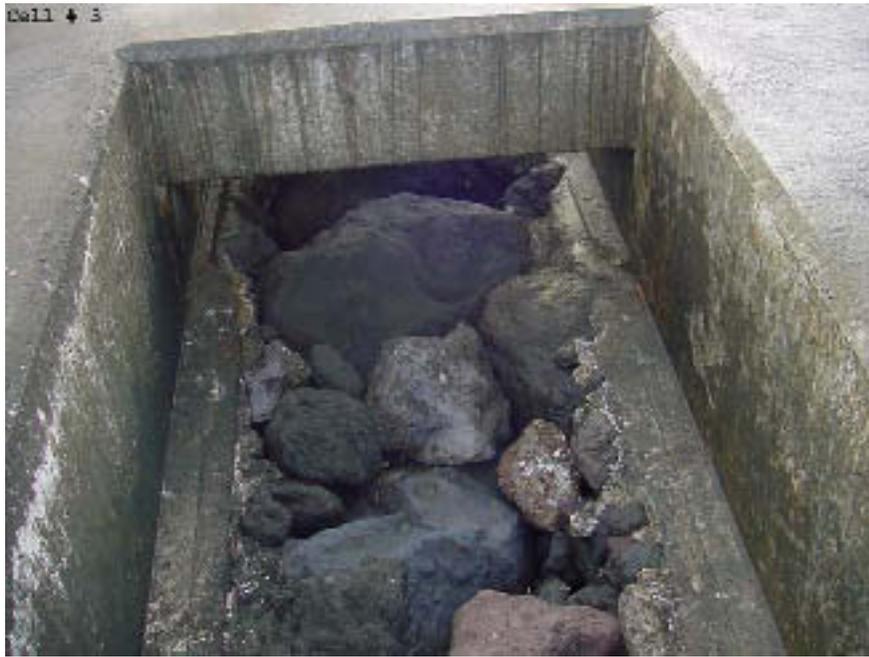
Cell 3 - Minor underlayer loss

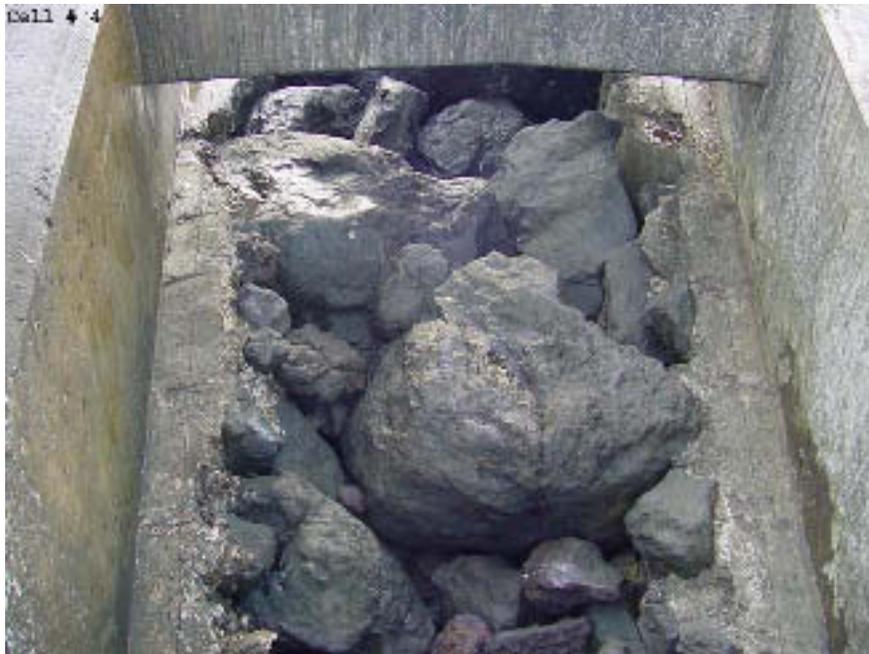
Cell 4 - Minor underlayer loss

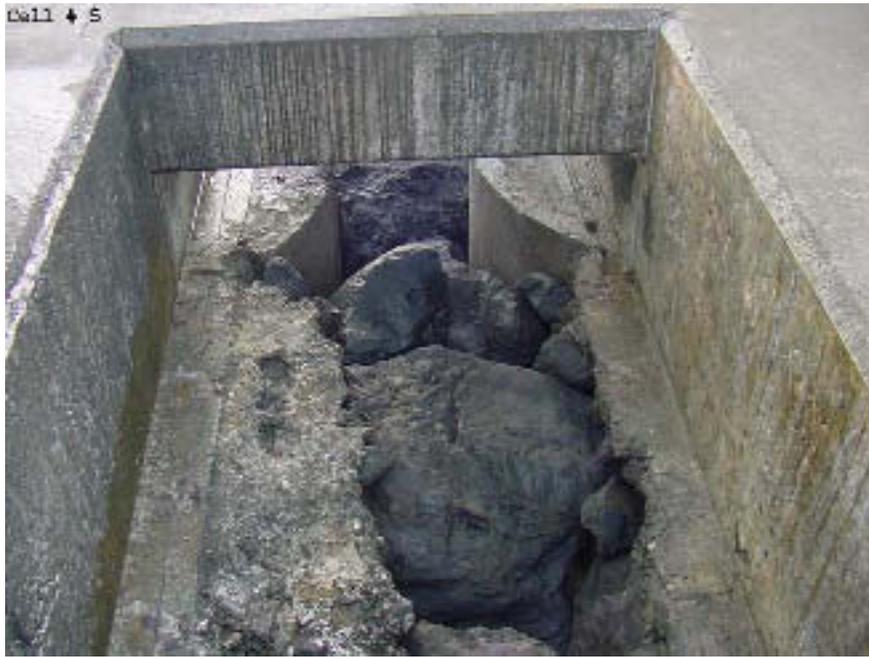
Cell 5 - Minor underlayer loss

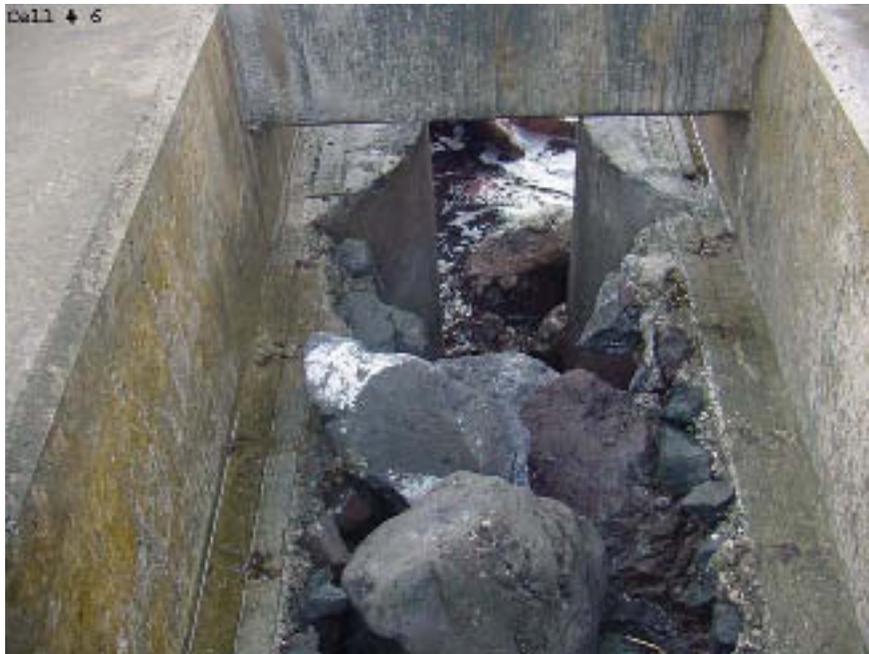
Cell 6 - Underlayer loss, 1 1/2' deep

There has been a loss of underlayer material in the cells of the rib cap between the ribs and beams. The typical section depicts two layers of 5 to 7 ton stone directly below the concrete cap and 1 to 3 ton stone underneath. Apparently, the specified stones were replaced with greatly undersized stone during construction. That undersized stone is slowly being washed away, creates a more porous structure that allows more energy into the harbor, and could ultimately threaten the stability of the breakwater:

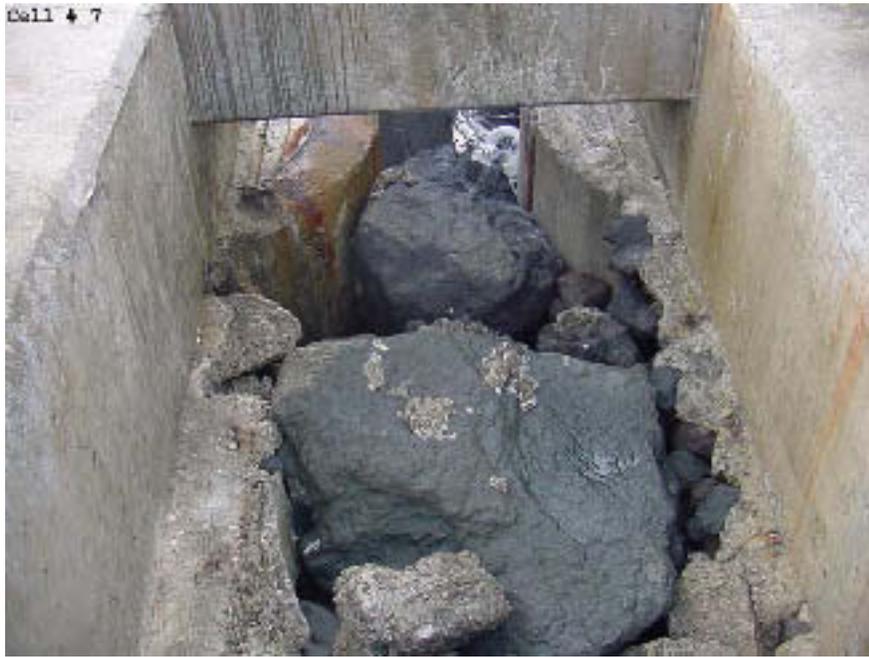
Cell 7 - Underlayer loss, 2' deep

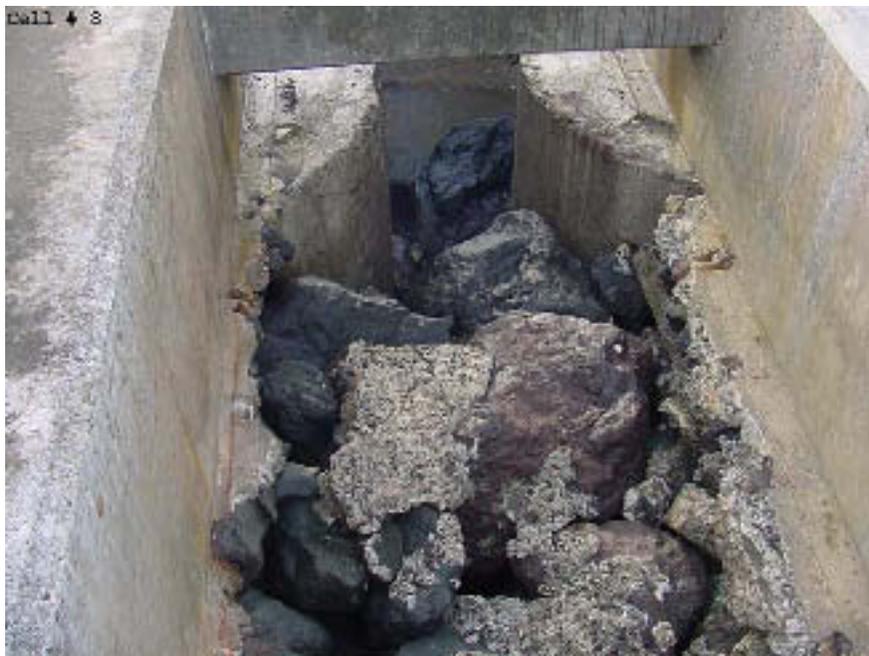
Cell 8 - Minor underlayer loss

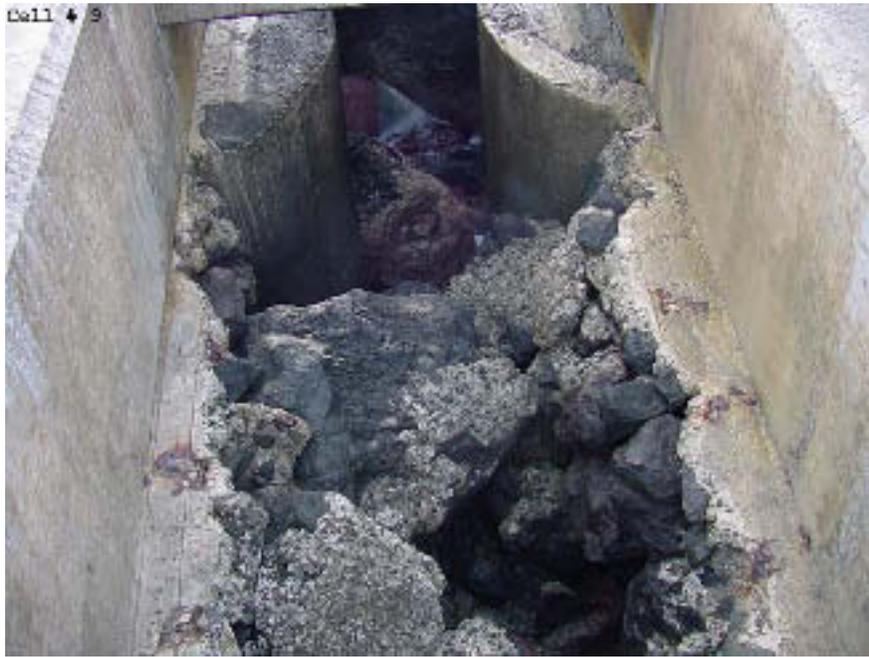
Cell 9 - Underlayer loss, 1 1/2 to 2' deep

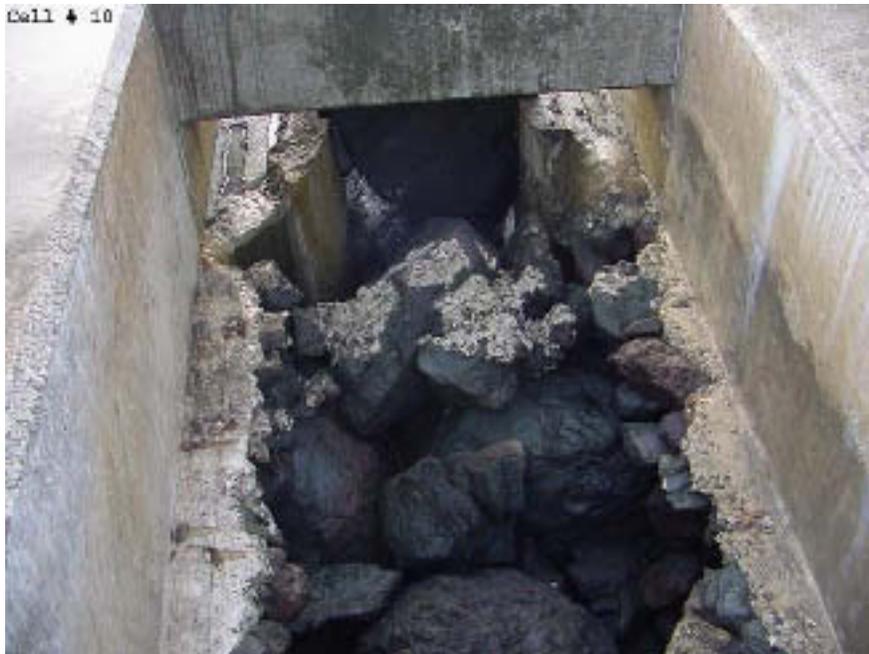
Cell 10 - Major underlayer loss, OS

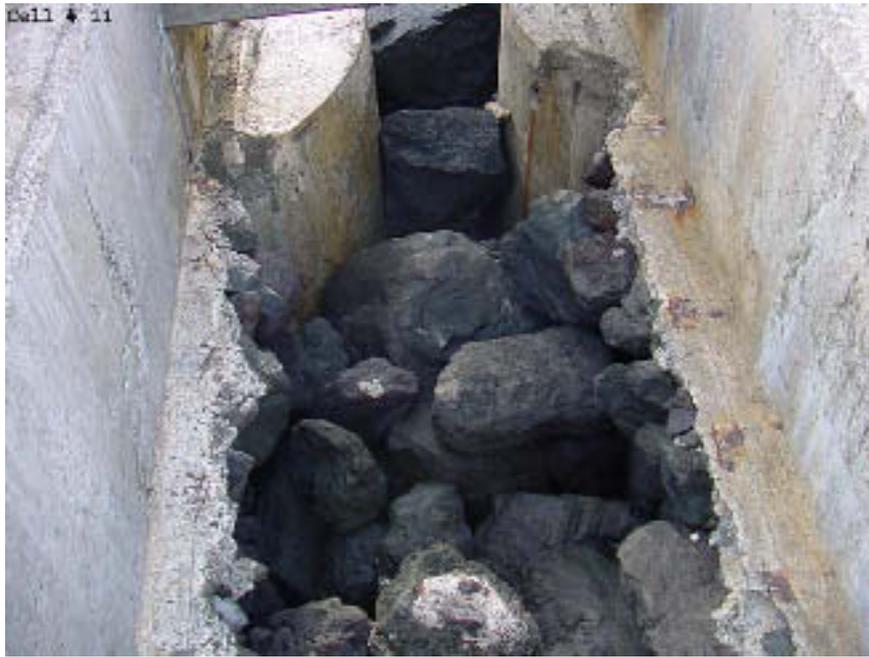
Cell 11 - Underlayer loss, 3' deep, getting worse.

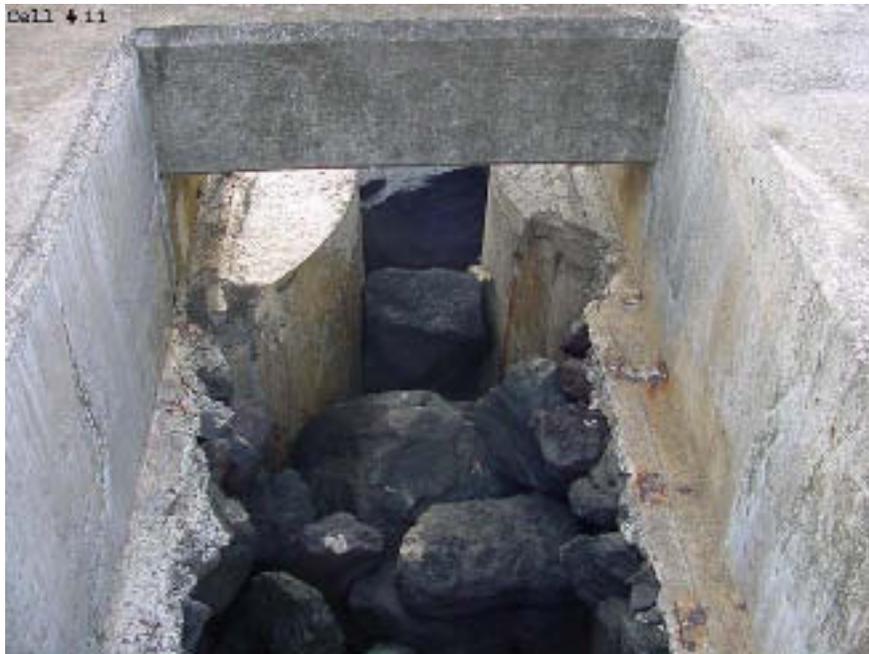
Cell 11 - Underlayer loss, 3' deep, getting worse.

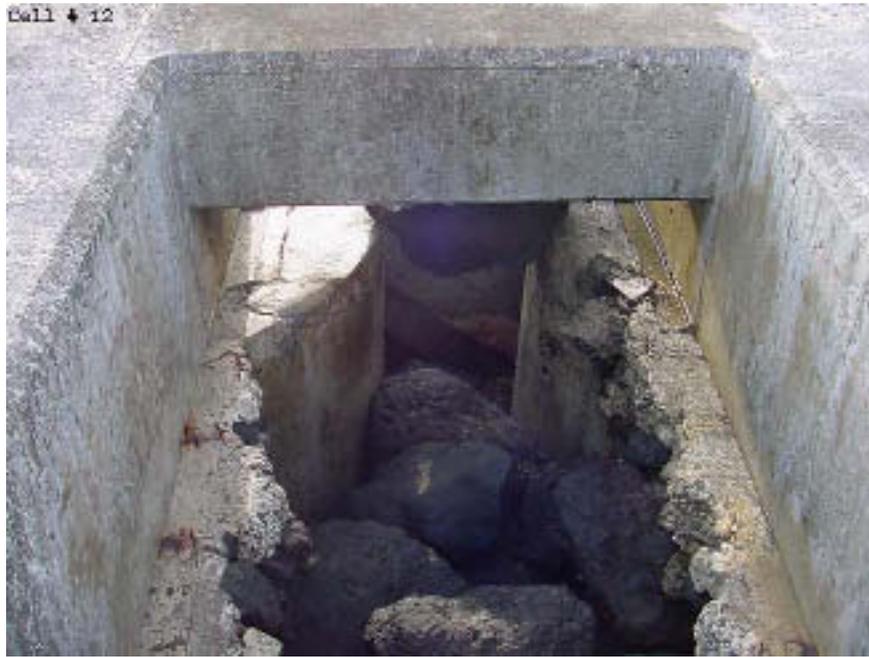
Cell 12 - Major underlayer loss, 3' deep, getting worse.

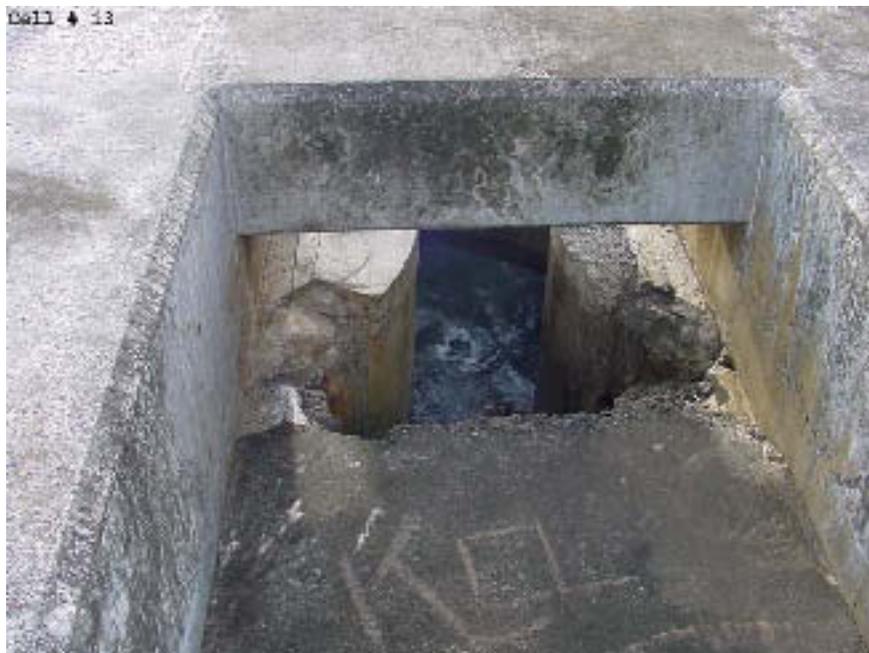
Cell 13 - Concrete capped but eroding under cap.

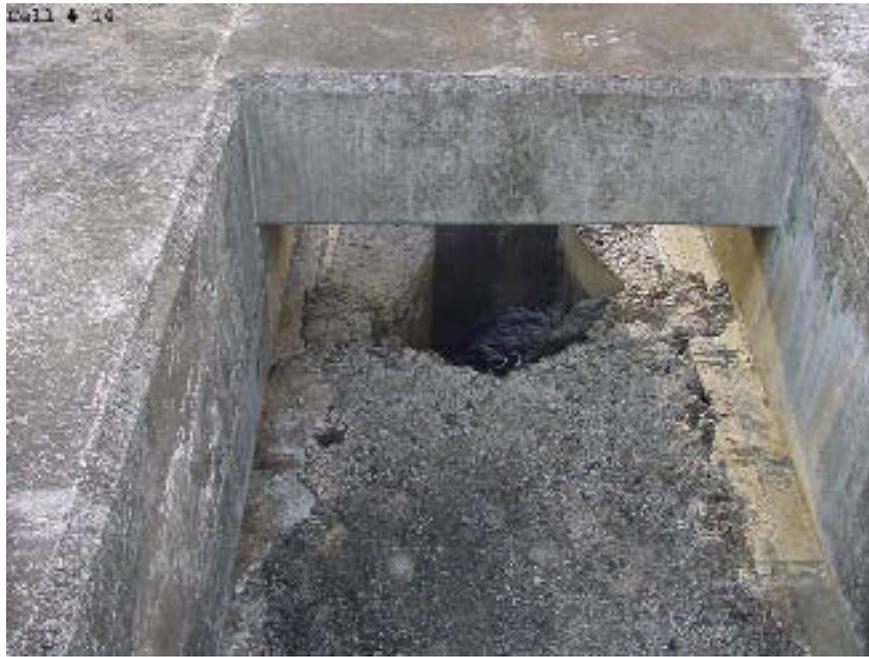
Cell 14 - Concrete capped but eroding under cap.
