CONTINUING ELIGIBILITY INSPECTION (CEI) REPORT
FOR HURRICANE & SHORE PROTECTION PROJECTS
Honolulu Engineer District
CEPOH-EC-T

1. Project Name: Matafao Shore Protection Project

2. Date of Inspection: April 14, 2004

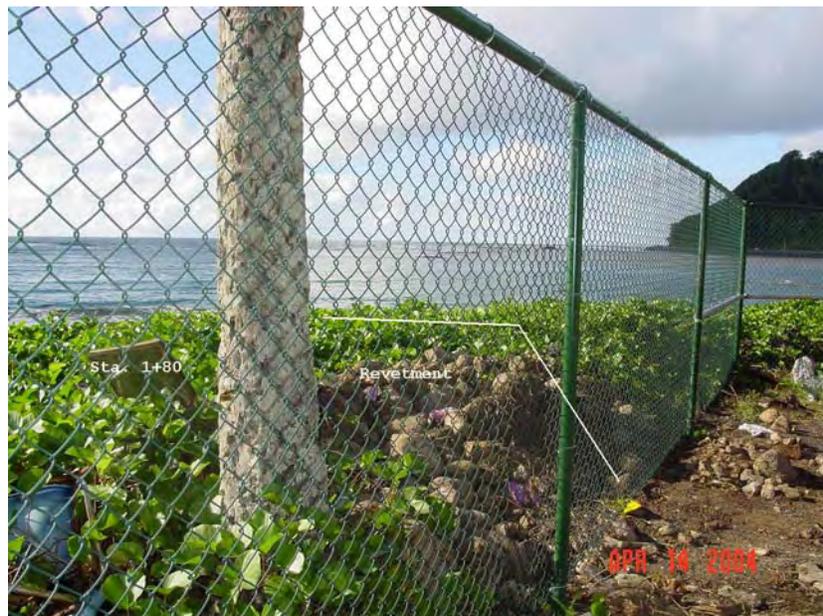
a. Sta. 1+80, New fence installed (no impact on project). Unable to inspect the revetment due to heavy vegetation.

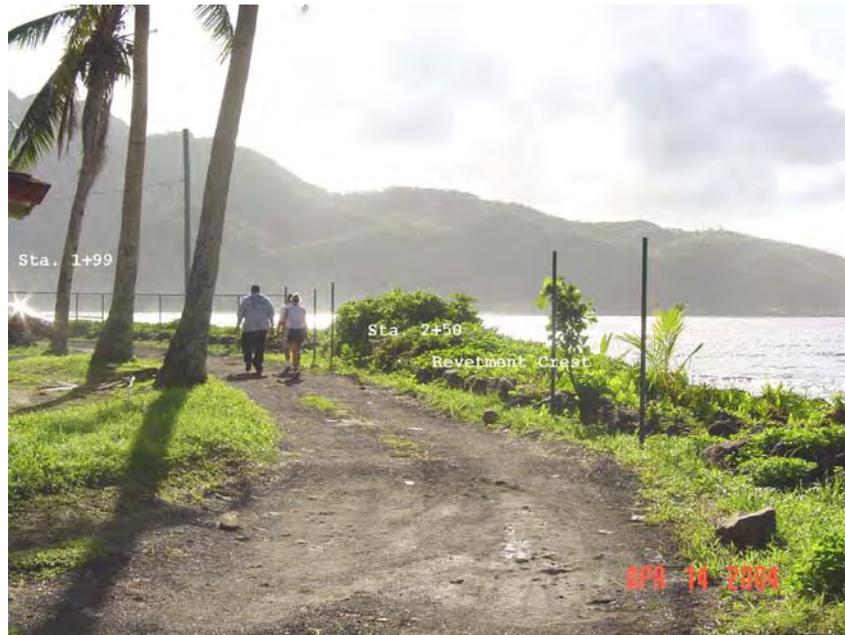
b. Sta. 1+99 thru Sta. 3+00, unable to inspect revetment crest due to heavy vegetation.

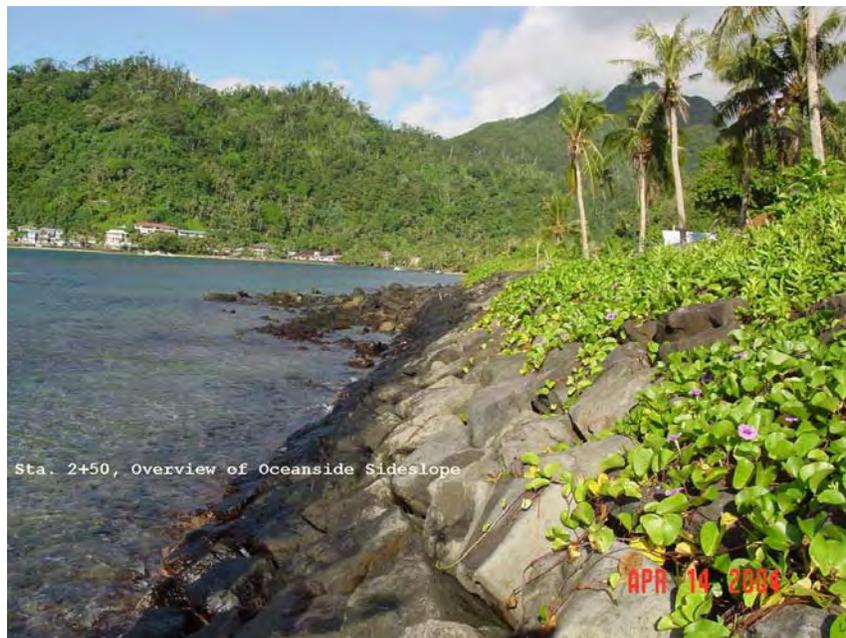
c. Sta. 2+50, Overview of Oceanside sideslope, unable to inspect approx. 25 % due to vegetation.

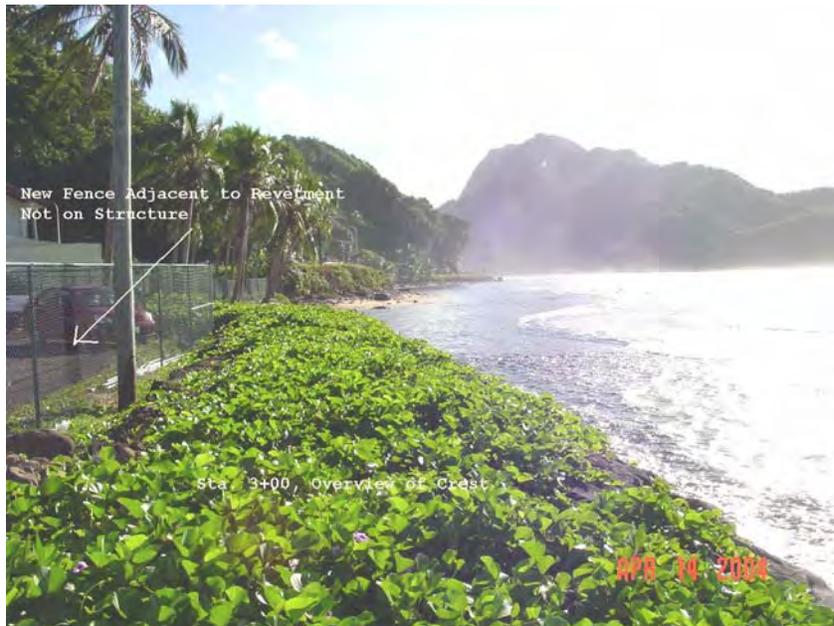
d. Sta. 3+00, Revetment crest, unable to inspect revetment due to heavy vegetation.

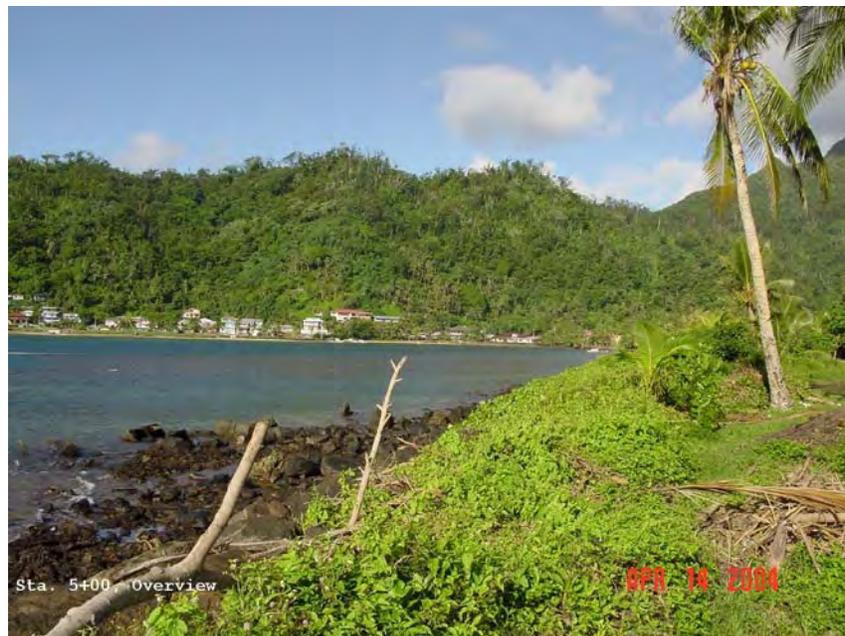
e. Sta. 5+00, Revetment crest, unable to inspect revetment due to heavy vegetation.

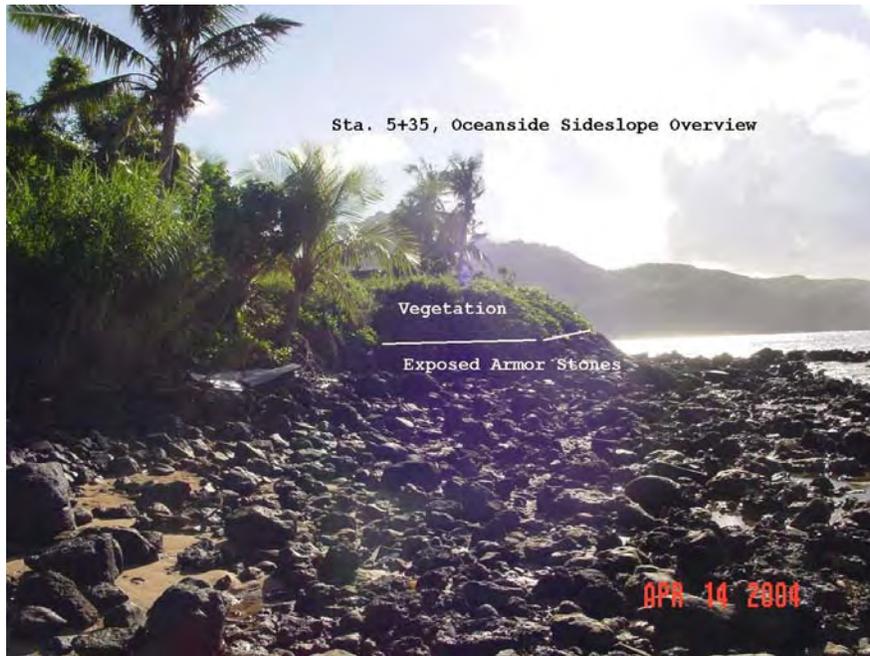
f. Sta. 5+35, Oceanside sideslope of revetment, unable to inspect approx. 50 % due to vegetation.

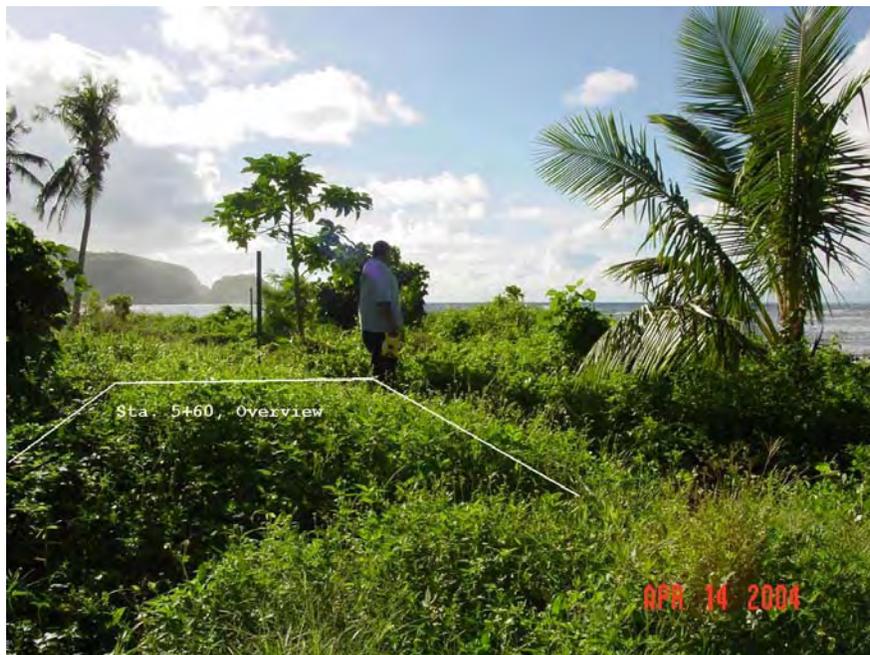
g. Sta. 5+60, End of revetment tieback, unable to inspect due to vegetation.

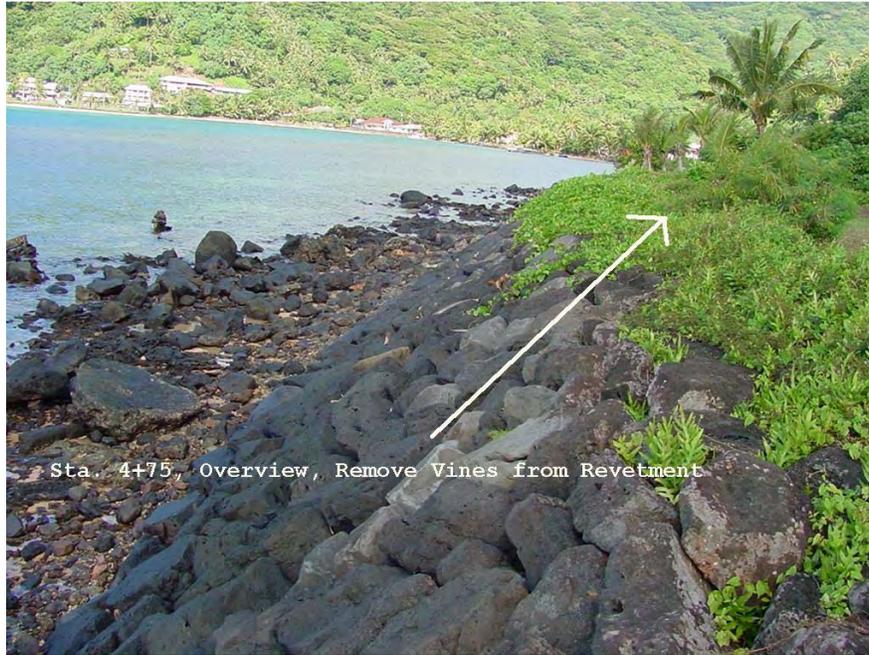
Sta. 4+75, Overview, Remove Vines from Revetment

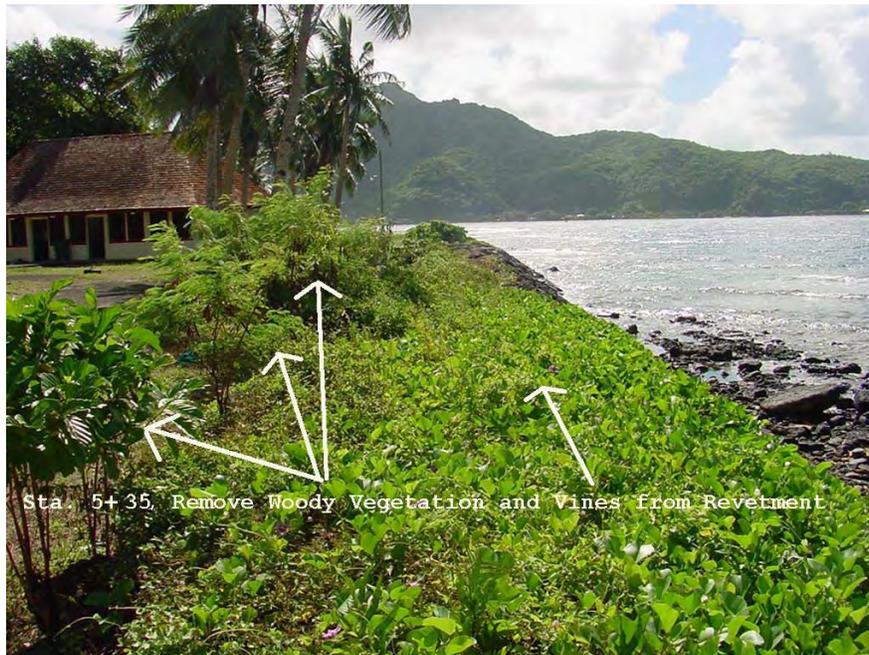
Sta. 5+35, Remove Woody Vegetation and Vines from Revetment
