**CONTINUING ELIGIBILITY INSPECTION (CEI) REPORT FOR
FLOOD CONTROL WORKS (FEDERAL)**

Honolulu Engineer District
CEPOH-EC-T

1. Project Name: Namu River Flood Control Project
2. Date of Inspection: March 25, 2004
3. Inspection Personnel:

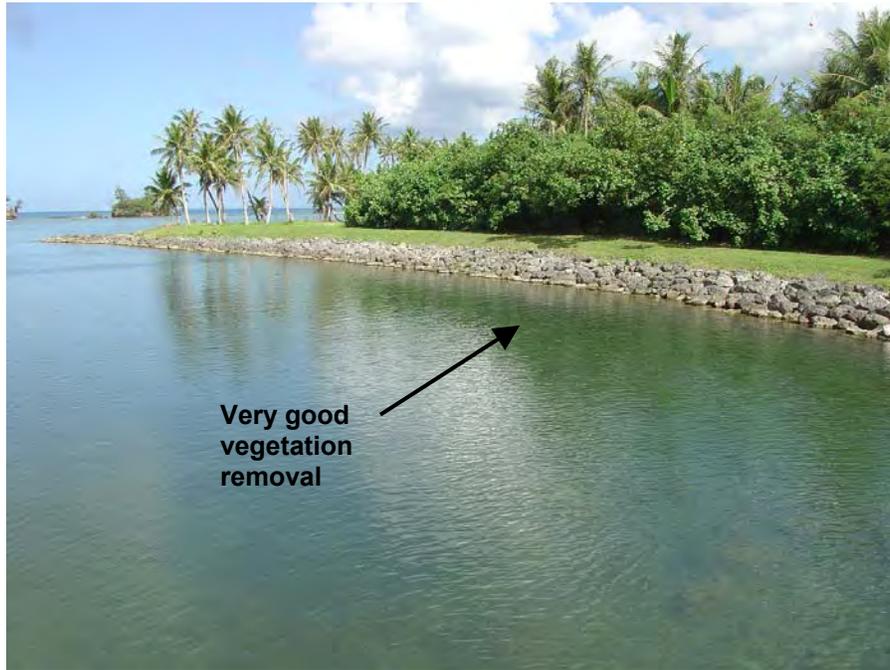
a. Sta. 3+90 to 0+00, RB looking d/s from Marine Drive, very good vegetation removal, occasional coconut needs to be removed

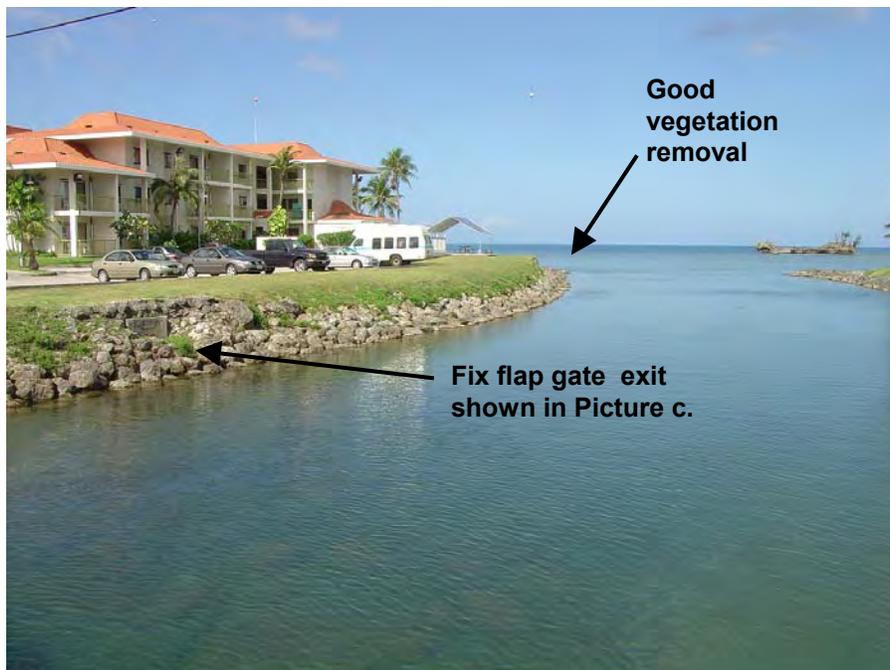
b. Sta. 3+90 to 0+00, LB looking d/s from Marine Drive, good vegetation removal, fix flap gate, as shown in c.

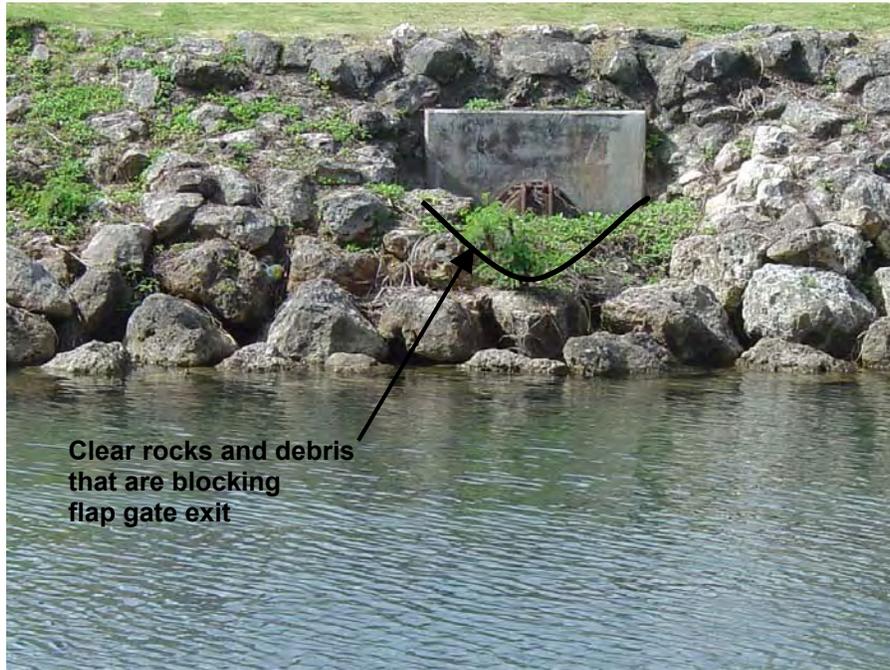
- c. Sta. 3+20 (approx), Clear rocks and debris so flap gate exit is clear and can work properly, grease flap gate hinges, LB d/s from Marine Drive

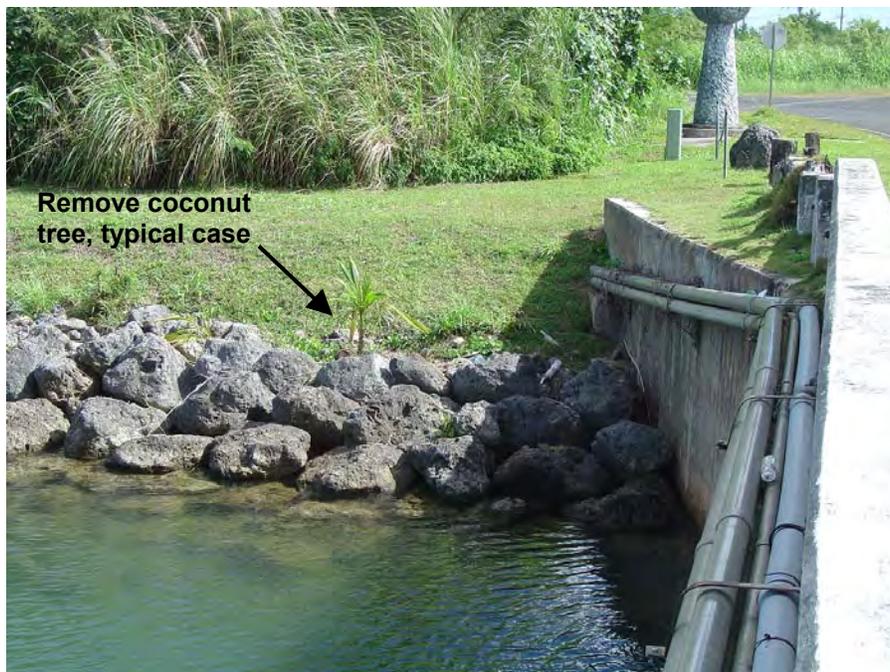
- d. Sta. 3+90 (approx), RB d/s at Marine Drive, typical case where coconut tree needs to be removed

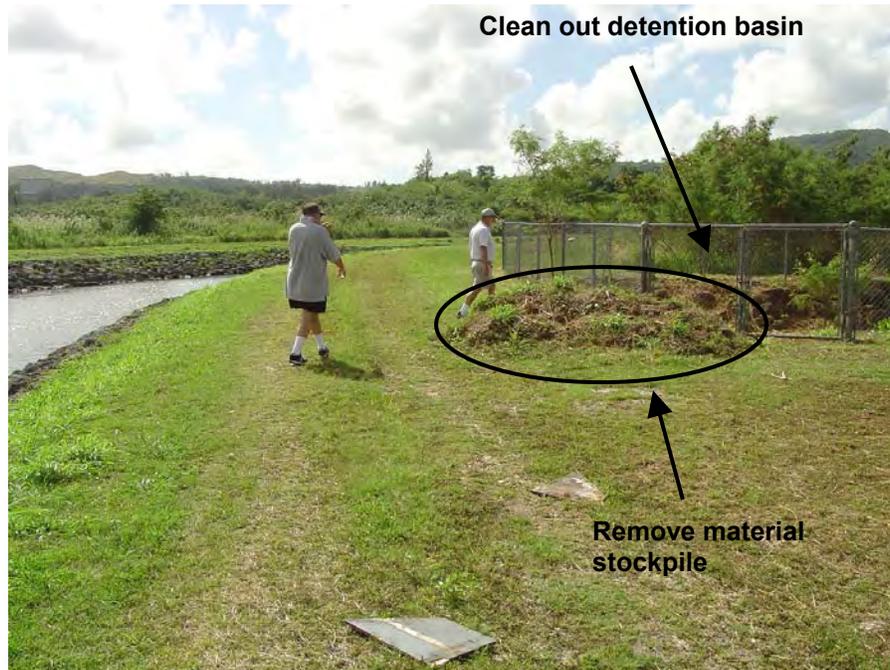
- e. Sta. 6+50, clean out the two detention basins on LB (other basin is near one shown) and remove stockpiles of material in maintenance ROW

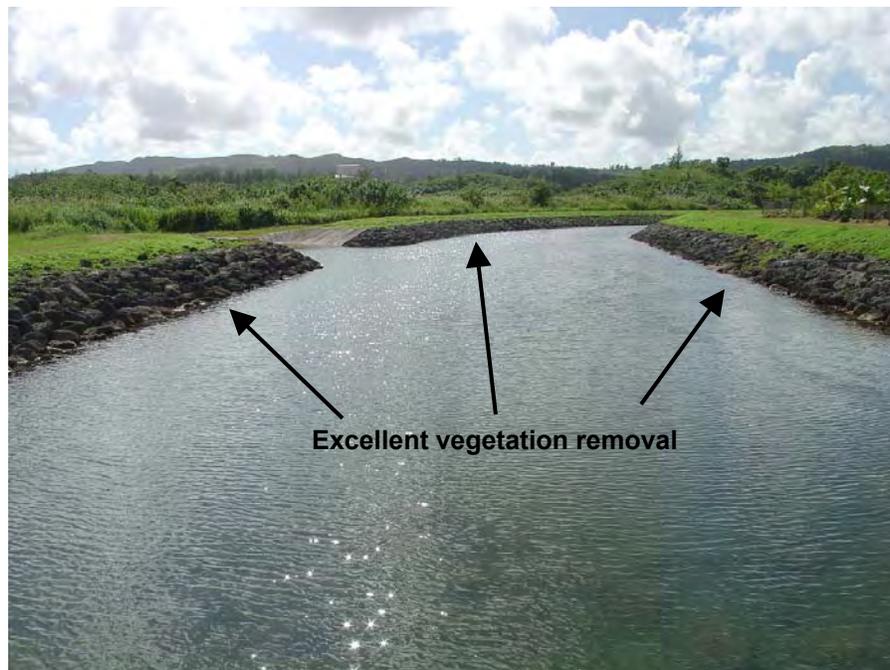
- f. Sta. 4+50, looking u/s from Marine Drive, excellent vegetation removal, can see riprap slopes

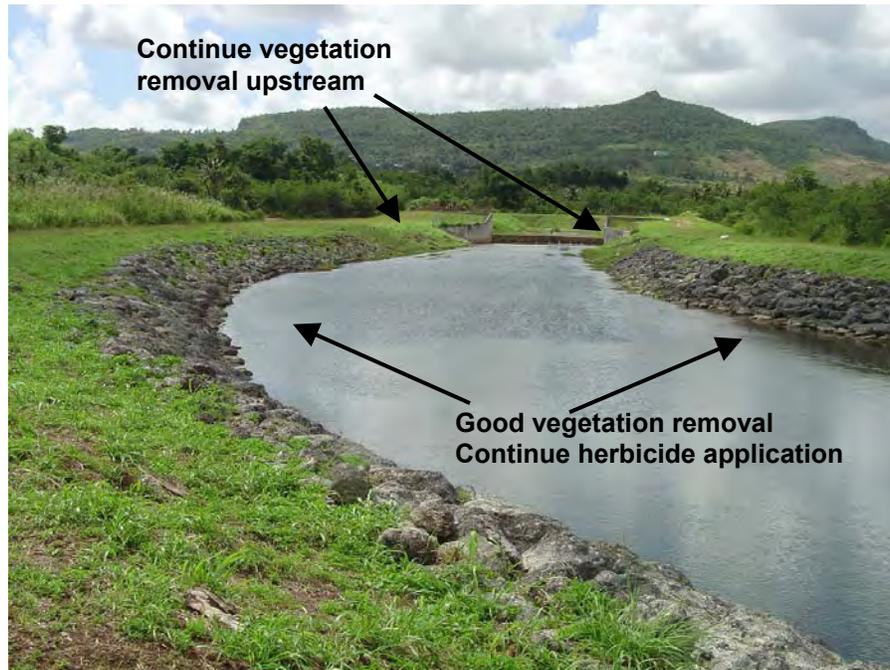
g. Sta. 7+55 (approx), looking upstream from RB, good vegetation removal, need to continue vegetation removal upstream, continue herbicide application to control vegetation throughout

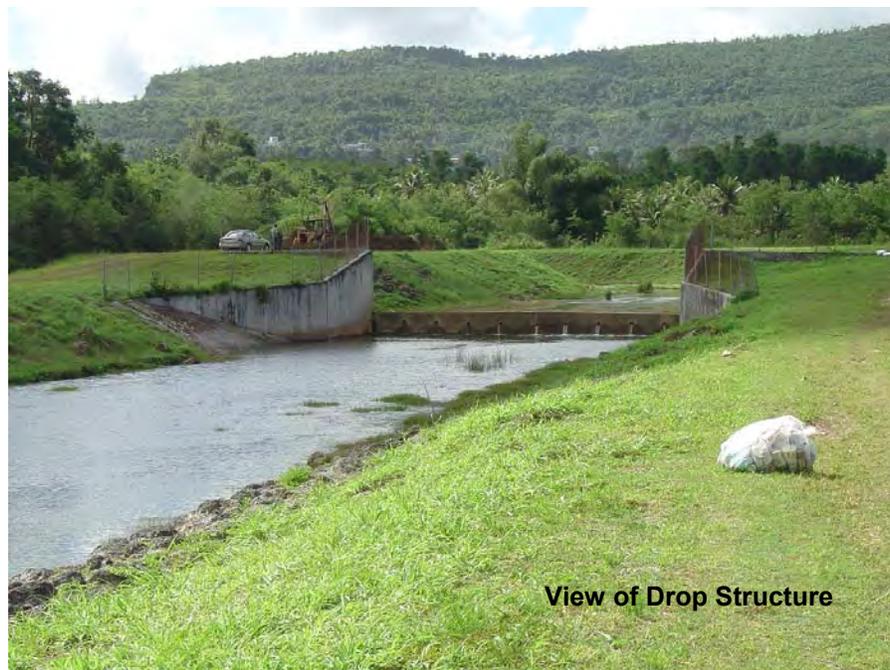
View of Drop Structure

h. Sta. 12+00 (approx), View of drop structure that has good flow through it, remove vegetation and material from banks so riprap is visible

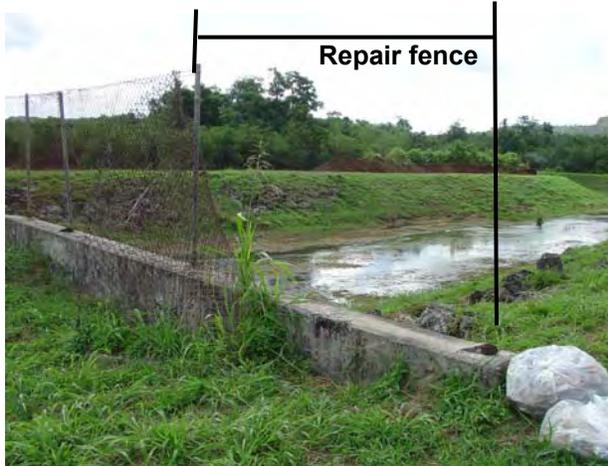
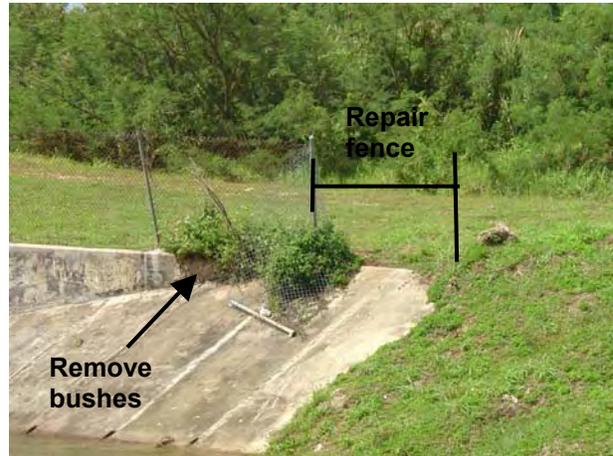
- i. Sta. 13+50, Repair fence at drop structure, u/s side (left) and d/s end (right), remove vegetation and bushes in fence

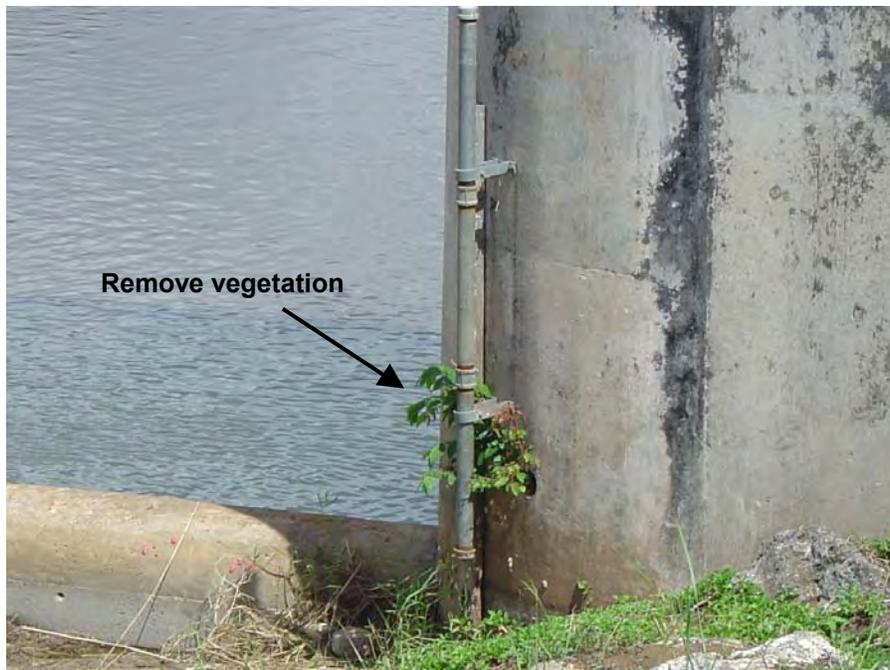
- j. Sta. 13+50, staff gage at drop structure, remove vegetation in and around drop structure and in any cracks of structure

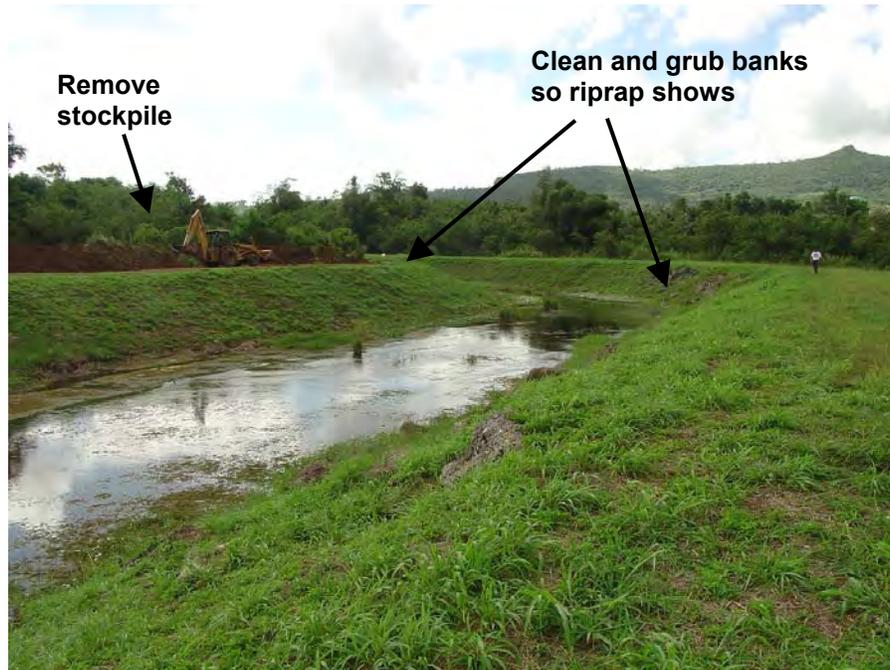
k. Sta. 14+00, remove vegetation and material to expose riprap slopes, remove stockpiles of material, looking u/s from LB at drop structure

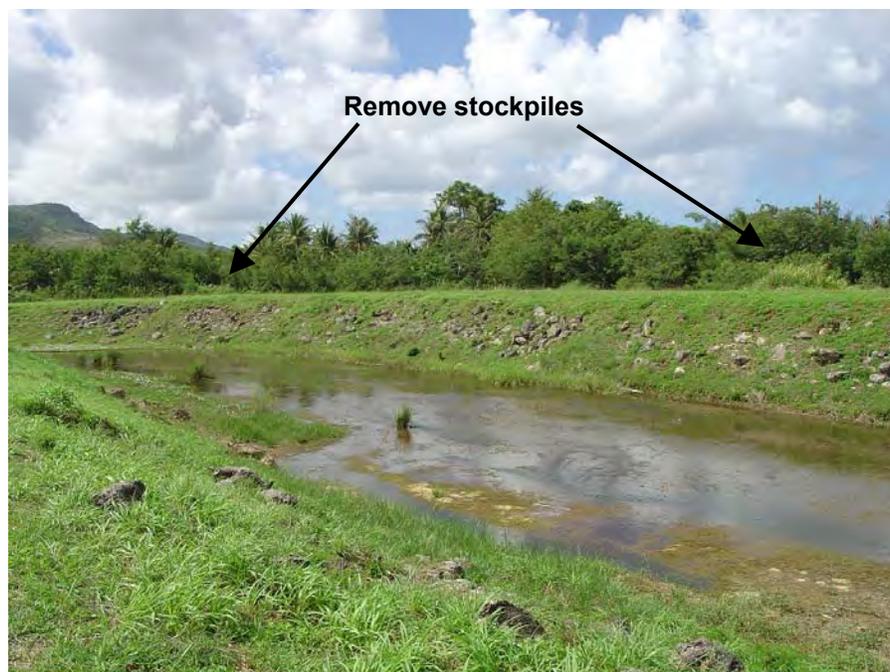
l. Sta. 14+00, remove vegetation and material to expose riprap slopes, remove stockpiles of material, looking u/s from RB at drop structure

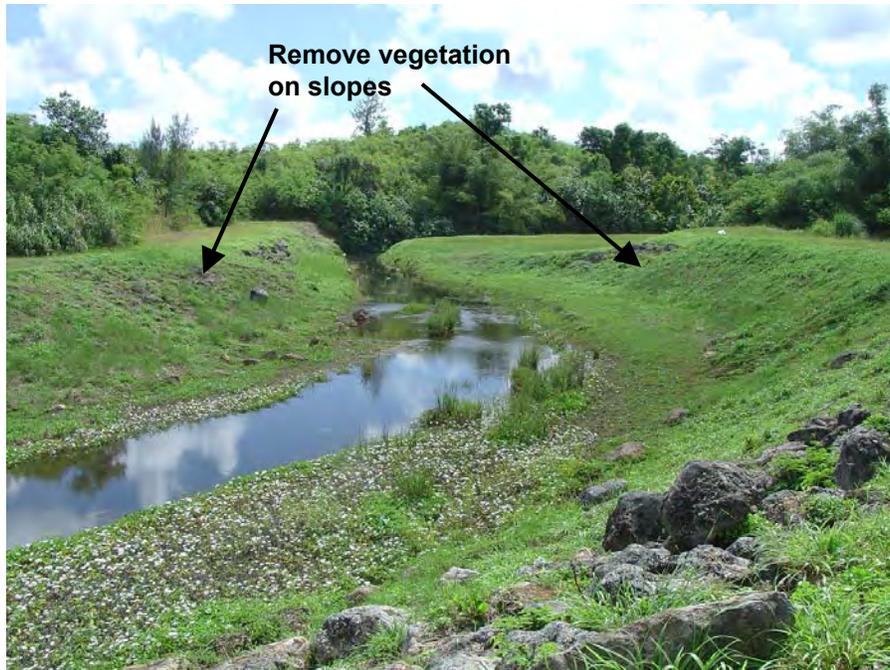
m. Sta. 17+50, Upper reach of Project, remove vegetation and soil from slopes to expose riprap. Place any riprap in channel bed back on slopes. Good job of mowing, looking u/s from LB.

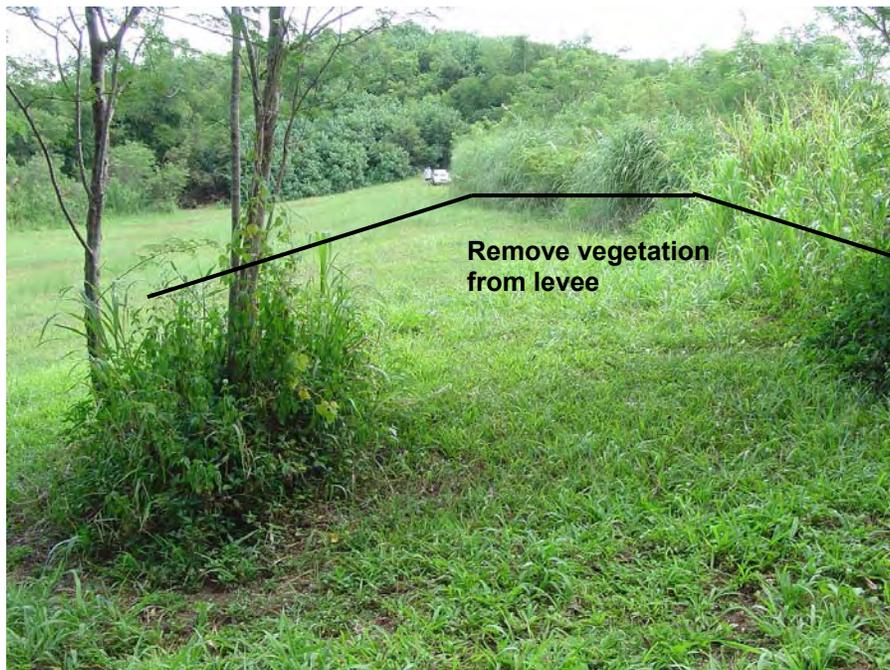
n. Sta. 0+00, Earthen Levee, remove woody vegetation from levee, mowed side looks very good, both side slopes and top need to look like this.
