**CONTINUING ELIGIBILITY INSPECTION (CEI) REPORT
FOR HURRICANE & SHORE PROTECTION PROJECTS**

1. Project Name: Pago Pago Int'l Airport Shore Protection Project
2. Date of Inspection: April 10, 2002
3. Inspection Personnel:

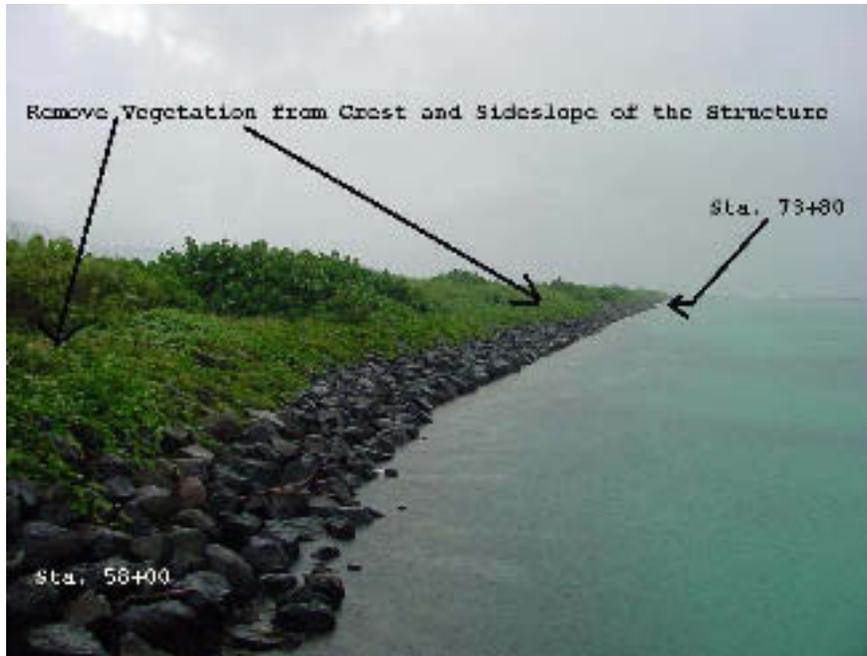
a. Sta. 58+00 to Sta. 73+80, this area was covered with too much vegetation (vines) to properly inspect.

The focus of the maintenance required should be directed at vegetation control. Removal or herbicides are recommended in lieu of cutting.

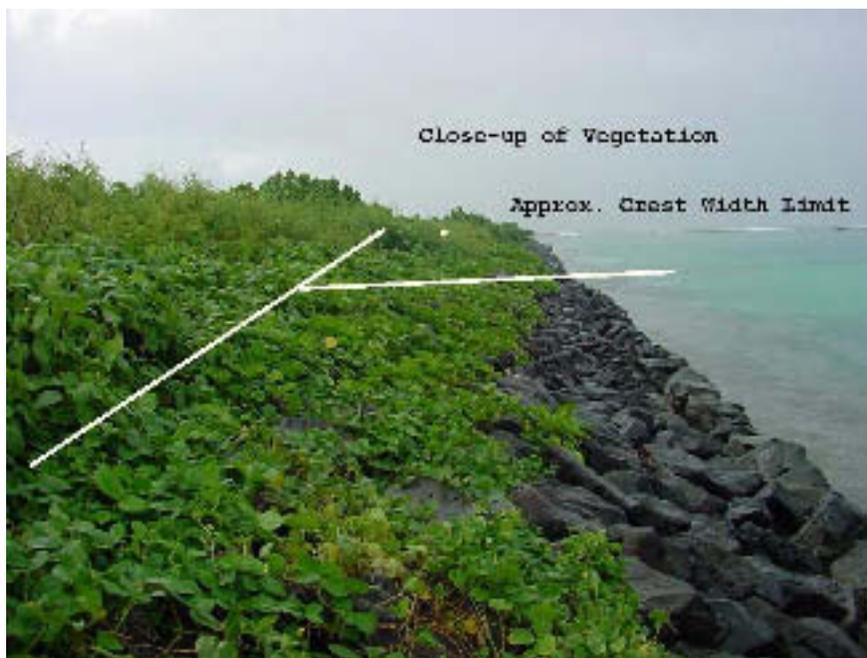
b. Sta. 60+00, Remove vegetation from revetment's splash apron, crest and sideslope. This area was covered with too much vegetation (vines) to properly inspect.

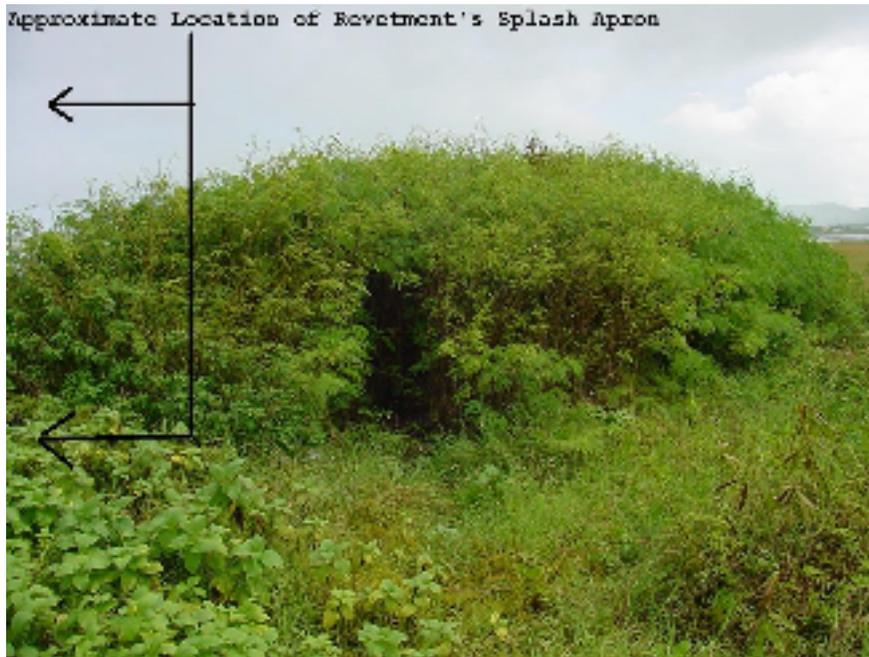
c. Sta. 73+80 (Facing West), this area was covered with too much vegetation (koa) to properly inspect. Remove vegetation from revetment.
