**CONTINUING ELIGIBILITY INSPECTION (CEI) REPORT
FOR HURRICANE & SHORE PROTECTION PROJECTS**

1. Project Name: Pago - Nuuuli Shore Protection Project
2. Date of Inspection: April 10, 2002
3. Inspection Personnel:

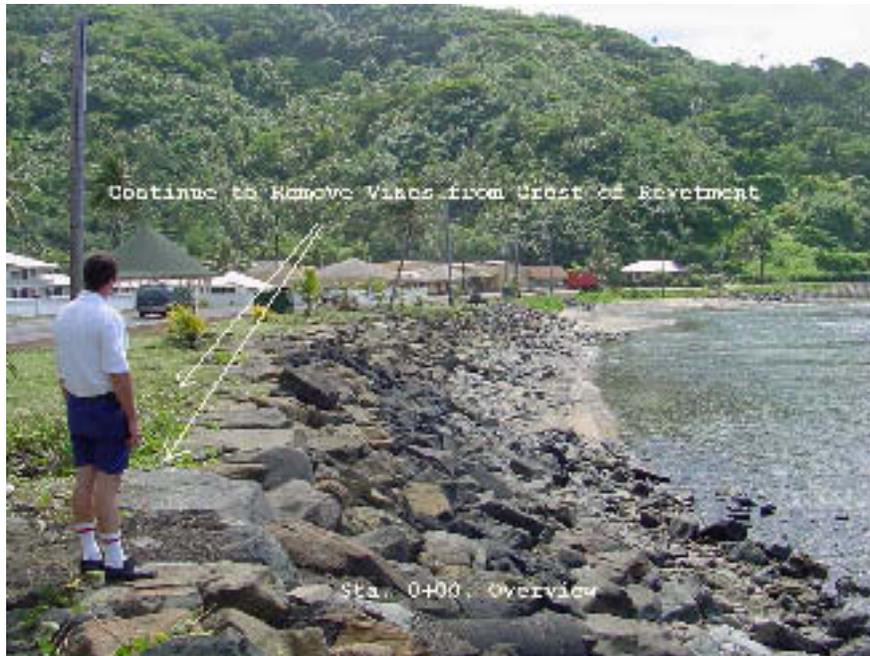
- a. Sta. 0+00, Remove vegetation from the revetment sideslope.
- b. Sta. 0+65, Monitor dislodged armor stone at the toe.
- c. Sta. 1+15, Reset 2 armor stones that are dislodged at the crest adjacent the power pole.
- d. Sta. 2+20 Monitor settlement adjacent bus stop, 20' wide.

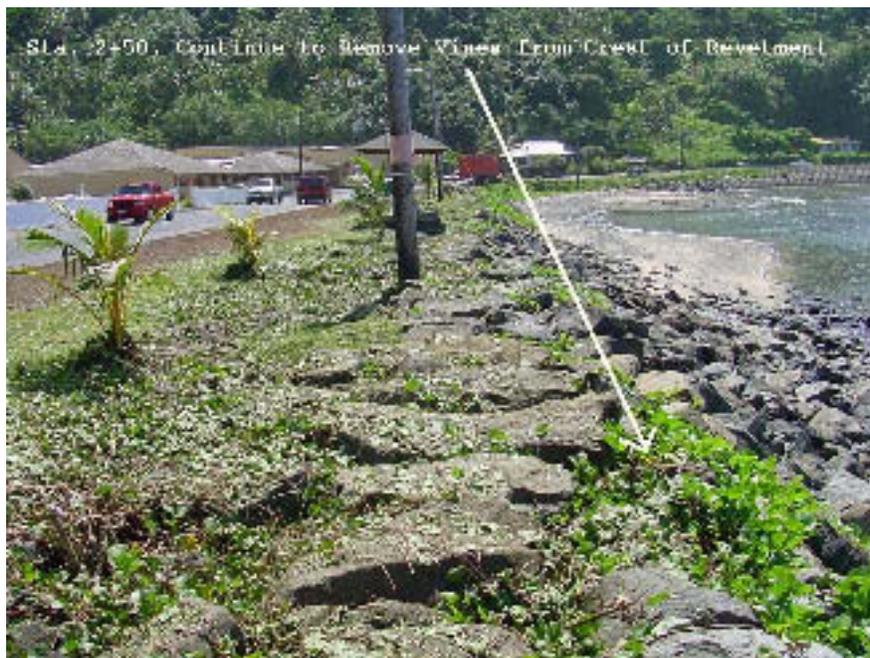
- e. Sta. 2+50, Remove vegetation from the revetment sideslope.

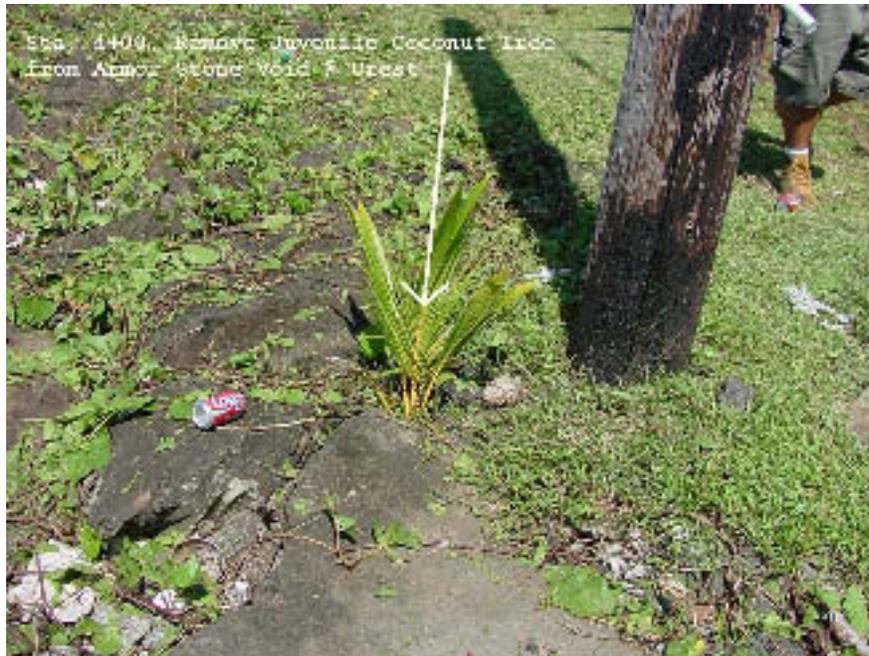
f. Sta. 4+00, Remove coconut tree from revetment.

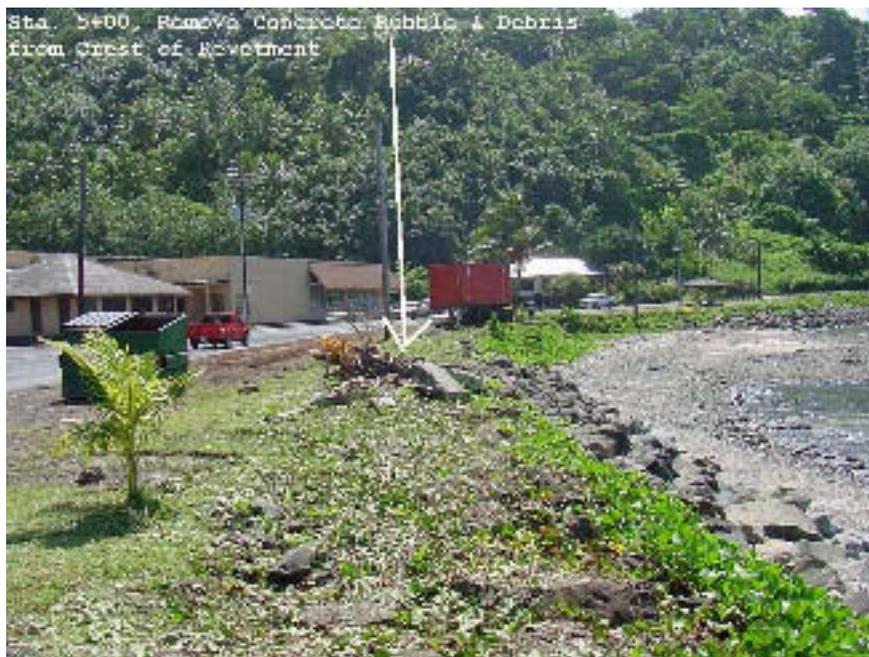
g. Sta. 5+00, Remove concrete rubble and debris from revetment.

- h. Sta. 5+15, Remove stockpile of concrete rubble from crest dumped on the crest of the revetment.

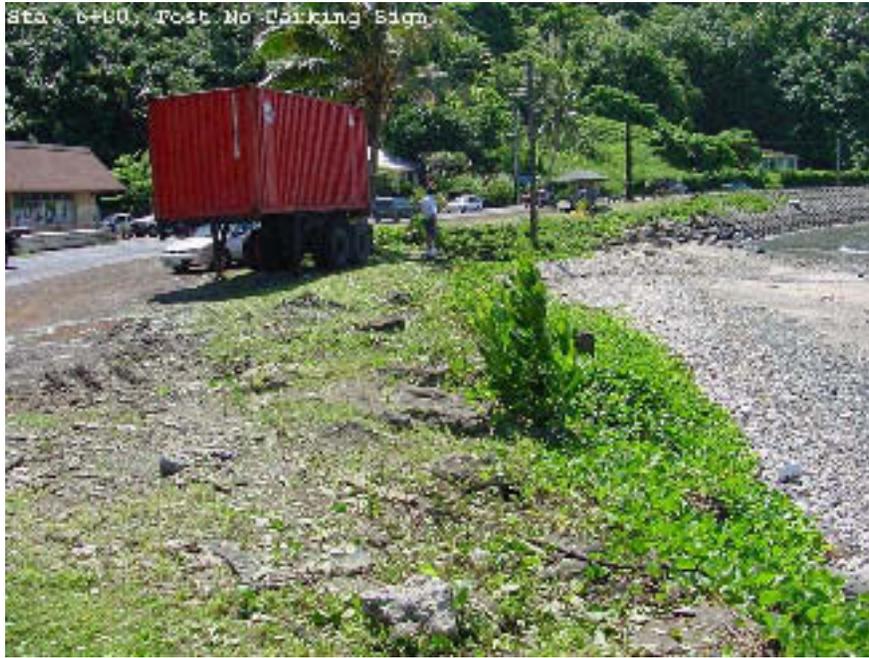
- i. Sta. 6+15 - Sta. 7+15, Prohibit parking of tractor trailers on the crest of the revetment, trailers were parked causing stone displacement and ruts.

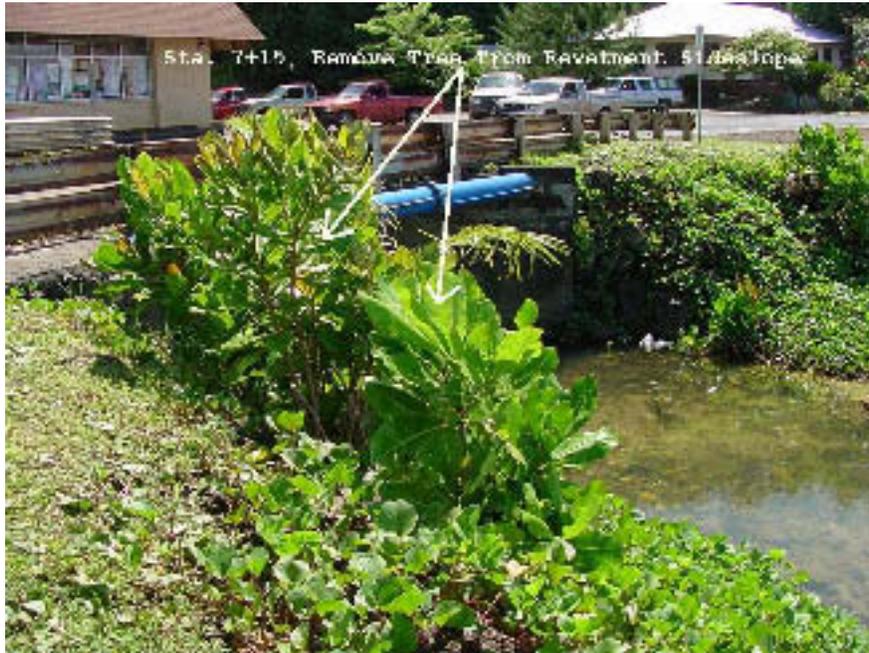
- j. Sta. 7+15, Remove vegetation from revetment's sideslope.

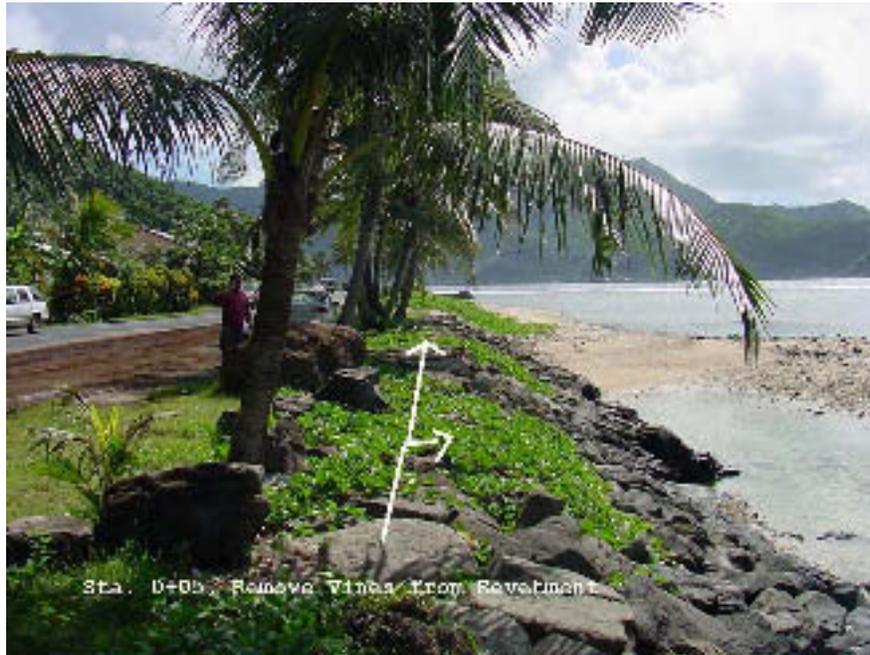
a. Sta. 0+05, Remove vines from the revetment.

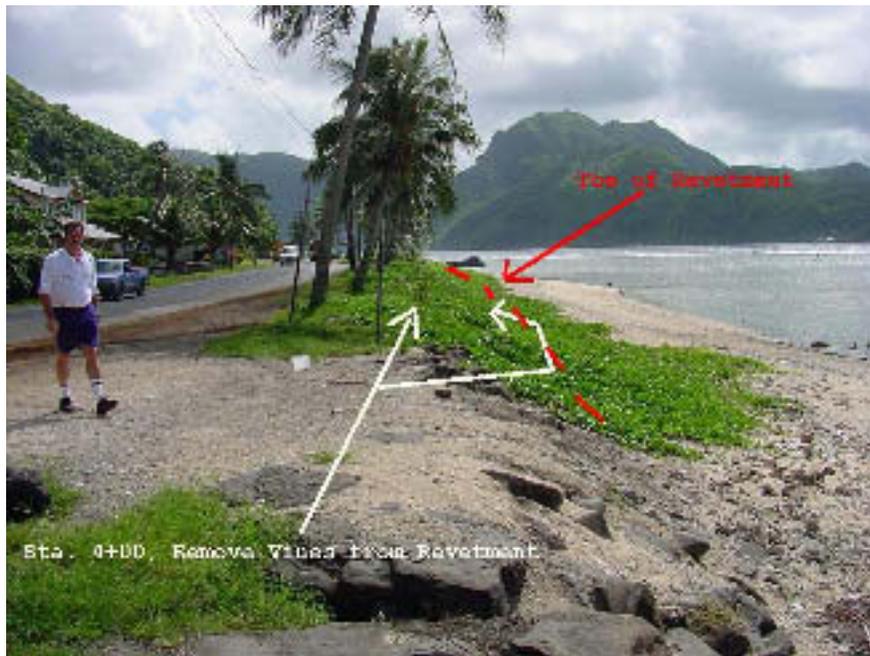
b. Sta. 4+00, Remove vines from revetment.

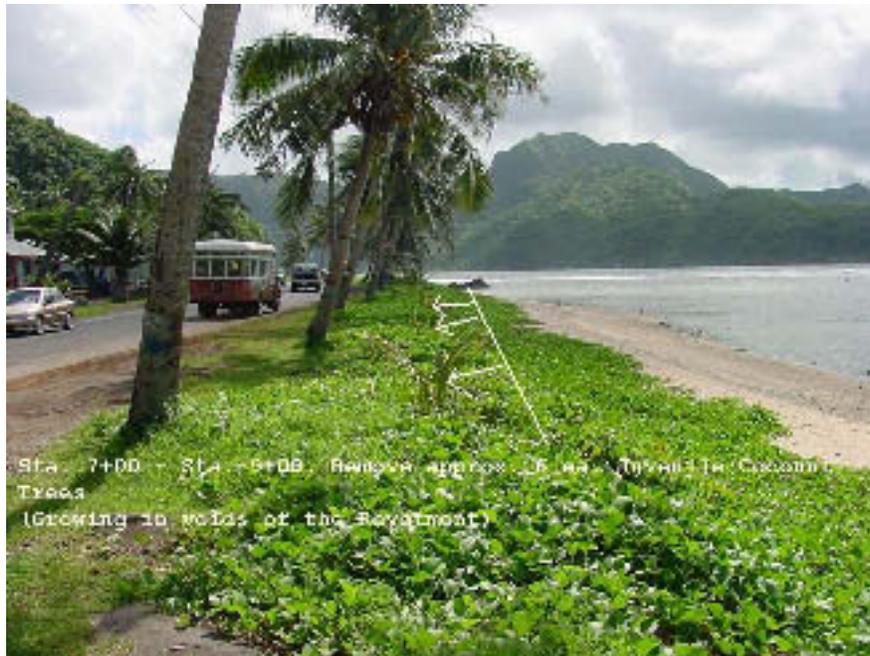
c. Sta. 7+00 - Sta. 9+00, Remove vines and juvenile coconut trees.

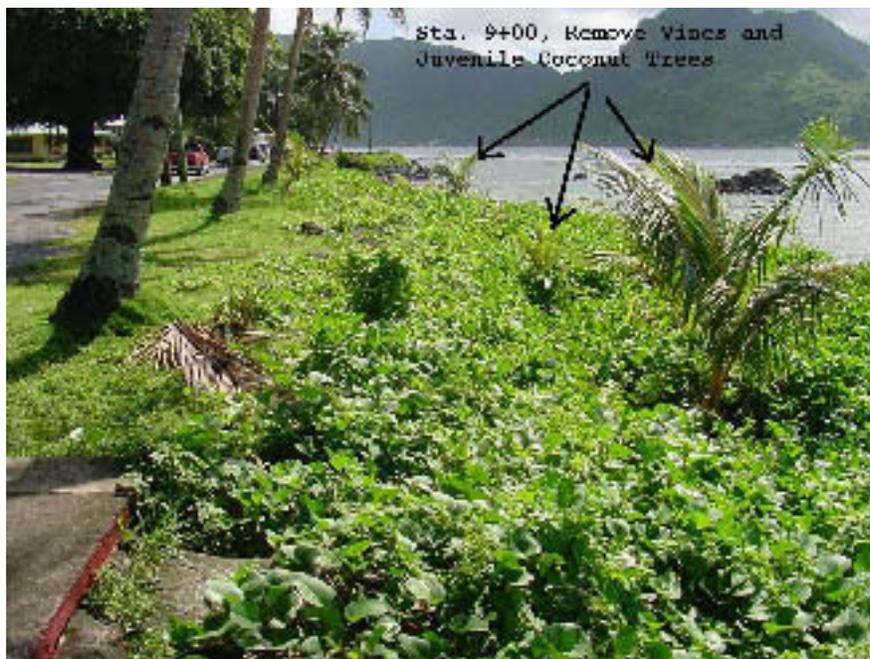
d. Sta. 9+00, Remove vines and juvenile coconut trees.

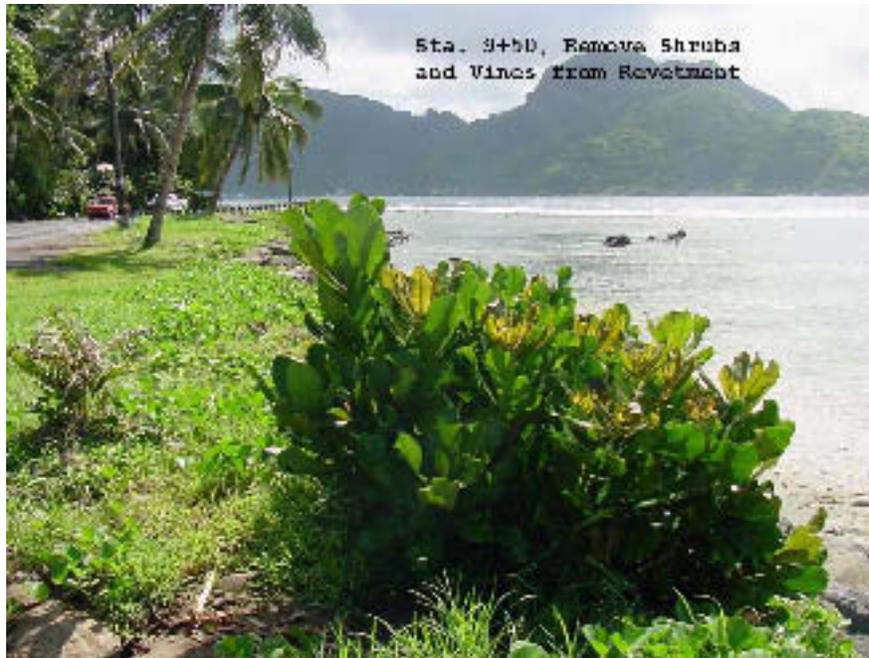
e. Sta. 9+50, Remove shrubs from revetment.
