**CONTINUING ELIGIBILITY INSPECTION (CEI) REPORT
FOR HURRICANE & SHORE PROTECTION PROJECTS**

1. Project Name: Poloa Shore Protection Project
2. Date of Inspection: April 10, 2002
3. Inspection Personnel:

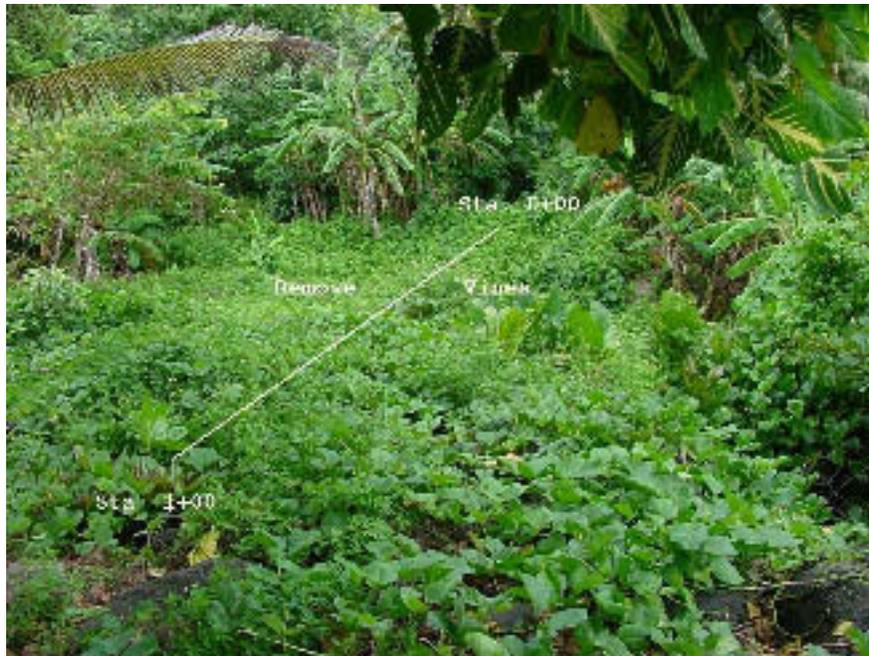
a. Sta. 0+10 to Sta. 1+00, is area was covered with too much vegetation (vines) to properly inspect.

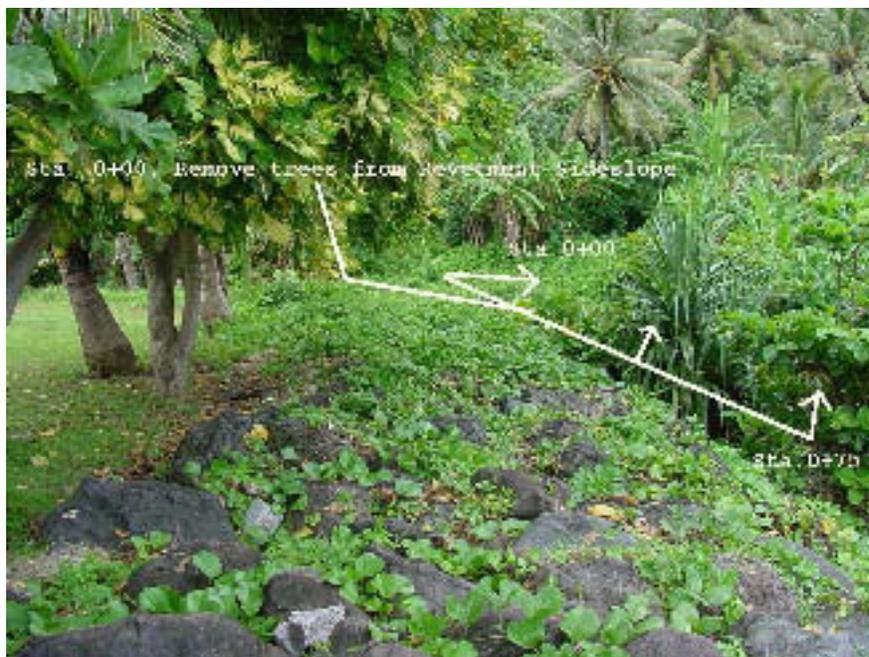
b. Sta. 0+00 to Sta. 0+75, Remove trees from revetment sideslope.

The focus of the maintenance required should be directed at vegetation control. Removal or herbicides are recommended in lieu of cutting.

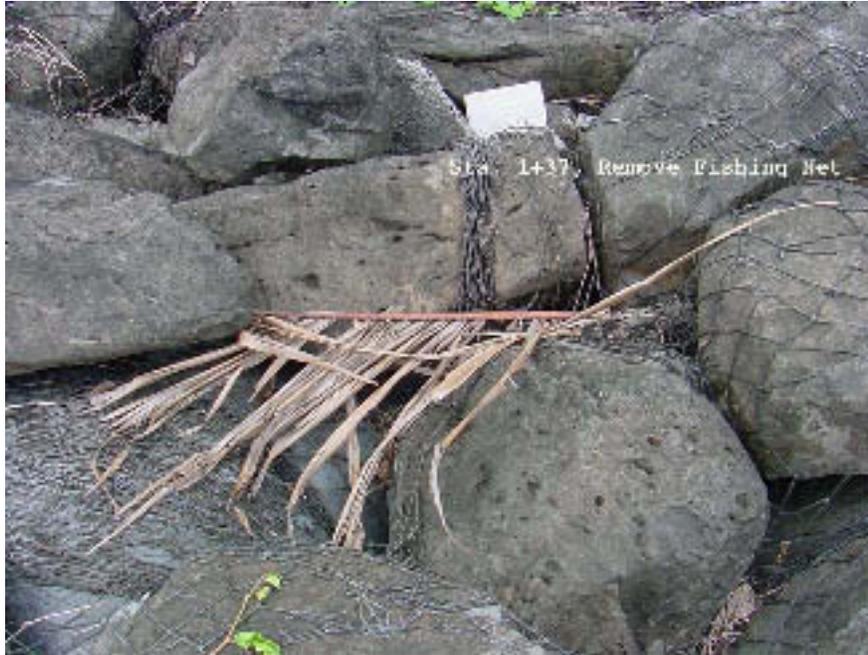
c. Sta. 1+37, Remove black fish net which encourages vines to grow. Note: The lower portion of the sideslope, the use of oversized armor stones has resulted in bridging.

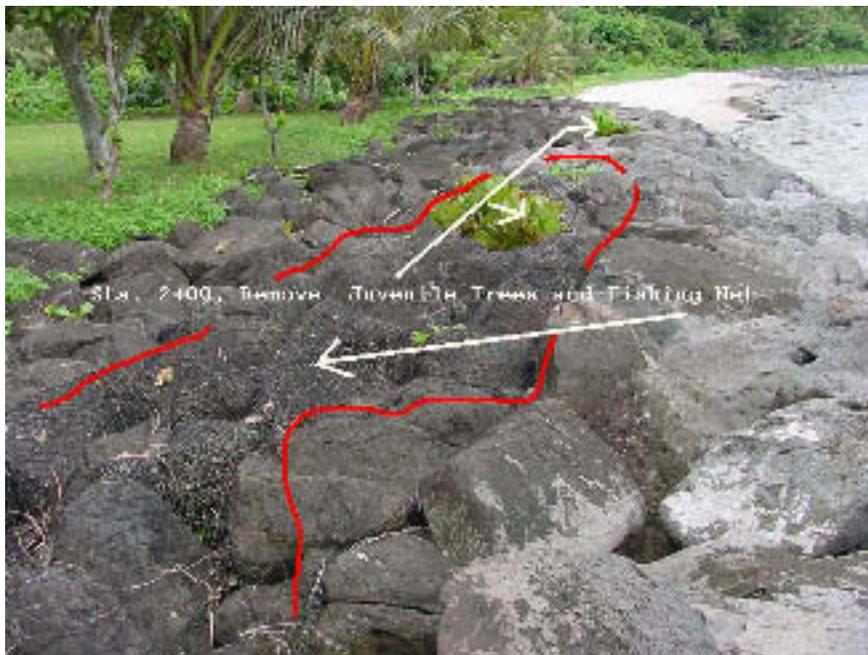
d. Sta. 2+00, Monitor sideslope settling 10' x 10' there appears to be excessive chinking, remove three trees which were recently cut as a result of previous inspection are starting to re-grow and remove fish net.

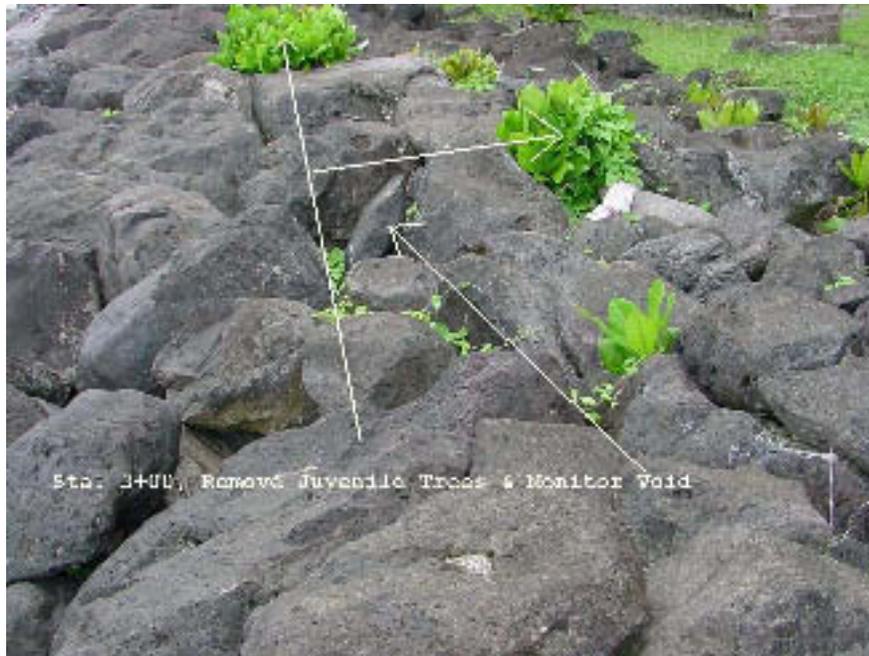
e. Sta. 3+00, Remove juvenile trees, which were recently cut as a result of previous inspection, as they are starting to re-grow.

f. Sta. 3+00, sideslope, 10' x 10' area of smaller armor stones (compared to adjacent stones) with poor contact.

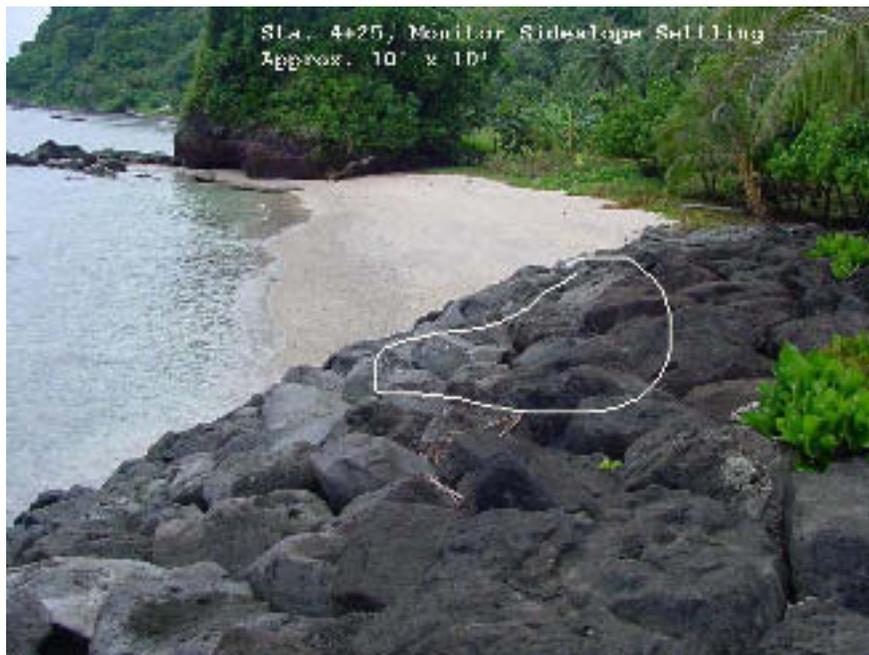
g. Sta. 4+25, Monitor the sideslope settling area approx. 10' x 10'.

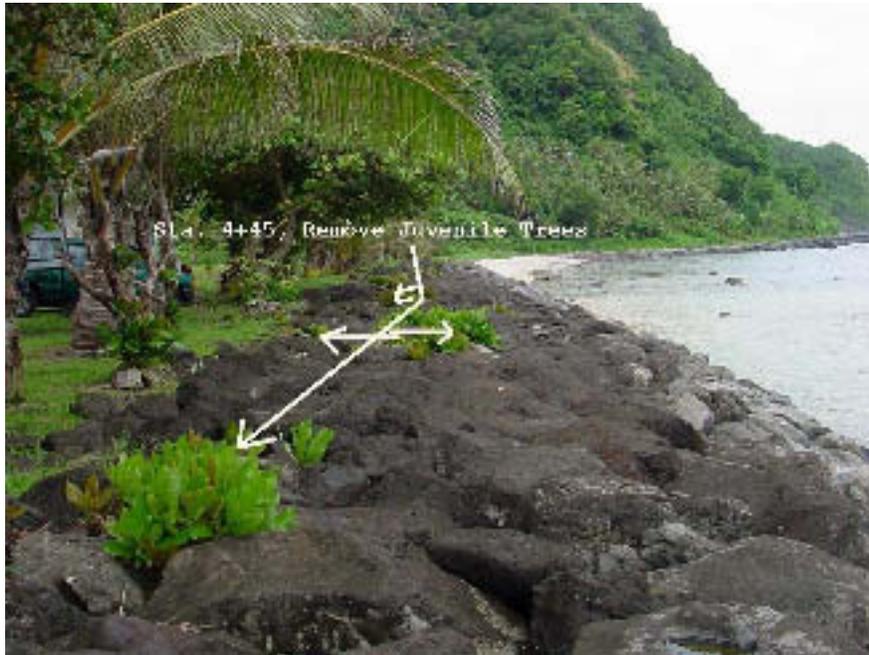
h. Sta. 4+45, Remove juvenile trees fro the crest of the revetment.
