1. Project Name: Rota SBH
2. Date of Inspection: January 28, 2004
3. Inspection Personnel:

4. Discussion:

Revetted Mole - 535 LF:

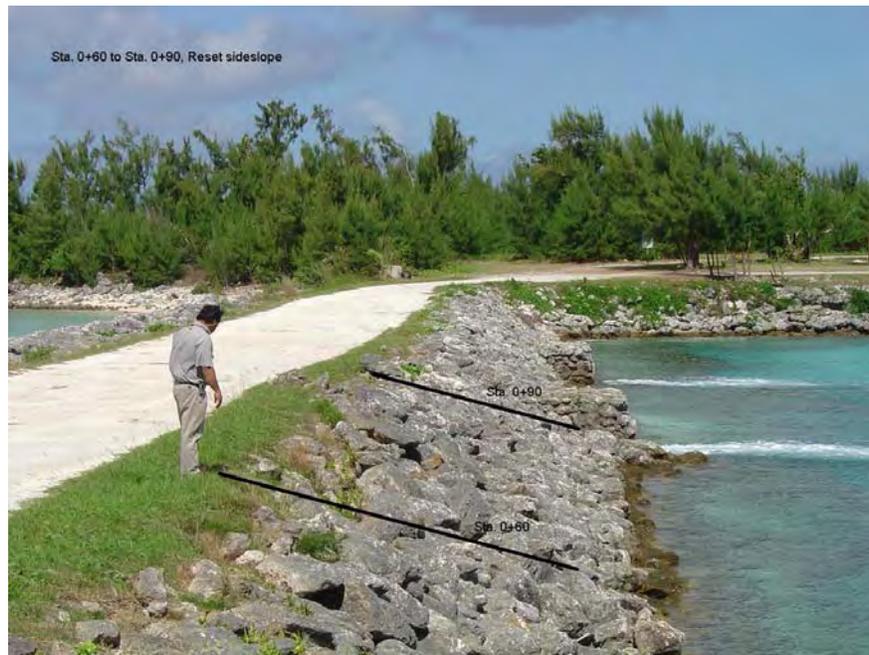
a. Sta. 0+60 to Sta. 0+90, Reset sideslope.

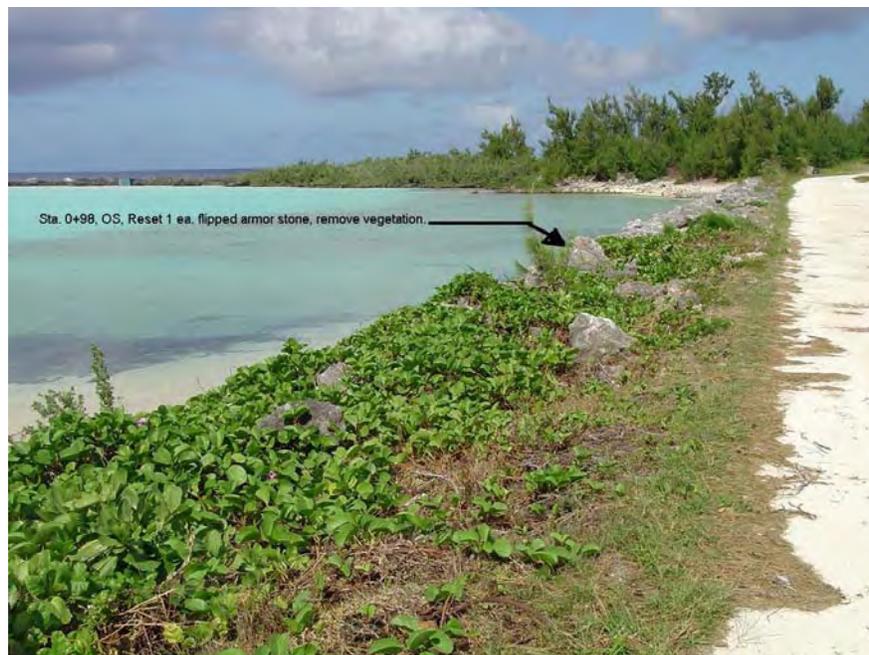
b. Sta. 0+98, OS, 1 ea. Repair/Replace dislodged armor stone and void.

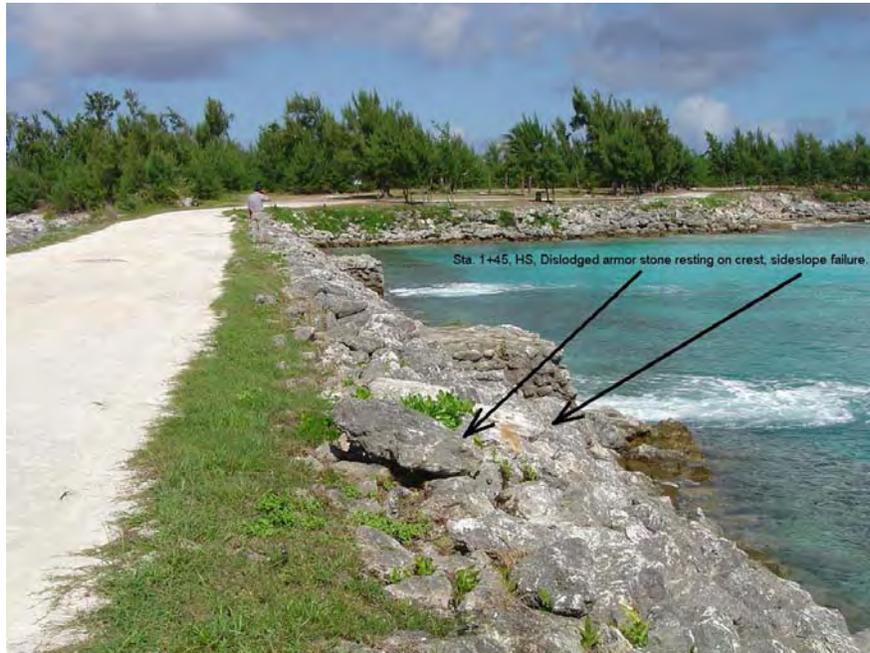
c. Sta. 1+45, Reset dislodged armor stone.

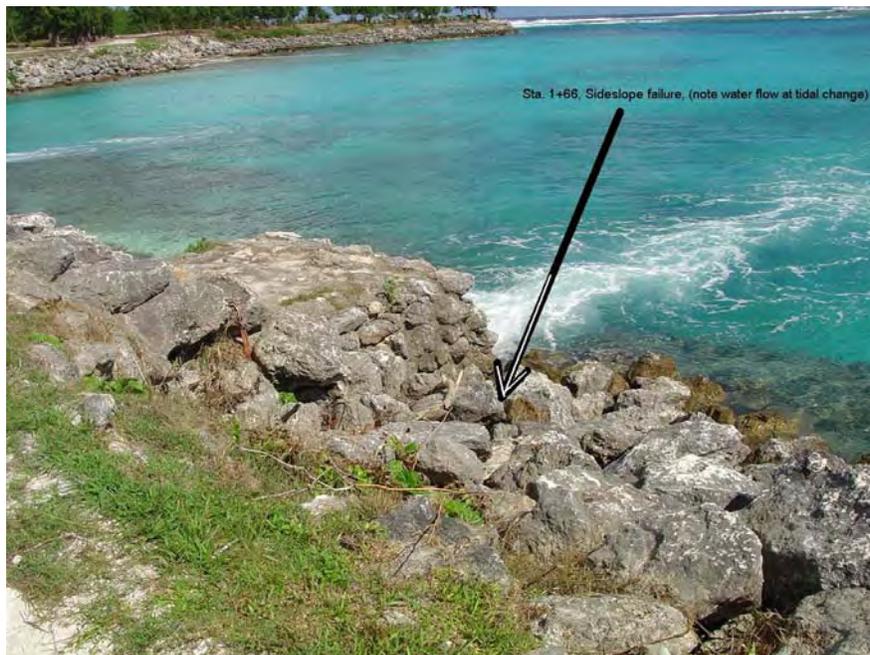
d. Sta. 1+66 (20LF) HS, missing armor stones and void approx. 1/3 of the sideslope.

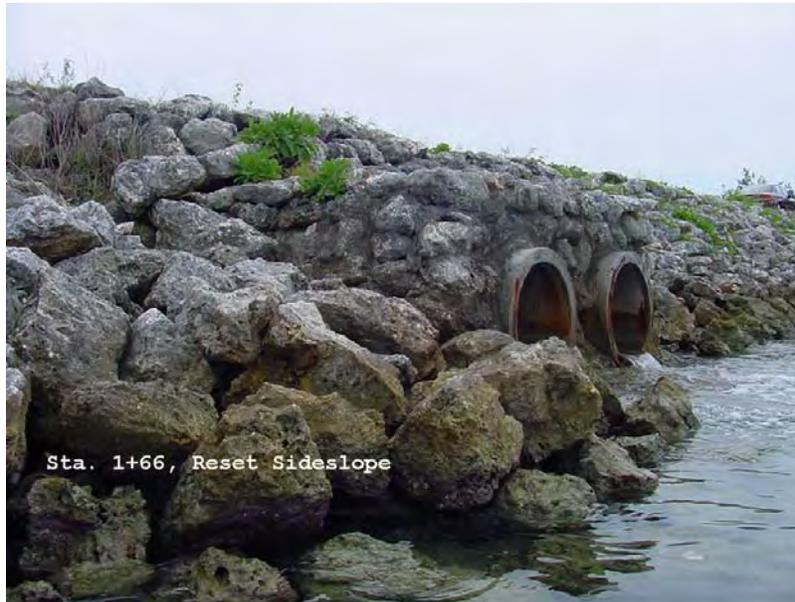
e. Sta. 1+66, Possible undermining of apron (FY03 photo)

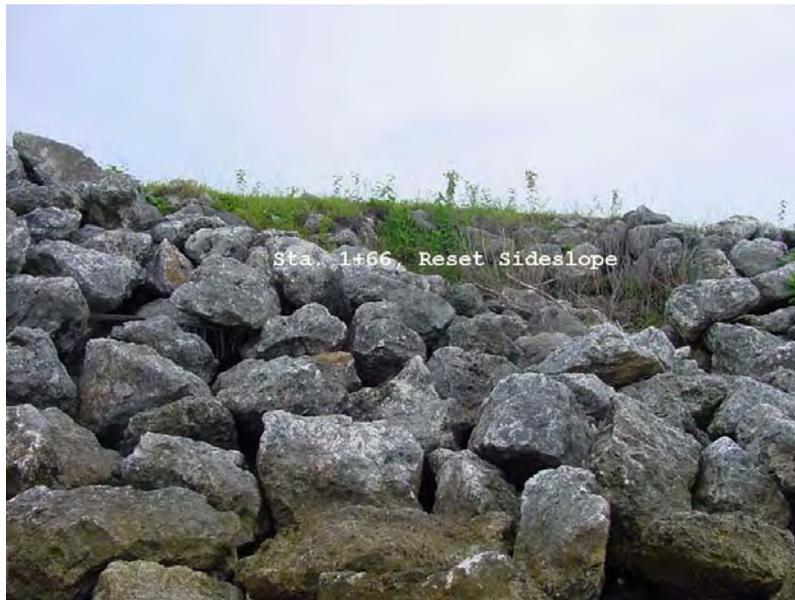
f. Sta. 1+66, Same as Above (FY03 photo)

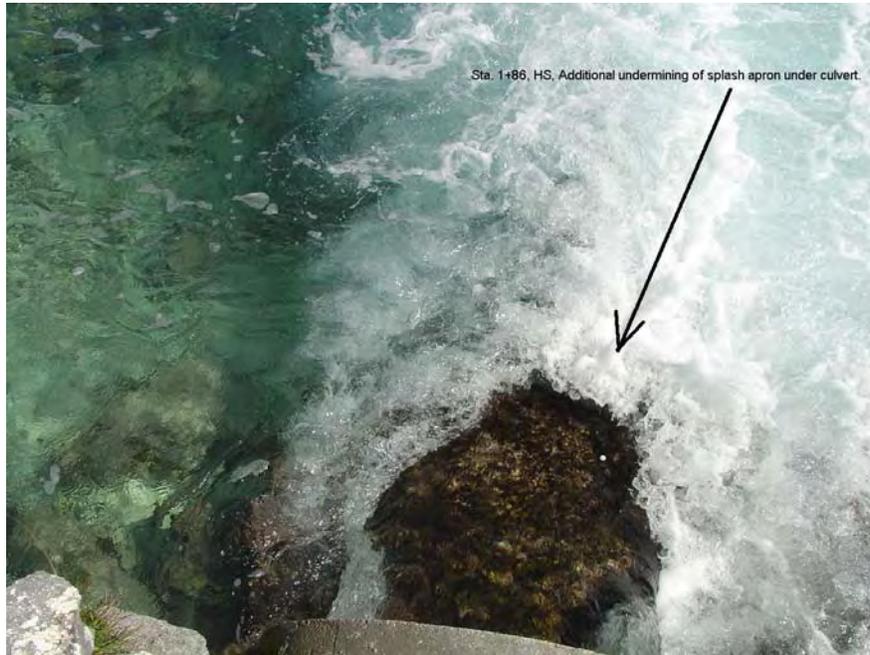
g. Sta. 1+86, Worsening of erosion/undermining beneath splash apron.

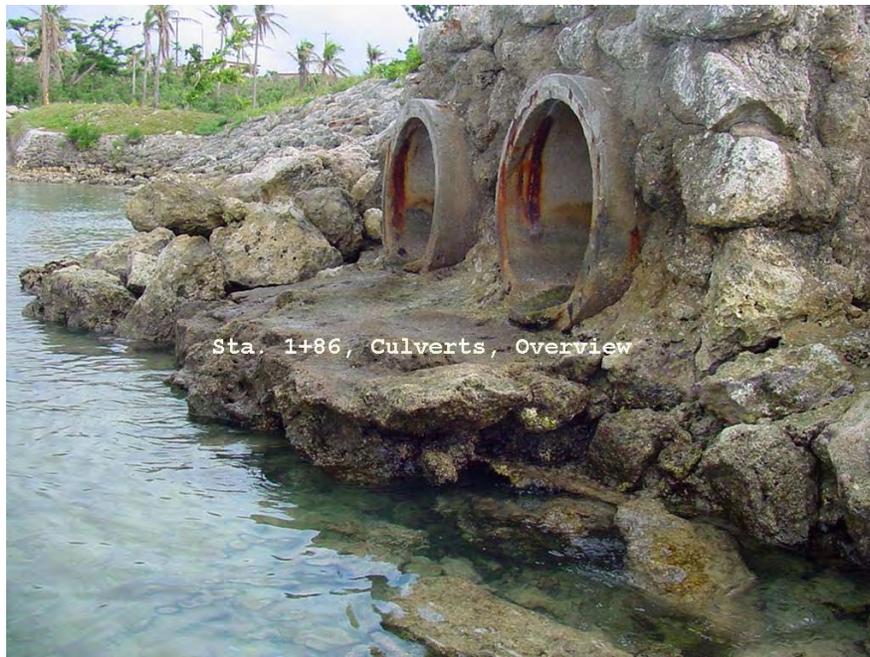
h. Sta. 1+86, Worsening of erosion/undermining beneath splash apron (FY03 photo).

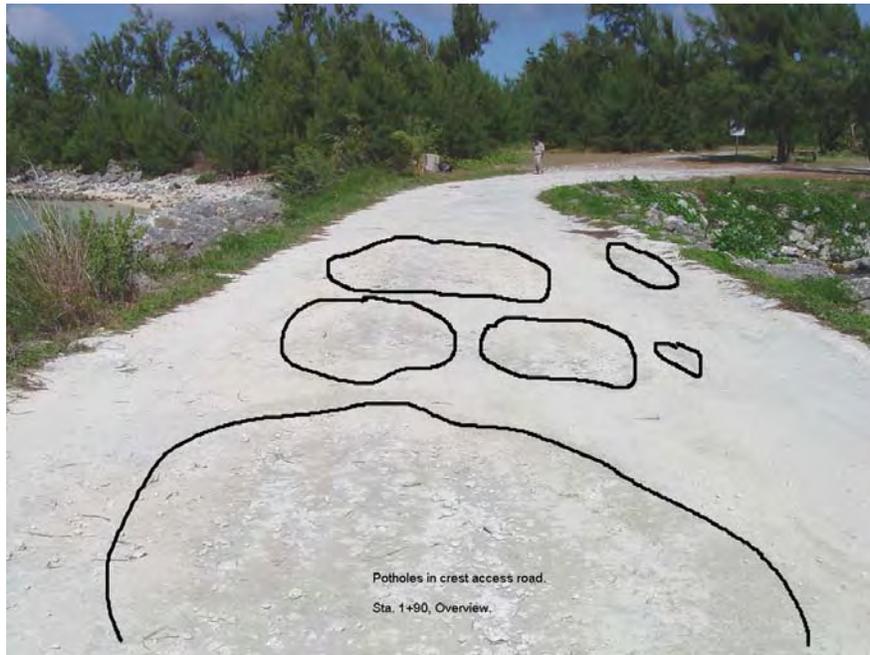
i. Sta. 1+90, Overview of potholes needing repair.

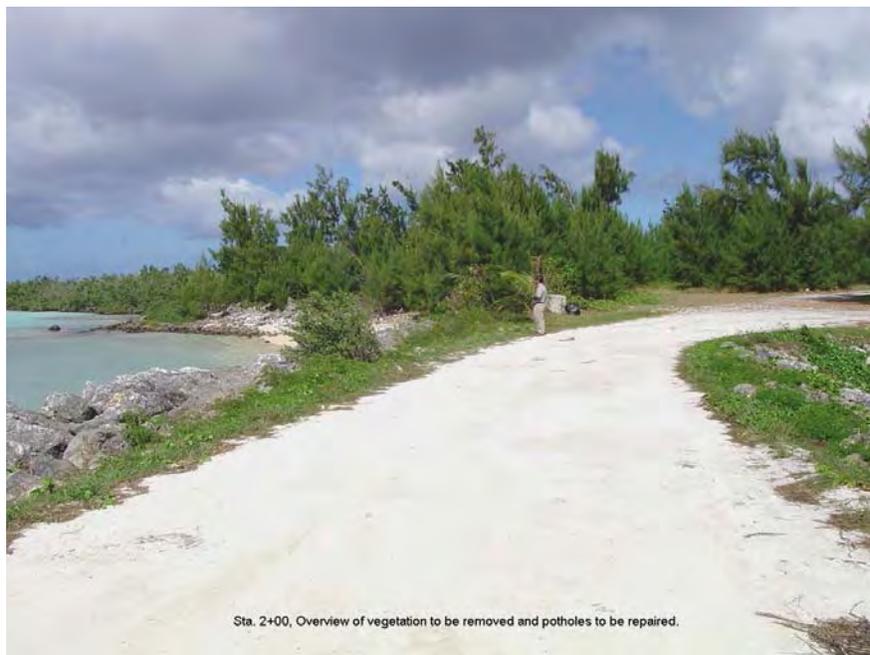
j. Sta. 2+00, Overview of vegetation to be removed and potholes to be fixed.

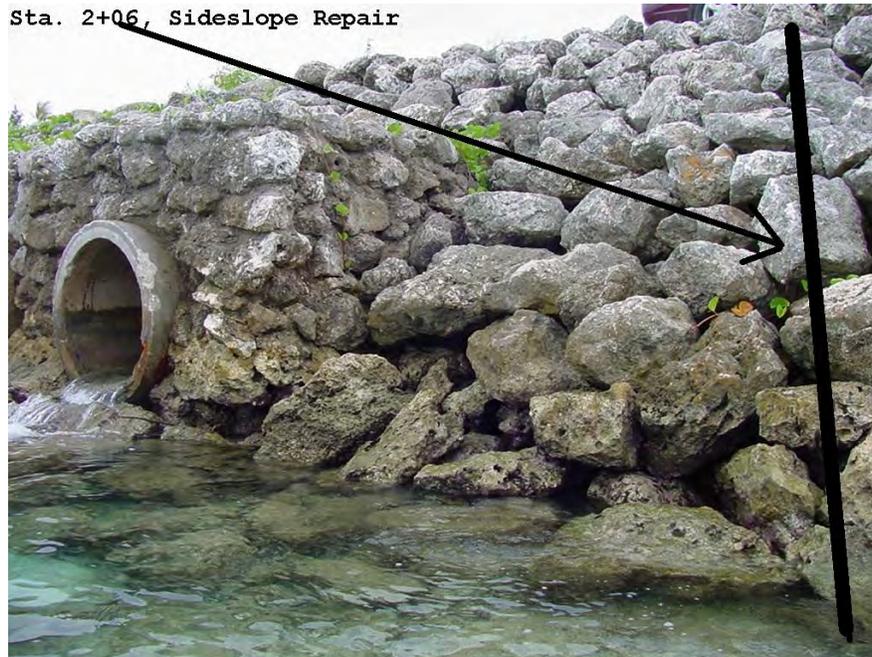
k. Sta. 2+06, (20LF) HS, missing armor stones and void approx. 1/3 of the sideslope (FY03 photo).

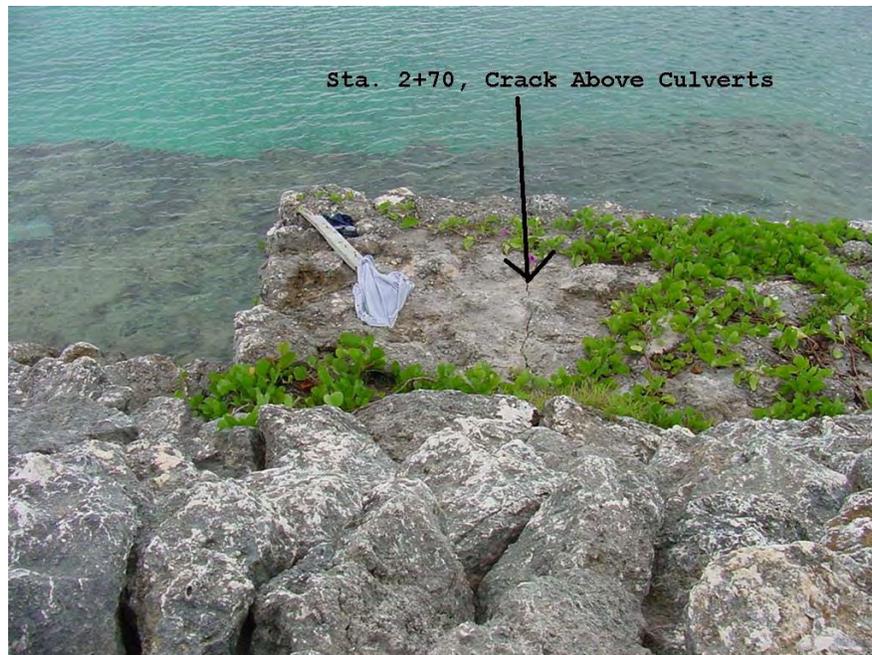
l. Sta. 2+66 - Sta. 2+86, HS, Reset armor stones on sideslope, repair concrete crack above culverts (FY03 photo).

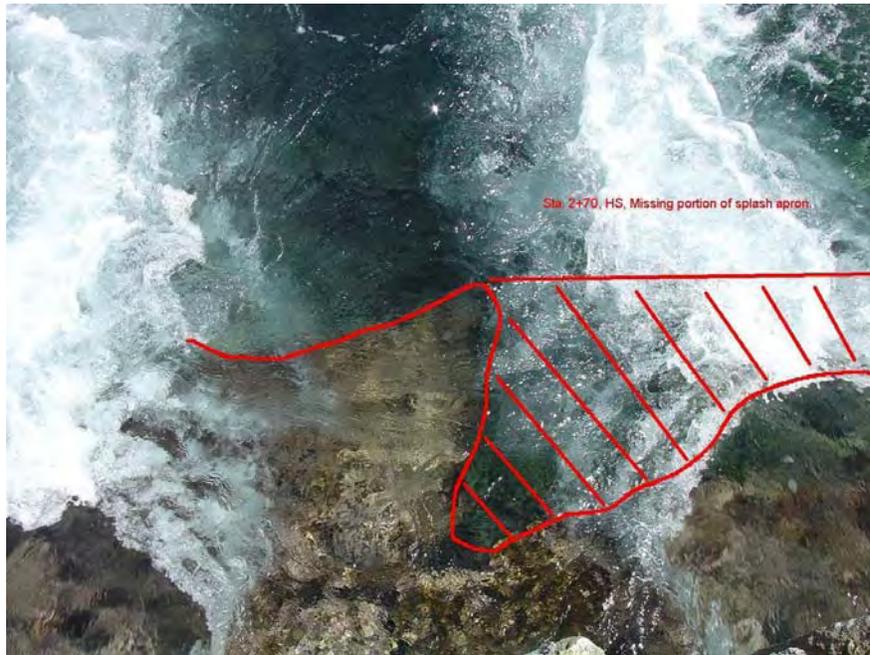
m. Sta. 2+70, HS, Repair broken culvert apron. Scour area is approximately 10' W x 3' D. Repair 10LF sideslope on both sides of the culvert.

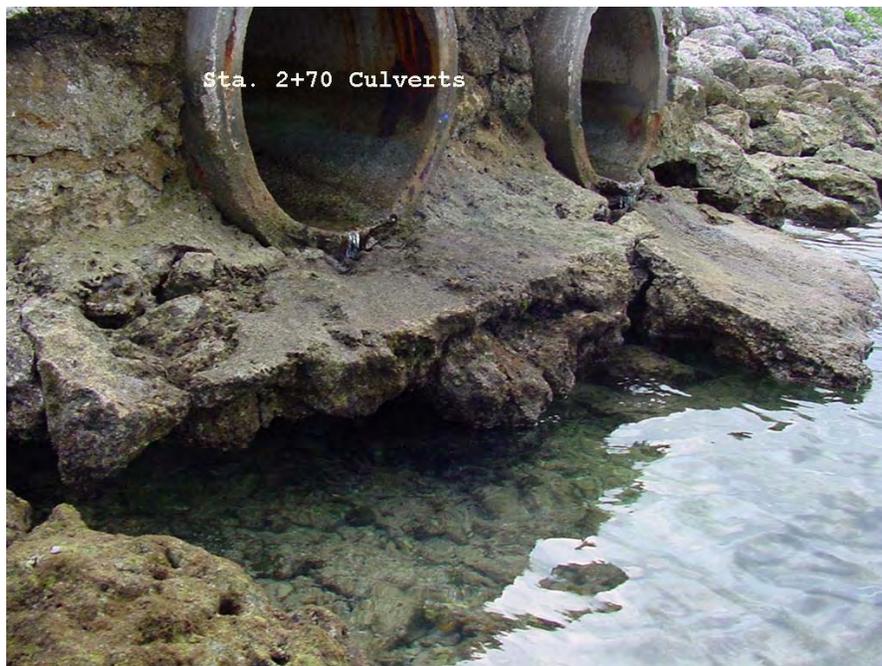
n. Sta. 2+70, HS, Same as above (FY03 photo)

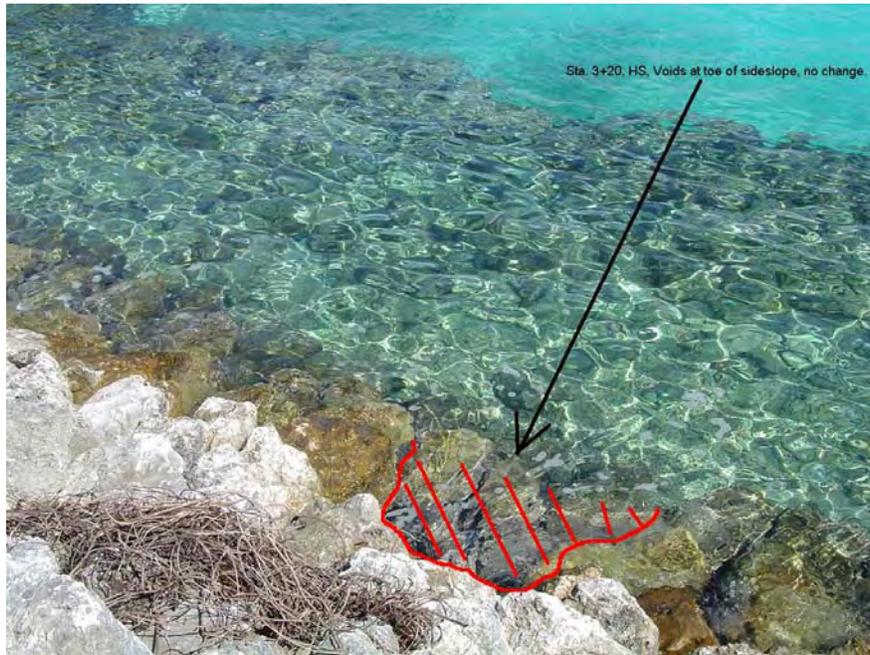
o. Sta. 3+20, HS, Repair voids at the toe.

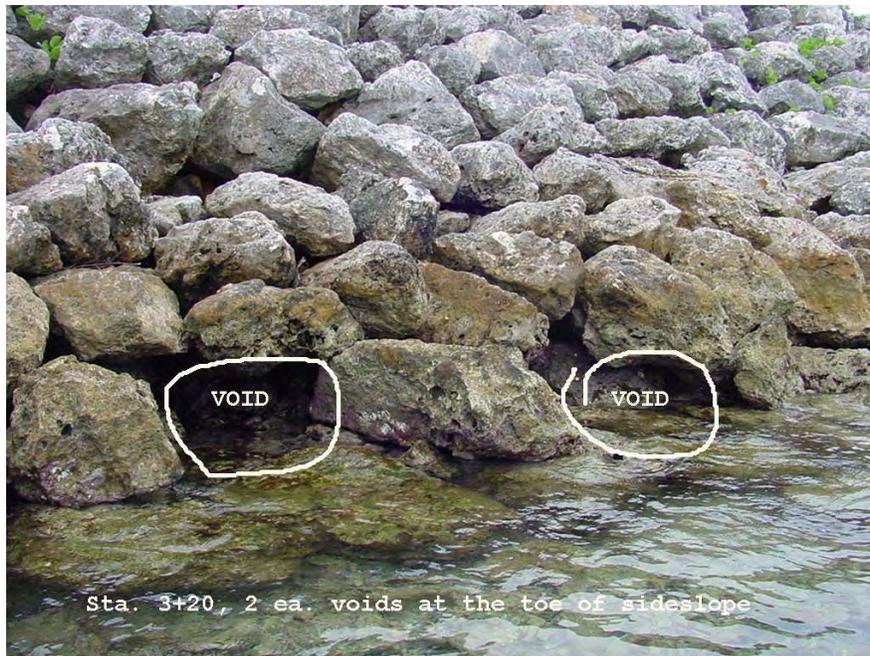
p. Sta. 3+20, HS, Same as above (FY03 photo)

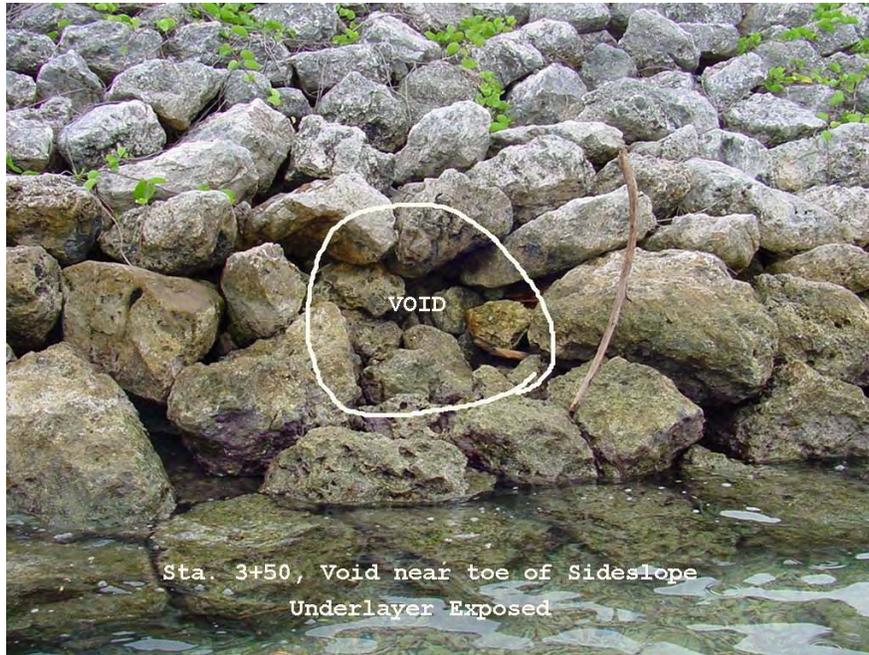
q. Sta. 3+50, HS, Repair void on sideslope (FY03 photo).

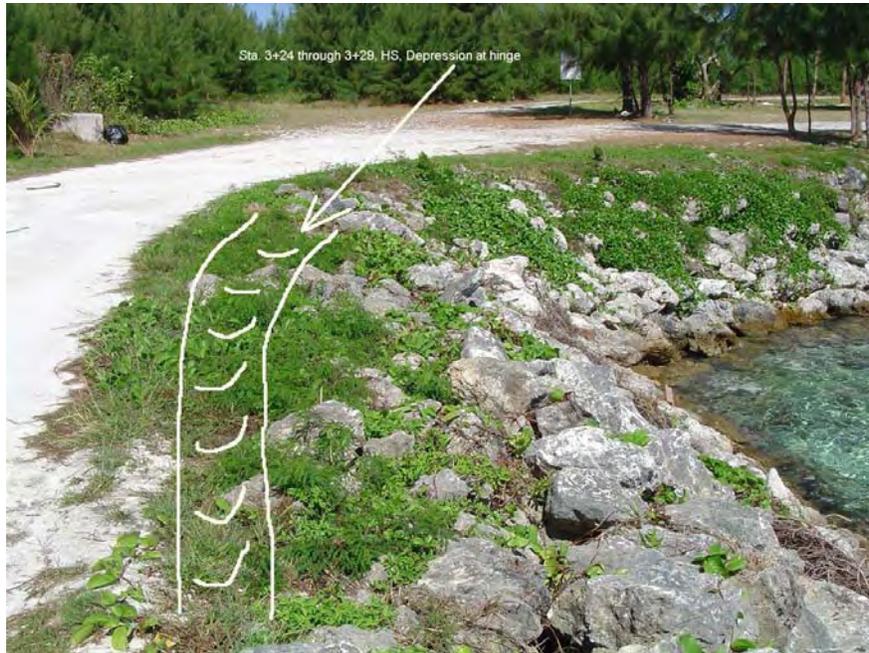
r. Sta. 3+54, HS, Settling / depression at hinge of sideslope.

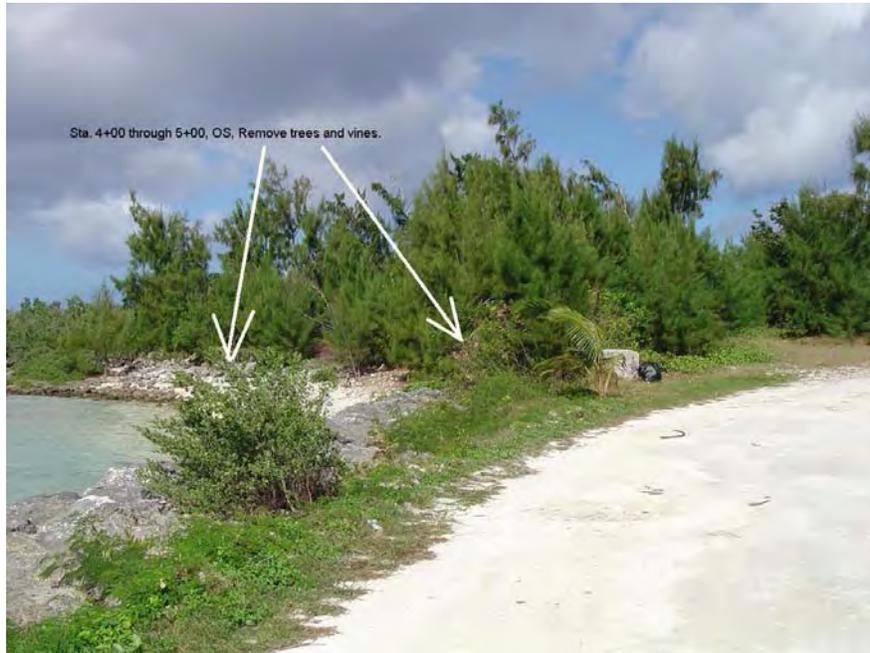
s. Sta. 4+00 to Sta. 5+00, OS, Covered with vegetation. Typical ov vegetation to be removed in this area.

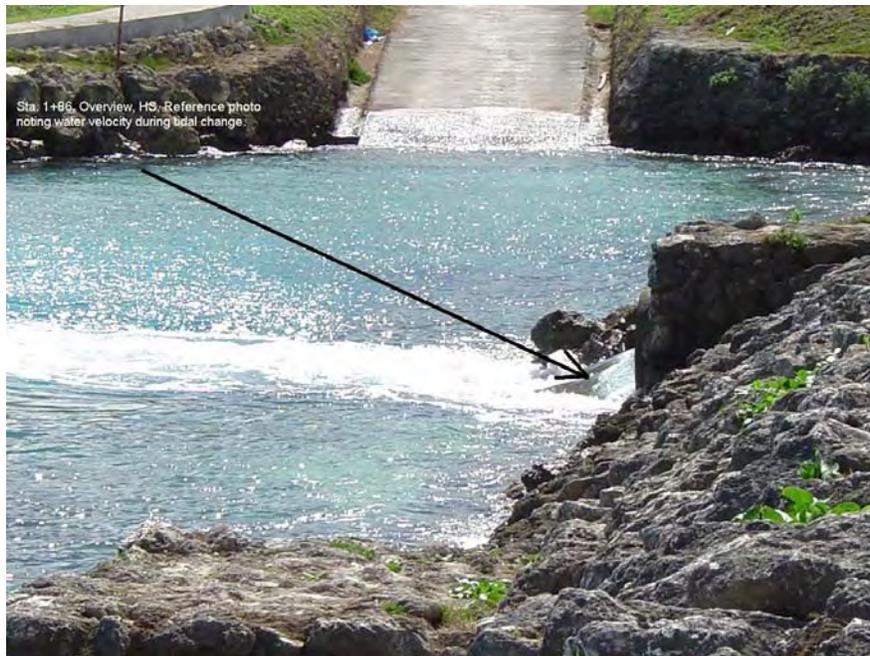
t. Sta. 1+86, HS, Overview, Reference photo noting water velocity during tidal change.
