O & M INSPECTION REPORT  
FOR NAVIGATION AND SHORE PROTECTION PROJECTS

1. PROJECT NAME: WAIANAE SMALL BOAT HARBOR

2. DATE OF INSPECTION: 29 AUGUST 2002

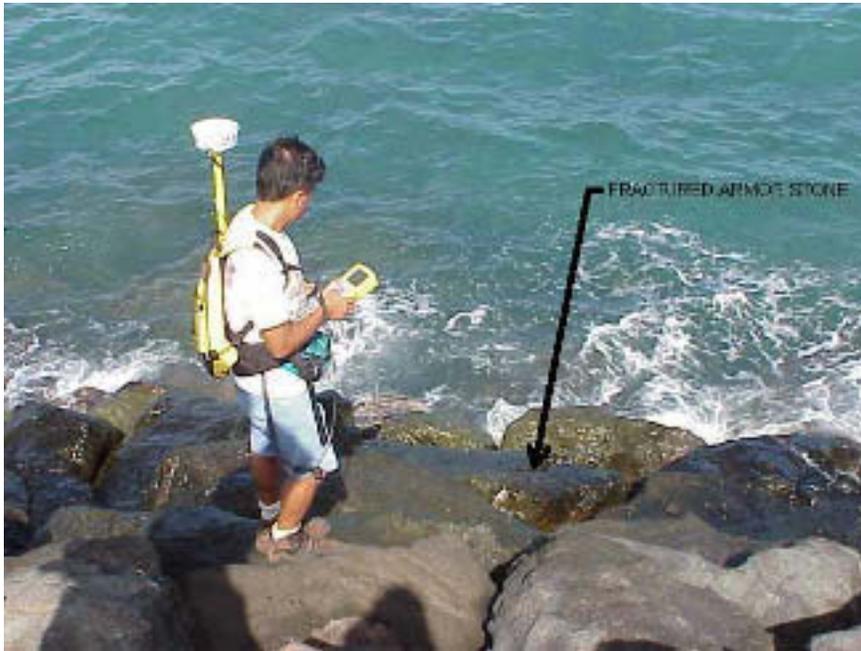
STA. 0+55, Crest: Fractured armor stone.

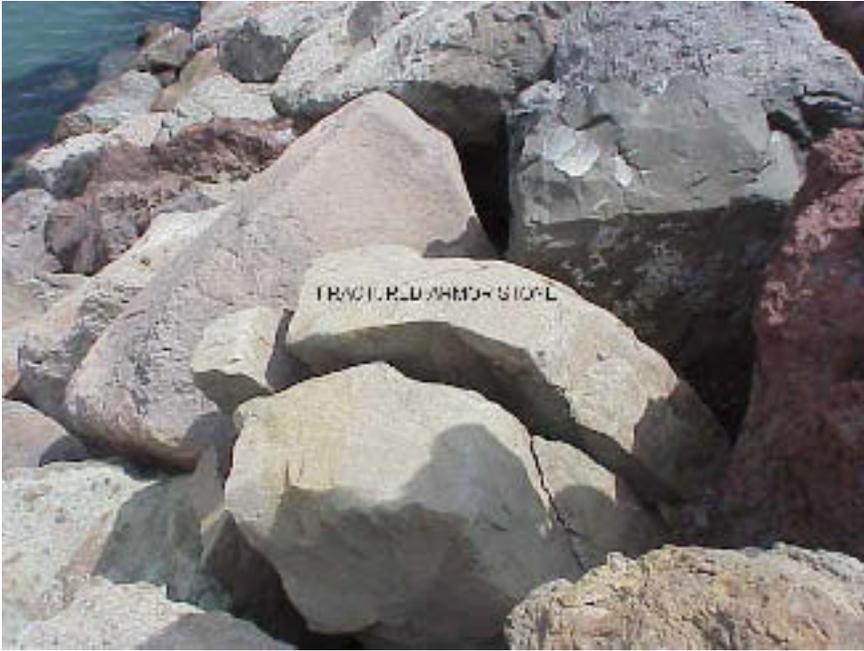
Sta. 2+92, Crest: Fractured armor stone.

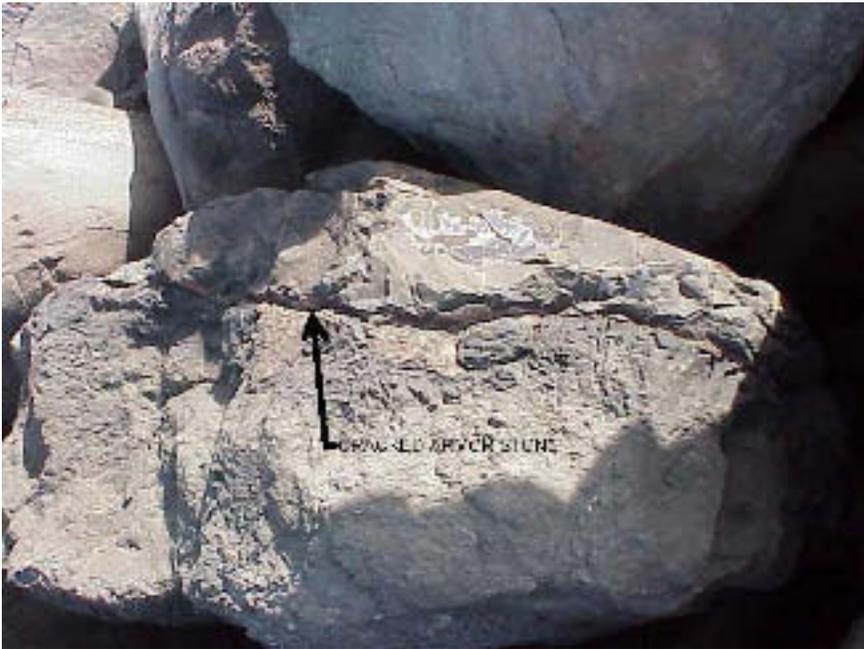
Sta. 3+29, Crest: Fractured armor stone.

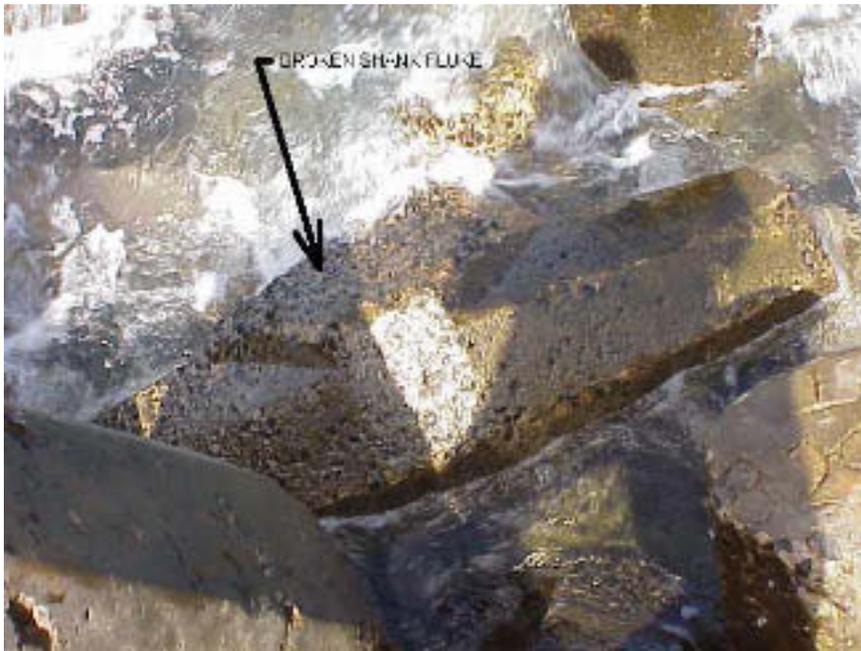
Sta. 5+25, OS: 2 - Dolosse on sidelsope with broken shank.

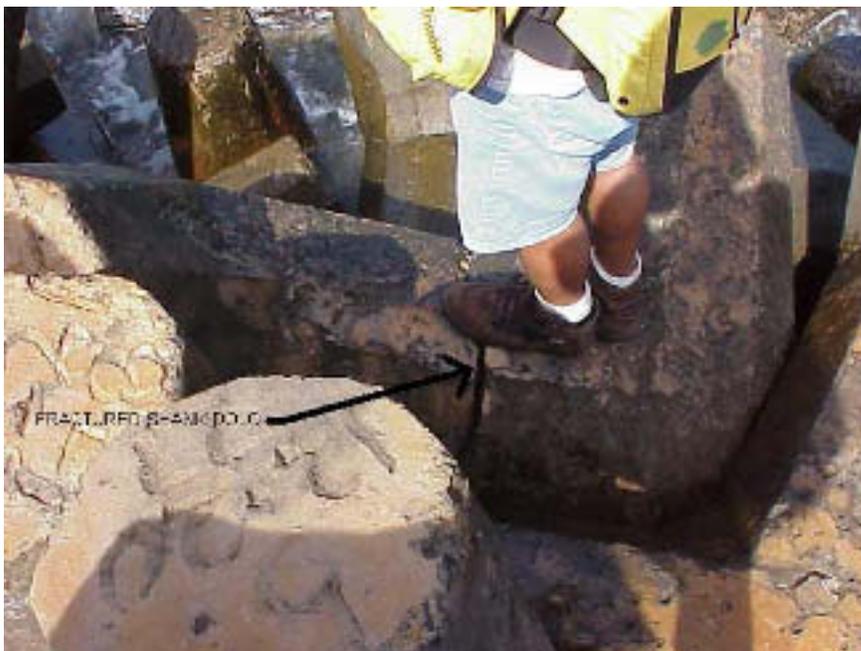
Sta. 5+35, OS: 1 - Dolosse at water line with broken fluke shank below #1, 8-2-77.

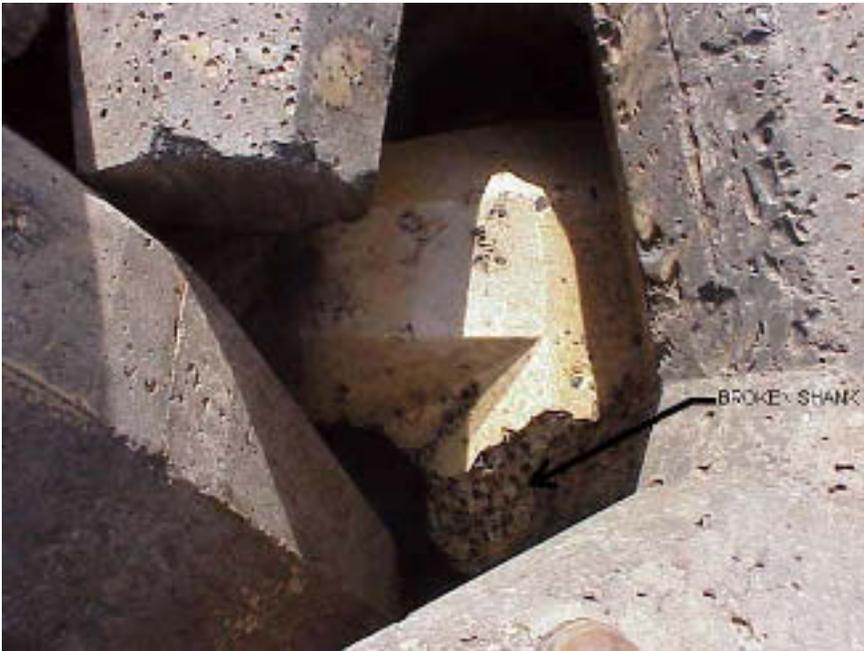
Sta. 5+70, OS: 1 - Dolosse on sideslope with broken fluke and shank. There is also a 1 foot separation between the crest hinge and start of the dolosse sideslope - possibly sliding of slope.

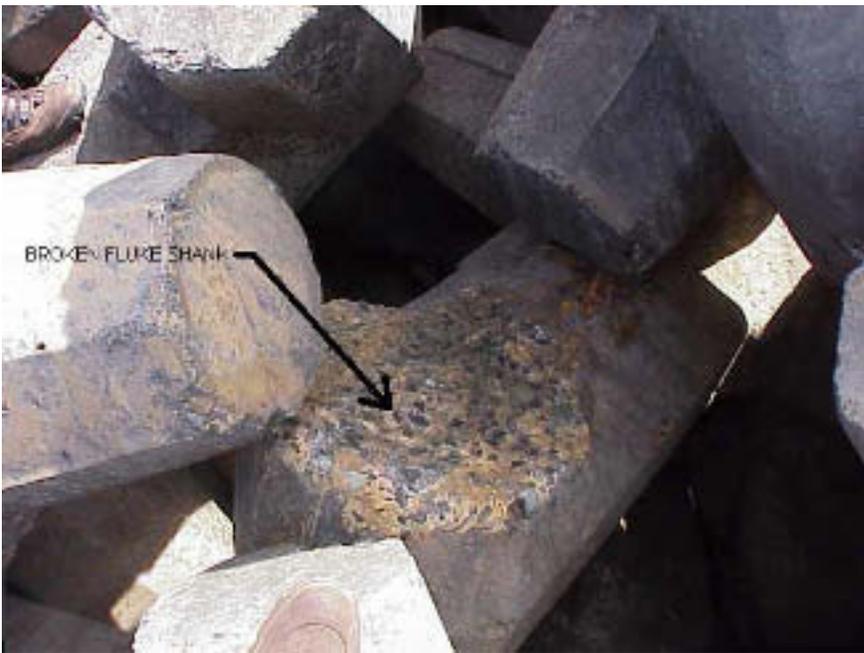
Sta. 5+75, OS: 1 - Dolosse on sideslope with broken shank.

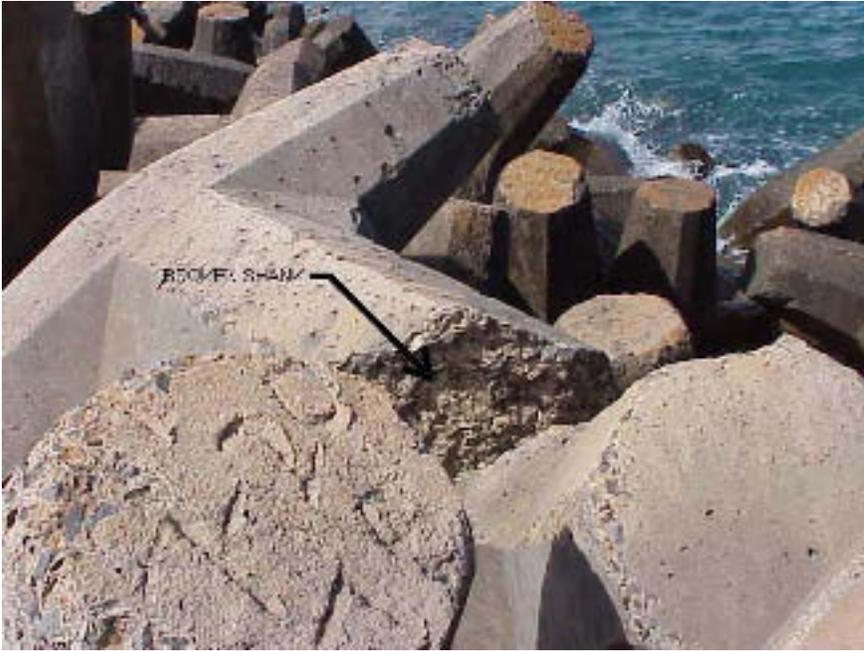
Sta. 5+80, OS: 1 - Dolosse, #10, 7-20-78, on sideslope with broken fluke shank.

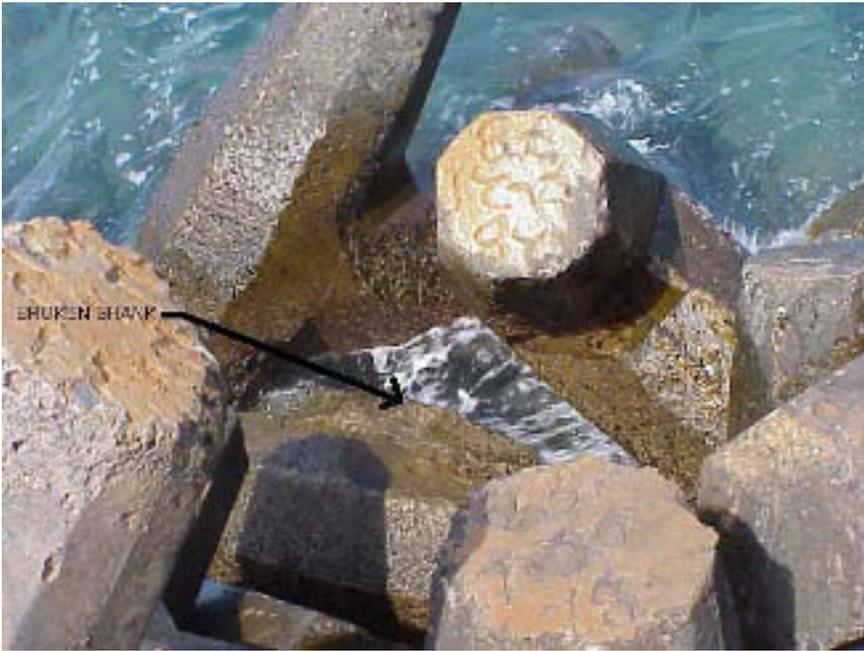
Sta. 5+88, OS: 1 - Dolosse, #34, 7-20-78, on sideslope with broken shank.

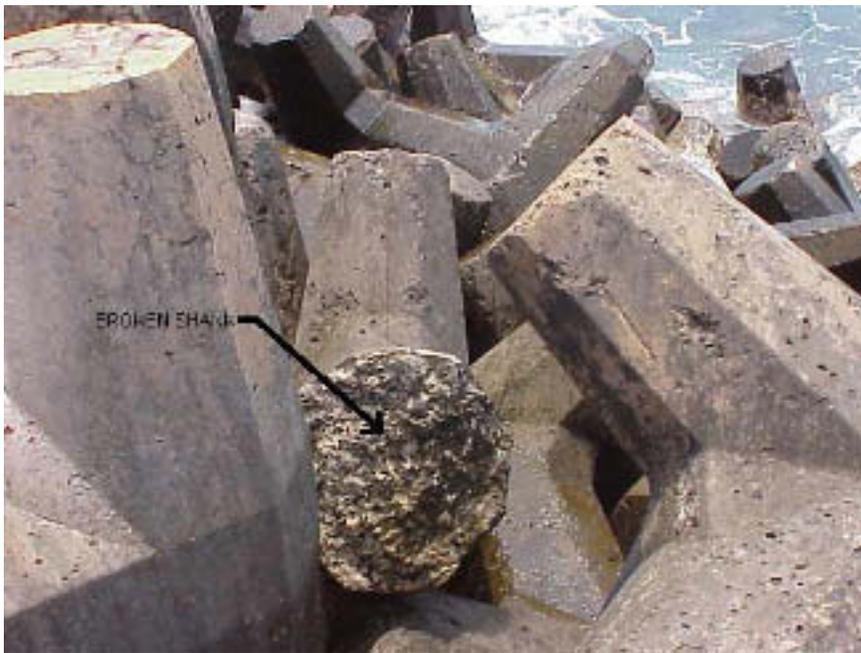
Sta. 14+75, OS: 1 - Dolosse on sideslope with broken fluke shank.  
Separation of dolosse from crest at hinge between sta. 14+55 and sta. 14+90.

THE MAIN BREAKWATER IS BEGINNING TO SHOW SIGNS OF DOLO MOVEMENT AND SIDESLOPE SETTLING, PARTICULARLY BETWEEN STA. 14+50 AND 16+00, OCEANSIDE. THIS AREA NEEDS TO BE MONITORED AND COMPARED TO PREVIOUS PHOTOGRAPHS ANNUALLY. THE STRUCTURE REMAINS SERVICEABLE AND NO FAILURE IS ANTICIPATED IN THE NEXT YEAR.

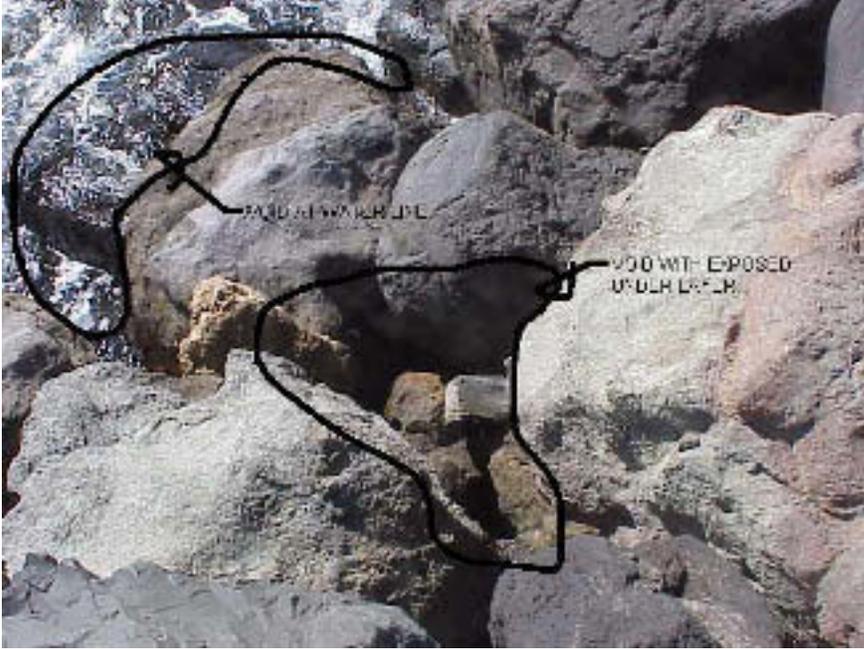
Sta. 0+78, OS, void on side slope with under layer exposed. Void also at water line.

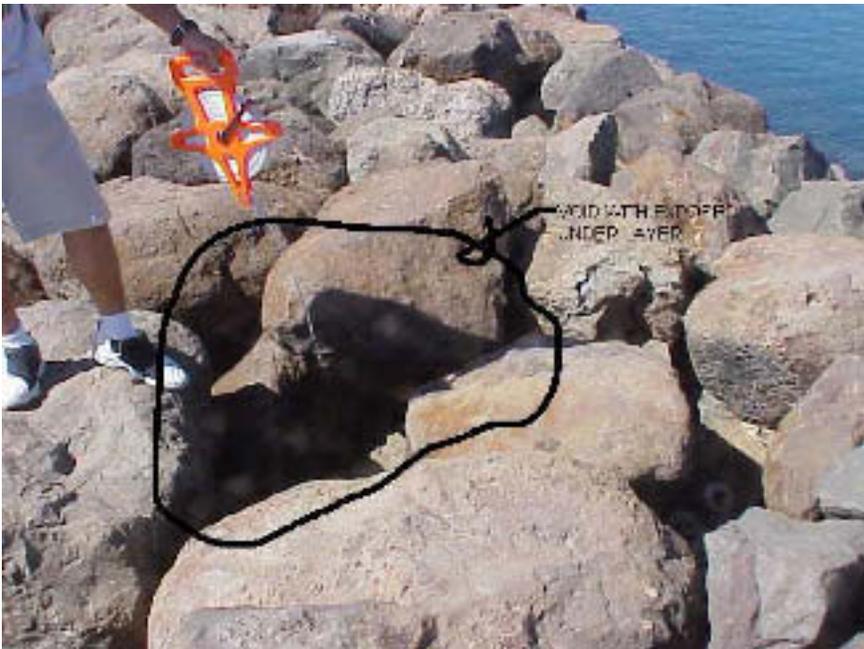
Sta. 0+86, Crest, 3.5'L x 2.5'W x 2.5'D void with exposed under layer.

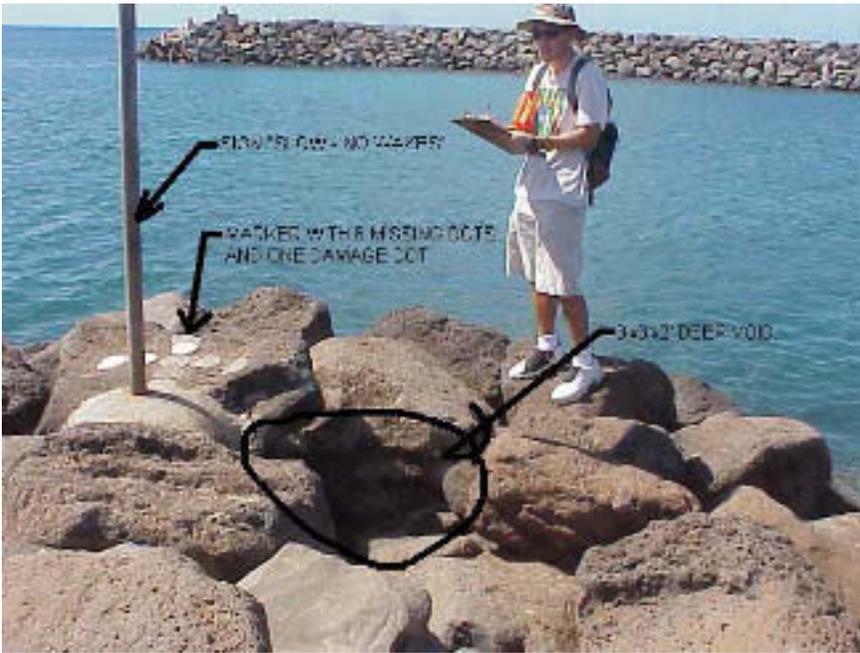
Sta. 2+20, Crest, 3'x3'x2' deep void. Nine (9) dot marker with 6 missing dots and 1 damaged dot. Sign stating, "Slow - No Wakes".
