# Public Notice of Application for Permit

Public Notice Date: May 11, 2012  
**Expiration Date: June 11, 2012**  
Permit File Number: POH-2011-00204

He'eia Fishpond Makai Wall Break Repair, Restoration, and Maintenance.

**Archaeological Literature Review and Field Inspection  
for the  
He'eia Fishpond Wall Repair Project,  
He'eia Ahupua'a, Ko'olaupoko District,  
O'ahu Island  
TMK [1] 4-6-005:001**

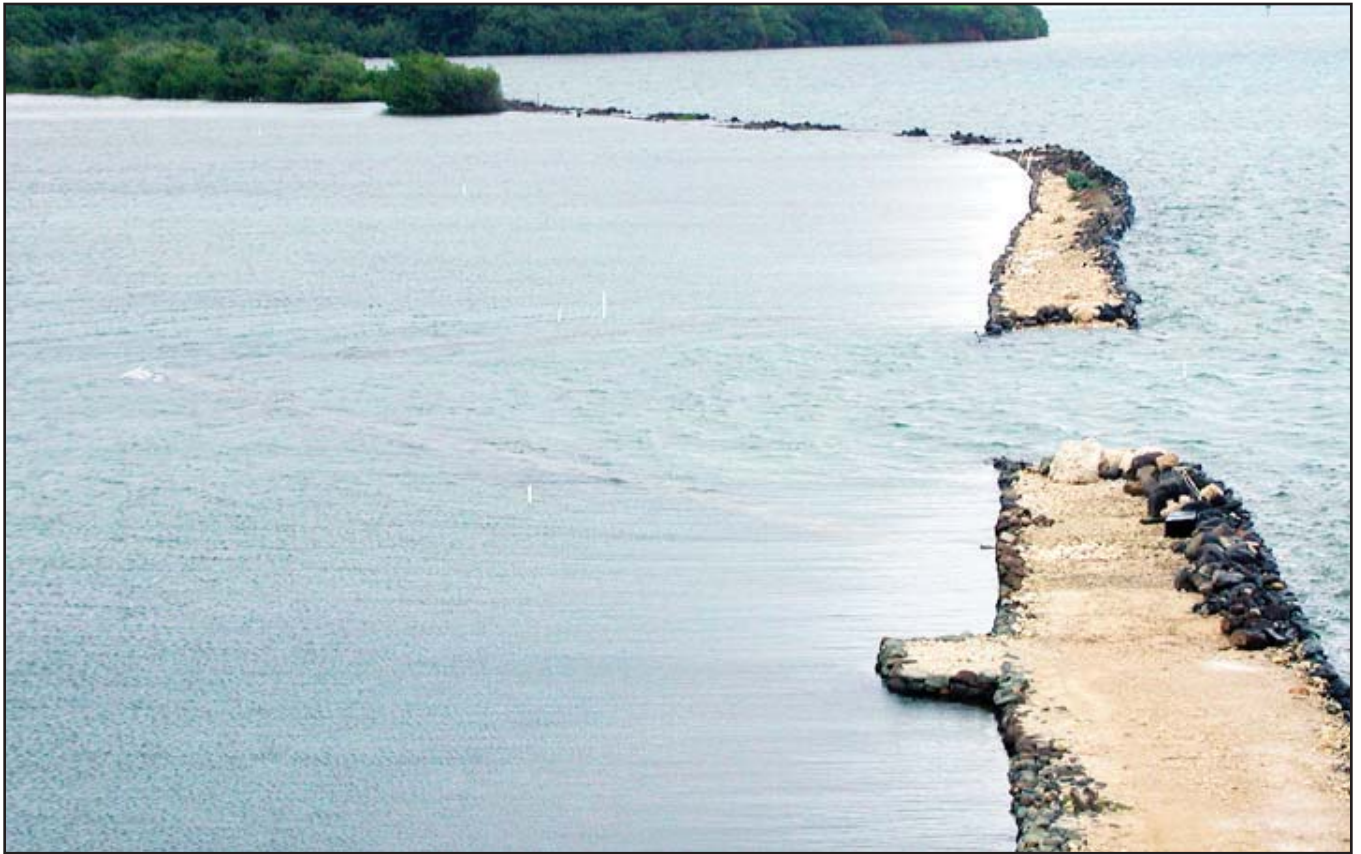
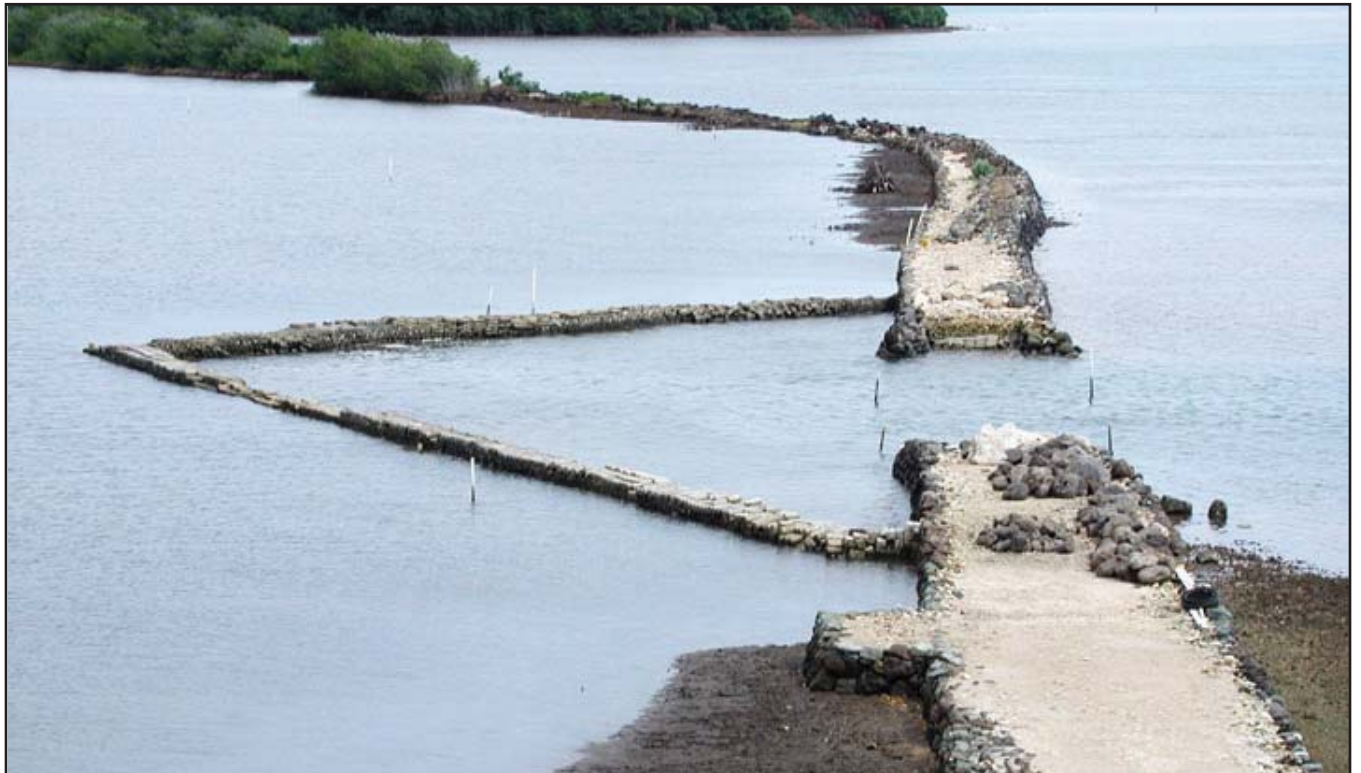
Figure 8. Submerged Temporary Wall and makai fishpond wall with break looking north at high high tide, 2.8 ft. (6/17/2011).

Figure 9 Same view at low low tide, -0.10 ft. (4/8/2011). The Temporary Wall is 3 ft. high and 3 ft. wide; The north wall segment is 95 ft. long, and south wall segment is 158 ft. long.

The Temporary Wall was intended to last about 5 years; it is now over 16 years old, and showing signs of failure—portions of the wall are sinking, and at every high tide episode the wall is easily breached by more than a foot of water, which diminishes the effectiveness and control of the fishpond as a aquaculture facility by allowing predator species to get into the fishpond and valued cultivated species to escape, while compromising water depth and the fresh water-sea water mixture in the pond. Note photos, Figures 17–19, of Temporary Wall damage from the June 6, 2011 heavy rains and flood.

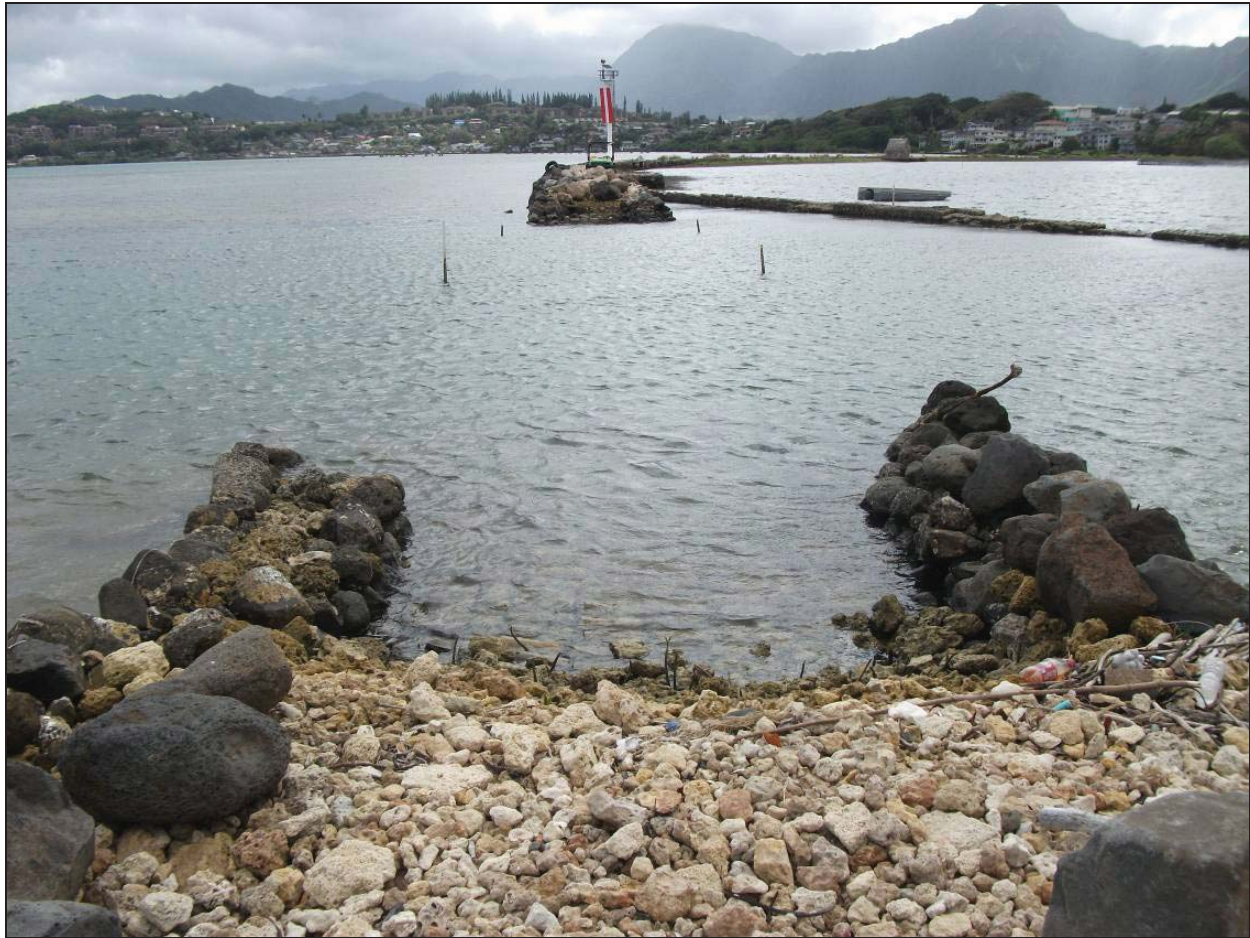
Figure 20. Looking across the Makai Break; a portion of temporary wall is visible to the right, view to south

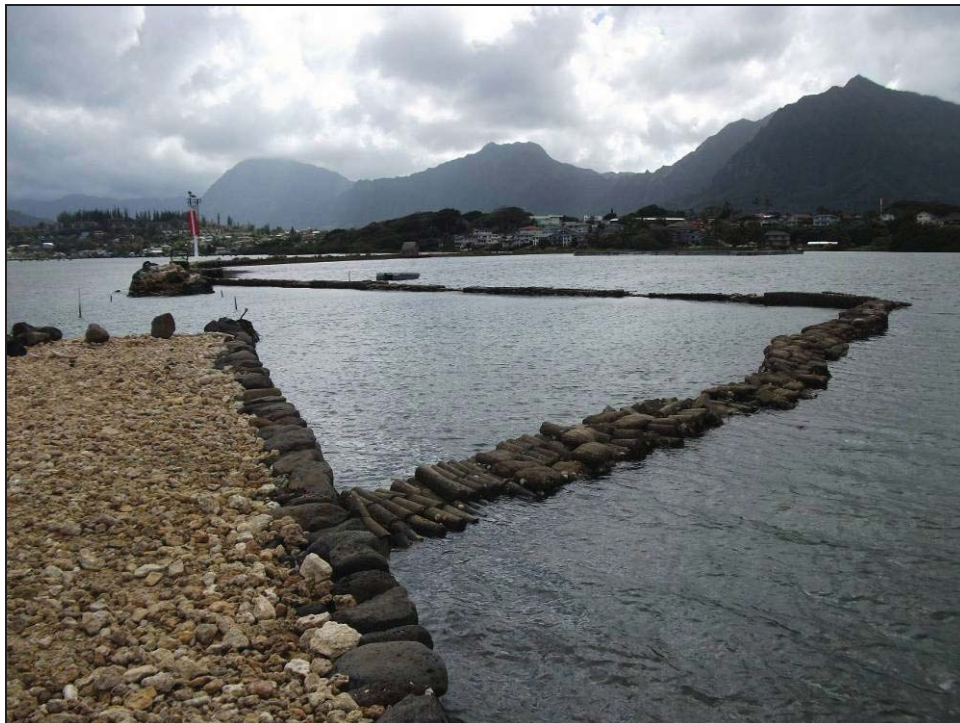
Figure 23. Detail of cement-cylinder wall *mauka* of break, view to southwest

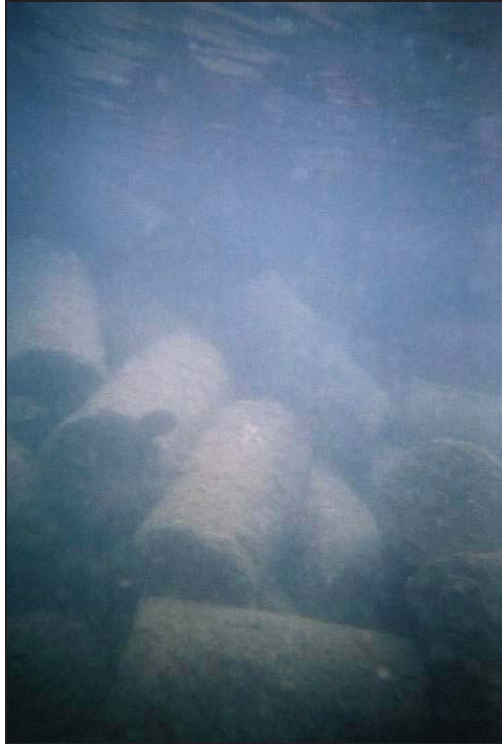
Figure 24. Underwater view of cement-cylinder wall, view to west

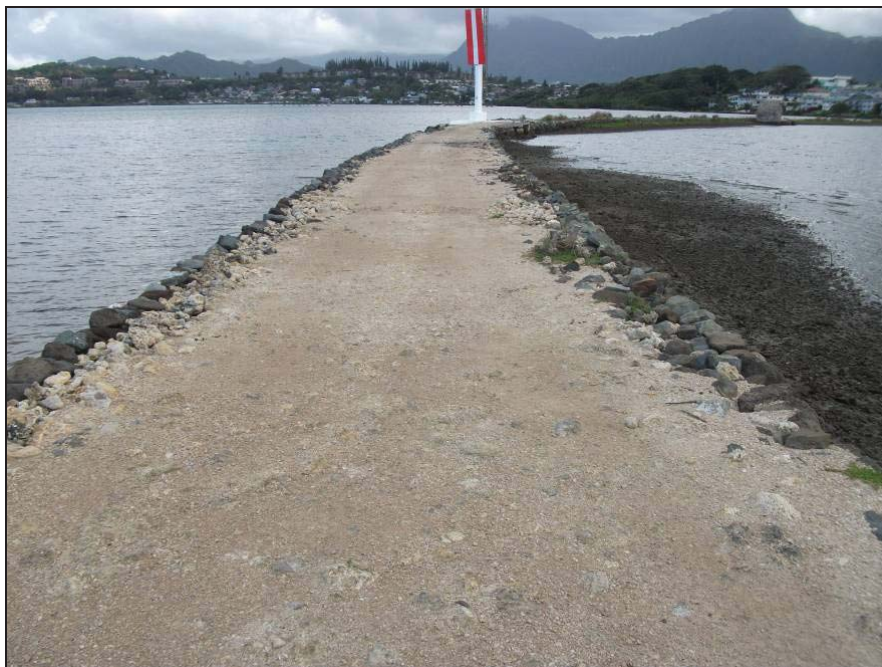
Figure 25. Upper surface of the *kuapā* facing a navigational marker in the background, view to south

As discussed with Paepae o Heeiea staff during the field inspection, wall stabilization is essential to preserving the *kuapā*. Basalt rock found outside of the *kuapā* has been salvaged at low tide and reused in areas where mangrove undermined the wall. Other salvaged basalt has been laid in line with the existing *kuapā*, as described in Table 3 above (this was noted at the 20-25 m-mark in the Makai Break). In some places, cement cylinders washed off the top of the temporary wall by tidal action and storms have been used as underlying fill for the *kuapā* in place of coral (Figure 28). However, the upper, exterior structure is maintained with coral as shown in Figure 25 and Figure 26.

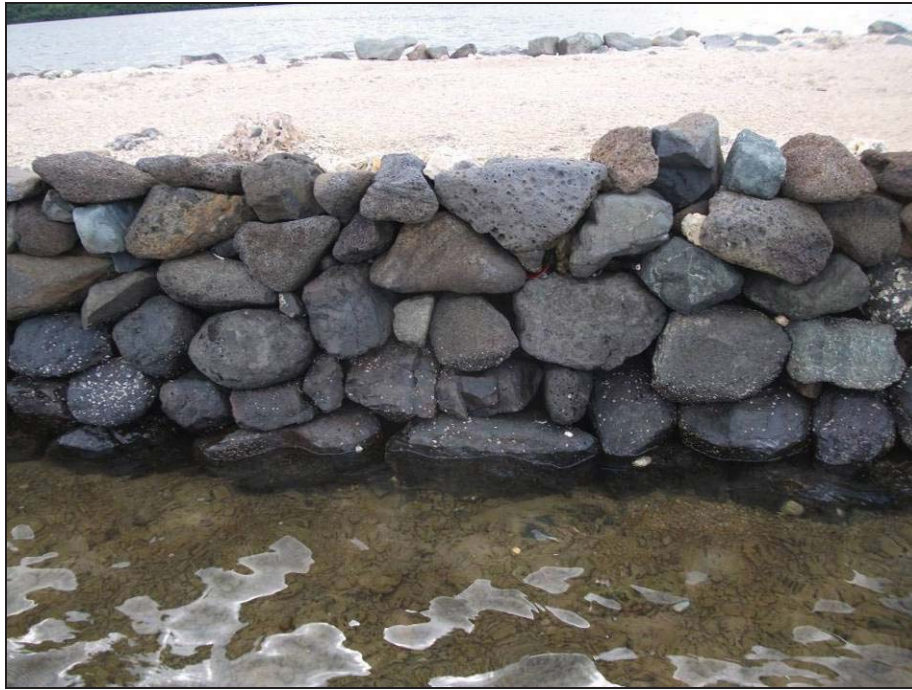
Figure 26. Interior *kuapā* face and upper surface with top of exterior face in background, view to east

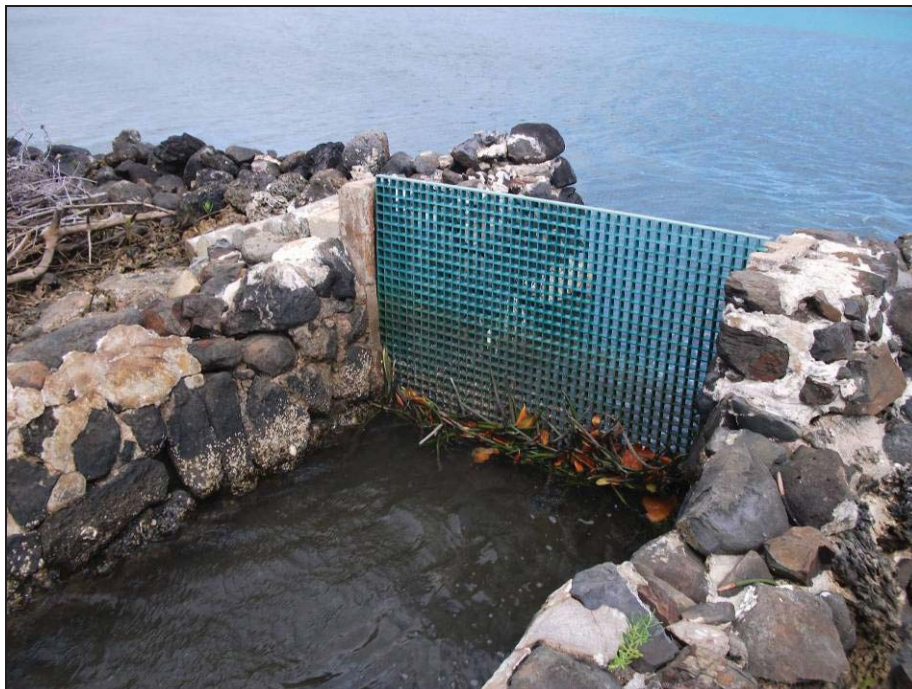
Figure 27. *Mākāhā* north of Makai Break; note use of concrete to maintain *kuapā*, view to northeast

All repairs to the *kuapā* in the vicinity of the Makai Break have been carried out using traditional methods (i.e., hand building with no mortar). Areas of the *kuapā* north of the Makai Break have been repaired sometime in the past (prior to 1991) using concrete, as described by Brooks (1991:5; see Section 3.6.1 He'eia Fishpond Wall Maintenance) (Figure 27).

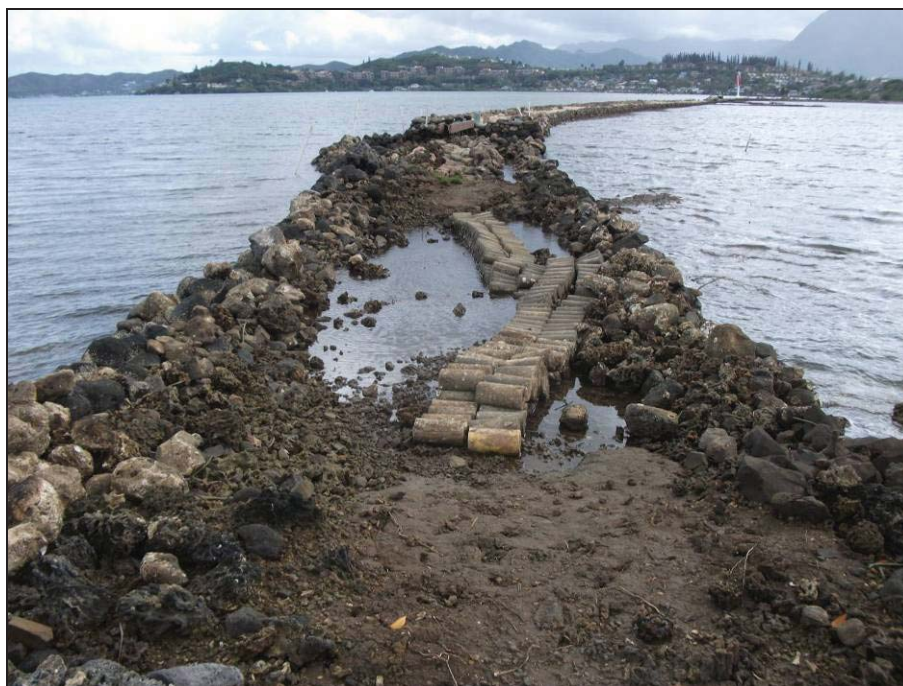
Figure 29. Photograph showing *makai* portion of *kuapā* where mangrove has been removed. Note the extent of damage to the *kuapā* from the mangrove and the use of cement cylinders as fill, view to south; the Makai Break is to the southwest

A review of the 2007 aerial photo showing the Makai Break (see Figure 17) shows extensive areas of mangrove on and adjacent to the *kuapā*. At the time of CSH's field inspection, all mangrove has been removed from the vicinity of the Makai Break (Figure 29).

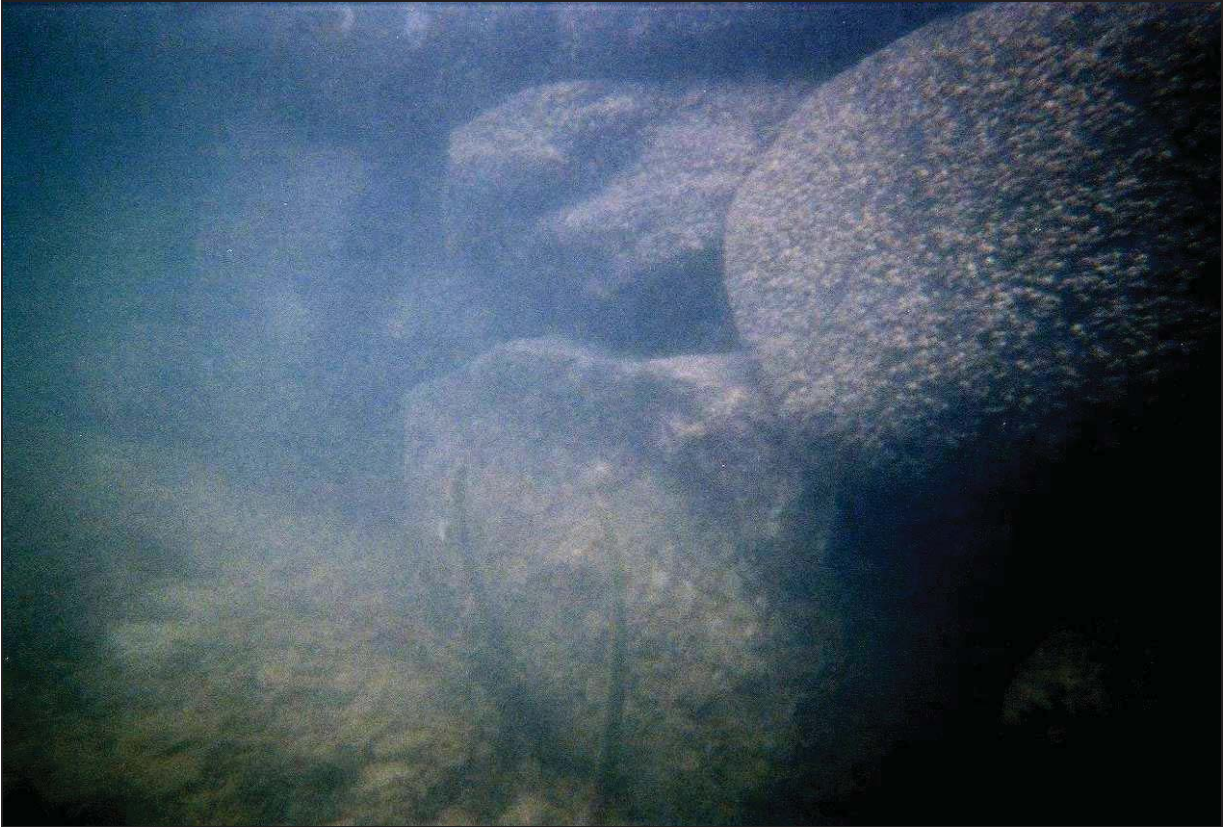
Figure 30. Photograph showing exterior face of *kuapā* just south of the Makai Break, view to east

According to Paepae o He'eia staff, the exterior face of the *kuapā* just south of the break is the most intact portion of the *kuapā* (Figure 30).
