Honolulu District
US Army Corps
of Engineers

Public Notice of Application for Permit

Public Notice Date: December 18, 2013
Expiration Date: January 17, 2014
File Number: POH-2011-00035

PURPOSE: Stabilize the eroding coastline to protect critical infrastructure.

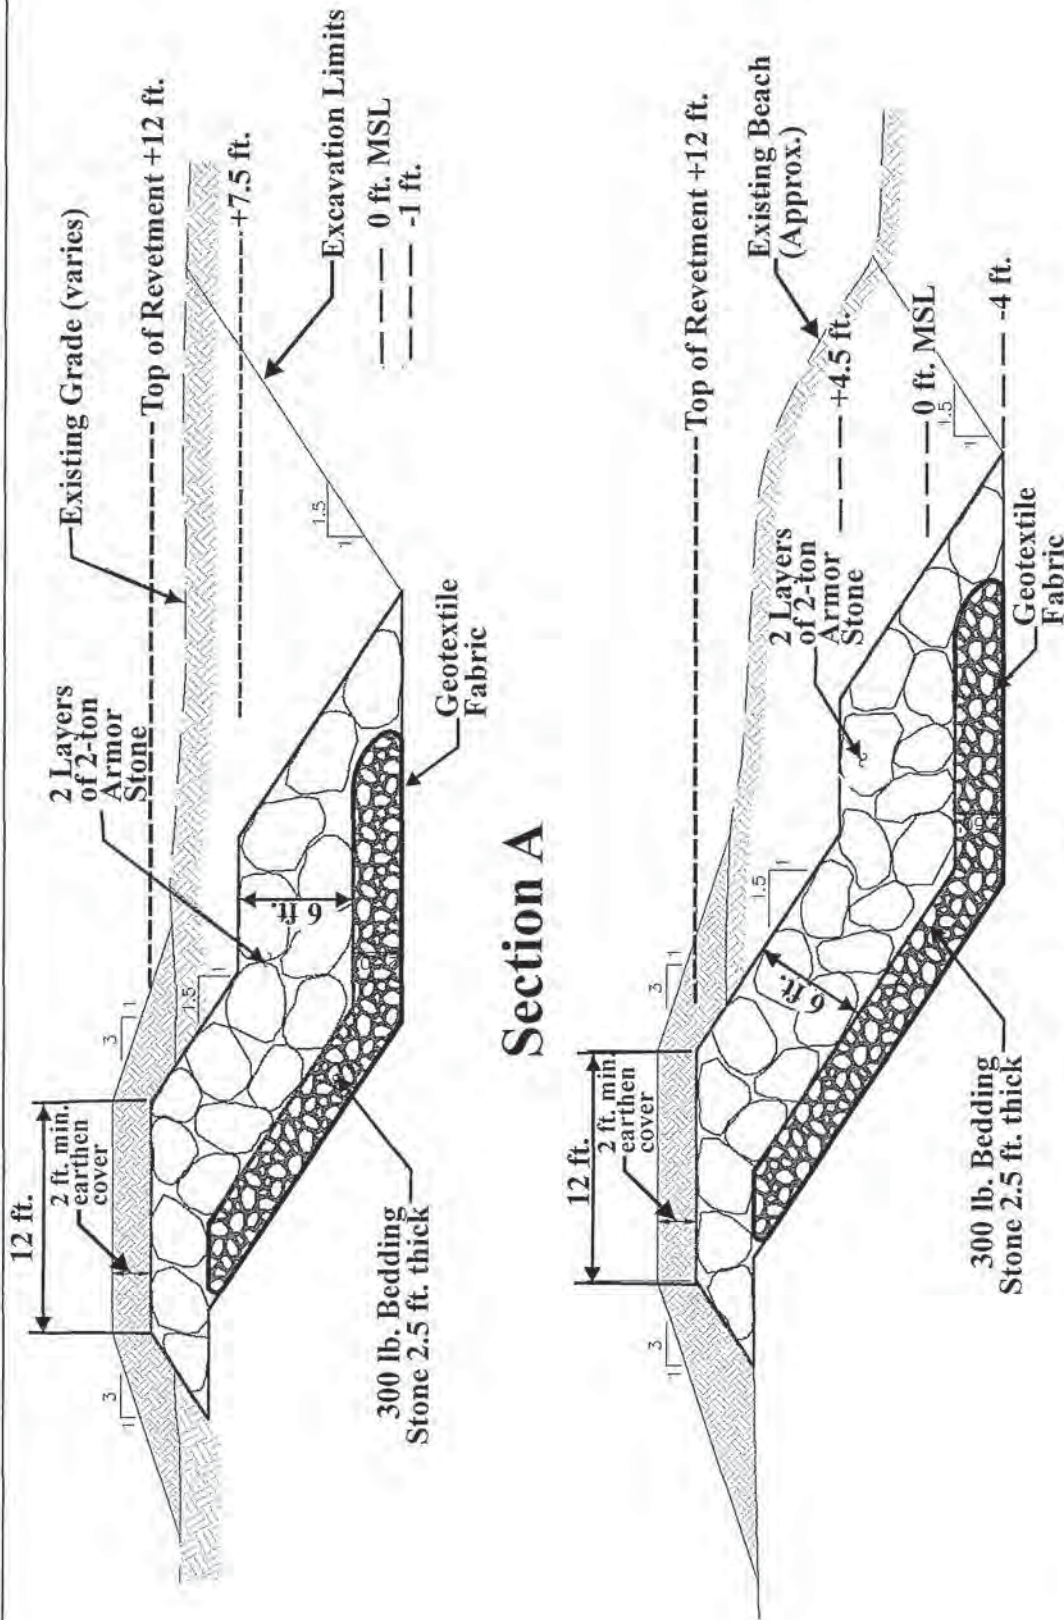
Figure 4 Proposed Wailuku-Kahului Wastewater Reclamation Facility Shoreline Protection Extension
Typical New Revetment Sections A and B

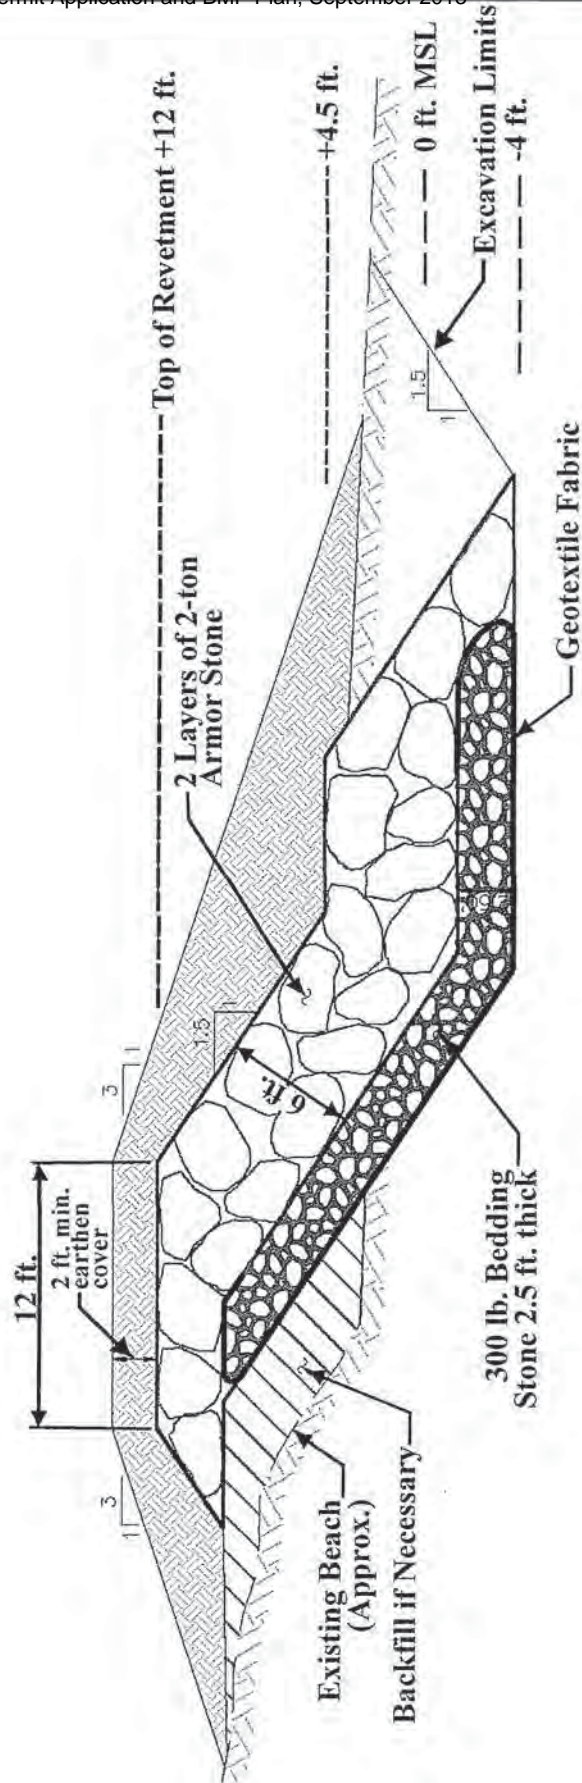
Figure 5 Proposed Wailuku-Kahului Wastewater Reclamation Facility Shoreline Protection Extension

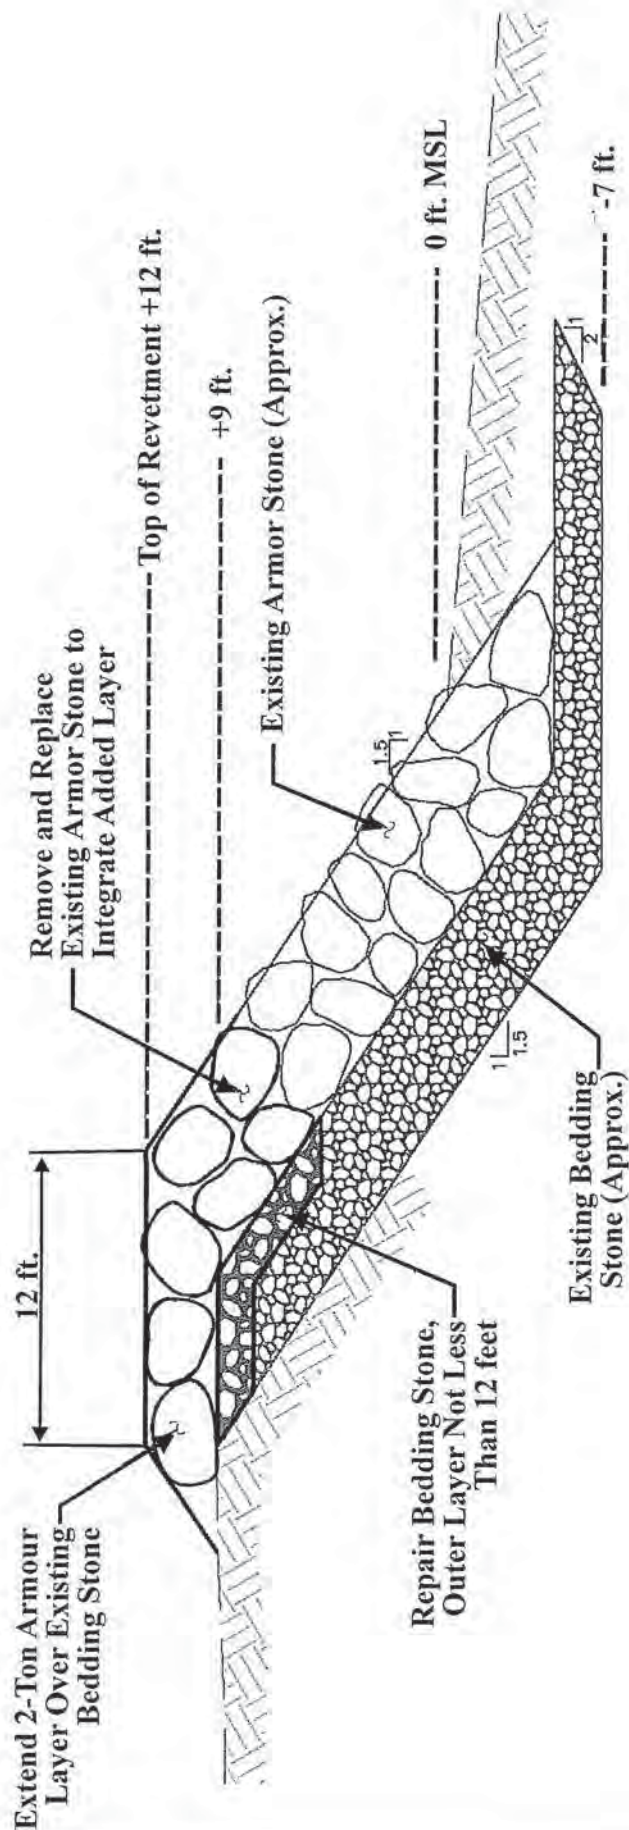
Figure 6 Proposed Wailuku-Kahului Wastewater Reclamation Facility Shoreline Protection Extension
Existing Revetment Improvement Section

The crest elevation of the existing revetment will be raised three (3) feet to match the new revetment crest height of +12 feet MSL to provide additional capacity to accommodate sea-level rise. See **Figure 6**.

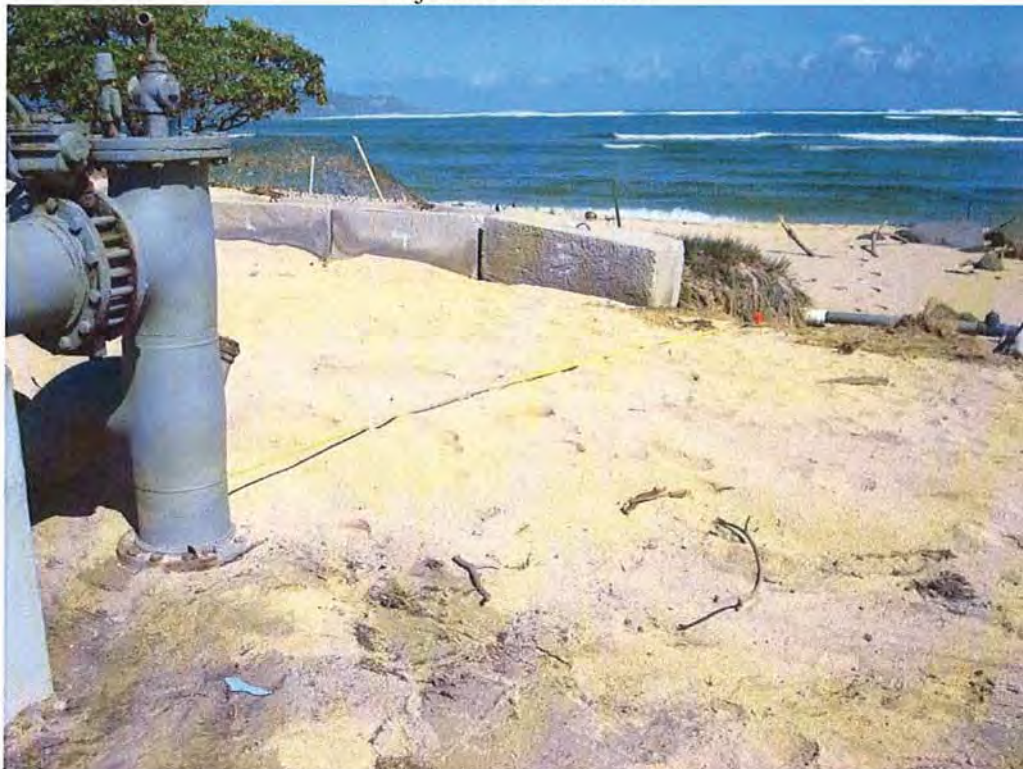
PHOTOGRAPH NO. 2: View looking towards shoreline from Injection Well No. 3 which is approximately 20 feet from eroded bank

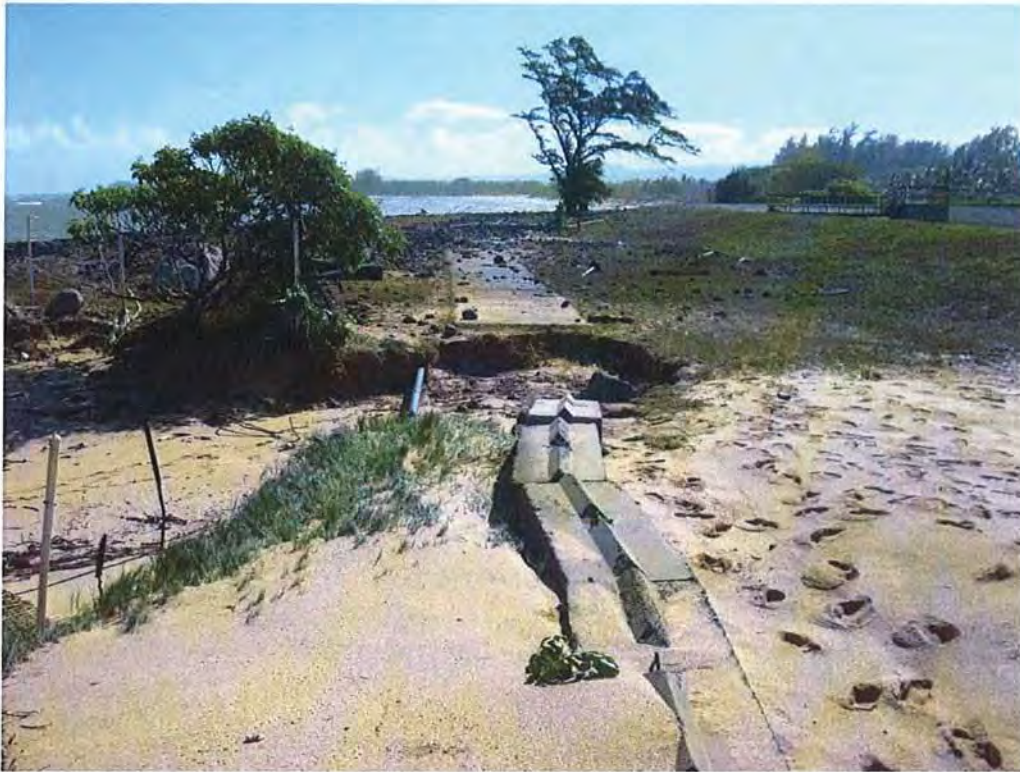
PHOTOGRAPH NO. 3: View looking east along access walkway behind existing revetment

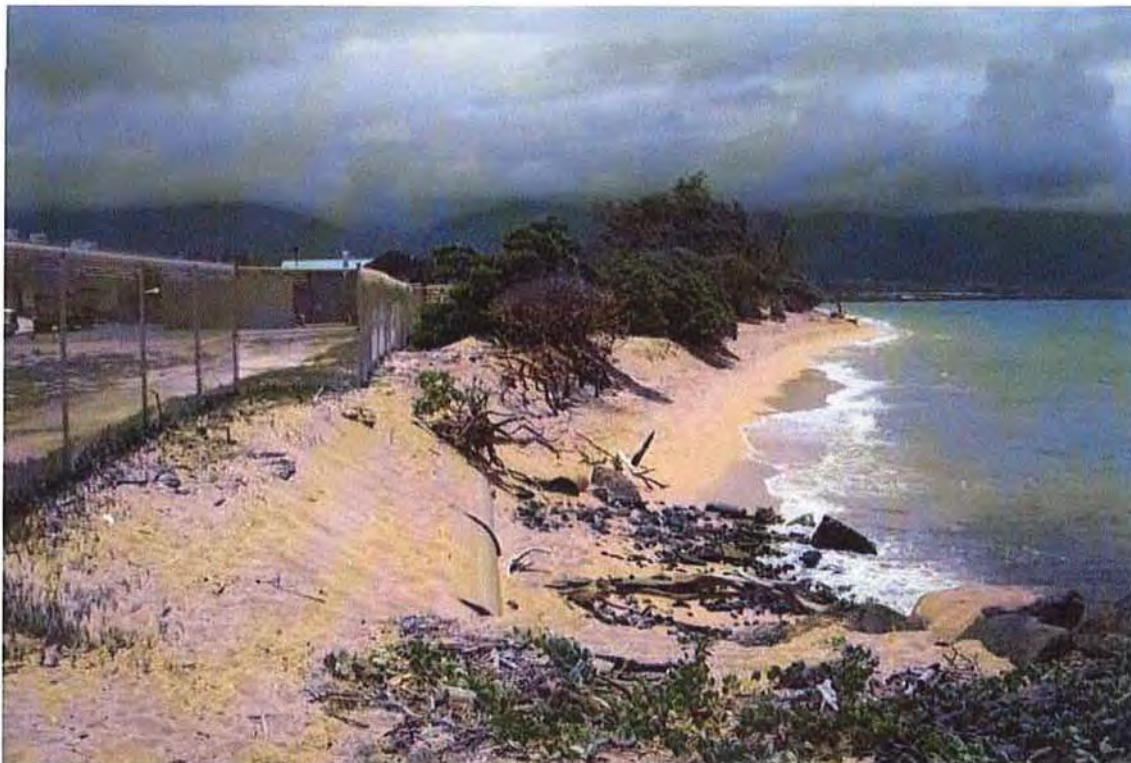
PHOTOGRAPH NO. 2: View west along shoreline near Injection Well No. 3

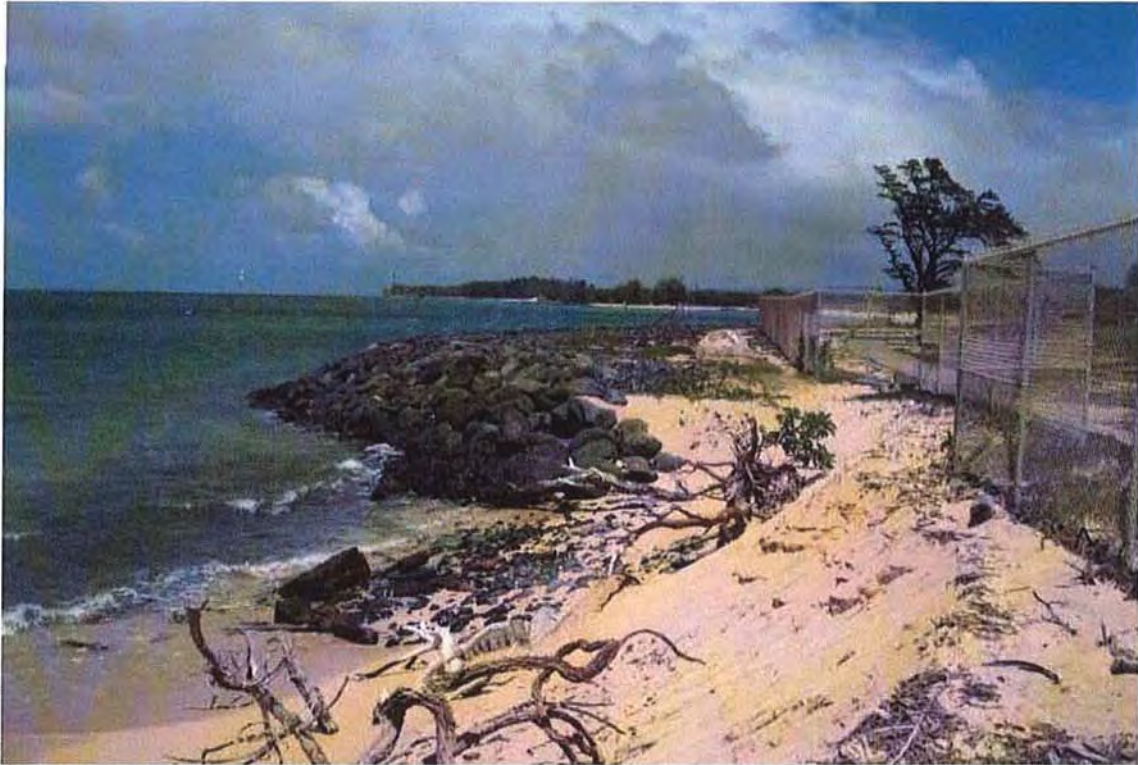
PHOTOGRAPH NO. 3: View looking east toward existing revetment

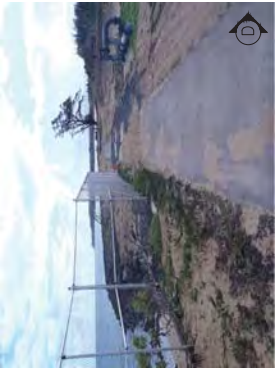
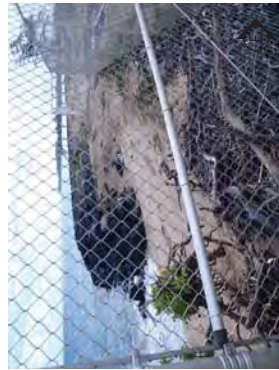
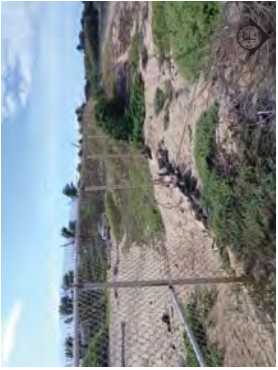
Sheet
Reference No.
R-2
5 of 25

DEMOLITION NOTES:

- 1 REMOVE TREES, DISPOSE OF AT APPROVED FACILITY.
- 2 REMOVE FENCE WITHIN LIMITS OF WORK.
- 3 REMOVE VEGETATION WITHIN LIMITS OF WORK.
- 4 RELOCATE 4" PVC PIPE.
- 5 REMOVE AN DISPOSE OF CONCRETE DEBRIS WITHIN LIMITS OF WORK.
- 6 REMOVE CONCRETE POSTS, WOOD FENCE, AND ASPHALT/GRAVEL PAD NEAR EAST END OF REVENMENT.
- 7 VERIFY LOCATION OF AND REMOVE ABANDONED EFFLUENT PIPELINE (APPROX 125 FEET OF 42" PIPE).

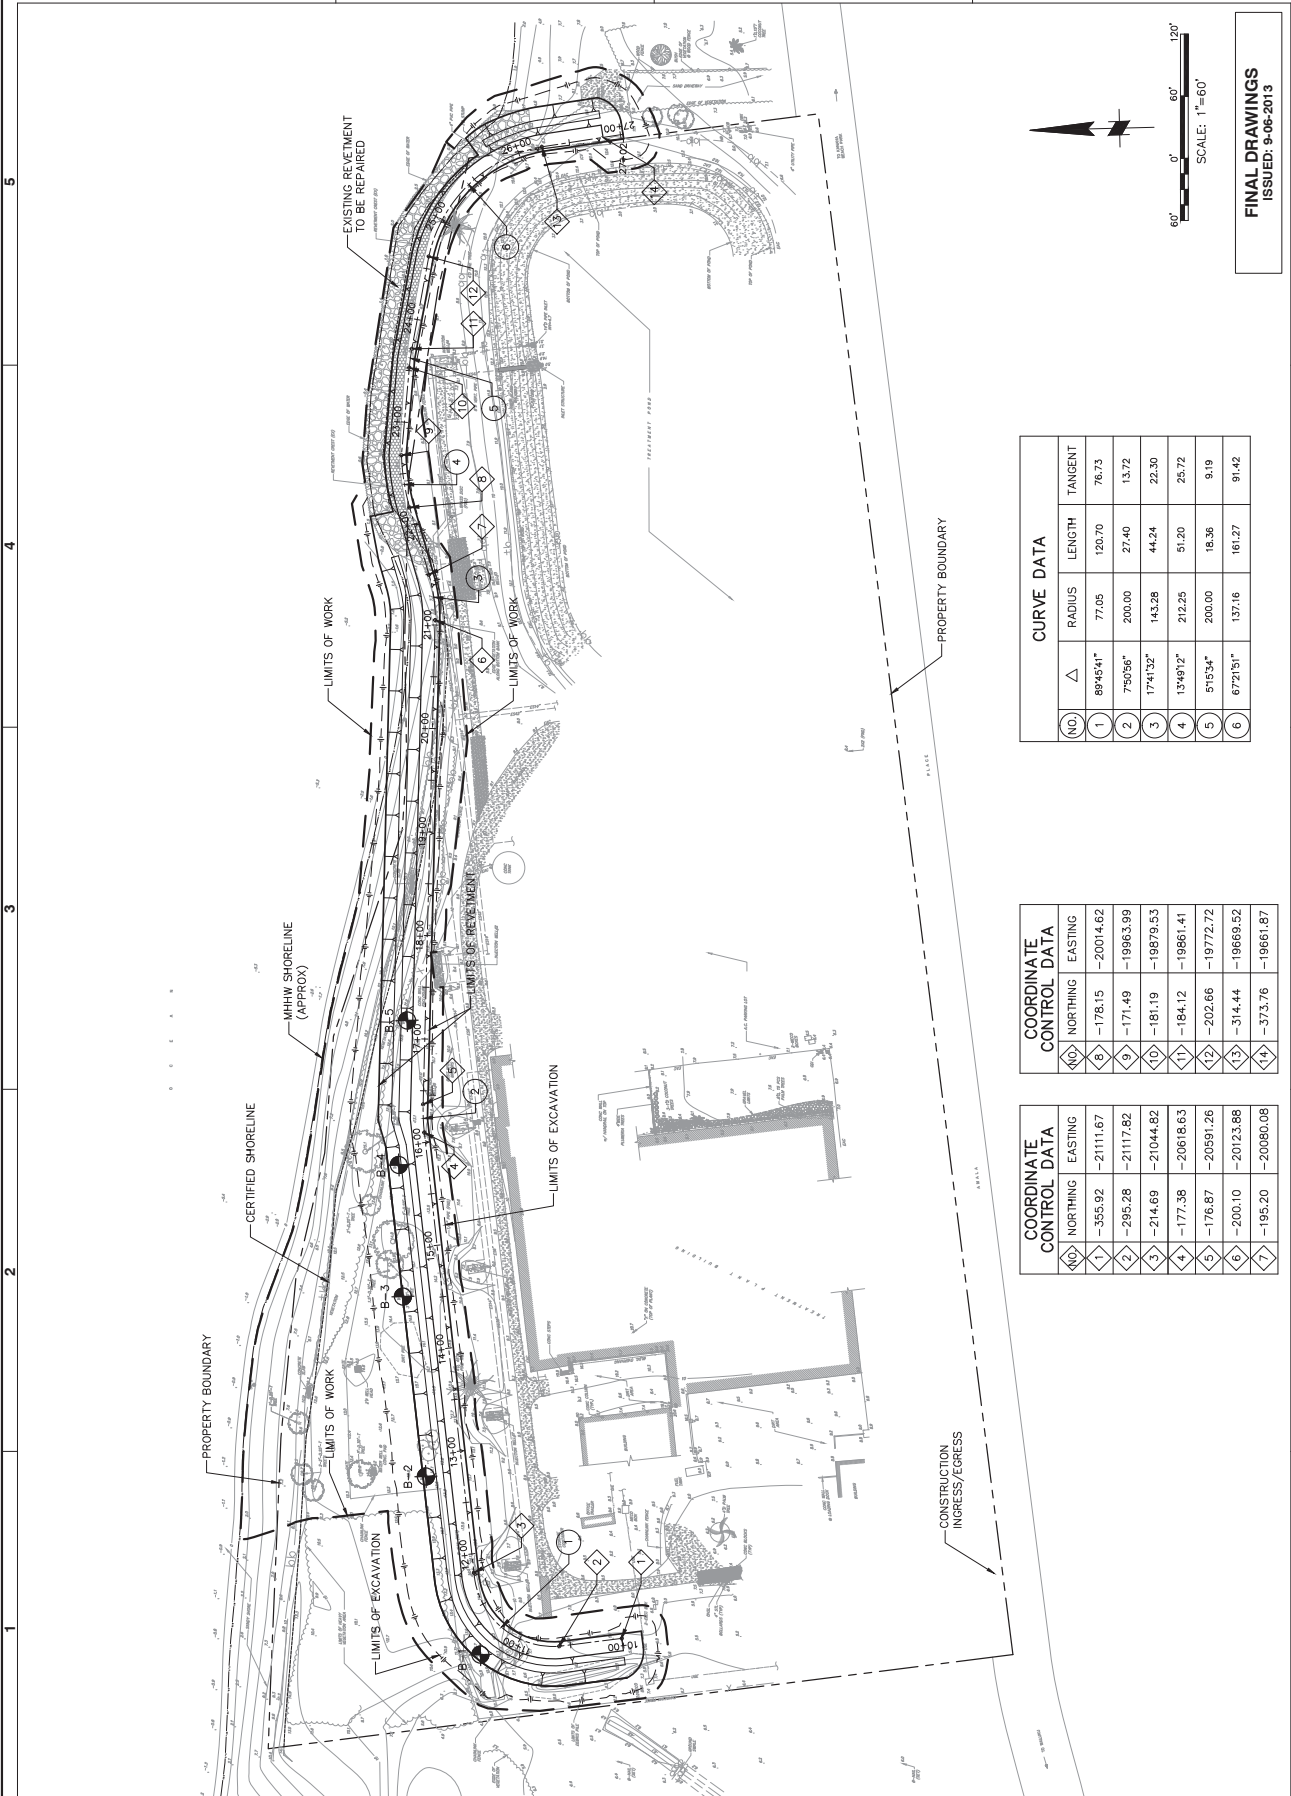
Sheet
Reference No.
S-1
6 of 35

CURVE DATA				
NO.	Δ	RADIUS	LENGTH	TANGENT
1	89°45'41"	77.05	120.70	76.73
2	7°50'56"	200.00	27.40	13.72
3	17°41'32"	143.28	44.24	22.30
4	13°49'12"	212.25	51.20	25.72
5	51°53'4"	200.00	16.36	9.19
6	67°21'51"	137.16	161.27	91.42

COORDINATE CONTROL DATA		
NO.	NORTHING	EASTING
1	-355.92	-2111.67
2	-295.28	-2117.82
3	-214.69	-2104.82
4	-177.38	-20618.63
5	-176.87	-20591.26
6	-200.10	-20123.88
7	-195.20	-20080.08

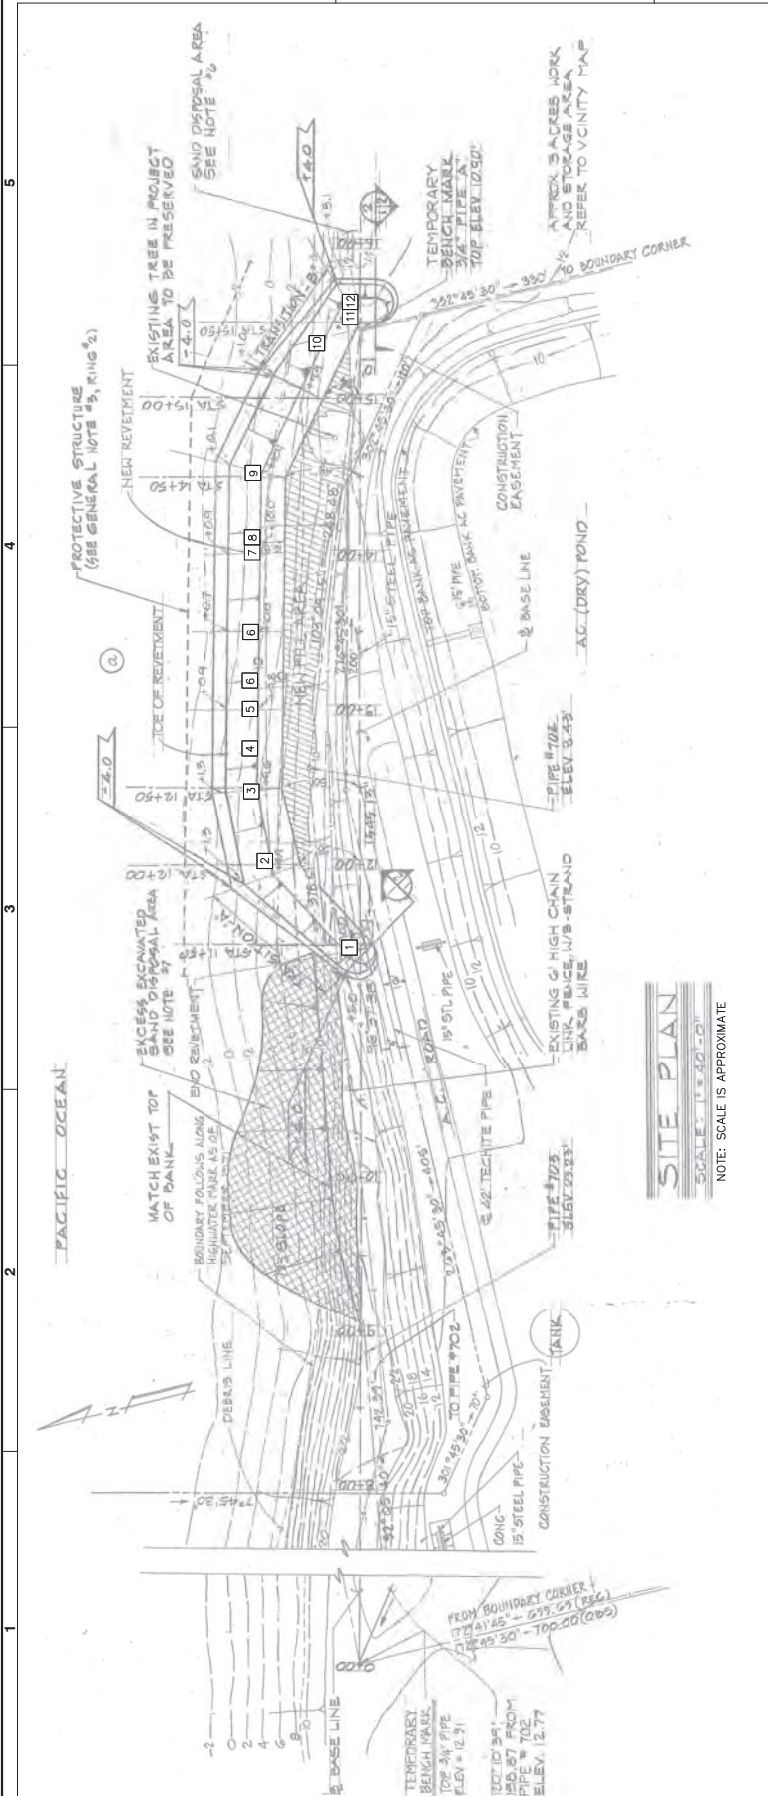
- REFER TO APRIL 12, 2010 USACE CONTINUING ELIGIBILITY INSPECTION REPORT FOR ADDITIONAL DESCRIPTIONS & PHOTOS OF REPAIR ITEMS.
- STATION REFERENCES BASED ON EXISTING REVENMENT CONTROL LINE SHOWN HEREON.
- ITEMS REQUIRING MONITORING MAY NEED REPAIR BASED ON FIELD CONDITIONS AT THE TIME OF CONSTRUCTION. REPAIR AT THESE LOCATIONS (IF NEEDED) WILL BE FIELD DIRECTED BY THE ENGINEER.
- REVENMENT REPAIRS TO THE CREST AND WITHIN THE TRANSITION AREAS WILL BE ADDRESSED BY THE PROPOSED REVENMENT IMPROVEMENTS DESCRIBED ON SHEETS C-4 AND C-5.

ITEM #	STATION	ACTION
1	11+50	REPAIR 20-25 LF OF DISPLACED ARMOR STONE
2	12+00	REMOVE CREST VEGETATION; RESET ARMOR STONE
3	12+50	REPAIR VOID; RESET BRIDGING ARMOR STONE
4	12+75	RESET FLIPPED ARMOR STONE
5	13+00	MONITOR FLIPPED ARMOR STONE
6	13+14 & 13+50	MONITOR DEPRESSION/SETTLING AT CREST
7	13+98 & 14+00	MONITOR STONE MOVEMENT AT TOE; REMOVE WEDGED TREE TRUNK
8	14+03	MONITOR SLIGHT DEPRESSION AT HINGE
9	14+50	ARMOR STONE RESTING AT TOE, NO OBVIOUS VOIDS
10	15+50 & 15+86	25 LF SIDESLOPE SETTLING & STONE MOVEMENT; UNDERLAYER EXPOSED
11	15+90	REMOVE VEGETATION
12	16+00	MONITOR SAND EROSION AT TIE-BACK

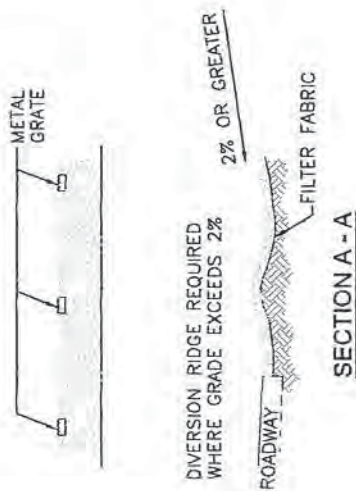
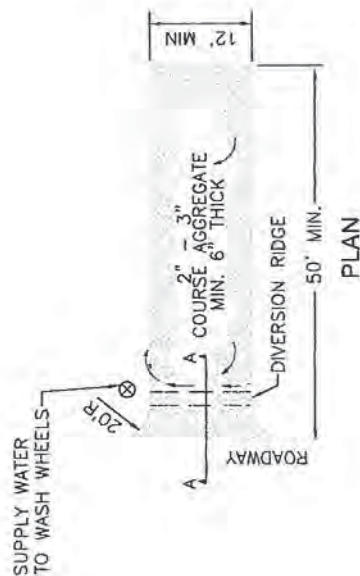
TEMPORARY CONSTRUCTION ENTRANCE

1. THE ENTRANCE SHALL BE MAINTAINED IN A CONDITION THAT WILL PREVENT TRACKING OR FLOWING OF SEDIMENT ONTO PUBLIC RIGHT-OF-WAYS. THIS MAY REQUIRE TOP DRESSING, REPAIR AND/OR CLEANOUT OF ANY MEASURES USED TO TRAP SEDIMENT.
2. WHEN NECESSARY, WHEELS SHALL BE CLEANED PRIOR TO ENTRANCE ONTO PUBLIC RIGHT-OF-WAY.
3. WHEN WASHING IS REQUIRED, IT SHALL BE DONE ON AN AREA STABILIZED WITH CRUSHED STONE THAT DRAINS INTO AN APPROVED SEDIMENT TRAP OR SEDIMENT BASIN.

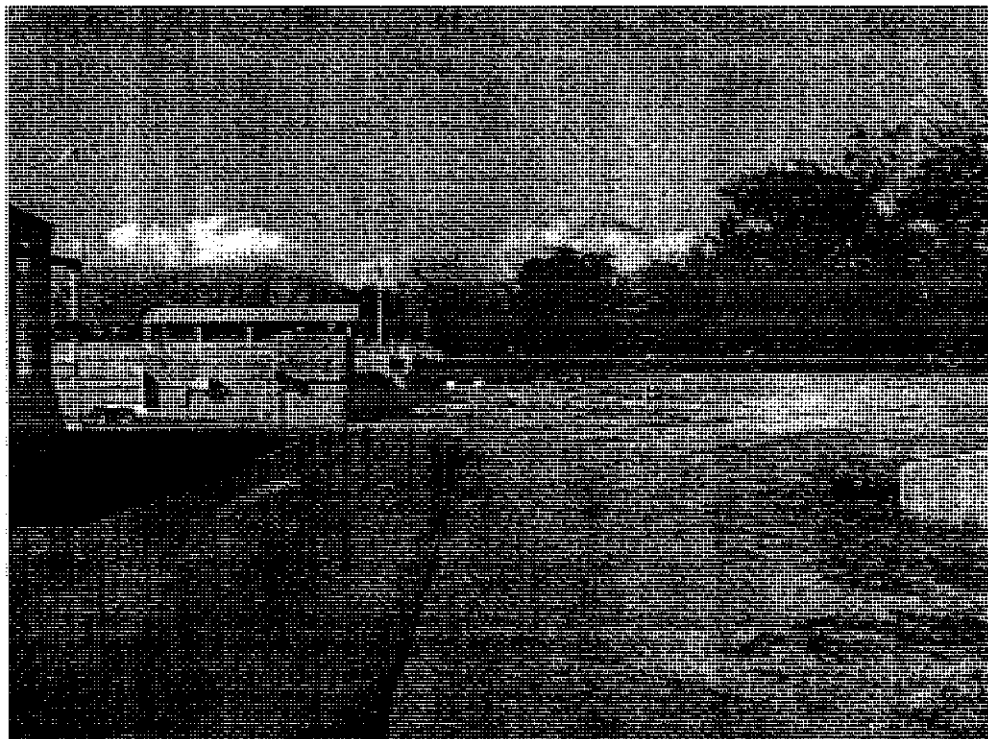
Photograph 3: View to the ENE of wave cut bank that was inspected.

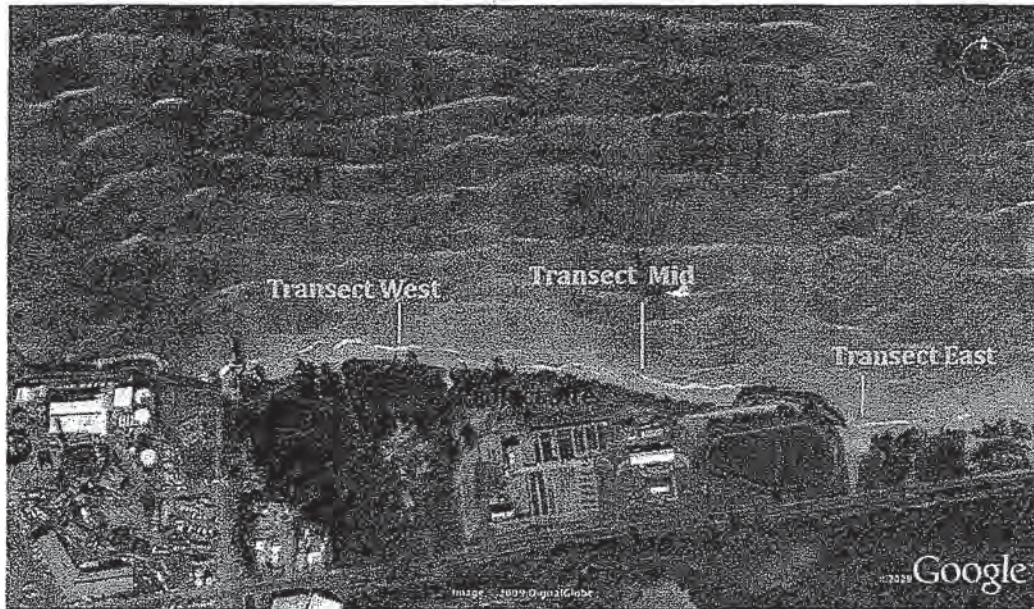
AECOS biologists surveyed the marine community in the nearshore waters fronting WKWWRf using SCUBA. Three transect lines were laid in a northern direction, starting approximately 3 m (9.8 ft) from the shoreline (Fig. 5): two 20-m (65.6-ft) transects off the western (Transect West) and eastern (Transect East) ends of the project area; and a 49-m (160.8 ft) transect off the middle of the project area (Transect Mid). Benthic composition along each transect was determined as percent cover using a point-intercept quadrat method. A 0.5 x 0.5 m (0.25 m²), polyvinyl chloride (PVC), quadrat frame was placed at every meter mark along each transect line, resulting in a total of 89 quadrat counts. The frame was strung with heavy nylon thread forming a 10 cm grid of five rows and five columns, and producing 25 point-intercepts. Due to high surf and heavy wave surge conditions, it was necessary for both biologists to secure and hold down the frame. Once laid and held in place, the item under each of the 25 cross points was recorded. From these counts, percent cover was determined by category.

Figure 5. Location of the December 17, 2009 survey transects along the project shoreline.

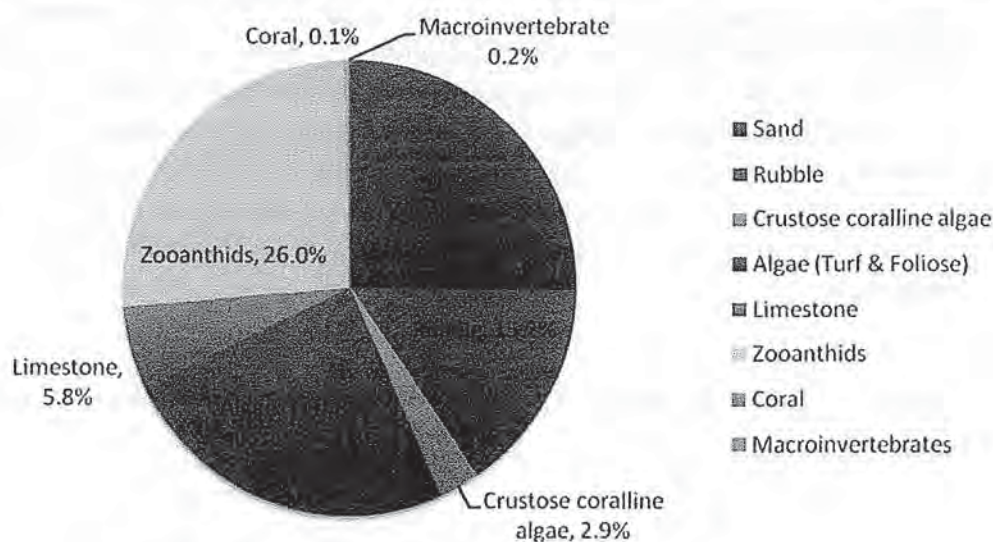
Only 2 of the 89 quadrats surveyed within the project area contained live coral heads, both occurring on Transect East. As calculated from the quadrat surveys, coral coverage accounts for less than one percent of the area sampled (Fig. 6). Two species of coral were identified in the area: lace coral (*Pocillopora damicornis*) and cauliflower coral (*P. meandrina*).

Figure 6. Percent benthic cover in nearshore waters of WKWWRf.
