Time Critical Removal Action

**Radford High School Track and Football Field
Portion of Makalapa Crater Geographic Study Area
Oahu, Hawaii**

INTRODUCTION

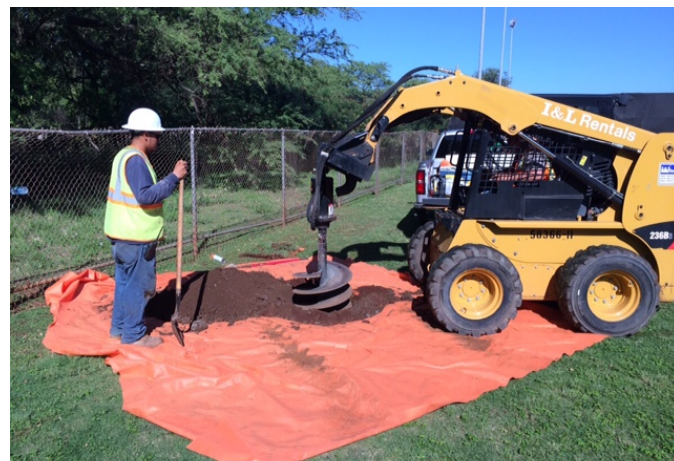
Photo 5: Drilling test pit borings at RHS baseball field

Site Assessment

The Navy is evaluating the current surface cover thickness at the RHS athletic complex and MES playground based on the assumption that subsurface debris may be similar to the type of debris encountered at the RHS track. The results of this assessment is being discussed with DOE, **Environmental Protection Agency Region 9 (EPA)** and the **State of Hawaii Department of Health (DOH)** to determine if additional actions are needed.

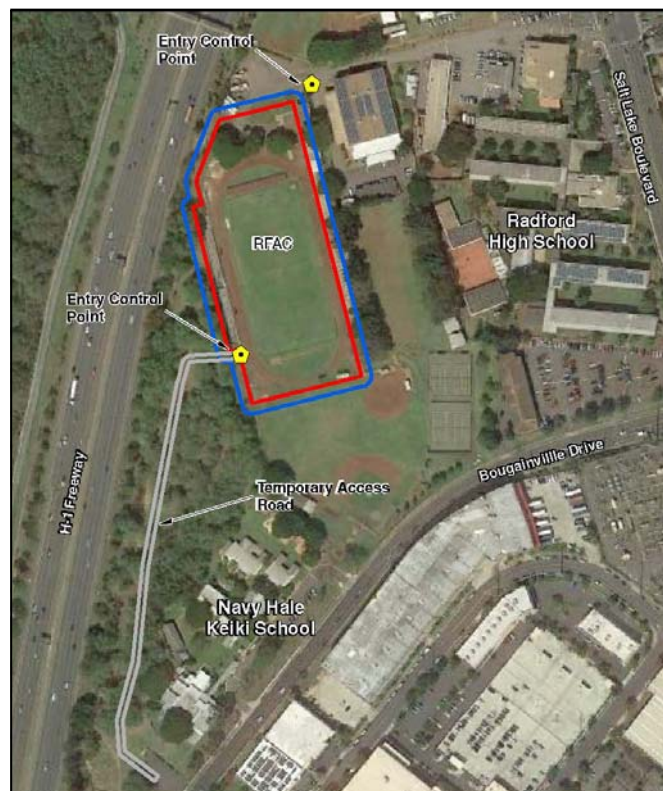
Figure 2: Radford High School TCRA location and Navy access road

Field and equipment mobilization was initiated on Aug. 25, 2014 and completed on Sept. 8, 2014. A temporary access road was built on Navy property via Bougainville Drive, to reduce truck traffic through the main RHS entrance off Salt Lake Boulevard (Figure 2).

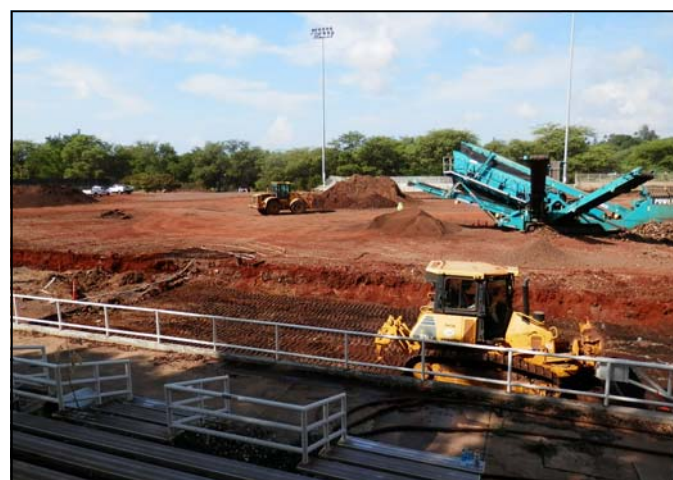
Photo 1: Excavation and mechanical screening at RHS track

Approximately 18,690 tons (14,370 cubic yards [CY]) of stockpiled and excavated soil and debris were screened for potential munitions related items from Sept. 8 to March 4, 2015. During the initial phase of the work (though Nov. 7, 2014), a mechanical screener was used to sift debris larger than 3/4-inches (largest size of an item with an explosive hazard) (Photo 1). All debris was inspected by certified UXO personnel to remove any suspected munitions related items. All munitions related items found during the TCRA were inspected and confirmed safe (no explosive hazard).

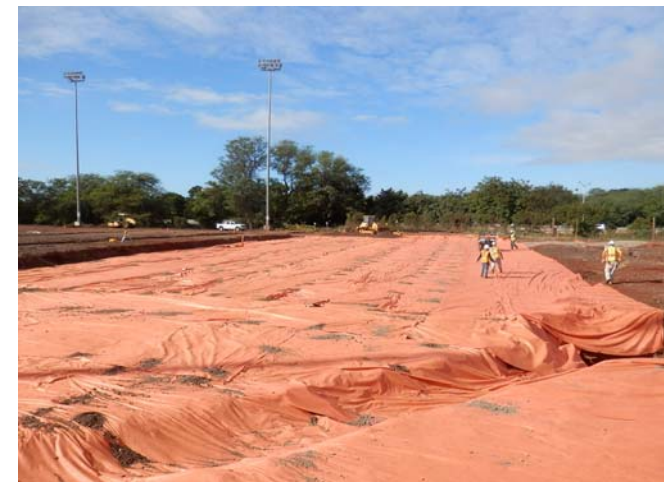
Photo 2: Geofabric liner installed prior to placing clean fill

Following excavation and debris screening, excavated areas of the track and football field were covered with an orange geotextile fabric liner prior to placement of 1 foot of compacted clean fill (Photos 2 & 3). The liner and fill placement and compaction was completed on March 6, 2015. This liner provides a visual indicator of the depth of contaminated soil and debris, for future construction and maintenance workers. The final elevations of the clean fill layer is at a depth that allows DOE to resume construction of the track safely, without excavation of contaminated soil or debris.

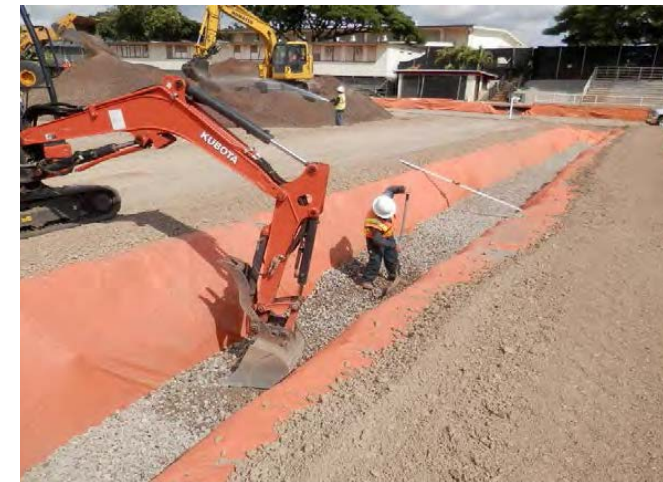
Photo 3: Select borrow (clean fill) placed on top of geofabric liner

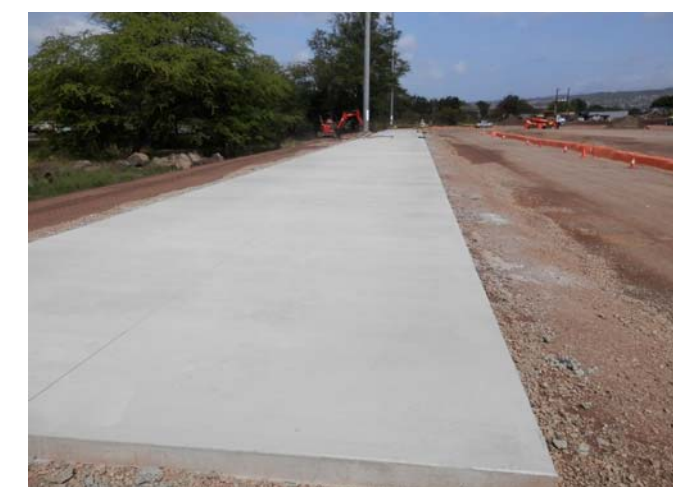
Photo 4: Slope stabilization and concrete cap

Surface and shallow subsurface samples for the area beneath and behind the bleachers were similar to contamination found at the track. The visitor bleachers were in poor condition. Therefore, the Navy consulted with DOE to determine the long-term use of the area. DOE determined that the existing bleachers required demolition and replacement. To eliminate exposure to the contaminated soil during future renovations, the

Navy demolished the bleachers, stabilized the existing slope, and placed a concrete cap to remove exposure to the contaminated soil (Photo 4).
